**EXXON** COMPANY, U.S.A.

MARINE DEPARTMENT

December 5, 1978

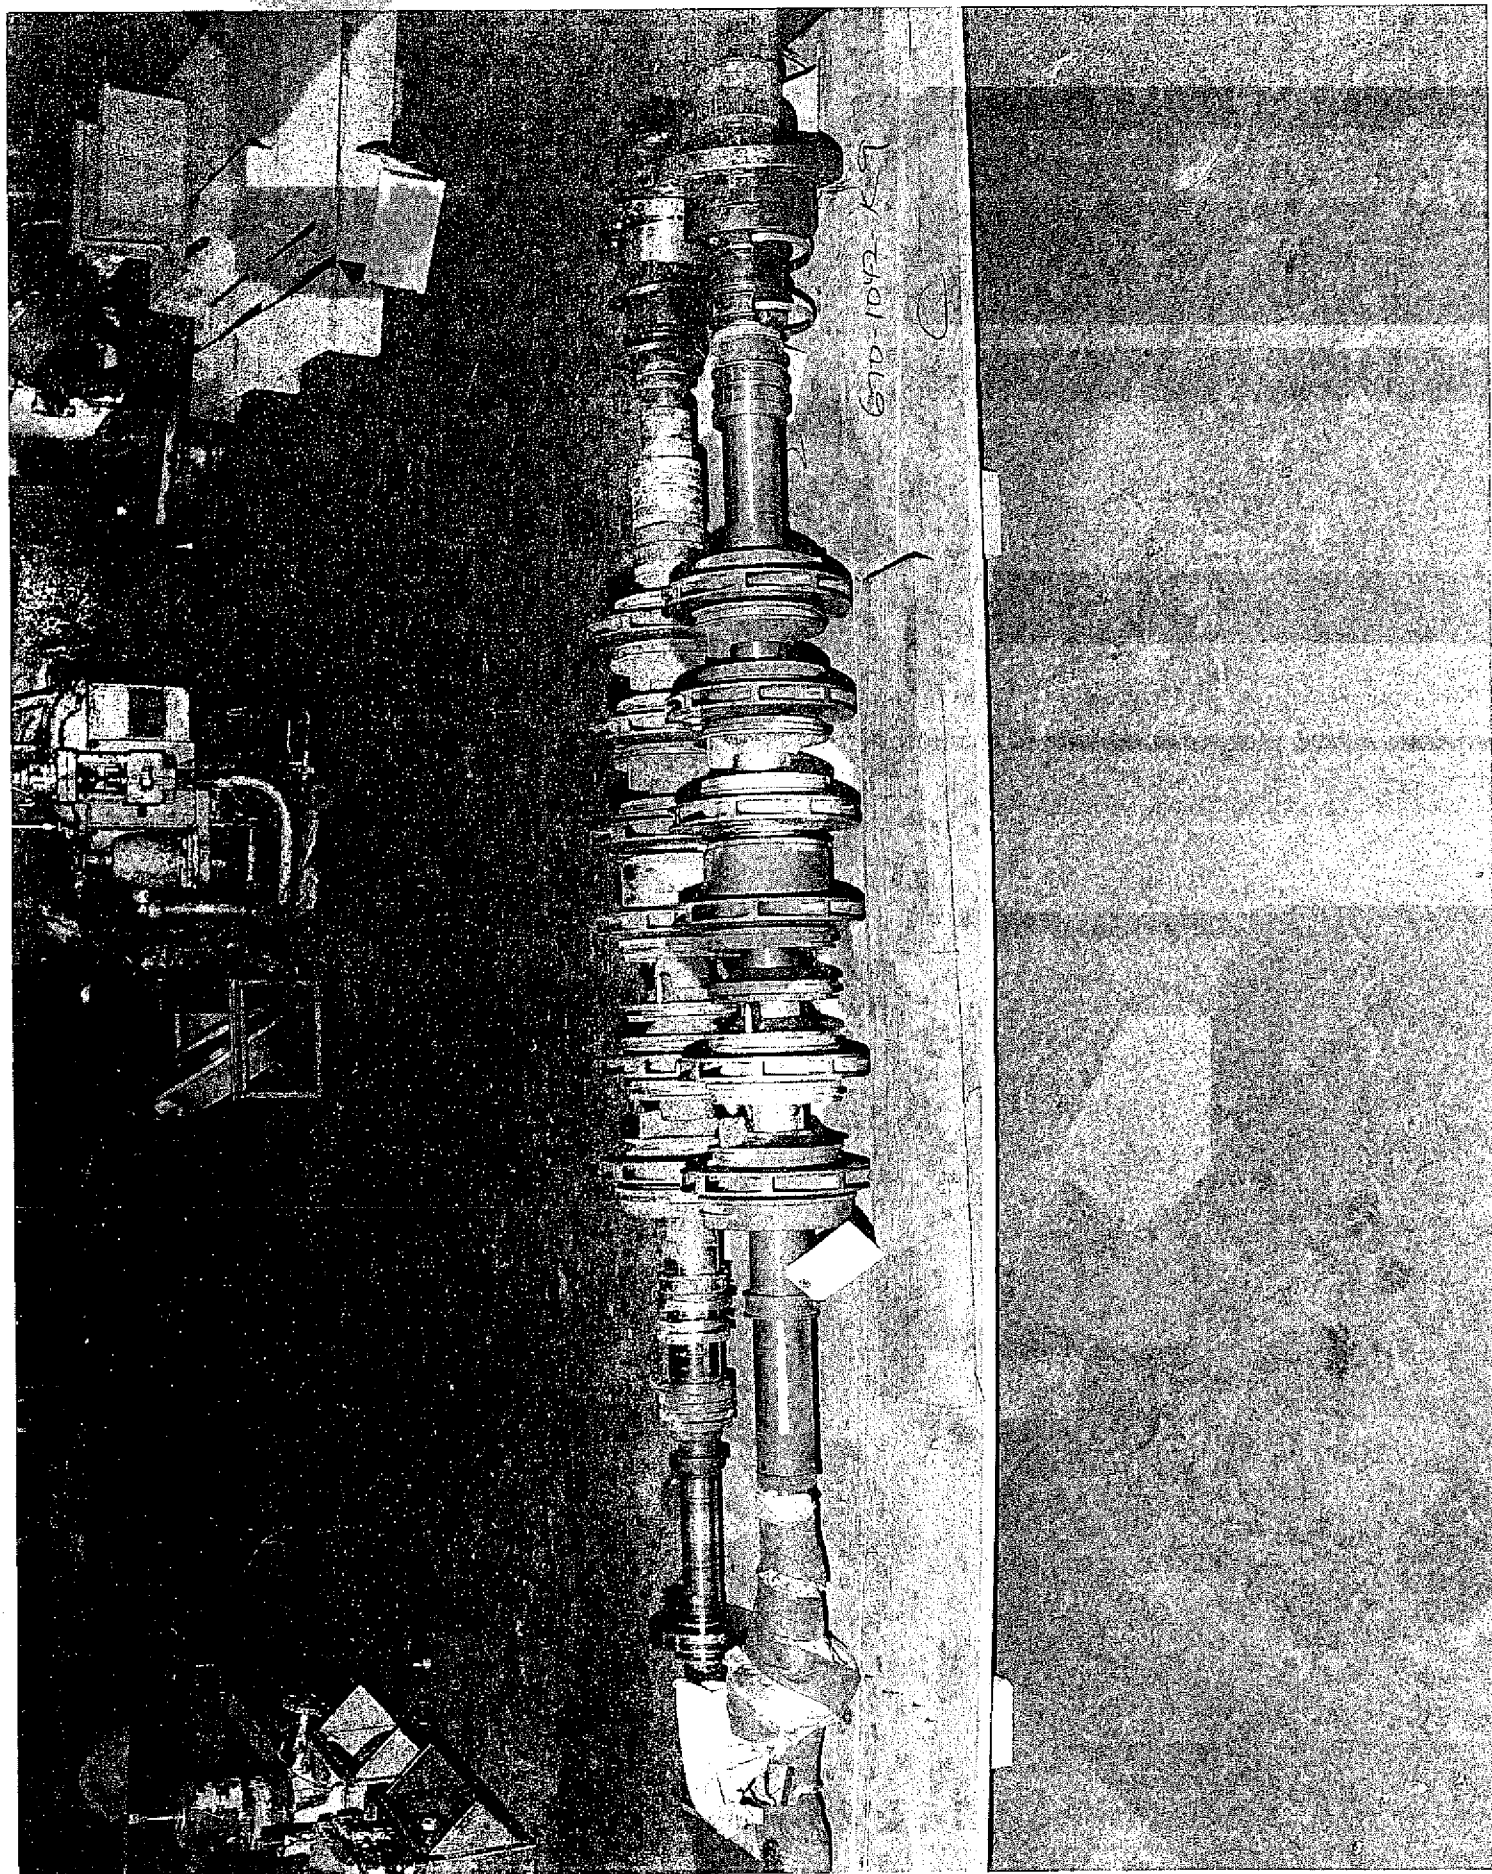
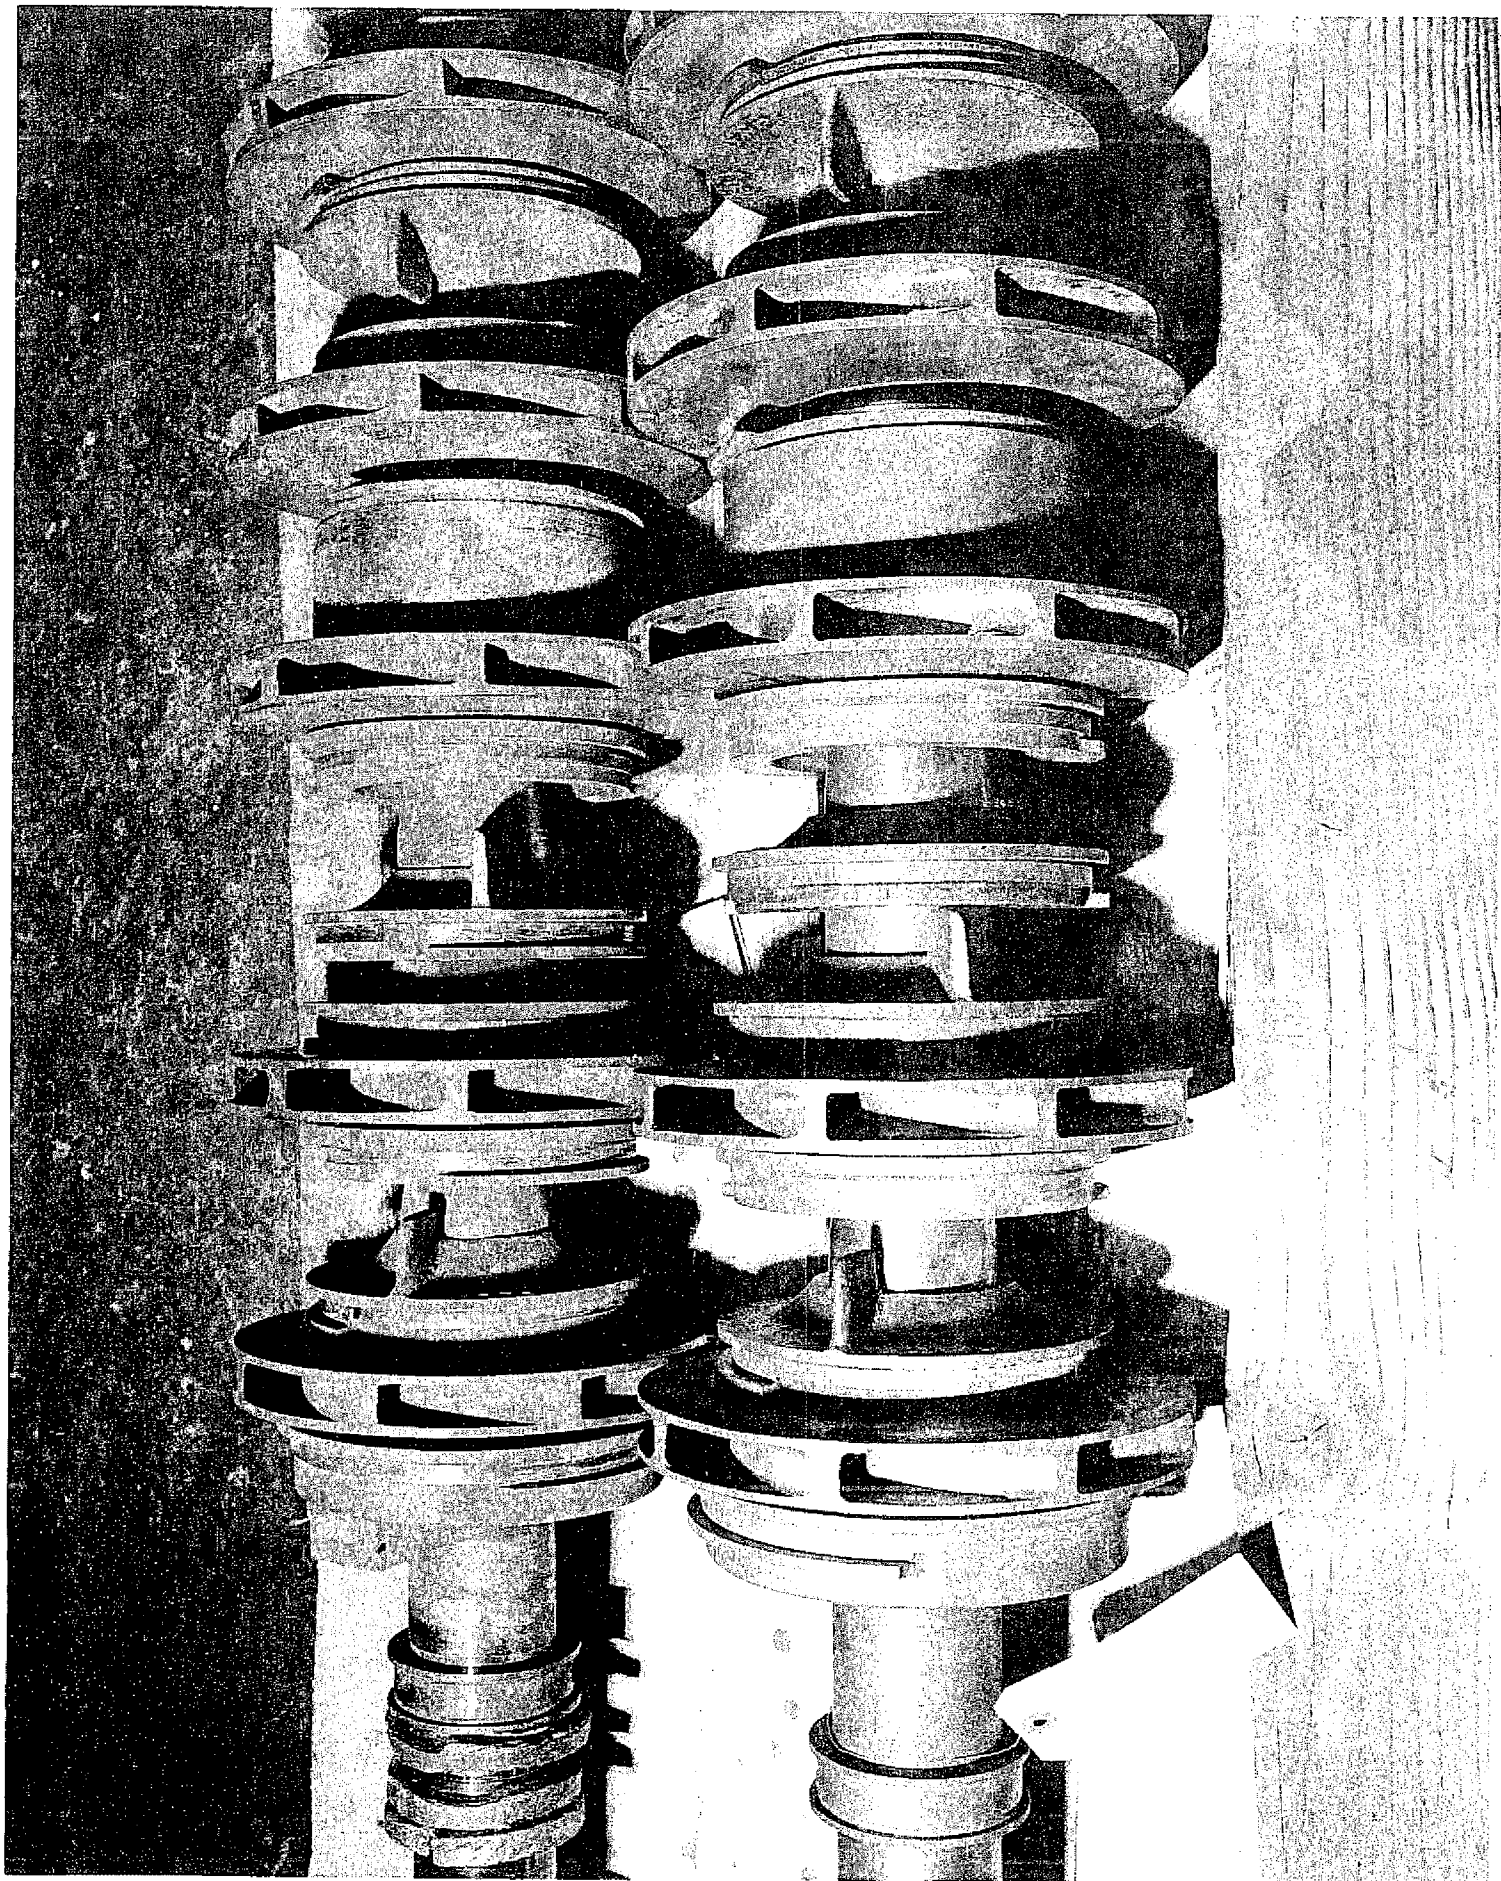
Enclosed, you will find photographs I have taken at Newport News Shipyard showing the old and overhauled rotating elements of the Warren feed pump aboard the EXXON WASHINGTON. As you can see, the pressure reducing ring PC.13 and channel ring PC. 17 are assembled in the wrong sequence, and in no way would the element fit down into the casing. I have marked the tangs in white chalk, so they would stand out. I had the shipyard disassemble the two end impellers and reverse the sequence with the Warren feed pump service engineer in attendance.
