## Clean Water Act Section 404: Site Visit/Case Development

| Site Name | Town of Marlborough - Highway Department | | | | |

# EPA CWA 404 Inspection Photolog

Town of Marlborough Highway Dept  
1650 Route 9W & 7 Woodcrest Lane  
Milton, NY

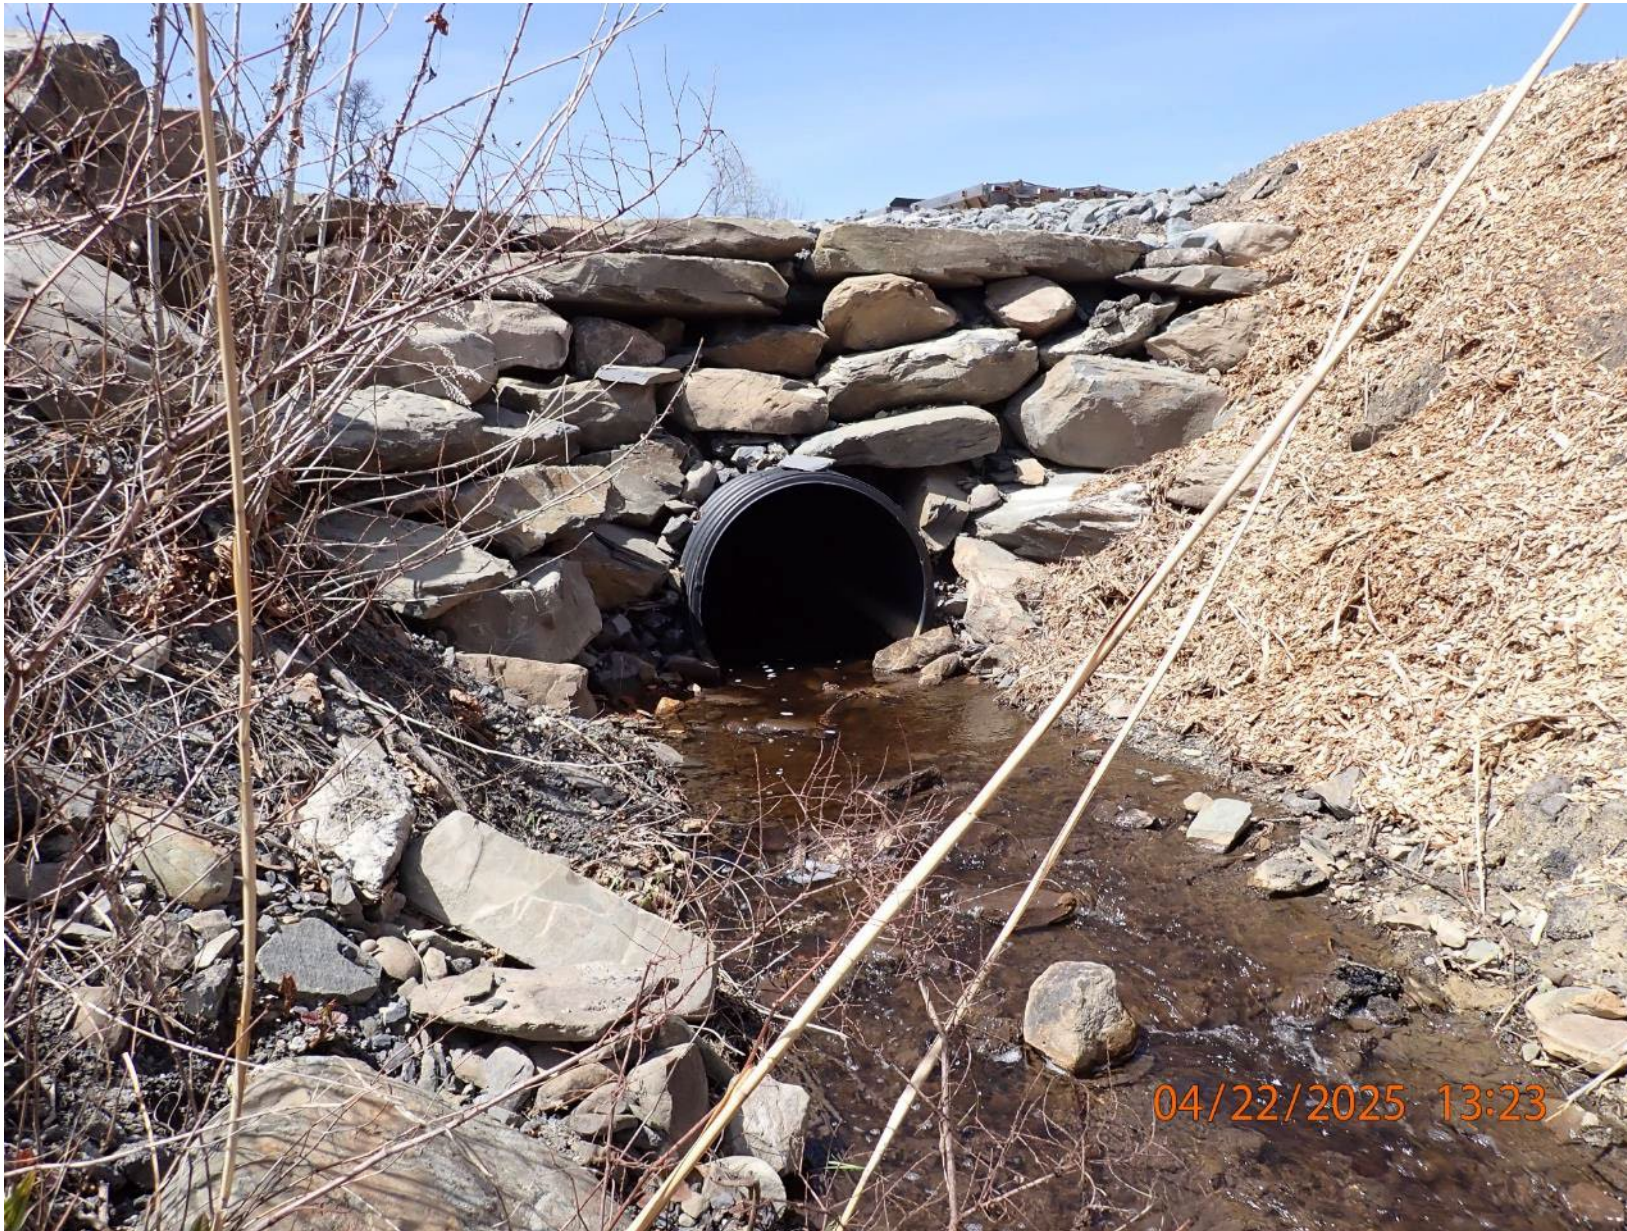
**Date:** 4/22/2025  
**Time:** 1:23 PM  
**Photographer:** S. Andreescu  
**Photo ID:** 1 – P4220799

Downstream end of 48"  
corrugated plastic culvert under  
filled portion of property

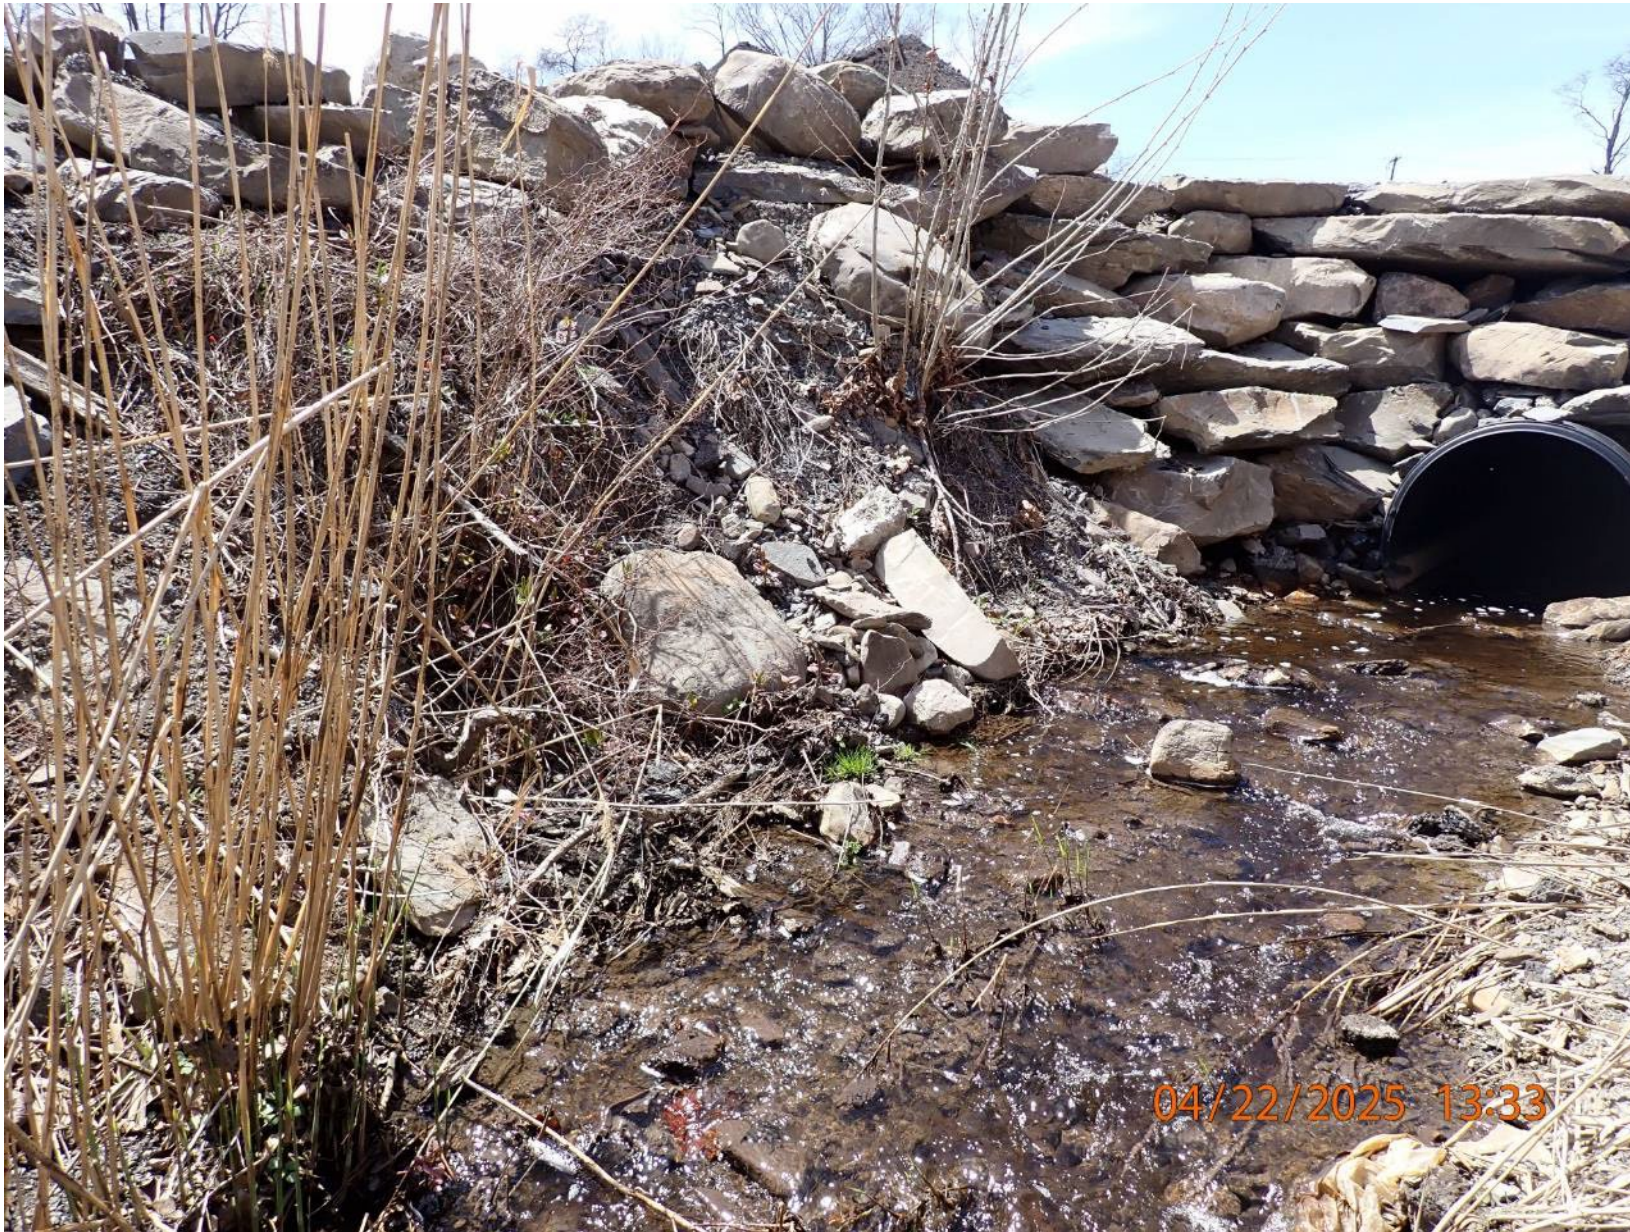
**Date:** 4/22/2025  
**Time:** 1:33 PM  
**Photographer:** S. Andreescu  
**Photo ID:** 2 – P4220800

Right descending bank of  
stream; downstream of culvert

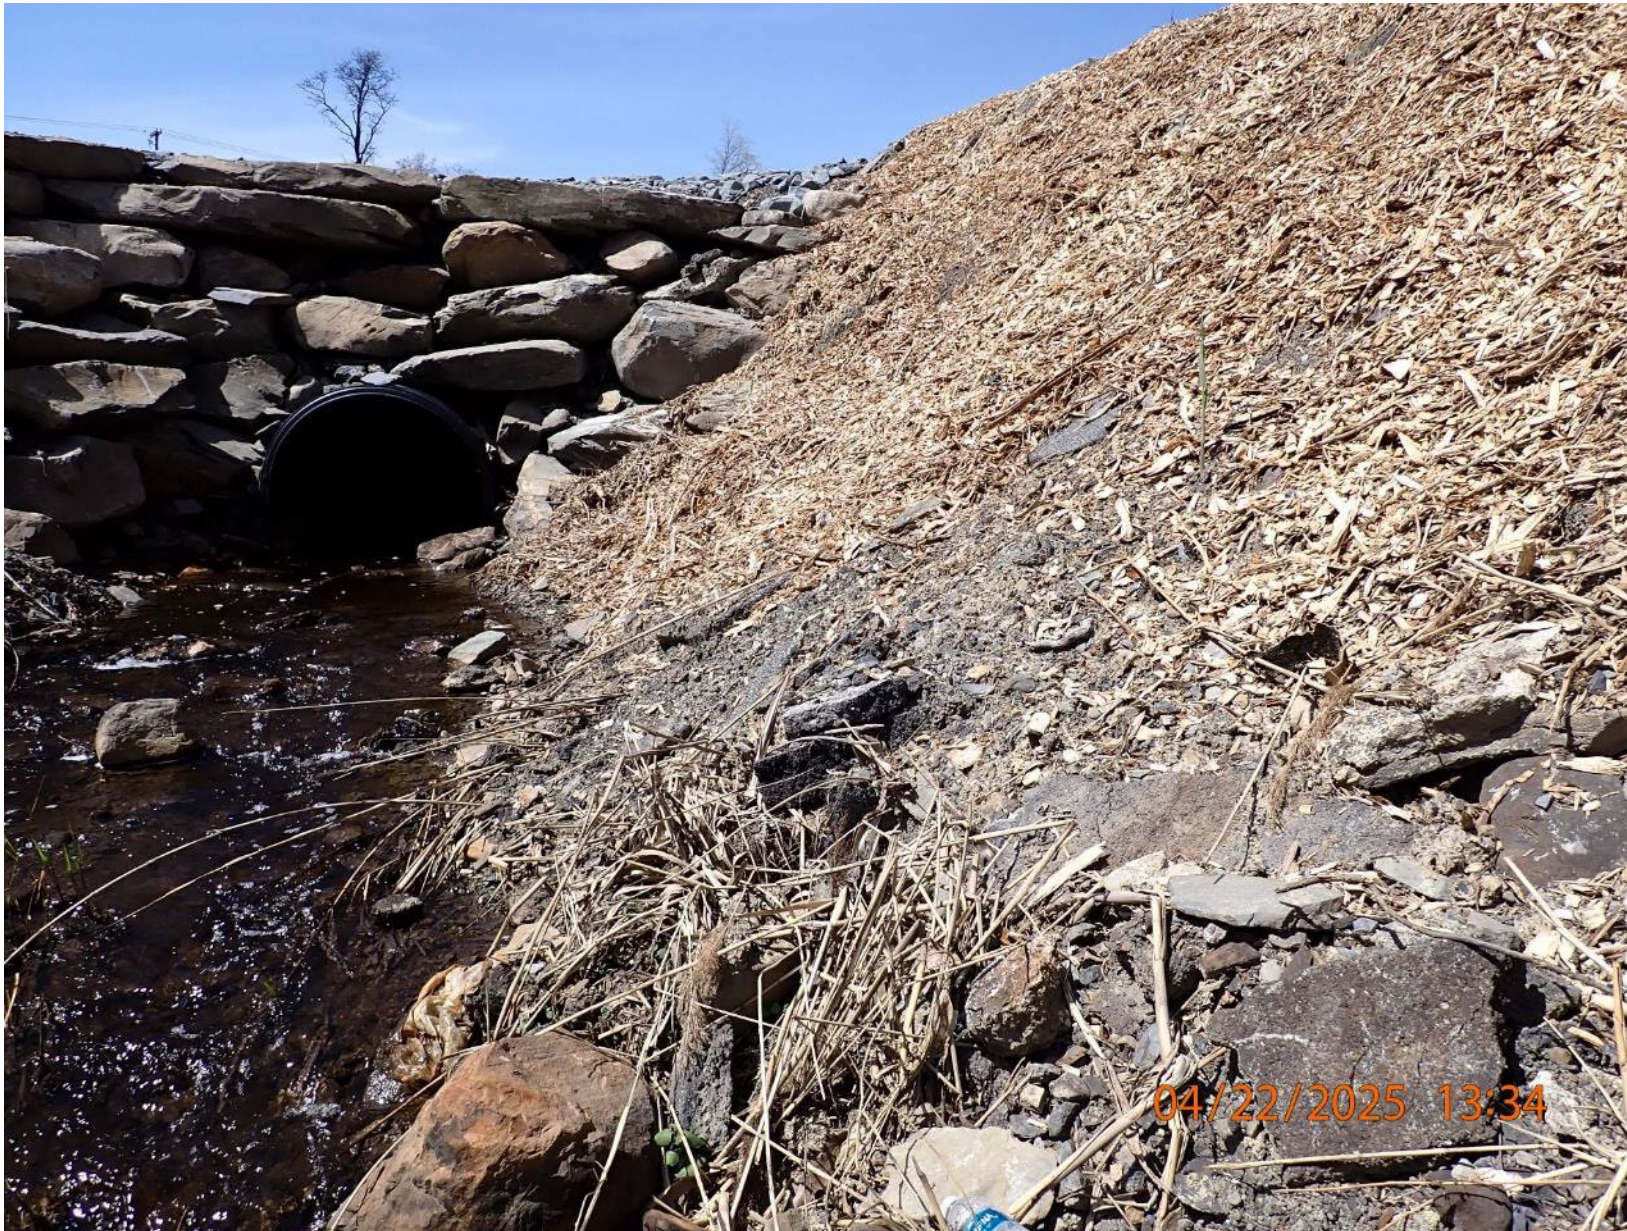
**Date:** 4/22/2025  
**Time:** 1:34 PM  
**Photographer:** S. Andreescu  
**Photo ID:** 3 – P4220801

Left descending bank of stream;  
downstream of culvert

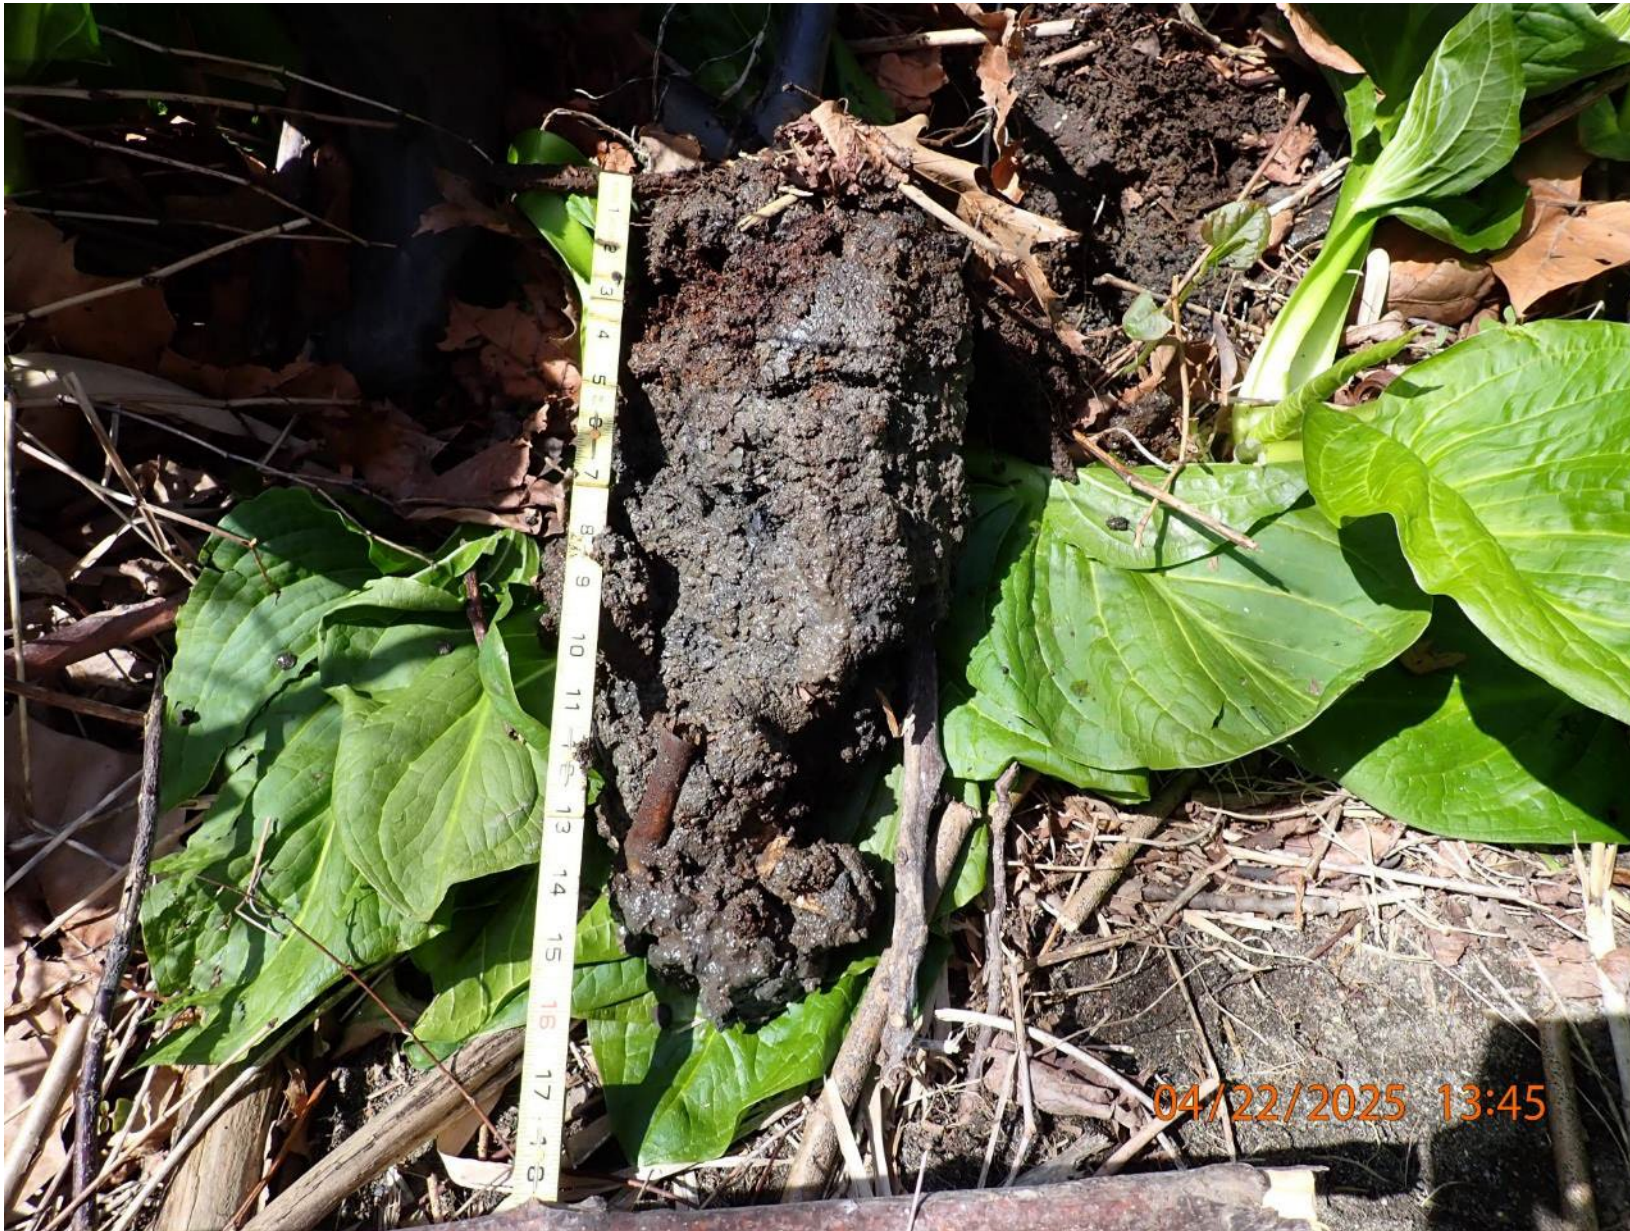
**Date:** 4/22/2025  
**Time:** 1:45 PM  
**Photographer:** S. Andreescu  
**Photo ID:** 4 – P4220802

**Description:**  
SS1 soil profile

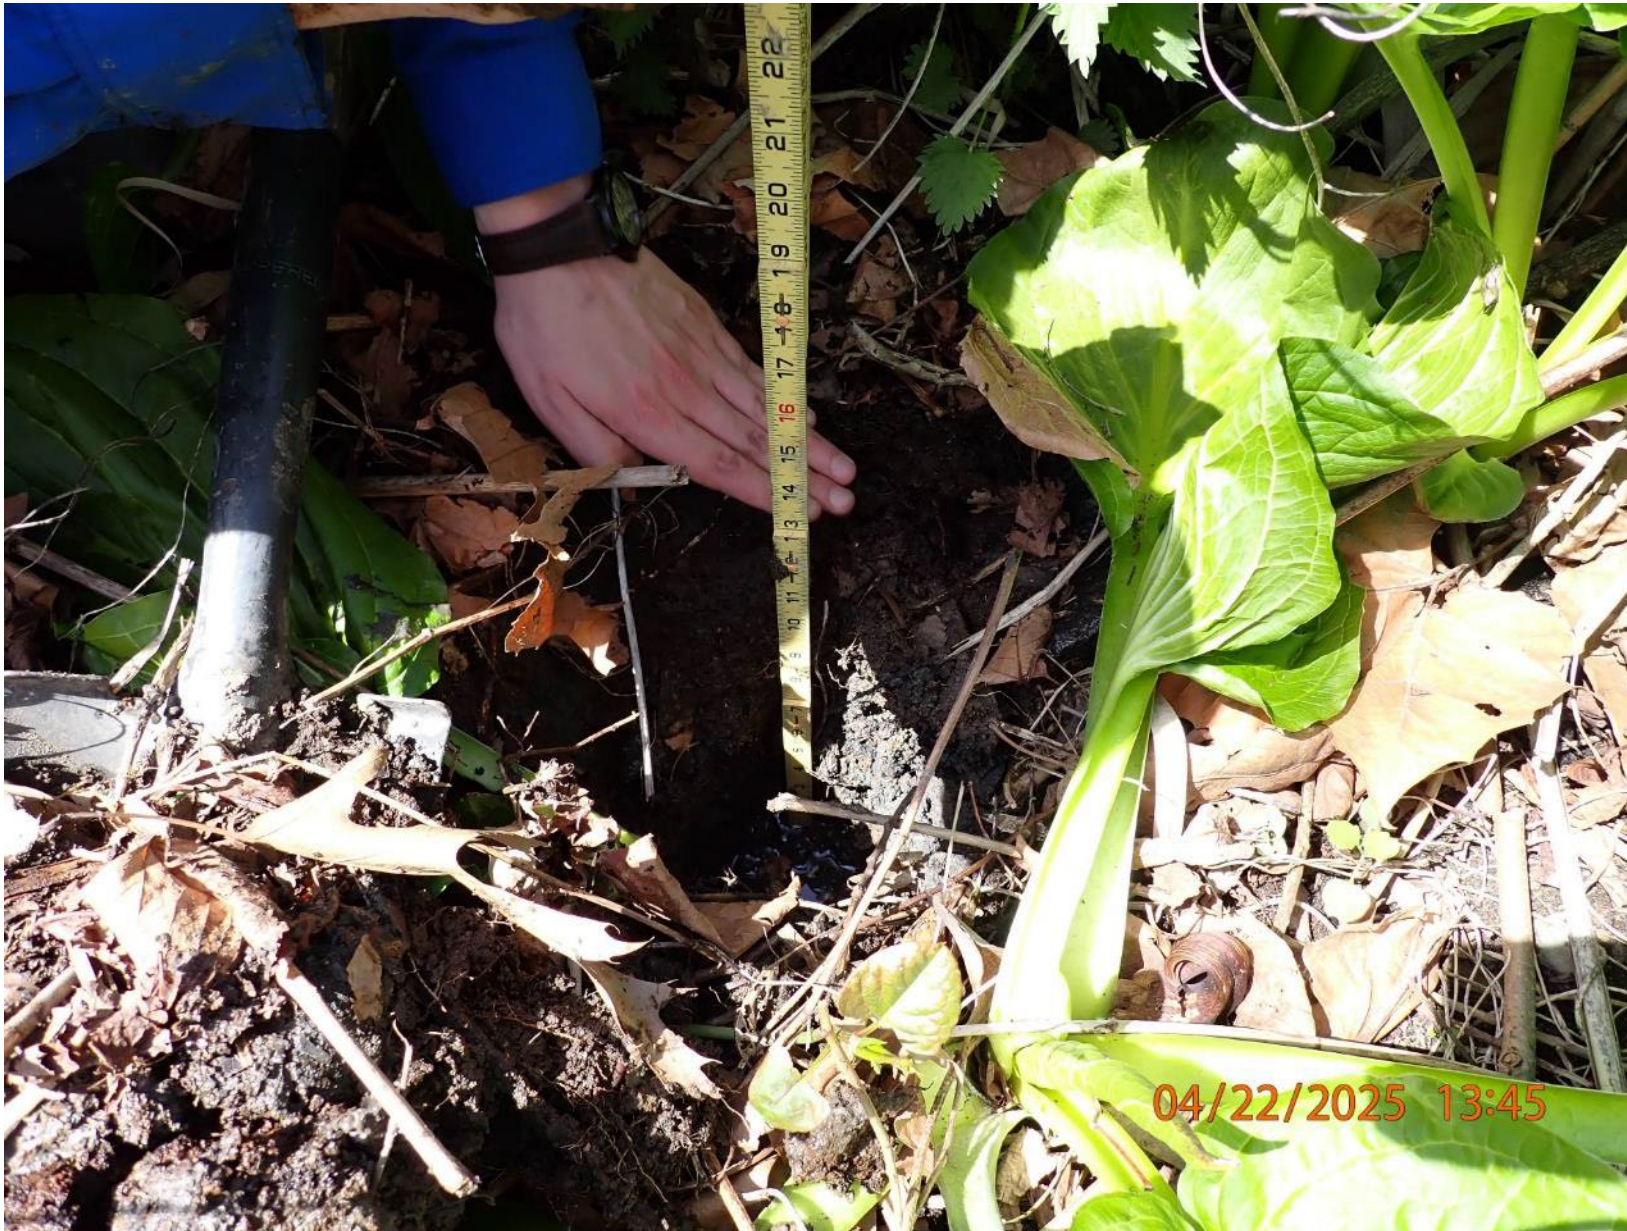
**Date:** 4/22/2025  
**Time:** 1:45 PM  
**Photographer:** S. Andreescu  
**Photo ID:** 5 – P4220803

SS1 soil pit water table at 11"  
below ground surface

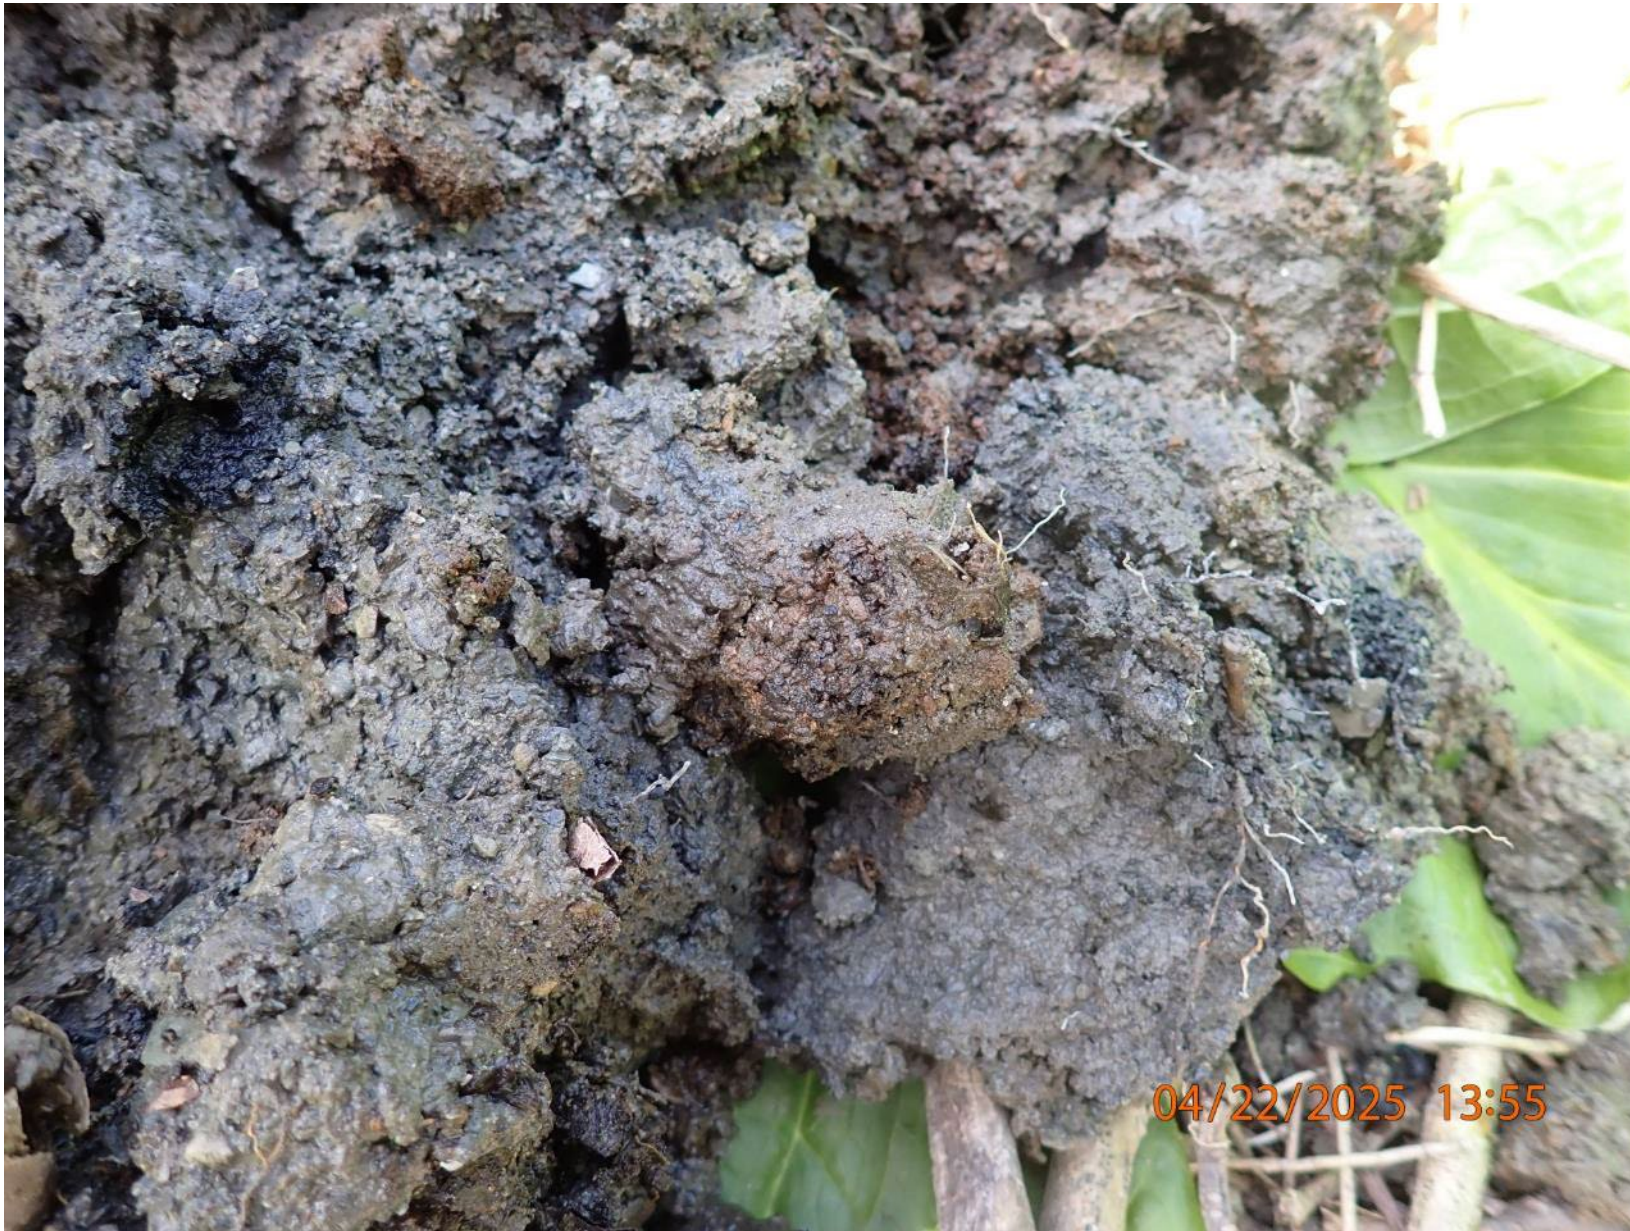
**Date:** 4/22/2025  
**Time:** 1:55 PM  
**Photographer:** S. Andreescu  
**Photo ID:** 6 – P4220804

Redoximorphic features in soil profile of SS1 soil sample

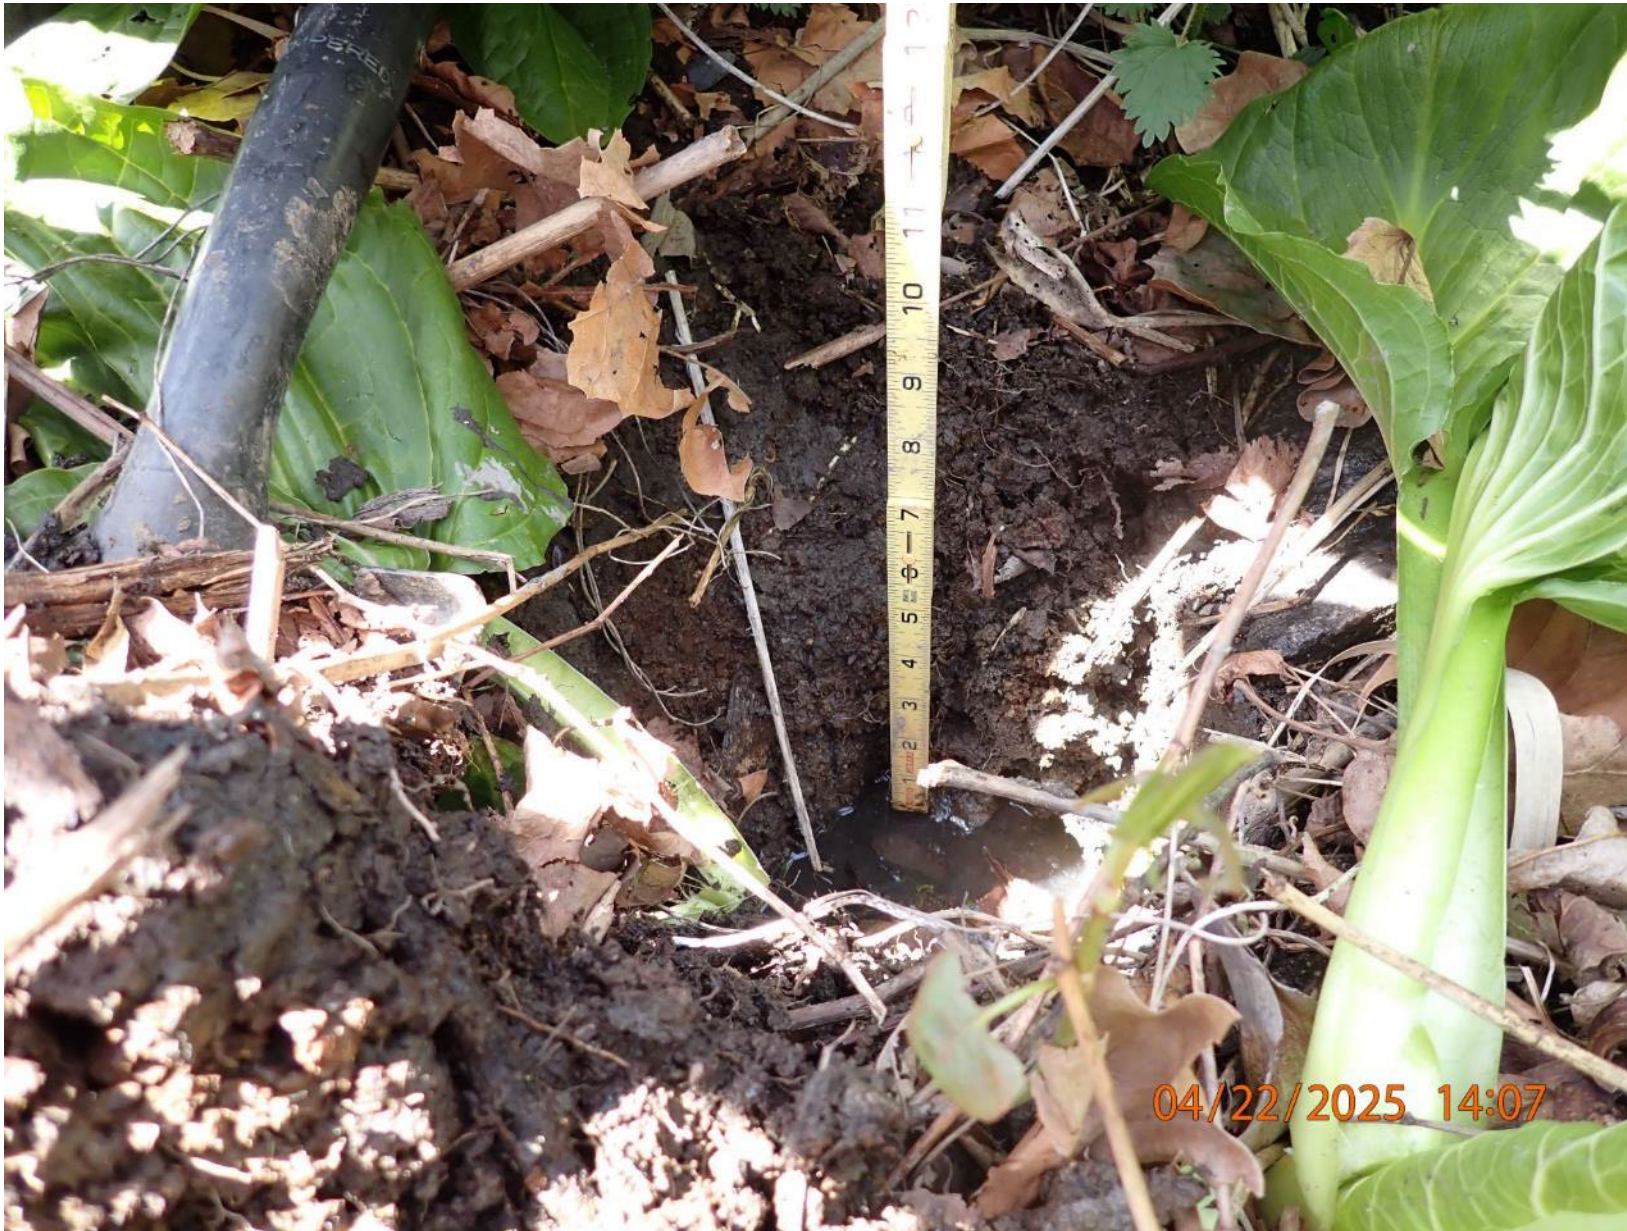
**Date:** 4/22/2025  
**Time:** 2:07 PM  
**Photographer:** S. Andreescu  
**Photo ID:** 7 – P4220805

SS1 soil pit water table at 7"  
below ground surface. Water  
table had risen over time.

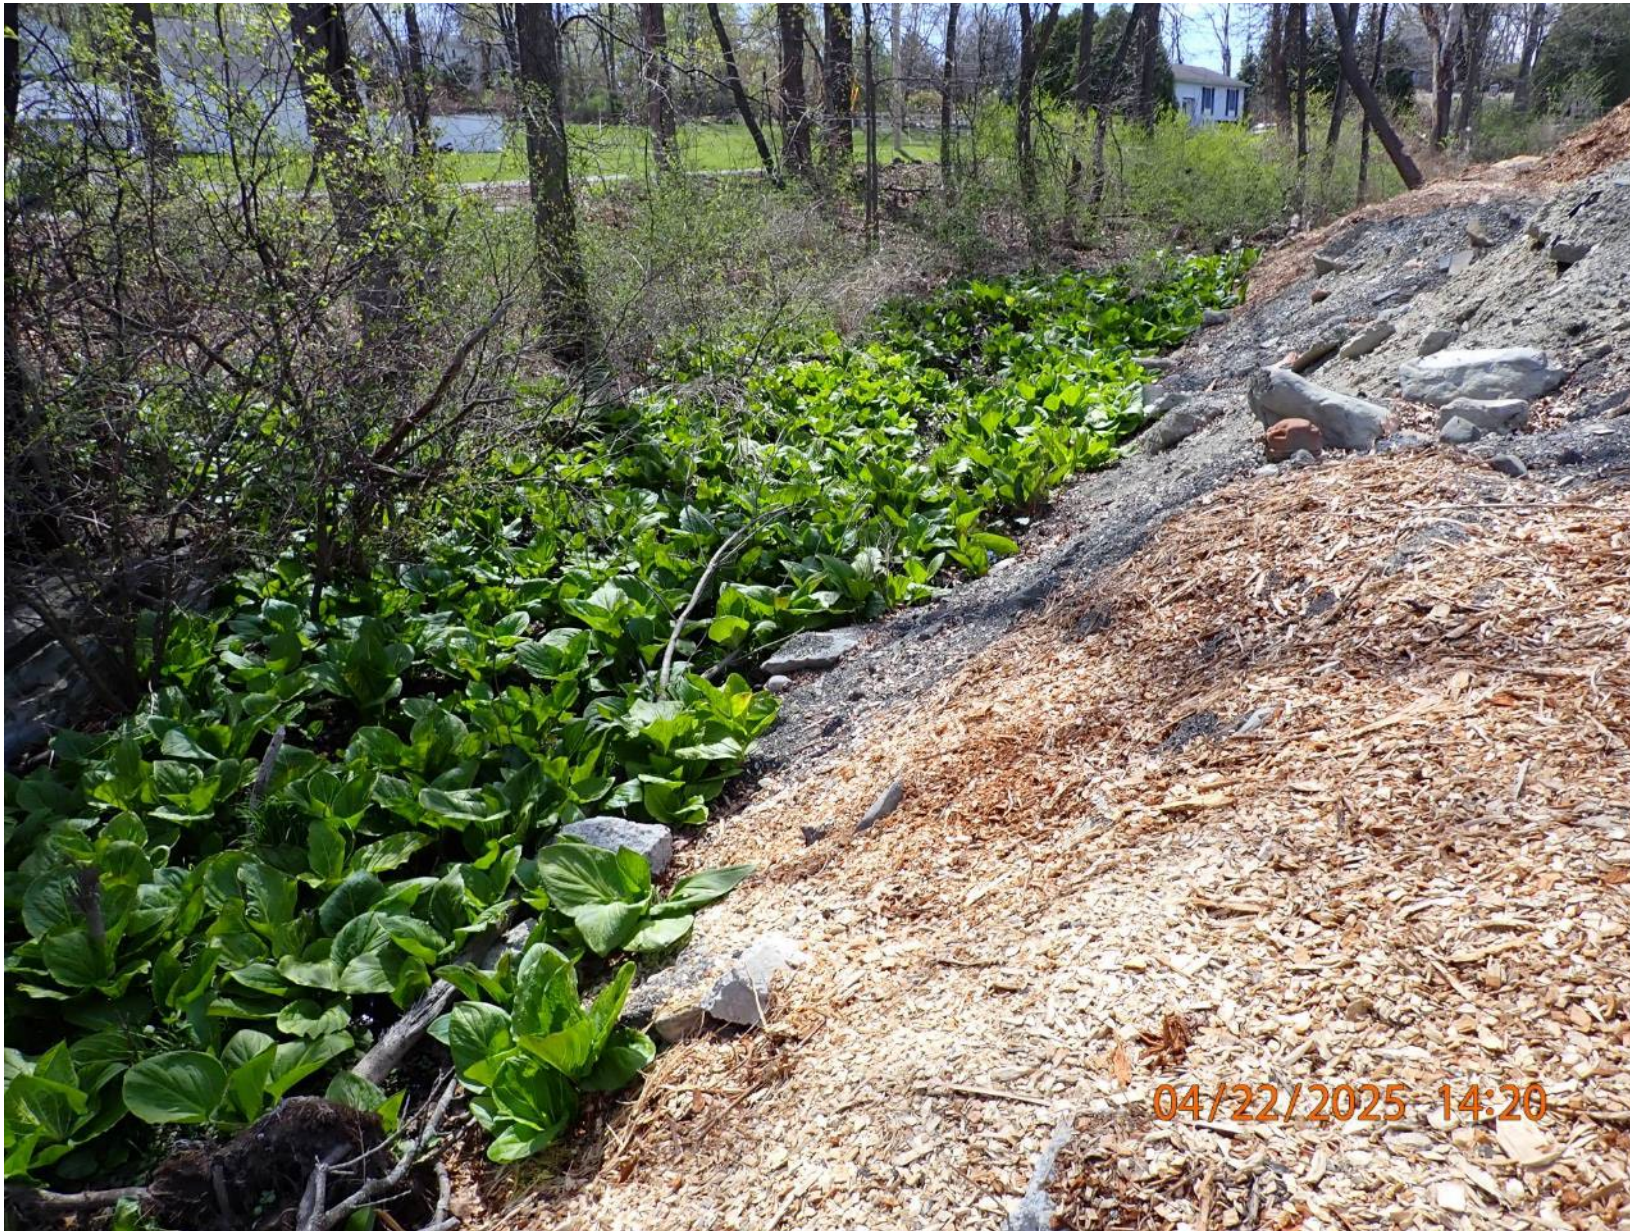
**Date:** 4/22/2025  
**Time:** 2:20 PM  
**Photographer:** S. Andreescu  
**Photo ID:** 8 – P4220806

**Description:**  
Wetland adjacent to fill material
