## Clean Water Act Section 404: Site Visit/Case Development

| Site Name | Town of Marlborough - Highway Department | | | | |

# EPA CWA 404 Inspection Photolog

Town of Marlborough Highway Dept  
1650 Route 9W & 7 Woodcrest Lane  
Milton, NY

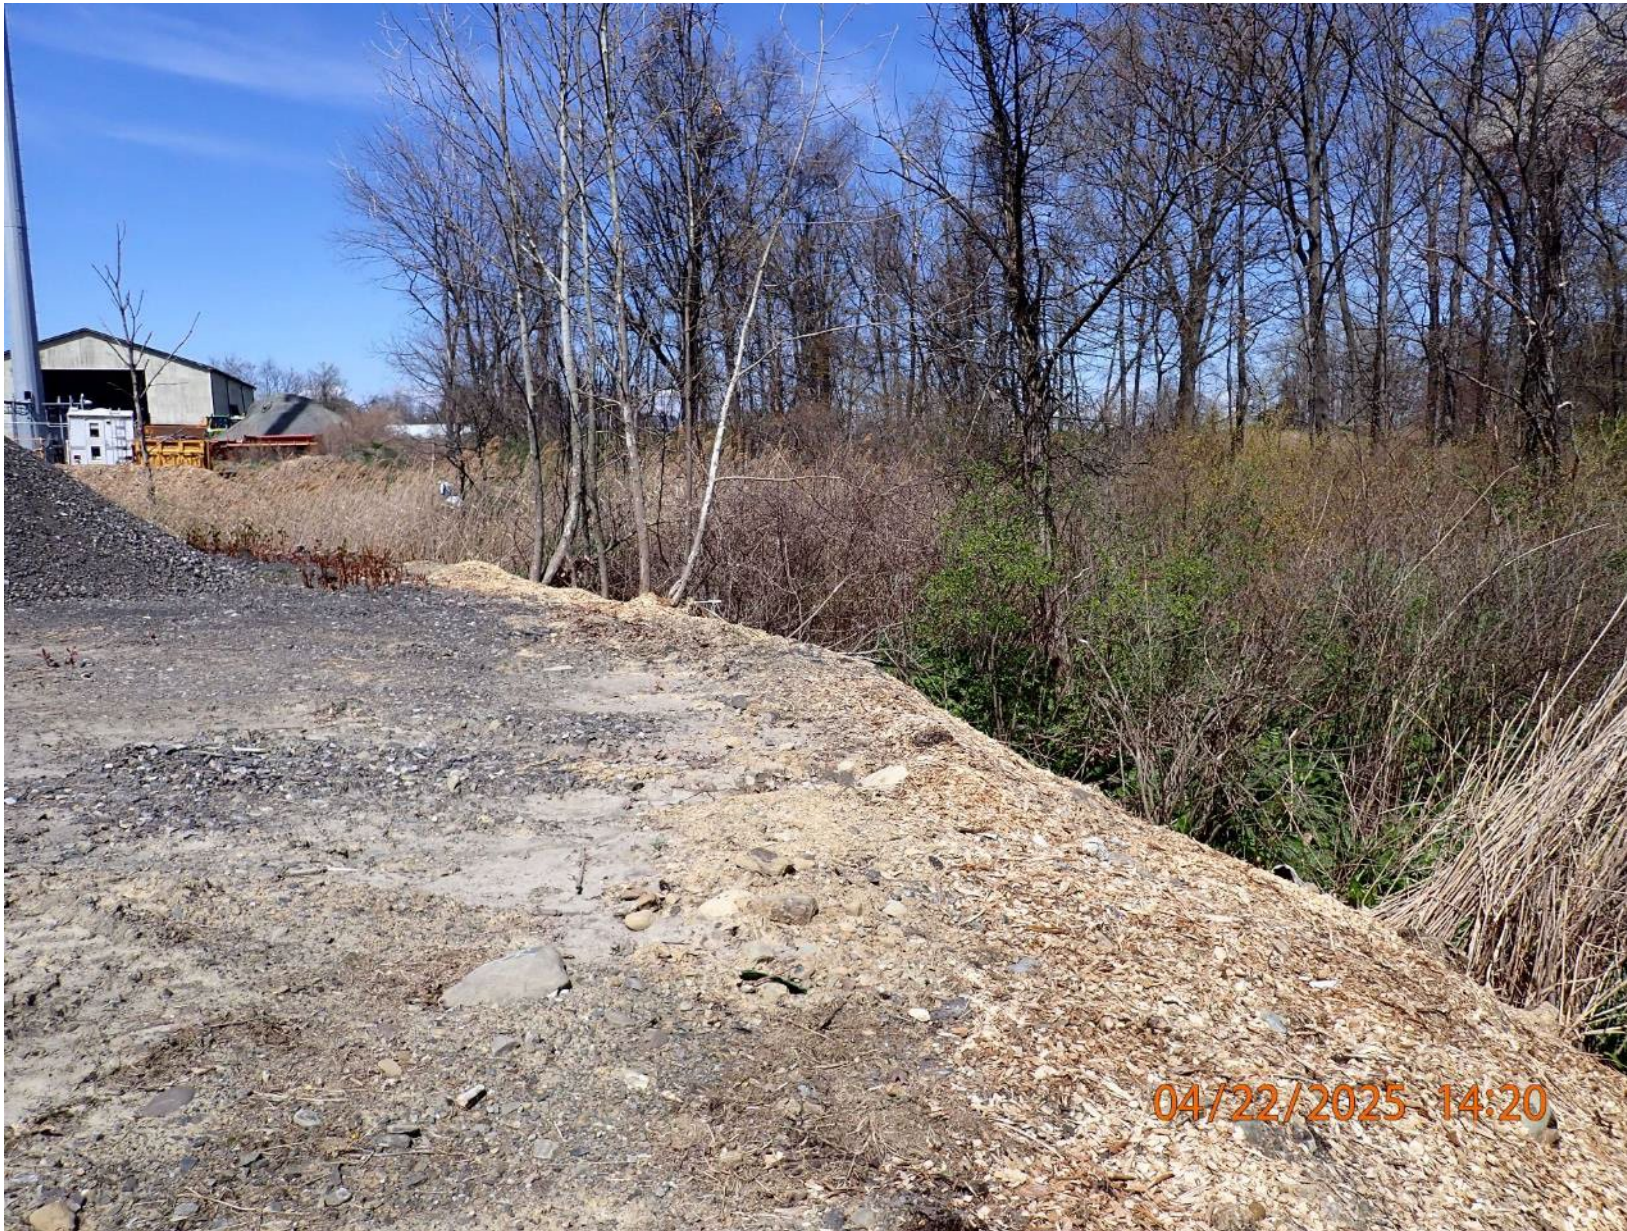
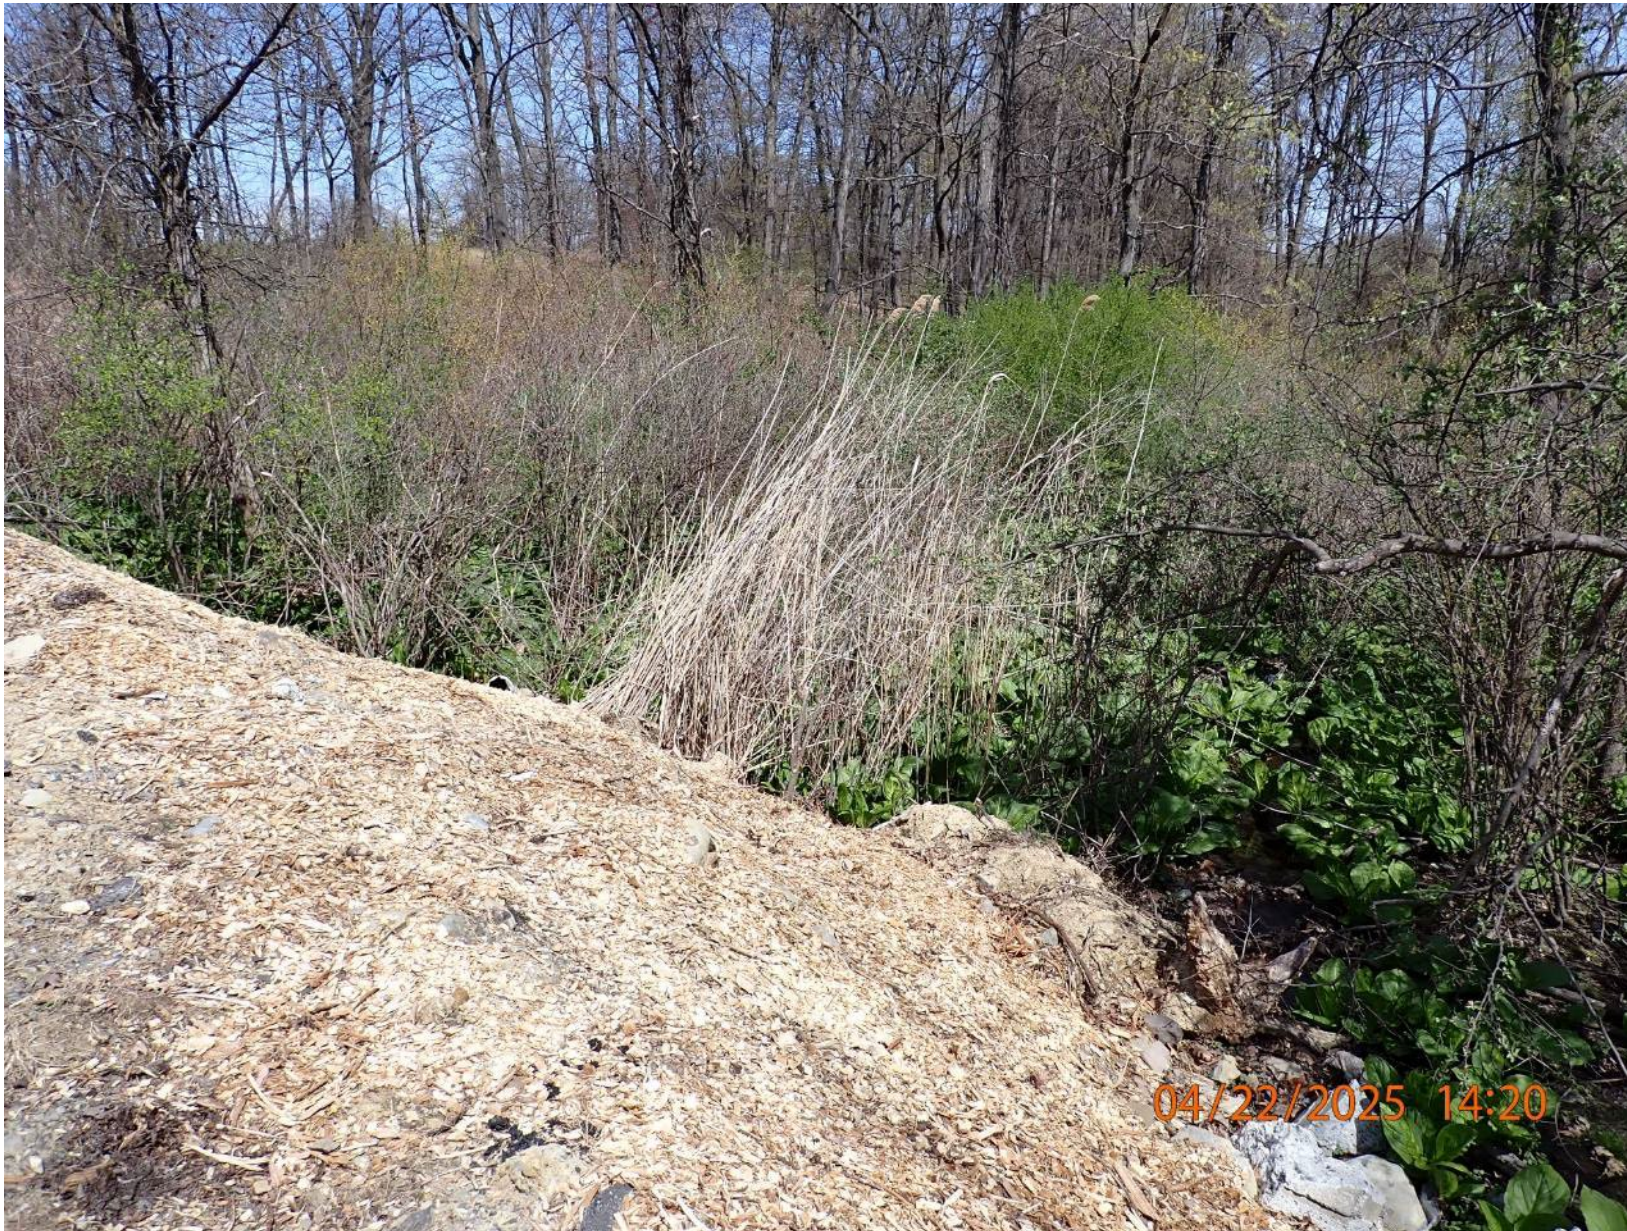
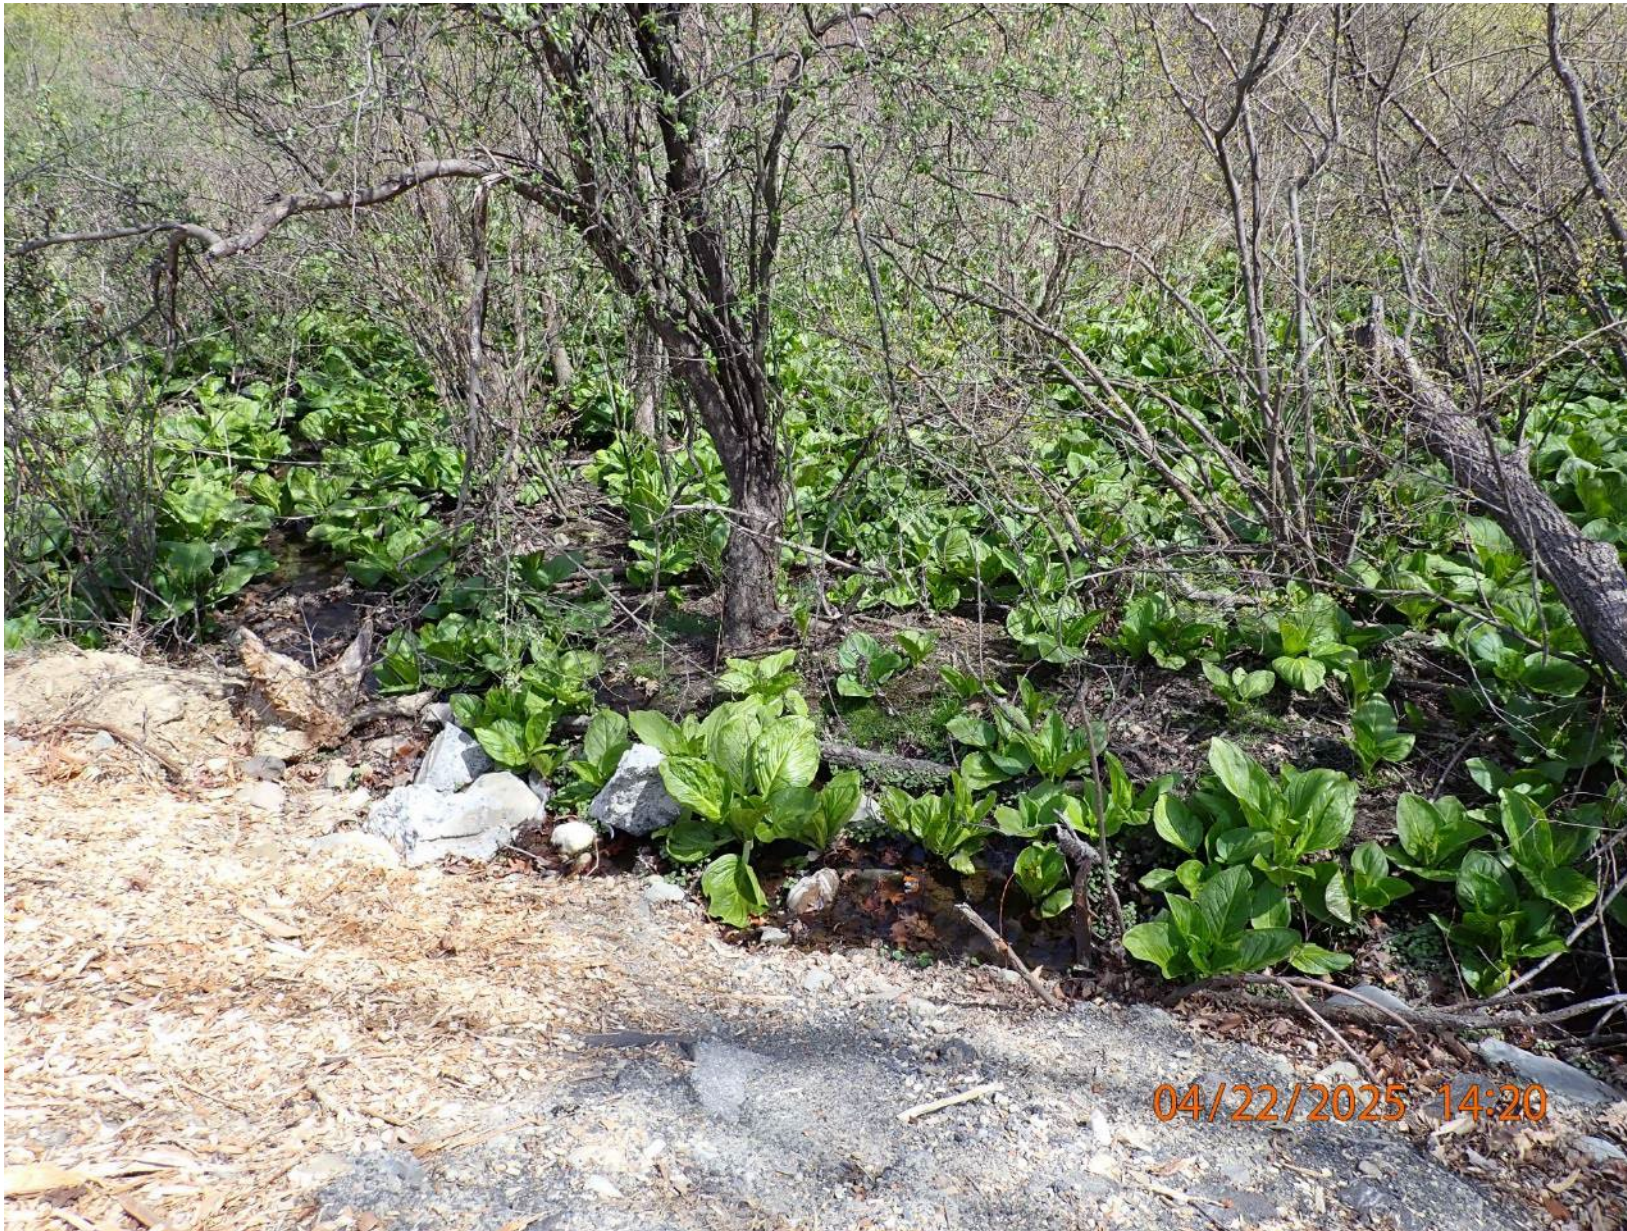
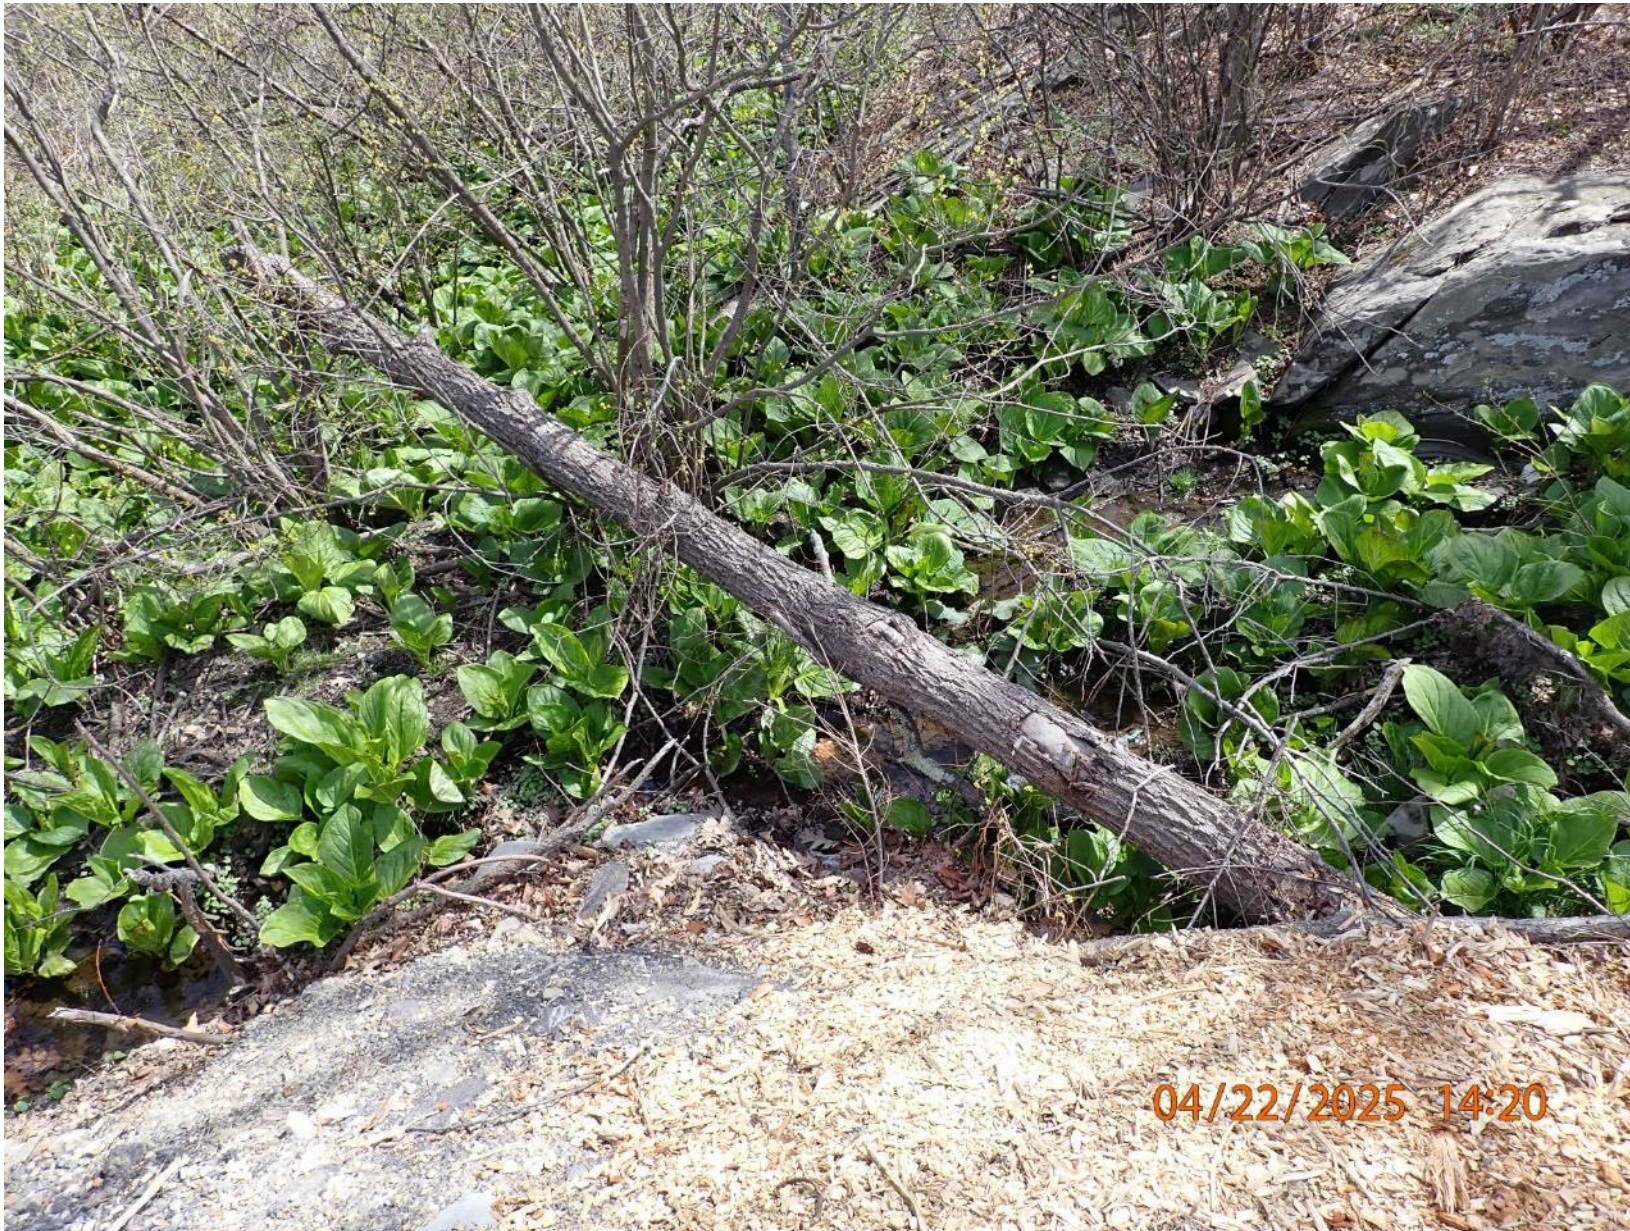
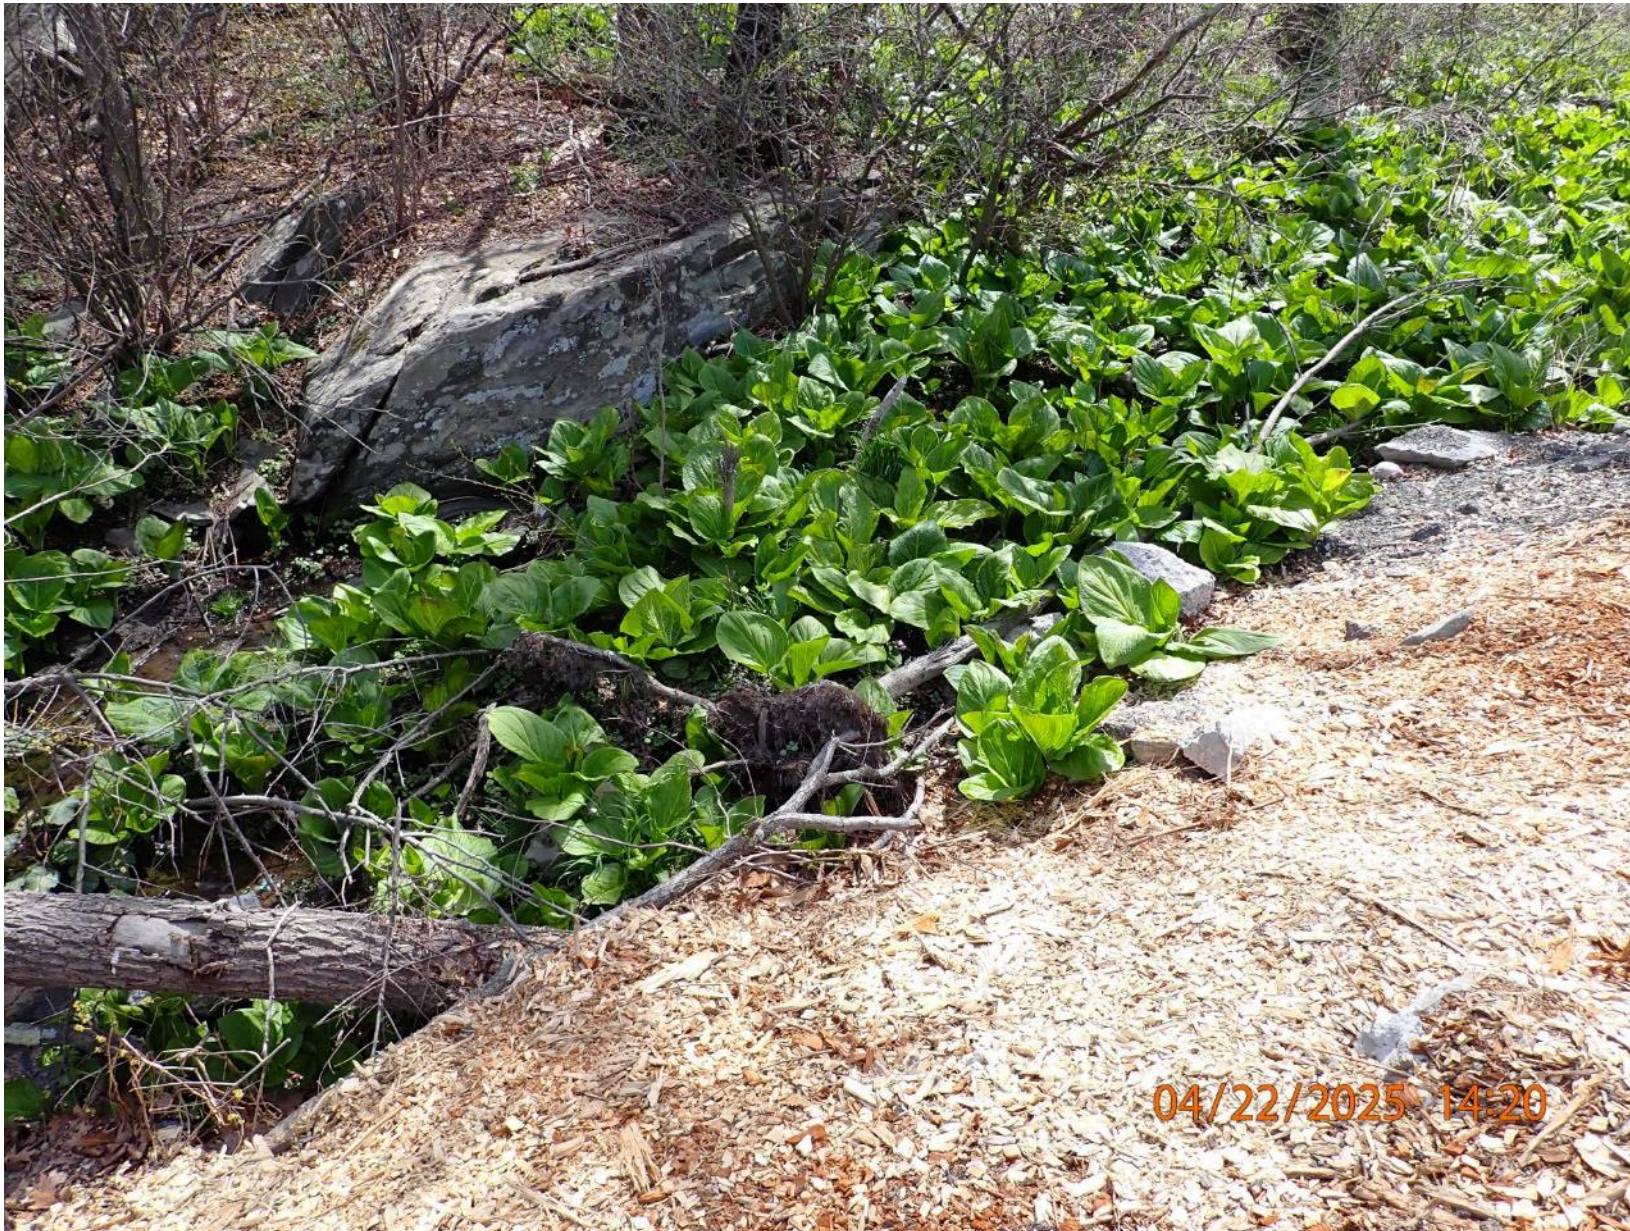
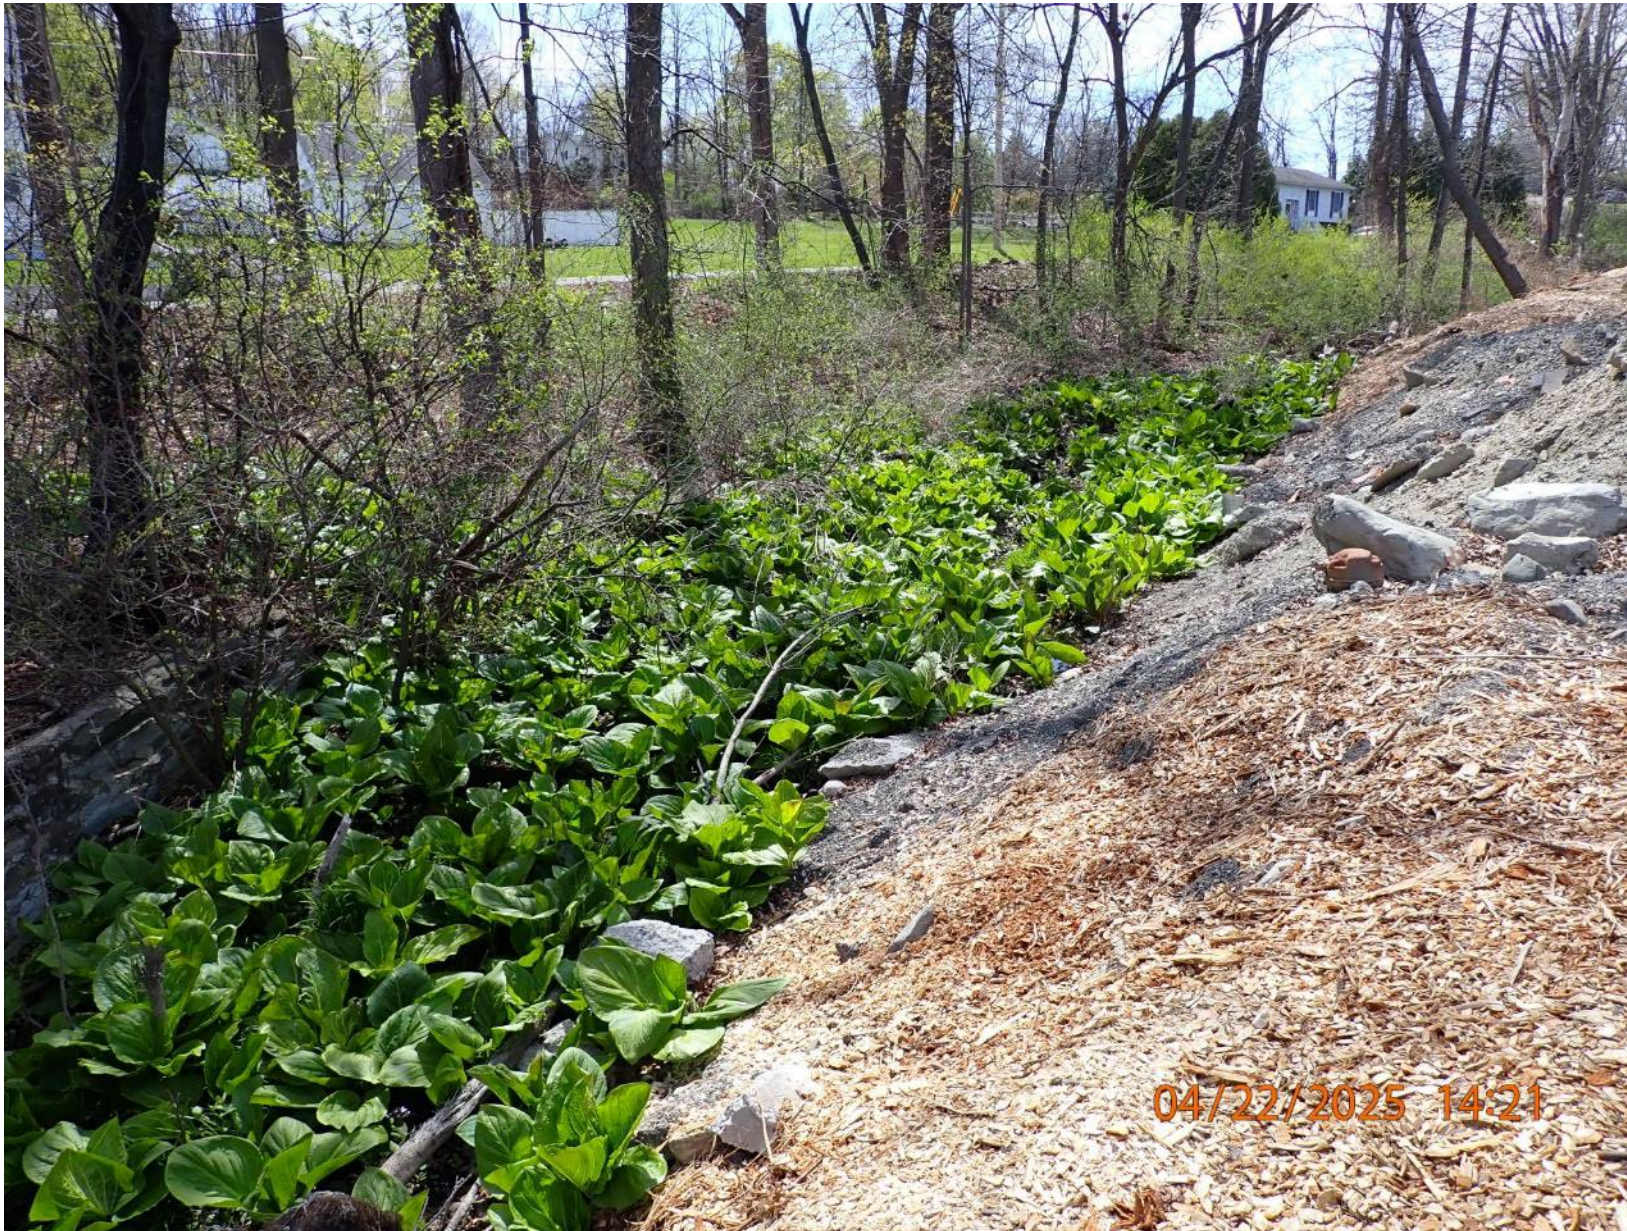
(1/6) Panorama of fill material  
adjacent to wetland

(2/6) Panorama of fill material  
adjacent to wetland

(3/6) Panorama of fill material  
adjacent to wetland

(4/6) Panorama of fill material  
adjacent to wetland

(5/6) Panorama of fill material  
adjacent to wetland

(6/6) Panorama of fill material  
adjacent to wetland

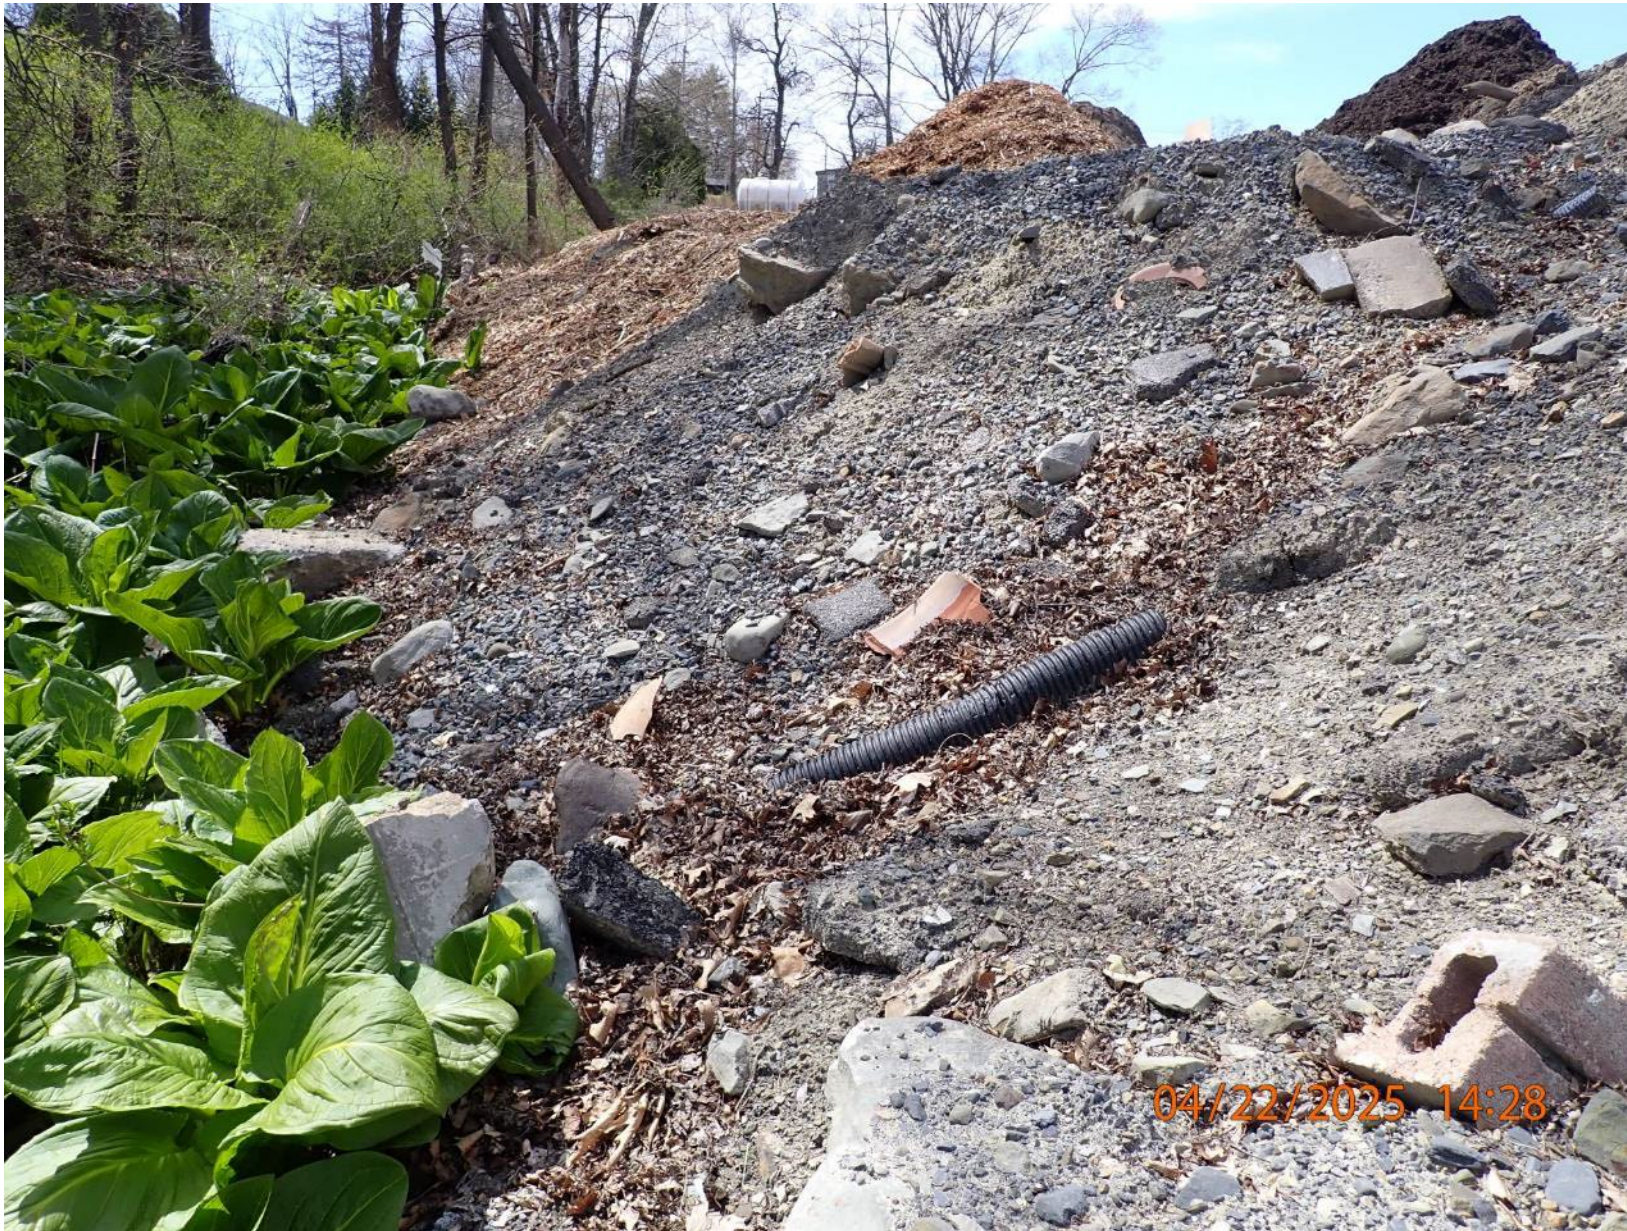
**Date:** 4/22/2025  
**Time:** 2:28 PM  
**Photographer:** S. Andreescu  
**Photo ID:** 15 – P4220813

Fill material – pipe, ceramic, cinderblock, cement, gravel, wood chips, dirt, rock, asphalt
