## Clean Water Act Section 404: Site Visit/Case Development

| Site Name | Town of Marlborough - Highway Department | | | | |

# EPA CWA 404 Inspection Photolog

Town of Marlborough Highway Dept  
1650 Route 9W & 7 Woodcrest Lane  
Milton, NY

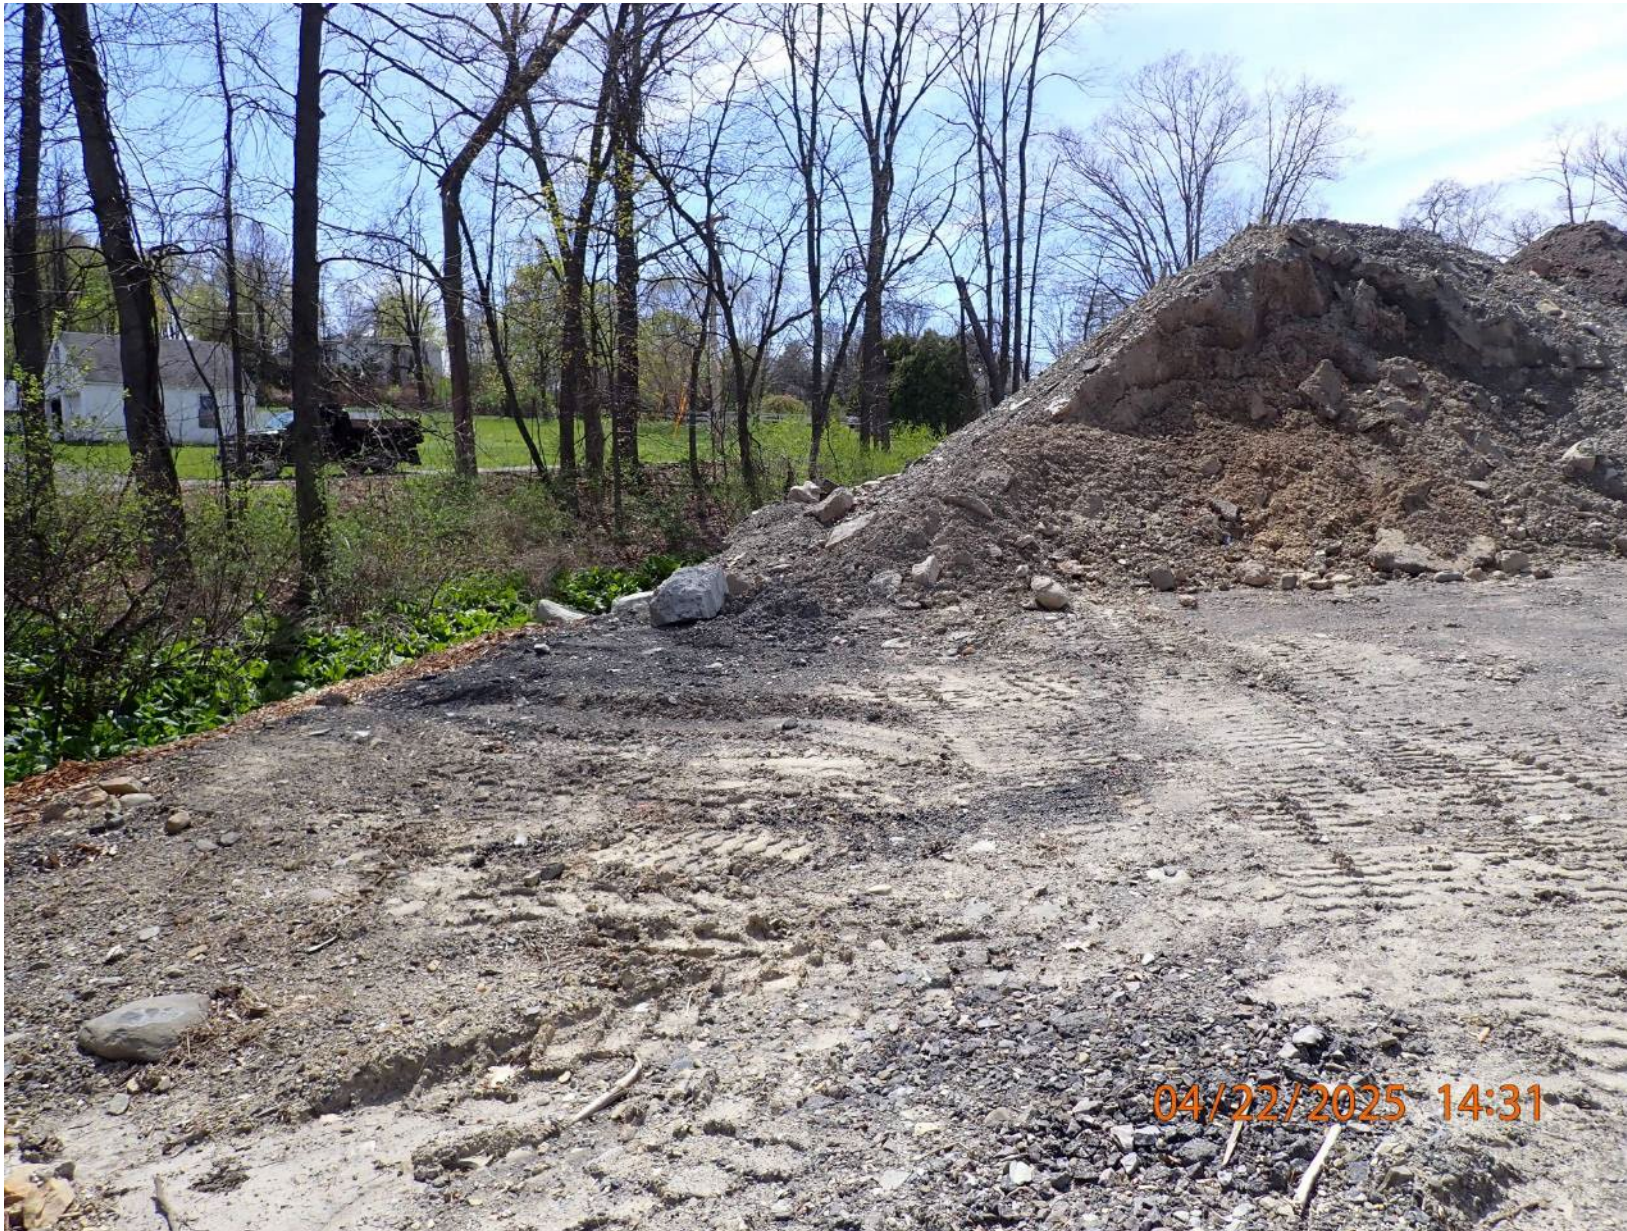
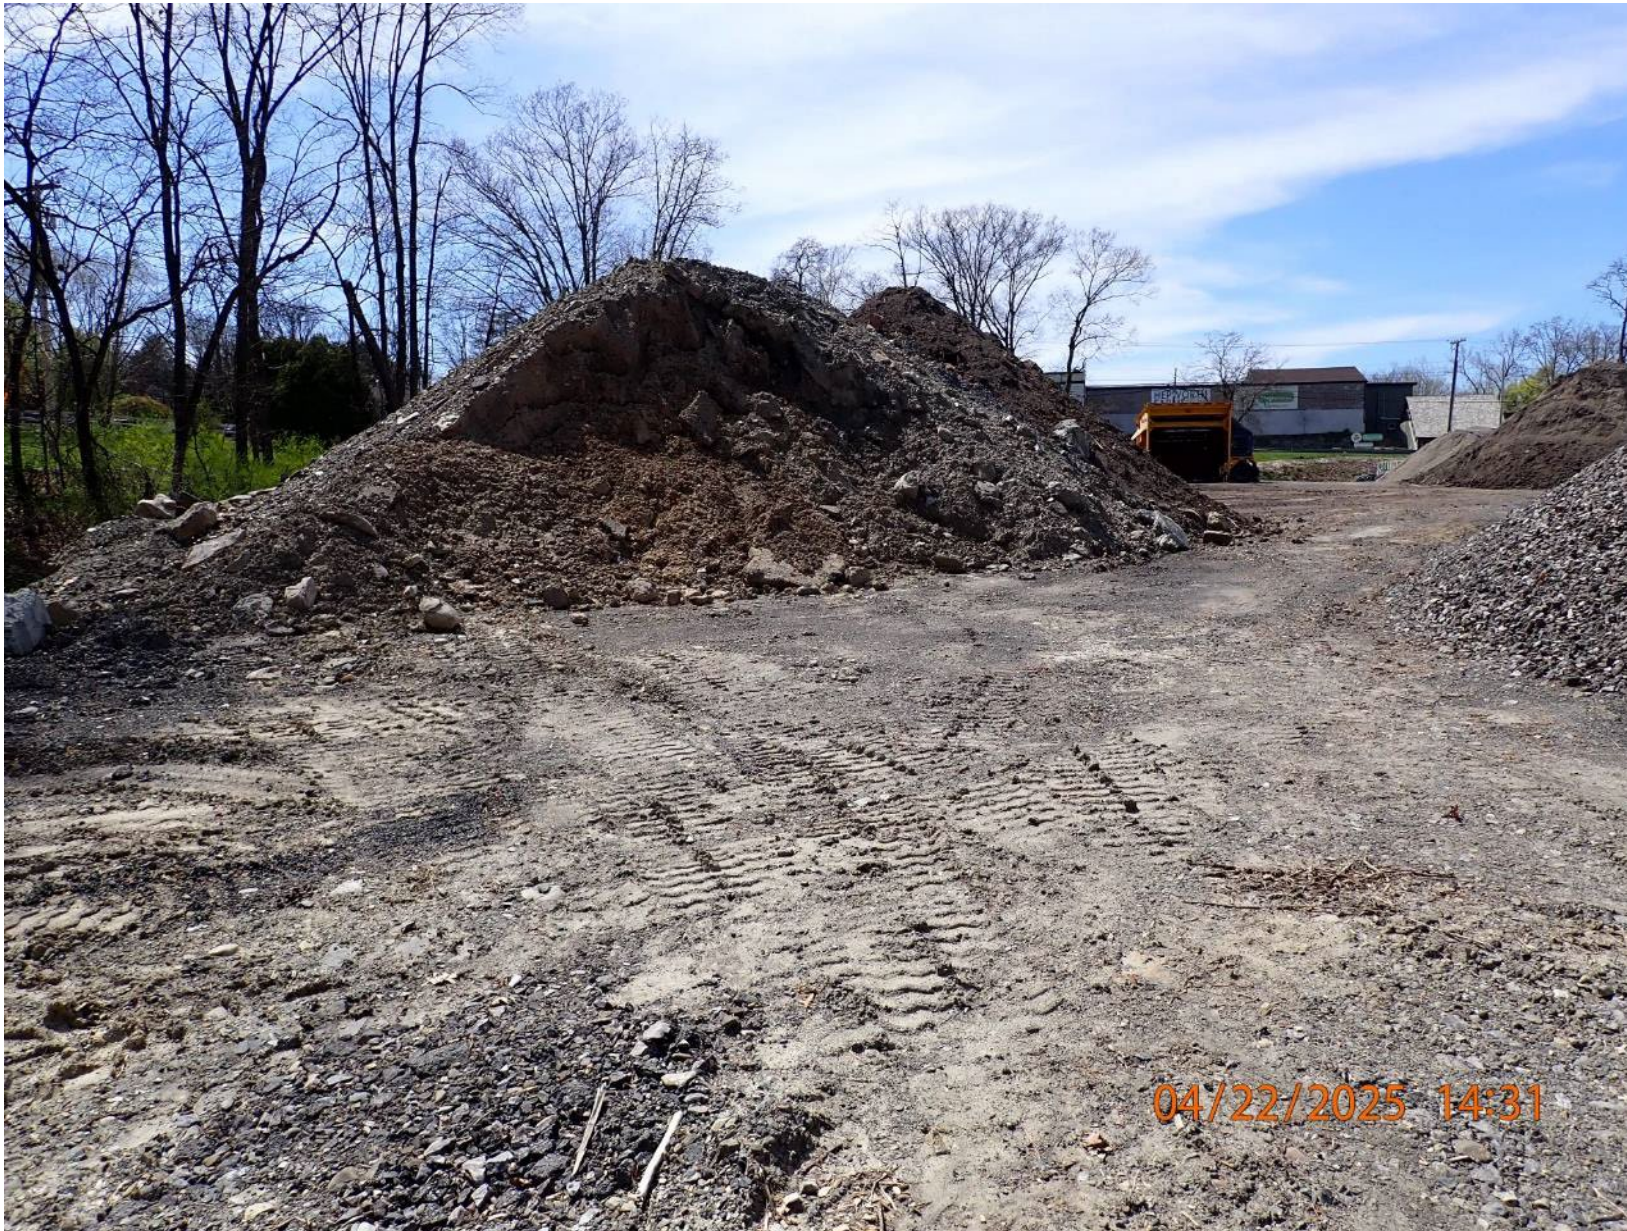
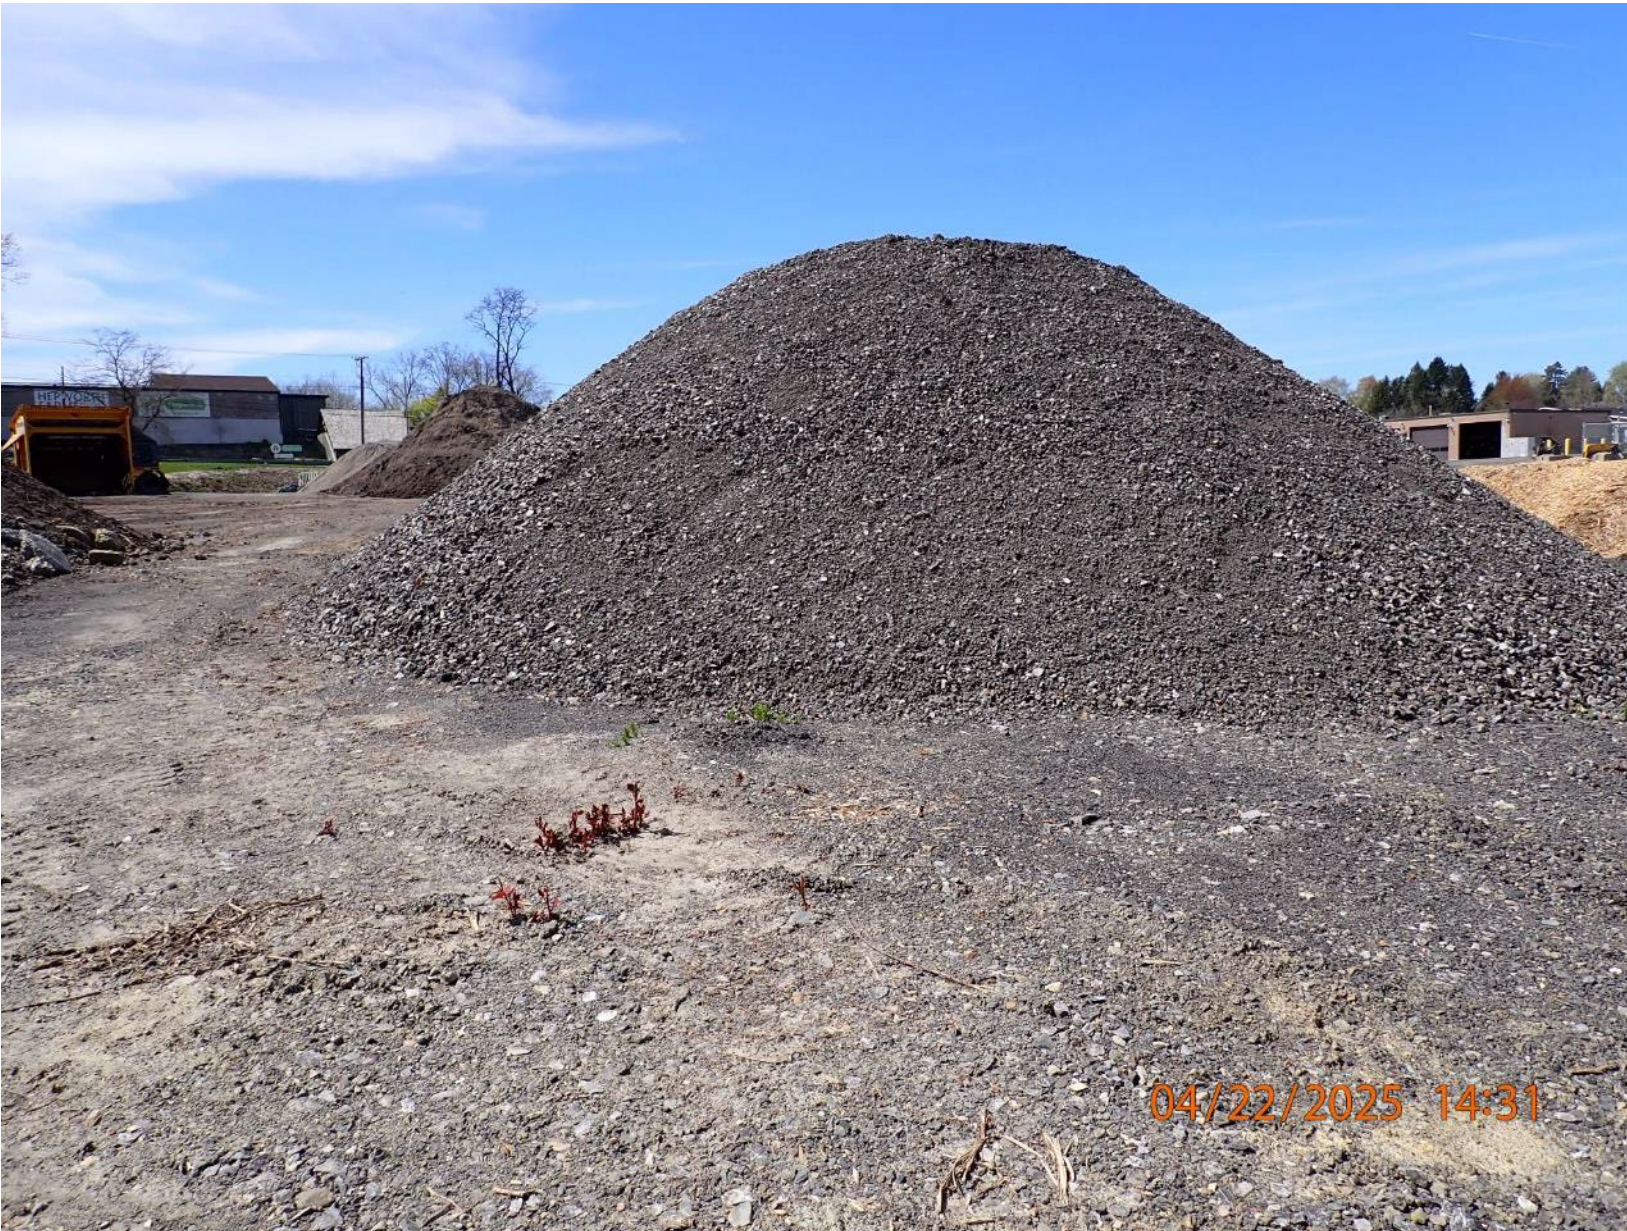
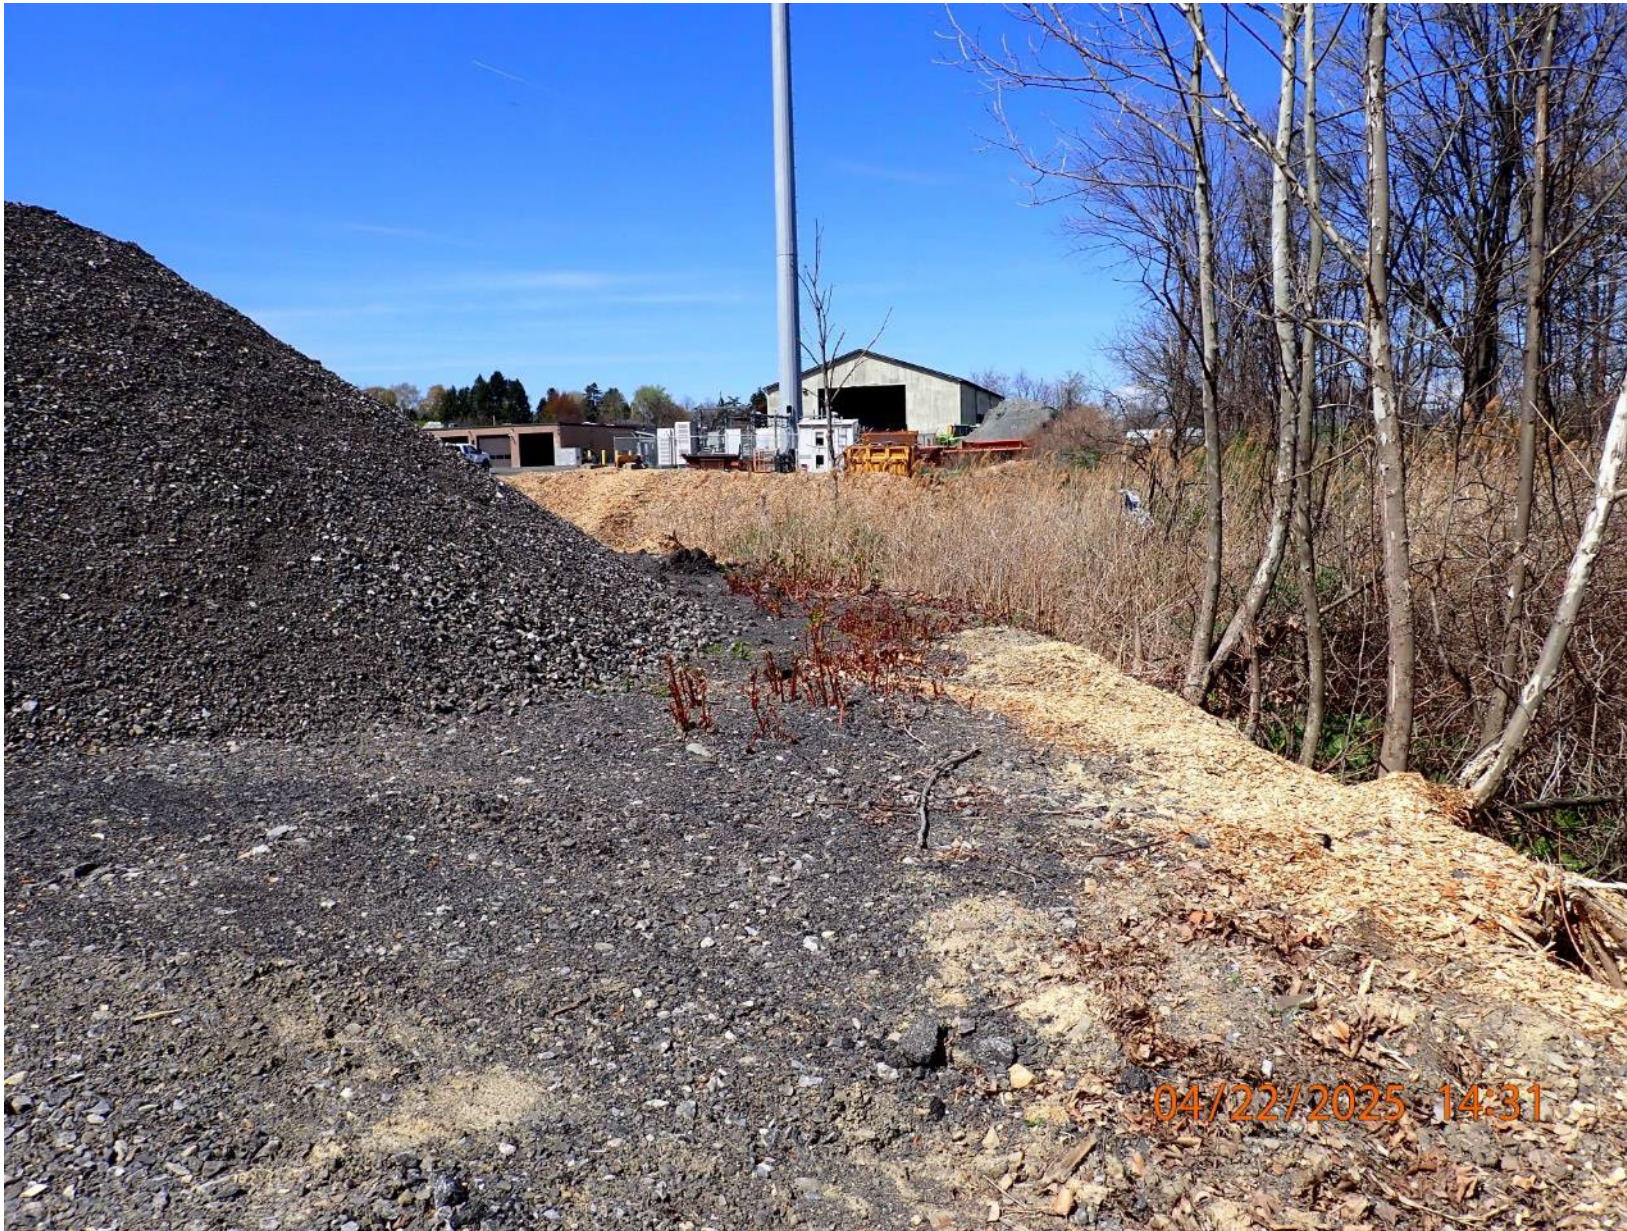
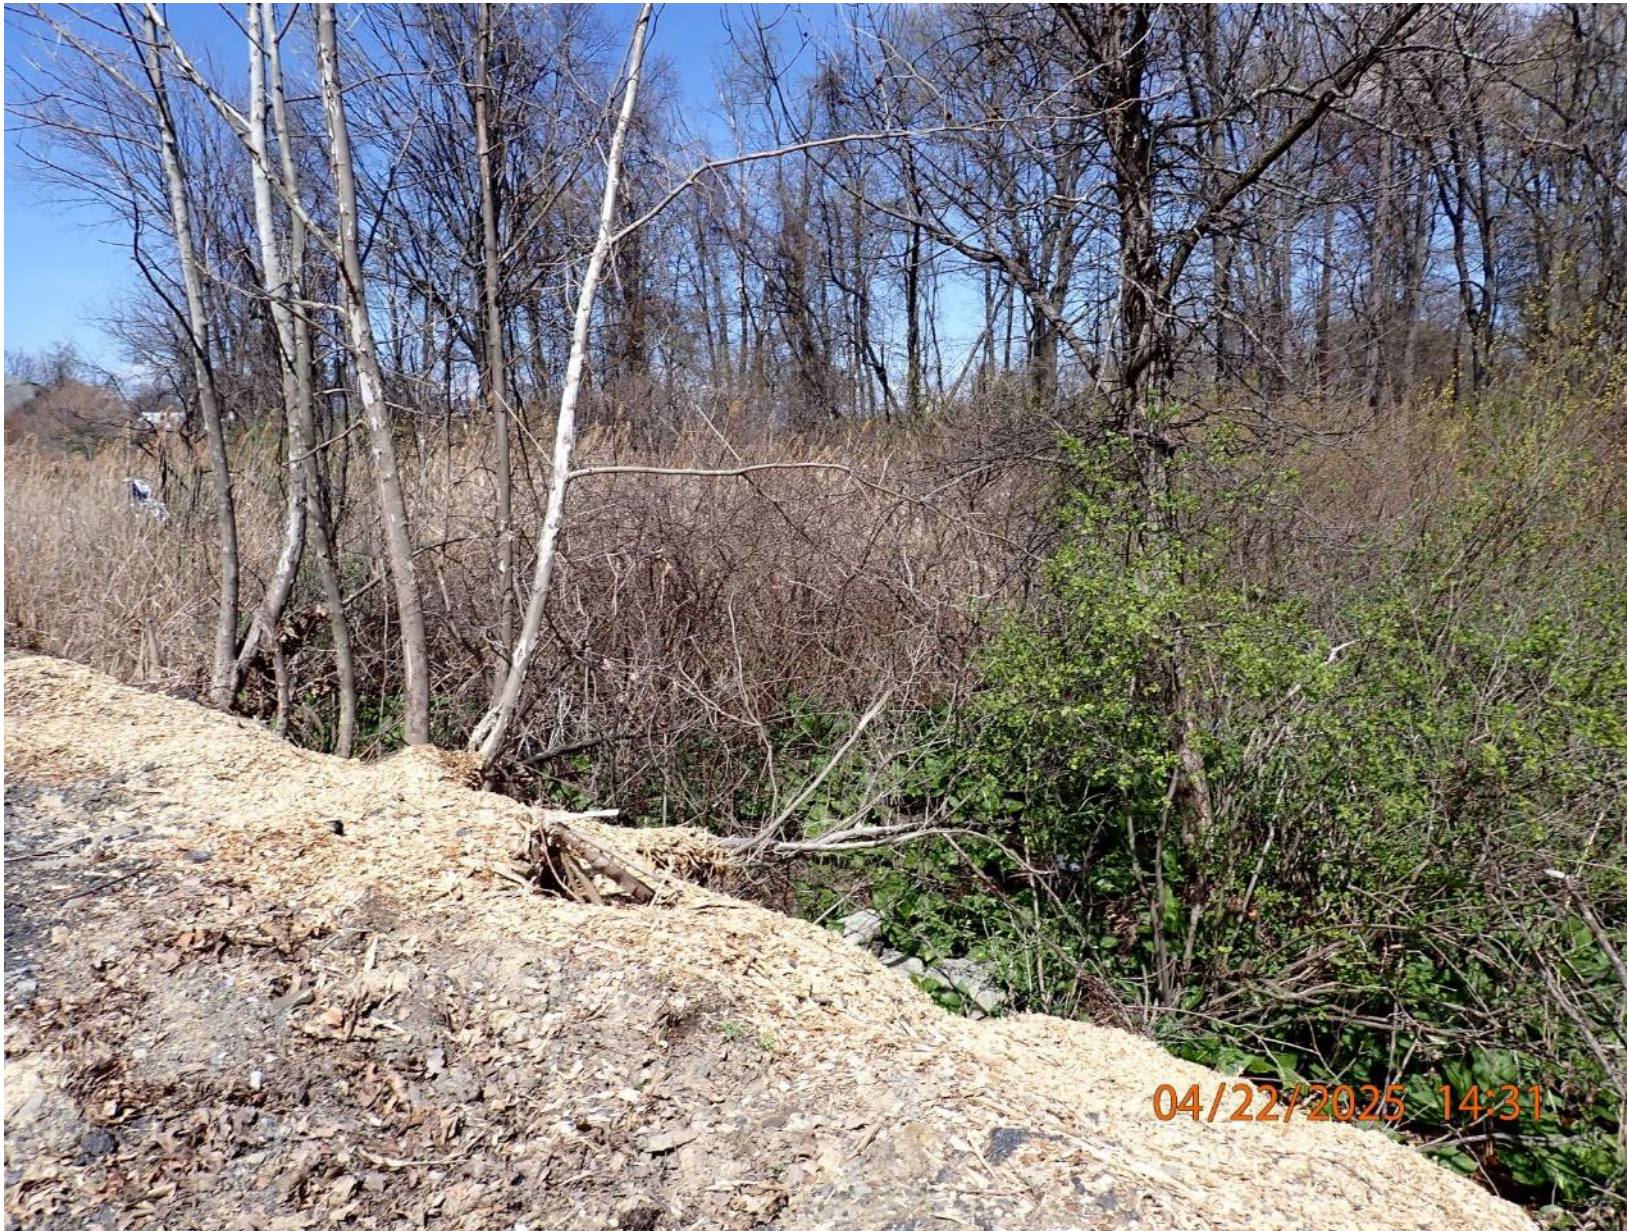
(1/5) Panorama of fill piles on site

(2/5) Panorama of fill piles on site

(3/5) Panorama of fill piles on site

(4/5) Panorama of fill piles on site

(5/5) Panorama of fill piles on site

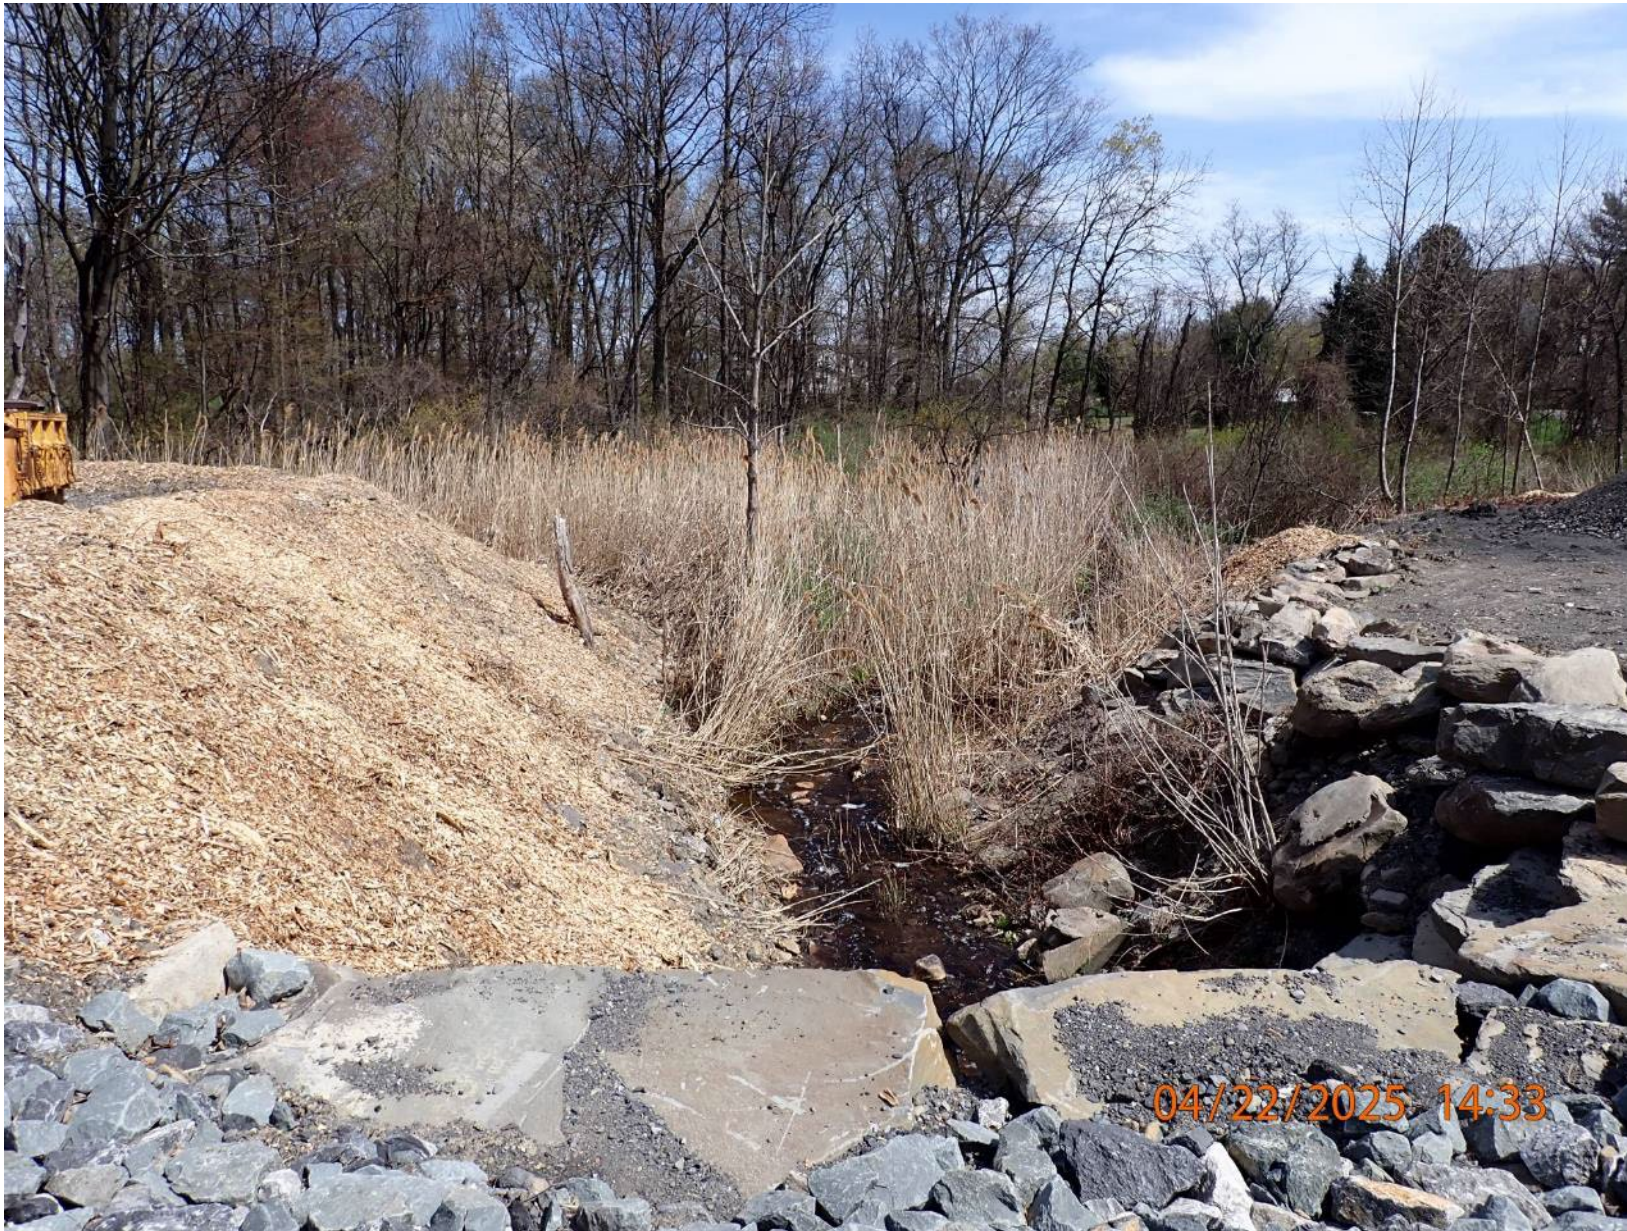
**Date:** 4/22/2025  
**Time:** 2:33 PM  
**Photographer:** S. Andreescu  
**Photo ID:** 21 – P4220819

Looking downstream from  
above downstream end of  
culvert

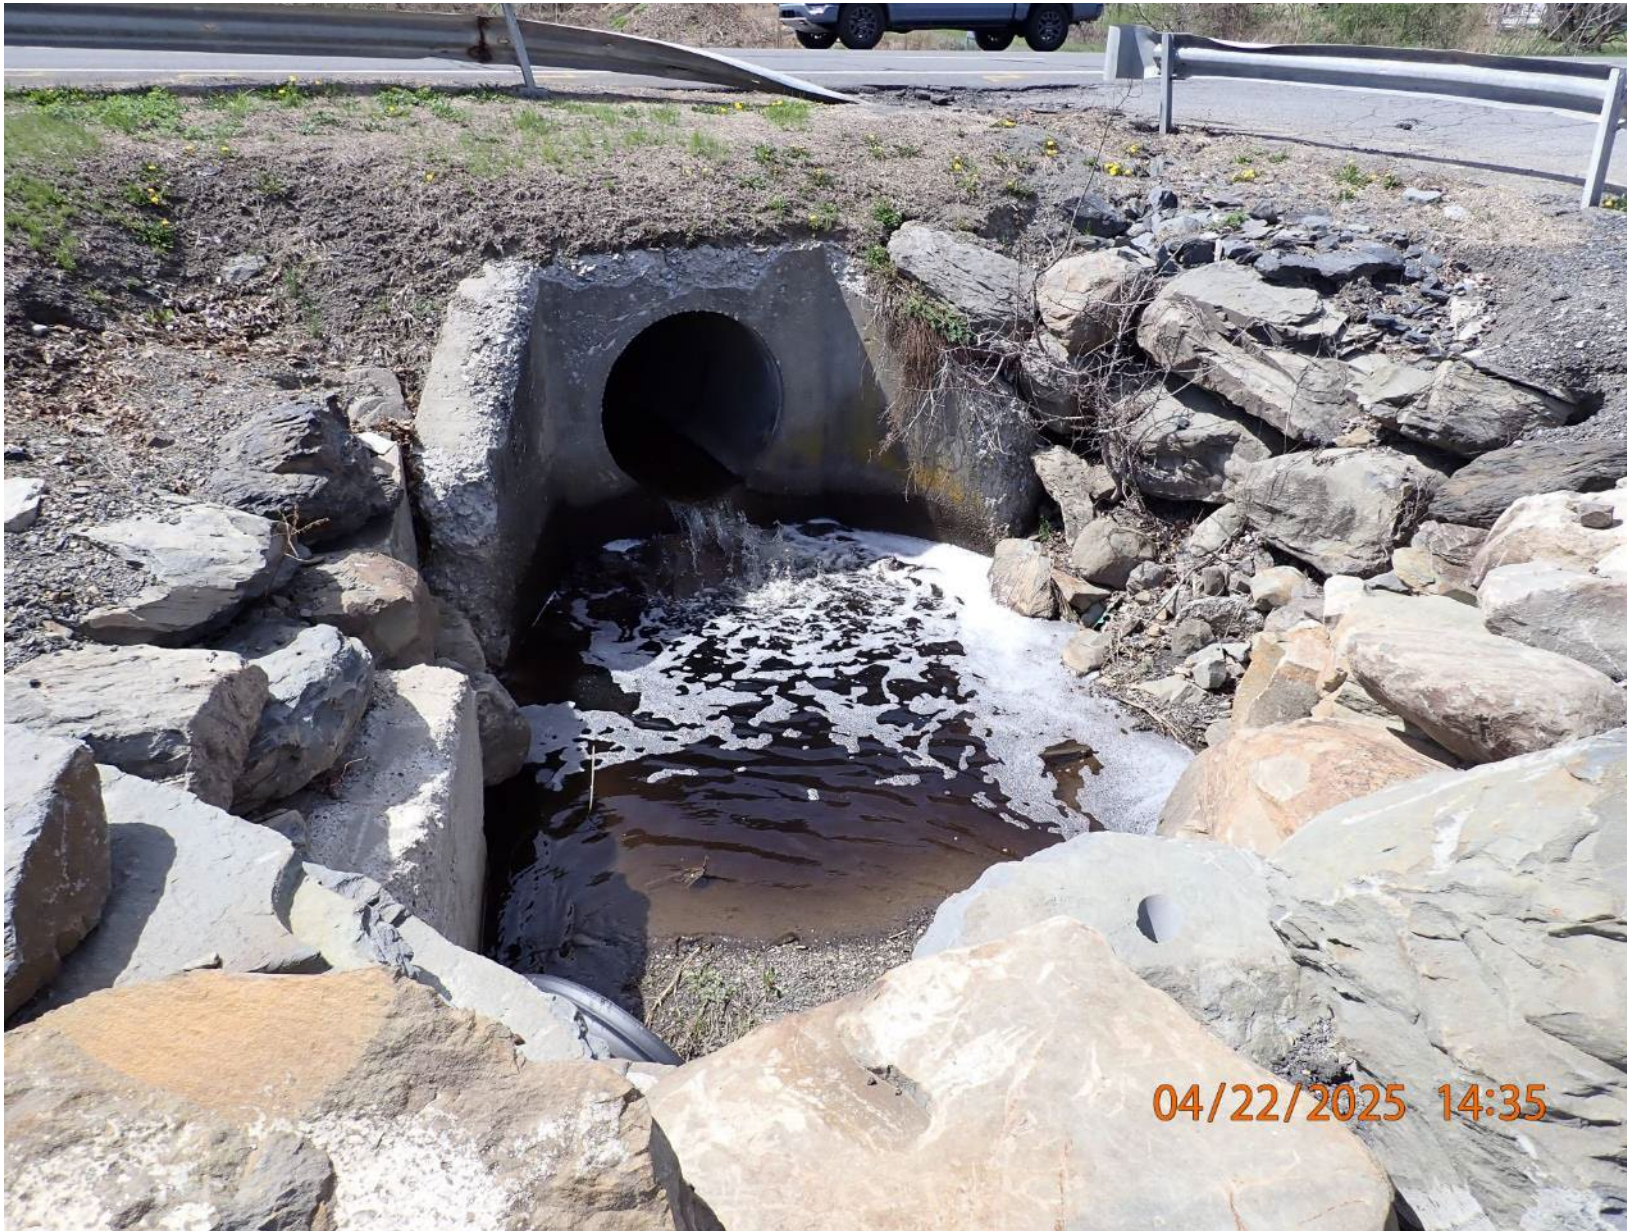
**Date:** 4/22/2025  
**Time:** 2:35 PM  
**Photographer:** S. Andreescu  
**Photo ID:** 22 – P4220820

Upstream end of corrugated plastic culvert piping stream under site; culvert conveying stream flow under NY State Route 9W

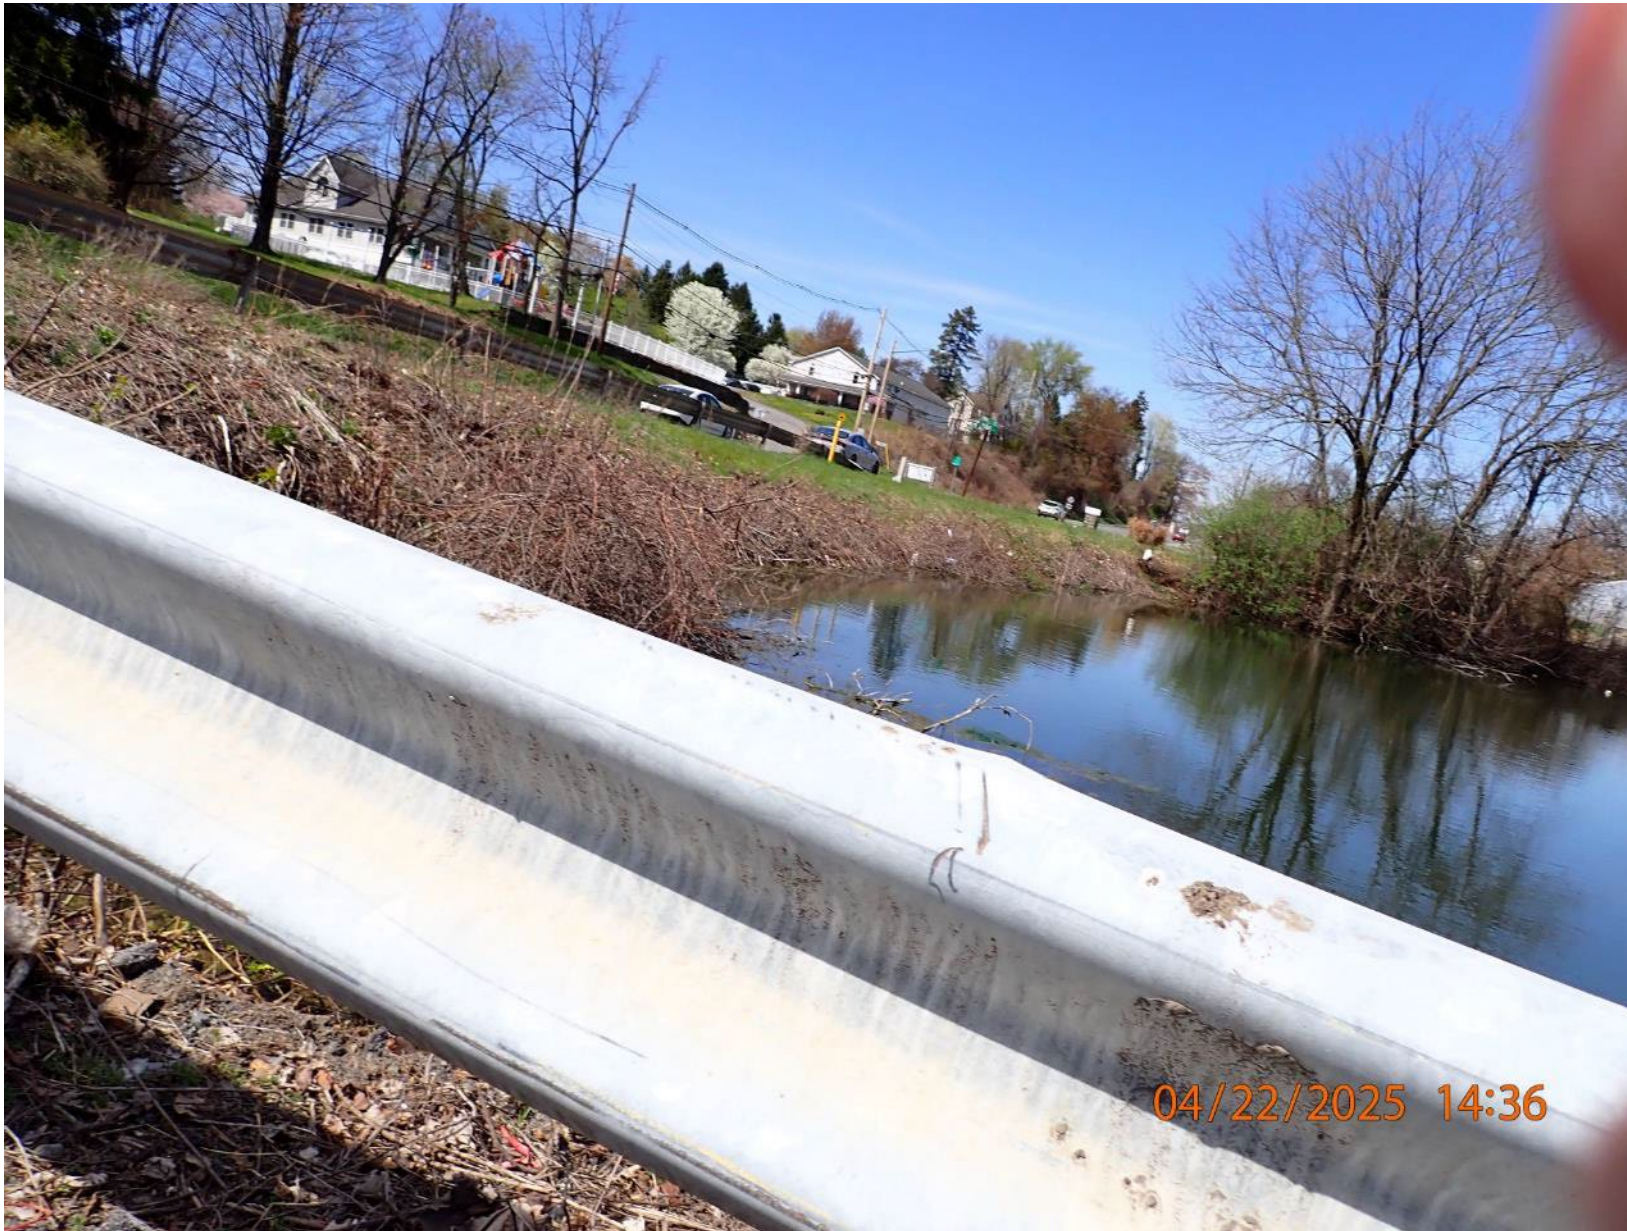
**Date:** 4/22/2025  
**Time:** 2:36 PM  
**Photographer:** S. Andreescu  
**Photo ID:** 23 – P4220821

On-site pond located on  
northern portion of property

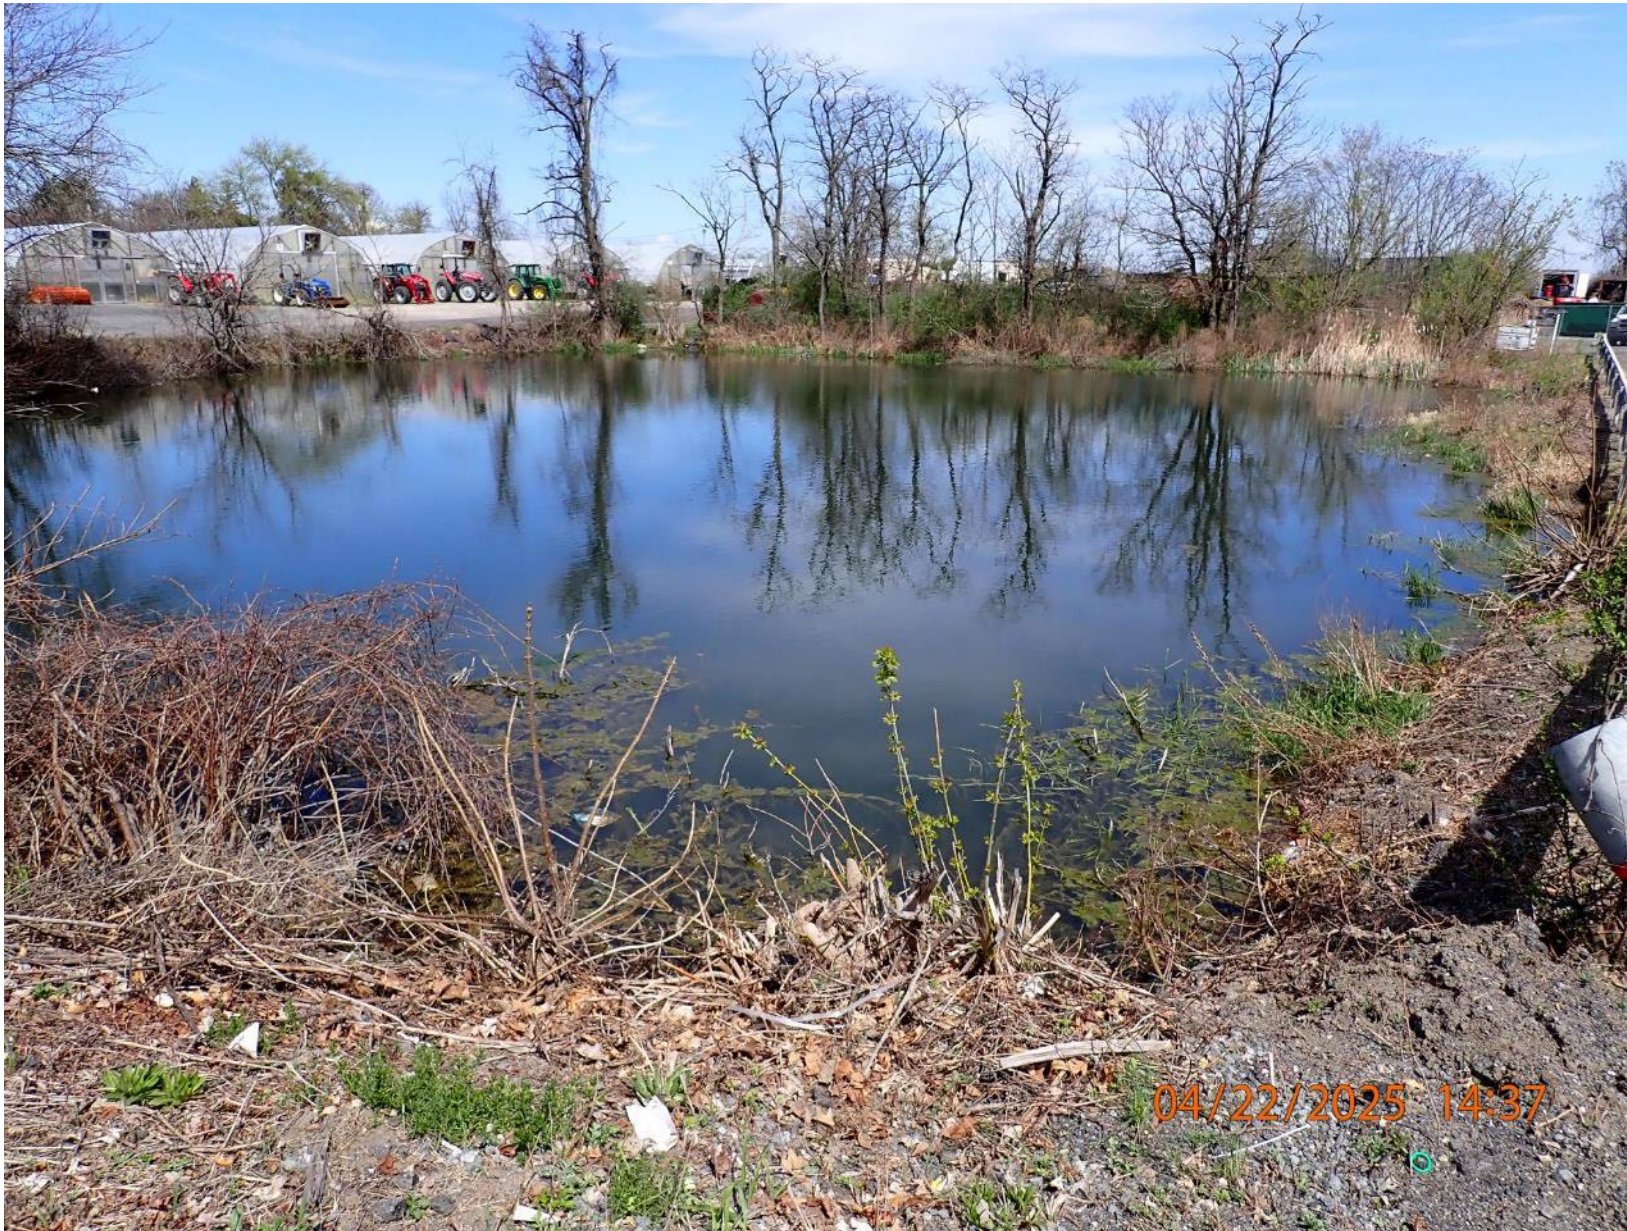
**Date:** 4/22/2025  
**Time:** 2:37 PM  
**Photographer:** S. Andreescu  
**Photo ID:** 24 – P4220822

On-site pond located on northern portion of property

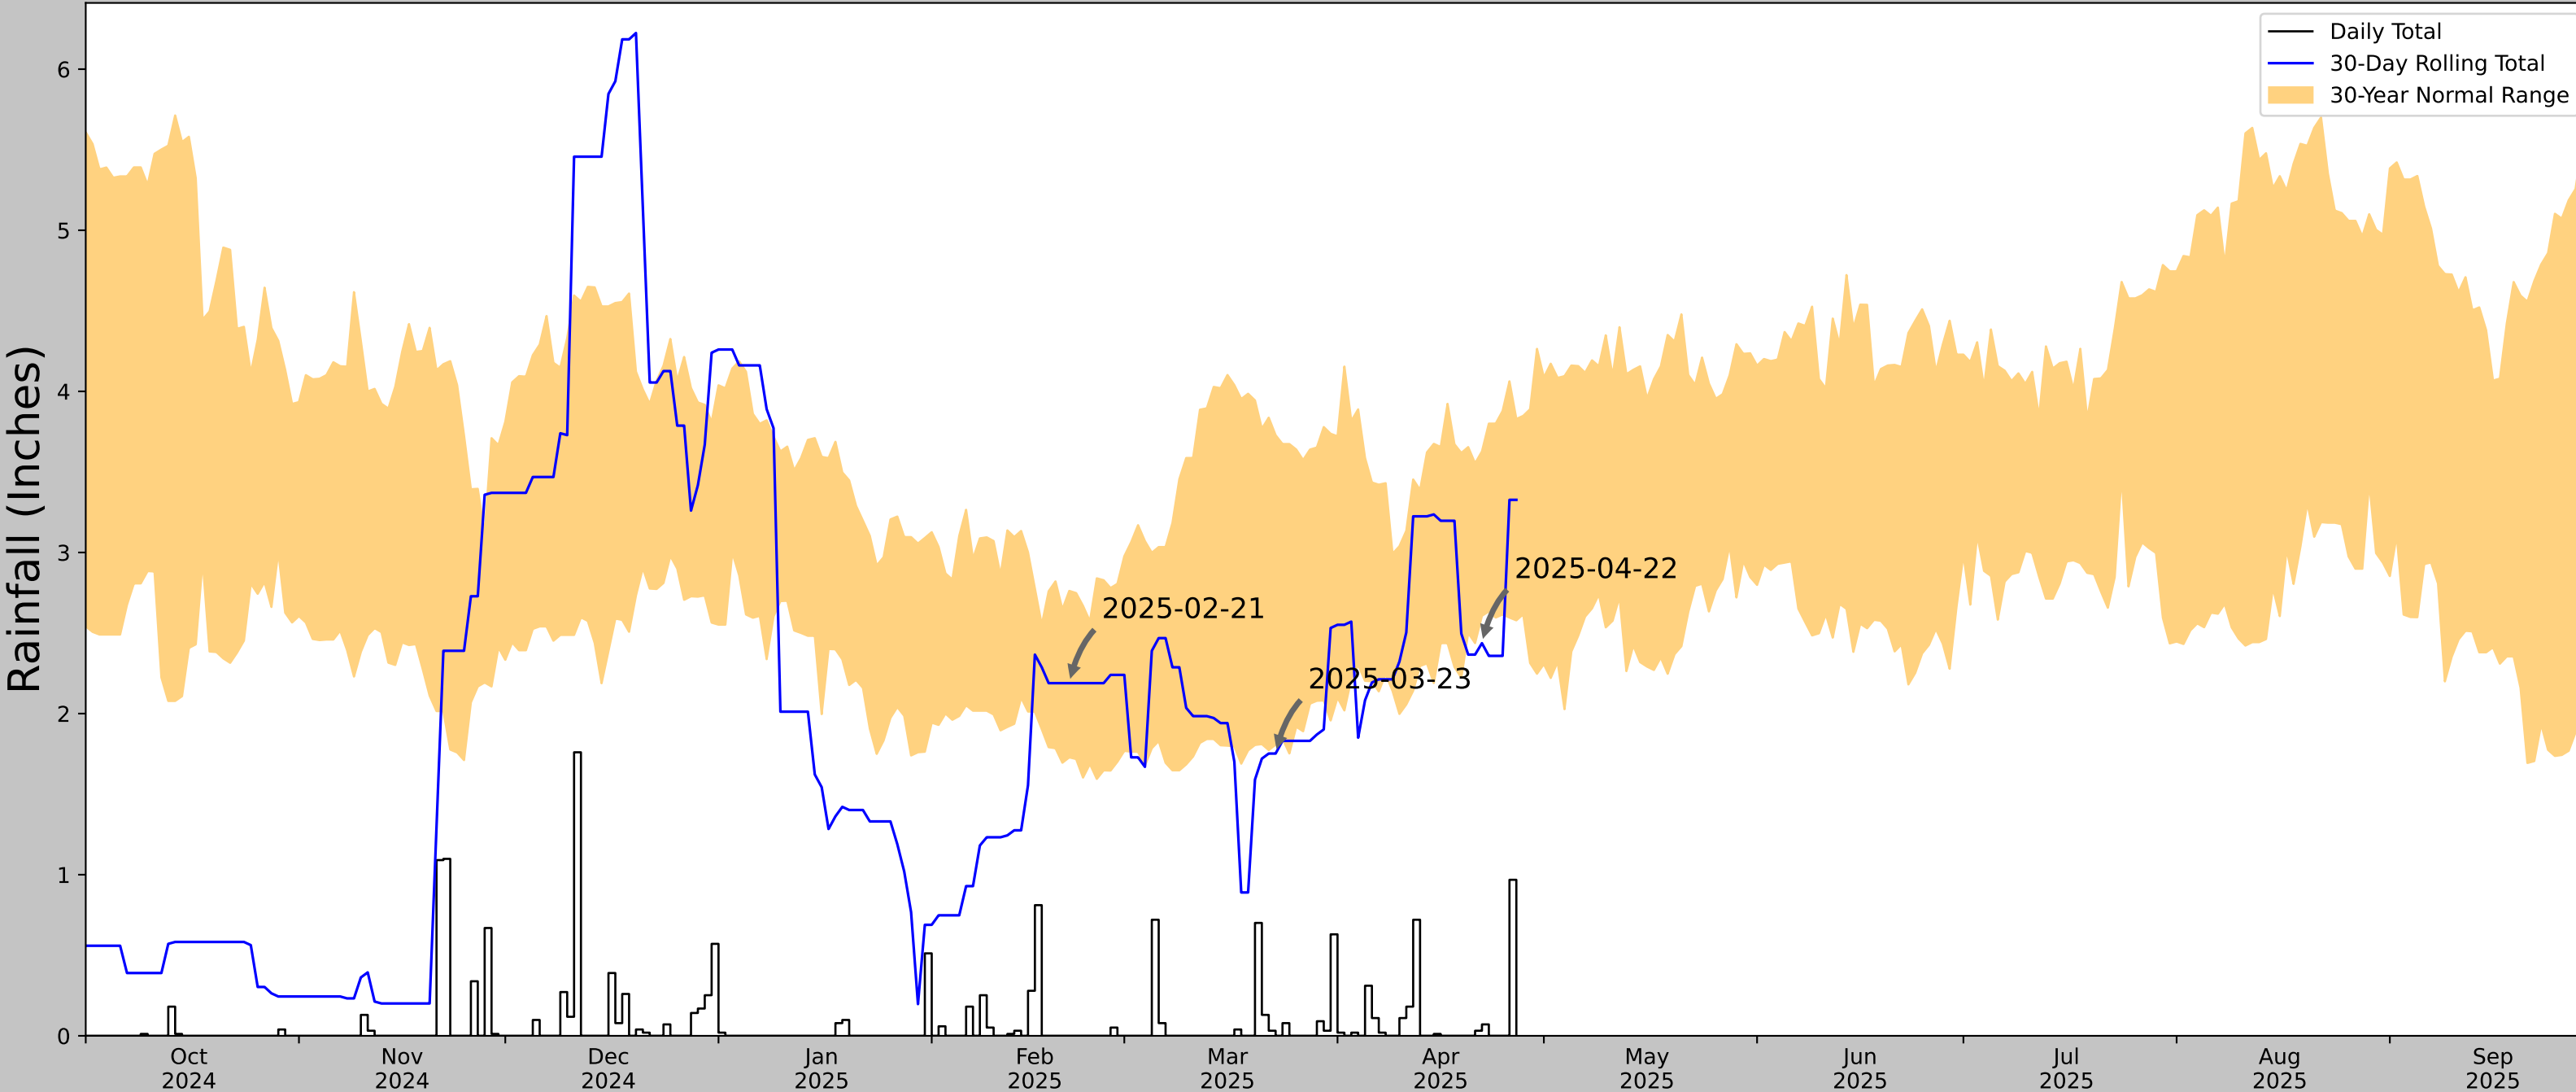
Antecedent Precipitation vs Normal Range based on NOAA's Daily Global Historical Climatology Network

| Drought Index (PDSI) | Moderate drought (2025-03) |

| 30 Days Ending | 30 <sup>th</sup> %ile (in) | 70 <sup>th</sup> %ile (in) | Observed (in) | Wetness Condition | Condition Value | Month Weight | Product |
|---|---|---|---|---|---|---|---|
| Result | | | | | | | Drier than Normal - 7 |
