RCRA Compliance Branch  
INSPECTION REPORT

| Inspection Date(s): | 3/27/2024 | Inspection Announced: No |
| Facility or Site Name: | Tunnel Barrel and Drum Company | |
| Facility/Site Physical Location: | 85 Triangle Boulevard, Carlstadt, NJ 07072 | |

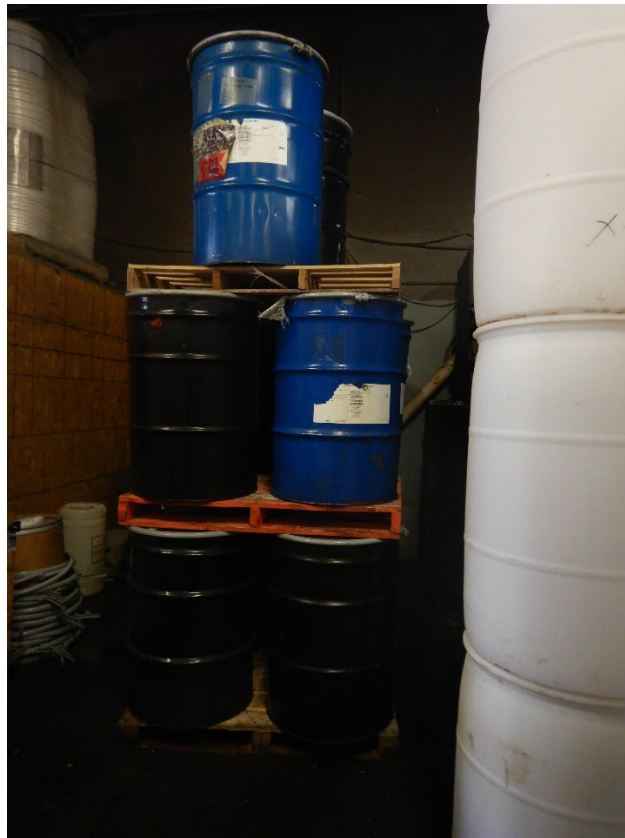
The inspection team observed the CAA, located adjacent to the wastewater treatment area on the western side of the building, where drums are received from the SAAs. Sixteen hazardous waste containers were observed in this area, stored on two rows of pallets and stacked two to three high. Thirteen of these drums were not labeled as hazardous waste, with an indication of their hazards, or with an accumulation start date. There was not adequate aisle space on either side of the row of hazardous waste drums (Photographs 5 -7 and 9, Attachment 1).

Overall view of the CAA. Ten drums of hazardous waste are stored on the first row of pallets seen here, none of which are labeled as hazardous waste, with an indication of their hazards, or with an accumulation start date. Six more drums are stored on the row behind this front row that but cannot be seen in this photo. Additionally, there is not adequate aisle space on either side of the drums. {Photograph 5, Attachment 1}

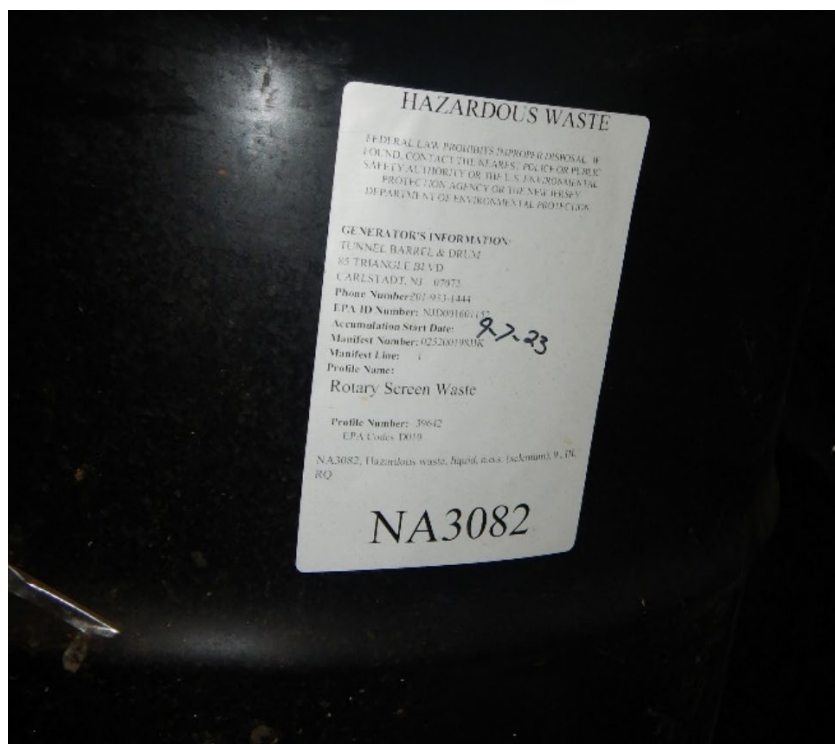
One 55-gallon steel drum in the back row of containers stored in the CAA was labeled as hazardous “rotary screen waste” with an accumulation date of 9/7/2023, indicating that the drum had been stored on-site for 202 days on the day of the inspection (Photograph 2, Attachment 1). This is in exceedance of the 90-day storage limit for hazardous waste containers at an LQG. The label also includes a manifest number 025200198JJK, which corresponds to a shipment that was shipped from TB&D on 8/11/2023.

Close-up view of the label on one of the rotary screen hazardous waste drums observed in the CAA. The accumulation date is listed as 9/7/2023.  
{Photograph 2, Attachment 1}

accumulation dates that exceeded 90 days (Photographs 2 and 4, Attachment 1). One drum was labeled with an accumulation date of 9/7/2023 and another was labeled with an accumulation date of 8/13/2023. At the time of the inspection, these containers had been stored on site for 202 and 227 days from their accumulation dates, respectively.

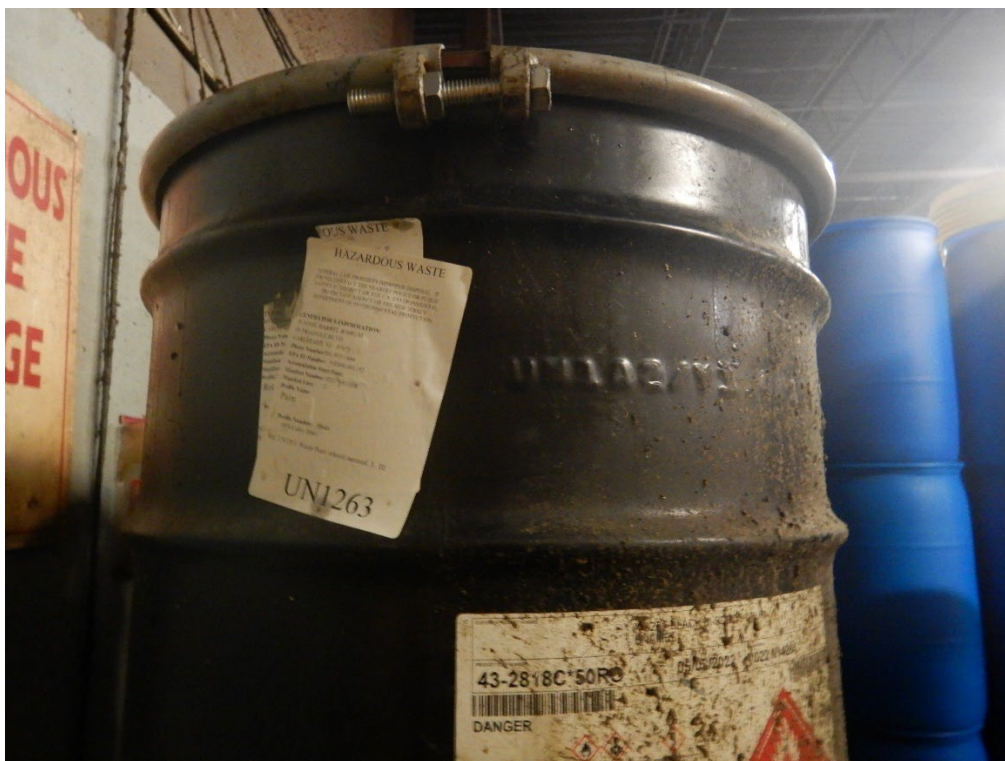
{Photograph 3, Attachment 1}

Another 55-gallon steel drum in the back row of containers stored in the CAA was labeled as hazardous “Paint” with no accumulation date listed (Photograph 3, Attachment 1). The label lists a manifest number, but it is not legible in the photograph.

View of the hazardous paint waste drum observed in the CAA. No accumulation date is listed on the drum.

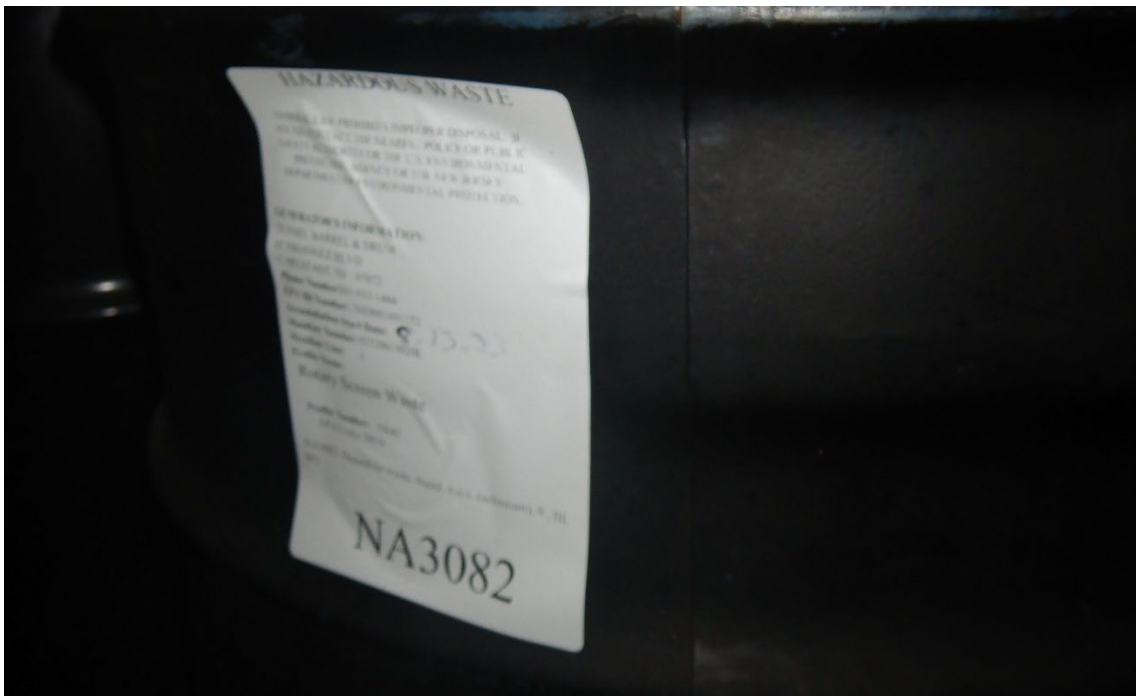
{Photograph 4, Attachment 1}

A third 55-gallon drum was observed in the CAA with a hazardous waste label. The drum was observed in the back row of containers stored in the CAA was labeled as hazardous “rotary screen waste” with an accumulation date of 8/13/2023, indicating that the drum had been stored on-site for 227 days on the day of the inspection (Photograph 4, Attachment 1). This is in exceedance of the 90-day storage limit for hazardous waste containers at an LQG.

Close-up view of the label on one of the rotary screen hazardous waste drums observed in the CAA. The accumulation date is listed as 8/13/2023.

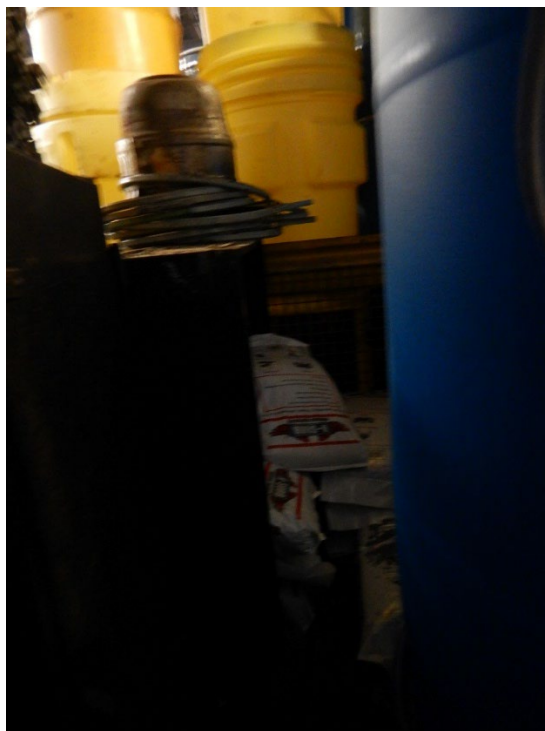
{Photograph 19, Attachment 1}

Facility personnel acknowledged that a waste pick-up had not been scheduled for a few months at the time of the inspection. They stated that they did not separately track or have a means to identify the accumulation dates on the drums that were not labeled. To determine what the contents of the drums were, they would need to open the containers and make visual observations. Additionally, a black storage cabinet was located adjacent to the CAA which contained sorbent materials. A number of poly drums were stored in front of the cabinet, making it difficult to access the spill response equipment (Photograph 19, Attachment 1).

View of the spill absorbent stored in a black cabinet adjacent to the CAA. The spill equipment was not readily accessible, due to drums blocking access.

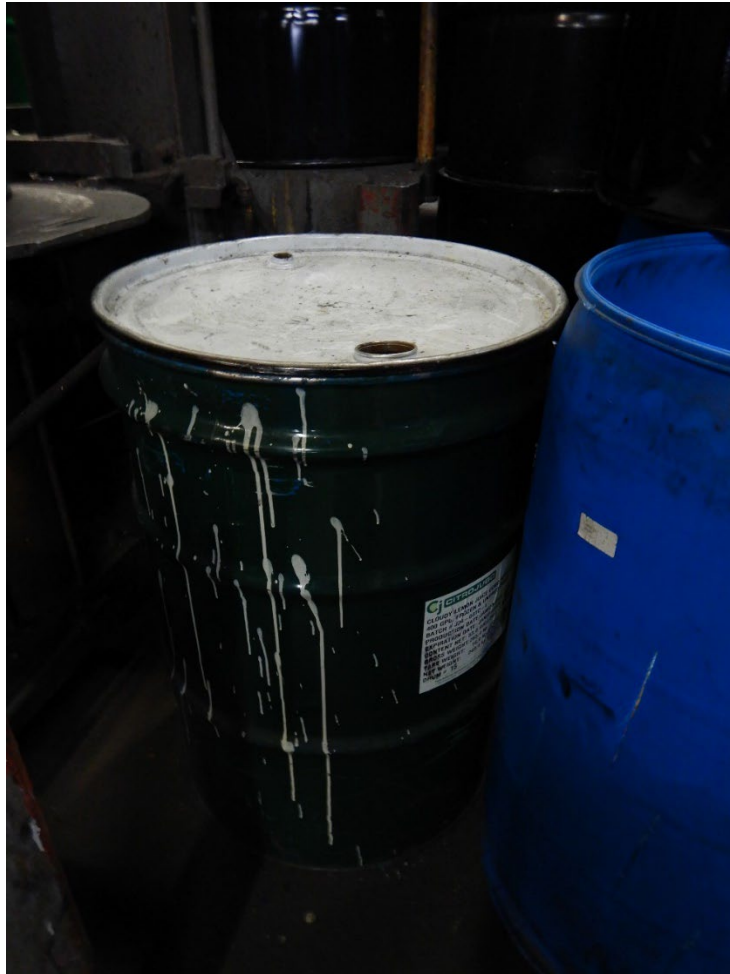
{Photograph 17, Attachment 1}

The inspection team observed the paint booth area, where washed and blasted drums are coated prior to shipment to customers. The facility has two paint booths, one that has automated spray guns and the another where paint is applied manually with a spray gun. Paint booth filters, which become paint waste were observed in the booths. There were pails in the vicinity of the paint booths use to capture paint waste, which also reportedly would be transferred to the paint waste drum. At the time of the inspection, a satellite drum used to collect paint waste was not observed in the area. Adjacent to the paint area, near the drum conveyor line, the satellite accumulation area for the spent solvent rags was observed. One 55-gallon drum was present (Photograph 17, Attachment 1). The container was not labeled as hazardous waste or with an indication of its hazards. The drum was covered with a lid, but the lid was not secured and the bung openings on the drum lid were not closed.

View of satellite accumulation drum of solvent rags, which was not properly closed and was not labeled as hazardous waste or with an indication of its hazards.

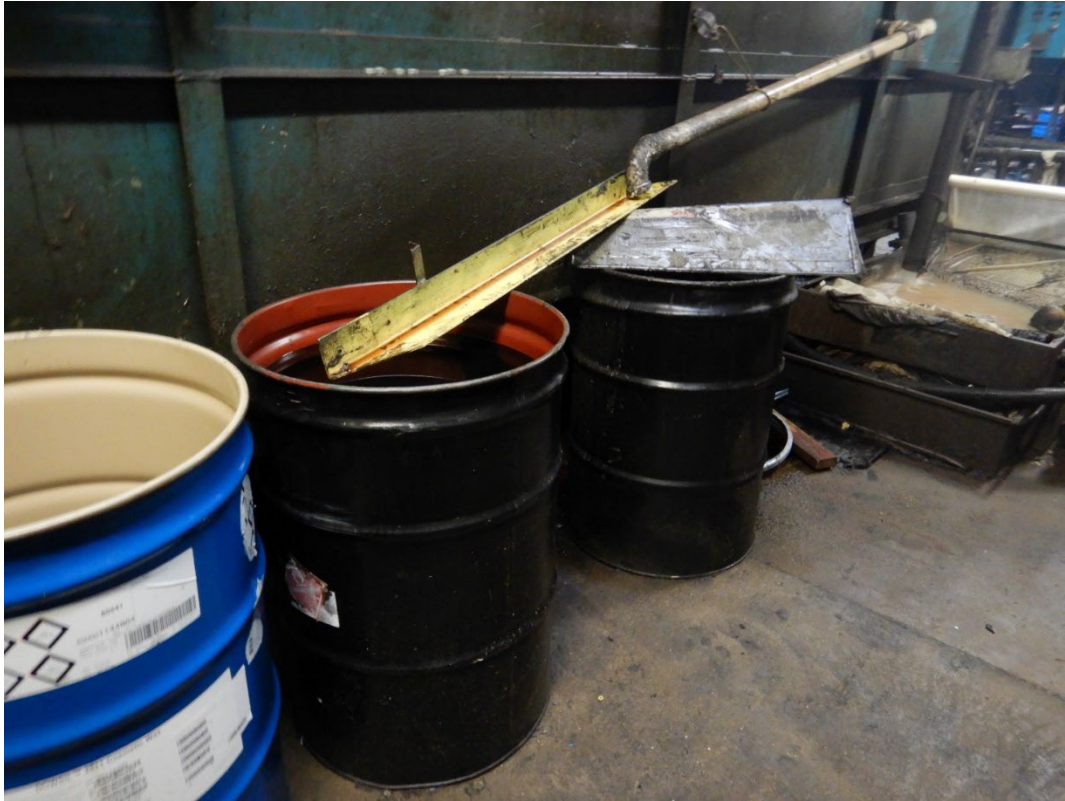
{Photograph 18, Attachment 1}

waste. This area serves as a satellite accumulation area for the rotary screen waste. Two drums of rotary screen waste were observed in the area, one which was still accumulating rotary screen waste, and the other drum was full (Photograph 18, Attachment 1). Neither of the drums were labeled as hazardous waste or with an indication of their hazards. Additionally, the SAA was storing more than 55-gallons of hazardous waste based on the two containers that were present.

Rotary screen waste satellite accumulation area, adjacent to the wastewater treatment equipment. The two black drums contain rotary screen waste. Neither of the drums are labeled or closed.

3. Pursuant to 40 CFR 262.34(c)(1), a generator may accumulate as much as 55 gallons of hazardous waste or one quart of acutely hazardous waste listed in §261.31 or §261.33(e) in containers at or near any point of generation where wastes initially accumulate which is under the control of the operator of the process generating the waste, without a permit or interim status and without complying with paragraph (a) or (d) of this section provided he: (i) Complies with §§265.171, 265.172, and 265.173(a) of this chapter; and (ii) Marks his containers either with the words “Hazardous Waste” or with other words that identify the contents of the containers. Pursuant to 40 CFR 265.173(a) a container holding hazardous waste must always be closed during storage, except when it is necessary to add or remove waste. The inspection team observed one SAA container of hazardous solvent rags (Photograph 17, Attachment 1) and two SAA containers of hazardous rotary screen waste (Photograph 18, Attachment 1) which were open in violation of 40 CFR 262.34(c)(1)(i).
