**Region 6 - Enforcement & Compliance Assurance Division**  
**INSPECTION REPORT**

| Company Name: | <b>Peabody Natural Resources Company</b> | |
| Facility Name: | <b>El Segundo Mine</b> | |
| Identification/Permit Number: | NM0030996 | |

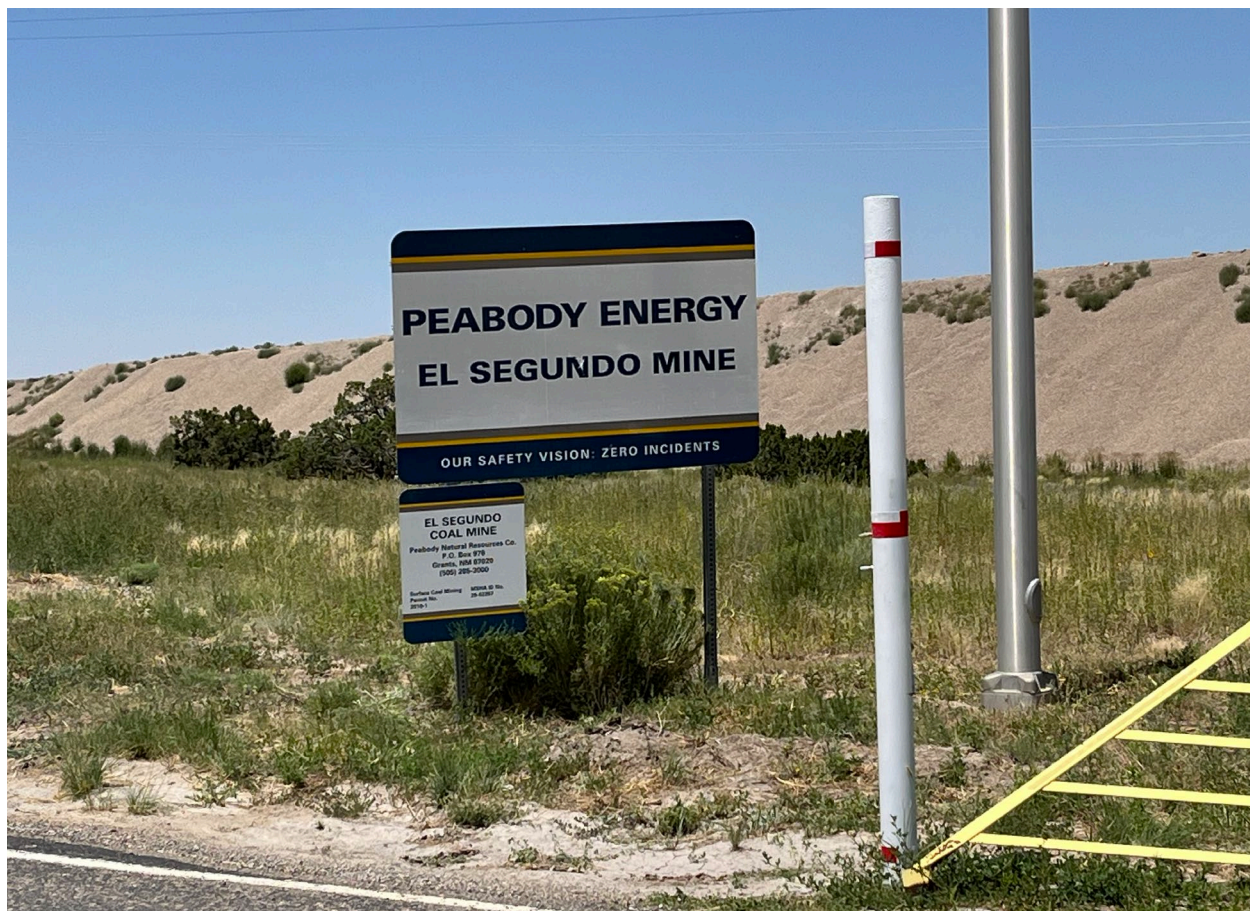
Photo No. 1

View of entrance sign at the Peabody-El Segundo Mine. (IMG\_0084). Photographed by D. Esparza

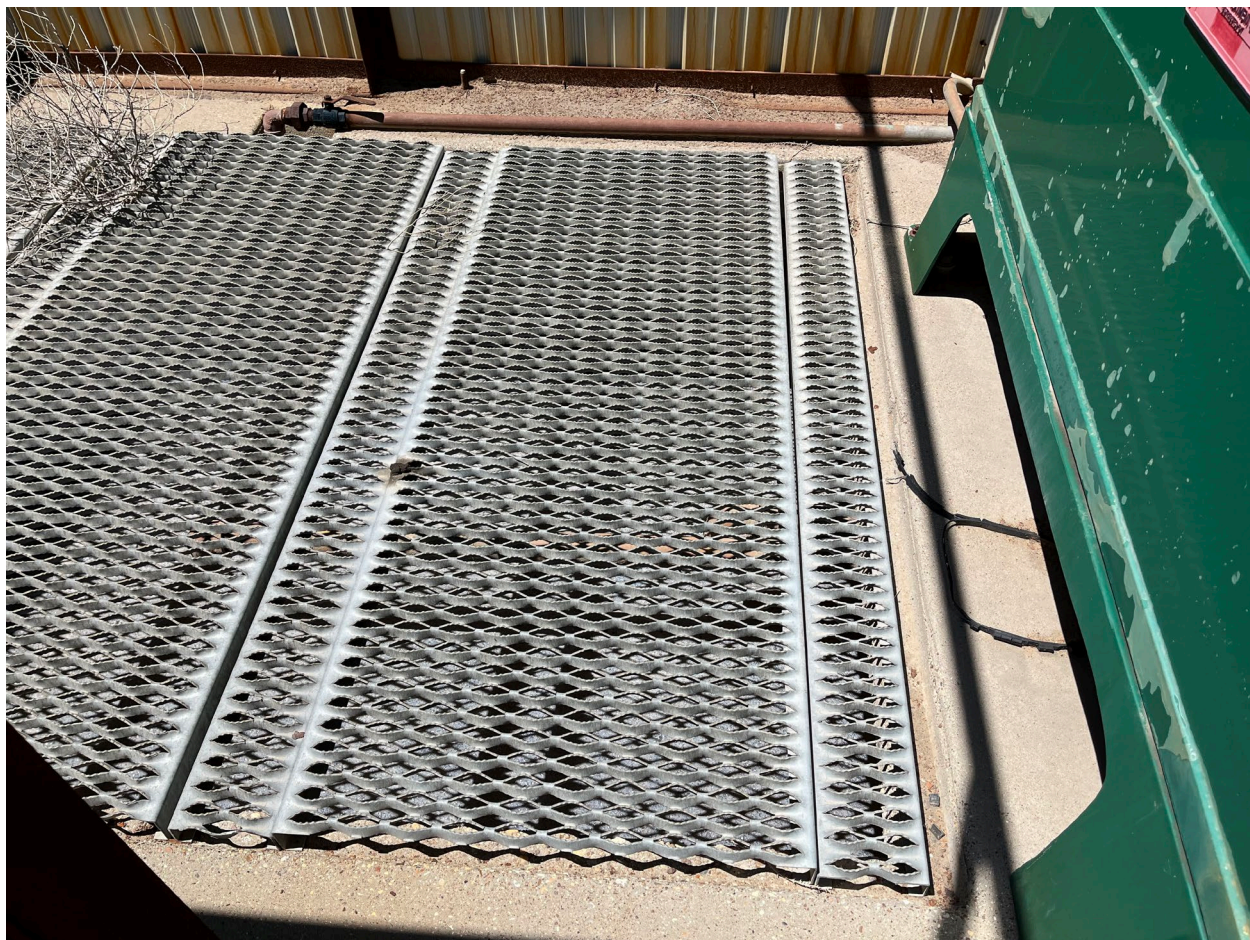
Photo No. 2

View of "diamond plate" steel grating covering the wastewater treatment headworks. (IMG\_0081).  
Photographed by D. Esparza

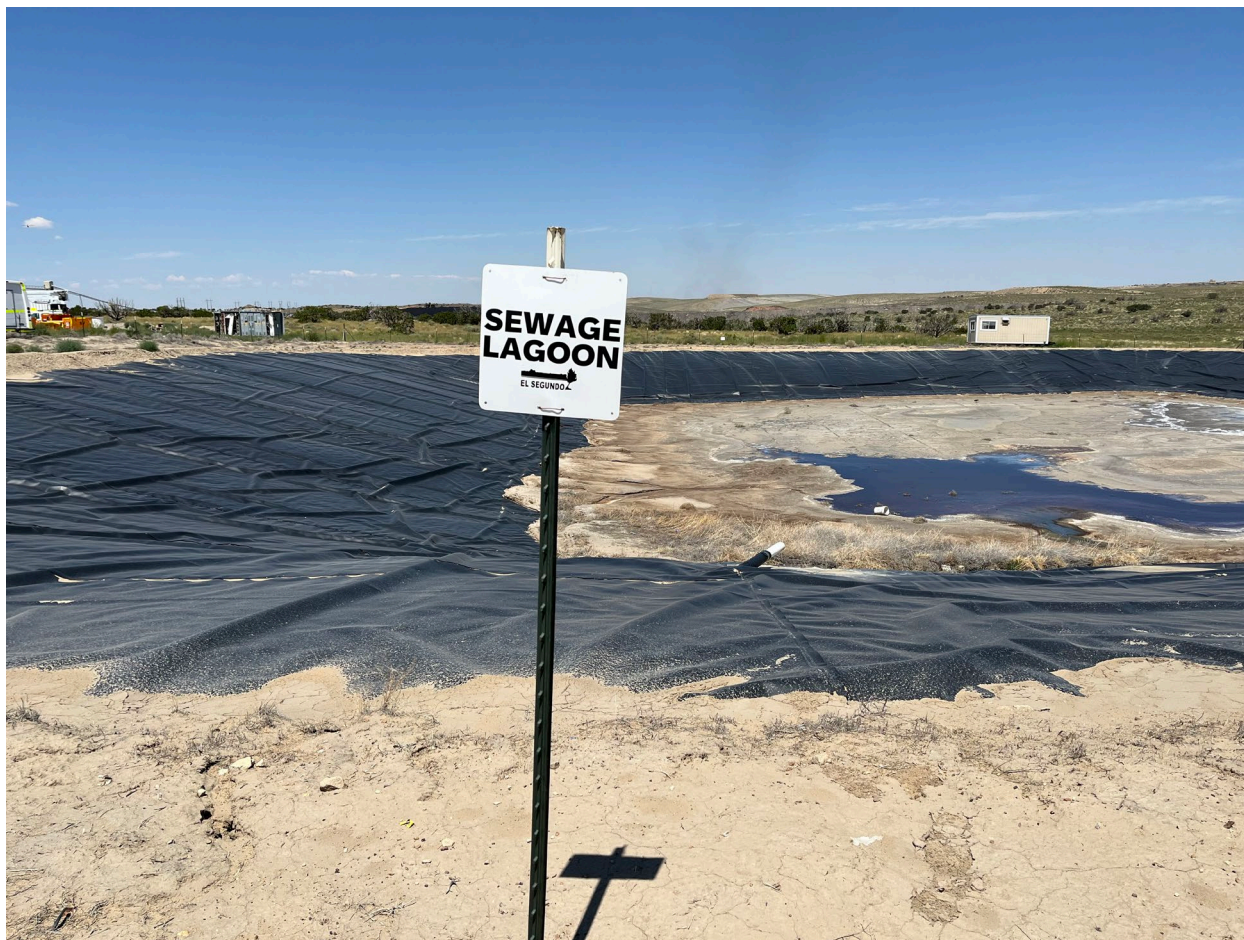
Photo No. 3

View of the existing sewage evaporative lagoon (pond) (listed as #018 on the El Segundo Outfall). **Note:** The integrity of the lagoon liner/fabric did not indicate visual signs of degradation or undermining by vagrant vegetation or vermin. (IMG\_0080). Photographed by D. Esparza
