**U.S. Environmental Protection Agency  
Region 5**

**Purpose:** Clean Water Act National Pollutant Discharge Elimination System Compliance Evaluation Inspection

**Facility:** Cleveland-Cliffs Inc. – Empire Mine  
County Road PEE  
Ishpeming, Michigan 49849

**Inspection Date:** September 13 - 15, 2022

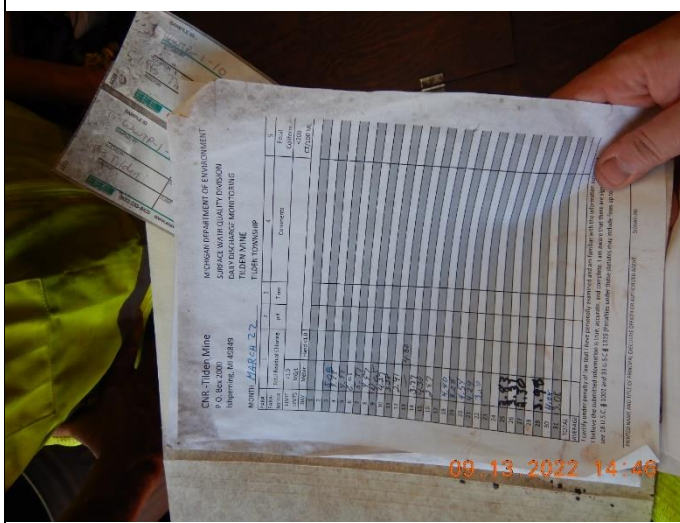
1: DSCN0960.JPG

- Chlorine measurements taken at the Empire wastewater treatment plant are taken with a Hach Colorimeter using a Mid-Range method. The midrange method range maximum is 4.00 mg/L. A review of the log book during the inspection showed multiple readings at 4.4 mg/L which appeared to be above the method range.

Description: Residual chlorine bench sheet from the sewage treatment system at Tilden.

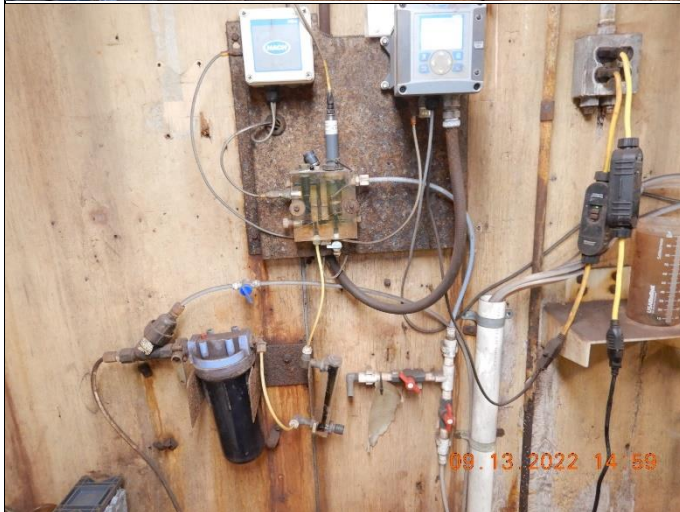
3: DSCN0962.JPG

Description: Continuous chlorine analyzer at the Tilden sewage treatment system. The chlorine probe was labeled for free chlorine analysis.

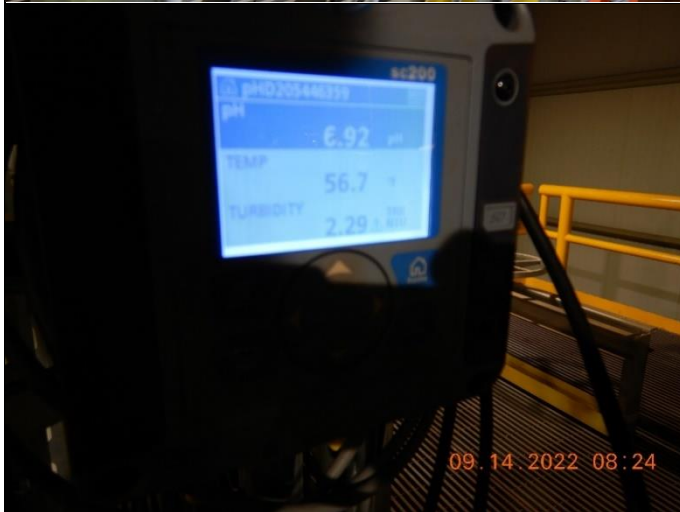
11: DSCN0970.JPG

Location: Tilden and Empire Mine  
Photographer: Jonathan Moody  
Date/Time: 9/14/2022 8:24 AM  
Description: pH, temperature and turbidity measurements on train #2 at the treatment facility for the Tilden tailings basin discharge. Per Michael Korvela, these continuous measurements are for operational purposes only. At the time of the inspection, the turbidity measurement had an active alarm.

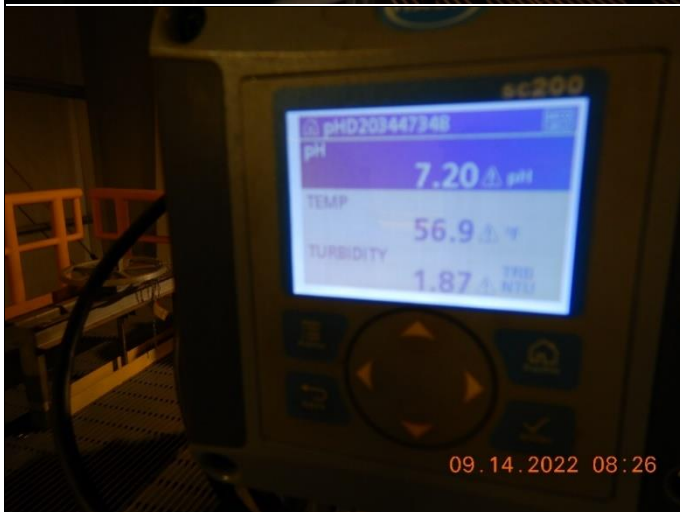
12: DSCN0971.JPG

Location: Tilden and Empire Mine  
Photographer: Jonathan Moody  
Date/Time: 9/14/2022 8:26 AM  
Description: pH, Temperature and Turbidity measurements on train #1 at the treatment facility for the Tilden tailings basin discharge. Per Michael Korvela, these continuous measurements are for operational purposes only. At the time of the inspection, pH, temperature, and turbidity all had active alarms.

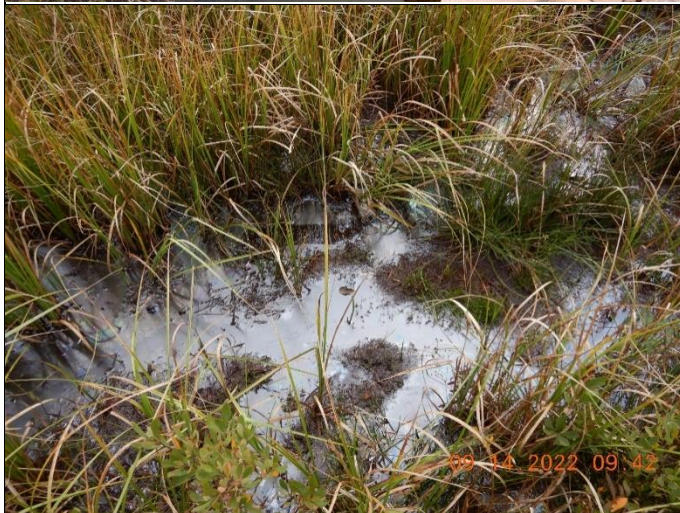
19: DSCN0983.JPG

- USEPA observed and conducted field monitoring on flowing water originating from a location near the toe of the outslope of the east side of the Tilden tailings basin, at a location north of the Gribben Clarification Facility. The waterway is shown in photos 19 through 24, including a video of the flowing water. This location is a possible daylighted seep, which is not monitored as an NPDES outfall, stormwater monitoring location, nor an SSMP location. USEPA field monitoring at this location showed a conductivity of greater than 1,000  $\mu\text{S}/\text{cm}$ , which is above the background values.

Description: Location of possible daylighted seep at the east side of the tailings basin. The water had an iridescent sheen.

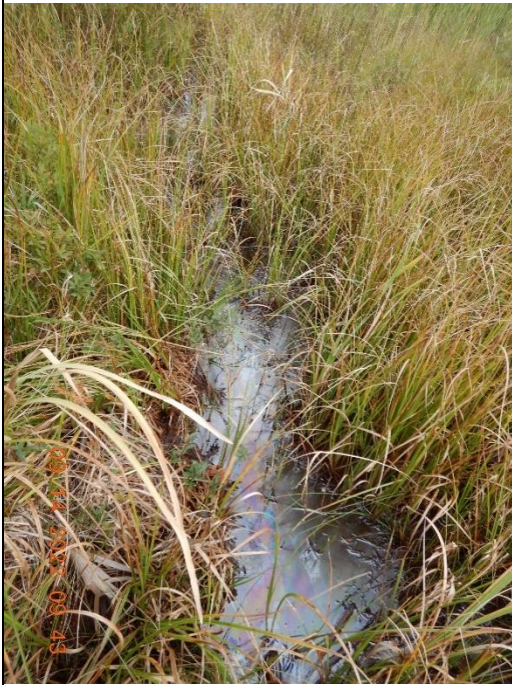
20: DSCN0984.JPG

Description: Location of possible daylighted seep at the east side of the tailings basin. Flow was visible. The water had an iridescent sheen.

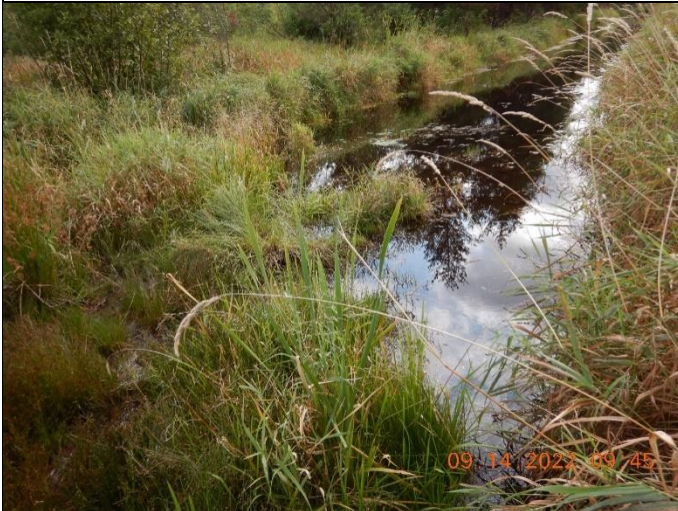
21: DSCN0985.JPG

Description: Location of possible daylighted seep at the east side of the tailings basin. Camera is facing downstream. Location of monitoring point 04.

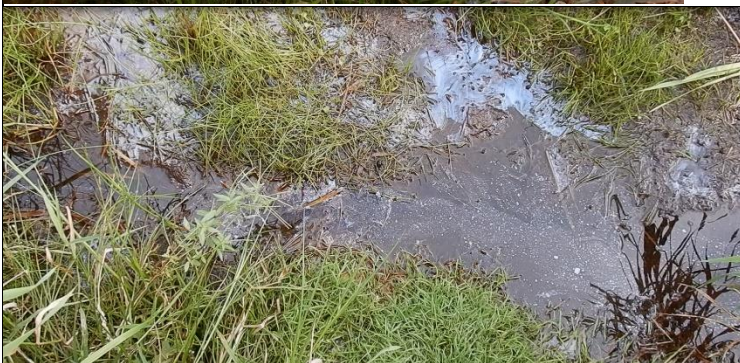
22: DSCN0986.MP4

the waterway shown in photo 21 where monitoring point 04 was conducted. At the time of the inspection, there was an iridescent sheen on this water at this location.

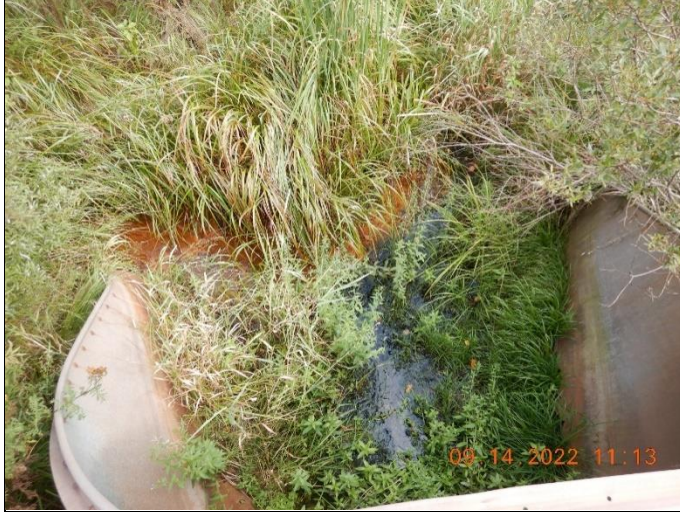
29: DSCN0993.JPG

- USEPA observed and conducted field monitoring of flowing water originating near Hoover Pond impoundment of process water. Water flowing from inside culvert connected to impoundment was originating from an unspecified source. Northeast of the culvert is a possible daylighted seep and EPA field monitoring at this location showed a conductivity of greater than 900  $\mu\text{S}/\text{cm}$  , which is above the background values. The waterway, culvert, and possible daylight seep are depicted in photos 29 through 32.

Location: Tilden and Empire Mine  
Photographer: Jonathan Moody  
Date/Time: 9/14/2022 11:13 AM  
Description: Downstream of Hoover Pond at the downstream end of a culvert leading away from Hoover Pond. This is the historic E003 discharge which is no longer an active outfall. At the time of the inspection there was water flowing through the culvert and joining with another surface conveyance of red discolored water. Monitoring point 06.

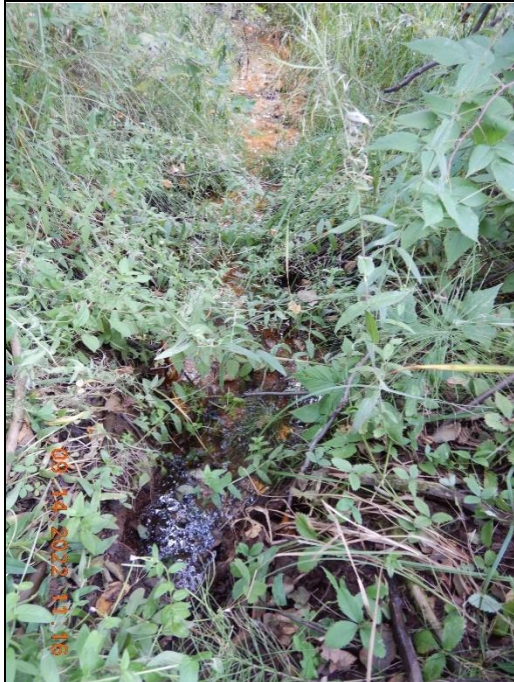
30: DSCN0994.JPG

Location: Tilden and Empire Mine  
Photographer: Jonathan Moody  
Date/Time: 9/14/2022 11:16 AM  
Description: Northeast of the location of the downstream end of the culvert shown in photo 29. Possible location of a daylighted seep. At the time of the inspection the water shown in this photo was flowing and had a red/orange discoloration.

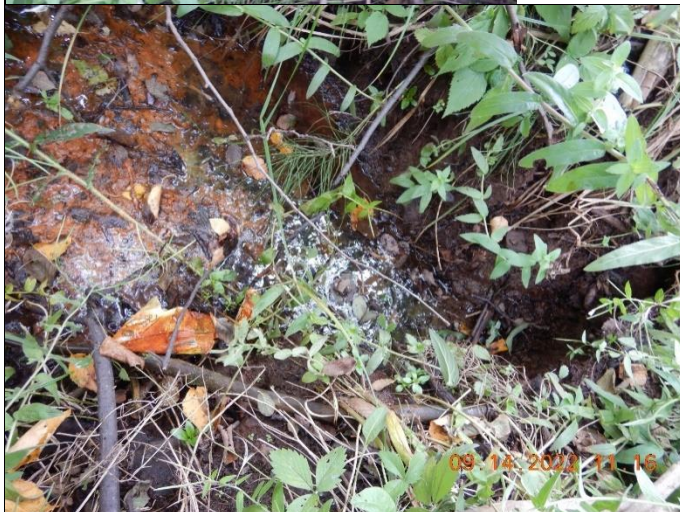
31: DSCN0995.JPG

was flowing and had a red/orange discoloration.

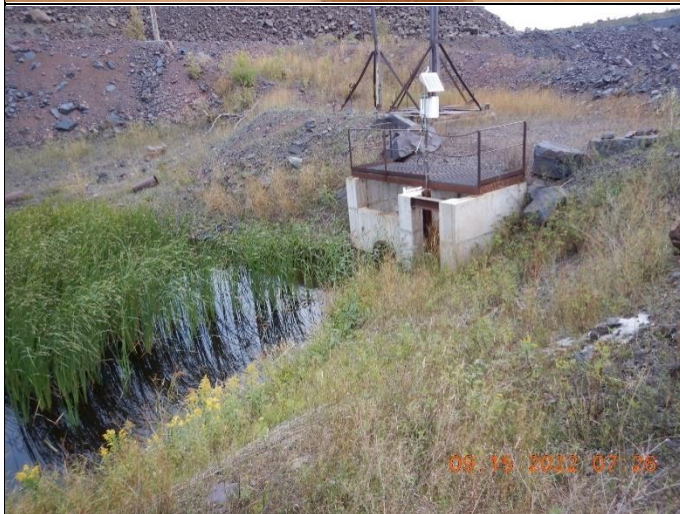
37: DSCN1001.JPG

- During the inspection, USEPA observed waste material from mining operations adjacent to a waterway known as Partridge Creek. Runoff from the slopes of the waste material would drain into a waterway flowing through a historic outfall 003. This is shown in Photos 37 through 42. The Facility representatives stated that NPDES compliance monitoring was no longer being conducted at this location because the discharge was not considered a wastewater. A copy of a cover letter from Michigan Department of Environmental Quality (now EGLE) on June 29, 2017, transmitting the compliance evaluation inspection notes from an April 27, 2017, visit at the Empire Mine (MI0000094) was given to EPA. The June 29, 2017 cover letter was provided as the record of the approval from EGLE. The June 29, 2017, letter references a low selenium concentration and no active mine pit dewatering as justification for changing the NPDES permit, which had expired in 2016.

Location: Tilden and Empire Mine  
Photographer: Jonathan Moody  
Date/Time: 9/15/2022 7:26 AM  
Description: Historic Empire outfall 003.  
At the time of the inspection, water flowing from this location was

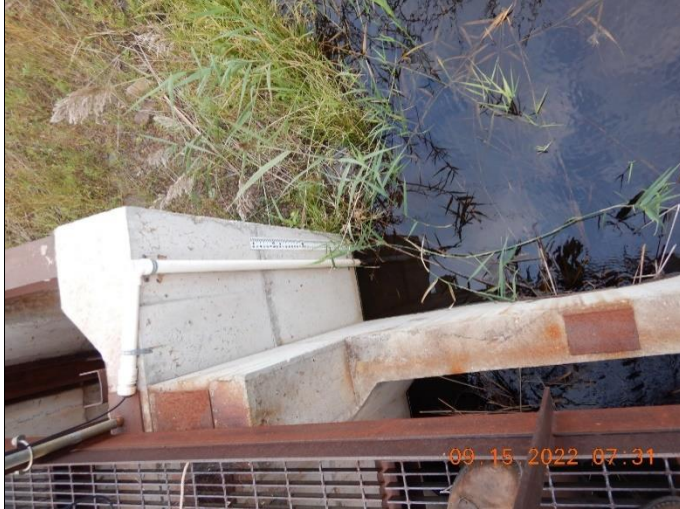
39: DSCN1003.JPG

Location: Tilden and Empire Mine  
Photographer: Jonathan Moody  
Date/Time: 9/15/2022 7:31 AM  
Description: Staff gage at the historic Empire Outfall 003. Facility representatives said they no longer use this staff gage. Location of monitoring point 09.

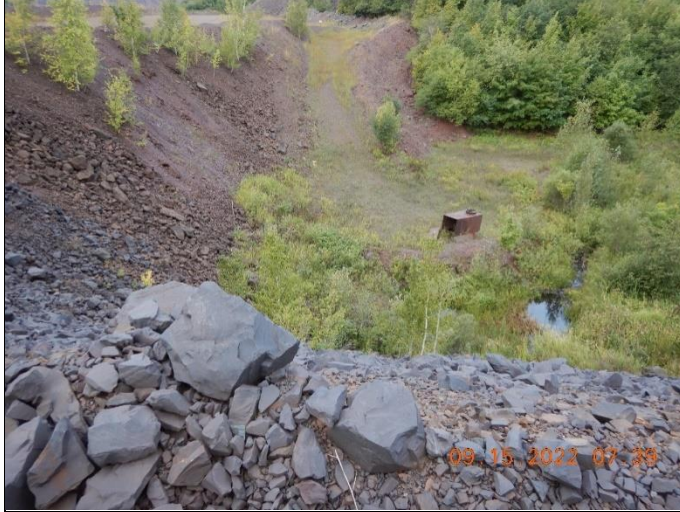
42: DSCN1006.JPG

- Figure 5 in the SWPPP includes a map showing the locations of significant materials, including rock stockpiles. Runoff from some rock stockpiles adjacent to the location of the historic Empire outfall E003. No stormwater monitoring point nor NPDES monitored outfall was associated with the control structure at the historic outfall E003.

Location: Tilden and Empire Mine  
Photographer: Jonathan Moody  
Date/Time: 9/15/2022 7:39 AM  
Description: Area tributary to Partridge Creek. Runoff from this area is tributary to the control structure shown in photos 37 through 41.

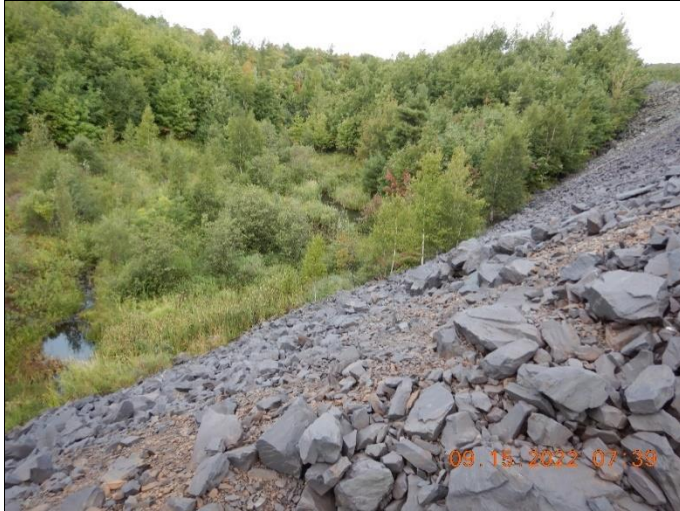
43: DSCN1007.JPG

Location: Tilden and Empire Mine  
Photographer: Jonathan Moody  
Date/Time: 9/15/2022 7:39 AM  
Description: Area tributary to Partridge Creek. Area tributary to Partridge Creek. Runoff from this area is tributary to the control structure shown in photos 37 through 41.

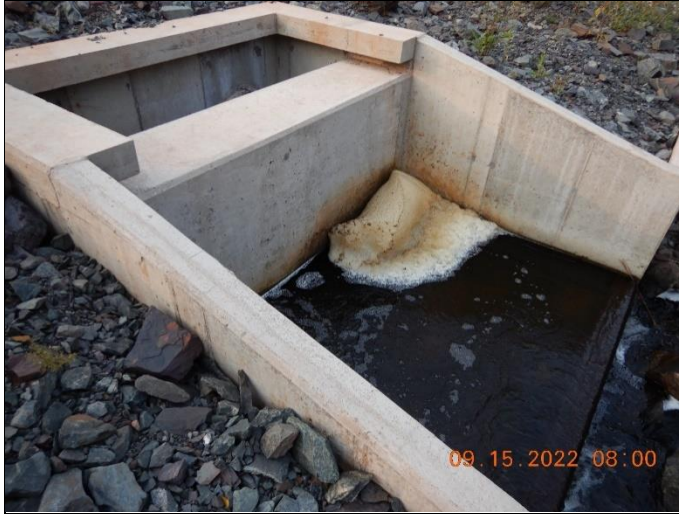
45: DSCN1009.JPG

Location: Tilden and Empire Mine  
Photographer: Jonathan Moody  
Date/Time: 9/15/2022 8:00 AM  
Description: At the location where replenishment water is discharged at CC-95. This location flows into a waterbody north of the collection point and out through the stormwater monitoring location.

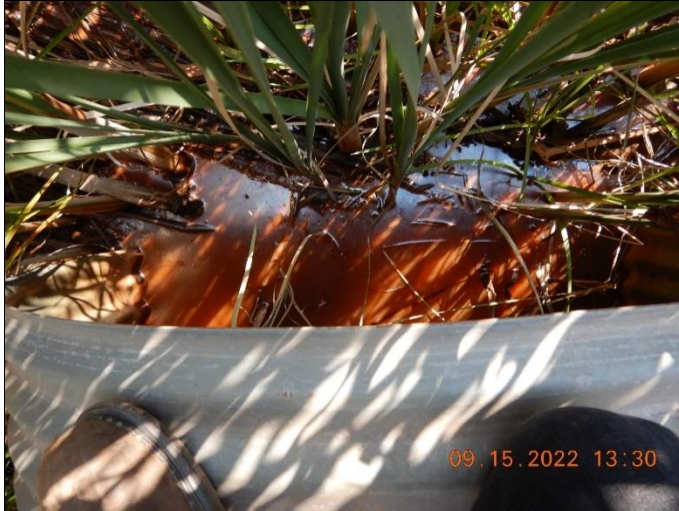
63: DSCN1027.JPG

- Locations CC-291 and CC-292 were not in the current version of the SWPPP available during the inspection, and are not associated with an NPDES outfall. USEPA field monitoring during the inspection showed a specific conductivity of 623  $\mu\text{S}/\text{cm}$  and 439  $\mu\text{S}/\text{cm}$  respectively. At the time of the inspection, these monitoring locations were flowing despite dry weather conditions.
- During the inspection, USEPA observed unvegetated rock piles in the tributary for the water flowing to the control structure for the historic Empire outfall E003.
- Several on-site water bodies present with dark orange coloring, suggesting high levels of iron and conductivity within the water.
  - Stormwater monitoring location '13' or CC-179, was visited during the inspection. The water at this location had an unnatural red color and is shown in photo 63.
