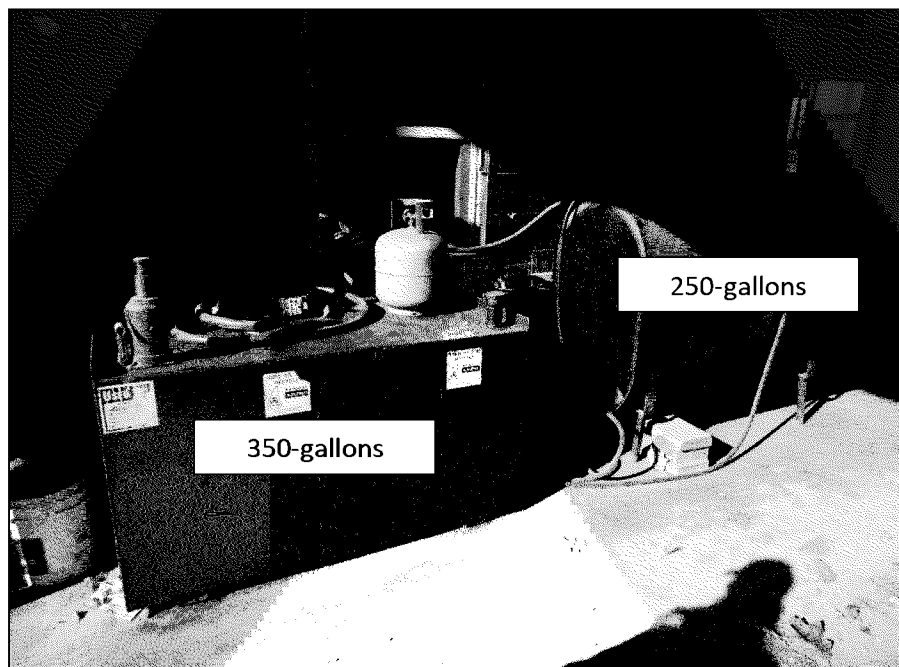
**Photograph 1.** Colony Auto Salvage 10/24/2024 10:34 DSCN9034.JPG

Description: View of two double-walled containers inside the main garage used for storing fuel extracted from used vehicles. The EPA Inspection Team estimated tank sizes were 250-gallons and 350-gallons.

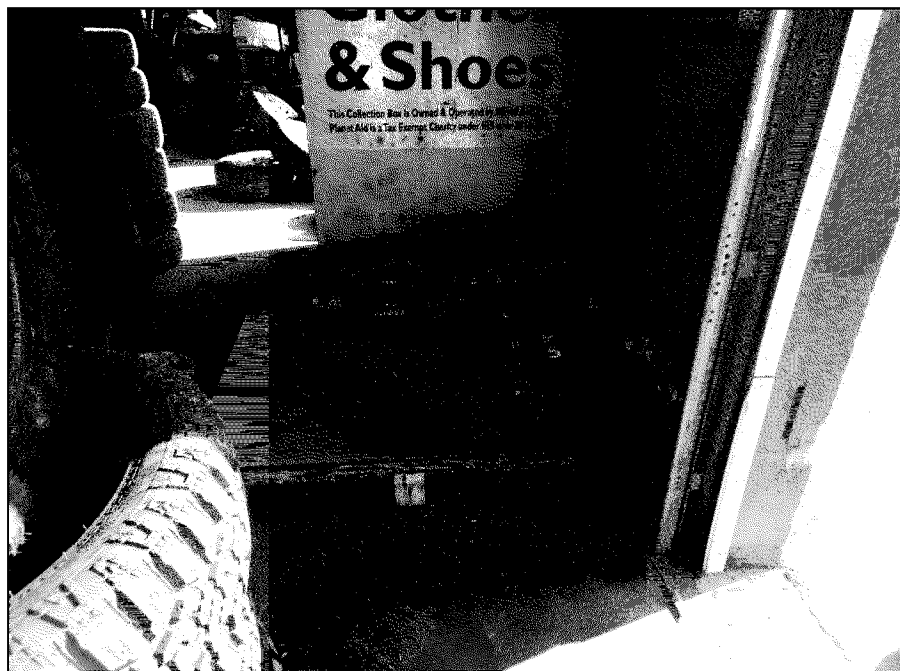
**Photograph 2.** Colony Auto Salvage 10/24/2024 10:35 DSCN9035.JPG

Description: View of scrap vehicle batteries stored inside the garage on wooden pallets.

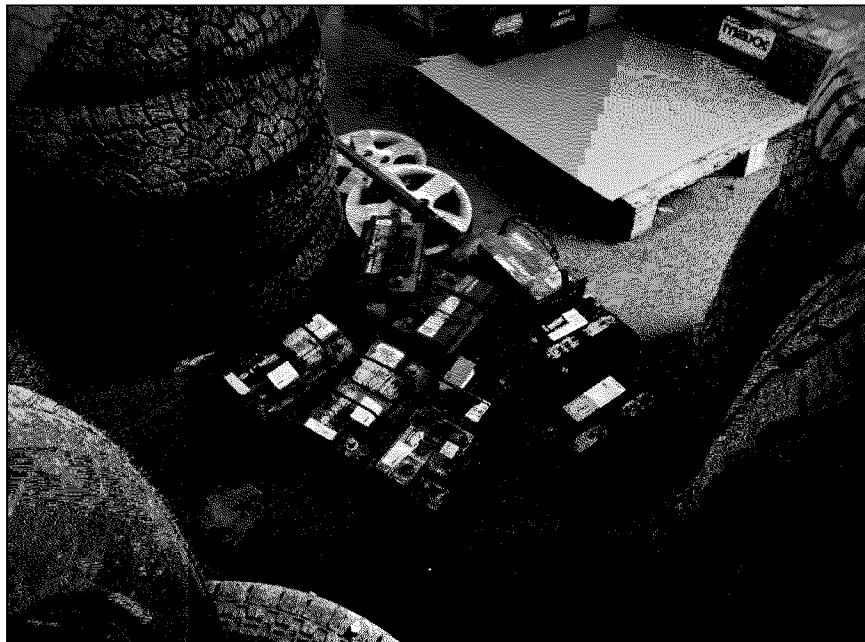
**Photograph 3.** Colony Auto Salvage 10/24/2024 10:35 DSCN9036.JPG

Description: View of scrap vehicle batteries stored inside the garage on the concrete floor adjacent to the used batteries on the pallet.

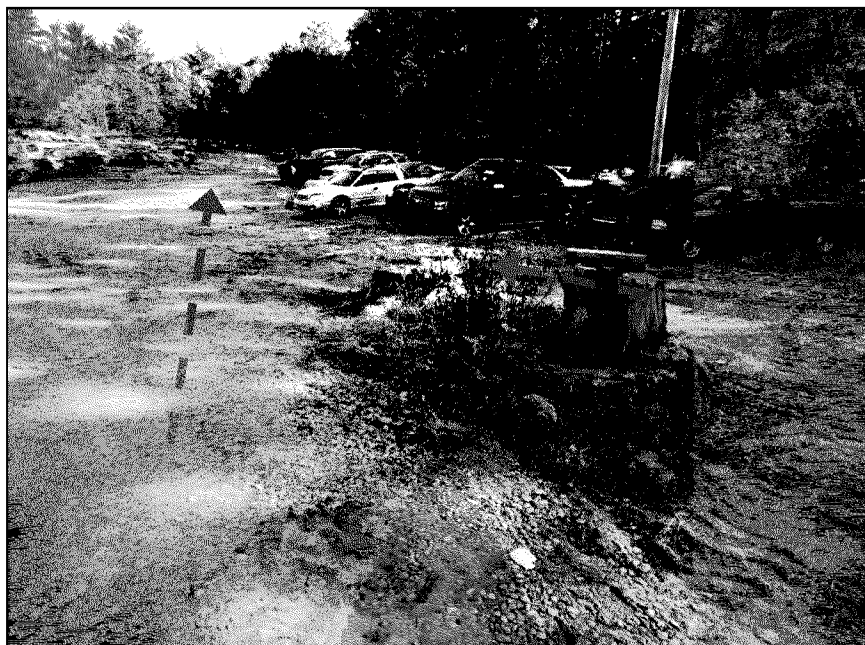
**Photograph 4.** Colony Auto Salvage 10/24/2024 10:40 DSCN9038.JPG

Description: Downgradient view, facing northeast, of end of life vehicles (ELVs) stored in the eastern portion of the Facility. Note the stormwater flow paths based on observed Facility grading.

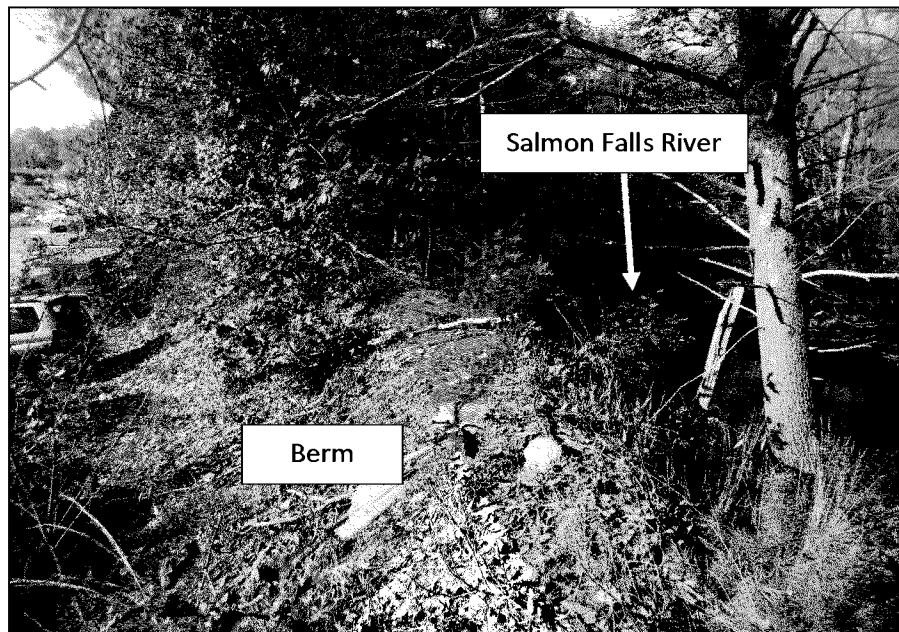
**Photograph 7.** Colony Auto Salvage 10/24/2024 10:34 DSCN9034.JPG

Description: View, facing west, of an earthen berm along the Facility's northern boundary. Salmon Falls River was approximately 10 feet north of the berm. The berm's height was approximately 4-6 feet high along the whole northern boundary.

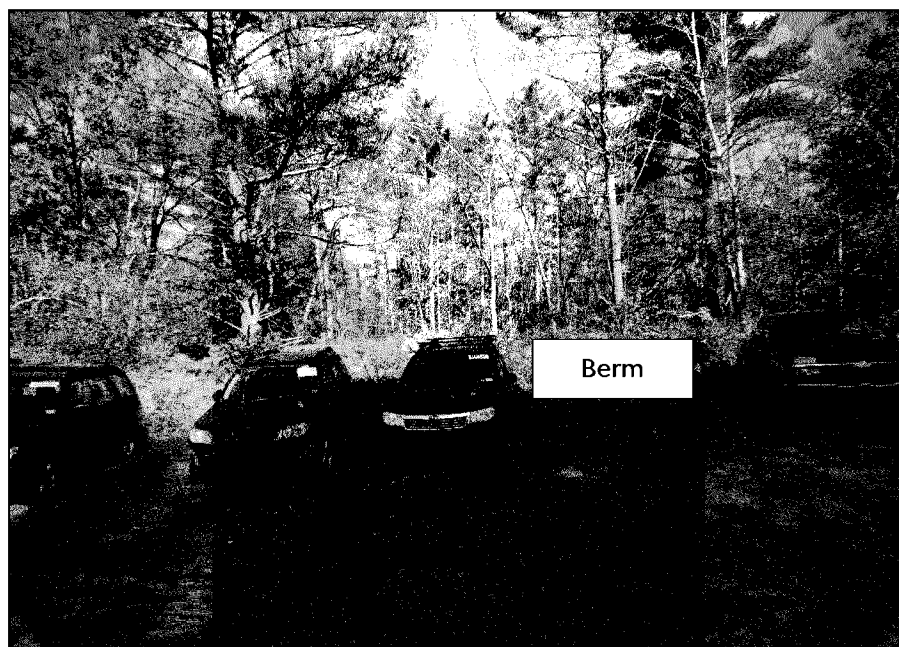
**Photograph 8.** Colony Auto Salvage 10/24/2024 10:46 DSCN9043.JPG

Description: View, facing north, of ELVs along the Facility's northern boundary. Note the berm in the background which separates the Facility from the Salmon Falls River.

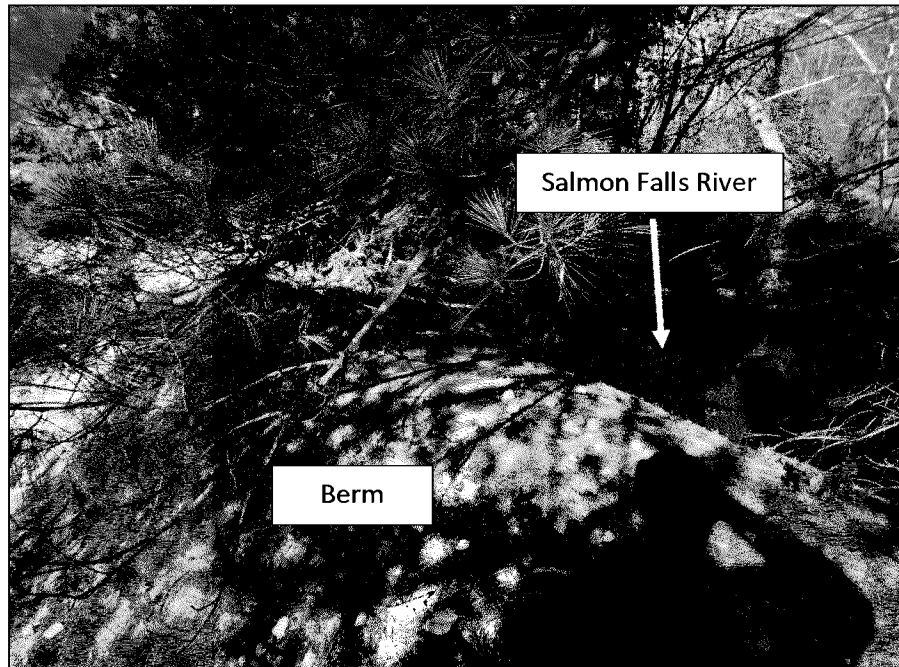
**Photograph 9.** Colony Auto Salvage 10/24/2024 10:48 DSCN9044.JPG  
Description: View, facing north, of the berm along the Facility's northern boundary.

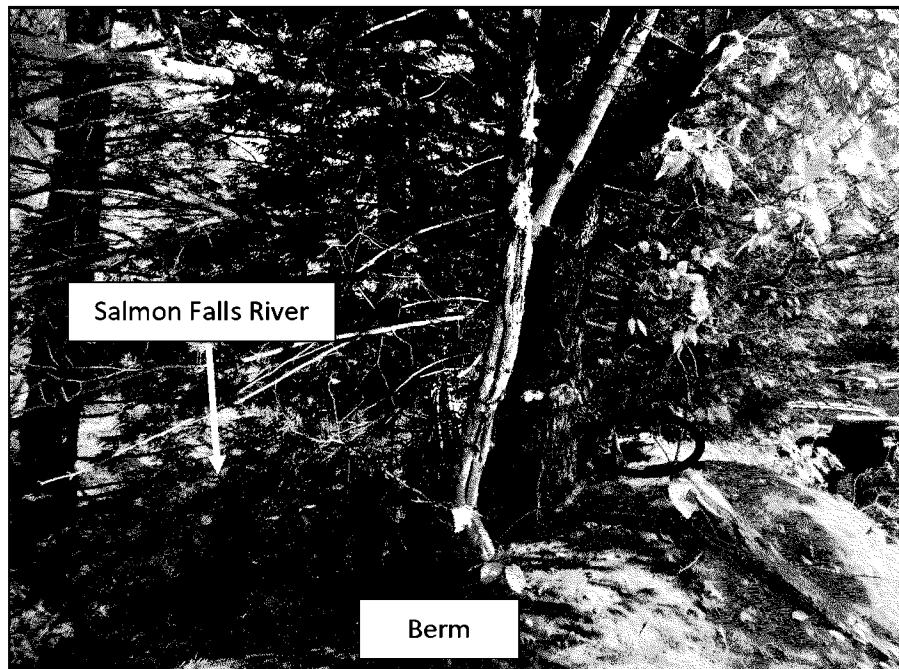
**Photograph 10.** Colony Auto Salvage 10/24/2024 10:49 DSCN9046.JPG  
Description: View, facing east, of the berm along the Facility's northern boundary. Note the used tire (red circle) and adjacent Salmon Falls River.

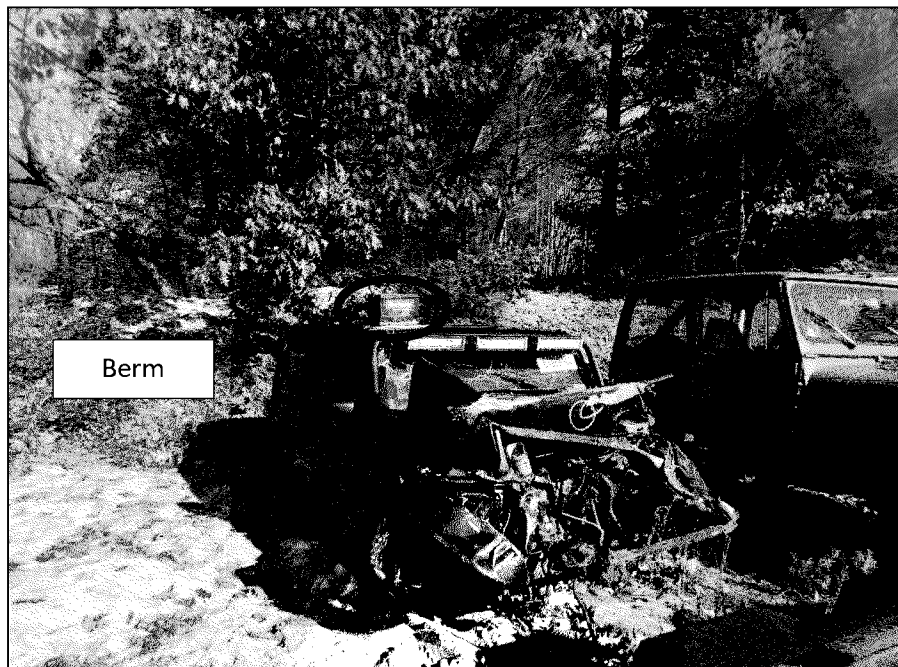
**Photograph 11.** Colony Auto Salvage 10/24/2024 10:50 DSCN9048.JPG

Description: View, facing north, of a used battery (red circle) stored on top of an ELV in the northern portion of the Facility. The Facility representative sent a photograph to the EPA Inspection Team the day of the inspection showing that the battery had been removed (refer to [Appendix B, Exhibit Log](#)).

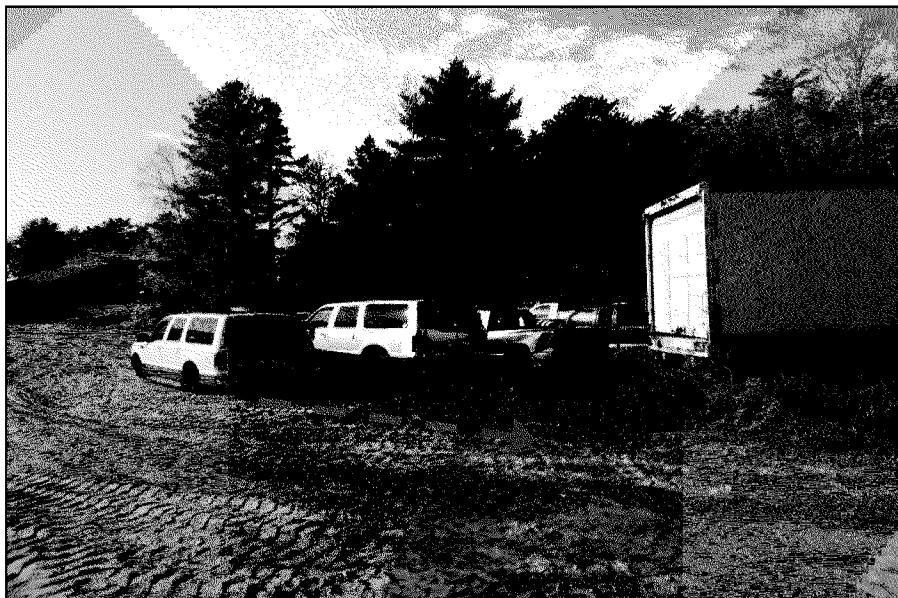
**Photograph 12.** Colony Auto Salvage 10/24/2024 10:54 DSCN9052.JPG

Description: View, facing southwest, of a low point in the northern portion of the Facility. Note the direction that stormwater would flow from the south to the north based on the ground sloping to the north.

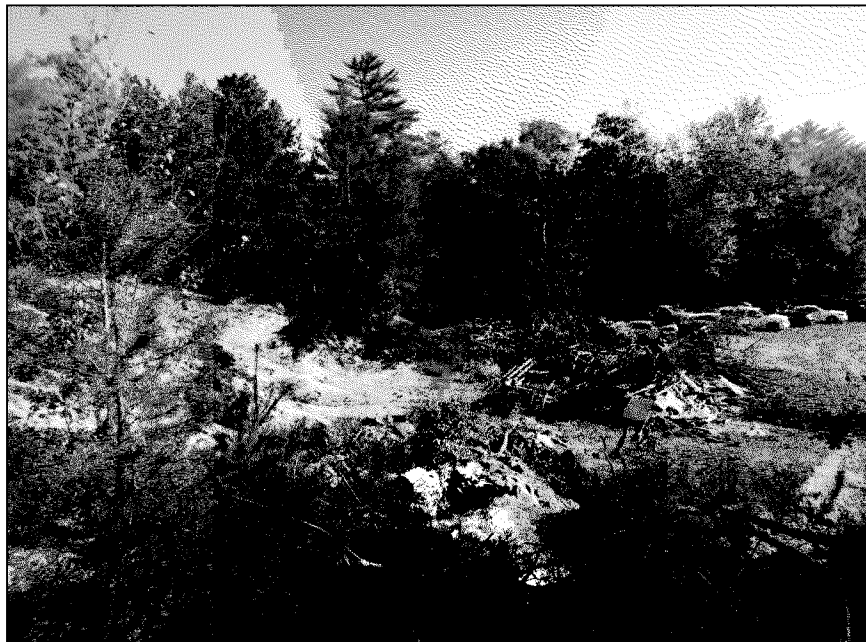
**Photograph 13.** Colony Auto Salvage 10/24/2024 11:03 DSCN9055.JPG

Description: Downgradient overview, facing northeast, of the northernmost portion of the Facility. Note, the location of the photograph is approximately 20 feet higher in elevation than the areas shown in Photographs 11 and 12.

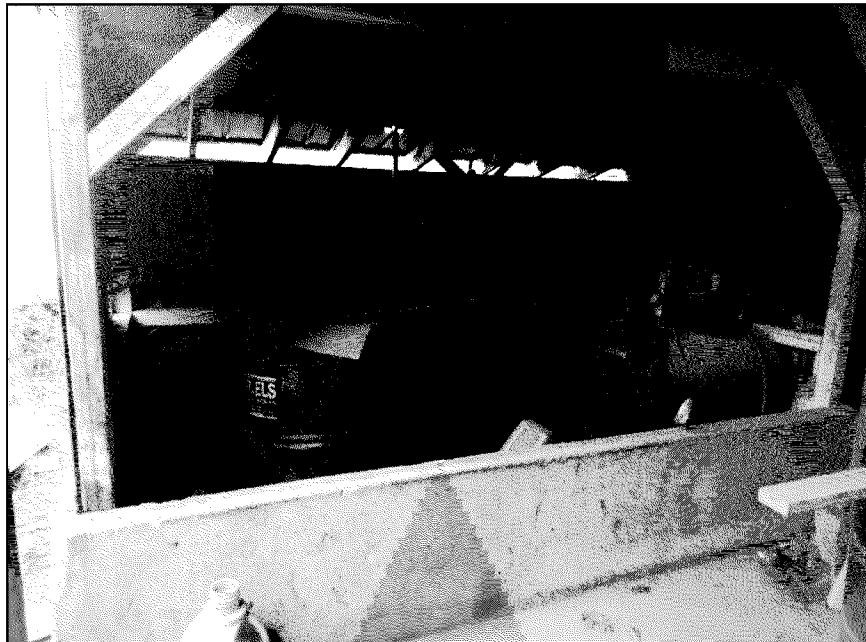
**Photograph 14.** Colony Auto Salvage 10/24/2024 11:13 DSCN9058.JPG

Description: View of used oil and gasoline stored inside concrete secondary containment and under cover.

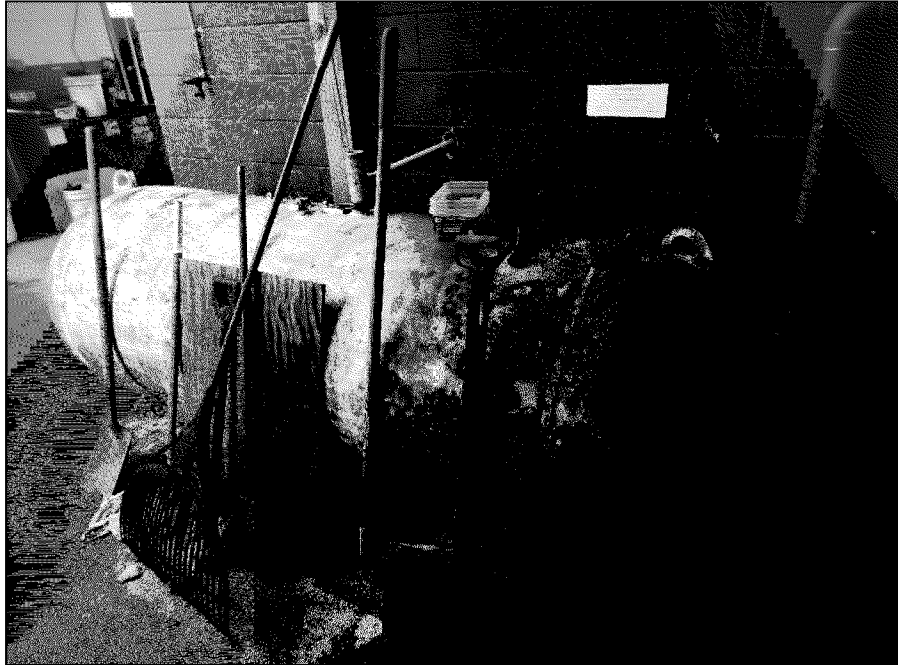
**Photograph 15.** Colony Auto Salvage 10/24/2024 11:14 DSCN9059.JPG  
Description: View of a tank located under cover used to store used antifreeze.

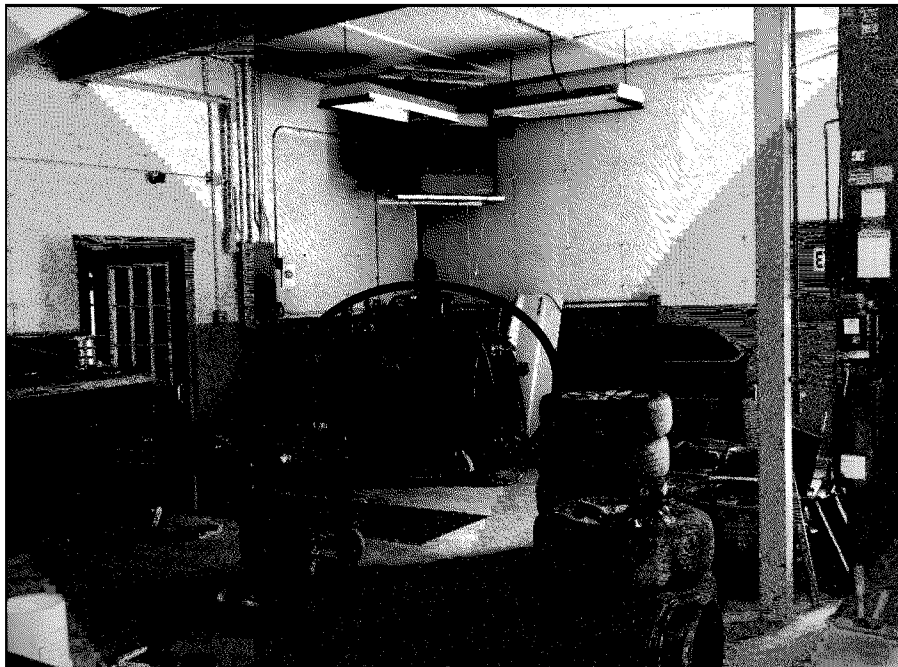
**Photograph 16.** Colony Auto Salvage 10/24/2024 11:16 DSCN9060.JPG  
Description: View of a mobile gas buggy (red circle) used to store oil drained from vehicles. The gas buggy was located inside the main garage.

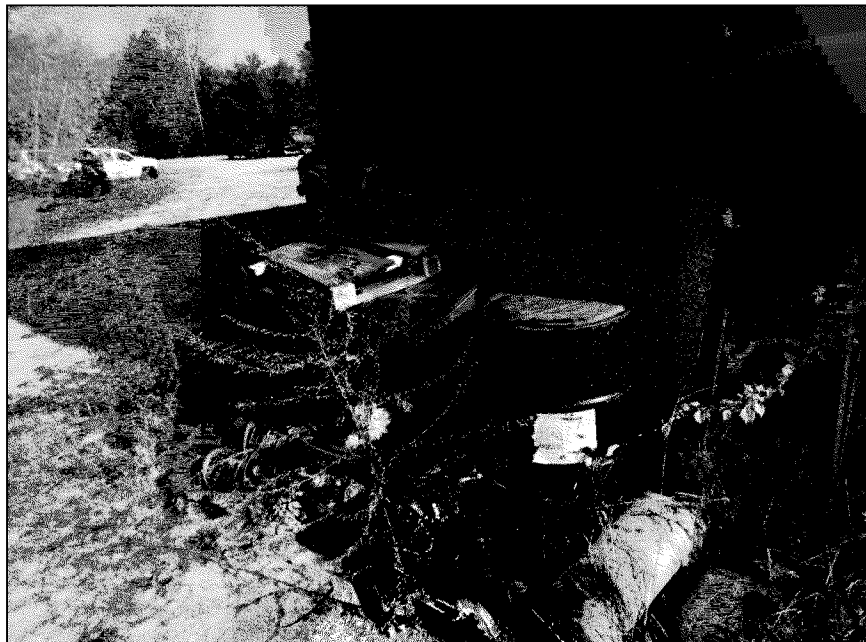
**Photograph 17.** Colony Auto Salvage 10/24/2024 11:17 DSCN9062.JPG

Description: View of three 55-gallon barrels stored outside on the ground. The two barrels on the left of the image had lids and contained metal scrap, and the third on the right side was empty.

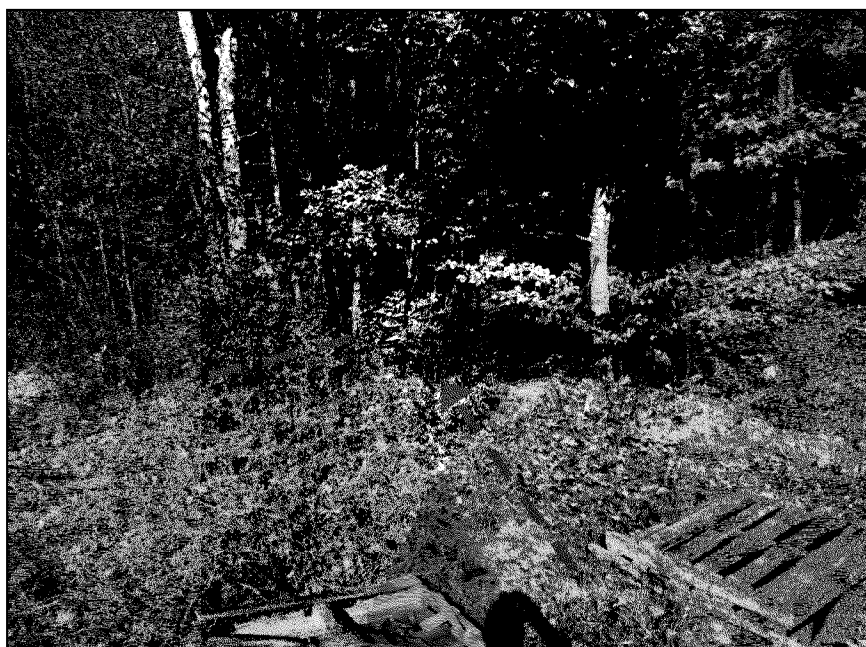
**Photograph 18.** Colony Auto Salvage 10/24/2024 11:19 DSCN9063.JPG

Description: View, facing west, of a low point along the western portion of the Facility. There was a wooded hillside serving as the western boundary of the Facility. Note the blue arrows indicating the direction stormwater would flow based on observed ground sloping.

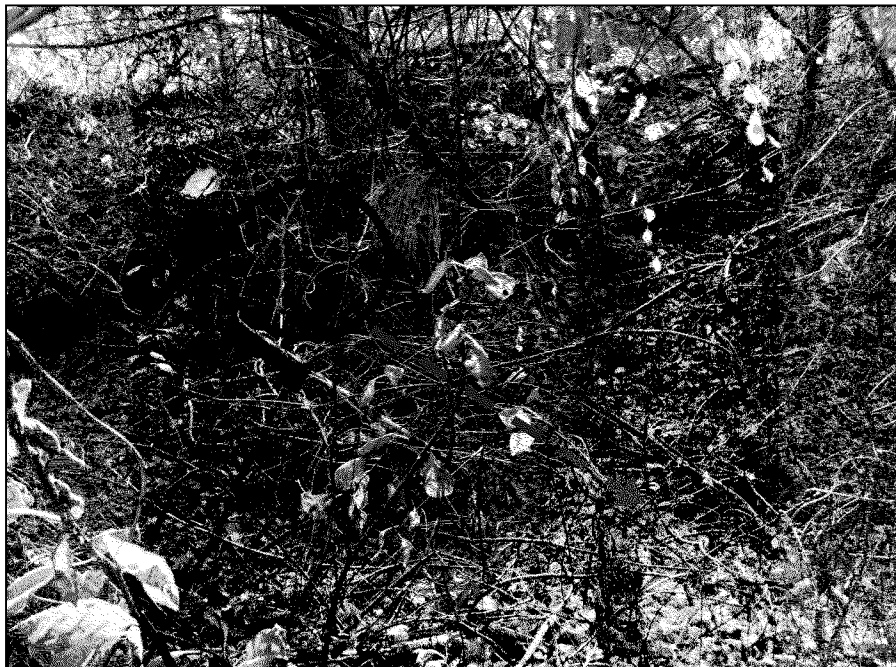
**Photograph 19.** Colony Auto Salvage 10/24/2024 11:22 DSCN9044.JPG

Description: View, facing south, of a corrugated plastic pipe (red circle) that conveys stormwater from the Facility access road off Milton Road into the western portion of the Facility. The western portion of the Facility is limited in industrial activity and primarily houses a storage garage.

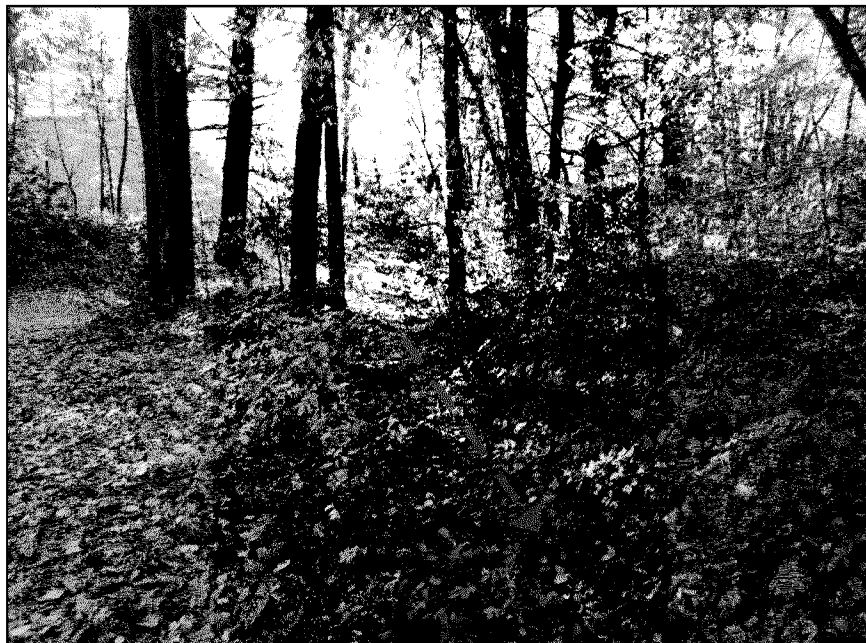
**Photograph 22.** Colony Auto Salvage 10/24/2024 11:31 DSCN9067.JPG

Description: Upgradient view, facing south, of the stormwater flow path into the corrugated pipe.
