**Region 4 Enforcement Division**  
**61 Forsyth Street, SW**  
**Atlanta, GA 30303**  
**INSPECTION REPORT**

| <b>Regulatory Program(s)</b> | NPDES – Industrial Pretreatment Program | | |
| <b>Company Name:</b> | Kia Motors, Inc. | | |

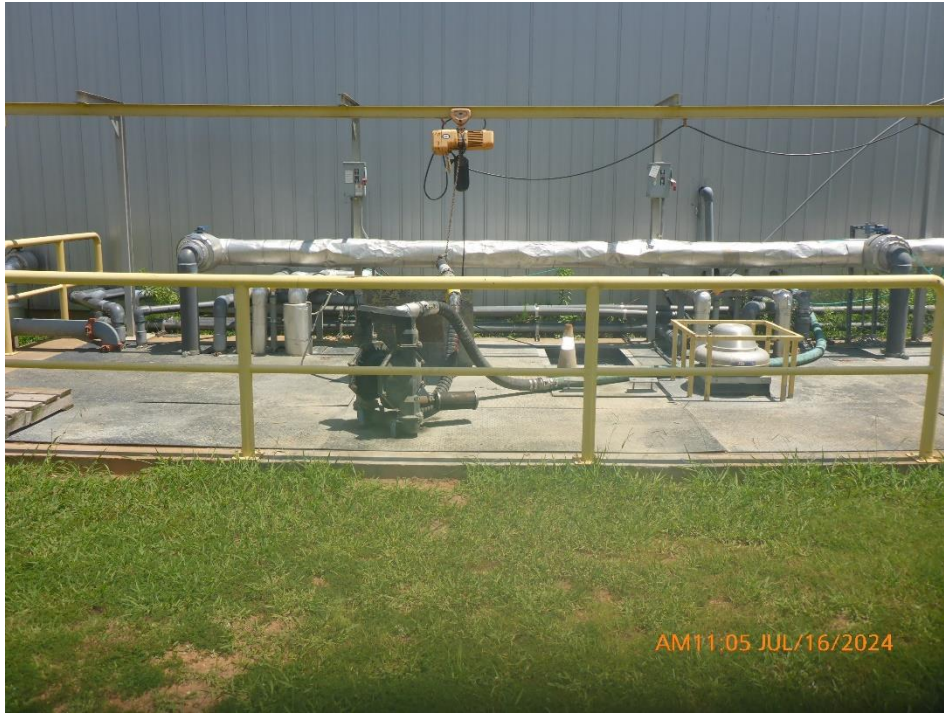
Wastewater from the production area flows into three inground pits that are approximately 66,000 gallons each (see Photograph 1). Wastewater is then pumped into two 100,000-gallon equalization tanks in parallel (see Photograph 2). Wastewater is

**Photograph 1:** Three 66,000-gallon wastewater collection pits (underground).

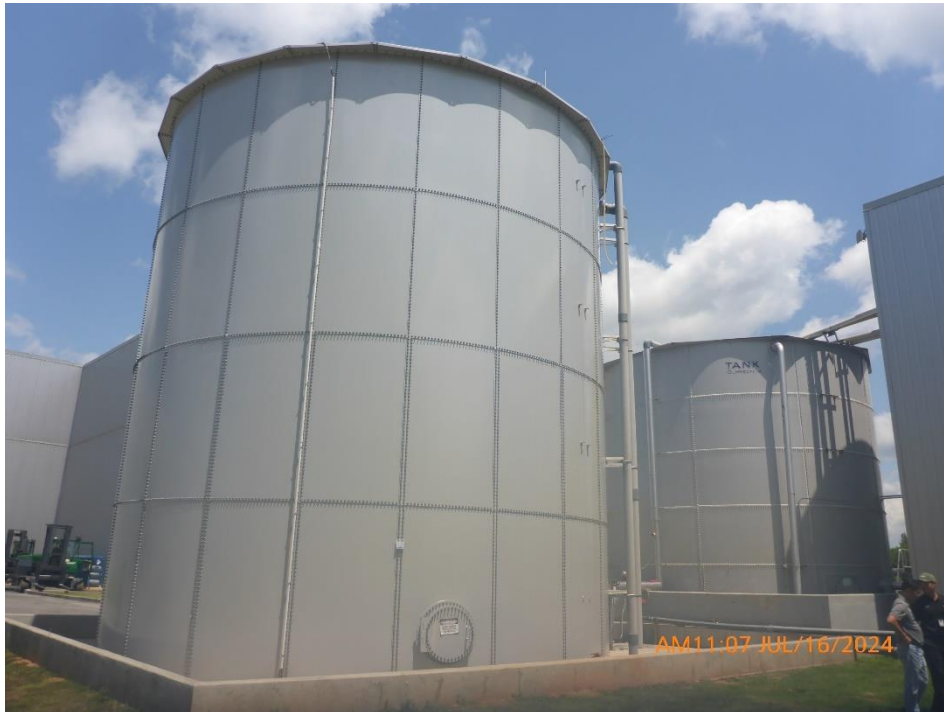
**Photograph 2:** Wastewater equalization tanks.

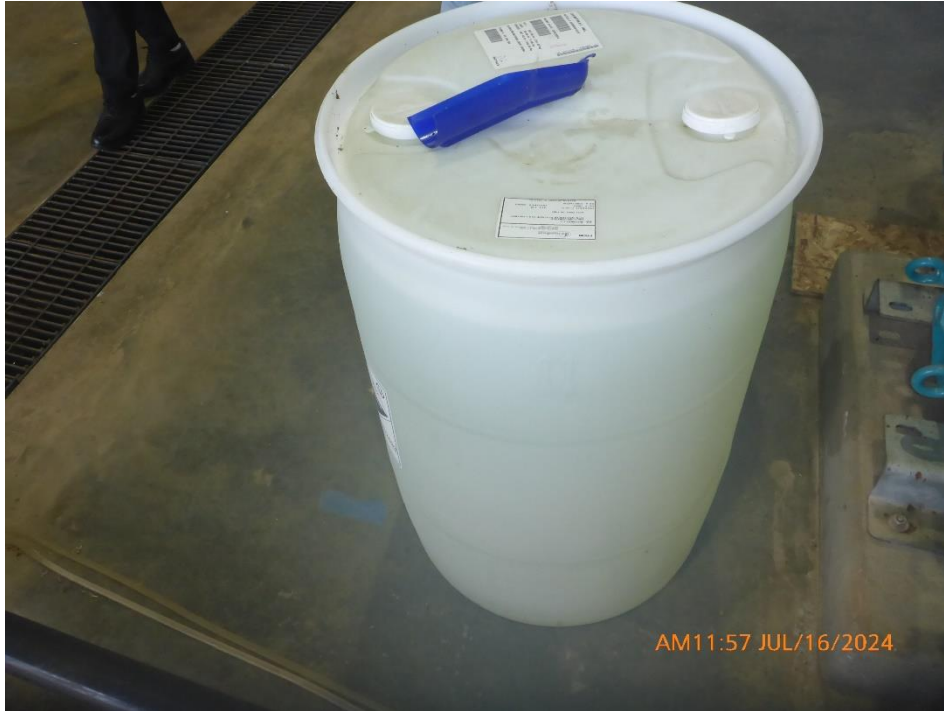
2. During the site inspection, the inspection team observed that the facility was not storing all chemicals in secondary containment. According to the facility representatives, chemicals are only stored in secondary containment if they are actively in use (see Photographs 3 and 5). Additionally, the inspection team observed a chemical tote under the paint line in the paint shop that was not fully on secondary containment. This tote was in the area of a floor drain discharging to the facility's wastewater pretreatment process. The inspection team recommends that the facility ensure that all chemicals are properly stored in secondary containment to ensure that they do not accidentally enter the wastewater treatment system in the event of a leakage or rupture.

**Photograph 3:** Drum of chlorine scavenger not on secondary containment near a floor drain in the wastewater treatment area.

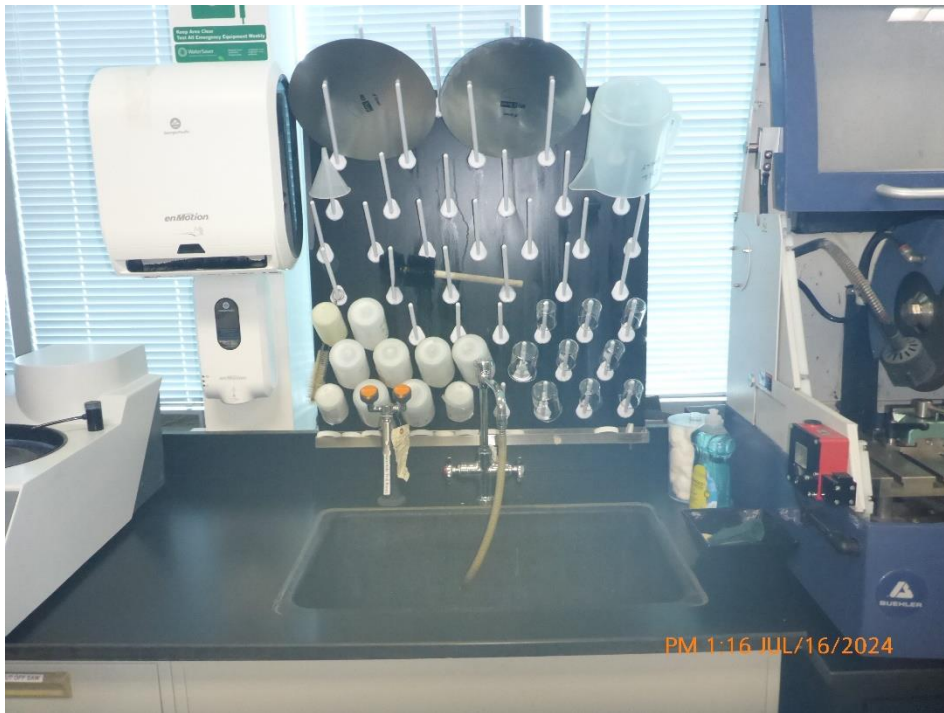
equipment. According to the facility representatives, this sink discharges to the facility's wastewater treatment process (see Area of Concern 1).

1. During the site inspection, the inspection team observed a sink in the facility's quality lab that discharges to the facility's wastewater treatment process (see Photograph 4). According to the facility representatives, this sink is used to rinse out lab equipment. The inspection team recommends that the facility place signage above the sink stating that expired or other waste bulk chemicals should not be poured down the drain.

**Photograph 4:** Sink in the quality lab that discharges to the wastewater treatment process.

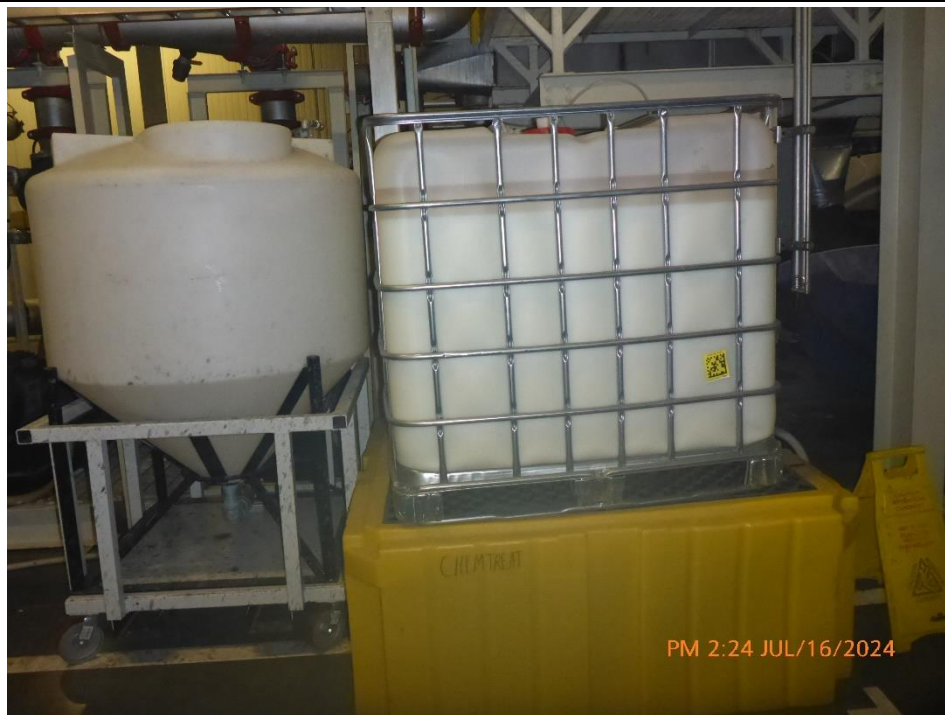
**Photograph 5:** Chemical tote in the paint shop observed to be partially on secondary containment.
