REPORT OF COMPLIANCE EVALUATION INSPECTION  
(INDUSTRIAL STORMWATER)

**Sun Line, Inc.**  
4000 6<sup>th</sup> Street SW  
Cedar Rapids, Iowa 52404

NPDES General Permit No. 1: **IA0018-0012**

ON  
OCTOBER 3, 2022

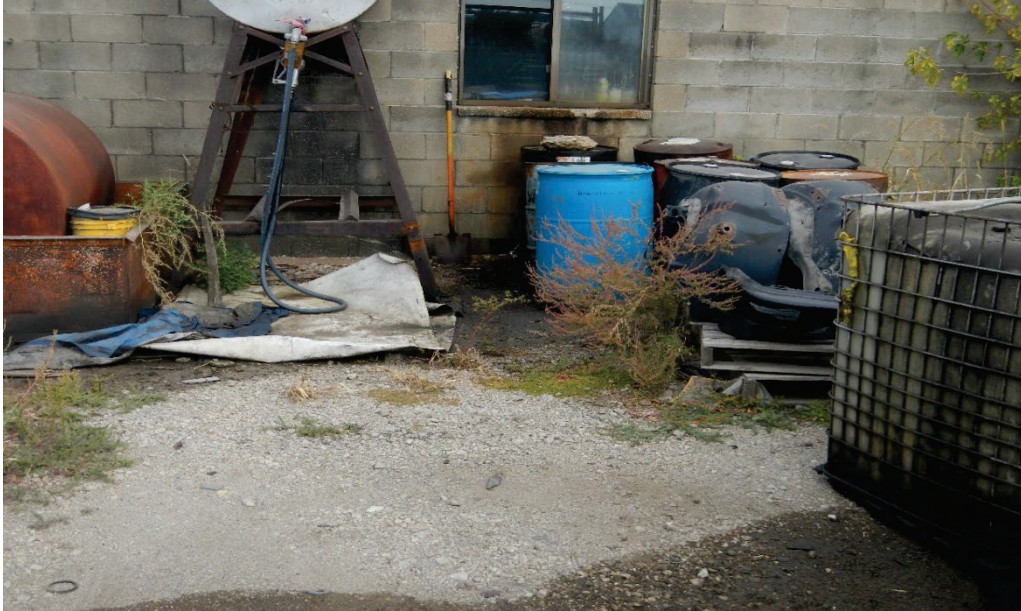
4. I issued NOPF #2 because during our visual inspection of the site, I noticed and pointed out to facility personnel evidence of poor housekeeping practices, improper handling and storing of fluids, and significant ground discoloration throughout the site, especially grounds surrounding the above ground storage tanks, totes, and drums in the vicinity of the vehicles processing building and the vicinity of the baler. I pointed out to facility personnel that the SWPPP and Part III.C.4.B.(4)(5) of the NPDES GP #1 requires good housekeeping practices and spill management.

**Photo 9, significant ground discoloration outside of the vehicle process building**

- 1) Failure to implement the SWPPP. We conducted and documented inspection activity on October 6, 2022. An updated SWPPP is included.
  - 2) Evidence of spills and ground discoloration. An inspection of the salvage yard was conducted on October 6, 2022, that identified the areas of discoloration around the onsite crusher and near a storage warehouse. Corrective actions are being taken:

- a. The warehouse area spill appeared to be a single incident and was easily cleaned up.
    - b. The crusher will have repairs made to the mechanical problems that lead to the ongoing small spills that created the discolored area as well as have catch basins put in place for any residual leakage from crushing cars. All cars that are crushed are evacuated of automotive fluids prior to crushing. Spill kits including hydrophobic mats will be located near the crusher.

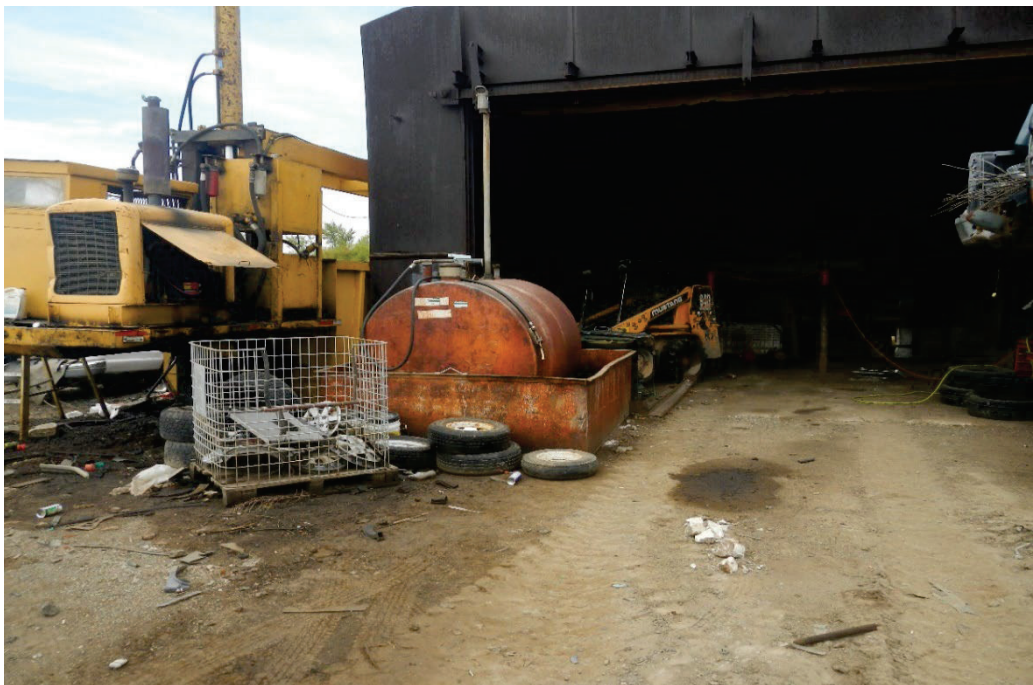
**Photo 14, significant ground discoloration in the vicinity of the bale**

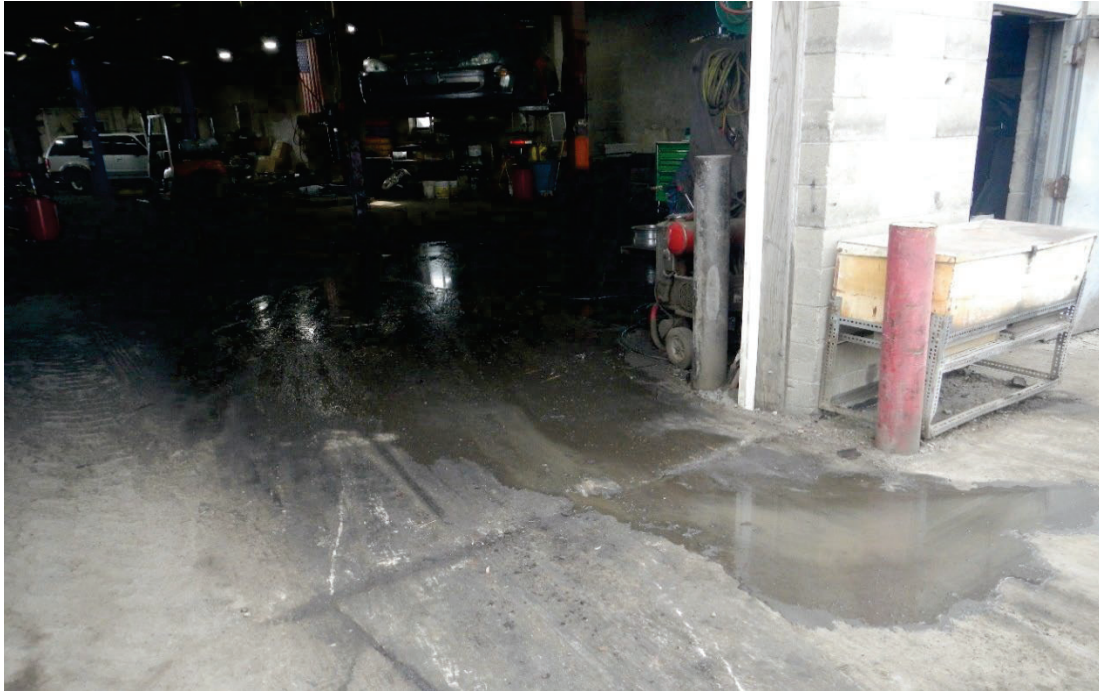
6. During the inspection I noticed and pointed out to Mr. Ackerman, that one of the site's employees was washing spilled oils/fluids on the shop floor directly beneath the vehicle on the hydraulic lift inside the shop to the outside of the building (photo 2 and

3). I explained to Mr. Ackerman that this is a contaminated water, when it leaves the premises, it will be considered a non-stormwater discharge and that should be managed.

**Photo 3, Spilled oils/fluids being washed to the outside**
