## NPDES Compliance Inspection Report

**Gundies, Inc.**

**Bellingham, WA**

**Inspection Date: February 10, 2021**

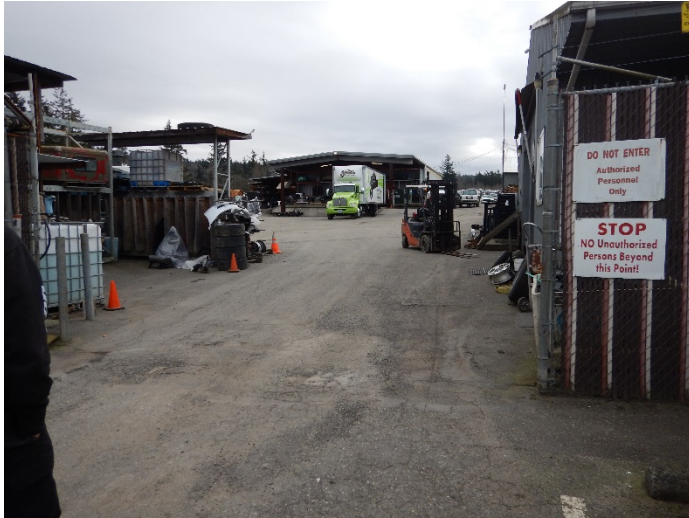
Photo #:01 (DSCN0601)

Description: Facing southeast, photo of the northeast section of the paved area.

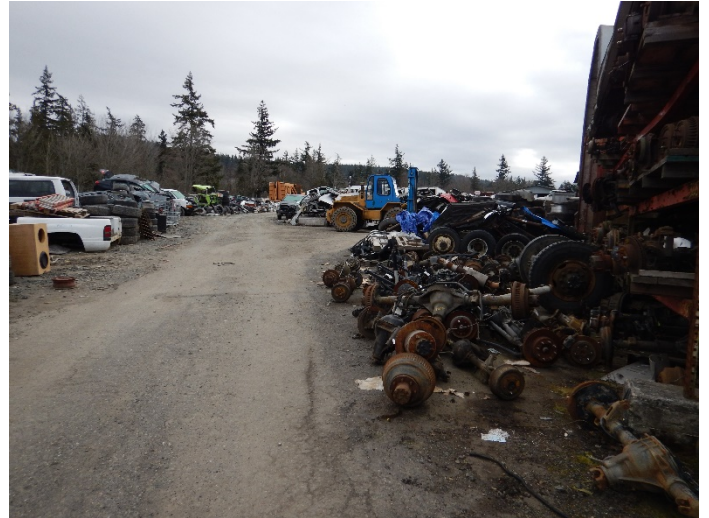
Photo #:02 (DSCN0602)

Description: Facing southeast, photo of parts storage within the paved portion of the facility.

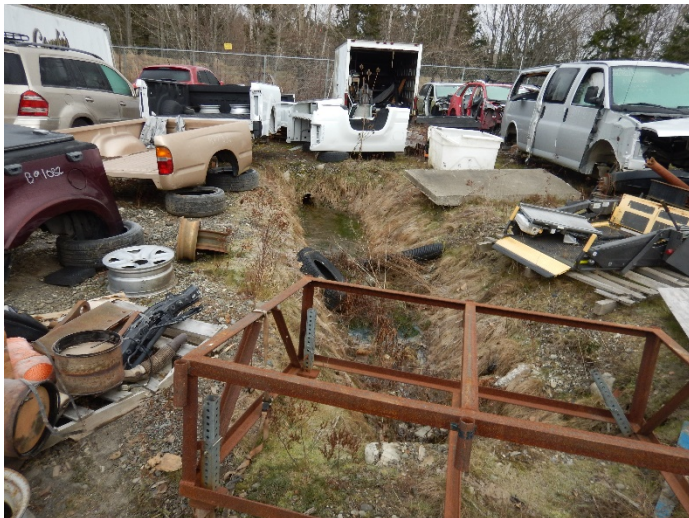
Photo #:03 (DSCN0603)

Description: Facing northeast, photo of one of the bioswales.

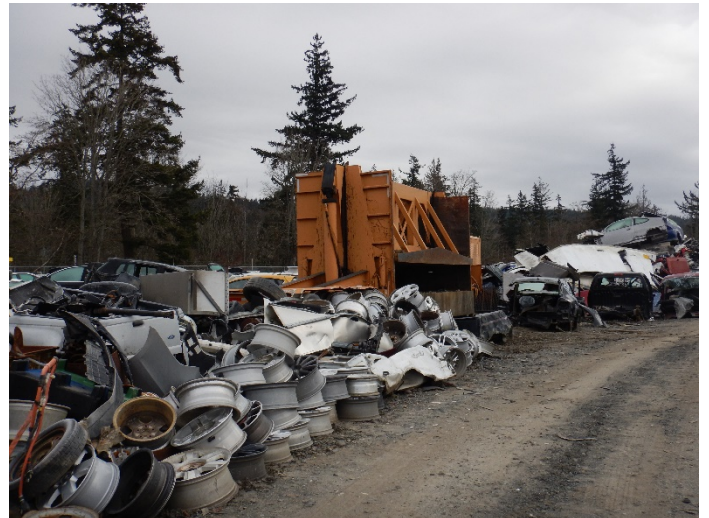
Photo #:04 (DSCN0604)

Description: Facing east, photo of the mobile crusher. Vehicle motors are drained prior to crushing.

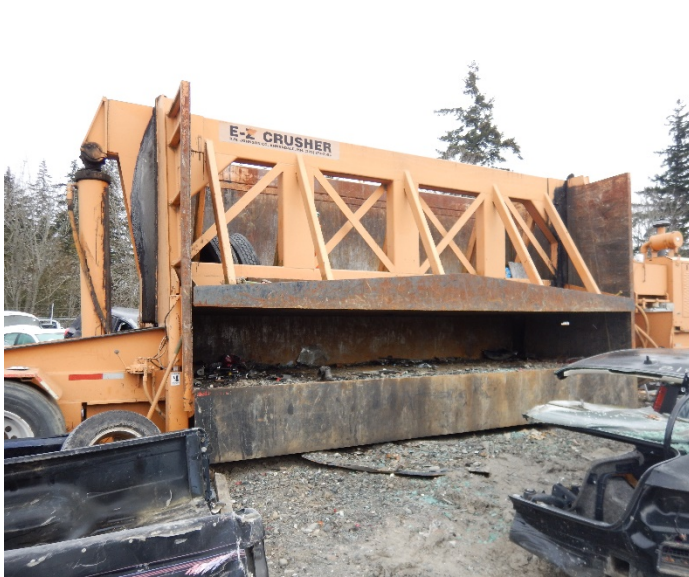
Photo #:05 (DSCN0605)

Description: Facing northeast, photo of the mobile crusher.

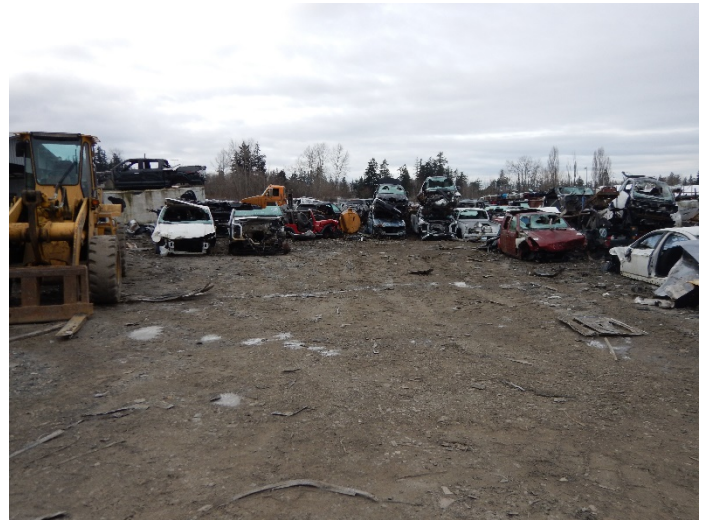
Photo #:06 (DSCN0606)

Description: Facing southeast, photo of stored vehicles and parts in the unpaved yard area.

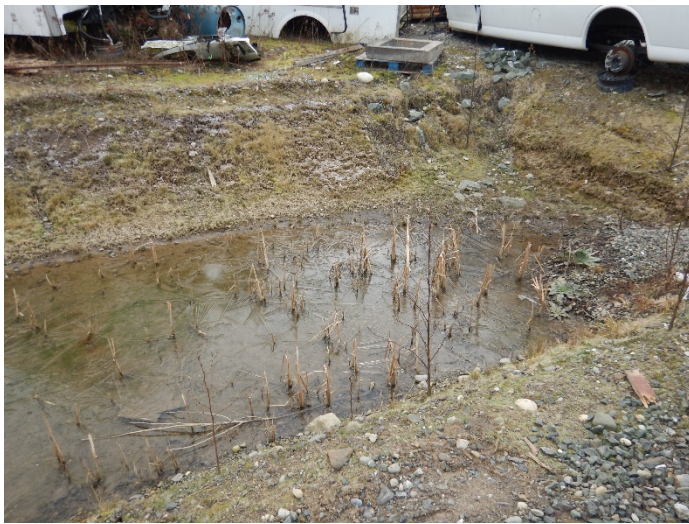
Photo #:07 (DSCN0607)

Description: Photo of one of the vegetated bioswales. The water was completely frozen at the time of the inspection.

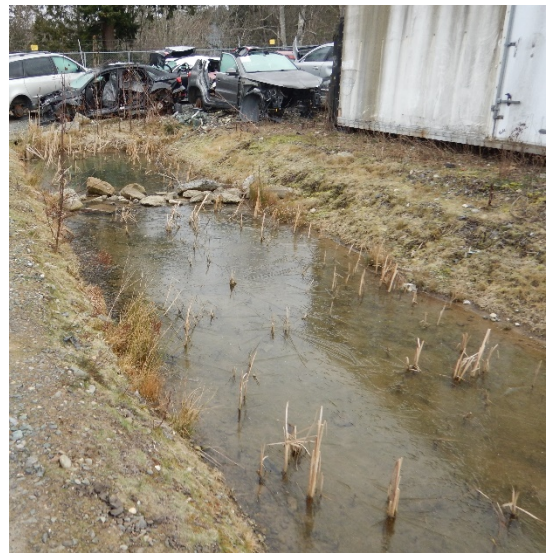
Photo #:08 (DSCN0608)

Description: Facing northeast, photo of one of the vegetated bioswales. Note the rock berm in the middle.

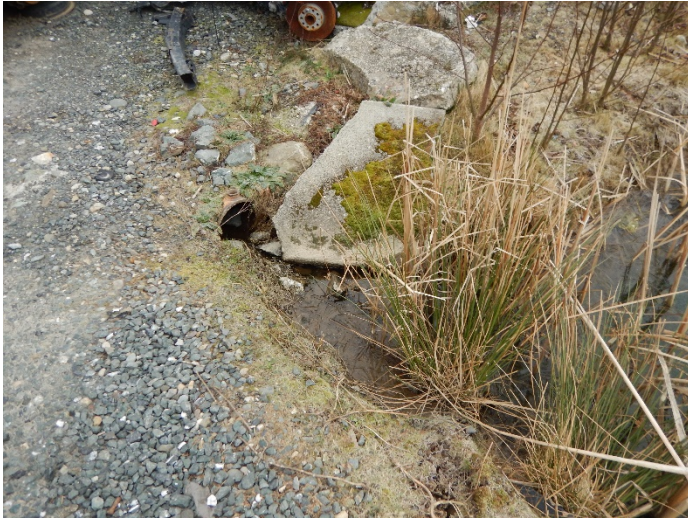
Photo #:09 (DSCN0609)

Description: Photo of one of the culverts that connects the bioswales.

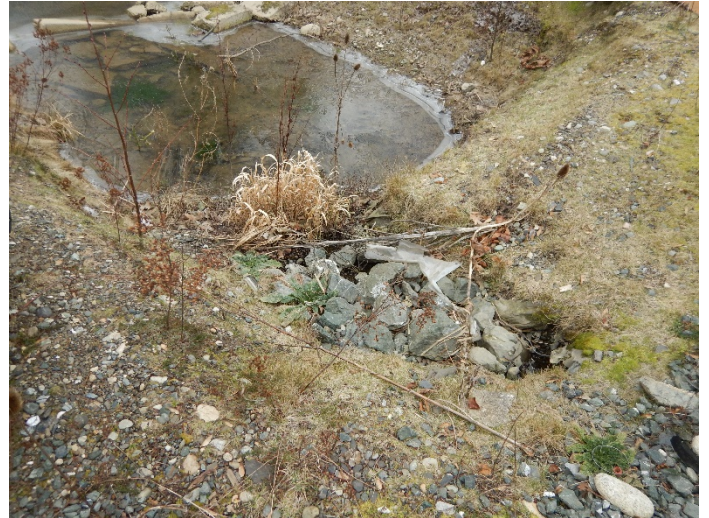
Photo #:10 (DSCN0610)

Description: Photo of one of the culverts that connects the bioswales.

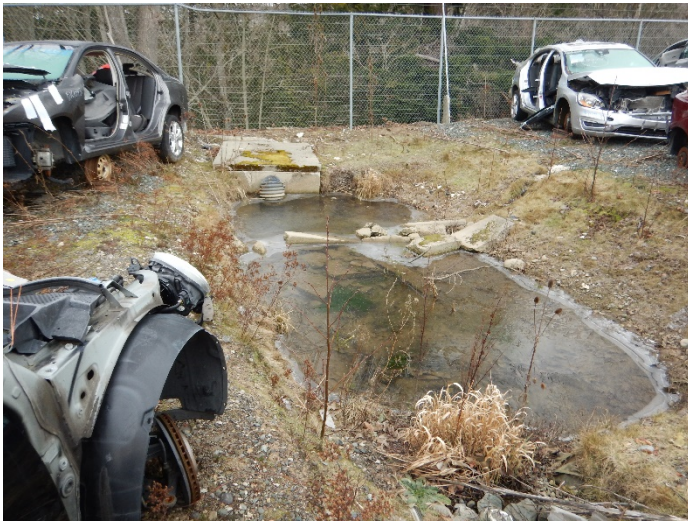
Photo #:11 (DSCN0611)

Description: Facing northeast, photo of one of the bioswales that routes stormwater to an oil/water separator. Note the rock berm in the middle.

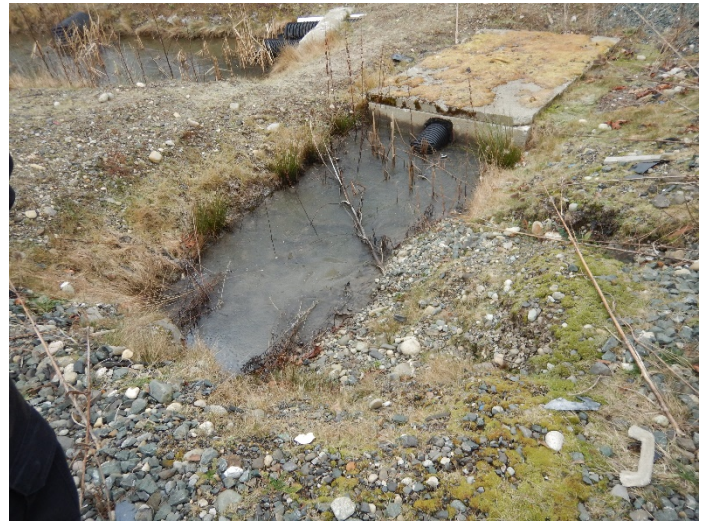
Photo #:12 (DSCN0612)

Description: Photo of one of the bioswales that routes stormwater to an oil/water separator.

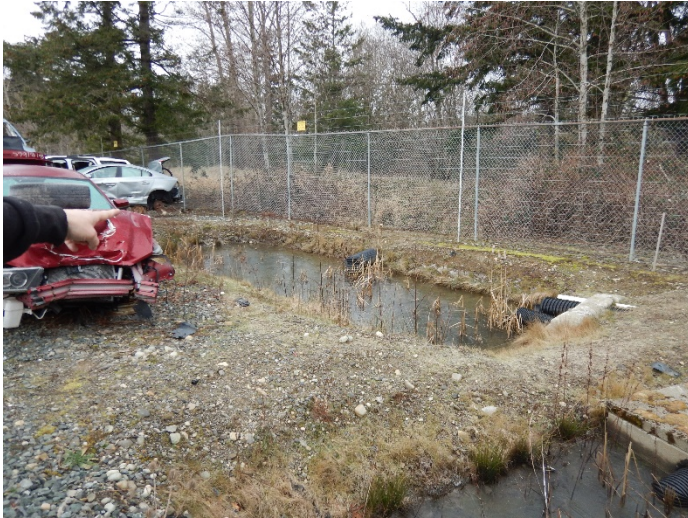
Photo #:13 (DSCN0613)

Description: Facing north, photo of one of the bioswales that routes water to an oil/water separator.

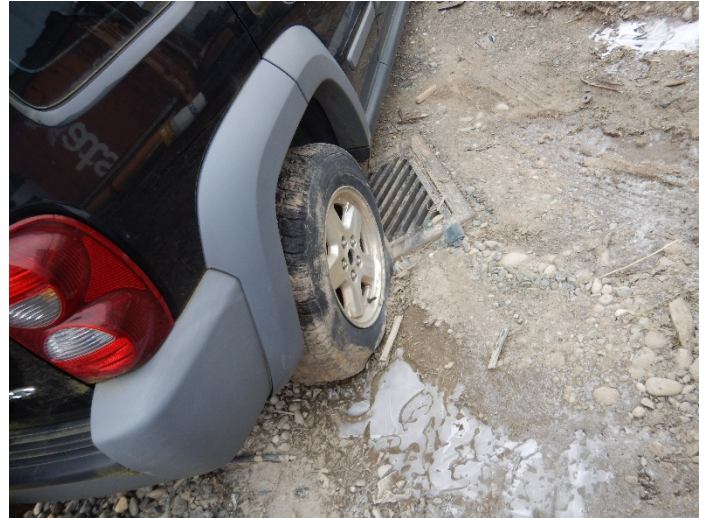
Photo #:14 (DSCN0614)

Description: One of the catch basins that routes stormwater to Monitoring Point B.

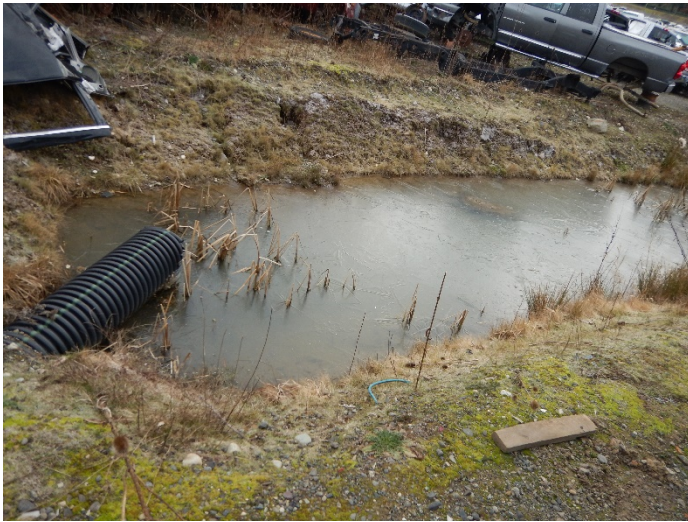
Photo #:15 (DSCN0615)

Description: Photo of one of the bioswales.

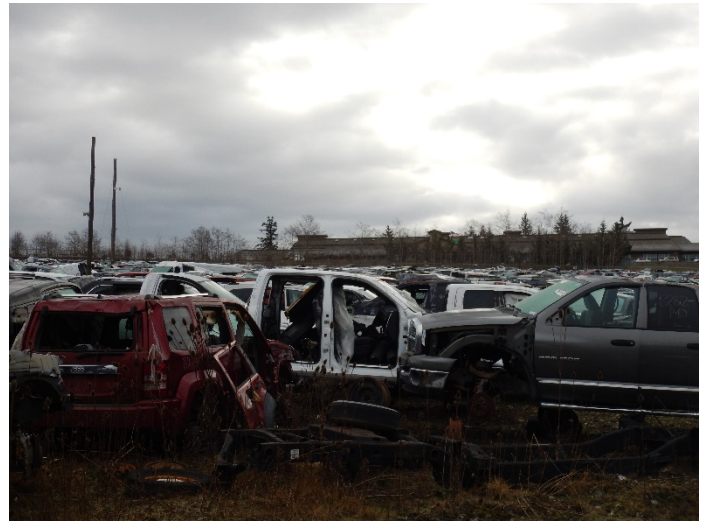
Photo #:16 (DSCN0616)

Description: Facing south, photo of the yard with Northern Heights Elementary School in the background.

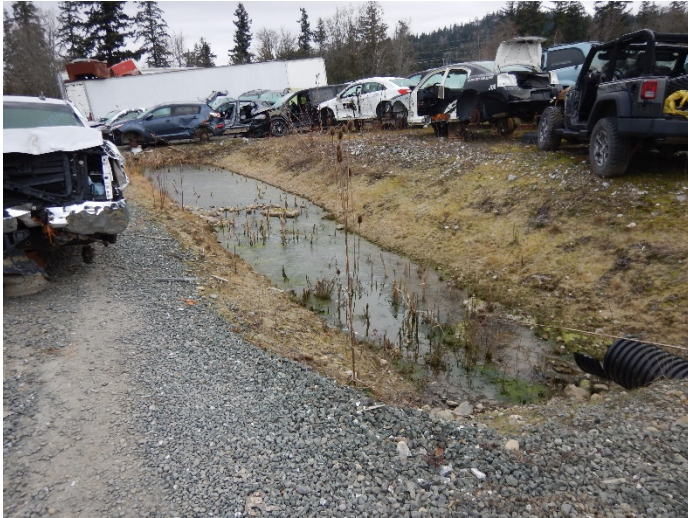
Photo #:17 (DSCN0617)

Description: Facing northeast, photo of one of the bioswales.

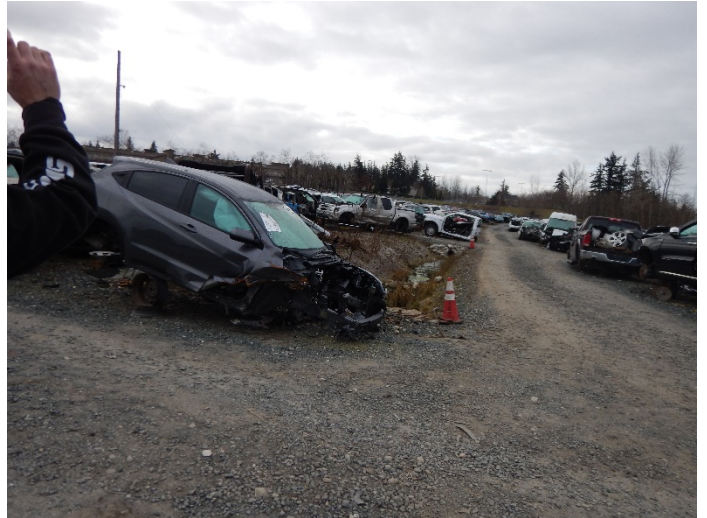
Photo #:18 (DSCN0618)

Description: Facing southwest, photo of one of the bioswales along the access road in the unpaved yard.

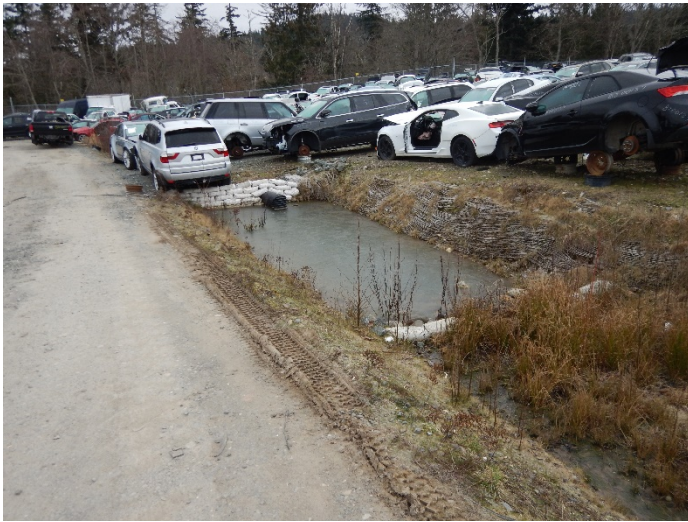
Photo #:19 (DSCN0619)

Description: Facing northeast, photo of one of the bioswales with erosion prevention materials at the entrance and exit.

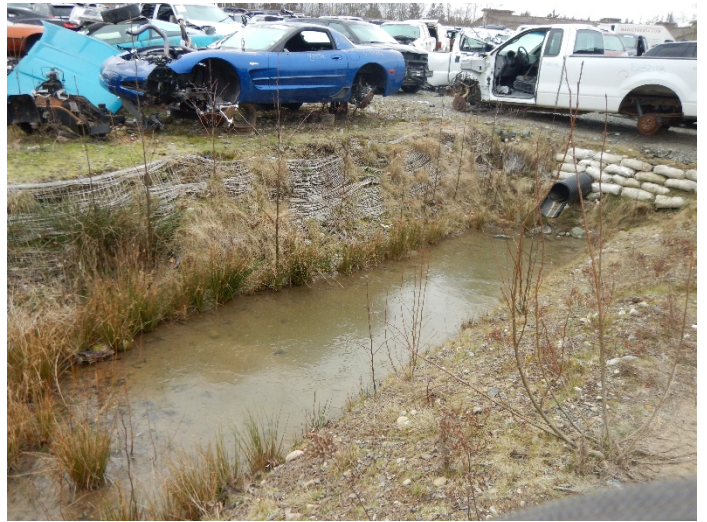
Photo #:20 (DSCN0620)

Description: Facing south, photo of one of the bioswales with erosion prevention materials at the entrance and exit.

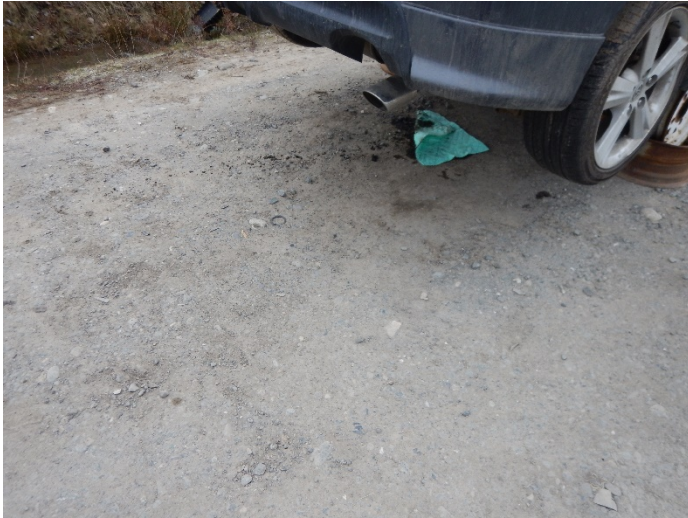
Photo #:21 (DSCN0621)

Description: Facing south, photo of a small fluid leak. Note the implementation of an absorbent pad.

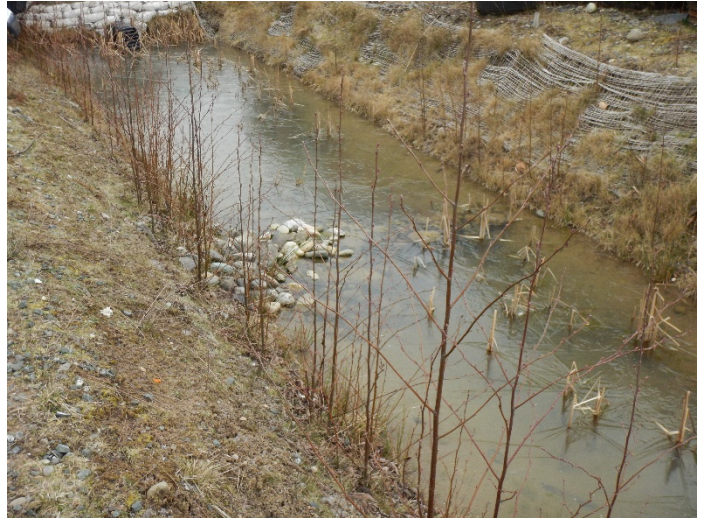
Photo #:22 (DSCN0622)

Description: Facing northeast, photo of on the of the bioswales with erosion prevention materials at the entrance and exit. Note the rock berm in the middle.

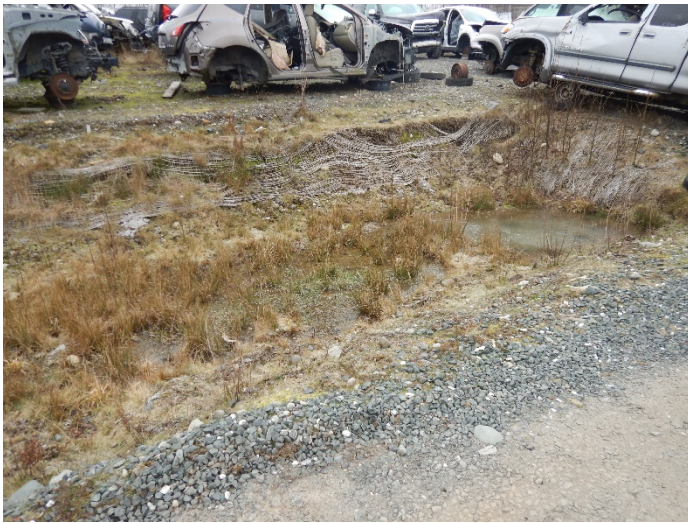
Photo #:23 (DSCN0623)

Description: Facing south, photo of one of the bioswales.

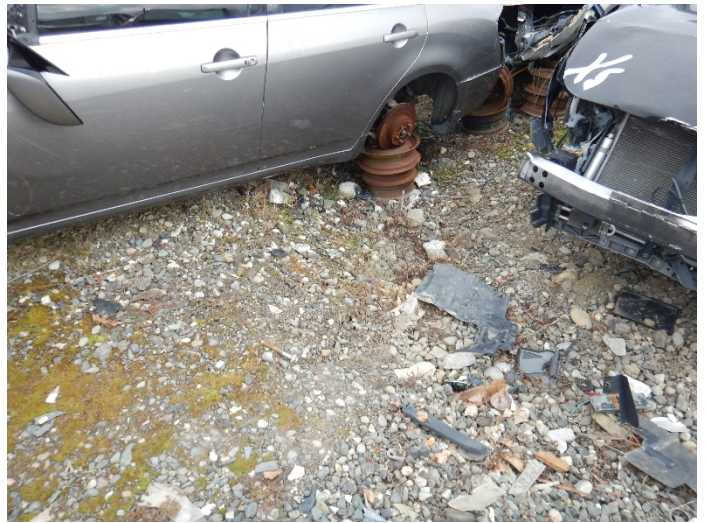
Photo #:24 (DSCN0624)

Description: Photo of stored materials in the unpaved yard.

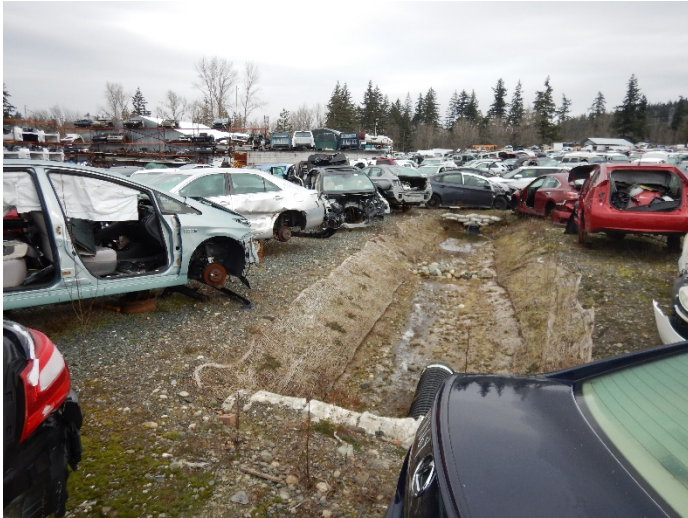
Photo #:25 (DSCN0625)

Description: Facing southwest, photo of one of the bioswales with erosion prevention materials and the entrance and exit.

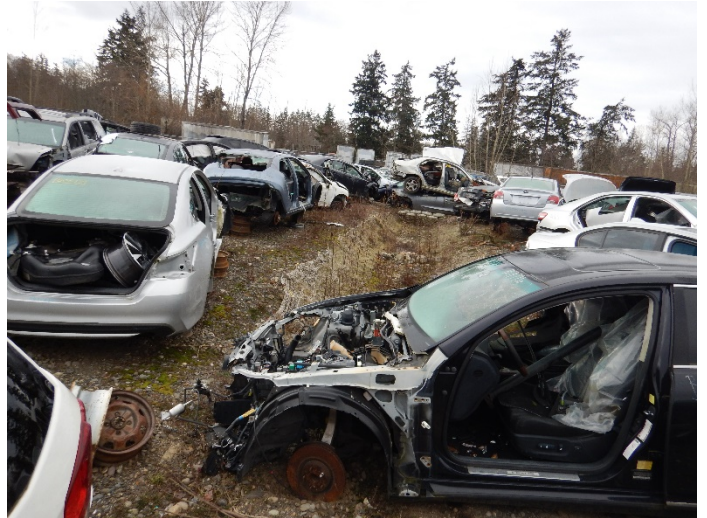
Photo #:26 (DSCN0626)

Description: Facing northeast, photo of one of the bioswales with erosion prevention materials and the entrance and exit.

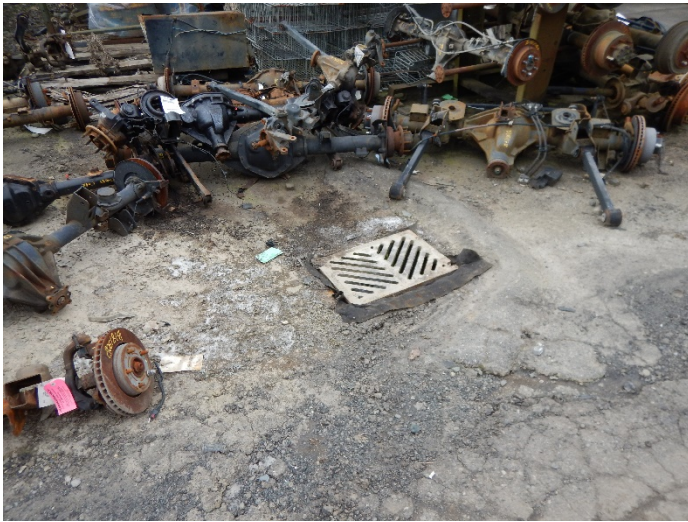
Photo #:27 (DSCN0627)

Description: Photo of one of the catch basins that route stormwater to Monitoring Point B.

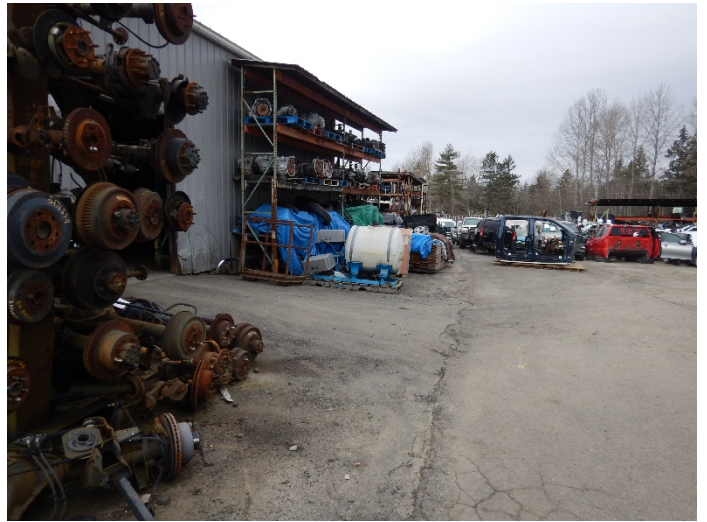
Photo #:28 (DSCN0628)

Description: Facing north, photo of parts storage near one of the storage sheds within the paved portion of the facility. Note the asphalt berm.

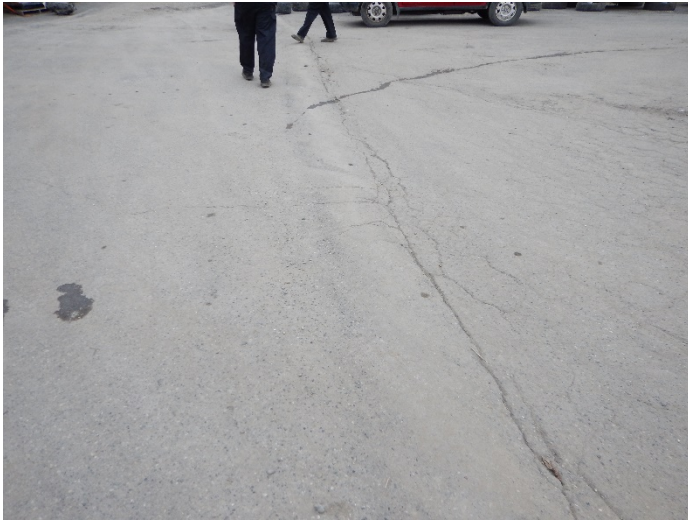
Photo #:29 (DSCN0629)

Description: Facing northeast, photo of stormwater flow patterns within the paved area of the facility.

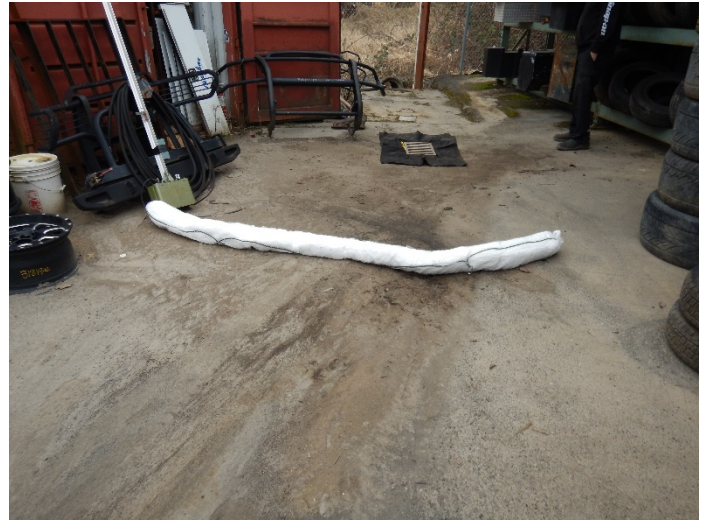
Photo #:30 (DSCN0630)

Description: Facing northeast, photo of one of the catch basins that route stormwater to an oil/water separator (ultimately to Monitoring Point A). Note the absorbent boom and filter sock.

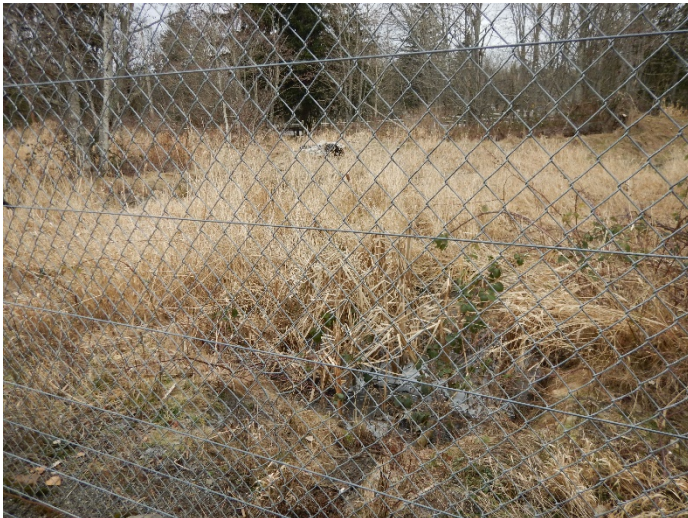
Photo #:31 (DSCN0631)

Description: Facing northeast, photo of a culvert that connects the large vegetated holding pond to a smaller pond. This smaller pond receives the stormwater that has been routed through the oil/water separators.

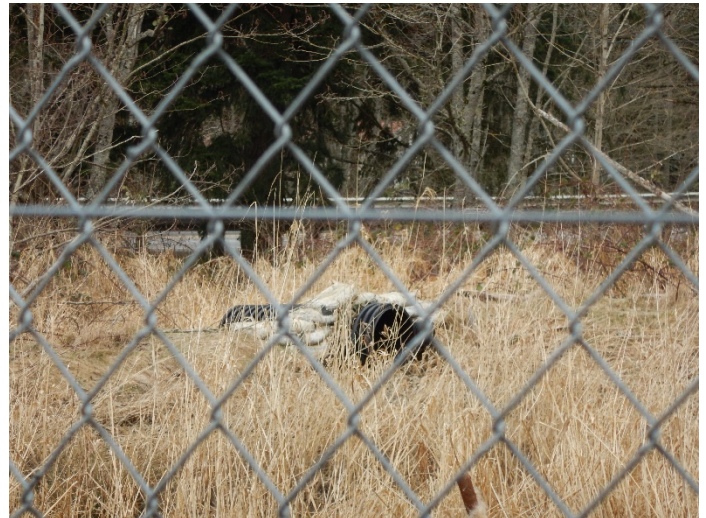
Photo #:32 (DSCN0632)

Description: Facing northeast, photo of a culvert that connects the large vegetated holding pond to a smaller pond. This smaller pond receives the stormwater that has been routed through the oil/water separators.

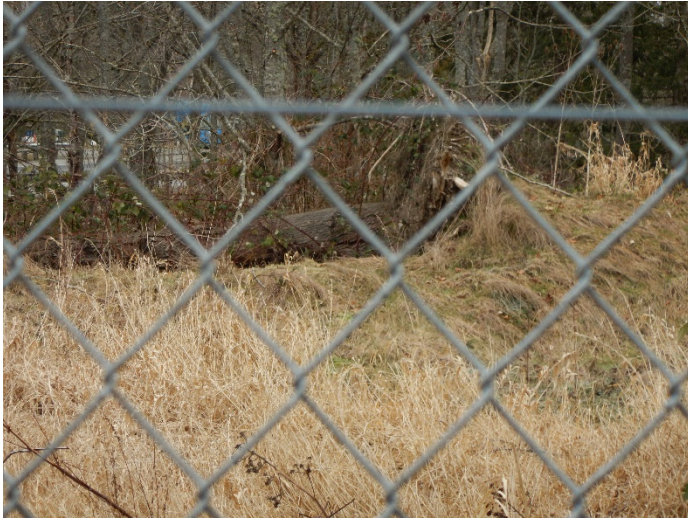
Photo #:33 (DSCN0633)

Description: Facing northeast, photo of the bermed barrier wall surrounding the holding pond that discharges to Outfall A.

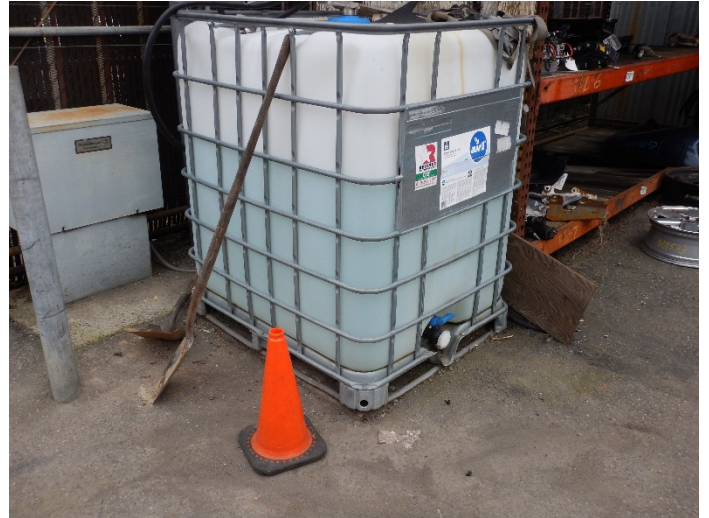
Photo #:34 (DSCN0634)

Description: Photo of a tote containing Diesel Exhaust Fluid (DEF). Mr. Kay informed me that this is the last tote remaining on-site. The facility plans to stop using DEF.

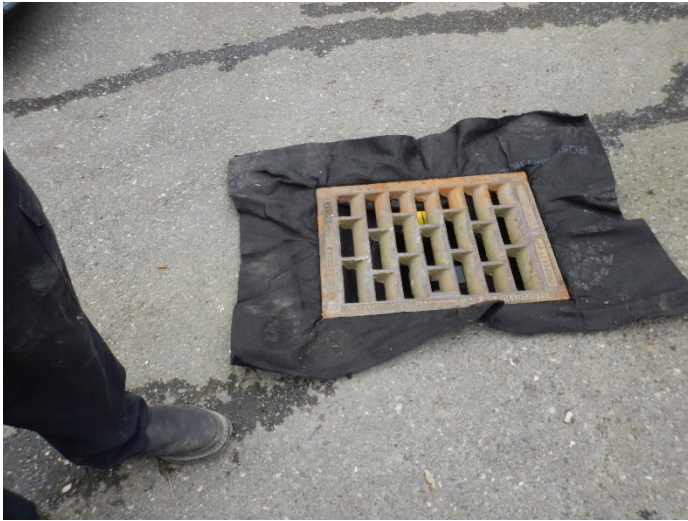
Photo #:35 (DSCN0635)

Description: Photo of one of the catch basins that route stormwater to Monitoring Point B.

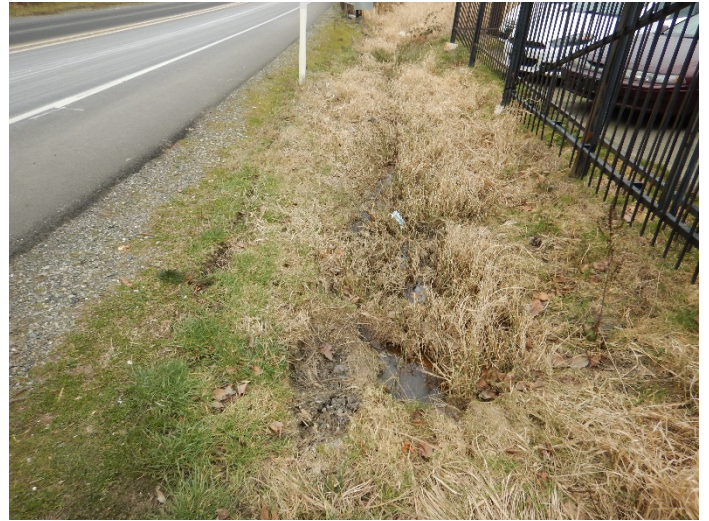
Photo #:36 (DSCN0636)

Description: Facing north, photo of Monitoring Point B. This drainage ditch connects to Outfall A.

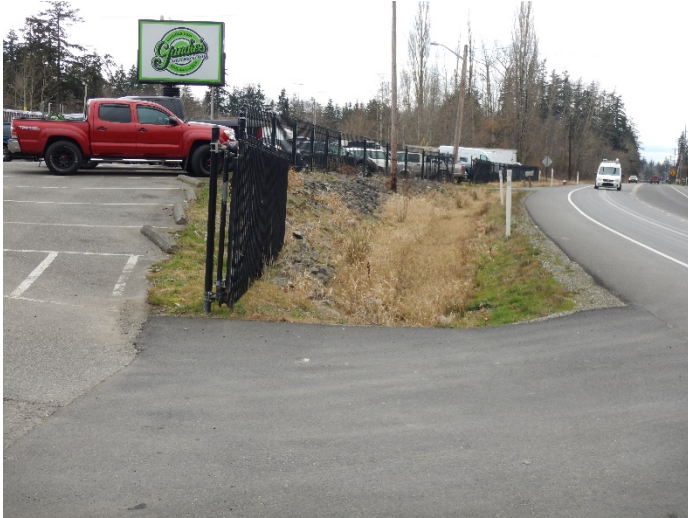
Photo #:37 (DSCN0637)

Description: Facing southwest, photo of the drainage ditch that connects to Monitoring Point B via a culvert.

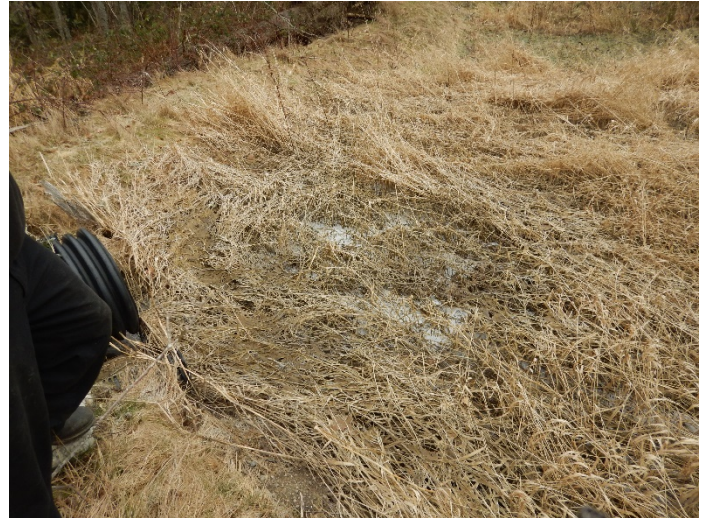
Photo #:38 (DSCN0638)

Description: Facing northeast, photo of Monitoring Point A. Note that the vegetated holding pond is frozen solid.

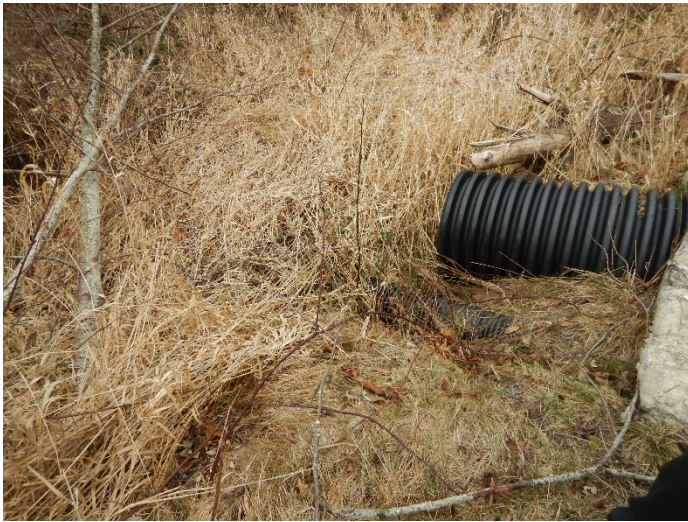
Photo #:39 (DSCN0639)

Description: Facing southwest, photo of Monitoring Point A.

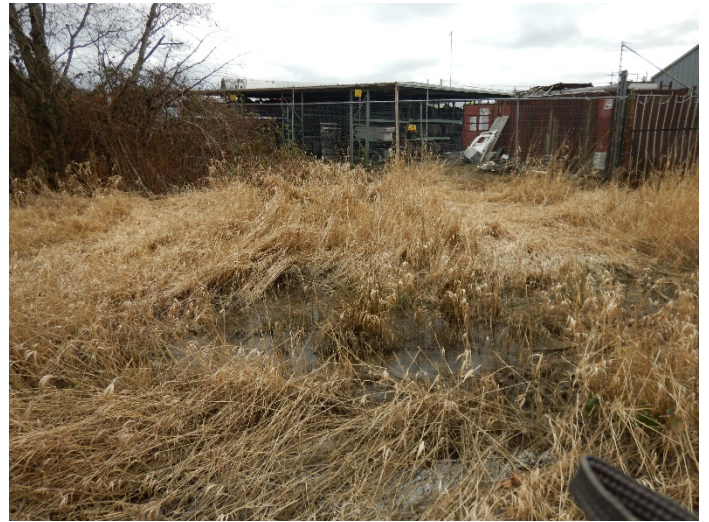
Photo #:40 (DSCN0640)

Description: Facing southwest, photo of the large holding pond.

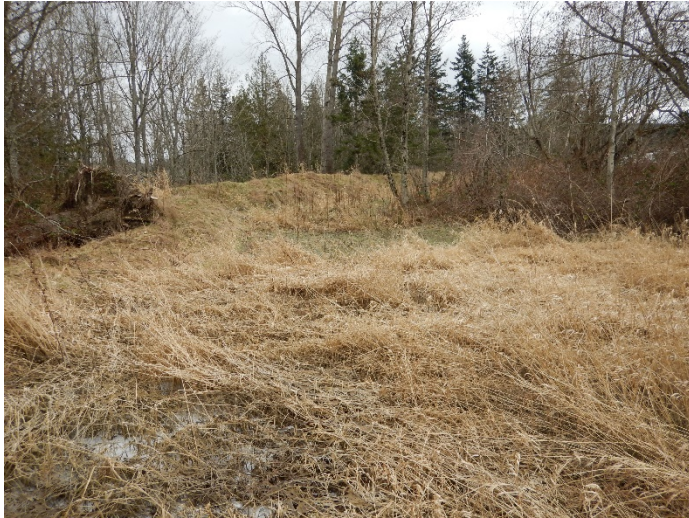
Photo #:41 (DSCN0641)

Description: Facing east, photo of the large holding pond.

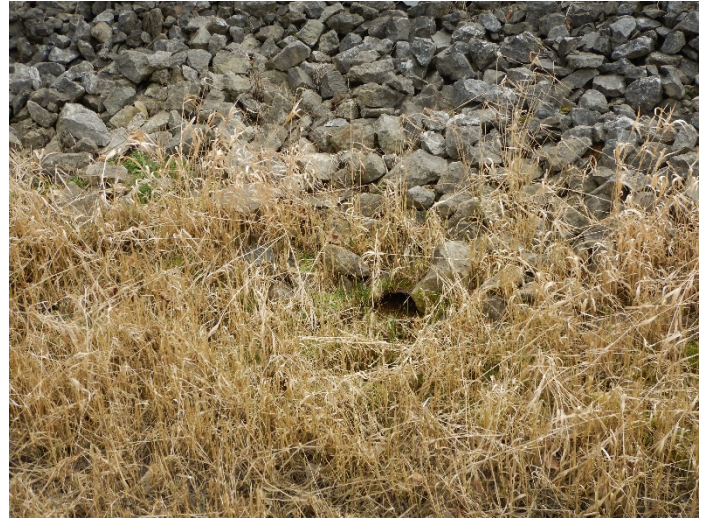
Photo #:42 (DSCN0642)

During my review of the facility, I noted a small downspout near Monitoring Point B (See Attachment B, Photo 42). Mr. Kay explained that this downspout was present on the property before Gundies had been established there. The source of this downspout is still unknown, despite multiple dye tests and research into the property’s history. Through the dye tests, they have determined that none of the facility’s catch basins or bioswales contribute to this downspout. Mr. Kay indicated that discharge has been observed at this downspout in the past, but it’s unclear if the source is on Gundies property.

Description: Facing southeast, photo of the unidentified discharge point.

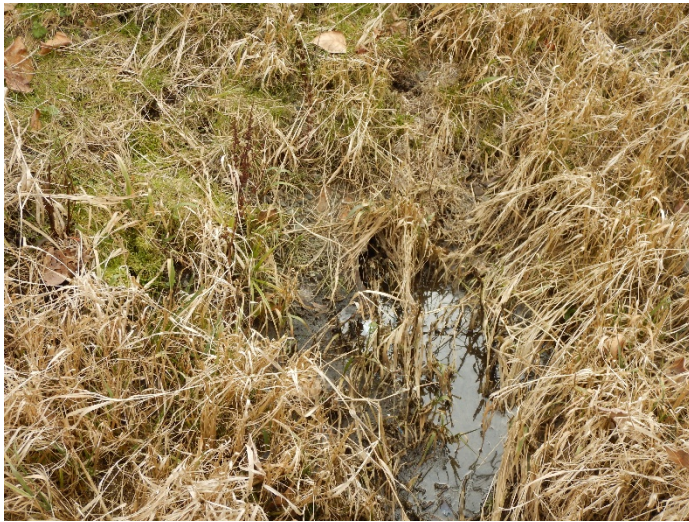
Photo #:43 (DSCN0643)

Description: Photo of the area around the unidentified discharge point.
