DOCUMENT DESCRIPTION: NIOSH Report - Air Sampling & Industrial Hygiene Survey - Rayloc

AIR SAMPLING  
&  
INDUSTRIAL HYGIENE SURVEY

GENUINE PARTS COMPANY  
RAYLOC DIVISION  
ATLANTA, GEORGIA

August, 1972

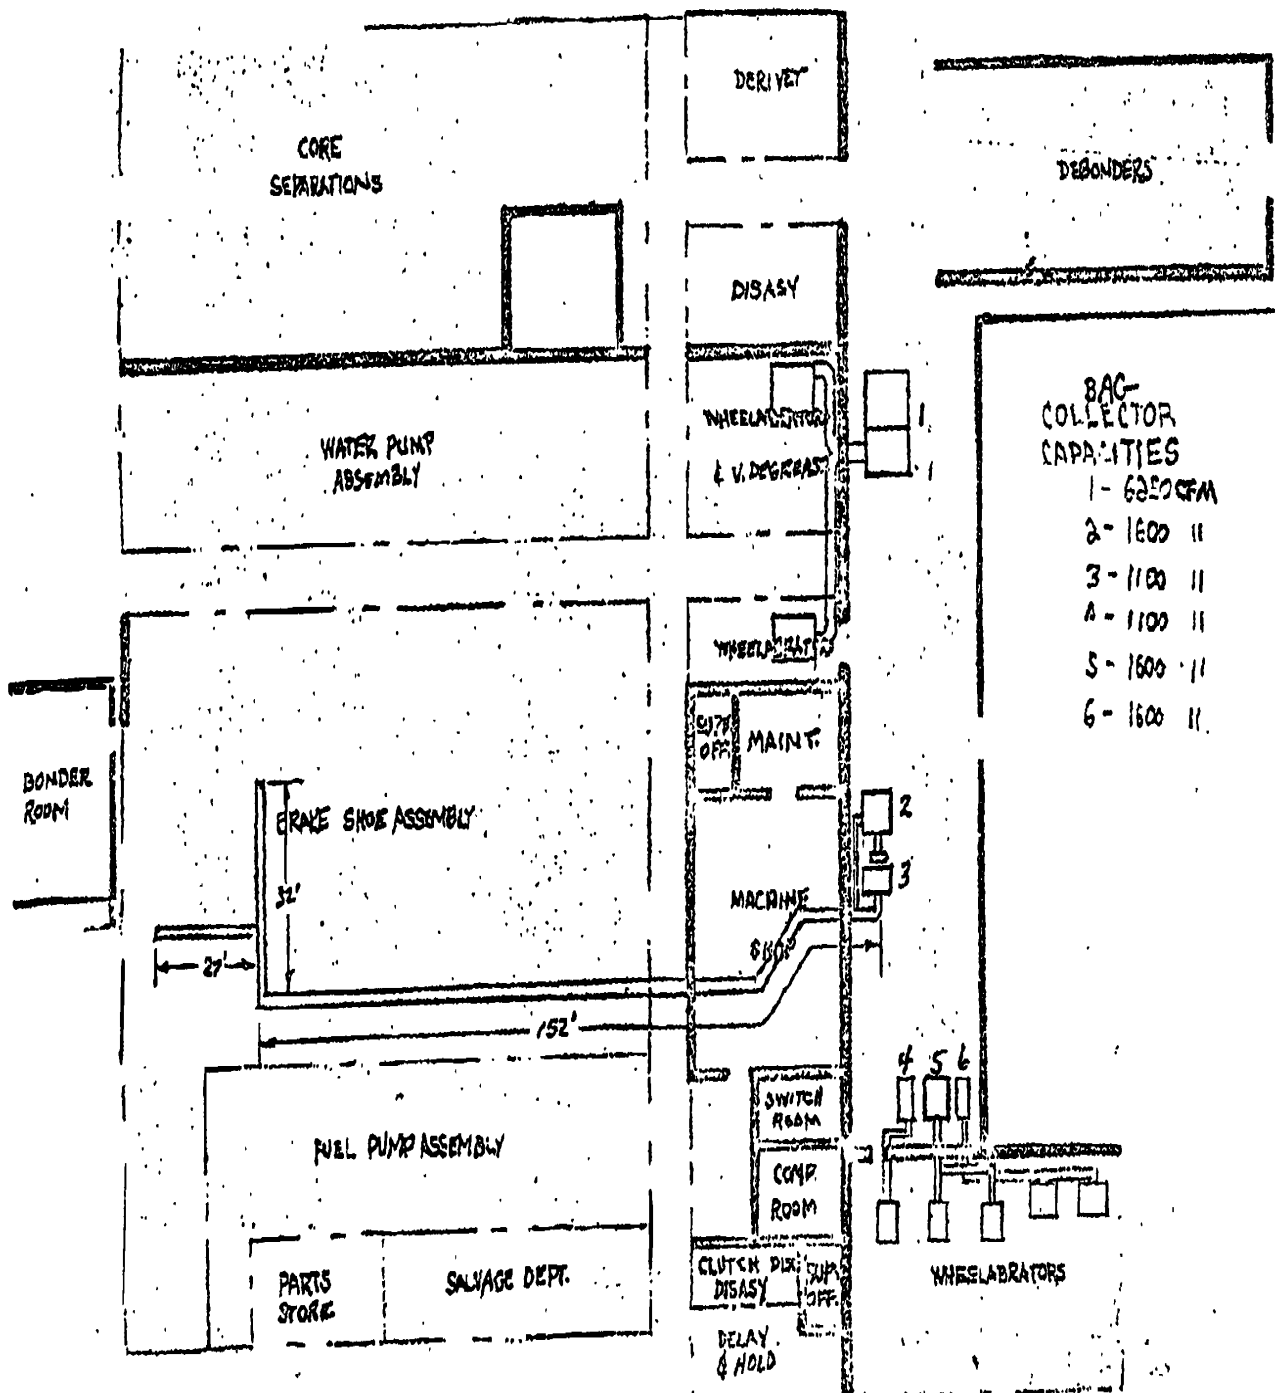
FIGURE 1: FRICTION PRODUCT LAYOUT WITH COLLECTORS

Local exhaust ventilation is provided on all 3 brake lining grinders and on all 5 "Wheelabrator" cleaning machines. These machines are vented to 6 "Wheelabrator" bag dust collectors.

Figure 1 shows a layout of the friction products area of the plant along with locations of the dust collectors and their respective capacities.

Velocity measurements at the entrance to the grinder hoods showed velocities ranging from 600 fpm to 1100 fpm. No ventilation is provided at the clutch deriveting operation.
