**Inspection Report Addendum for Well: MT20000-01111**  
**Inspection Date: 10/25/2023**

| <b>U.S. Environmental Protection Agency</b><br><b>Region 8</b> | | <b>UIC PHOTOGRAPHIC LOG</b> | |
| <b>Facility Location:</b><br>MT20000-01111 (101-W4), Glacier County, UT | | <b>Photographer:</b><br>Gary Wang | <b>Camera:</b><br>Ricoh WG-5 |

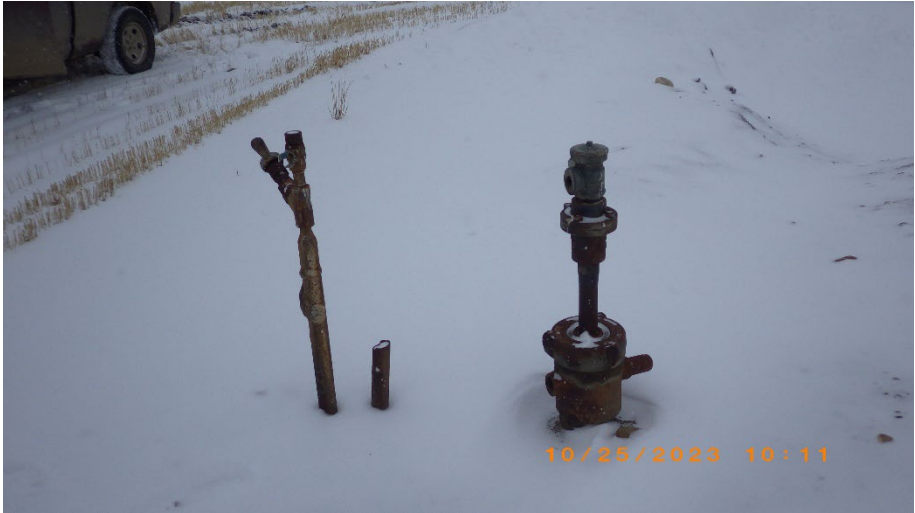
| <b>Photo No.</b><br>1 of 3 | <b>Time:</b><br>10:11 am | | |

| <b>Photo Description:</b><br><p>Wellhead was observed to be disconnected from pipe flowline (left of the wellhead).</p> | | | |

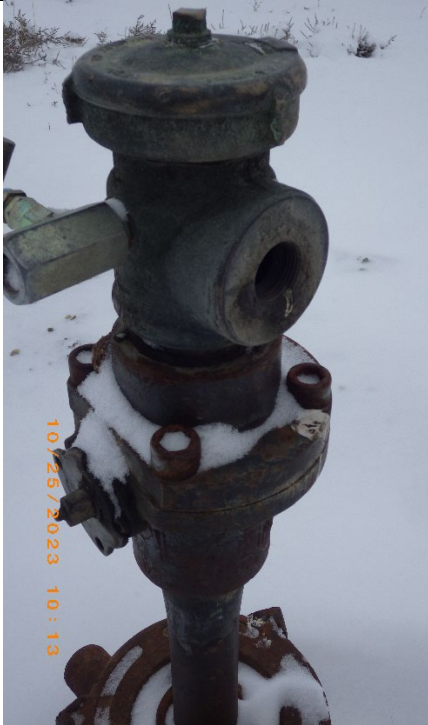
| <b>Photo Description:</b><br><p>Operator opened tubing master ball valve to check tubing pressure. Well showed no pressure in tubing.</p> <p>Records show operator reported mechanical integrity loss on the well on 2/27/2023. EPA responded with Notice of non-compliance letter on 3/2/2023. No follow up correspondence regarding mechanical integrity status since NON issuance.</p> | | | |

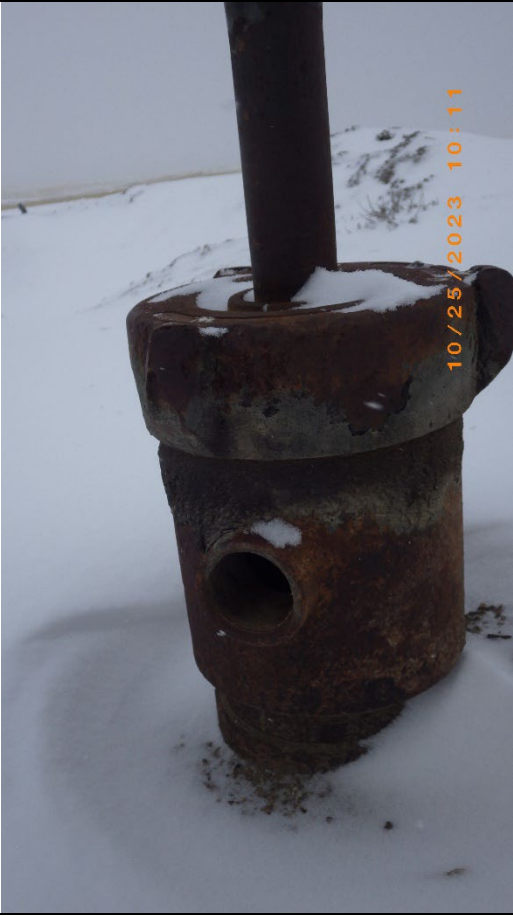
| <b>Photo No.</b><br>3 of 3 | <b>Time:</b><br>10:11 am | | |

| <b>Photo Description:</b><br>Tubing-casing annulus observed to be maintained continuously open to atmospheric pressure. | | | |
