# NPDES Compliance Inspection Report

**Wilbur-Ellis Company  
Woodburn, Oregon**

**Permit #: ORR237045**

**Inspection Date: December 15, 2021**

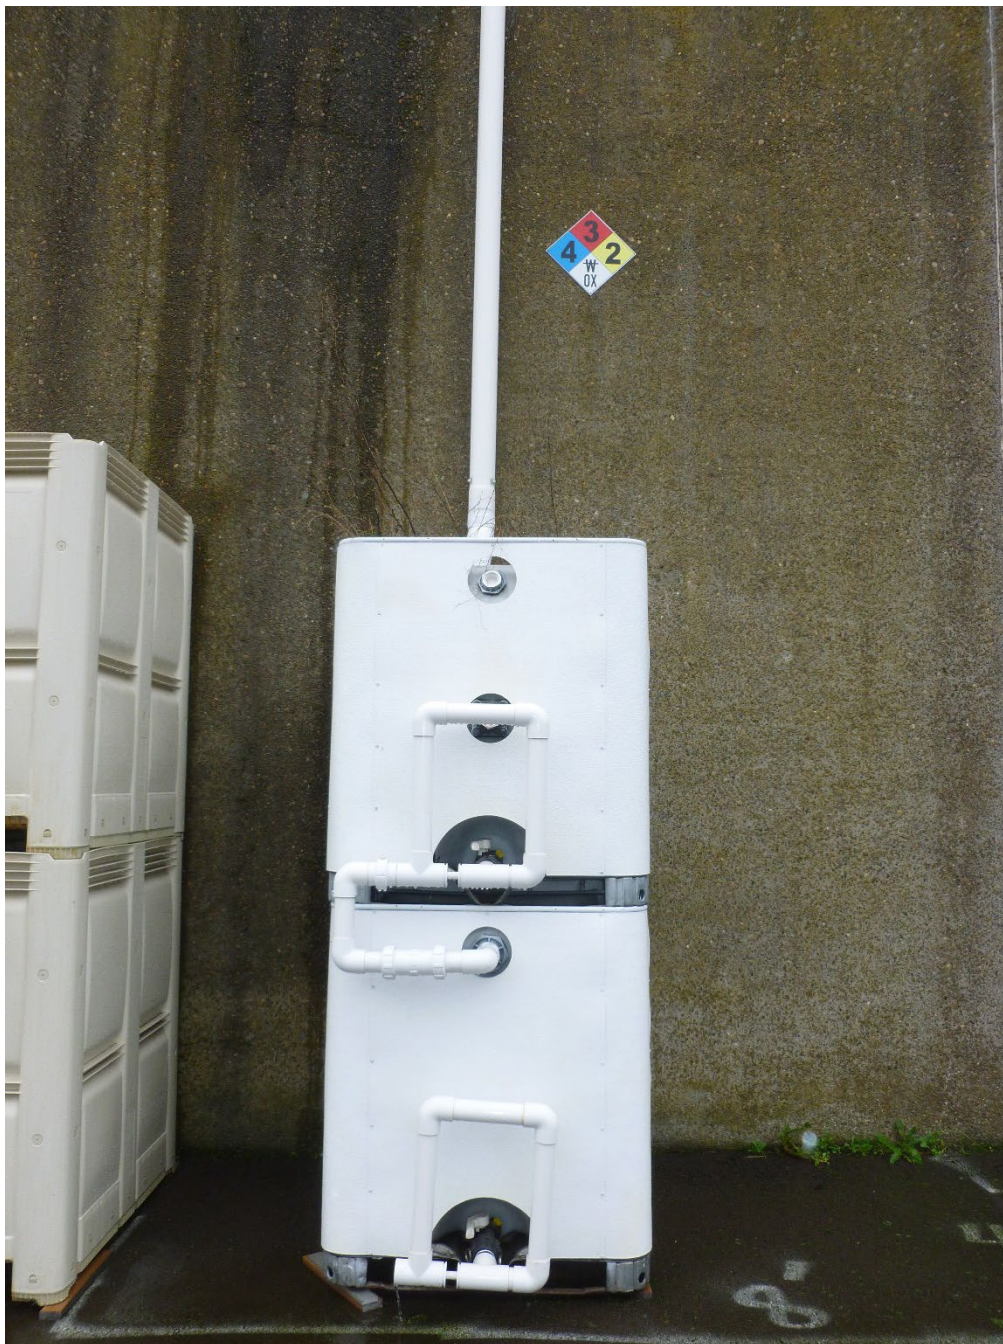
Photo 1 / P1010066 – Micro-filter

After I looked at MP-001, we walked back to building B-4. On the northwest corner of the building, I observed one of the facility's four micro-filter units (**Photo 1**). The micro-filter receives water from the rooftops to reduce the zinc load of discharged stormwater. Co-located with the micro-filter was a macro-filter (**Photo 2**). The facility maintains four macro-filters. The macro-filter receives

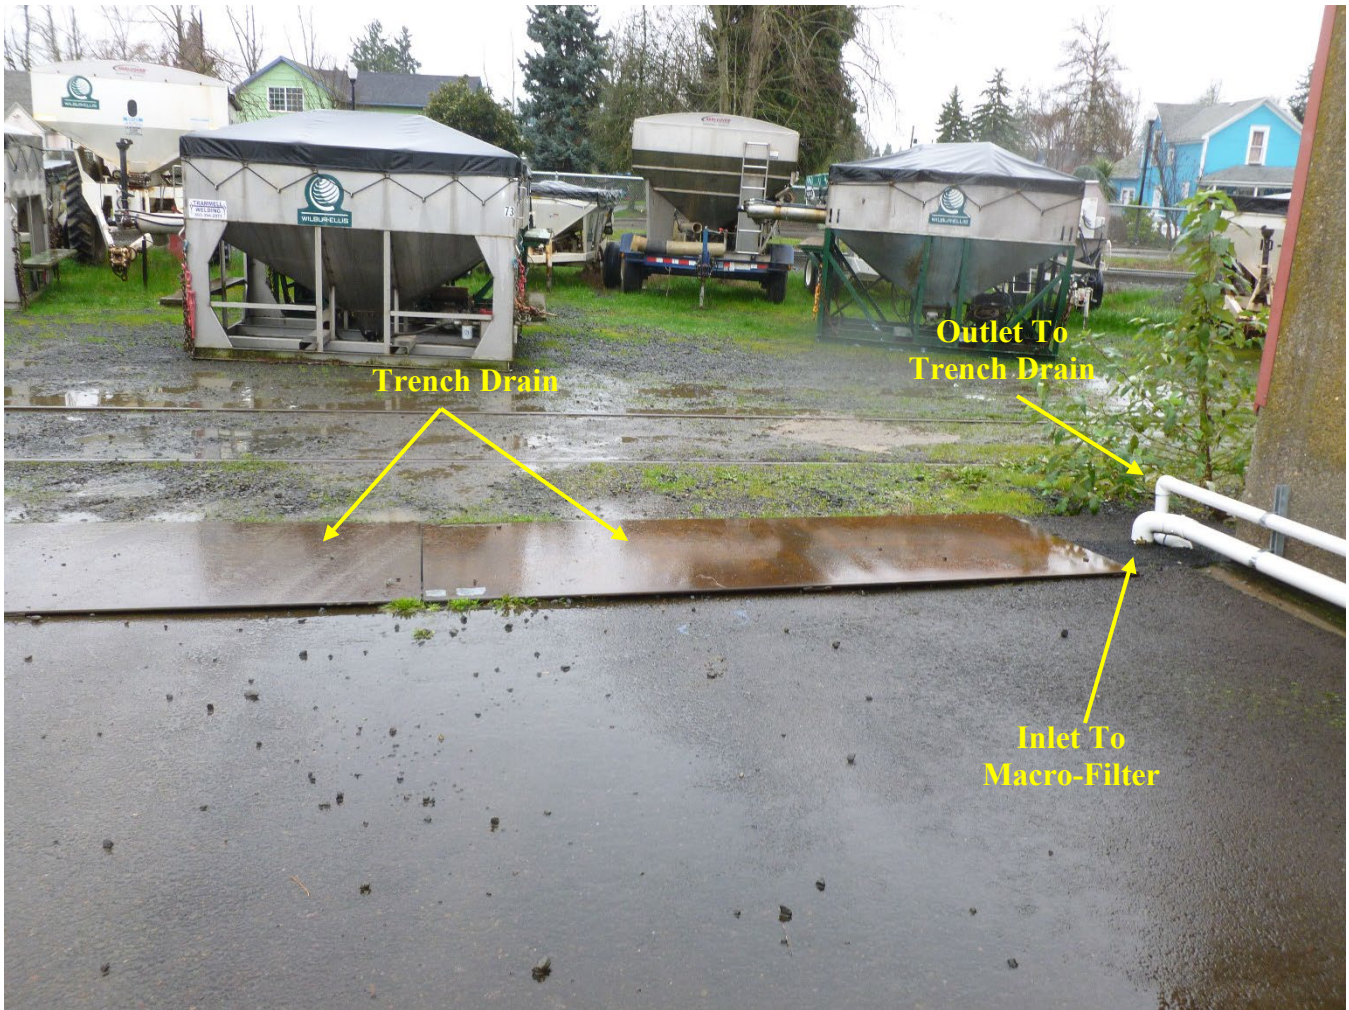
**Photo 3 / P1010070** – Covered Trench Drain with Inlet and Outlet

stormwater from a sump pump in a covered trench drain (**Photo 3**). The trench drain is divided so the macro-filter receives stormwater from the sump pump. After the stormwater has been filtered, it gravity flows into a portion of the trench drain that prevents the water from backflowing and mingling with water entering the system. Once the water has been filtered, it flows to MP-001 followed by discharge into the tributary to Mill Creek through DP-01.

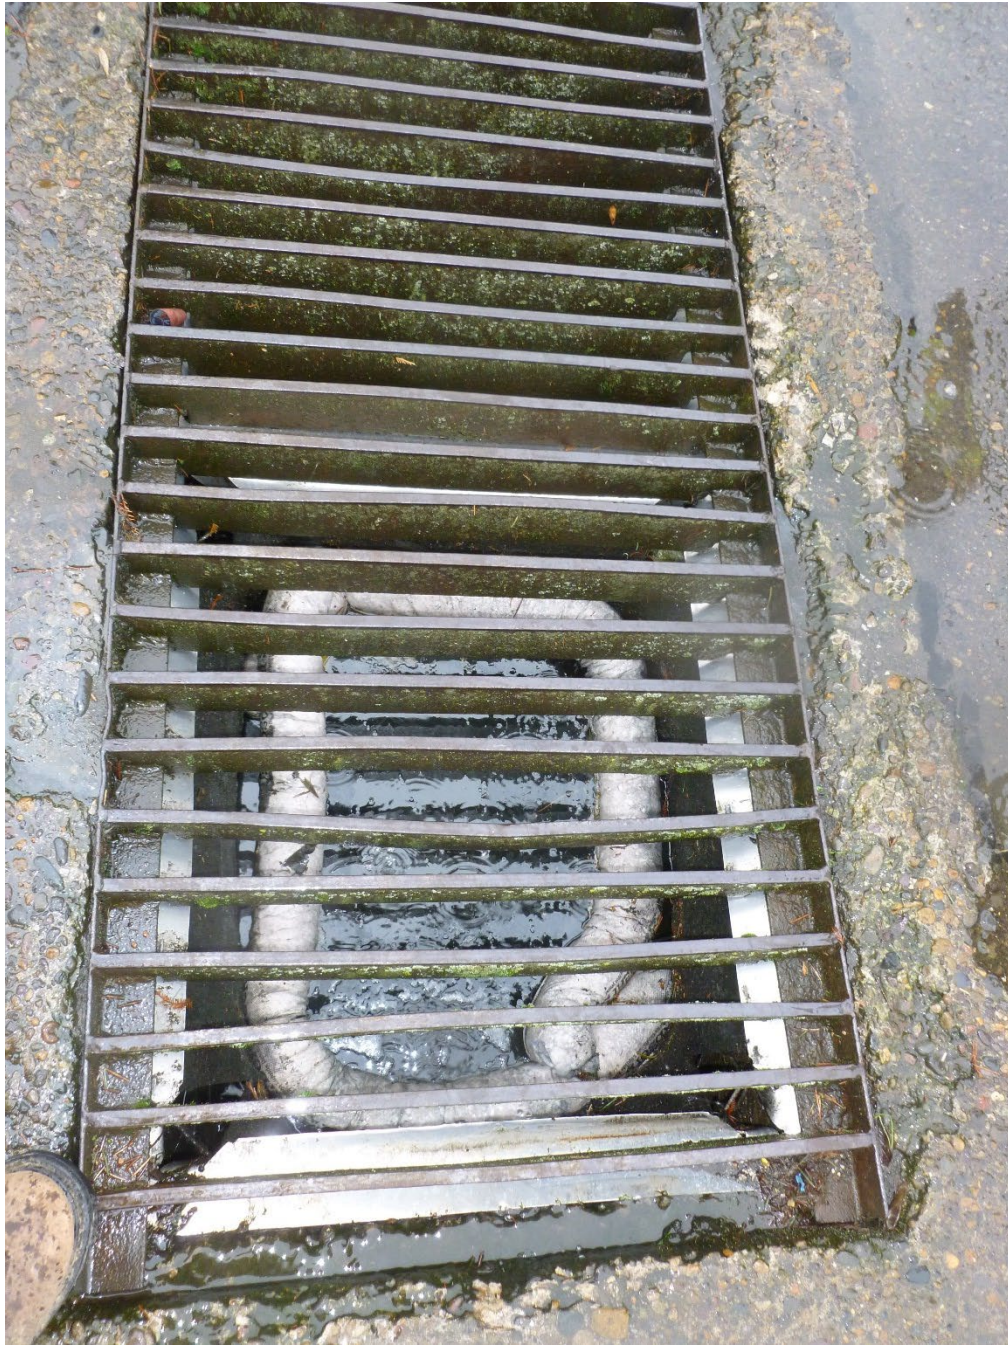
**Photo 4 / P1010072 – Catch Basin, with insert**

Upon leaving MP-001, we turned slightly northeast and walked to toward building B-5 which houses the Freezer Bagging Plant and Bulk Dry Freezer. Along the way to B-5, I observed one of several catch basins distributed throughout the site that is fitted with an insert filter that collects debris and filters out zinc and copper (**Photo 4**). Building B-5 partially falls into both DB-02 and DB-08. Catch basins in DB-02 direct all water towards a “vault” (**Photo 5**). A grab sample is collected from MP-002 as the stormwater exits the PVC pipe that enters the vault chamber from the back wall. The stormwater discharges to the City’s stormwater conveyance system. A valve can be closed to prevent the stormwater from flowing into the City’s system in the event of a pollutant spill. Closing the valve causes stormwater to backflow into a detention swale (**Photo 6**). As seen in photo 6, a catch basin is located in the center of the swale to allow stormwater to be recaptured. We turned east and walked to MP-005. MP-005 (**Photo 7**) is located on the site’s eastern perimeter at the edge of the site’s stormwater detention pond (**Photo 8**). Grab samples are collected from holes in the upright pvc pipe. According to the Representatives, most of the water in the detention pond comes from underground piping from the macro-filters.
