**Inspection Report Addendum for Well: MT20000-01131**  
**Inspection Date: 10/24/2023**

| <b>U.S. Environmental Protection Agency</b><br><b>Region 8</b> | | <b>UIC PHOTOGRAPHIC LOG</b> | |
| <b>Facility Location:</b><br>MT20000-01131 (71-W1), Glacier County, UT | | <b>Photographer:</b><br>Gary Wang | <b>Camera:</b><br>Ricoh WG-5 |

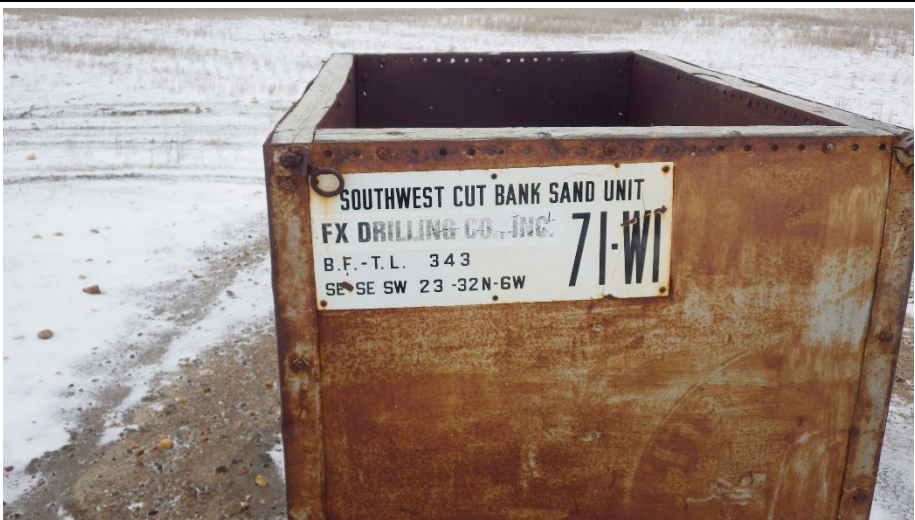
| <b>Photo No.</b><br>1 of 4 | <b>Time:</b><br>4:33 pm | | |

| <b>Photo Description:</b><br>Well sign by wellhead. | | | |

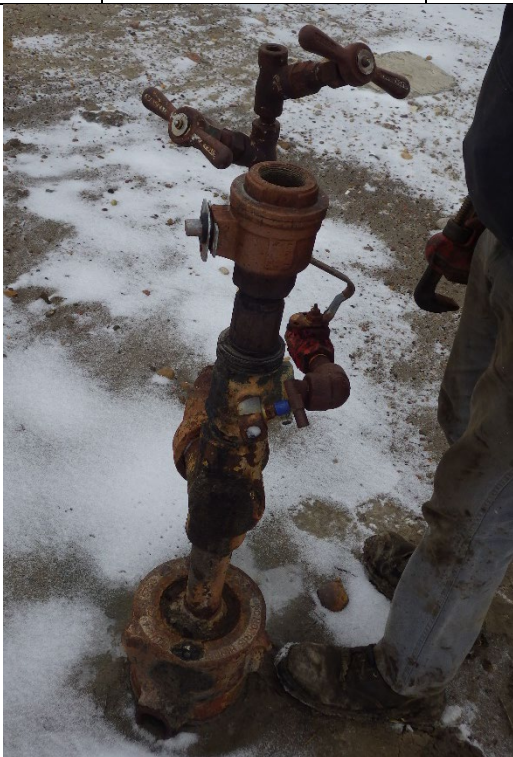
| <b>Photo No.</b><br>2 of 4 | <b>Time:</b><br>4:33 pm | | |

| <b>Photo Description:</b><br>Wellhead is observed to be disconnected from flowline (behind the wellhead). | | | |

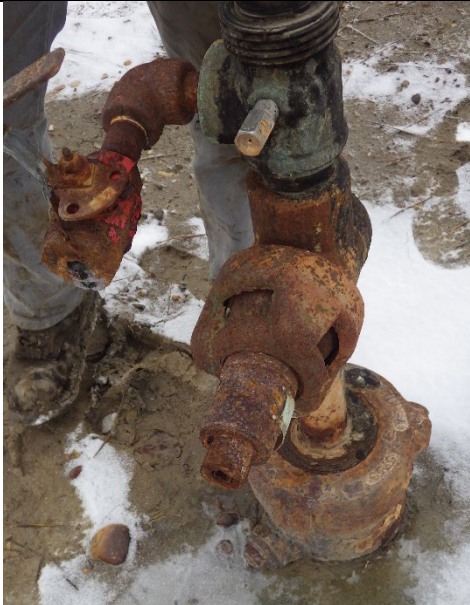
| <b>Photo Description:</b><br>Tubing valve was frozen shut during inspection and operator was unable to open valve. Tubing pressure was not checked. Operator noted that they will get pumper to thaw open the valve and return to the well to check the tubing pressure values the next day. Inspector did not return to well to recheck value. | | | |

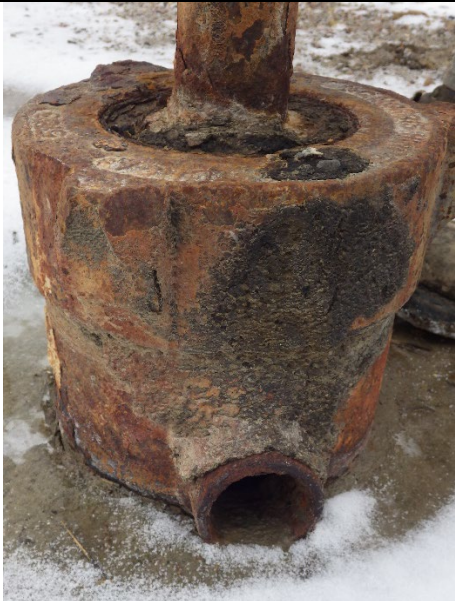
| <b>Photo No.</b><br>4 of 4 | <b>Time:</b><br>4:33 pm | | |

| <b>Photo Description:</b><br>Tubing-casing annulus observed to be maintained continuously open to atmospheric pressure. | | | |
