**Region 6 Compliance Assurance and Enforcement Division  
INSPECTION REPORT**

| Inspection Date(s): | 04/12/2017 | | |
| Media: | Water | | |
| Company Name: | Dallas Fort Worth International Airport | | |

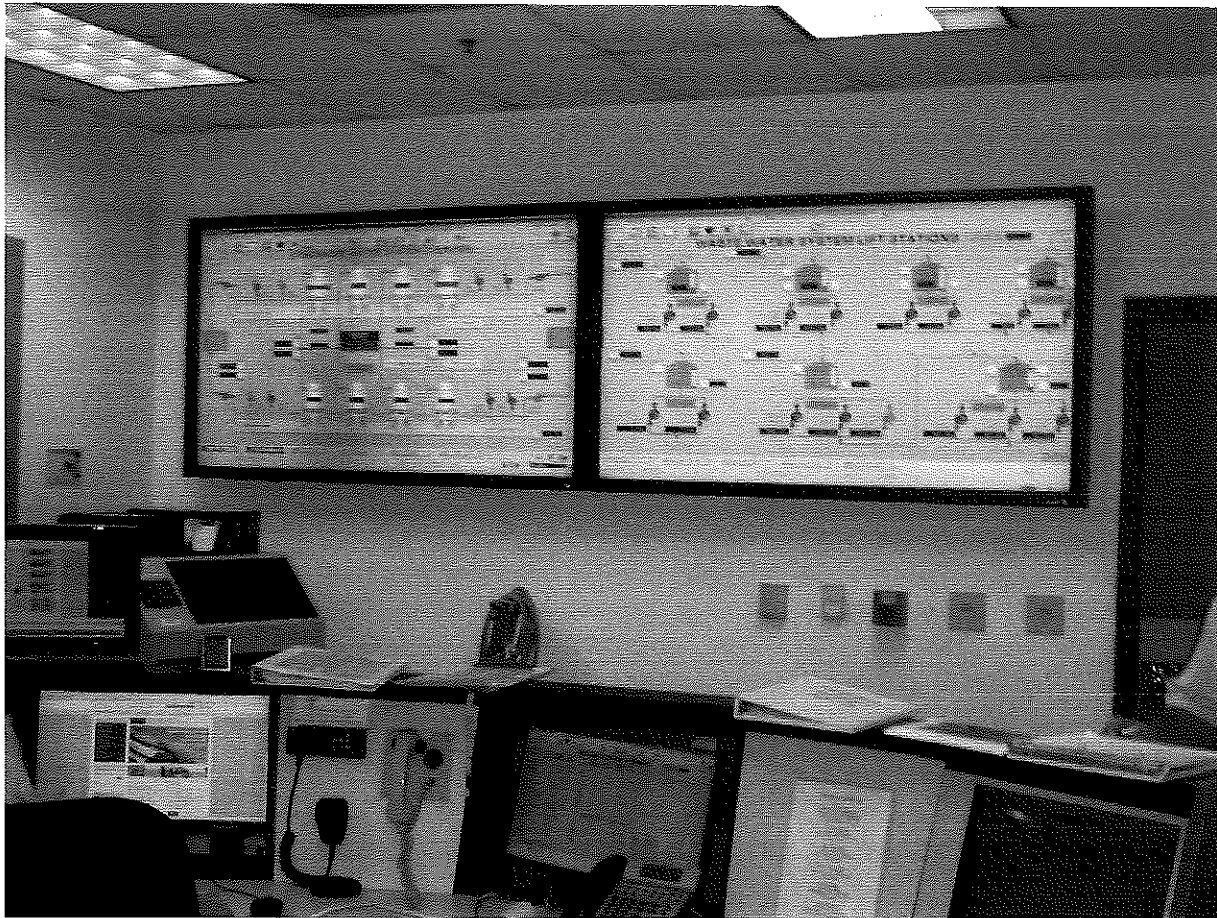
Photo File Name: P4120552.JPG

Description: DFW Airport SCADA Control Room

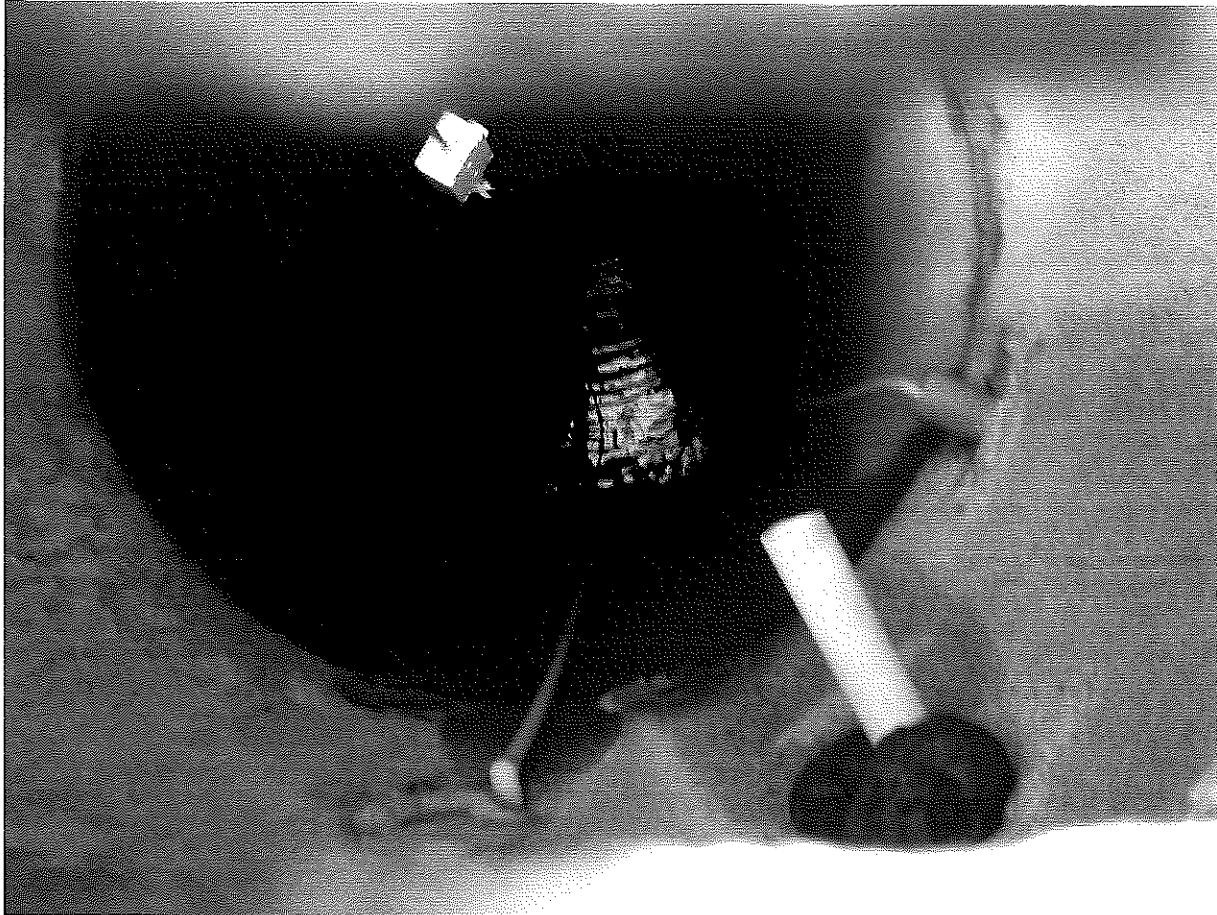
Photo File Name: P4120550.JPG

Description: DFW Airport Lift Station Manhole
