**Region 6 Compliance Assurance and Enforcement Division  
INSPECTION REPORT**

| Company Name: | <b>Wachtman-Schroeder</b> | | |
| Facility Name: | <b><i>Whitetail Stuart Lease</i></b> | | |
| Identification/Permit Number: | OKU000872 | | |

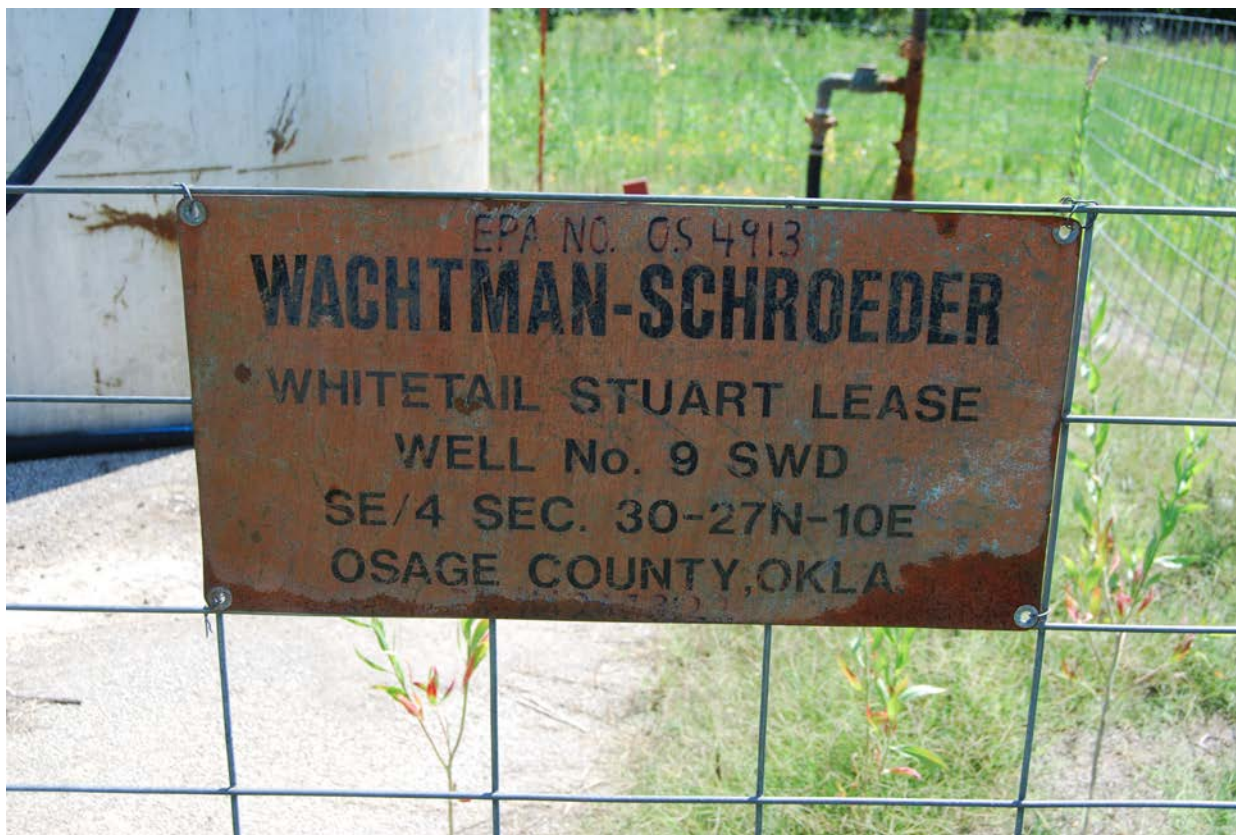
Photo No. 1

Description: This is the sign of the facility where the discharge originated.

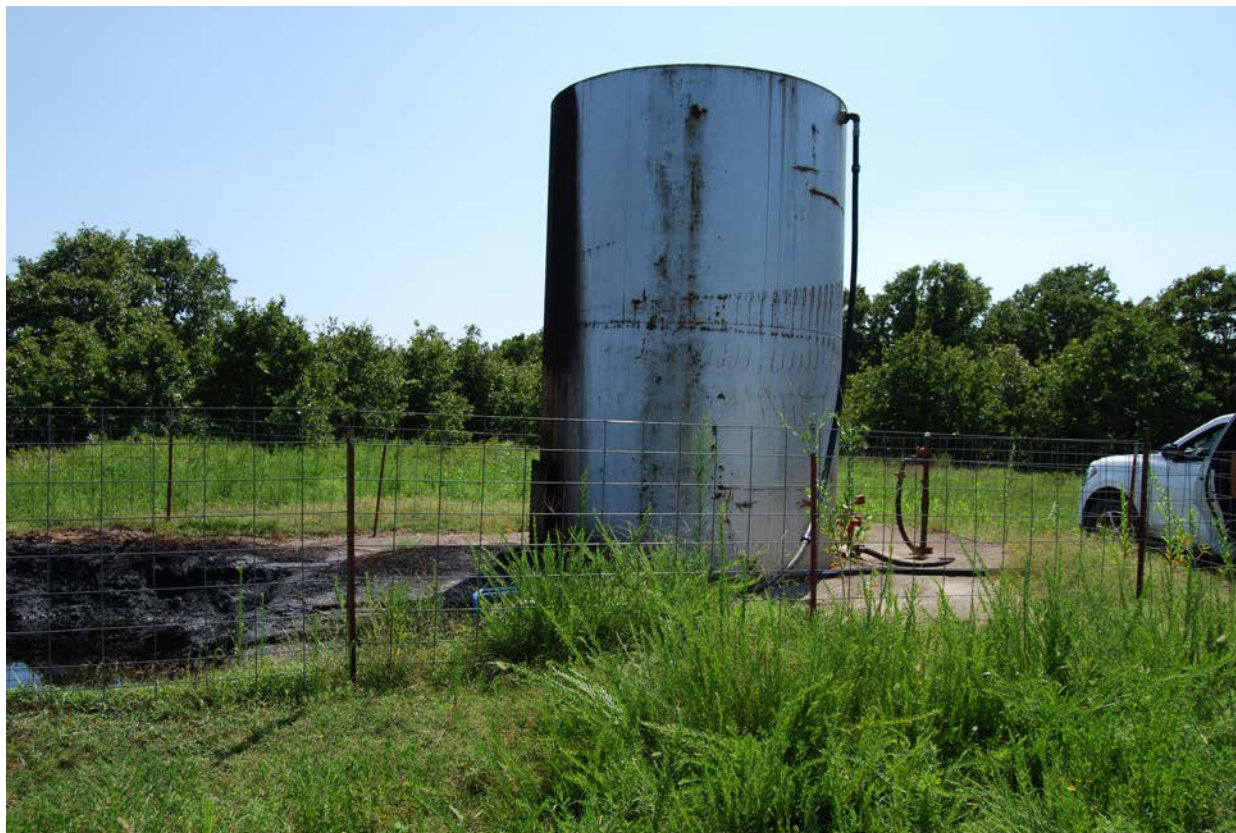
Photo No. 2

Description: The fluids, including brine overflowed from this tank into the secondary containment, or pit before discharging. The fluids flowed from the discharge point to the tributary of Elm Creek.

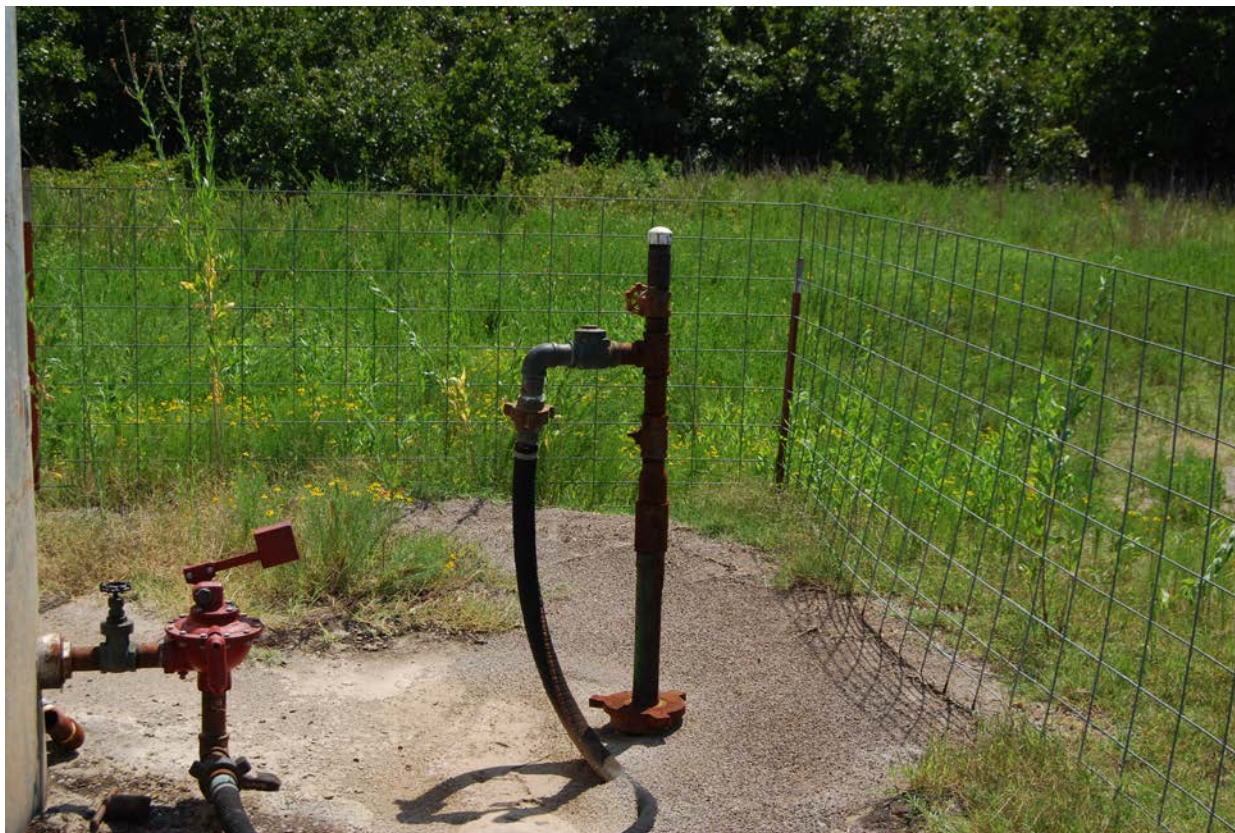
Photo No. 3

Description: The injection well was located a few feet west of the tank. I observed that the injection well appeared to be operating on a vacuum.

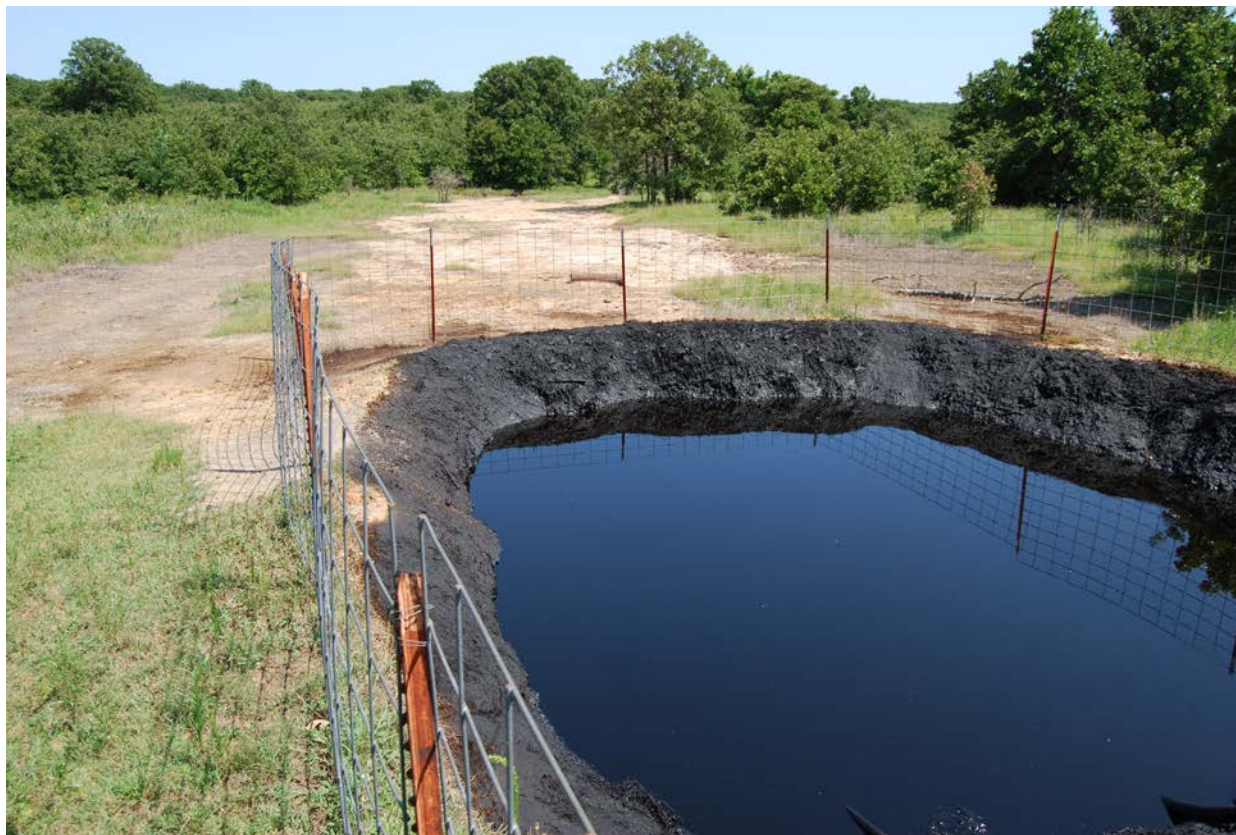
Photo No. 4

Description: I observed a large pit at the site that was a part of the source of the fluids discharged from the facility. The tributary of Elm Creek was located along the tree line east of the pit seen in this photo.

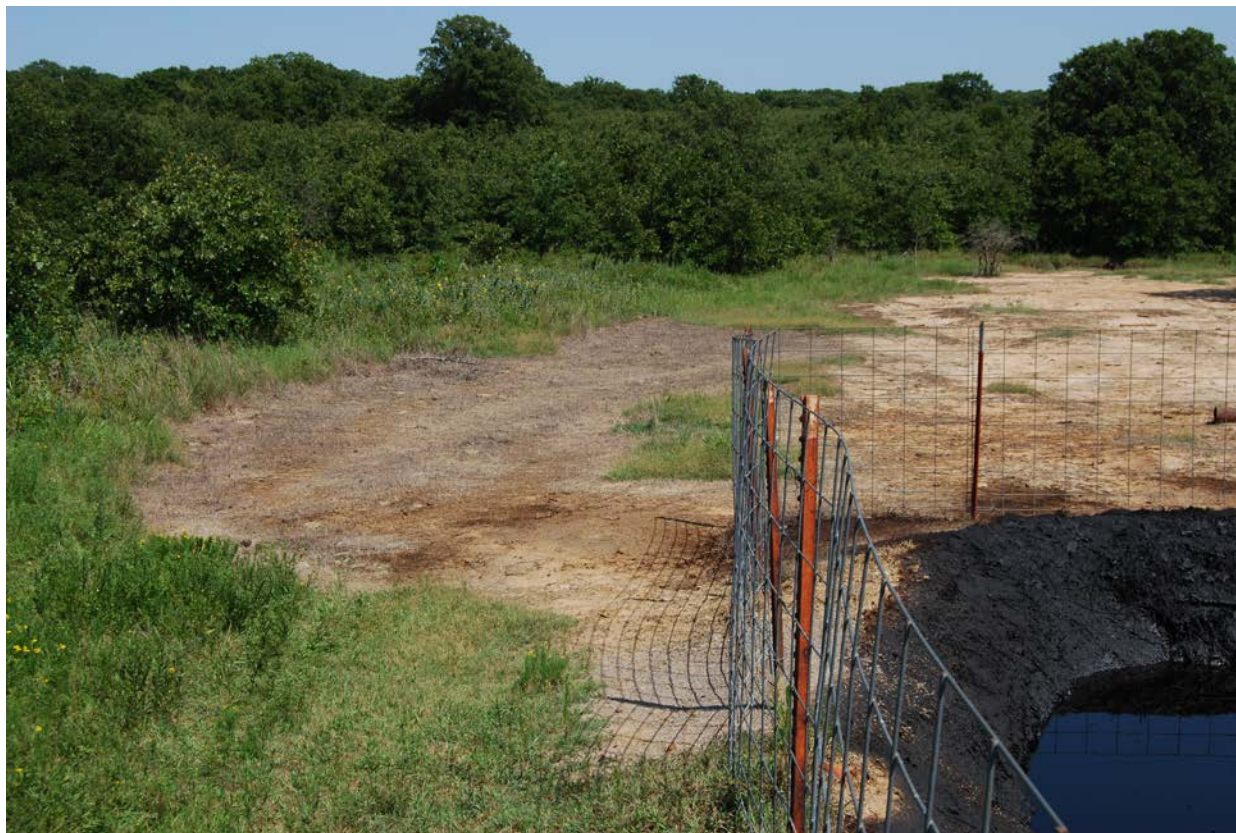
Photo No. 5

Description: I observed surface damage to the north and south sides of the pit and flow path. There was dead vegetation along the flow path and previous brine spill had killed the vegetation towards Elm Creek. This photo shows the north side of the flow path.

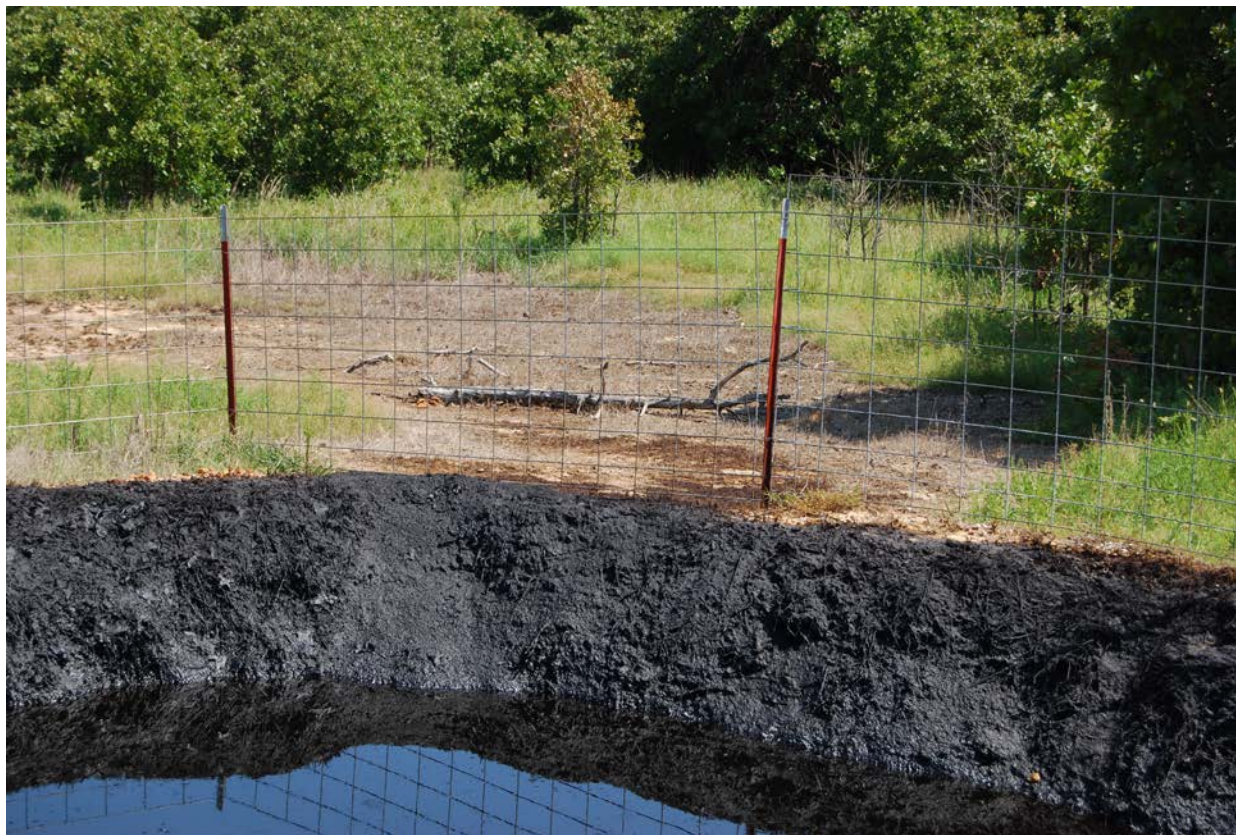
Photo No. 6

Description: The current discharge of fluids occurred on the south side of the facility from the secondary containment.

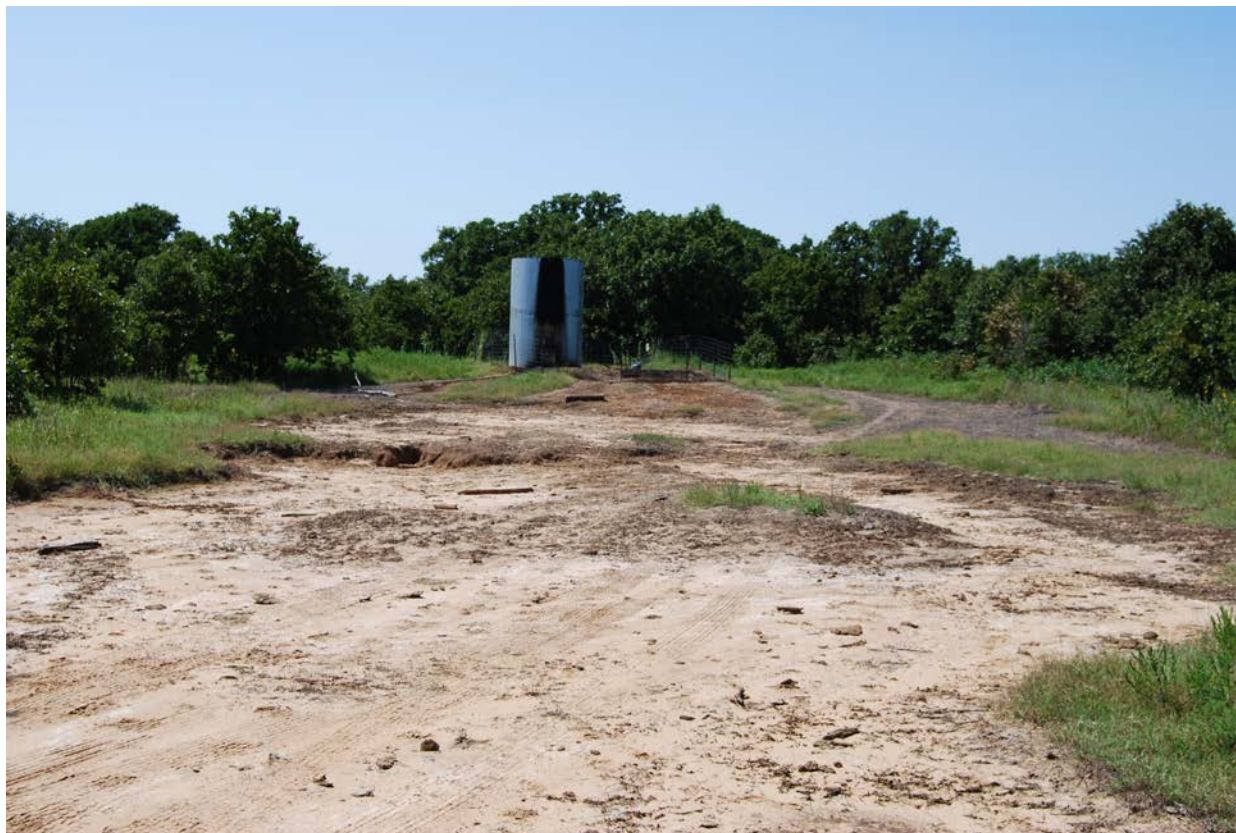
Photo No. 7

Description: This is a view of the brine discharge and flow path from the pit and tank area to the tributary of Elm Creek. The flow path went south from the facility towards the tributary of Elm Creek.

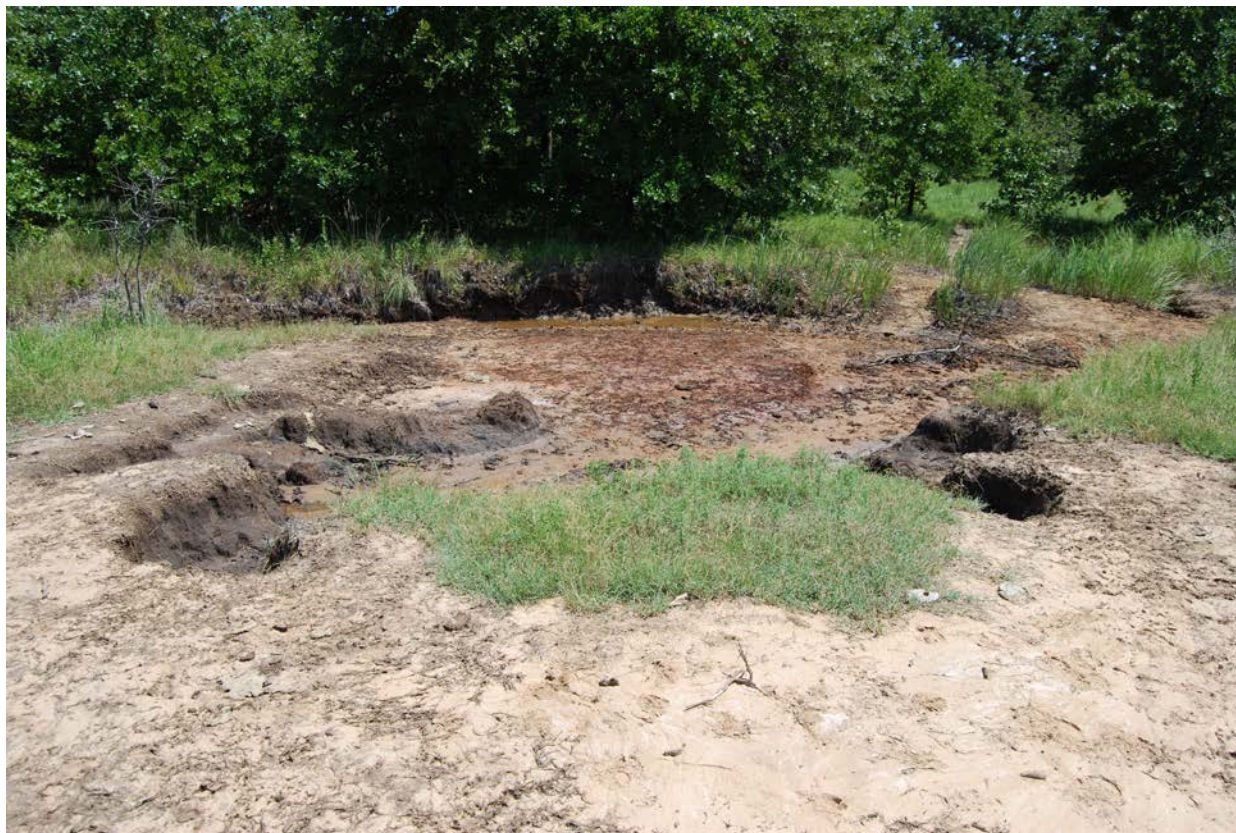
Photo No. 8

Description: The point of entry to the tributary of Elm Creek was shown here. The flow path had no vegetation along it and there were visible salt crystals in the area as well.

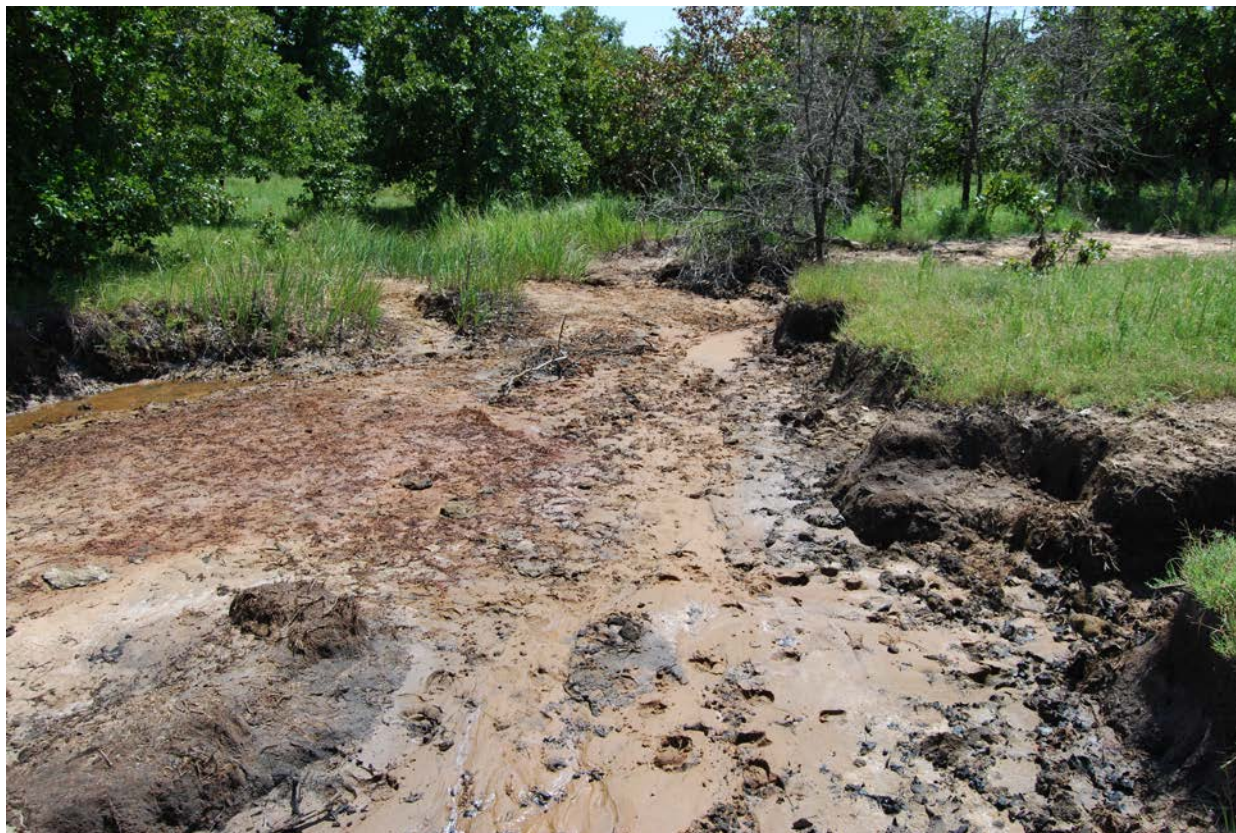
Photo No. 9

Description: This is the entry point to the tributary of Elm Creek. I observed pools of brine and some oil in the tributary and I smelled brine fluids as well. There was bed and bank at this location in the tributary of Elm Creek.

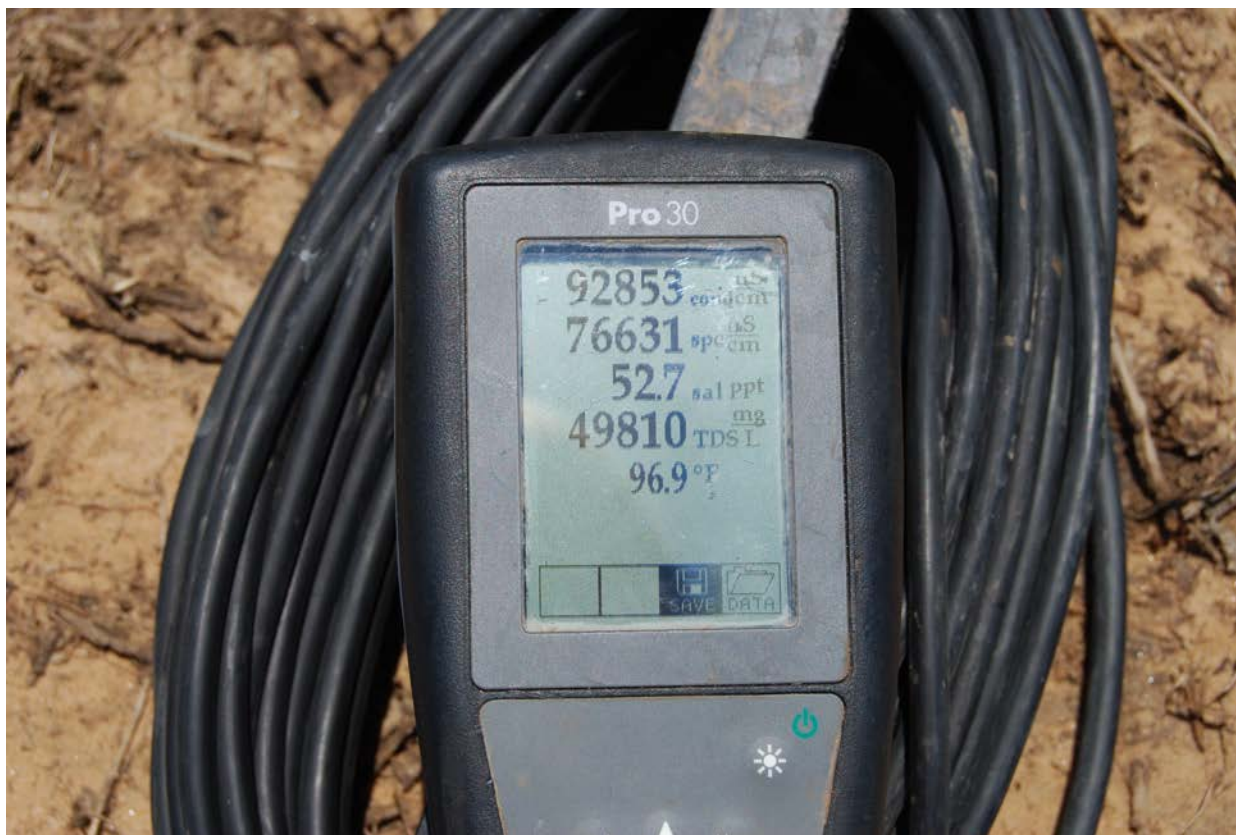
Photo No. 10

Description: With a calibrated YSI Pro 30 conductivity meter, a Total Dissolved Solids (TDS) reading of the tributary of Elm Creek was taken the point of entry and was 49,810 milligrams per liter (mg/L).

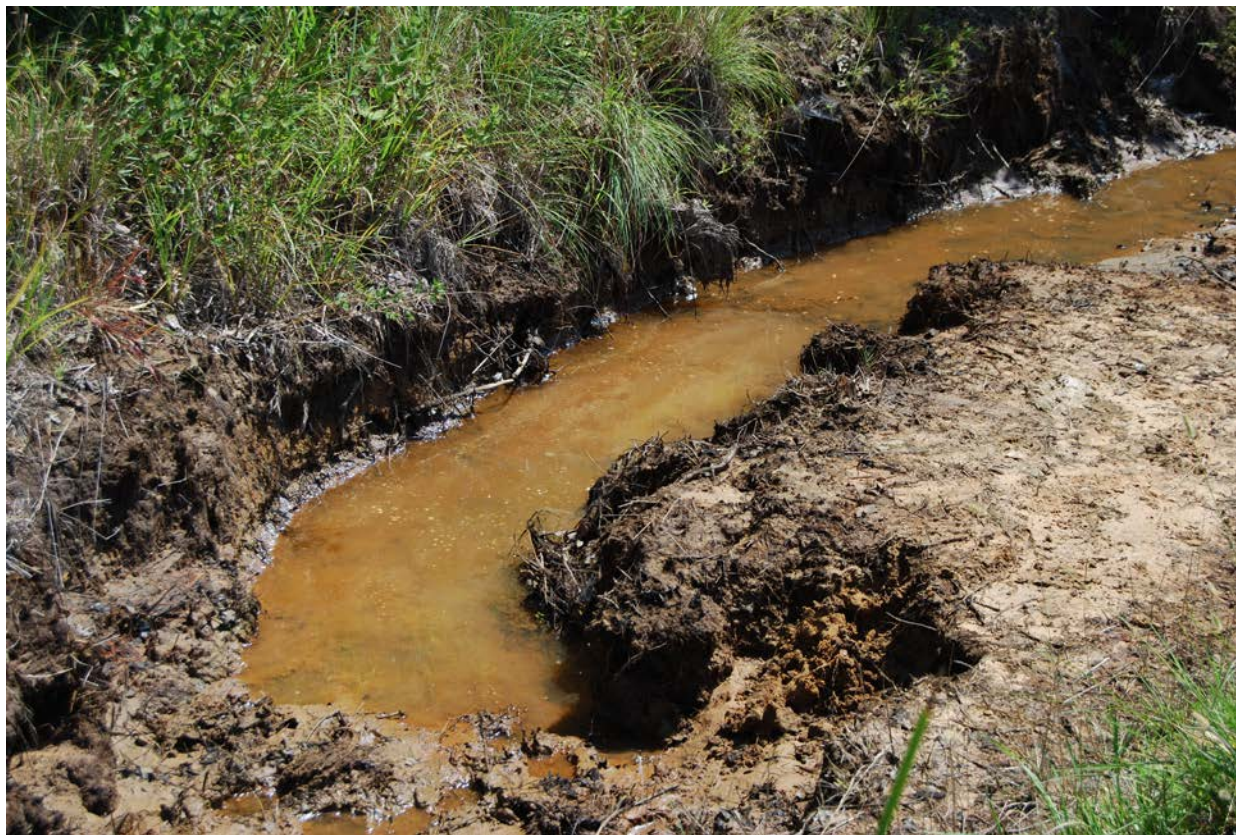
Photo No. 11

Description: This photo shows the tributary of Elm Creek, downstream and near the point of entry depicted in Photos 9. I observed brine fluids in the tributary and some oil staining along the banks of the tributary during the inspection.

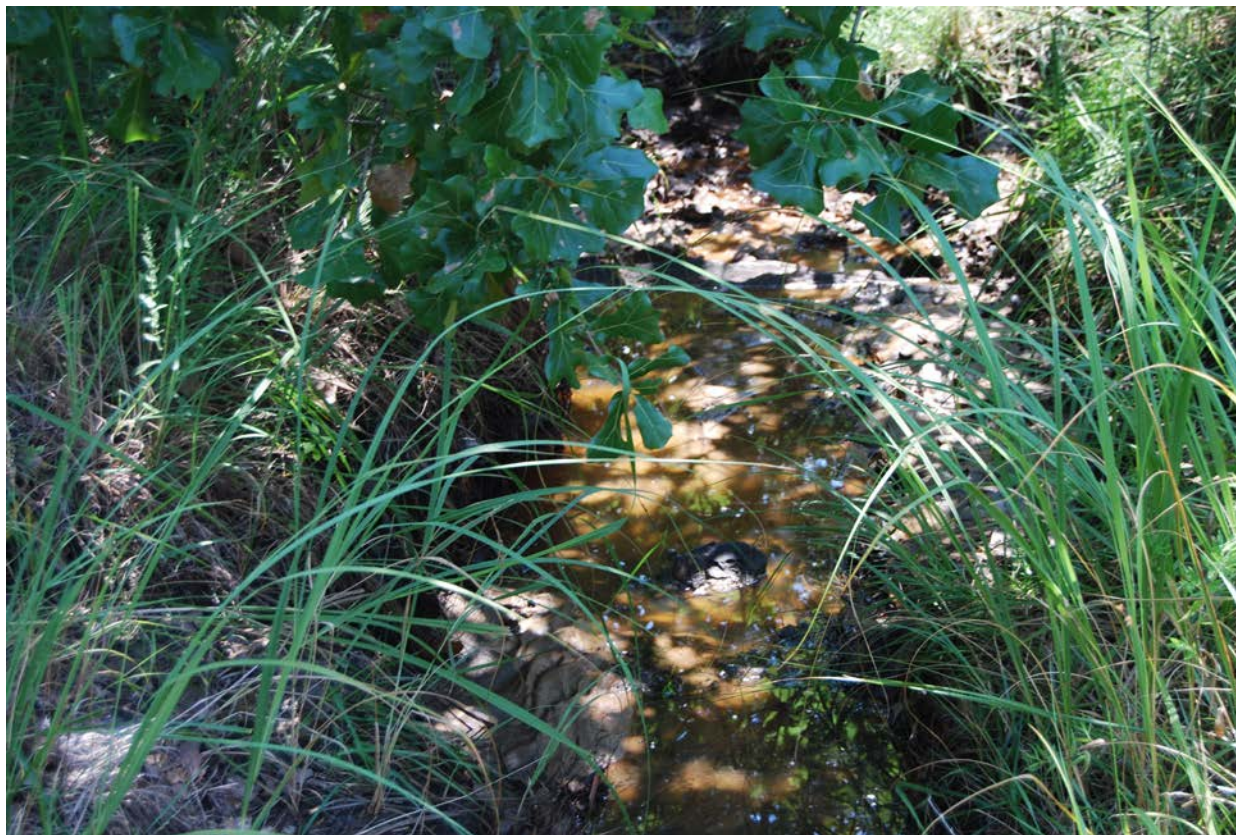
Photo No. 12

Description: Further south along the tributary of Elm Creek, from the discharge entry point, I observed some oil staining. The tributary had a slight flow south in it during the inspection.

Description: A TDS reading of the tributary of Elm Creek shown in Photo 12 was 19,638 mg/L.

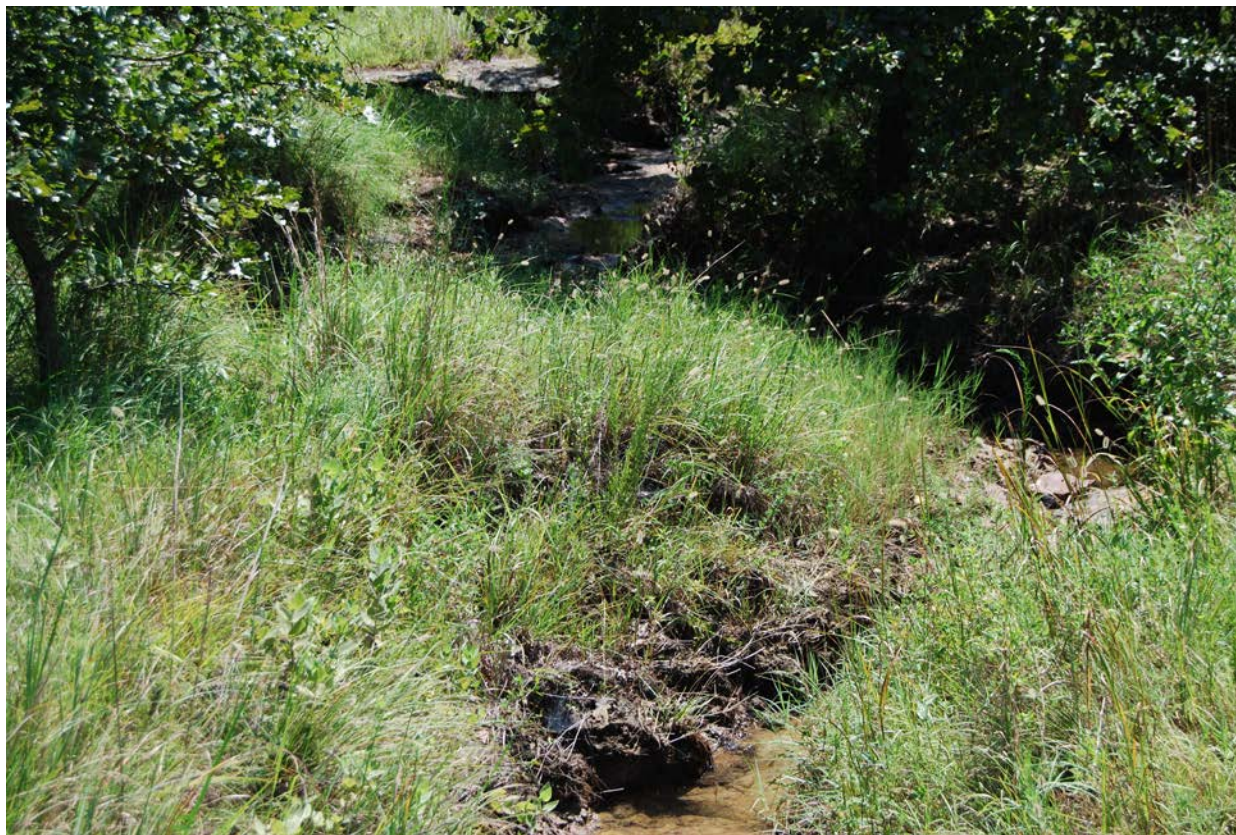
Photo No. 14

Description: This is the tributary of Elm Creek farther south of the point shown in Photo 12. I observed bed and bank at this location in the tributary.

Description: The TDS of the tributary shown in Photo 14 was 14,150 mg/L.

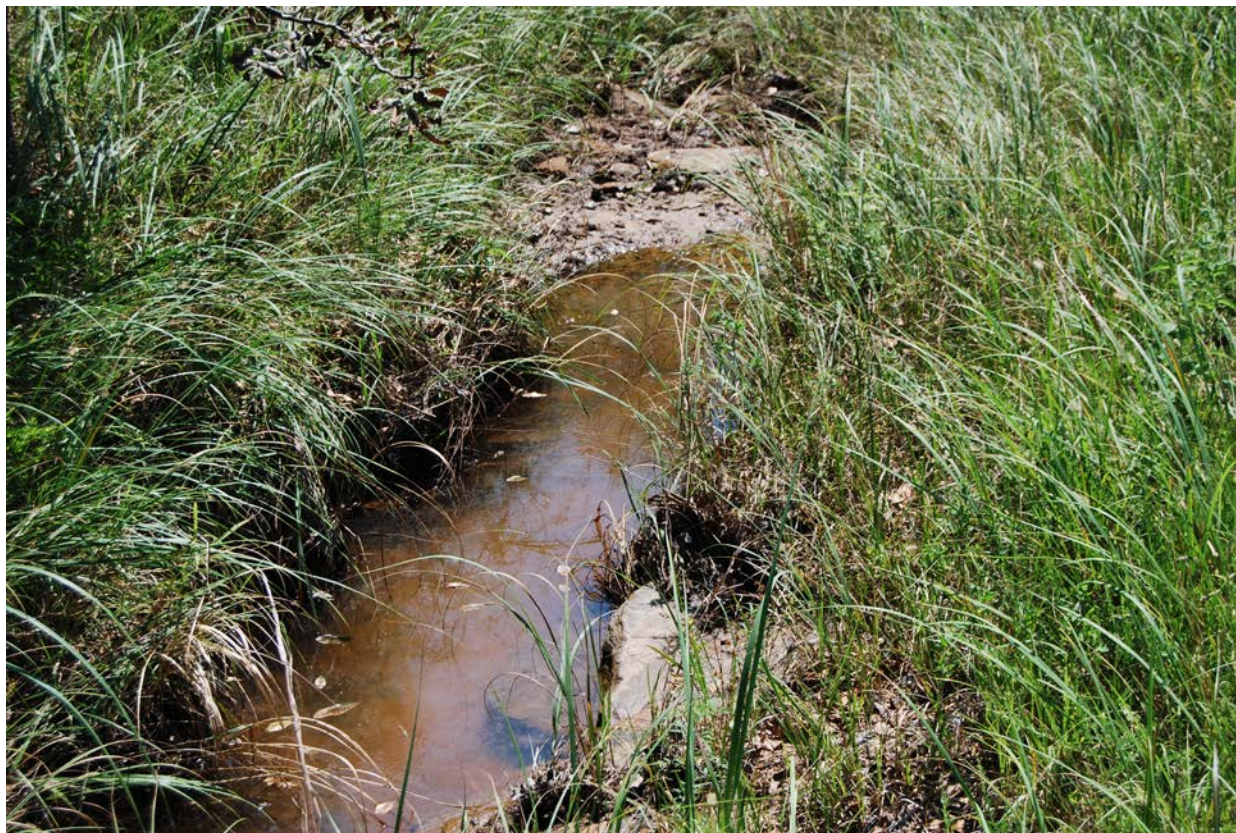
Photo No. 16

Description: The tributary at this location, south of Photo 14, had oil staining on the vegetation.

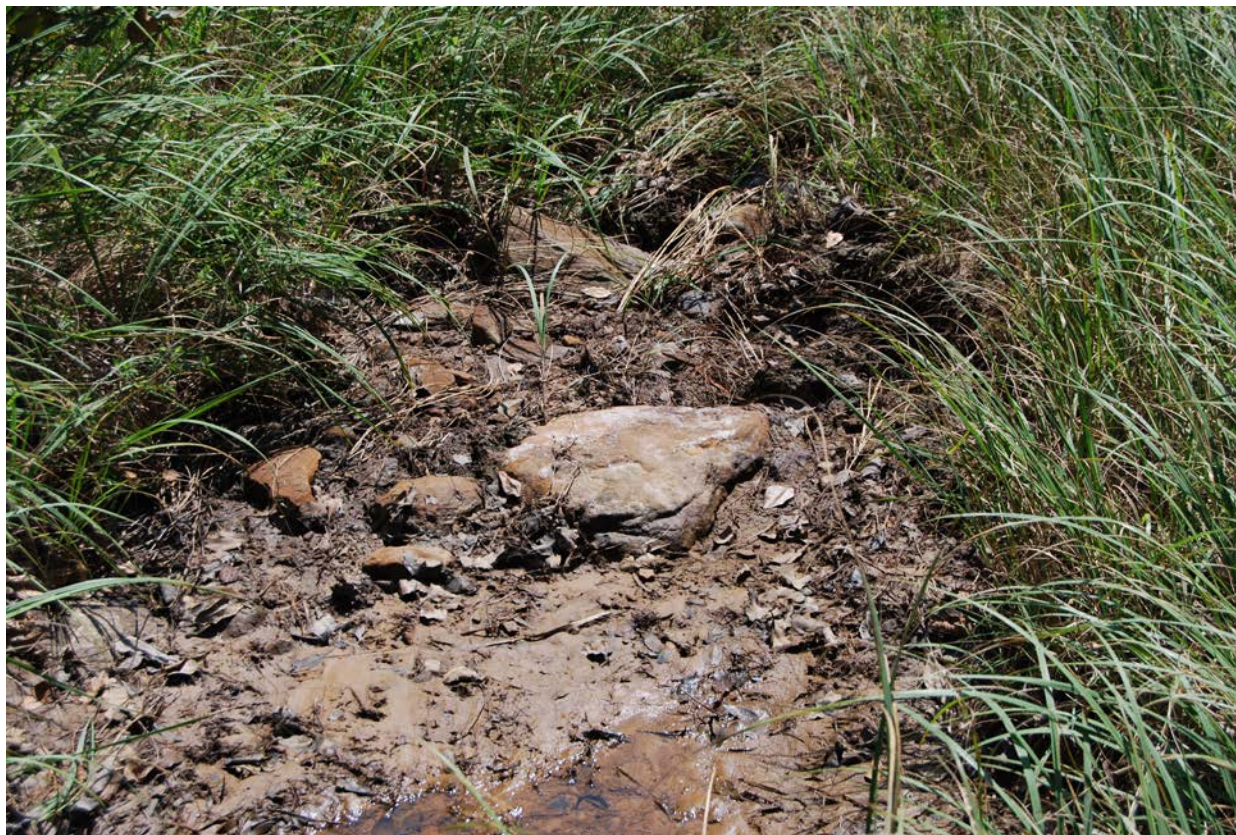
Photo No. 17

Description: I observed that salt staining was also present in the tributary of Elm Creek, as seen here in this photo.

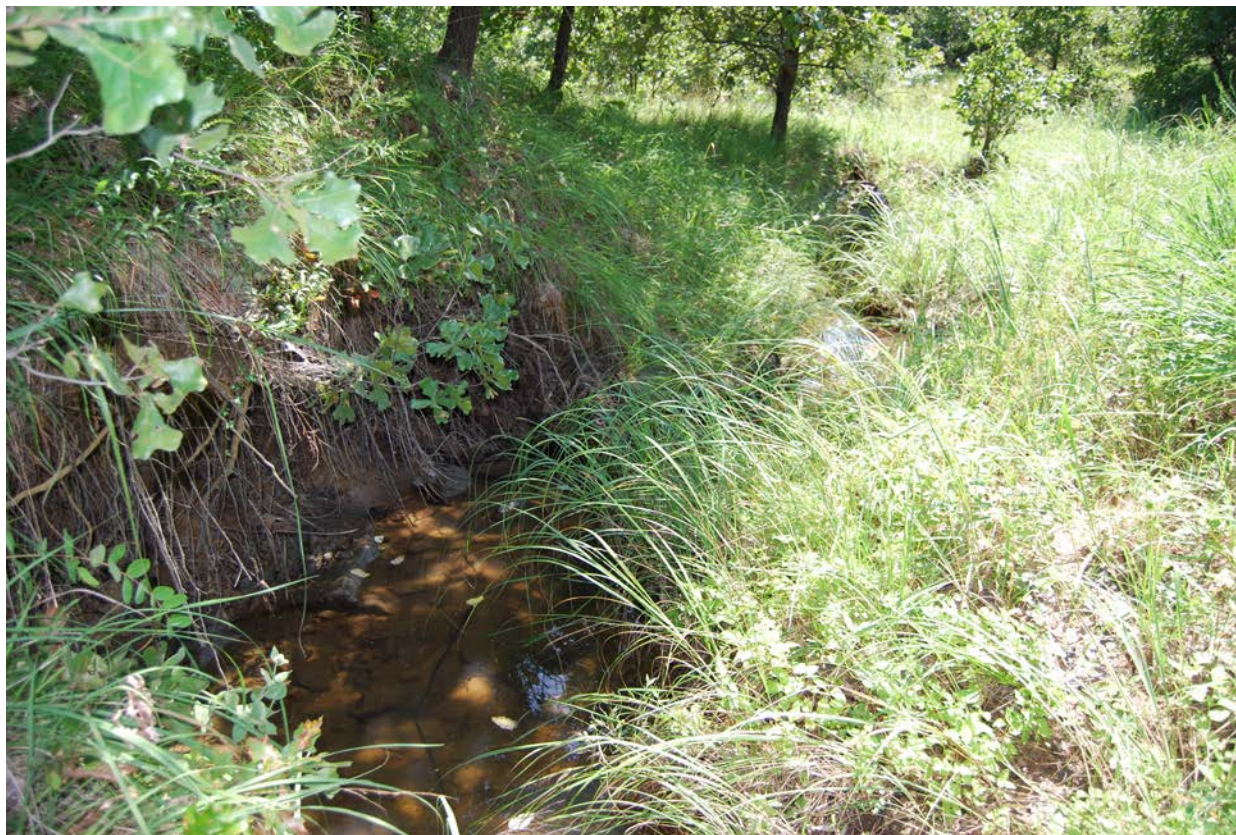
Photo No. 18

Description: I observed the farthest point measured south, downstream, from the discharge entry point.

Description: The TDS at the location shown in Photo 18 was 1,515 mg/L.

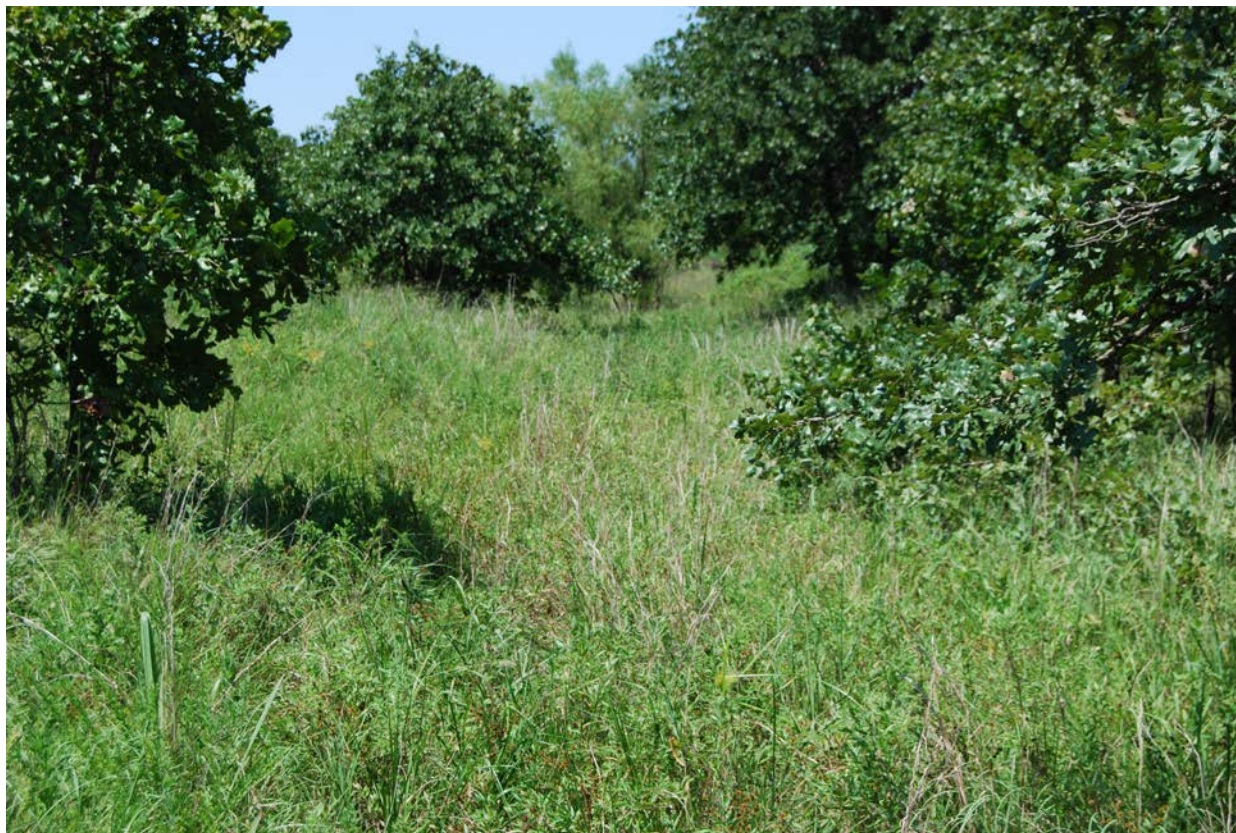
Photo No. 20

tributary. I observed it was dry with green vegetation. A background TDS reading was not taken because the tributary was dry upstream during the inspection.

Description: This was a view upstream of the discharge entry point. I observed that the tributary of Elm Creek was dry at this location and had live vegetation.
