**Well Inspection**  
**Osage DNR / Environmental Protection Agency**  
**1201 Elm Street, Suite 500**  
**Dallas, Texas 75270**

| <b>Operator Info</b> | Contango Resources, LLC<br>1717 South Boulder, Suite 900<br>Tulsa, OK 74119<br>Phone: 918-392-3396 | <b>Inventory ID</b> | OS2843000 | | |
| | | <b>Lease Name</b> | NRU | | |
| | | <b>Well ID</b> | 6W1 | | |

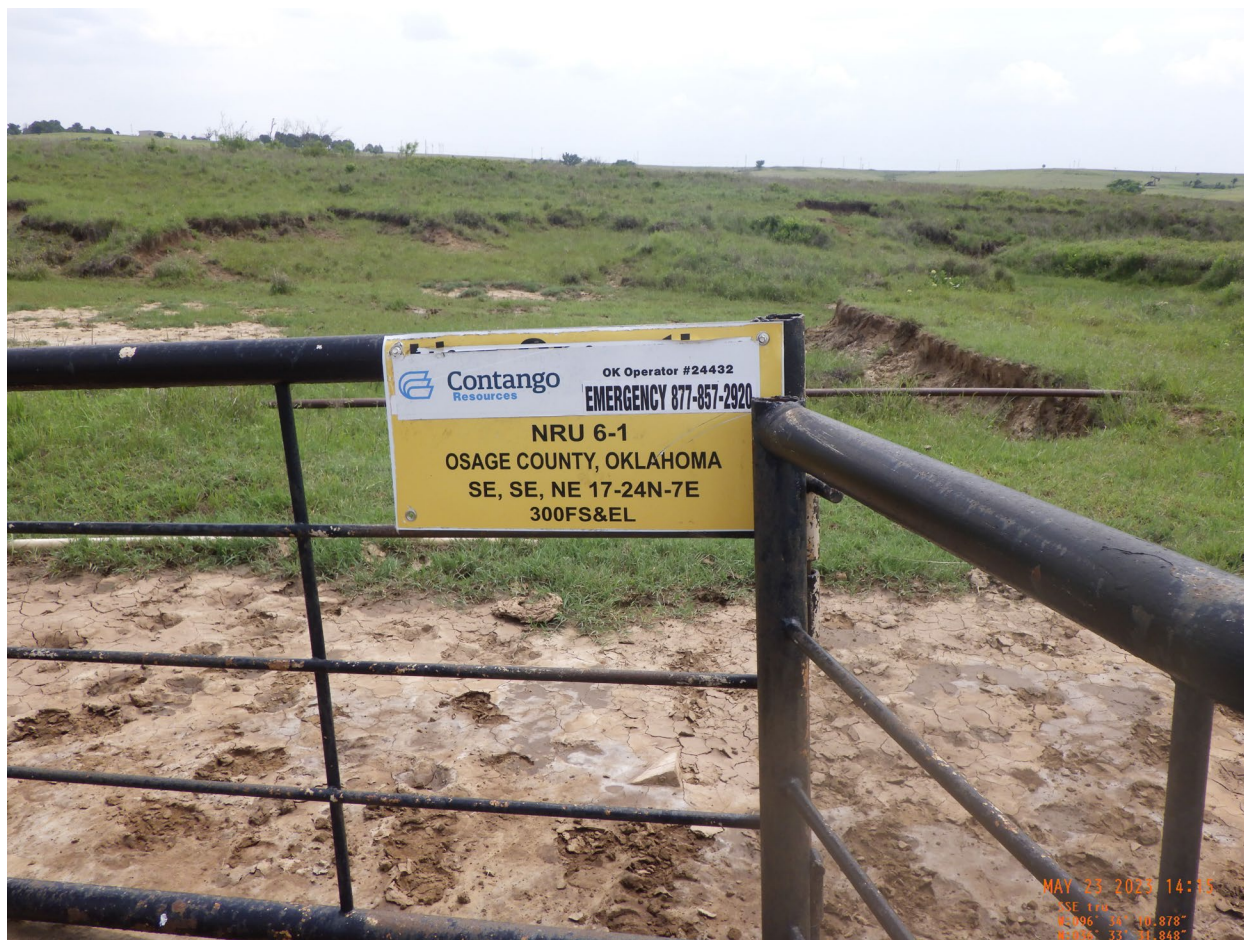
Photo No. 1

**Description:** This was the injection well OS2843000 sign at the time of the inspection.

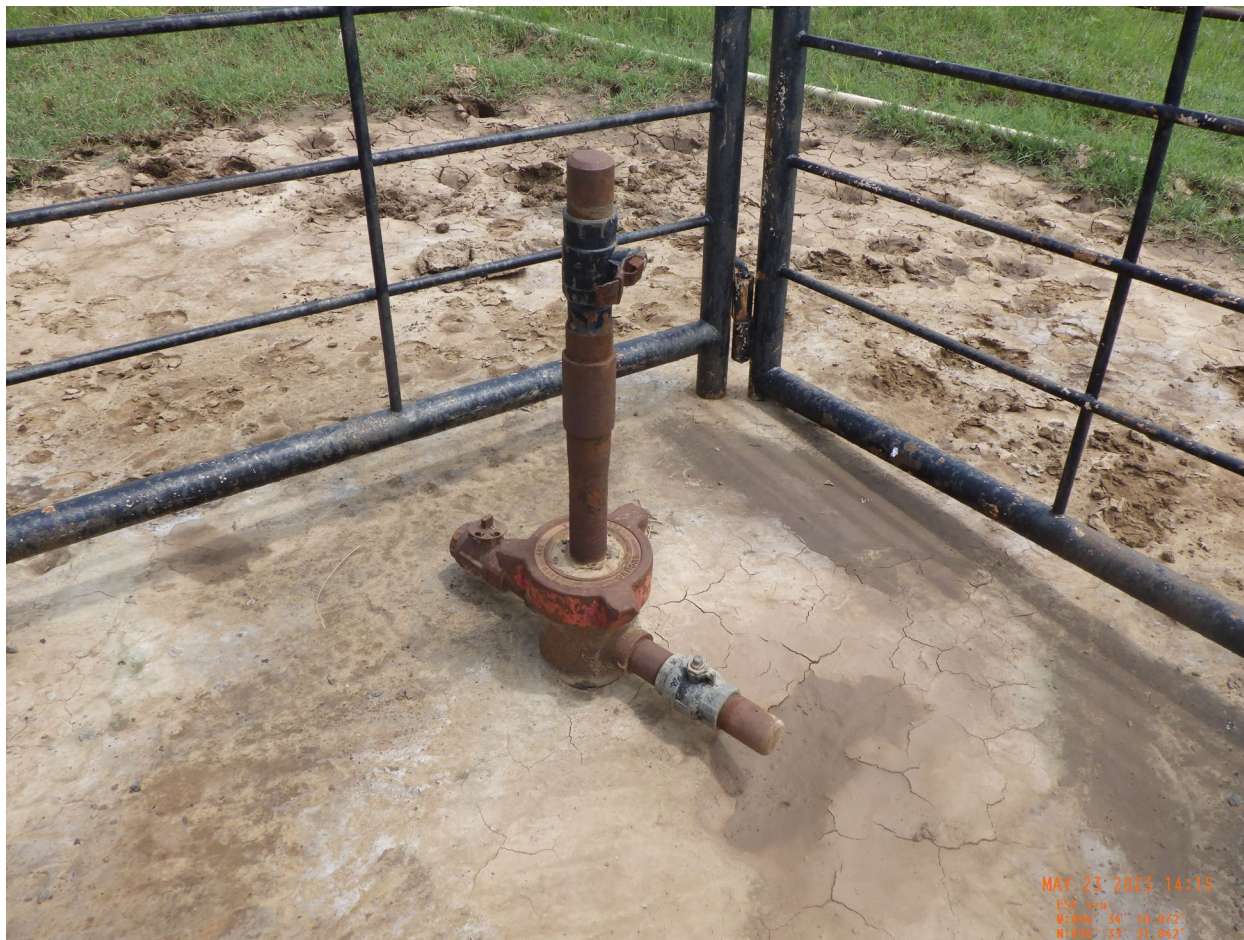
Photo No. 2

| <b>Inspection Comments</b> | A fluid level was taken with a properly calibrated EPA Echometer. The fluid level taken during the inspection was 263 feet deep. This well was not connected during the inspection. Two photographs were taken during this inspection and can be seen in the Inspection Photo Log. | | | | |

**Description:** This was the injection well OS2843000 at the time of the inspection. The well was not connected at the time of the inspection.
