Bill Fultz - Plant Manager, Pedricktown Plant  
FROM: Ron Szmerda - Latex and Tank Farm Mgr., Pedricktown Plant  
DATE: February 7, 1991

Near Miss Incident  
Vinyl Chloride Gasket Leak

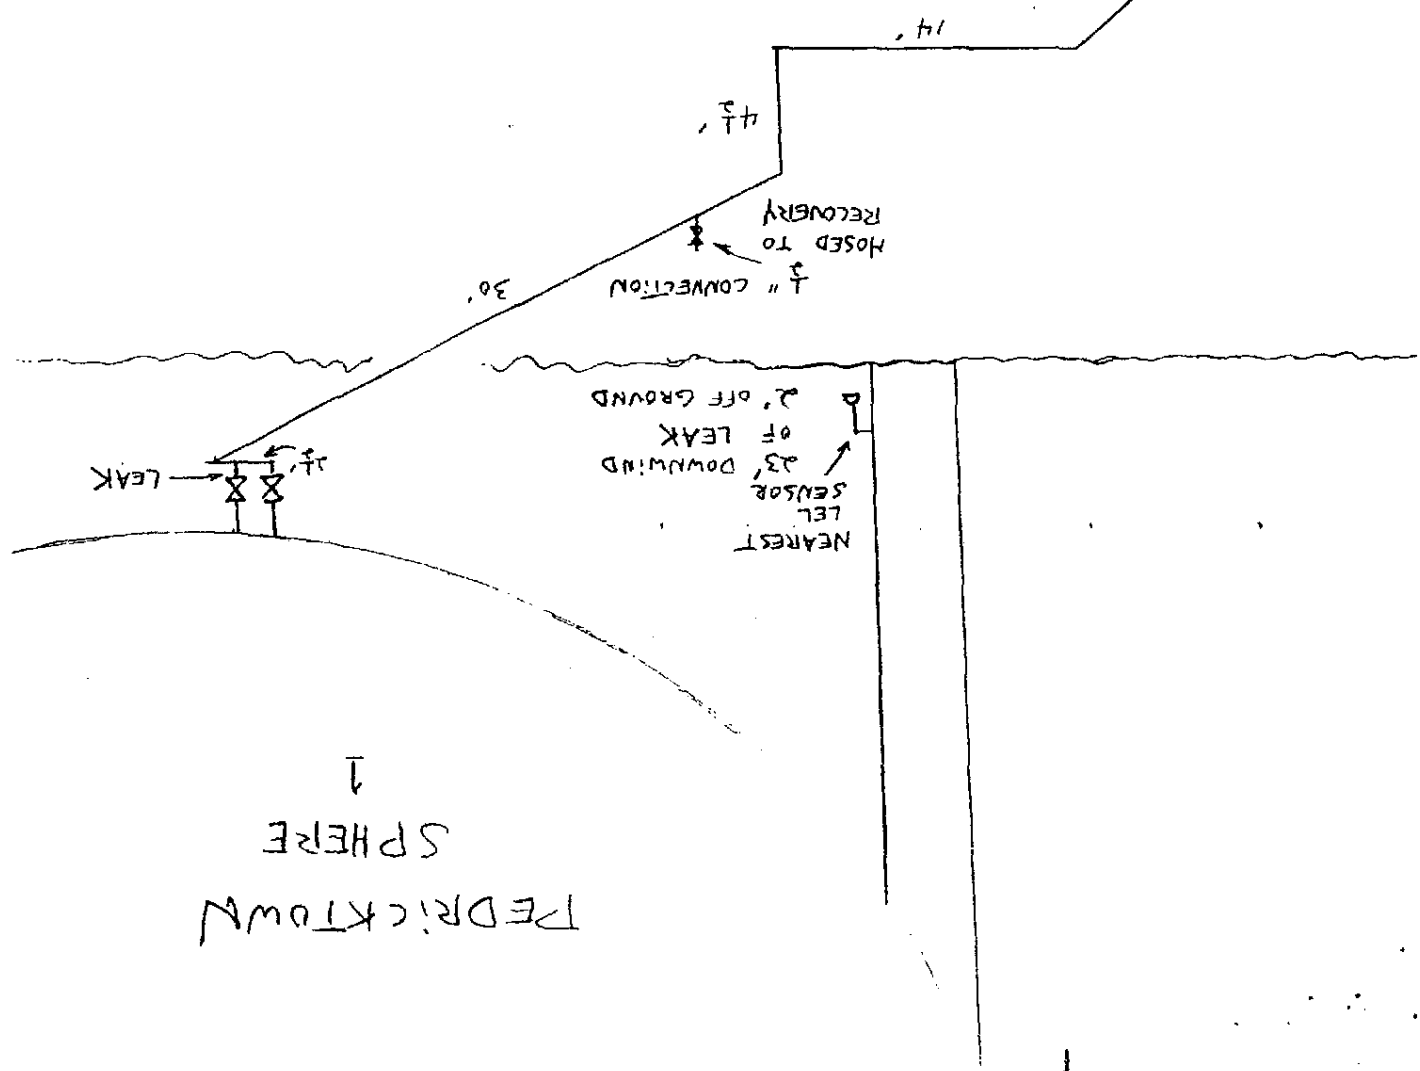
PEDRICKTOWN  
1  
SPHERE

The lack of hydrostatic relief is the most likely cause of this incident. The hydrostatic valve was installed incorrectly in 1979 as part of the Large Poly construction project. Pointed in the direction that it was installed, it would not have provided the intended safeguard, even if the valves on either side of it were in the proper (open) position.

EXCEPT FOR THE TWO  
4" VALVES ON THE BOTTOM OF  
THE SPHERE+ THE IMMEDIATE PIPING  
THE MAJORITY OF THE  
OF LINE IS 6" DIAMETER.  
THE VOLUME IN THE LINE IS  
96 GALLONS

CLOSED 1/2" VALVES  
ON EITHER SIDE OF  
THE HYDROSTAT  
TO RELIEVE IN THE  
WRONG DIRECTION  
VALVE INSTALLED  
HYDROSTATIC RELIEF  
1/2"

Label hydrostatic relief valve piping for flow direction.

Establish a plant hydrostatic relief valve testing/changeout frequency.
