# NPDES Reconnaissance Inspection Report

**Division Five, Inc.**

**Tukwila, Washington**

**Inspection Date: May 29, 2024**

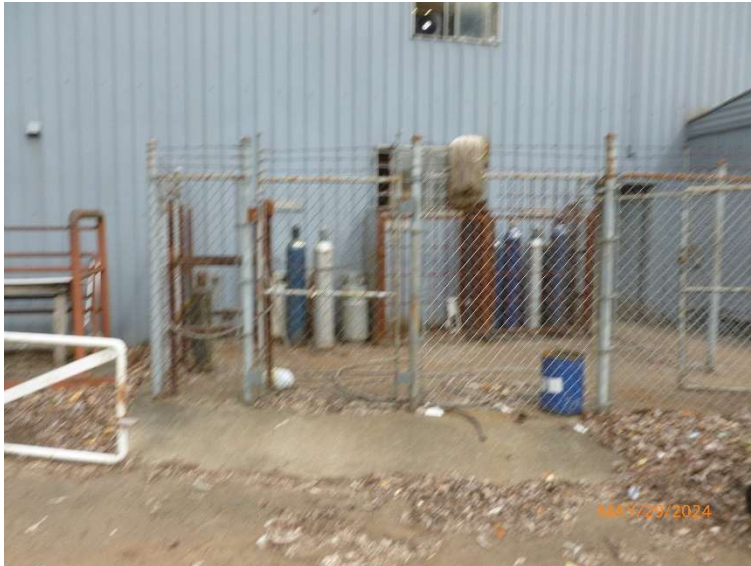
Photo 1: P1010571

A garden hose was observed in the area of the fenced welding gas storage area and a Facility Rep indicated that infrequent vehicle washing occurred here. *See Photo 1.*

SE Corner Main Bldg Outdoor Storage – Water Hose – Infrequent Vehicle Washing

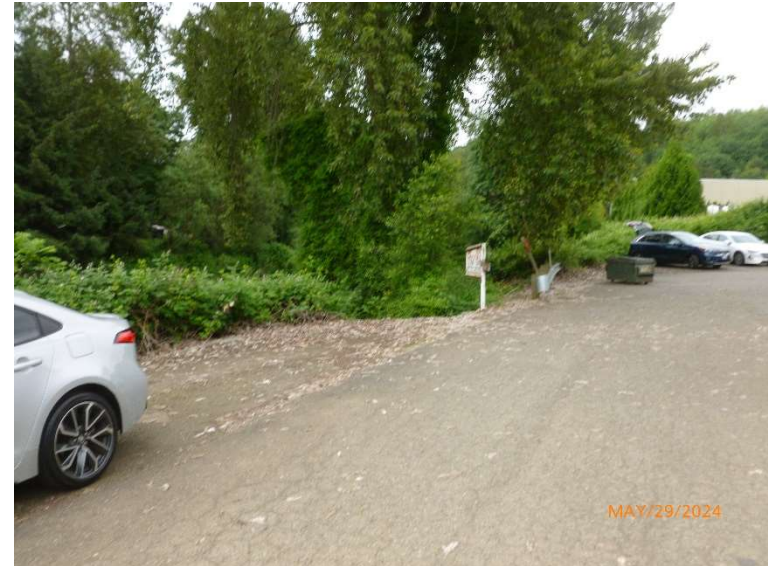
Photo 2: P1010572

We started by walking out the S. 144<sup>th</sup> Street office entrance and up the asphalt drive area on the eastside of the Facility. The southern portion of the asphalt drive area is sloped and the flow path crosses the gravel shoulder toward and down the riverbank at the end of S. 144<sup>th</sup> Street. *See Photo 2.*

SE Corner Asphalt Entrance Sloped to 144<sup>th</sup> Street River Bank

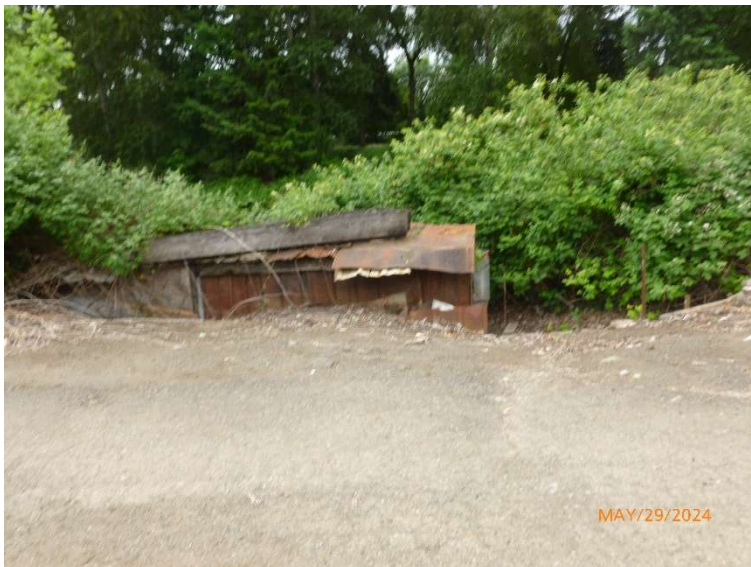
Photo 3: P1010573

The drive area gravel shoulder gently slopes toward a path around the unused, abandoned fish shack down the riverbank. *See Photo 3.*

East Side Main Building Area - Unused Fish Shack on River Bank

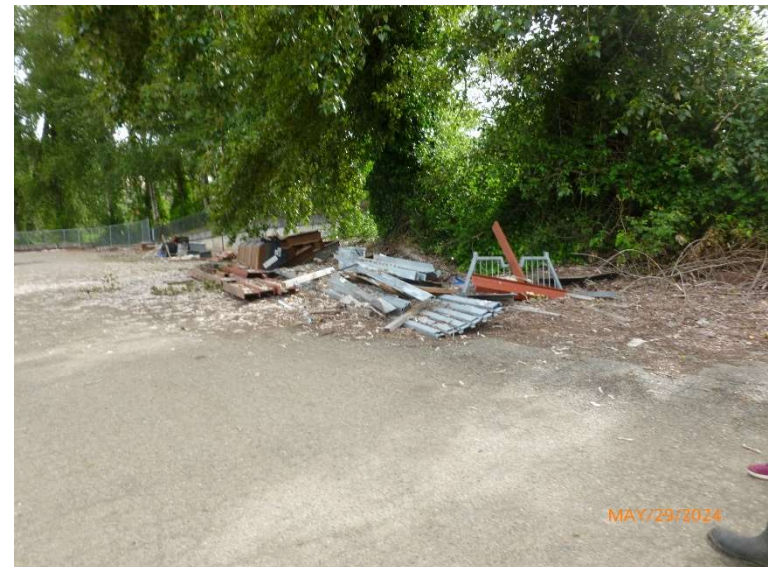
Photo 4: P1010574

There are equipment and metal supply storage areas on the east side of the Facility's main building, near the canopied work area. *See Photos 5 – 6.* Directly east of this fenced equipment and metal storage areas, are located piles of metal supplies on the gravel areas off the asphalt drive area, directly above the riverbank. *See Photo 4.*

Metal Storage Area – Treeline on River Bank

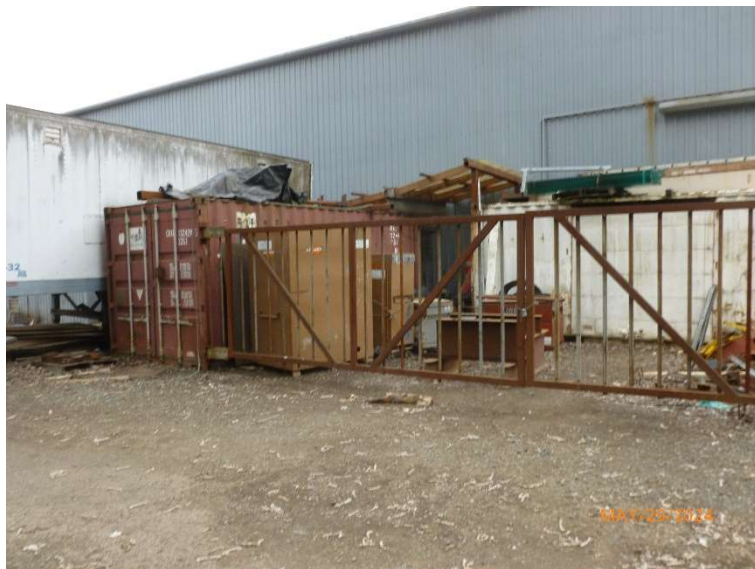
Photo 5: P1010575

Storage Area East Side of Main Building

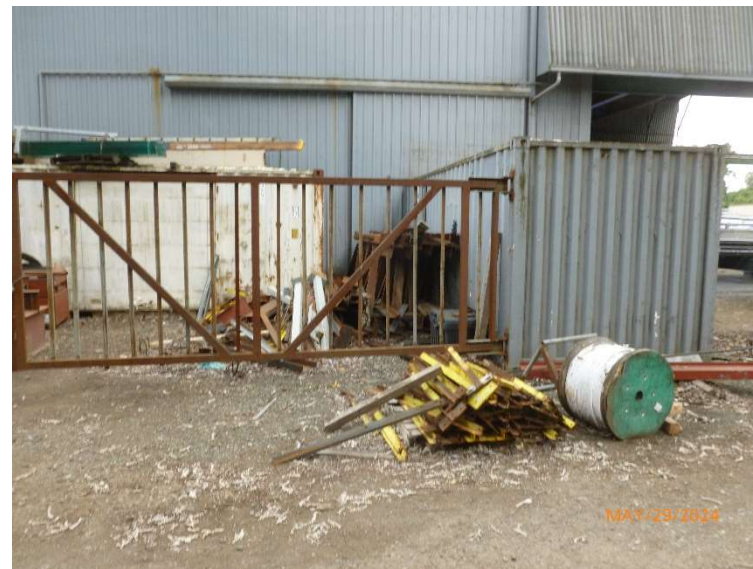
Photo 6: P1010576

Metal Equipment Storage at Main Bldg/Canopied Work Area

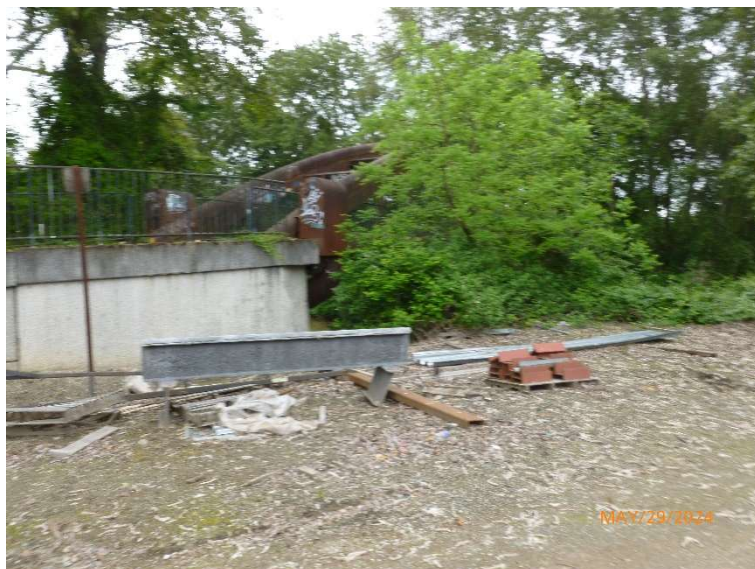
Photo 7: P1010577

The Green River Trail bridge crosses the Green-Duwamish River about mid-Facility and its concrete supporting structure abuts a Facility drainage swale that directs any swale-captured flow around the concrete structure down the riverbank, with various piles of used tires and metal supplies and metal storage located on or next to the swale. *See, e.g., Photos 7 – 9.*

Metal Materials Storage near Swale Under Green River Trail Structure

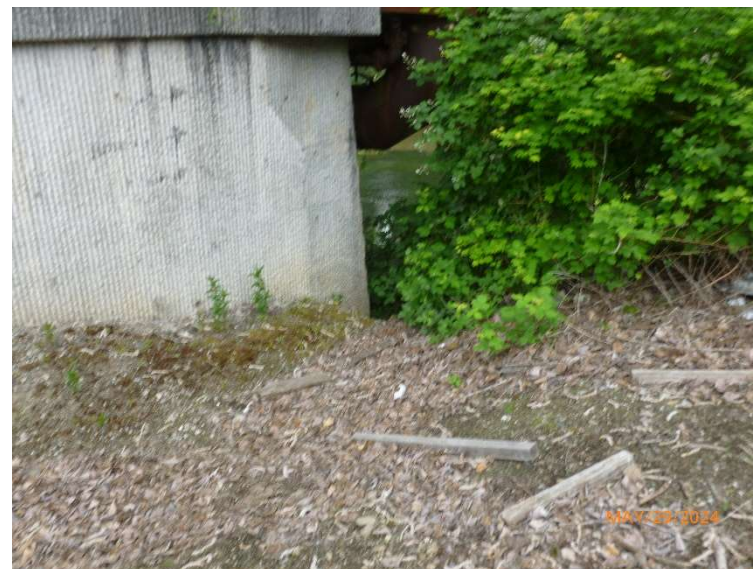
Photo 8: P1010578

Drainage Swale Around Green River Trail Structure to River

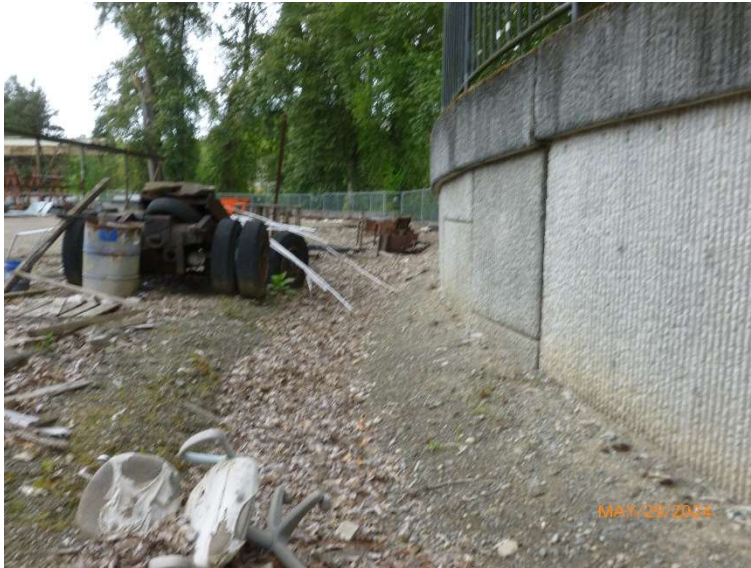
Photo 9: P1010579 05/29/2024  
Drainage Swale Along Facility-Green River Trail Structure Border (looking north)

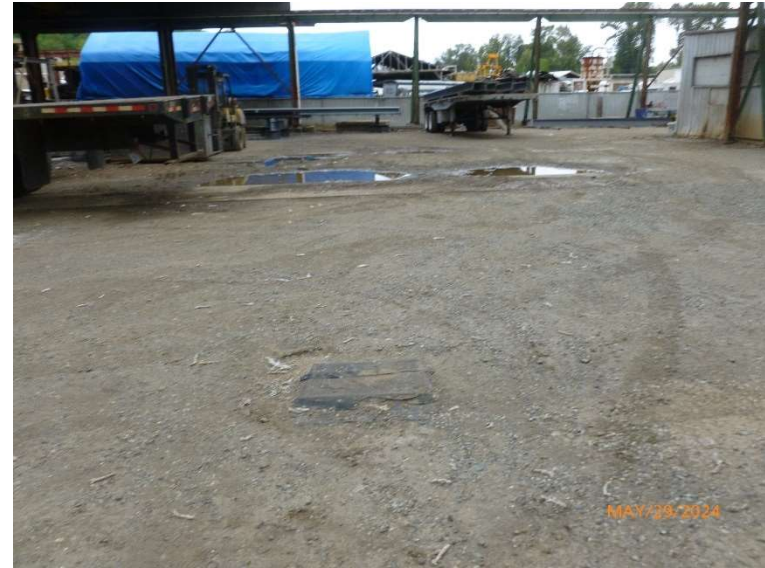
The Facility's southern stormwater catch basin, located just east of the canopied work area, is located in the drive area approximately mid-point between the main storage yard and the swale entry point to the riverbank. *See Photo 10 (CB).* The Facility's northern stormwater catch basin is located about 125 feet north of the southern CB, approximately mid-point between the main storage yard and the Facility's eastern boundary with the Green River Trail. *See Photo 12 (CB).* Both stormwater catch basins were observed with the filtration fabric installed on the grate covers.

Photo 10: P101580 05/29/2024  
Southern Stormwater Catch Basin with Filtration BMP – Directly East of North End  
Of Canopied Work Area

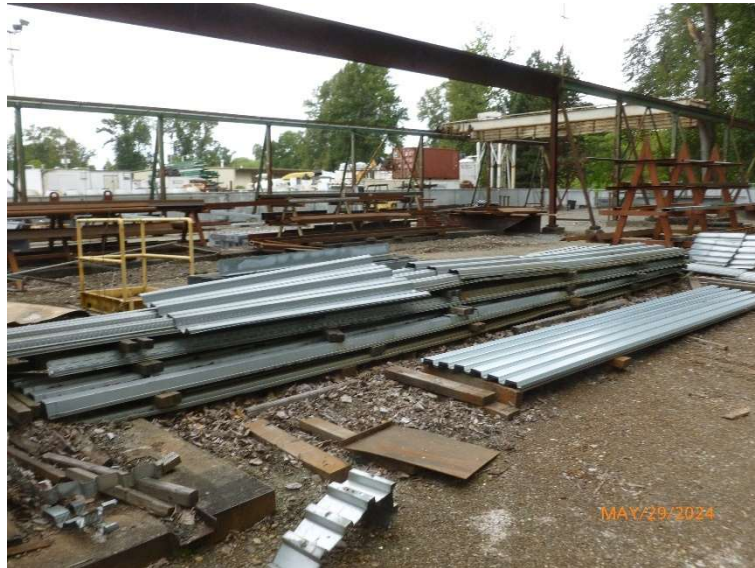
Photo 11: P1010581 05/29/2024  
Metal Supplies in Storage Yard Along Overhead Craneway

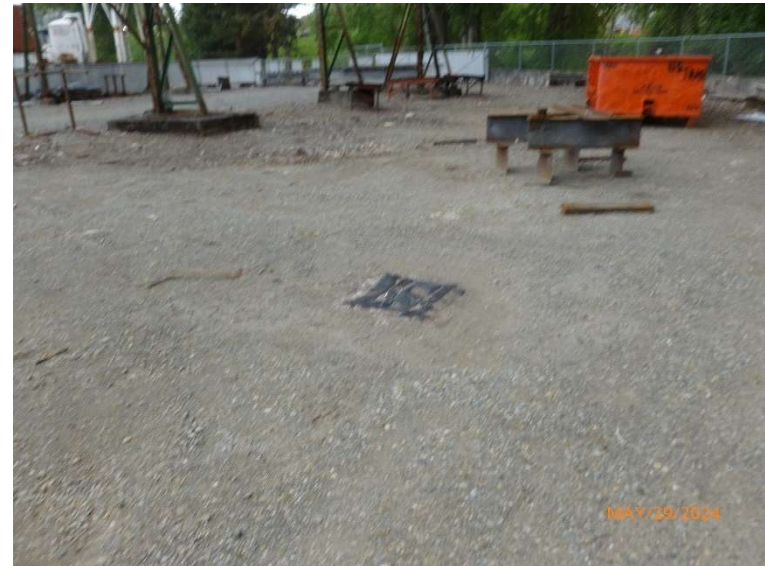
Photo 12: P1010582 05/29/2024  
Northern Stormwater Catch Basin with Filtration BMP – Looking North toward  
Facility's Entrance/Exit to South 143<sup>rd</sup> Street

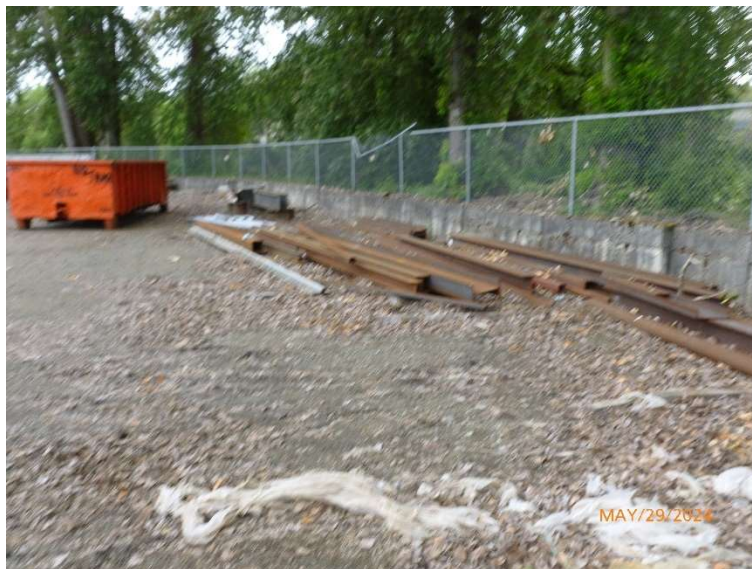
Photo 13: P1010583

Metal Storage in Facility NE Corner

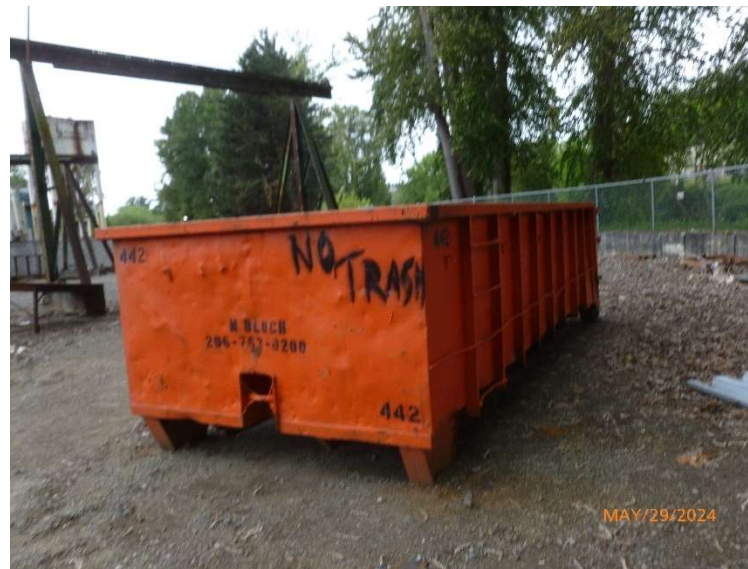
Photo 14: P1010584

The Facility’s northern operational area included uncovered material storage, like an uncovered metal recycling roll-off, an uncovered waste storage bin, and an uncovered metal recycling bin. See **Photos 14 – 15, 20 – 21**.

Uncovered Metal Recycling Roll-Off – looking north

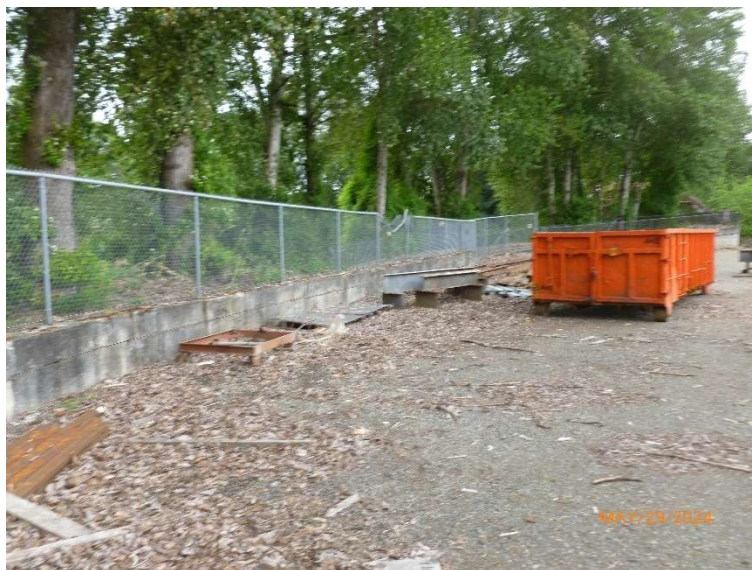
Photo 15: P1010585

Metal Storage & Uncovered Metal Recycling Roll-Off – looking south/SE

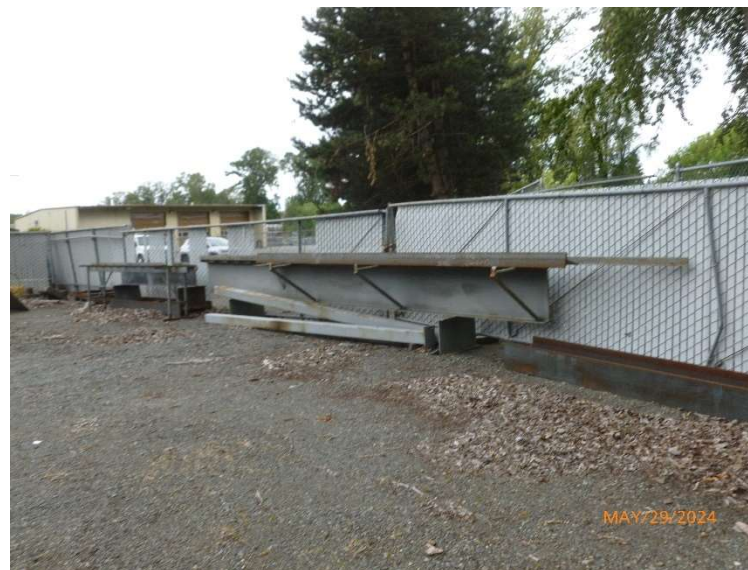
Photo 16: P1010586

Metal Storage at Facility Entrance/Exit (Blocked) to S. 143<sup>rd</sup> Street

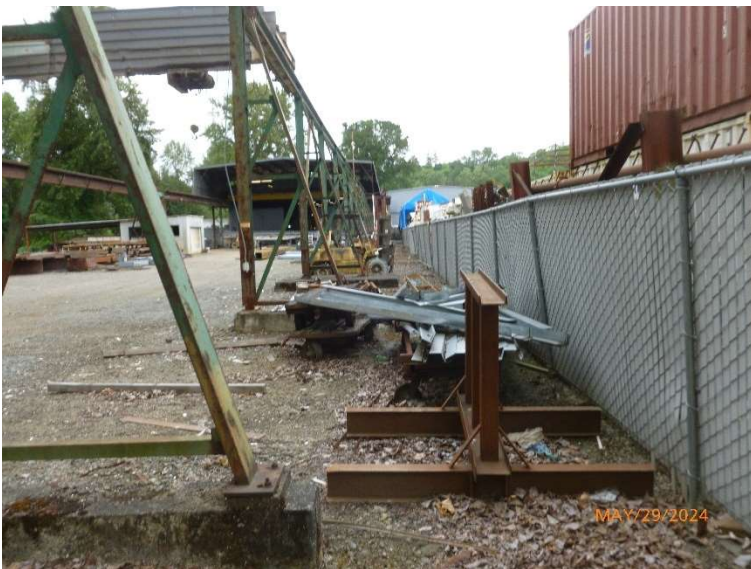
Photo 17: P1010587

Facility Western Border/Craneway – looking S/SE toward Canopied Work Area

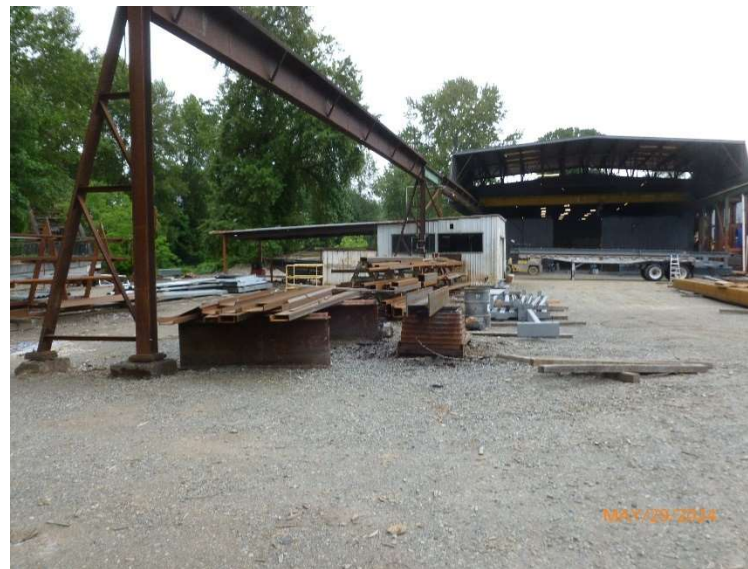
Photo 18: P1010588

Structural Metal Storage Yard – looking South

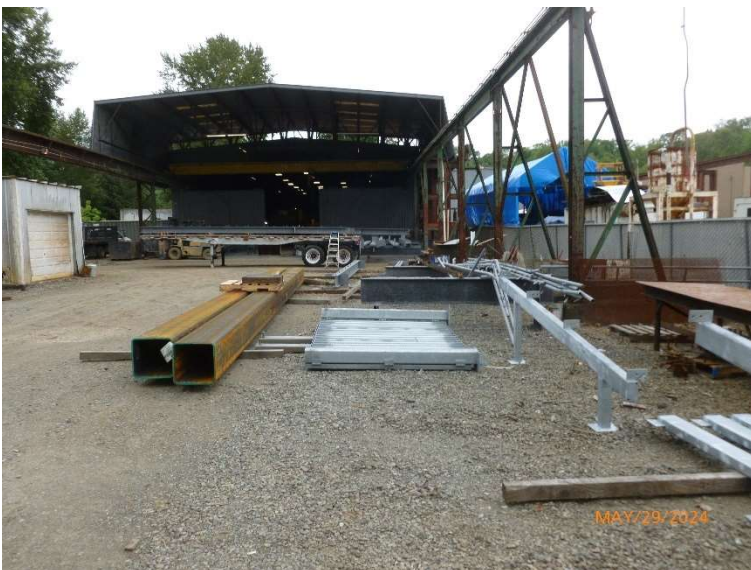
Photo 19: P1010589

Facility Storage Yard – looking South

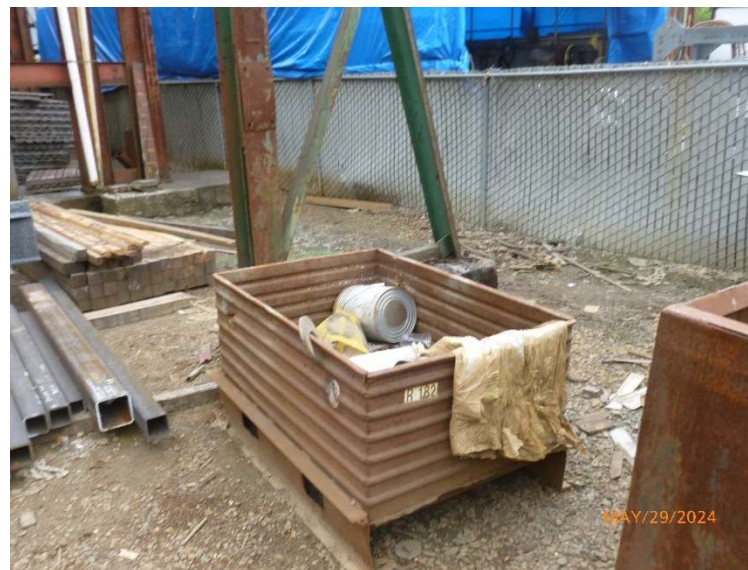
Photo 20: P1010590

Uncovered Waste Storage Bin

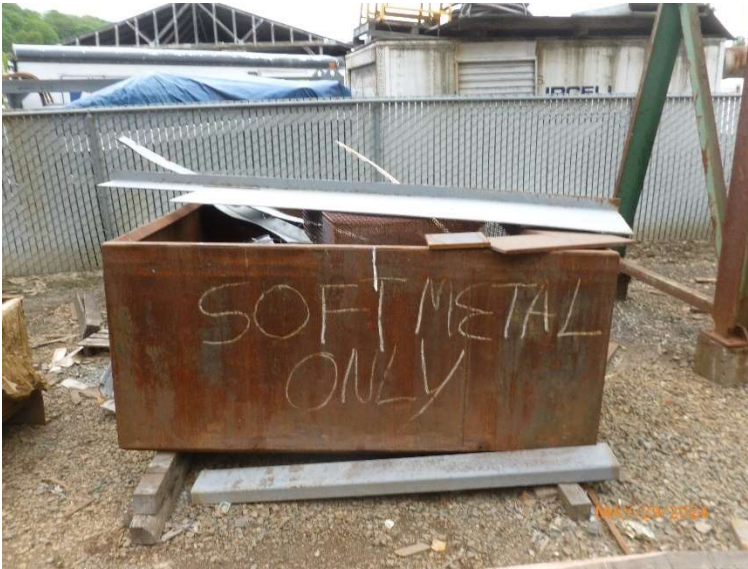
Photo 21: P010591

Uncovered Metal Recycling Bin in Facility Storage Yard
