**Region 6 Compliance Assurance and Enforcement Division  
INSPECTION REPORT**

| Inspection Date(s): | 07/24/2018 | | |
| Company Name: | <b>City of Socorro</b> | | |
| Facility Name: | <b>Socorro Wastewater Treatment Facility</b> | | |

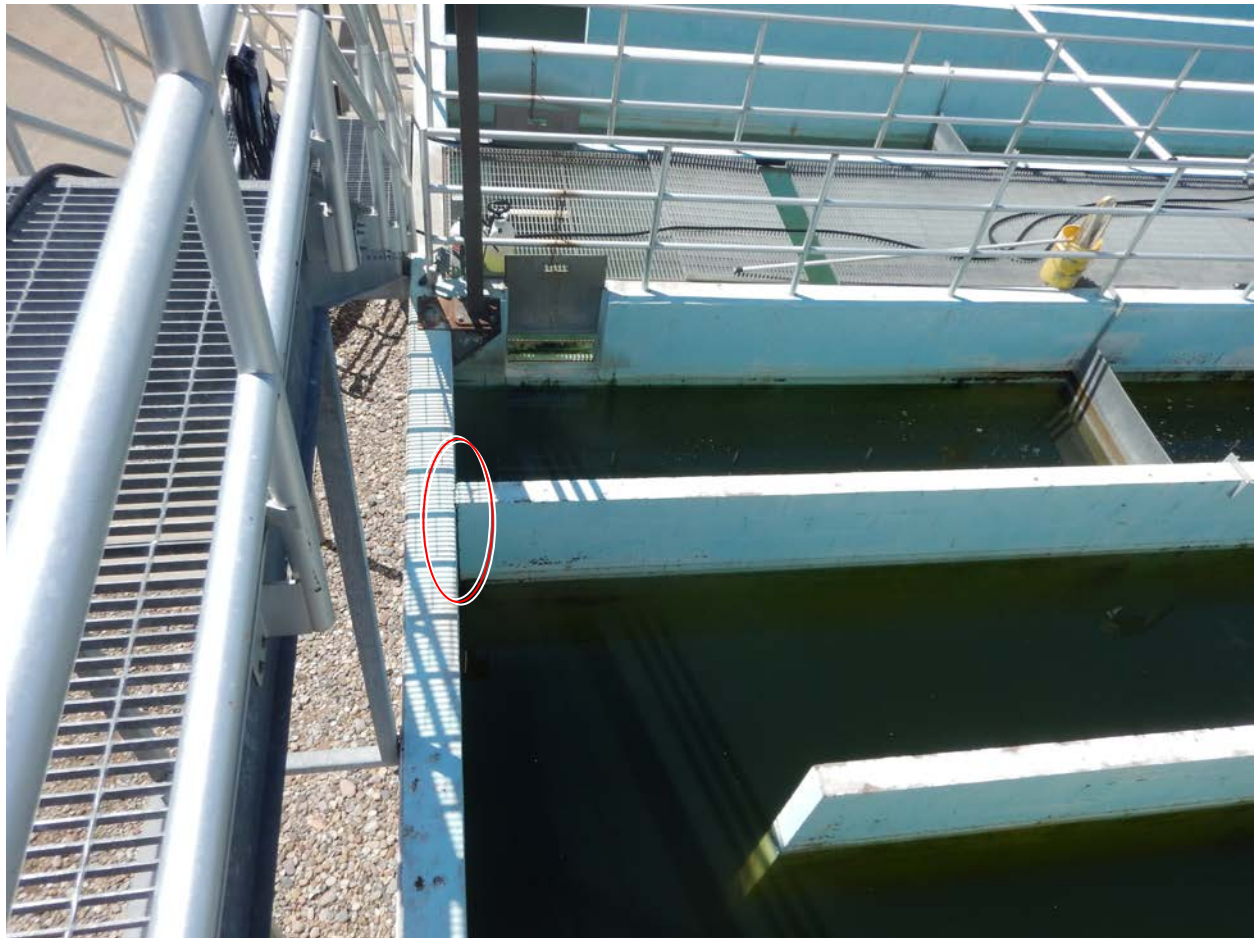
Photo No. 2

There is a crack in one of the walls of the chlorine contact chamber (see Photo 2 of the Photo Log in Appendix 1) which is causing a short circuit in the chlorine contact chamber and potentially shortening the total duration of chlorination. It is possible that this short circuit was caused by the same structural failure that is causing the cracking and deflection in the SBR basin, as the eastern wall of the chlorine contact chamber is in line with the eastern wall of the SBR basin.

Description: Short circuit in chlorine contact chamber (circled)

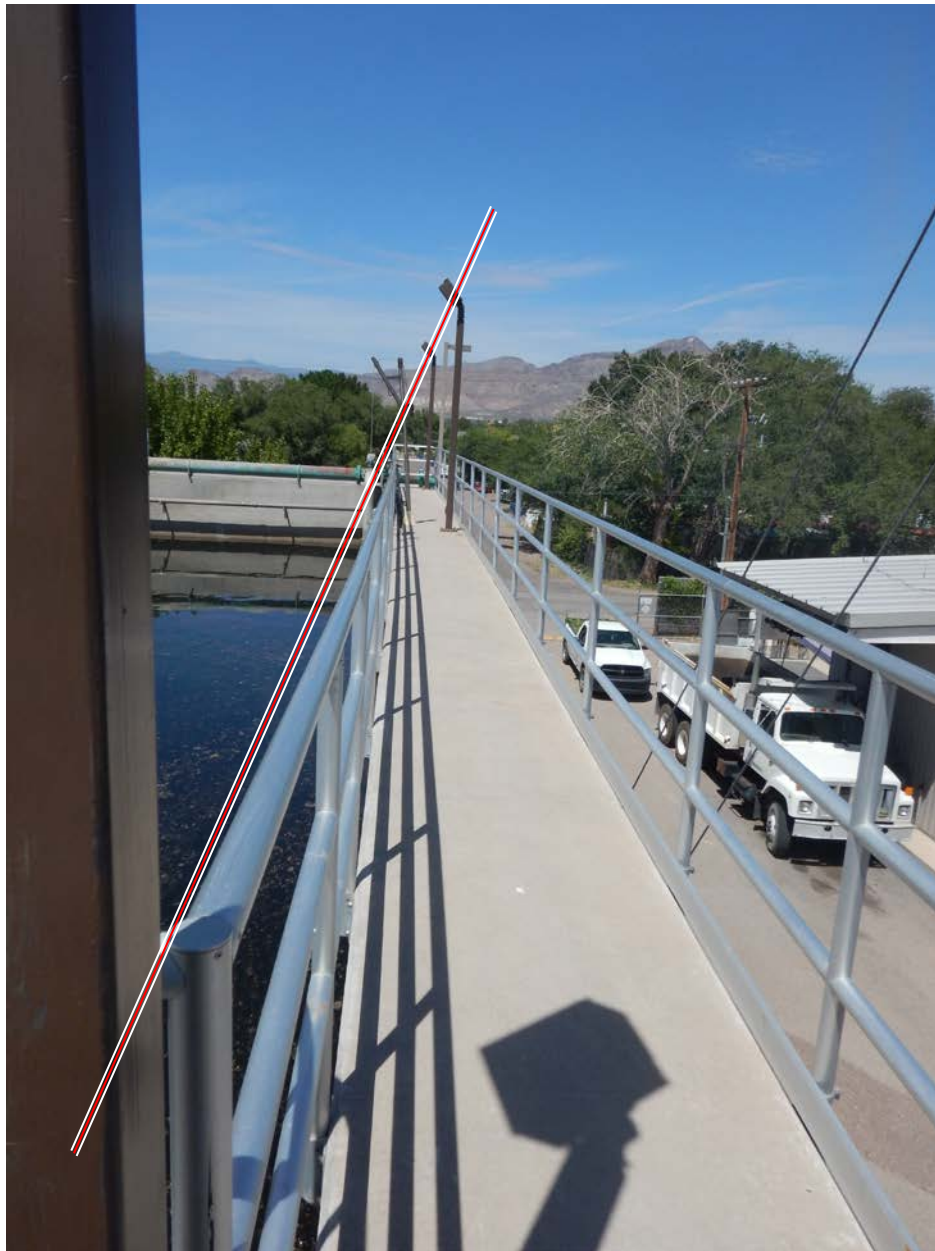
Photo No. 3

The perimeter wall of the SBR basin is showing stress cracking in the concrete as well as significant deflection of the wall (see Photos 3, 4 and 5 of the Photo Log in Appendix 1). An engineering assessment of the wall has been done by a contracted engineering firm, and monitoring of the cracks via strain gauges is ongoing (see Photo 6 of the Photo Log in Appendix 1). The assessment states that reinforcement of the wall is currently not required, however catastrophic failure is possible. Recommendations from the engineering firm indicate that the cracking in the wall should be repaired with epoxy injection and the wall should be monitored monthly for further movement and increased cracking. Should additional movement or cracking of the wall be observed, the basin should be emptied immediately and the wall shored before the basin is refilled.

Description: Visible deflection of the north wall of the SBR basin, as seen from the walkway around the perimeter of the basin (straight line added for reference).

1. Repair the wall cracking with epoxy injection as recommended in the PER.
2. Monitor the wall for further movement. This should be done monthly and increased cracking and movement shall be reported to DEC immediately.
3. Should additional movement or cracking of the wall be observed, the basin should be emptied immediately, and the wall shored before the basin is filled.
4. For safety concerns, plan and budget to design and construct a system to reinforce the wall.

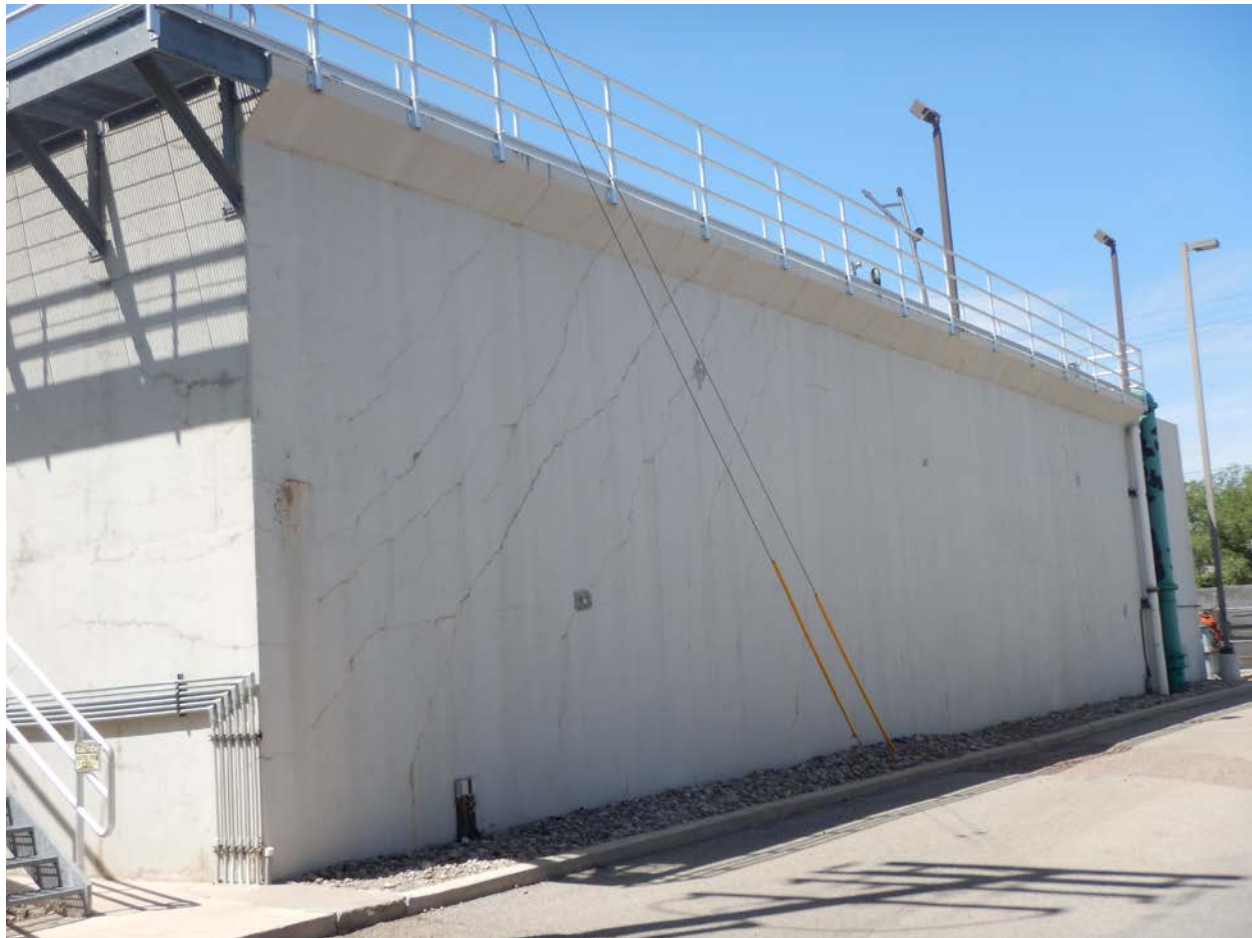
Photo No. 4

Description: Significant diagonal cracking that can be seen from the ground looking up at the north wall of the SBR basin.

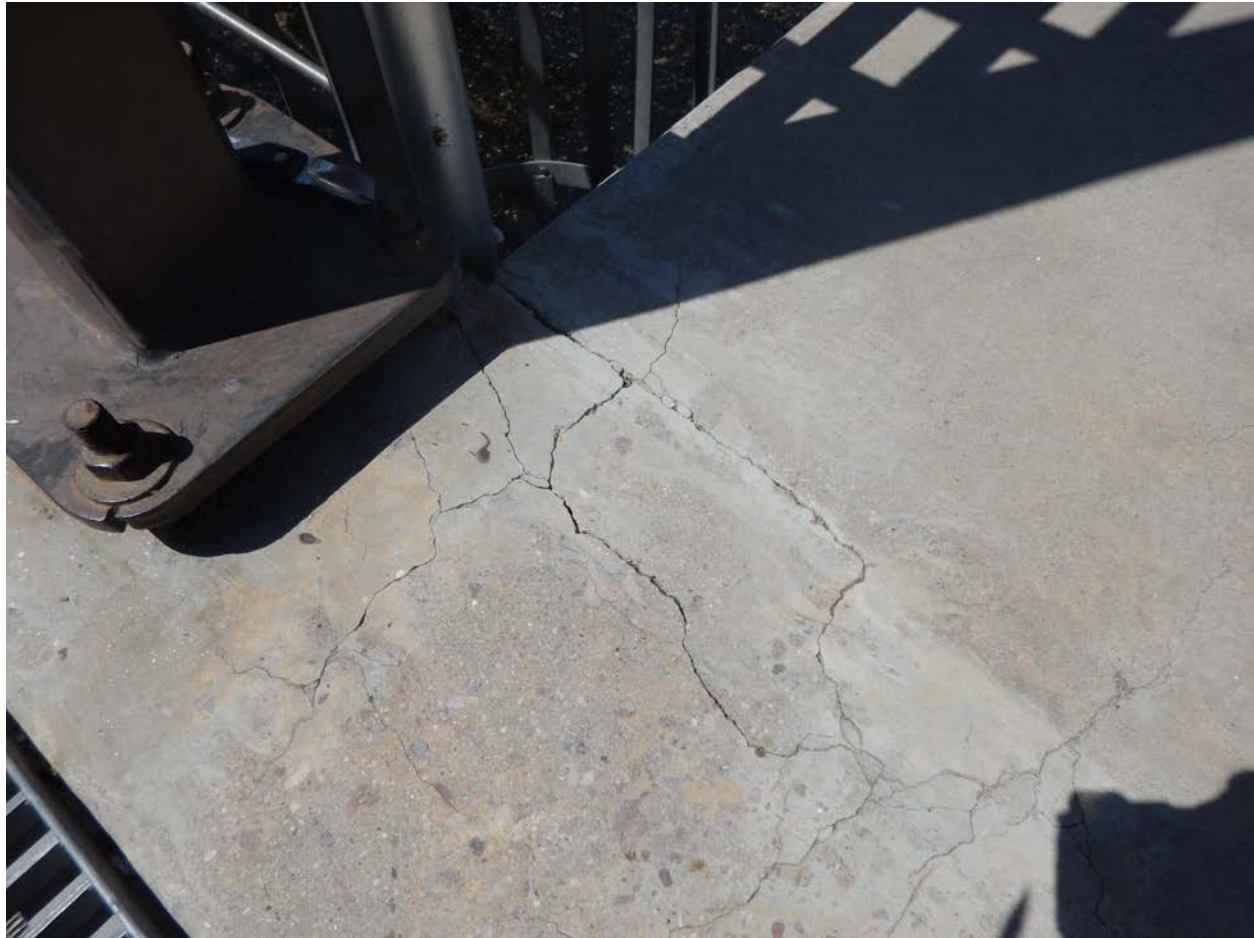
Photo No. 5

Description: Cracking at the exterior corner of the SBR basin as seen from the walkway around the top of the basin.

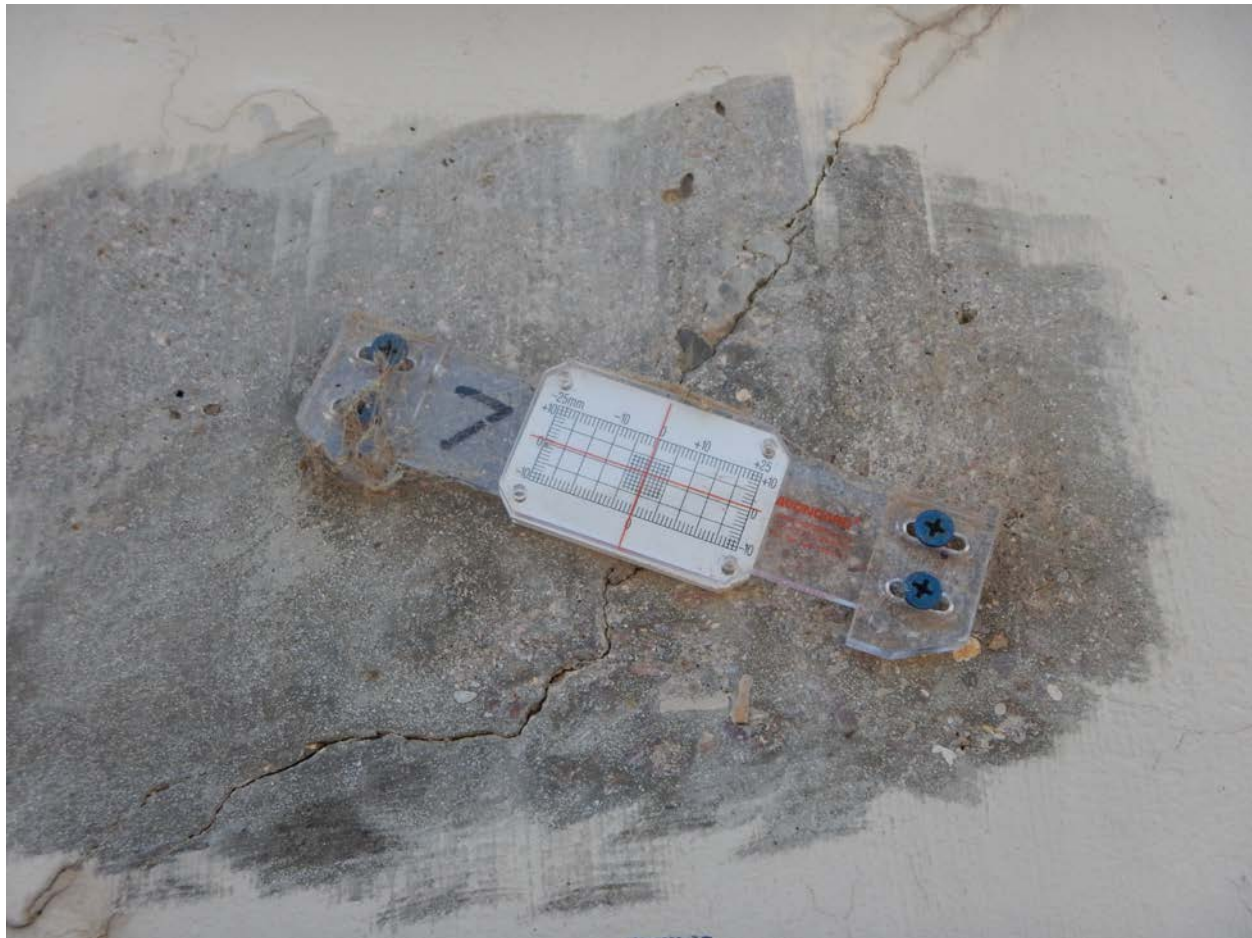
Photo No. 6

Description: Strain gauge used to monitor changes in cracking.

With the exception of gauge #7, changes in the crack widths were not observed. Gauge #7 indicated a small increase in crack width with some rotation around May 16, 2017. However, the gauge reading remained constant during the remainder of the monitoring period. The crack gauge reading records and a photo of gauge #7 is included in Attachment C.

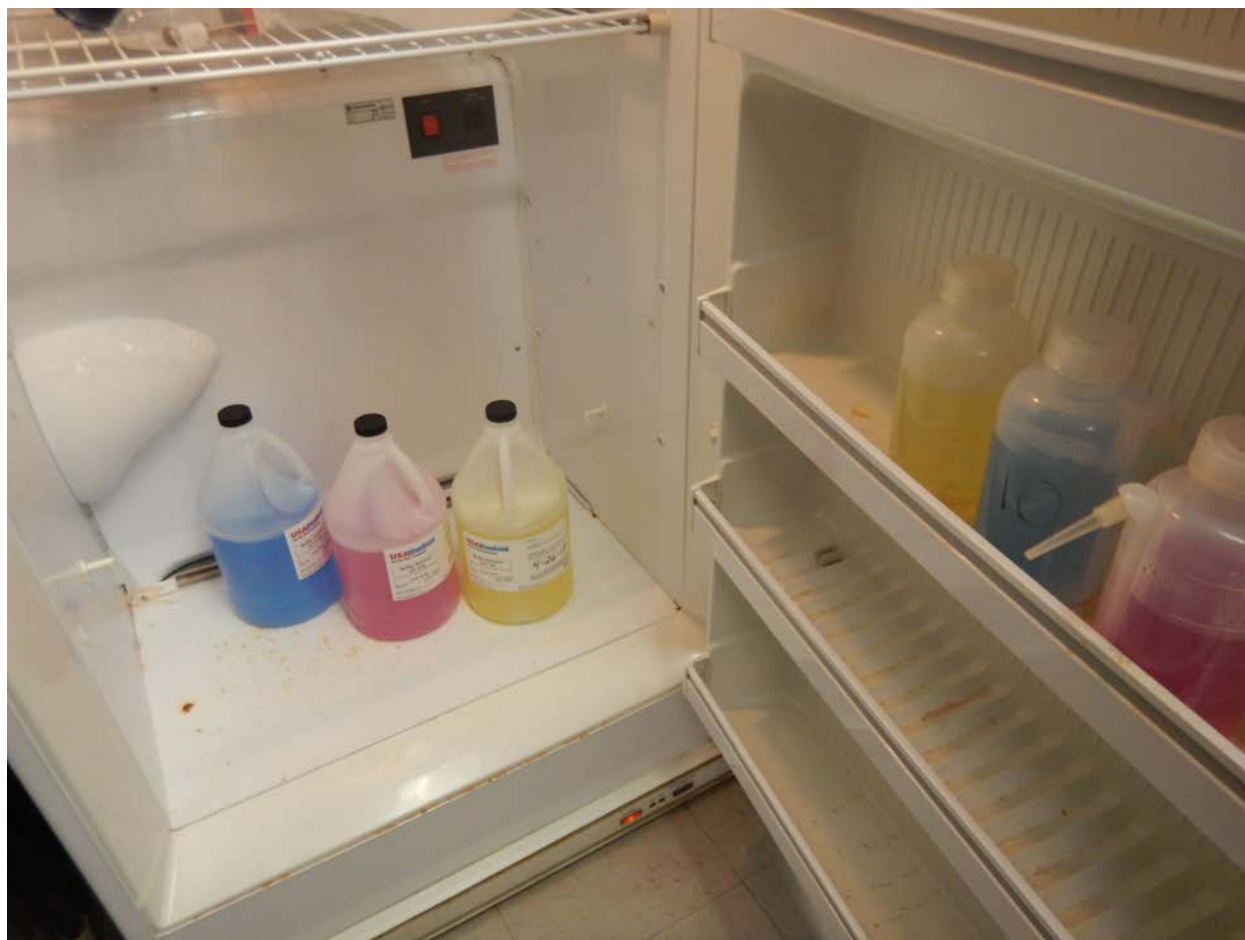
Photo No. 7

pH buffer solutions had a hand-written date on them, however it wasn't clear if this date was the received-on date, the opened-on date, or the expiration date (see Photo 7 of the Photo Log in Appendix 1). Additionally, pH buffer solutions had been transferred from the original bottles (with the hand-written date) into smaller bottles for ease of use. The smaller bottles did not have specific identifying marks on them, including opened-on and expiration dates. It was therefore not possible to confirm proper calibration of the pH instrument.

Description: Larger pH buffer bottles have a single hand-written date with no specific identification as to whether that date is the received-on, opened-on, or expiration date. Smaller pH buffer bottles on the right have no identifying labels or dates.
