**Region 6 - Enforcement & Compliance Assurance Division**  
**INSPECTION REPORT**

| Inspection Date(s): | 11/08/2024 | |
| Company Name: | <b>SMI Operating Company, LLC</b> | |
| Facility Name: | <b>E Gregory #5 Tank Battery</b> | |

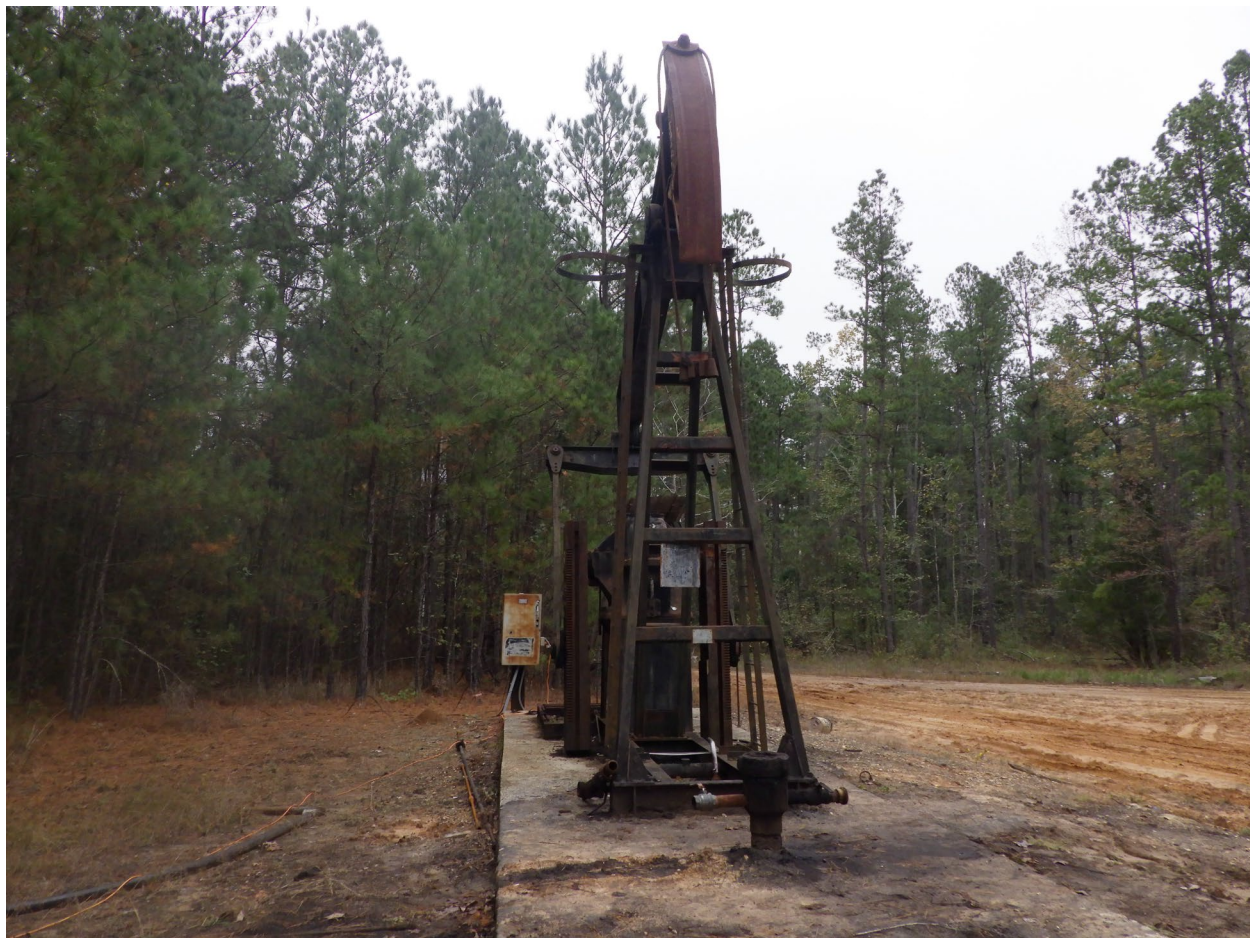
Photo No. 1

**Description:** Looking N, this photo shows a production well associated with the facility.

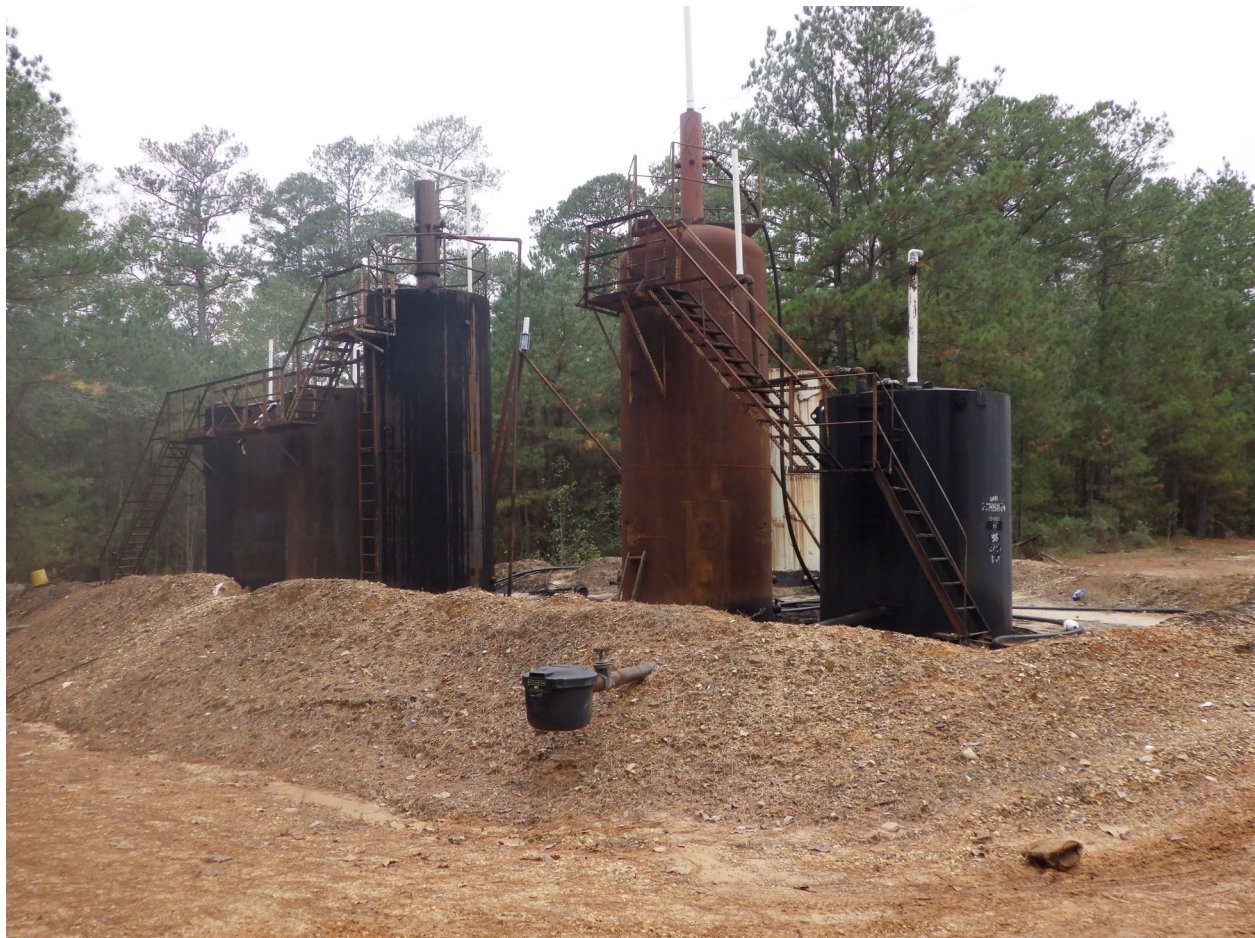
Photo No. 2

**Description:** Looking WSW, this photo shows an overview of the facility.

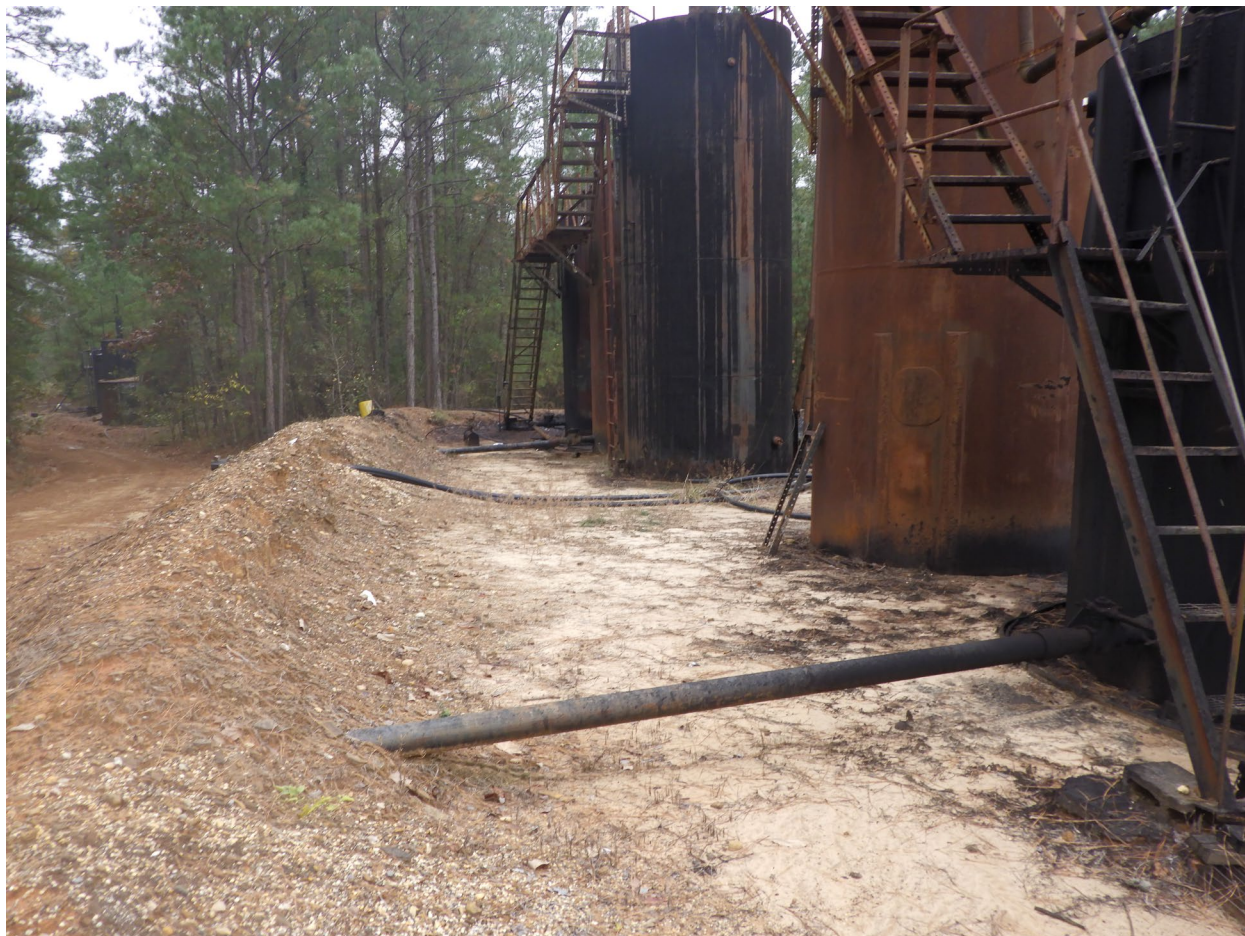
Photo No. 3

**Description:** Looking SSW, this photo shows the front of the tank battery at the loading lines.

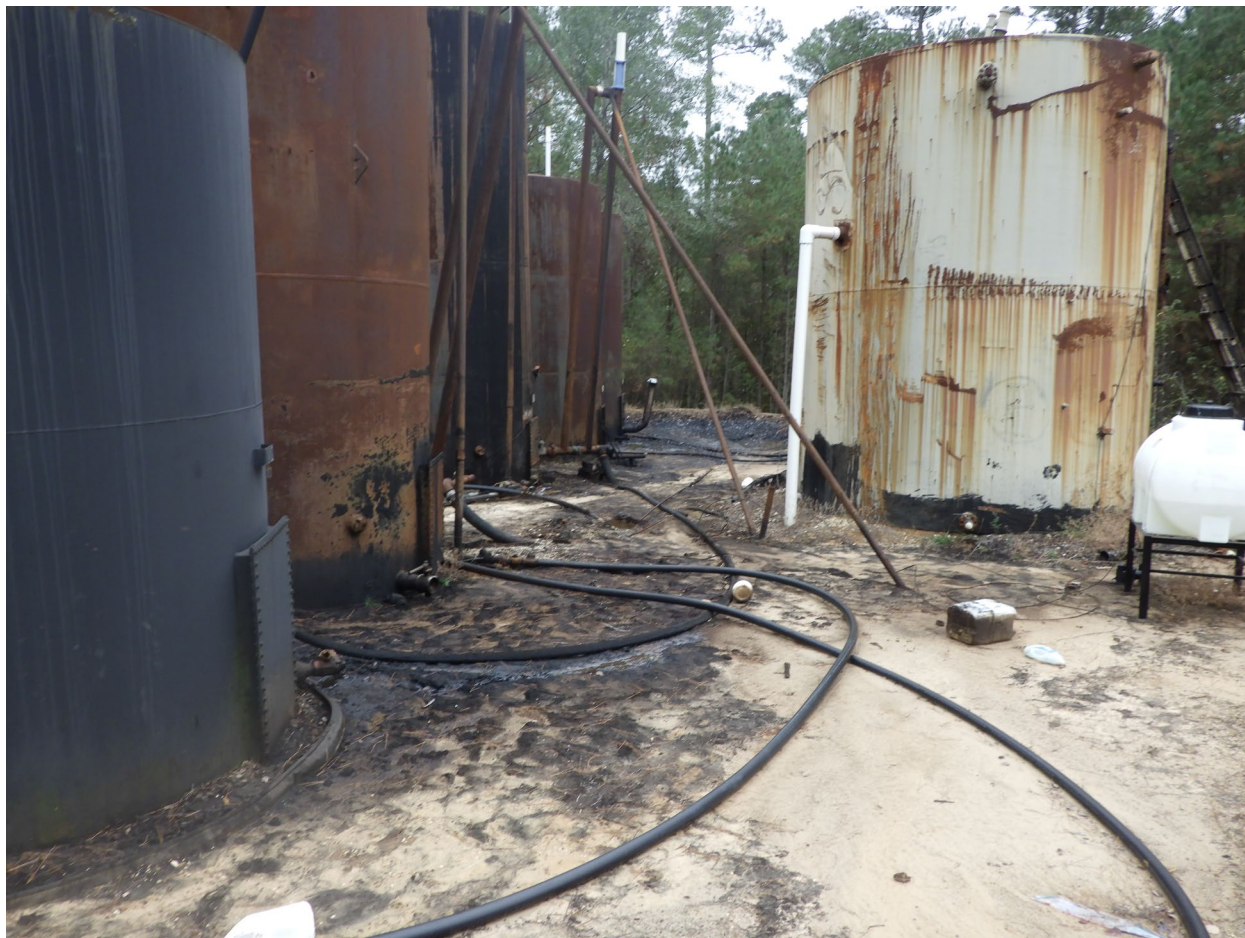
Photo No. 4

I observed loose oil and active leaks inside the secondary containment, see Photos No. 3 through No. 6.

**Description:** Looking S, this photo shows loose oil inside secondary containment.

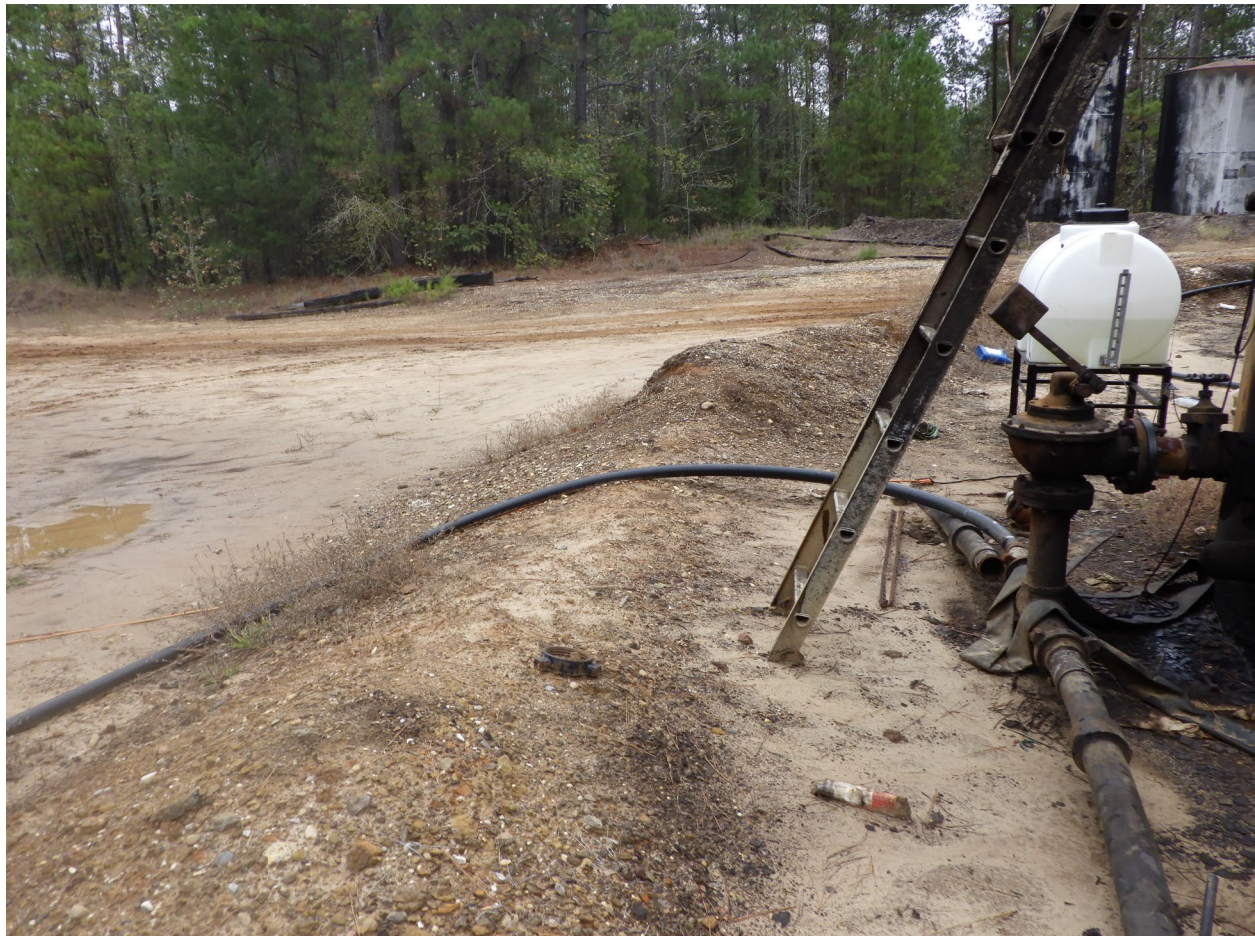
Photo No. 5

**Description:** Looking NE, this photo shows loose oil inside secondary containment.

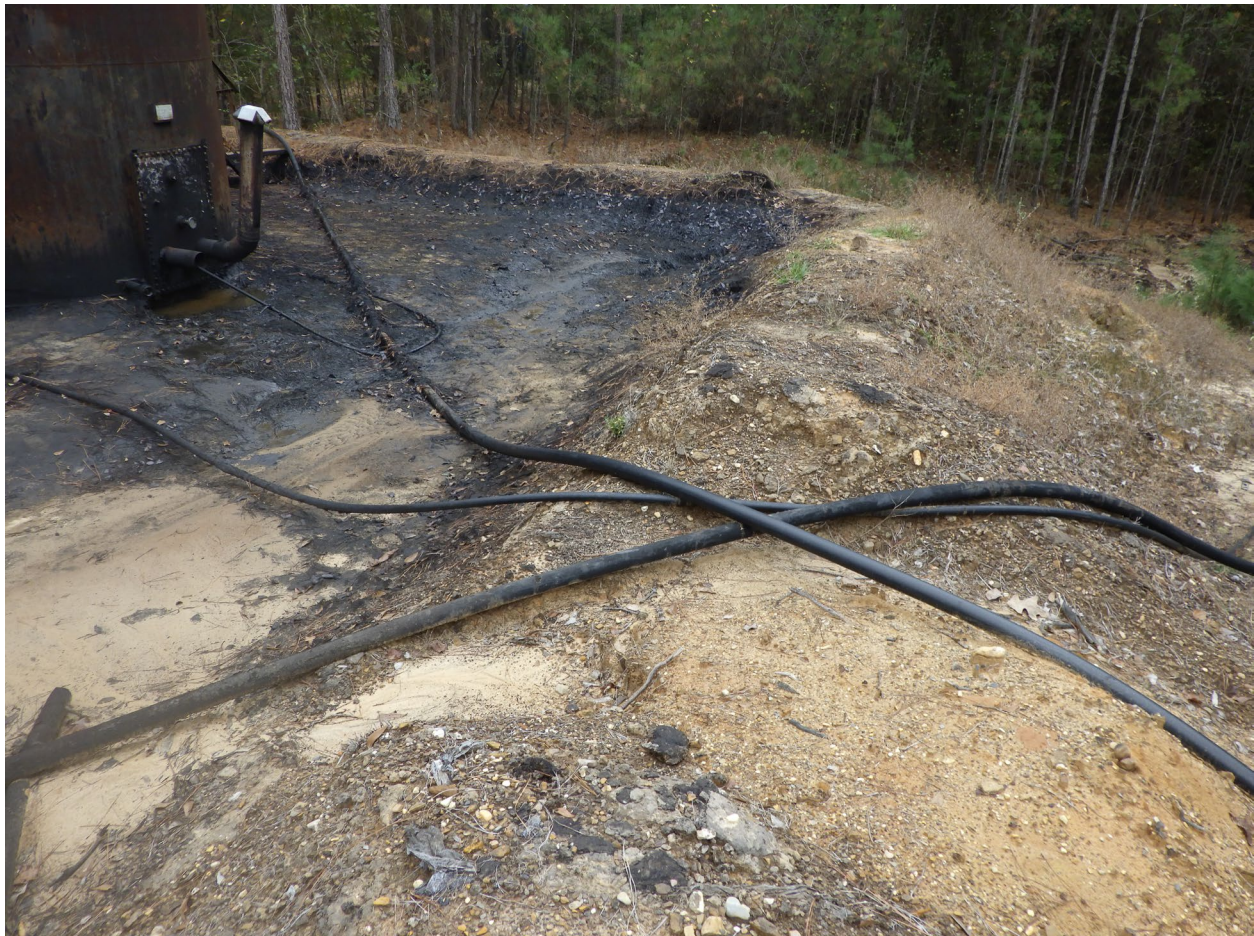
Photo No. 6

**Description:** Looking SE, this photo shows loose oil and pooled saltwater inside the secondary containment.

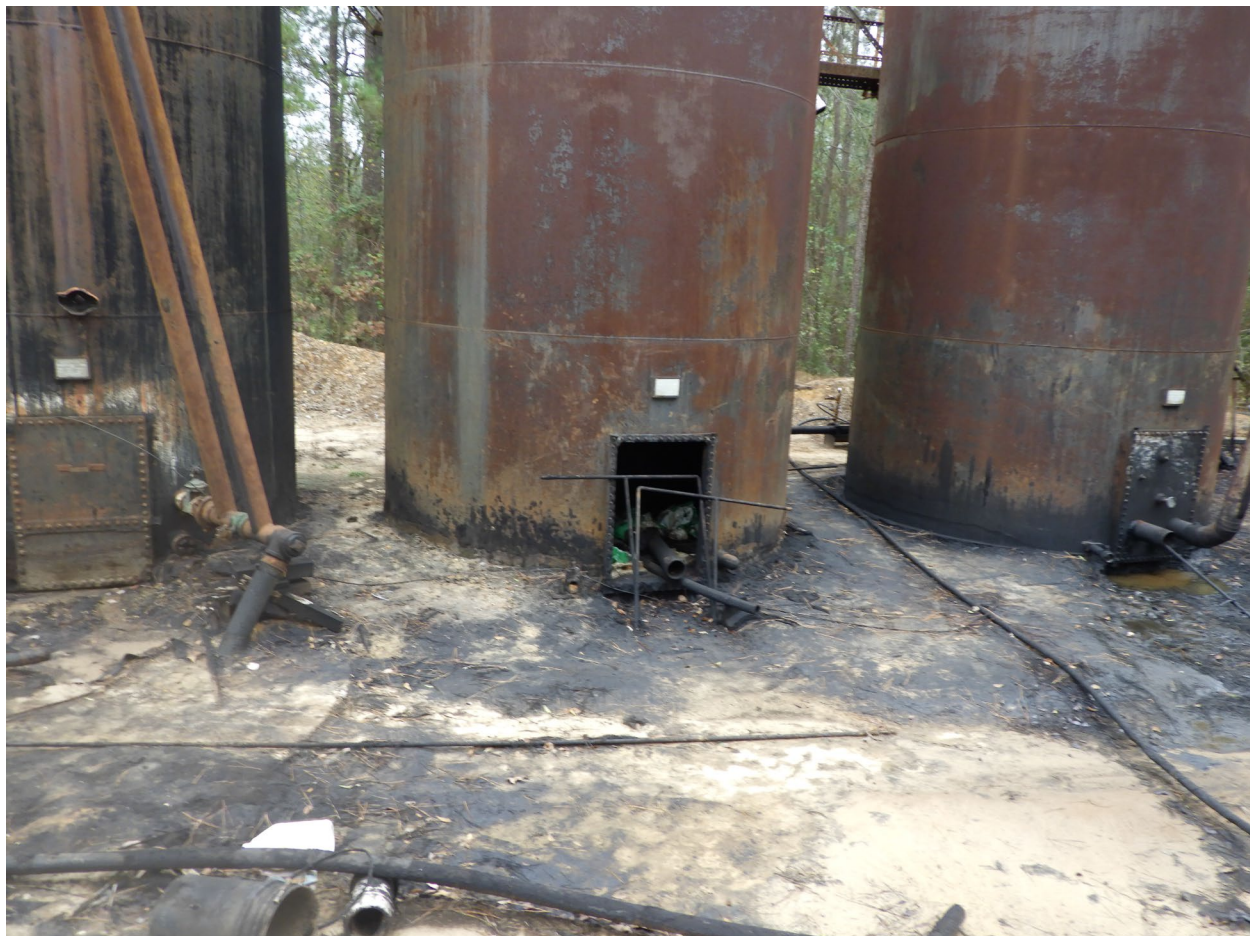
Photo No. 7

I observed an open hatch for one storage tank, see Photos No. 7 and No. 8.

**Description:** Looking ESE, this photo shows loose oil and pooled saltwater inside secondary containment and one (1) tank with an open hatch.

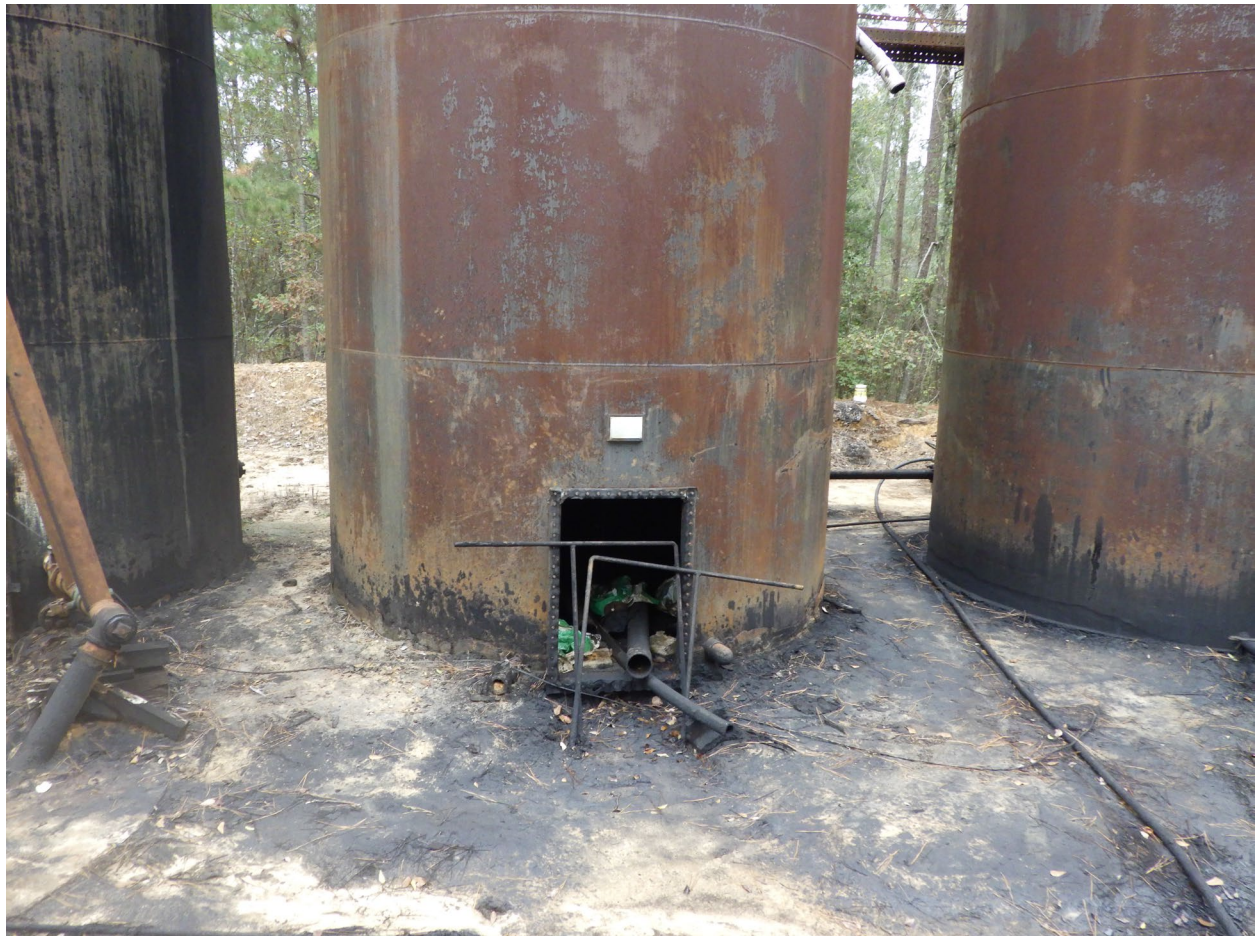
Photo No. 8

**Description:** Looking ESE, this photo shows a closeup of the tank with an open hatch and pipe inside secondary containment.

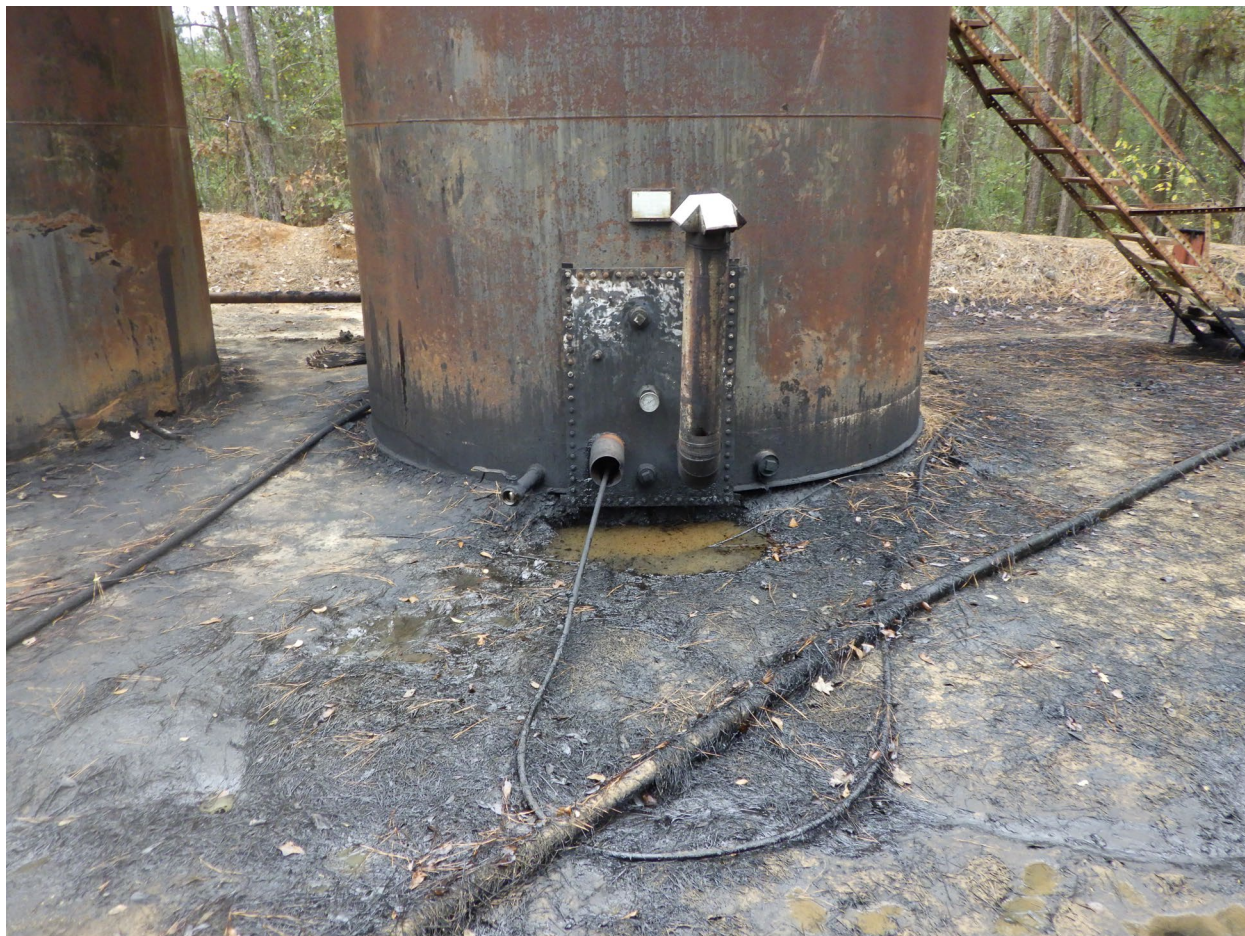
Photo No. 9

I observed active leaks and pools of saltwater inside the secondary containment with flow indicators directed towards the drainpipes, see Photos No. 9 through No. 12.

**Description:** Looking E, this photo shows saltwater pooled below a tank inside secondary containment; there was a gap under the tank bottom.

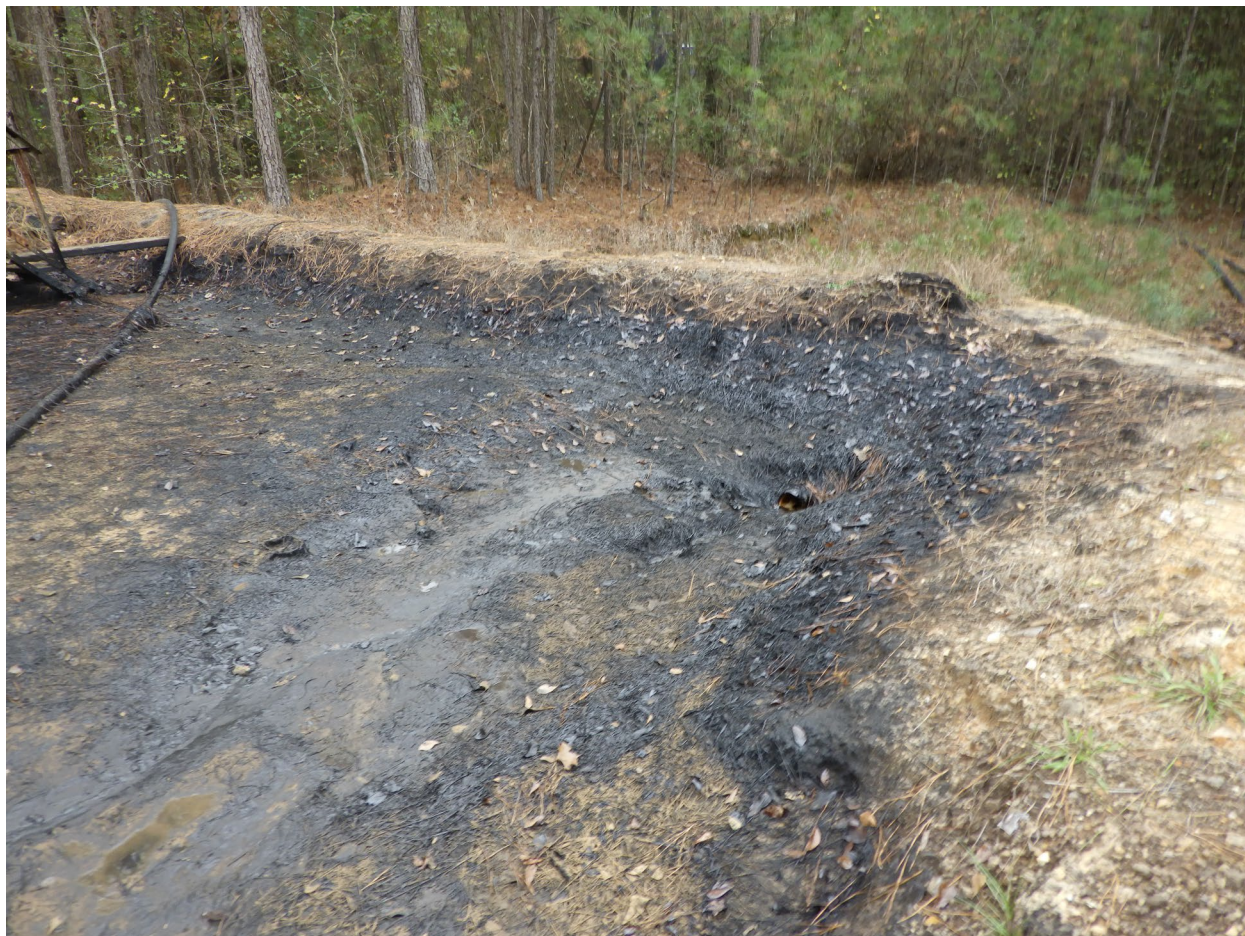
Photo No. 10

**Description:** Looking SE, this photo shows high-level marks and flow indicators for crude oil and saltwater inside secondary containment that was directed toward the drainpipe.

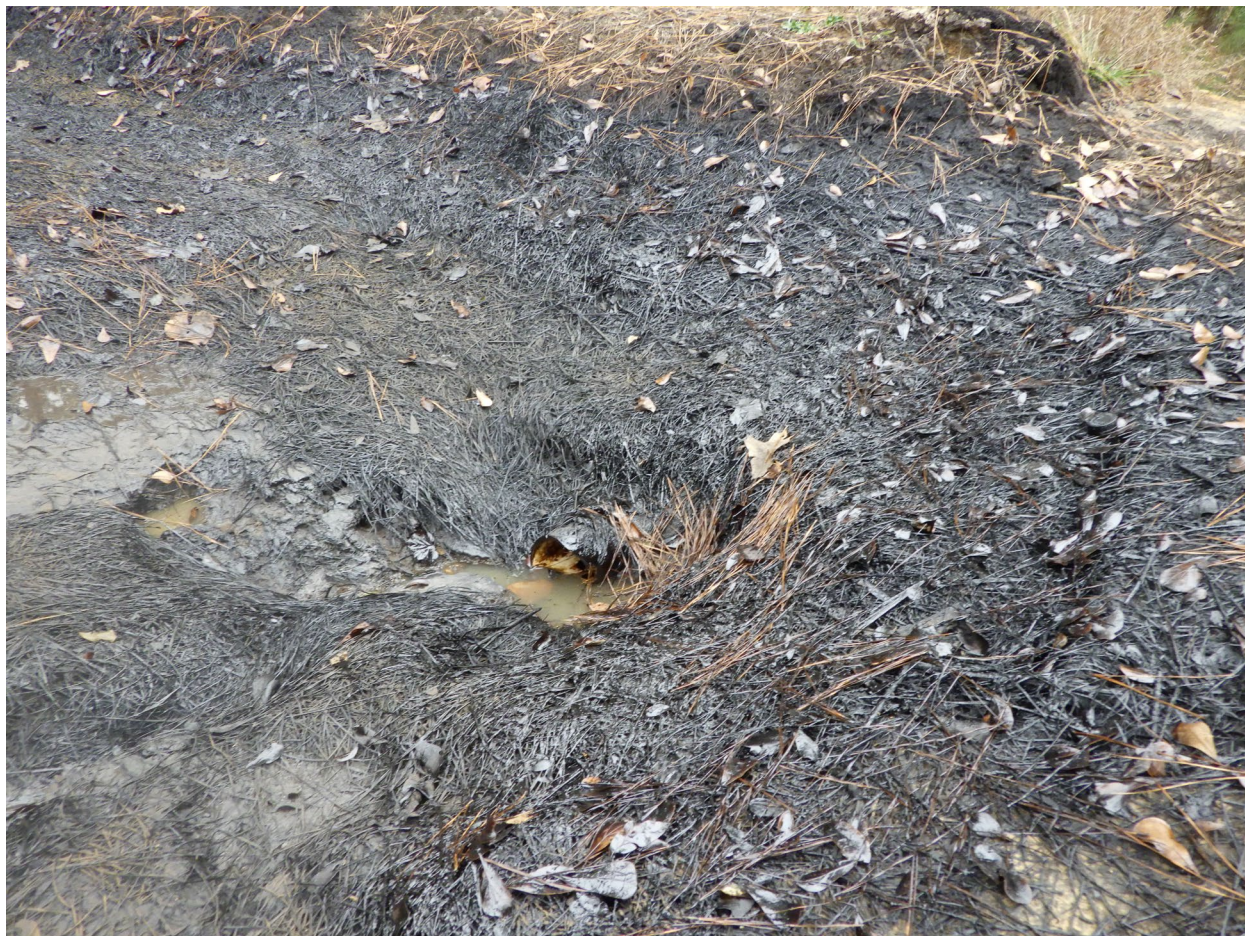
Photo No. 11

**Description:** Looking ESE, this photo shows a closeup of the drainpipe with loose oil and pooled saltwater noted in the area.

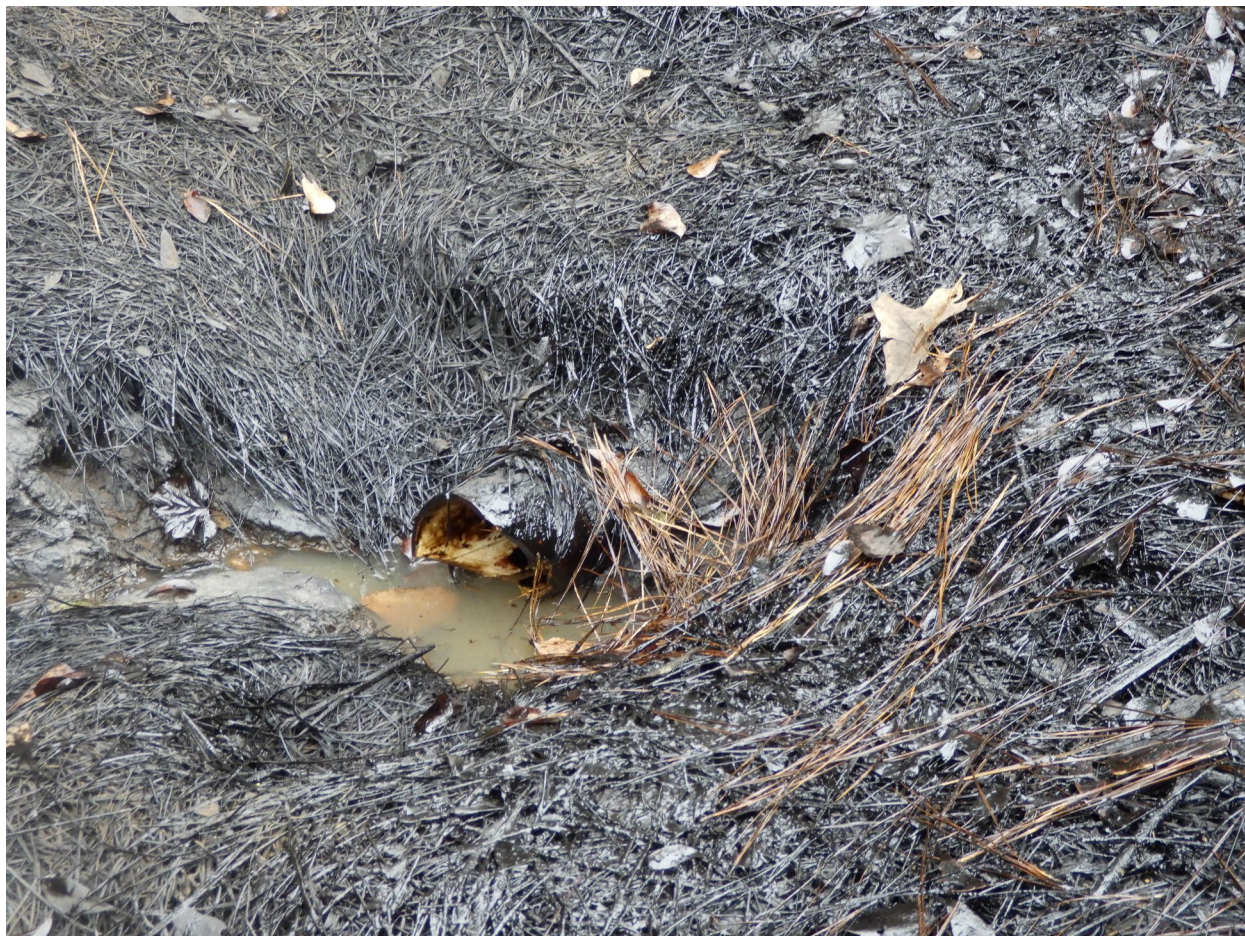
Photo No. 12

**Description:** Looking ESE, this photo shows an additional view of the drainpipe for secondary containment.

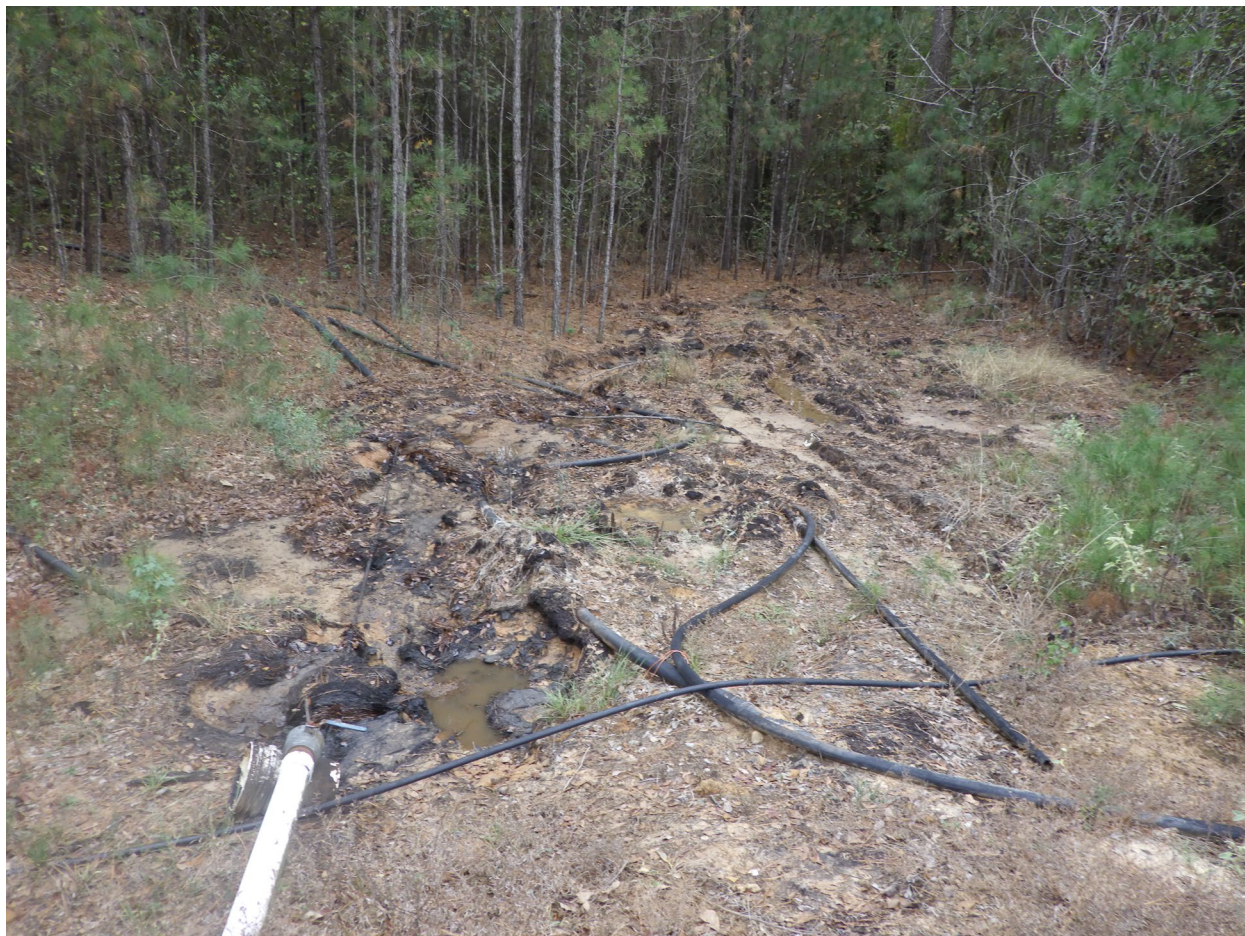
Photo No. 13

I observed evidence of releases of crude oil and saltwater from two drainpipes for the secondary containment, see Photos No. 13 through No. 18. Both drainpipes were closed with either a shutoff valve or a cap during the inspection.

**Description:** Looking WSW, this photo shows residual loose oil and pooled saltwater with flow indicators downstream of the drainpipe for secondary containment.

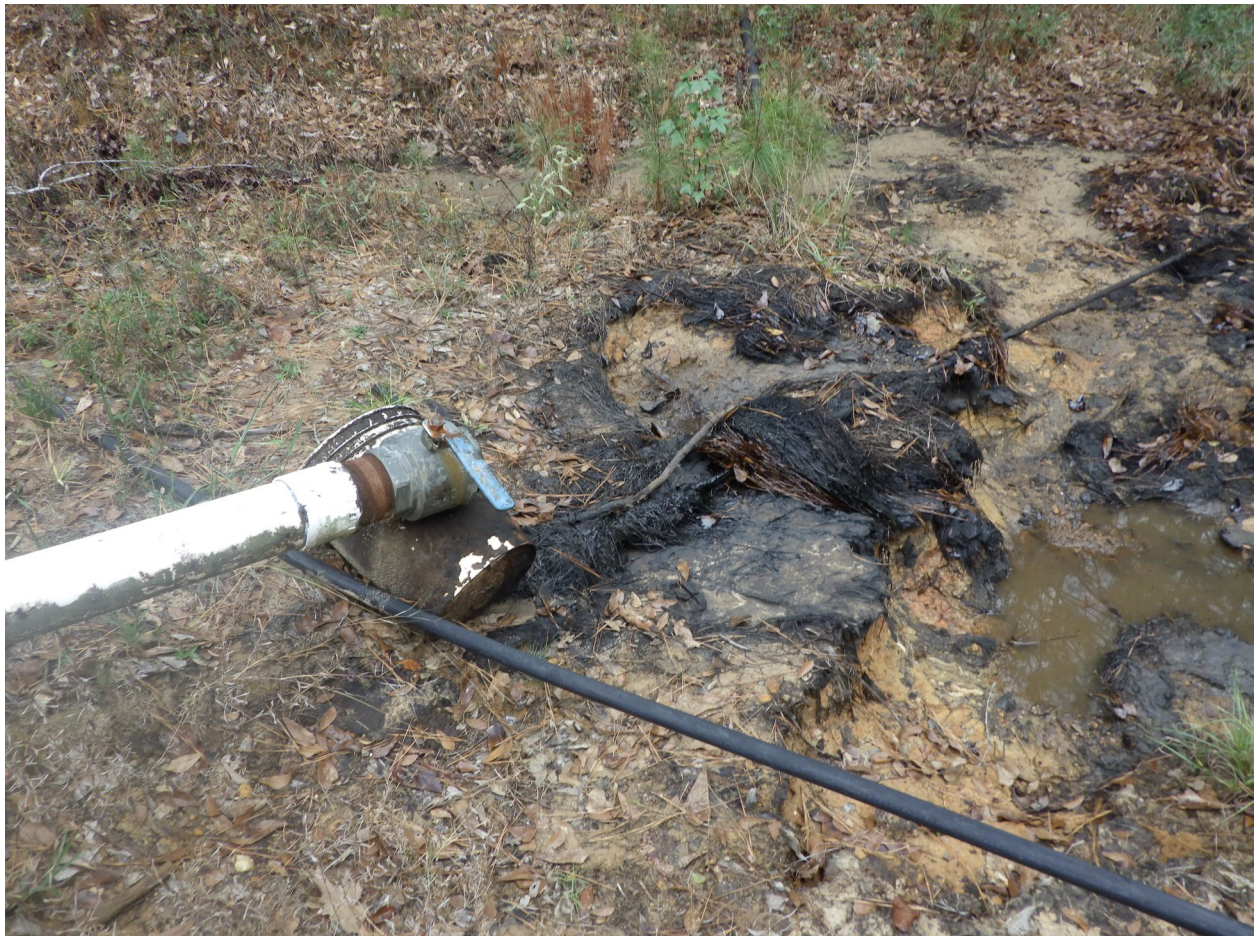
Photo No. 14

**Description:** Looking E, this photo shows one of the drainpipes for secondary containment with a closed valve but no cap with residual loose oil and pooled saltwater downstream of the pipe.

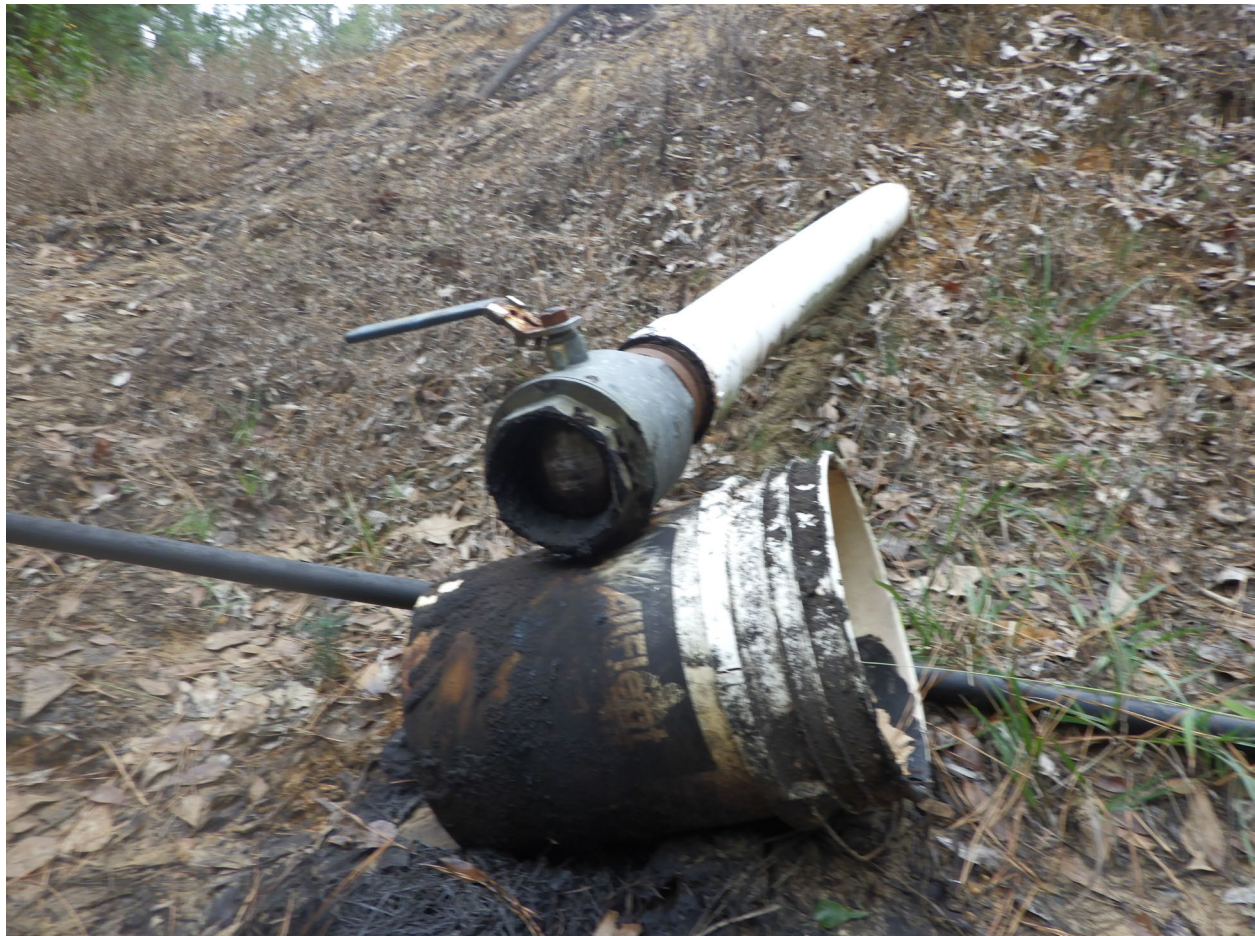
Photo No. 15

**Description:** Looking NE, this photo shows one of the drainpipes for secondary containment with a closed valve but no cap (upstream view).

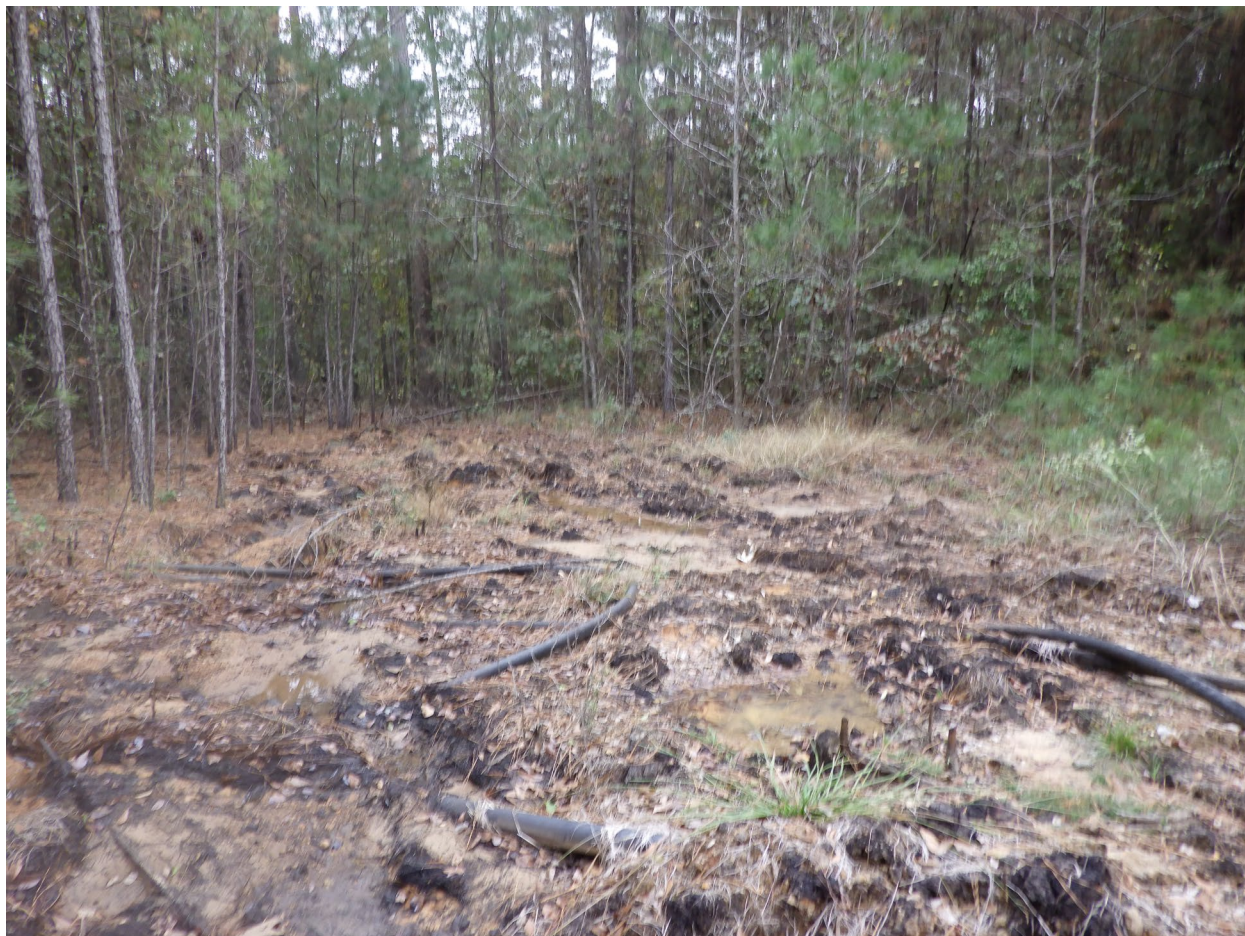
Photo No. 16

**Description:** Looking WNW, this photo shows residual loose oil and flow indicators downstream of the drainpipe for secondary containment.

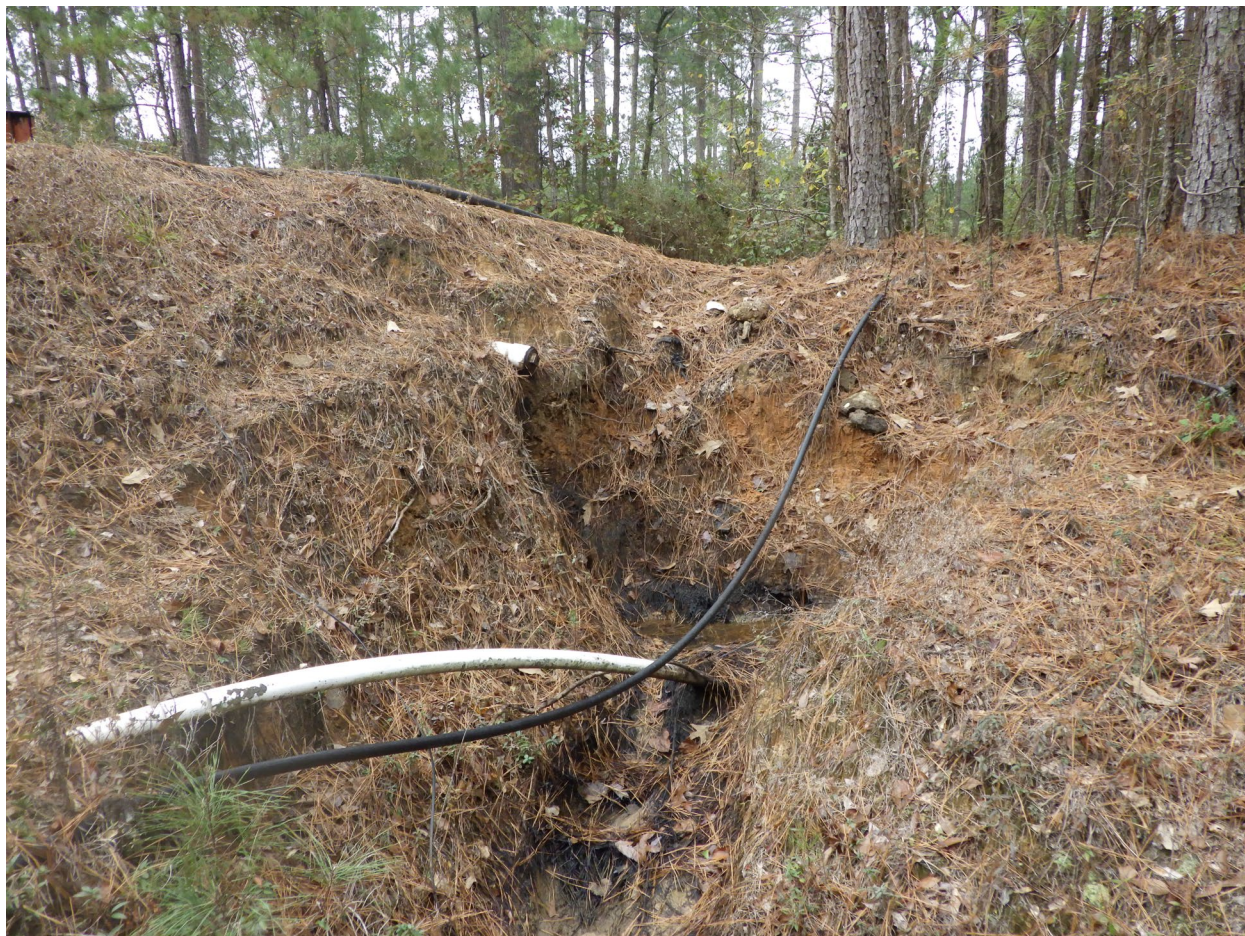
Photo No. 17

**Description:** Looking E, this photo shows another drainpipe with a cap for the secondary containment with residual loose oil and flow indicators downstream of the pipe.

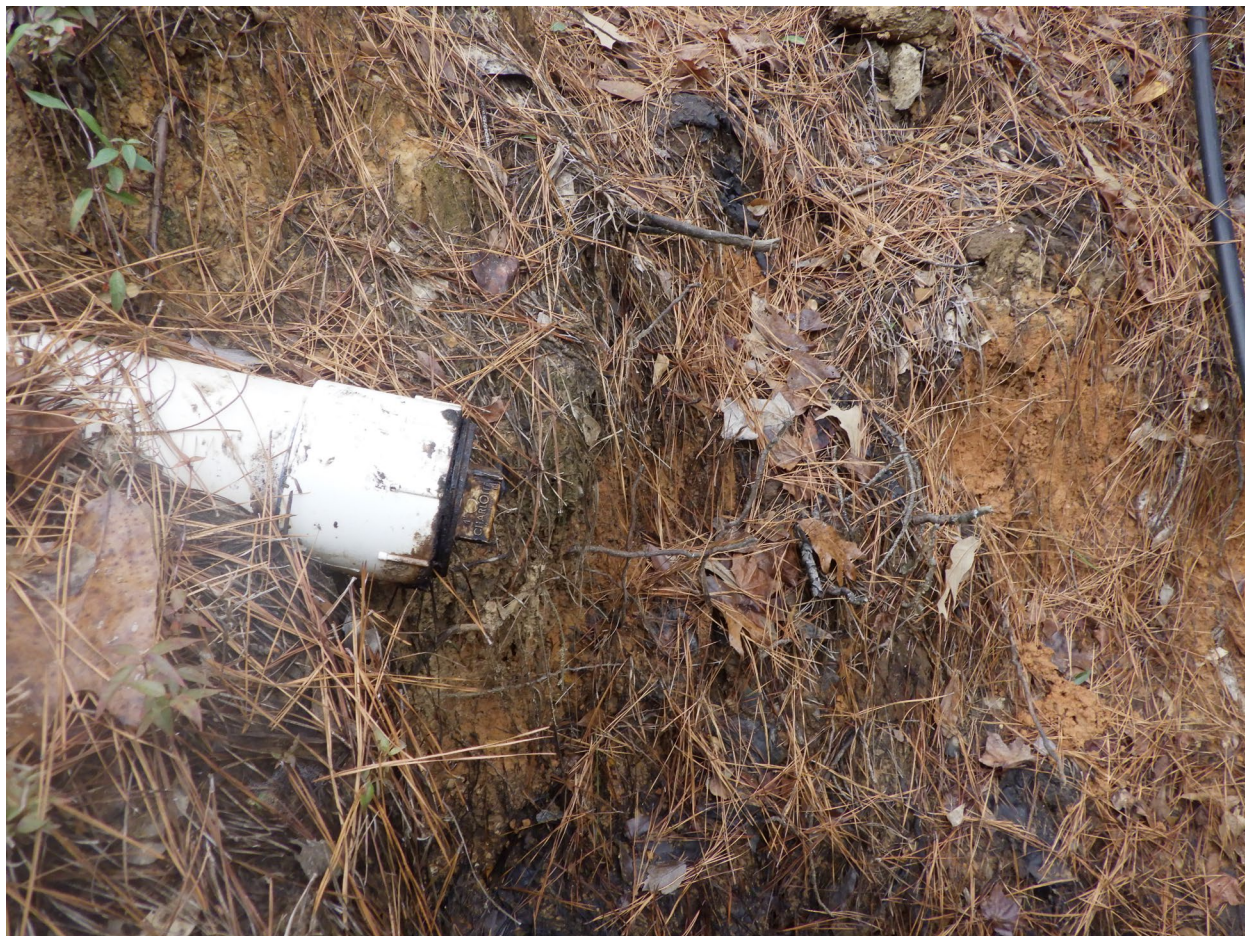
Photo No. 18

**Description:** Looking E, this photo shows a closeup of the drainpipe from Photo No. 17.

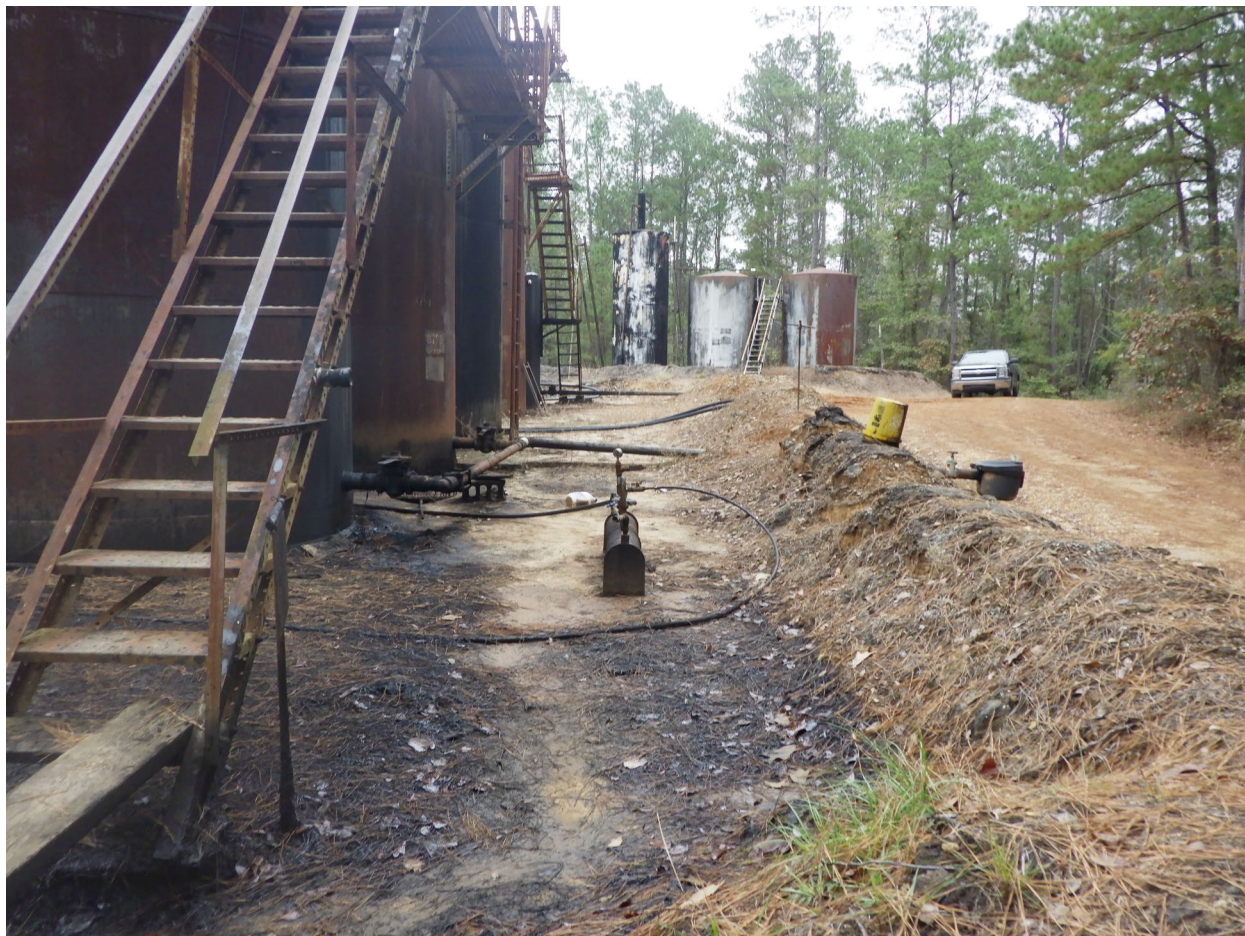
Photo No. 19

I observed the loading lines and catchment buckets outside secondary containment, see Photos No. 19 and No. 20.

**Description:** Looking NE, this photo shows loose oil inside secondary containment (front view).
