**Region 6 - Enforcement & Compliance Assurance Division**  
**INSPECTION REPORT**

| Inspection Date(s): | 11/08/2024 | |
| Company Name: | <b>SMI Operating Company, LLC</b> | |
| Facility Name: | <b>E Gregory #5 Tank Battery</b> | |

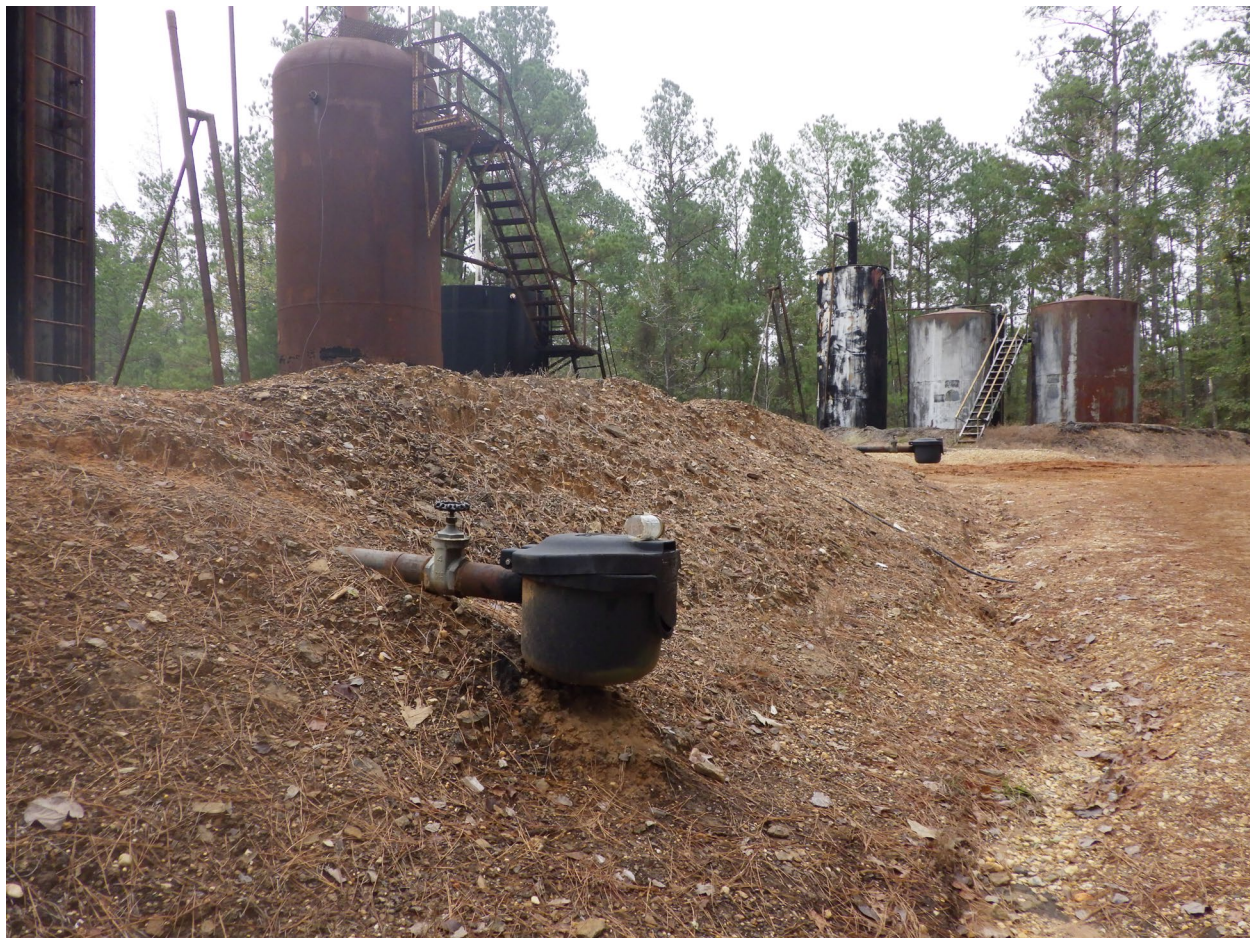
Photo No. 20

I observed the loading lines and catchment buckets outside secondary containment, see Photos No. 19 and No. 20.

**Description:** Looking NE, this photo shows catchment buckets at the loading lines from crude oil storage.
