**Well Inspection**  
**Environmental Protection Agency**  
**1201 Elm Street, Suite 500**  
**Dallas, Texas 75270**

| | | <b>Lease Name</b> | E Binger Un (Cook D-1) | | |
| | | <b>Well ID</b> | 58-GI-1 | | |
| <b>Inspection Reason</b> | MIT | <b>Responsible Company at Time of Inspection</b> | Binger Operations, LLC | | |

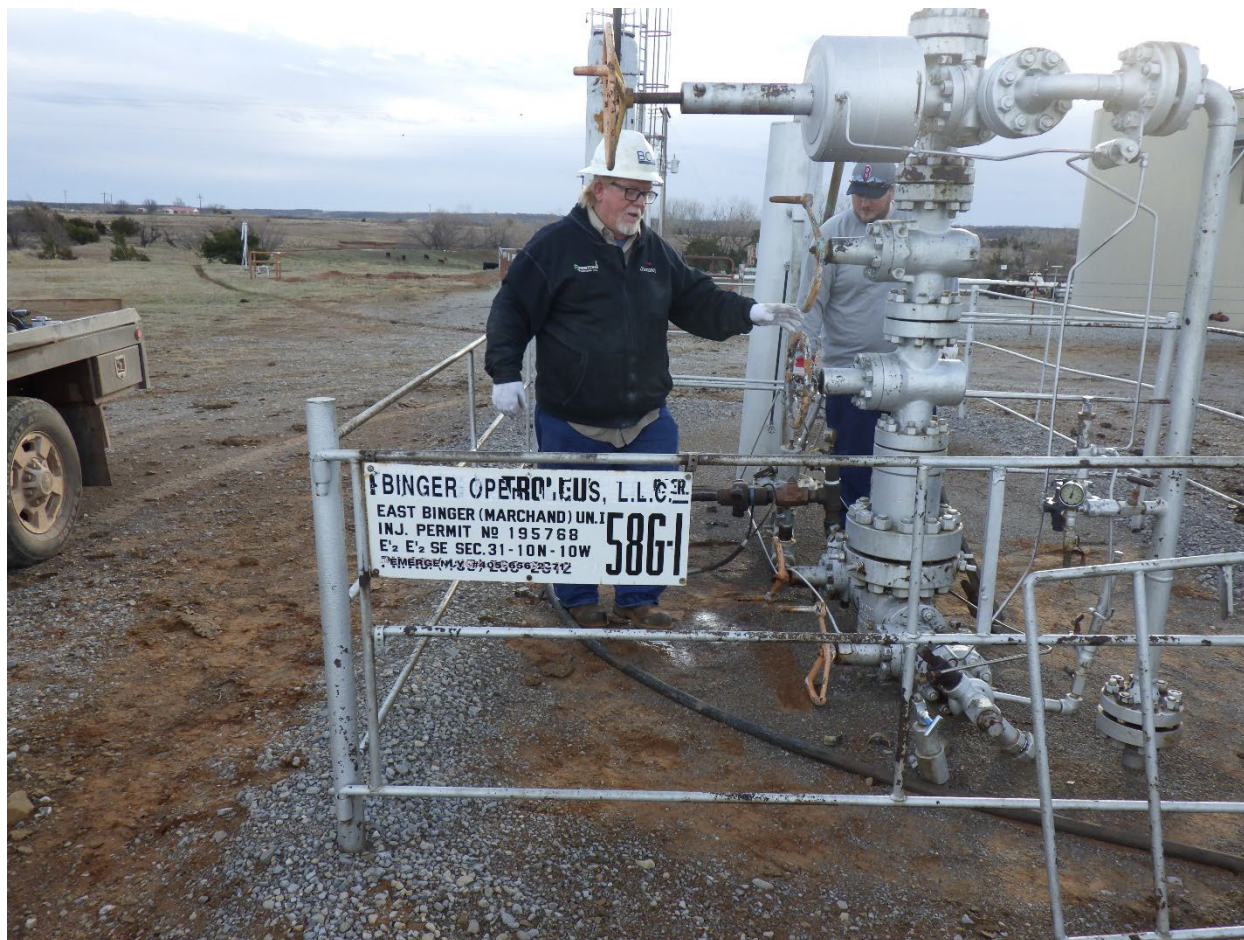
Photo No. 1

**Description:** This was the injection well OK0118000 sign at the time of the inspection.

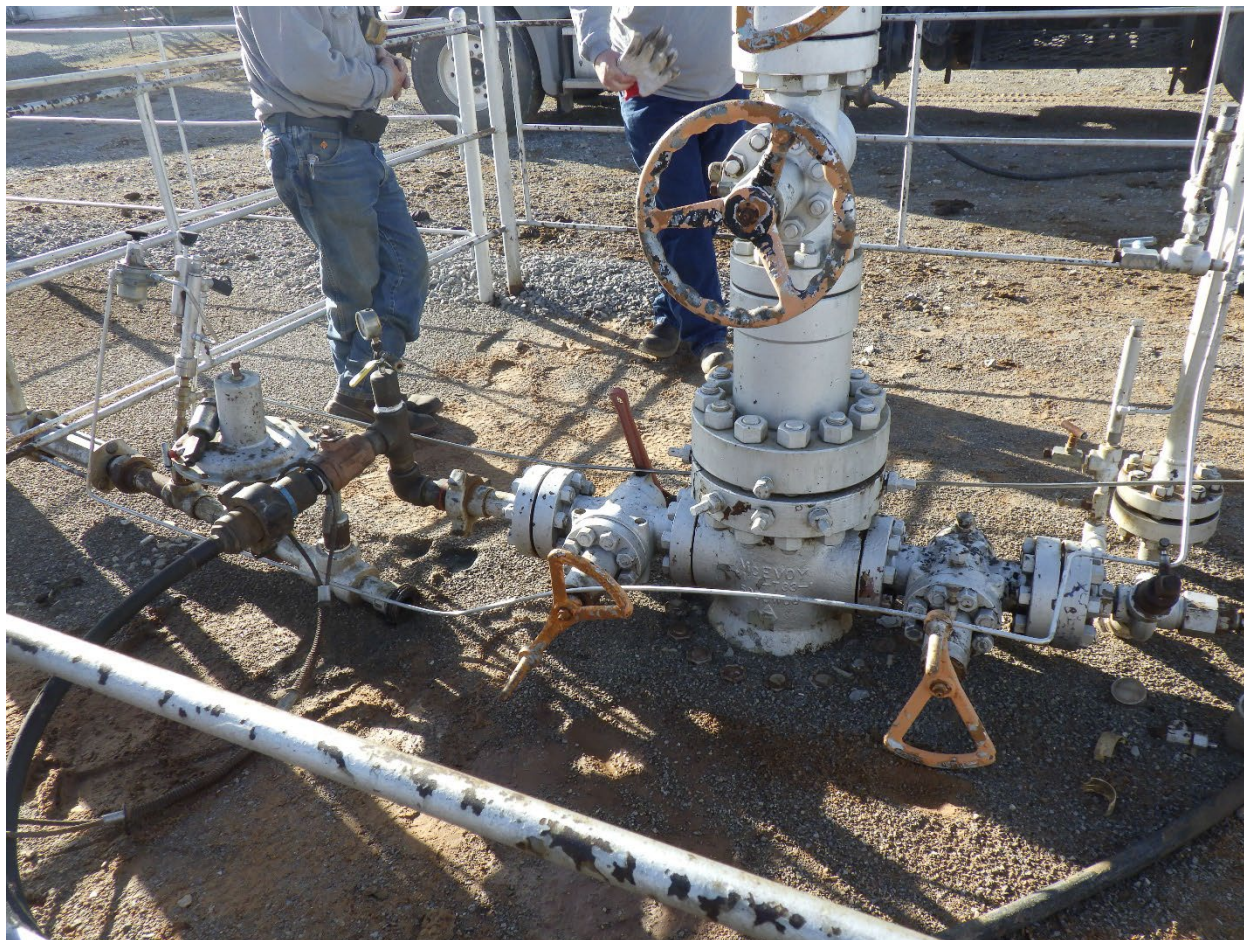
Photo No. 2

**Description:** This was the injection well OK0117000 at the time of the inspection.
