## CAA112(r) INSPECTION REPORT

| <b>Name:</b> Associated Electric Cooperative, Inc. – New Madrid Power Plant | |
| <b>County:</b> New Madrid | <b>Case No:</b> 24MO0514 |

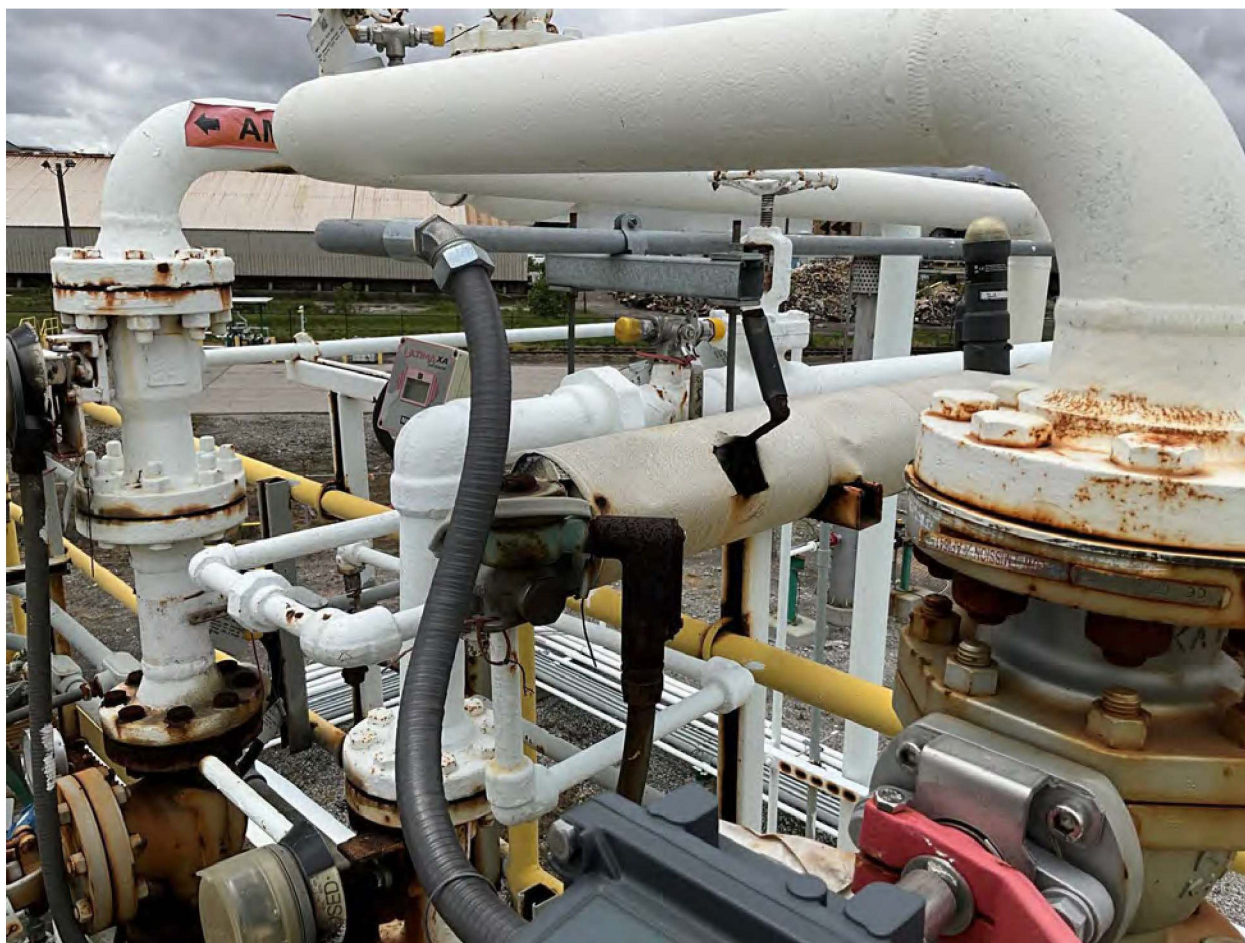
We climbed stairs on the east side of SCR Unit 2, Tank # 1 to a catwalk located above the tank, so that I could get an image of the tank's safety relief device manifold (Appendix 1, image IMG\_0038.JPG). While in that location I observed the anhydrous ammonia monitor above the tank and the one of the water curtain outlets that are used to mitigate releases. I also observed that the water curtain on/off valve appeared to be in the off position and asked if the water curtain for this location was currently shut off. Mr. Halstead indicated that the valve appeared to be in the off position (Appendix 1, image IMG\_0039.JPG).

Mr. Halstead radioed for an AECL maintenance worker to come to the tank. The maintenance person confirmed the water curtain mitigation system was shut off at this location due to work that had been performed to fix leaks within the system. He stated that the valve had been inadvertently missed and not turned back on at the end of the maintenance work. Please see the Management of Change section of this report for further discussion.

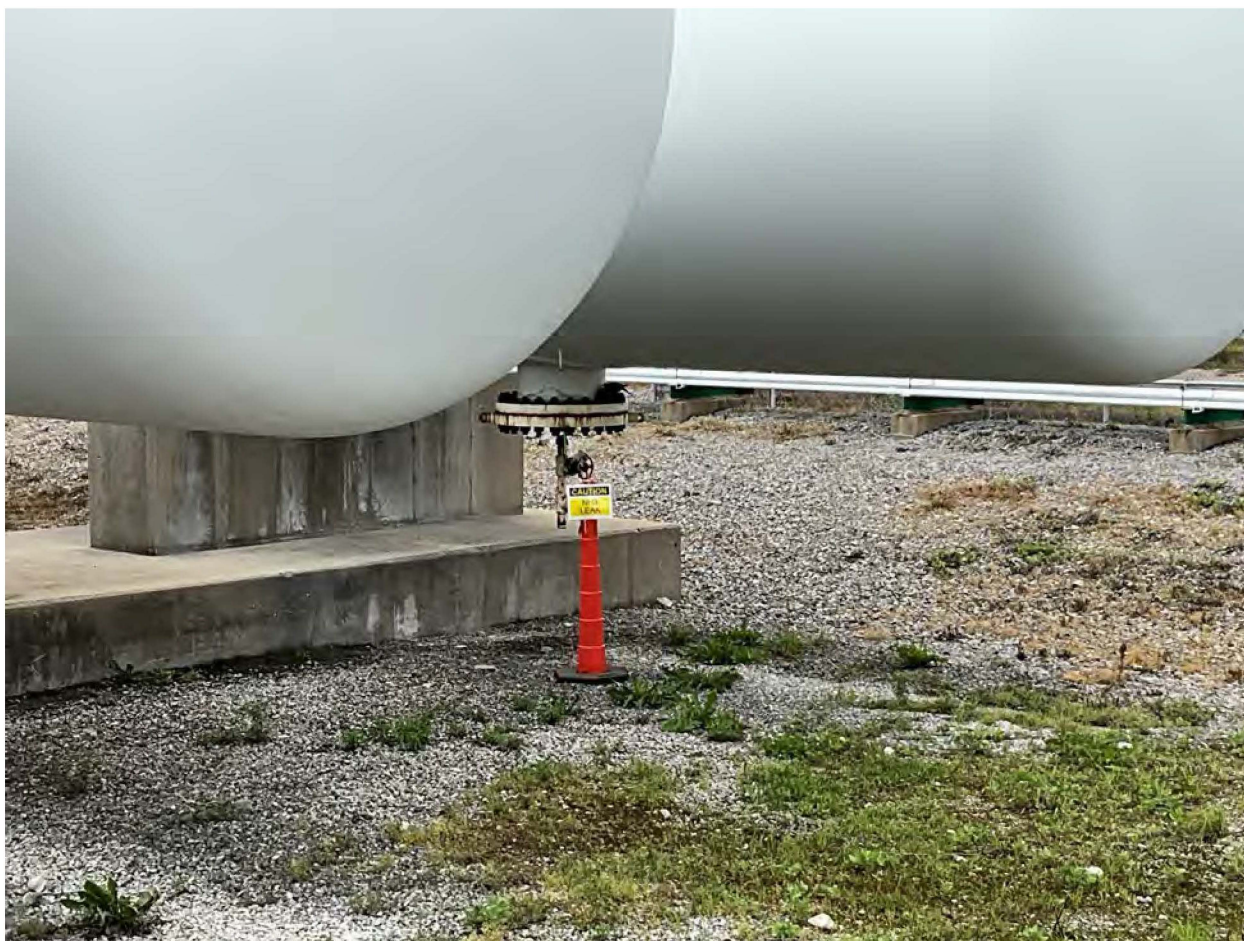
Appendix 1, image IMG\_0041.JPG

After walking across the catwalk above all three tanks in SCR Unit 2, we walked northward toward the remaining three tanks in the area. While walking in that direction, we noticed an orange cone located at the back end of SCR Unit 2, Tank # 1 (Appendix 1, image IMG\_0040.JPG). As sign on the orange cone read "Caution NH3 Leak" (Appendix 1, image IMG\_0041.JPG). I asked about this leak which is located at a threaded nut between the manway door the top isolation valve, which was described as an excess flow valve. When asked about the repair schedule for this device, Mr. Halstead stated that repairs would be made after September or October when the ozone season would be concluded. Please see the Mechanical Integrity section of this report for further discussion.

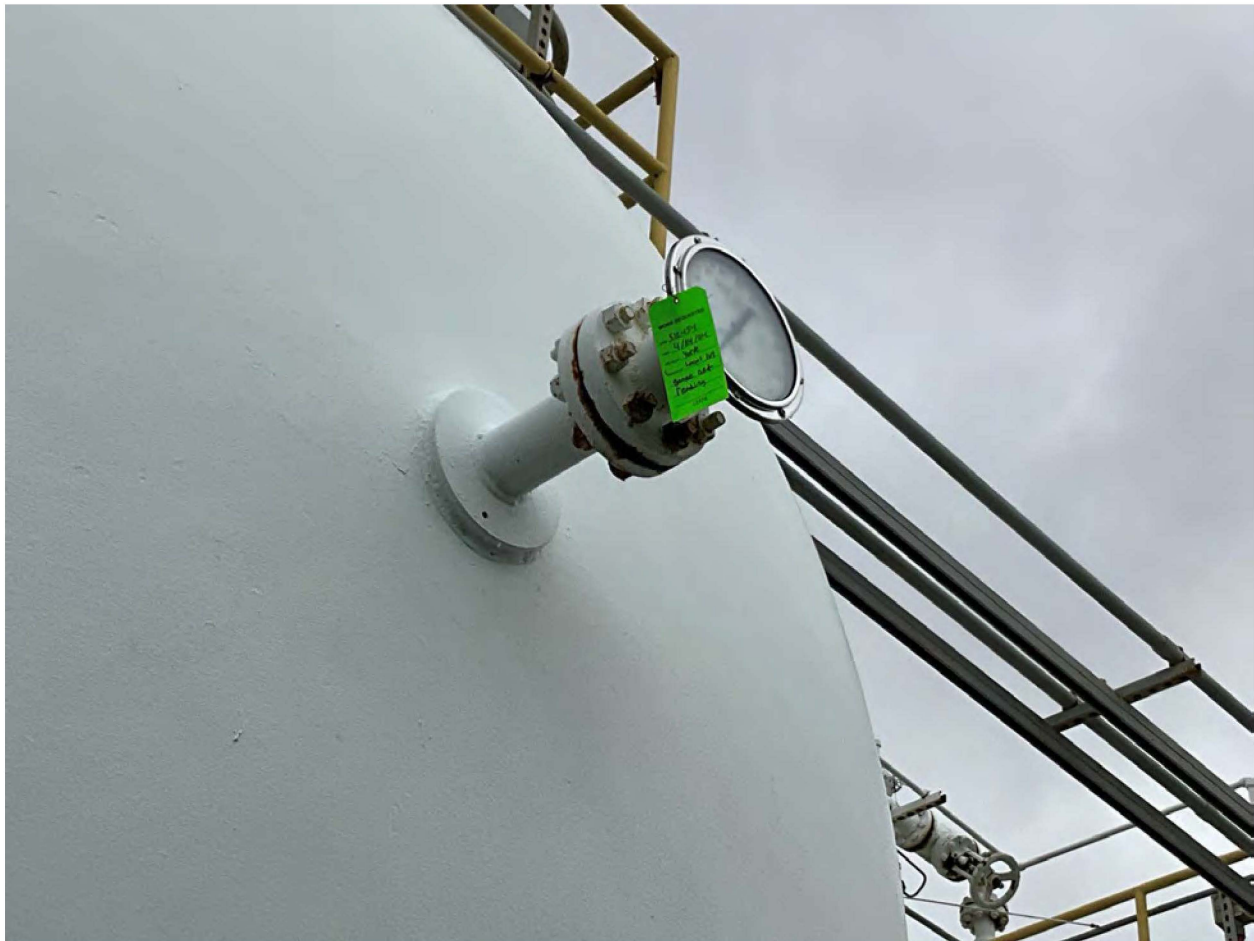
Appendix 1, image IMG\_0046.JPG

I observed and took a digital image of SCR Unit 1, Tank #2 liquid level gauge and noted that it appeared to be empty however there was a green tag attached to the gauge (Appendix 1, image IMG\_0043.JPG). I was told that the liquid level gauge was not functioning. I took digital images of the tag which indicated that maintenance had identified the liquid level gauge was not functioning on April 24, 2024 (Appendix 1, images IMG\_0044.JPG through IMG\_0046.JPG). When asked about the repair schedule for this device, Mr. Halstead stated that repairs would be made after September or October when the ozone season would be concluded. Please see the **Mechanical Integrity** section of this report for further discussion.

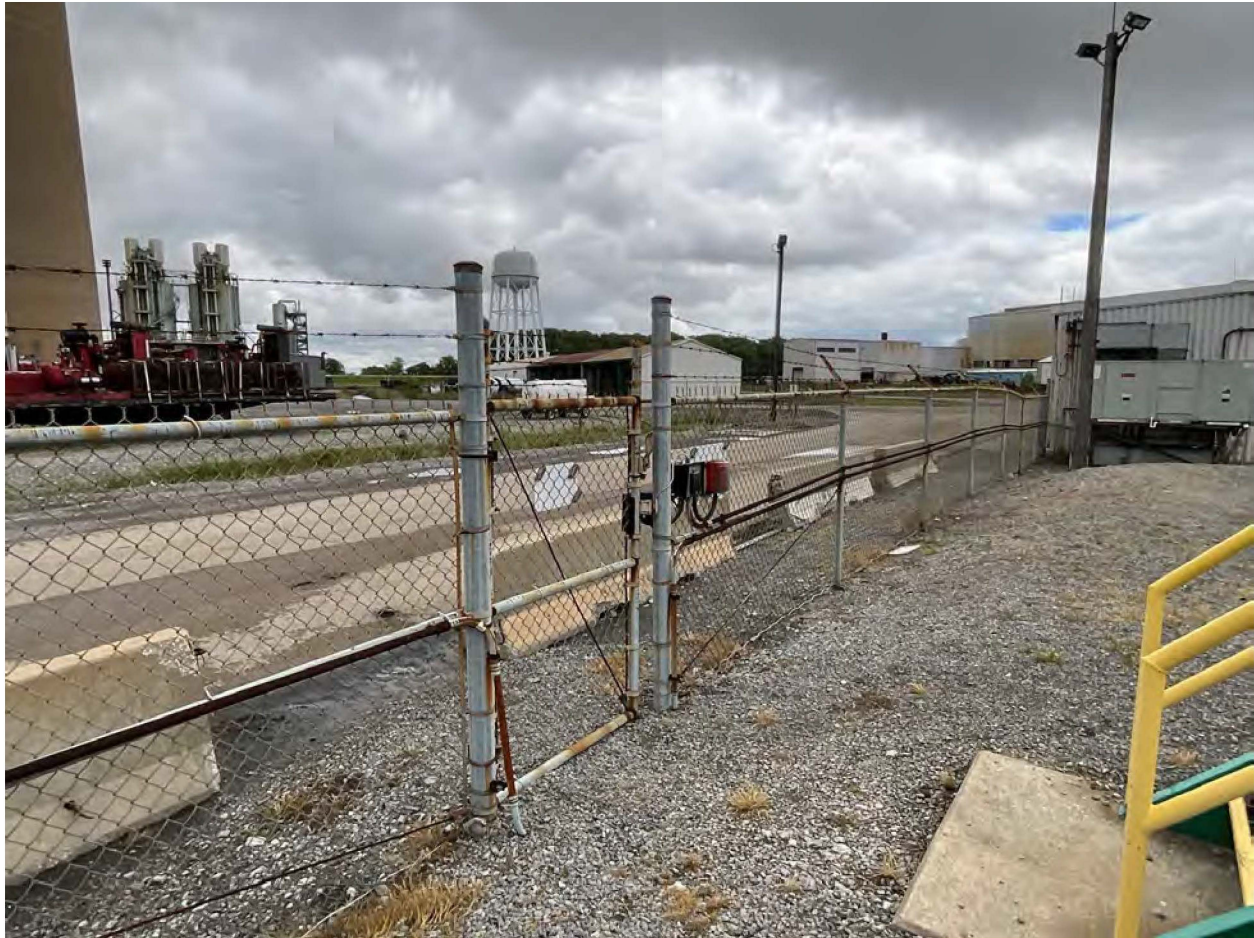
Appendix 1, image IMG\_0058.JPG

We went back inside fenced and diked anhydrous ammonia storage area and I observed an emergency exit gate on the west end of the area near SCR Unit 1, Tank #1 that had a crash/panic bar to open the gate (Appendix 1, image IMG\_0056.JPG) and another located on the east end of the area SCR Unit 1, Tank #3 that did not have a crash/panic bar to open the gate but appeared to have electronic badging access (Appendix 1, image IMG\_0057.JPG). I observed another exit gate on the east side of the fenced and diked anhydrous ammonia storage area that was on the east side near SCR Unit 2, Tank #3. This gate appeared to have electronic badging access also, but this gate does not swing freely or securely closed due to the rocks (Appendix 1, image IMG\_0058.JPG). All exits had signage that stated that authorized personnel only could enter. For additional discussion on this topic, please refer to the **Process Hazard Analysis** section of this report.

Additionally, as discussed in the Field Tour section of this report, the gate access to the anhydrous ammonia bulk tank storage area was not secure. The east gate would not close, and Mr. Halstead stated that the badging system was not functional. It is highly recommended that AECl review the PHA nodes and identify how often the gate security should be evaluated and what actions are needed going forward.
