**Region 6 - Enforcement & Compliance Assurance Division**  
**INSPECTION REPORT**

| Inspection Date(s): | August 28, 2023 | |
| Company Name: | <b>City of Aztec</b> | |
| Facility Name: | <b>Aztec Water Treatment plant</b> | |

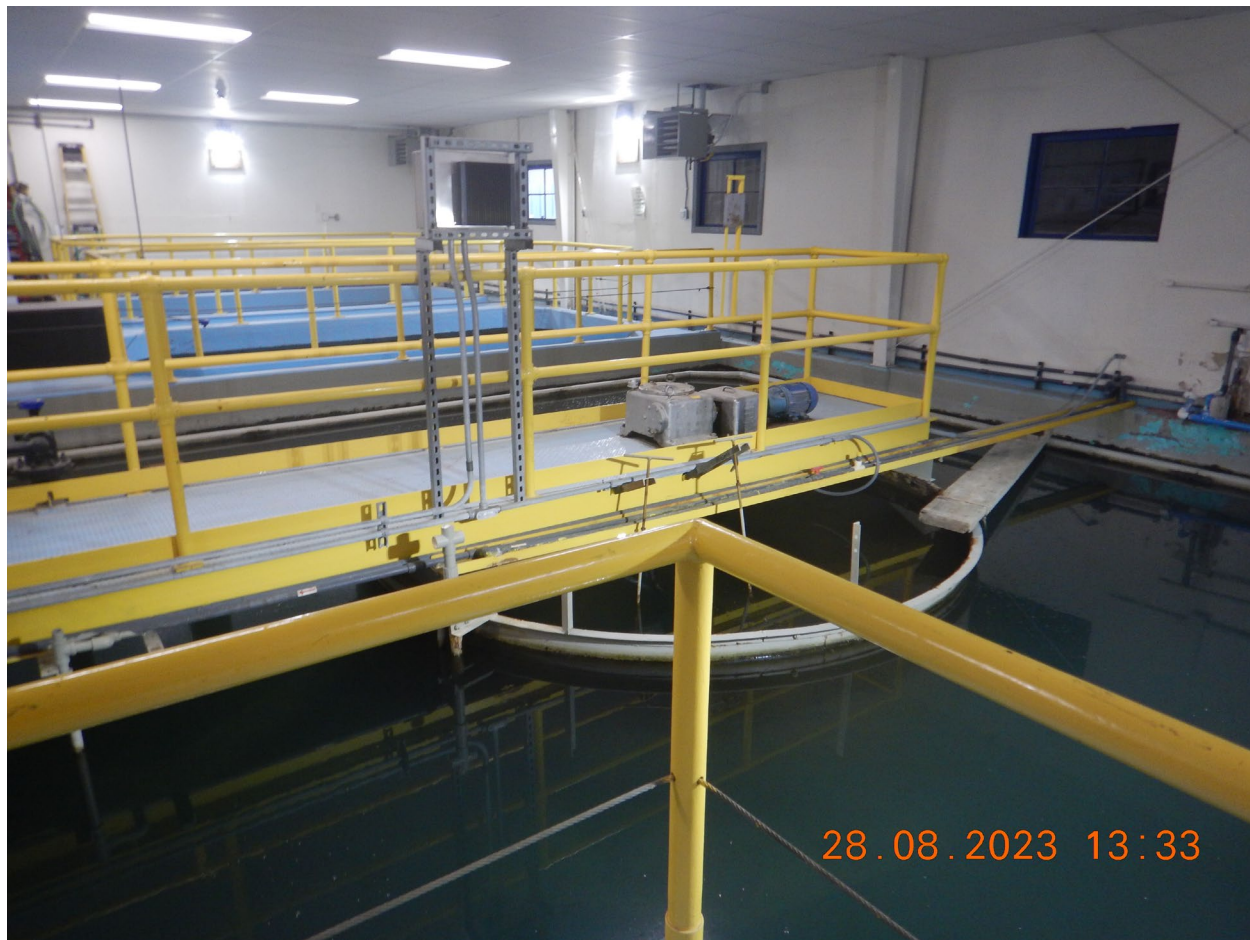
Photo No. 1

View of the Plant #1 clarifier and filters #1 and #2. (DSCN2605). Photographed by D. Esparza

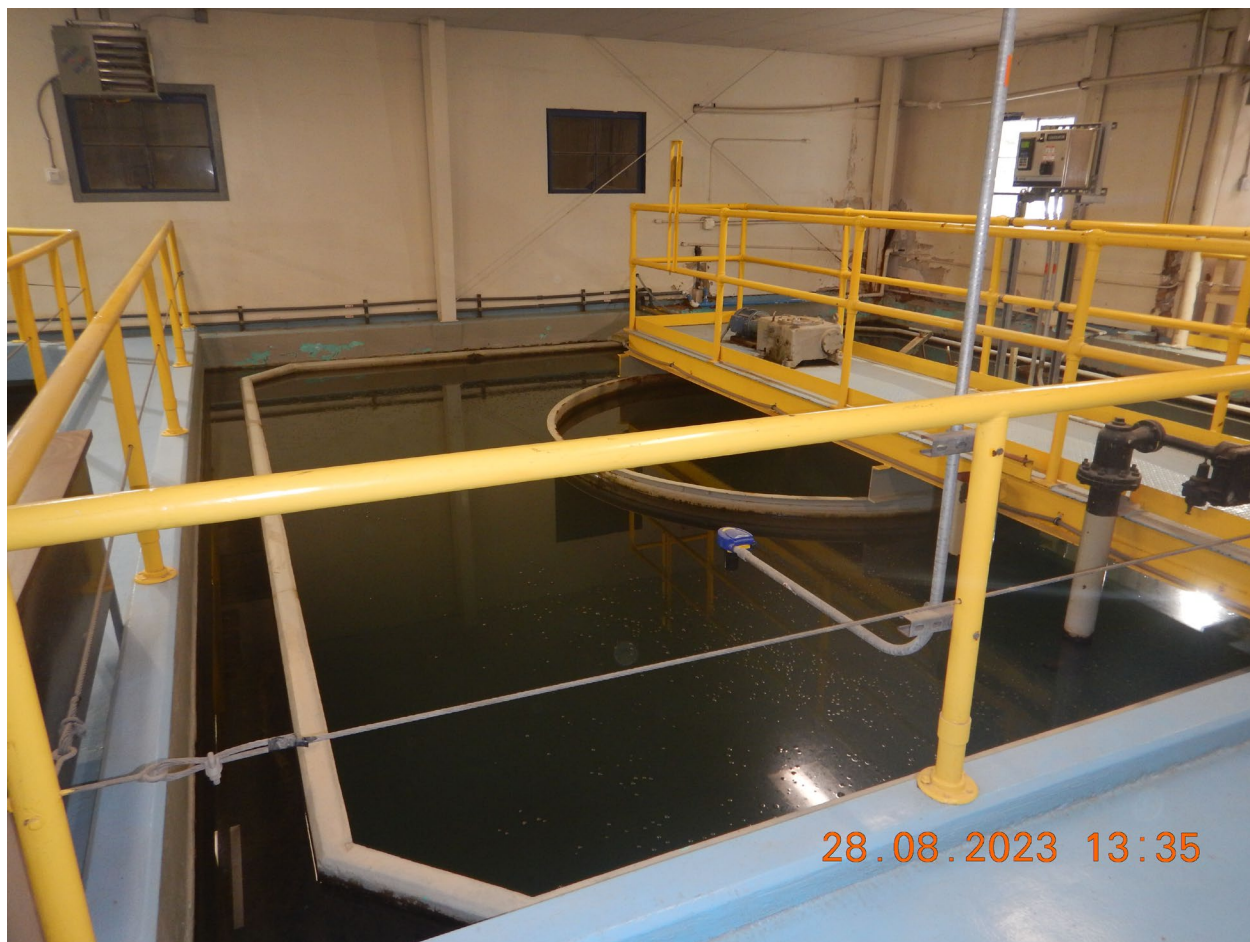
Photo No. 2

View looking towards Plant #2 clarifier. (DSCN2606). Photographed by D. Esparza

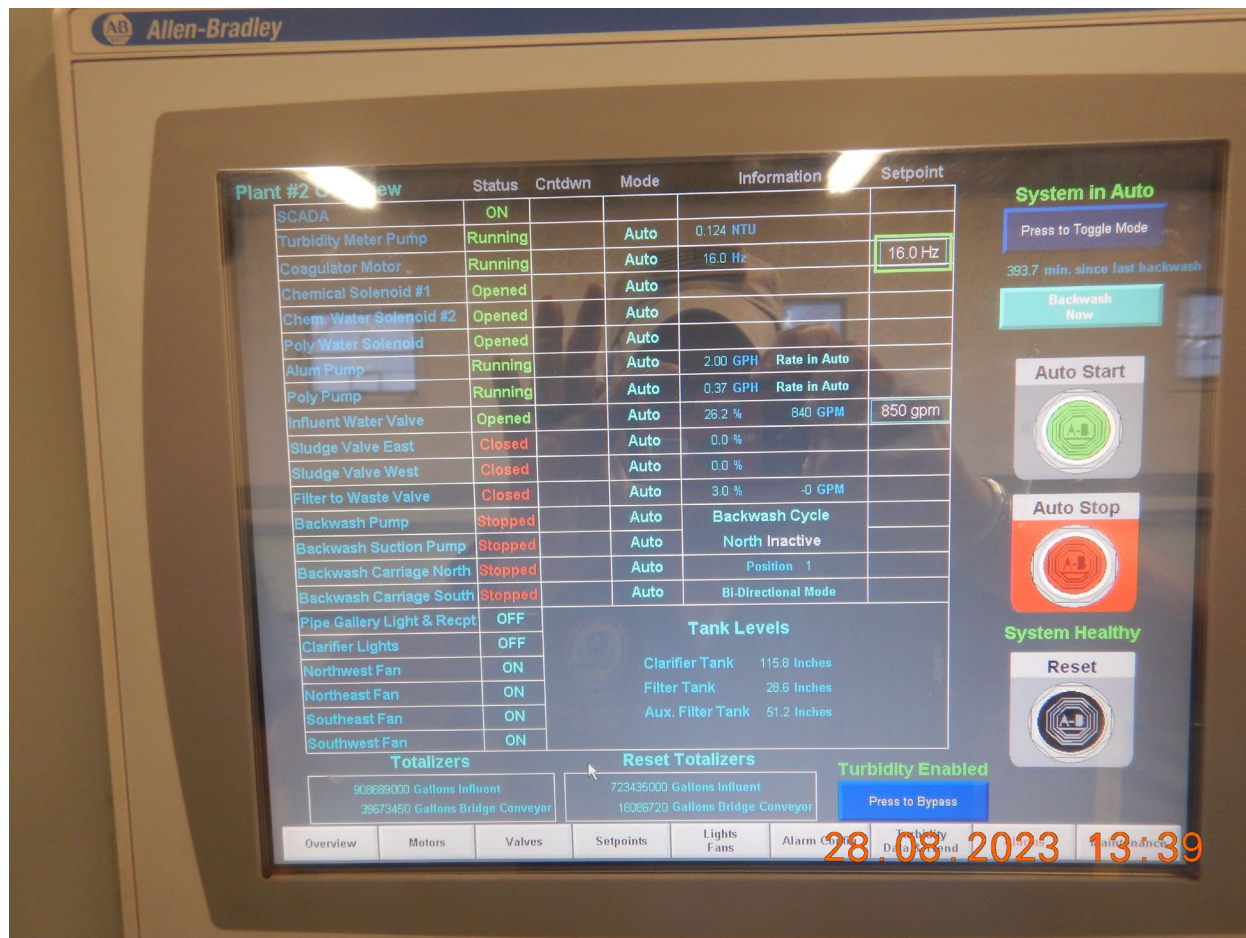
Photo No. 3

View of Plant #2 Supervisory Control and Data Acquisition (SCADA) data display. (DSCN2609). Photographed by D. Esparza

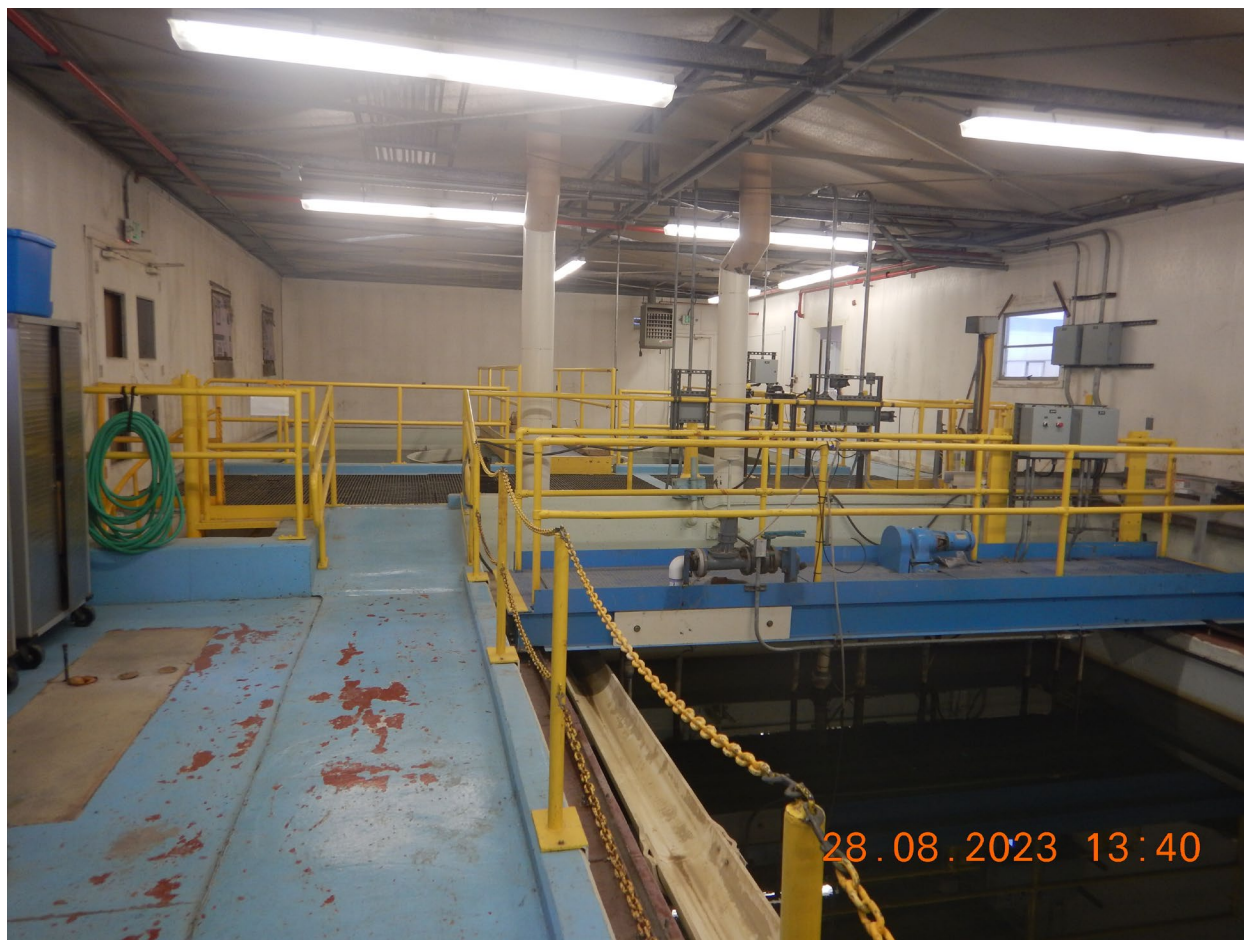
Photo No. 4

View looking towards Plants #3 and #4. (DSCN2610). Photographed by D. Esparza

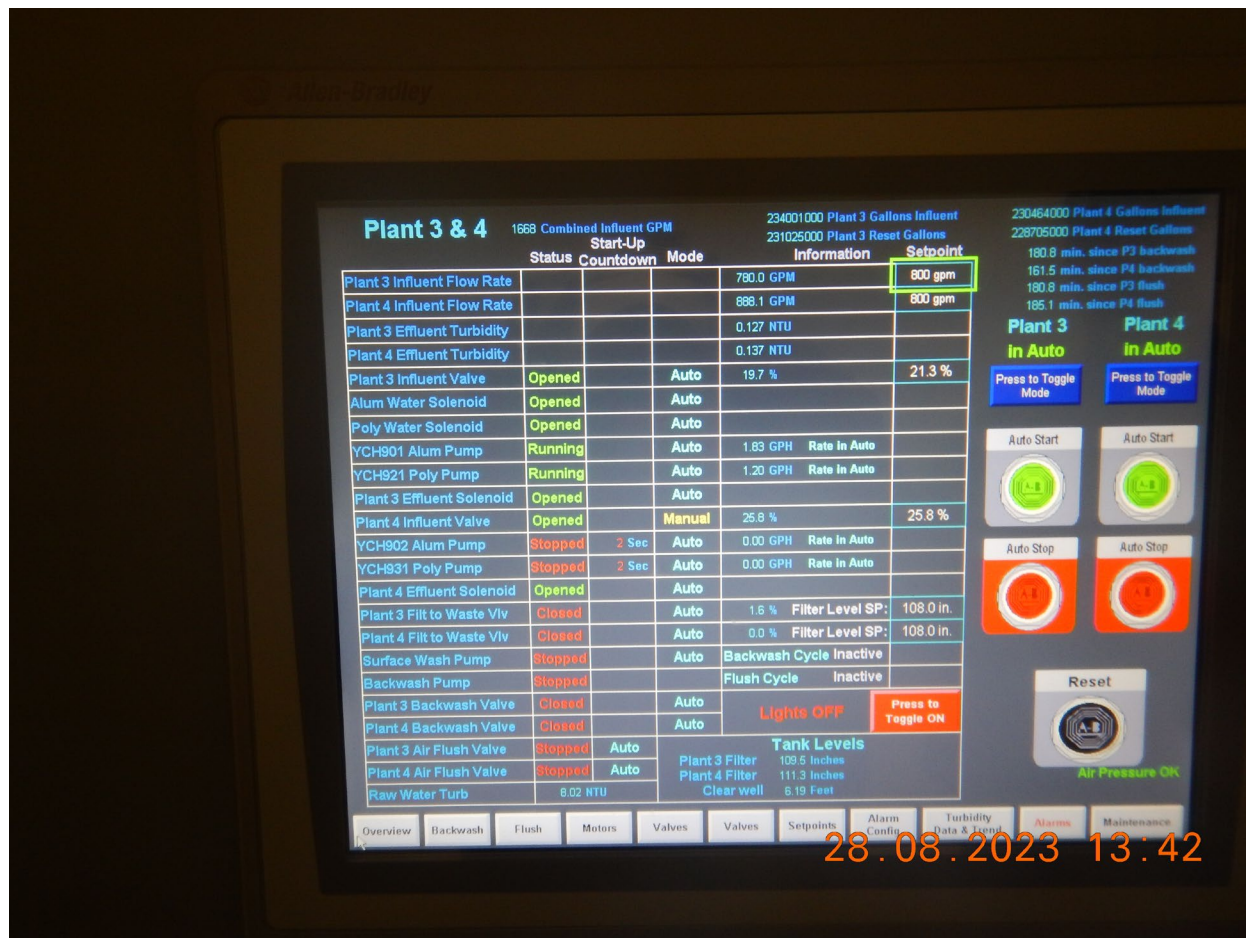
Photo No. 5

View of Plants #3 and #4 Supervisory Control and Data Acquisition (SCADA) data display. (DSCN2611). Photographed by D. Esparza

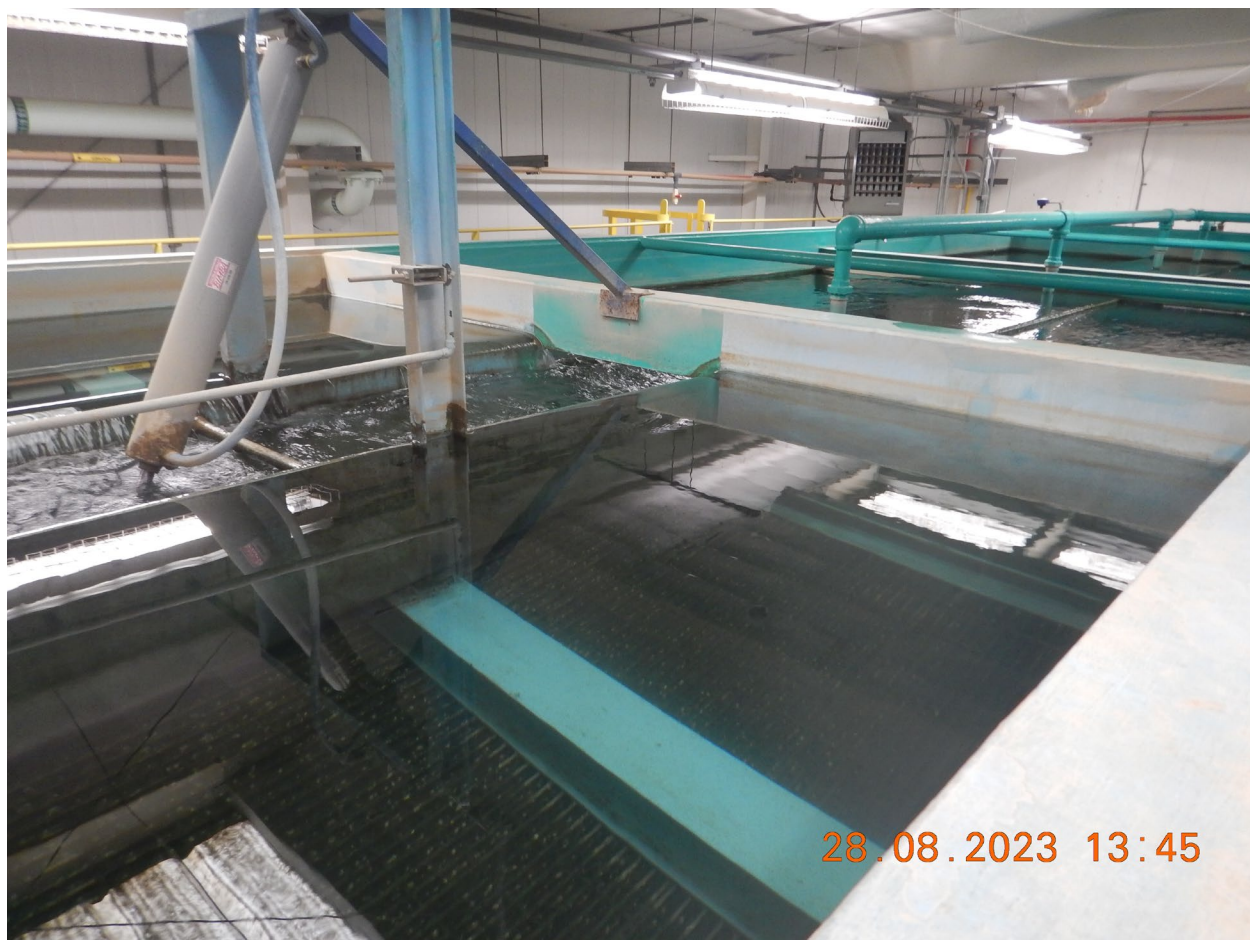
Photo No. 6

View of a portion of the treatment processes of Plant #3 and #4. (DSCN2612). Photographed by D. Esparza

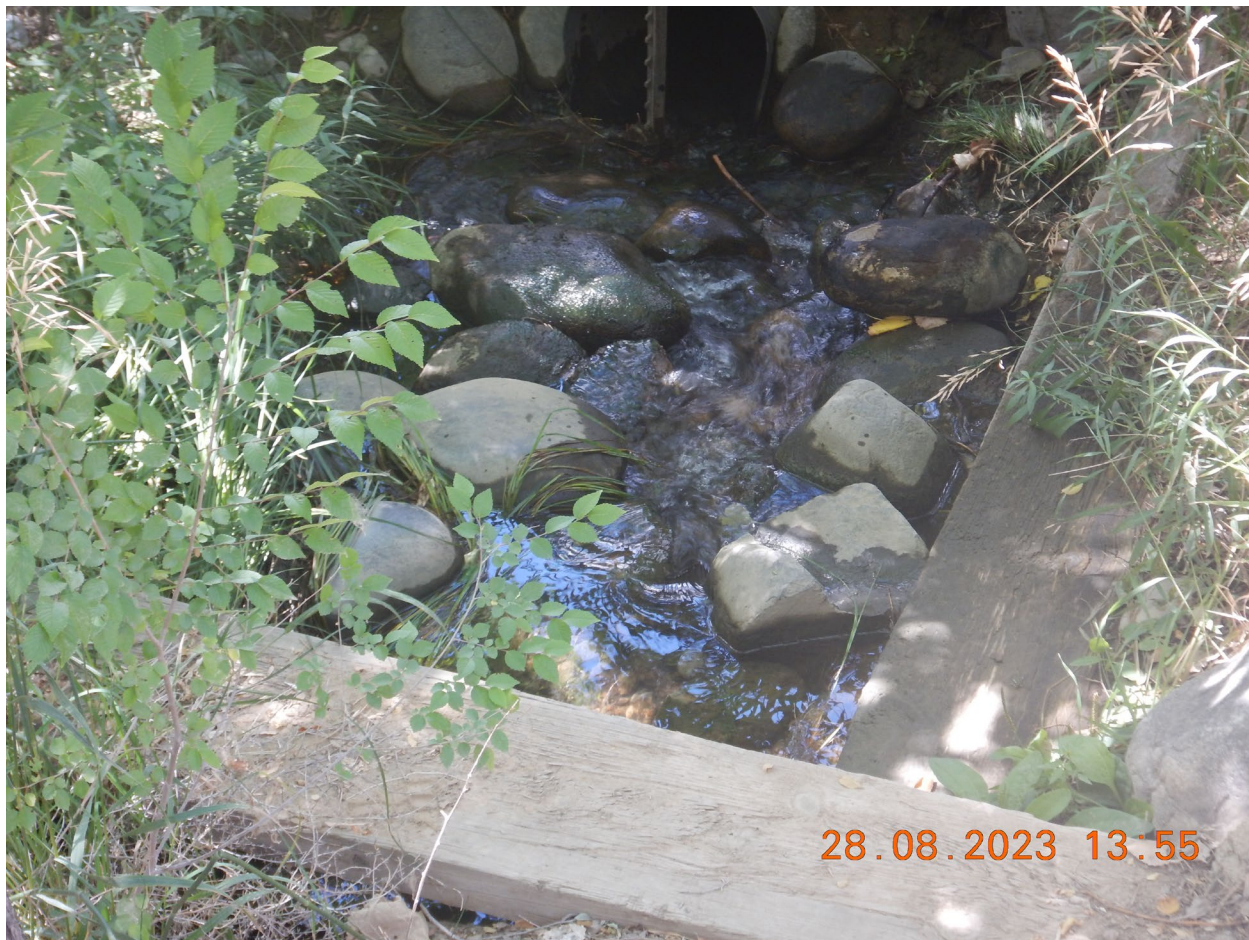
Photo No. 7

- Effluent flow at the open channel in the Lower Animas Ditch appeared to be clear. No foam, aromatics, discoloration, or stressed vegetation was observed.

View of the discharge into the open channel, thence into a closed conduit and ultimately into the Lower Animas Ditch. (DSCN2613). Photographed by D. Esparza

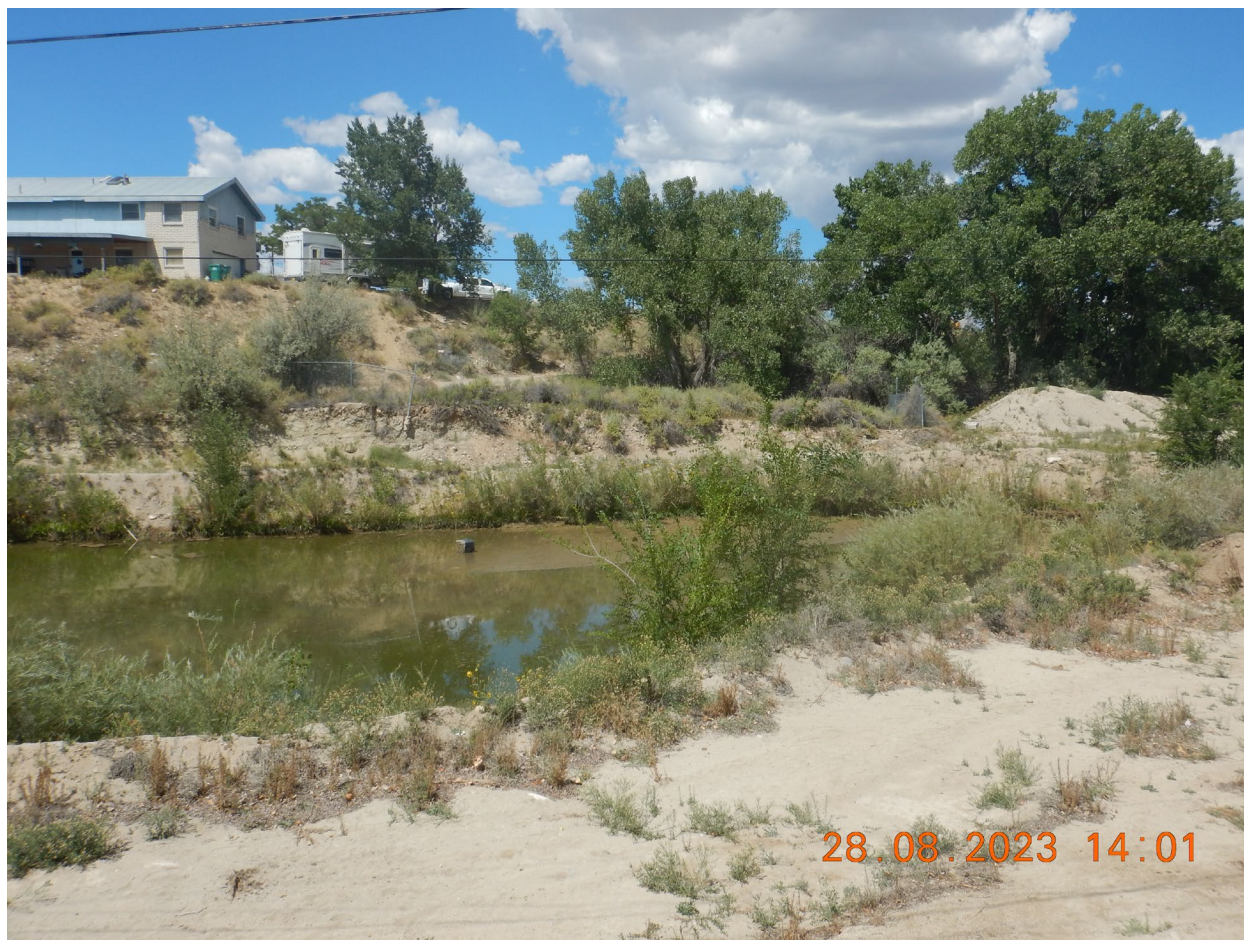
Photo No. 8

- Backwash and system flush traverses through the WTP’s sump system to an on-site settling pond (called “backwash pond” by the plant operators). The backwash pond lacks secure perimeter fencing, signage and is located downgradient and adjacent to residential housing.

View looking approximately Northwest towards the on-site settling pond (called “backwash pond” by the plant operators). The backwash pond lacks secure perimeter fencing, signage and is located downgradient and adjacent to residential housing. (DSCN2615). Photographed by D. Esparza

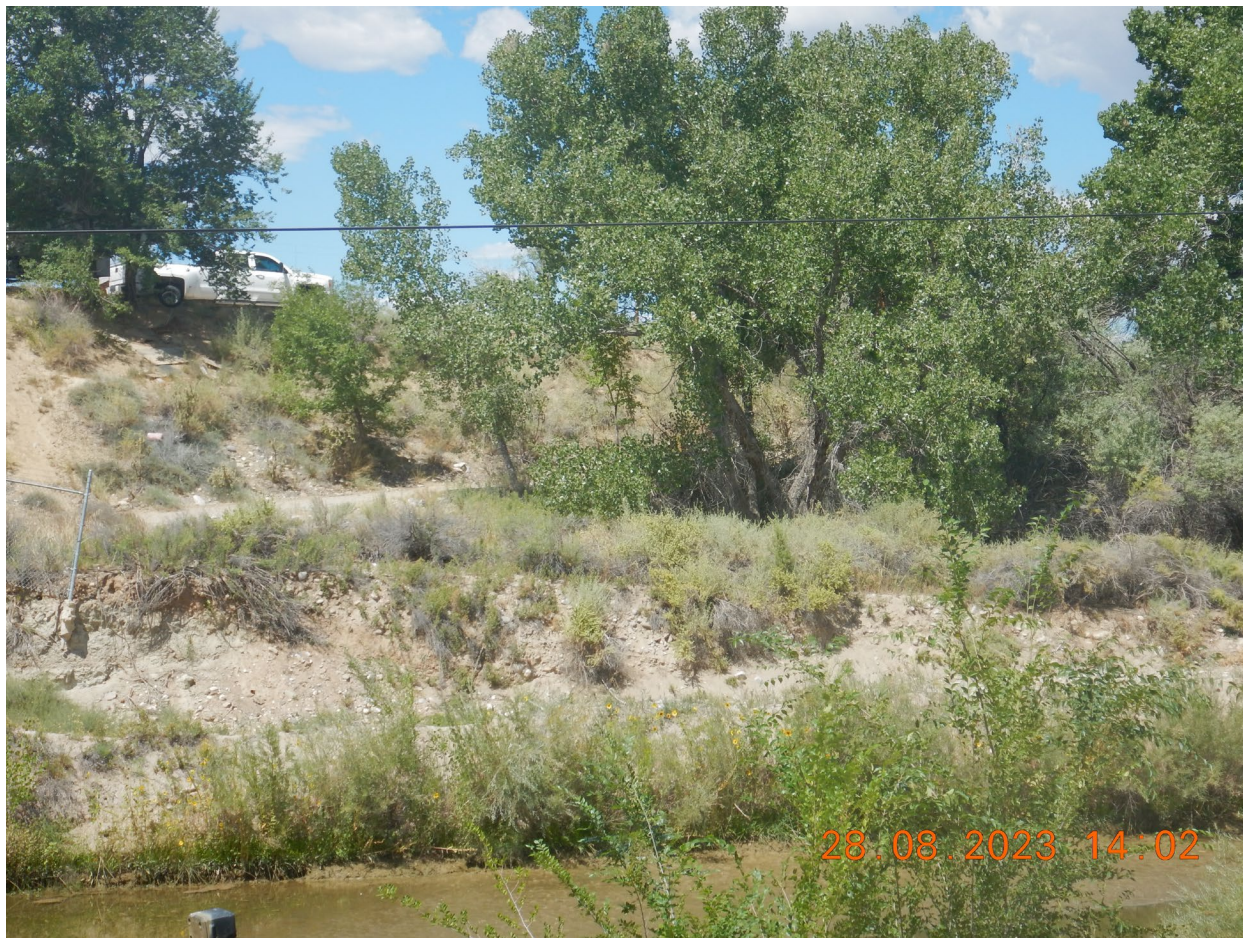
Photo No. 9

- The backwash pond lacks secure perimeter fencing and signage and is located downgradient and adjacent to residential housing.
- The WTP does not have emergency generators either fixed or mobile to continue operations of their treatment processes or booster stations in the event of a local power outage.

Another view looking towards the on-site settling pond (called “backwash pond” by the plant operators). Note: the backwash pond lacks secure perimeter fencing, signage and is located downgradient and adjacent to residential housing. (DSCN2616). Photographed by D. Esparza
