**Region 6 - Enforcement & Compliance Assurance Division**  
**INSPECTION REPORT**

| Regulatory Program(s) | NPDES Stormwater/CWA 402 | |
| Facility Name: | The Heights at Uptown Phase 1 | |
| Identification/Permit Number: | TXR1503NN | |

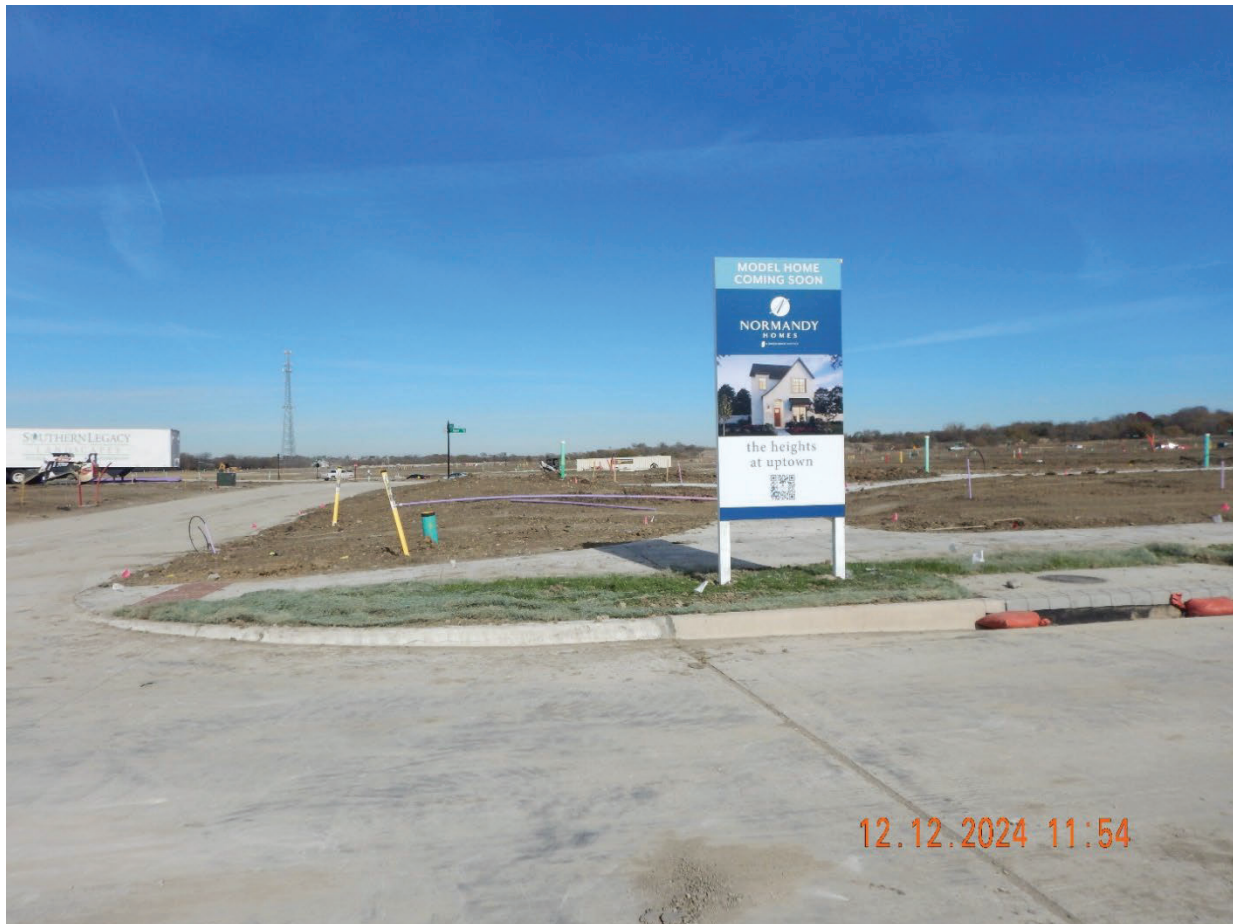
Photo no. 1

- Many lots throughout the site did not have BMPs installed to minimize the amount of soil exposed. However, erosion control blankets were observed in sections on multiple streets including Banks Street, Duke Lane, Walker Parkway, Taylor Parkway, and North Oklahoma Drive (**Appendix 1, Photos 1-5 and 8**).

- Approximately 60-65% of the lots had no BMPs present, resulting in a significant amount of exposed soil throughout the site (**Appendix 1, Photos 1-4 and 6-9**).

Description: View of erosion control blanket(s) along some of the lots on North Oklahoma Drive. The lots perpendicular to North Oklahoma Drive, along Blake Mews and Dover Mews have no BMPs present to minimize exposed soil.

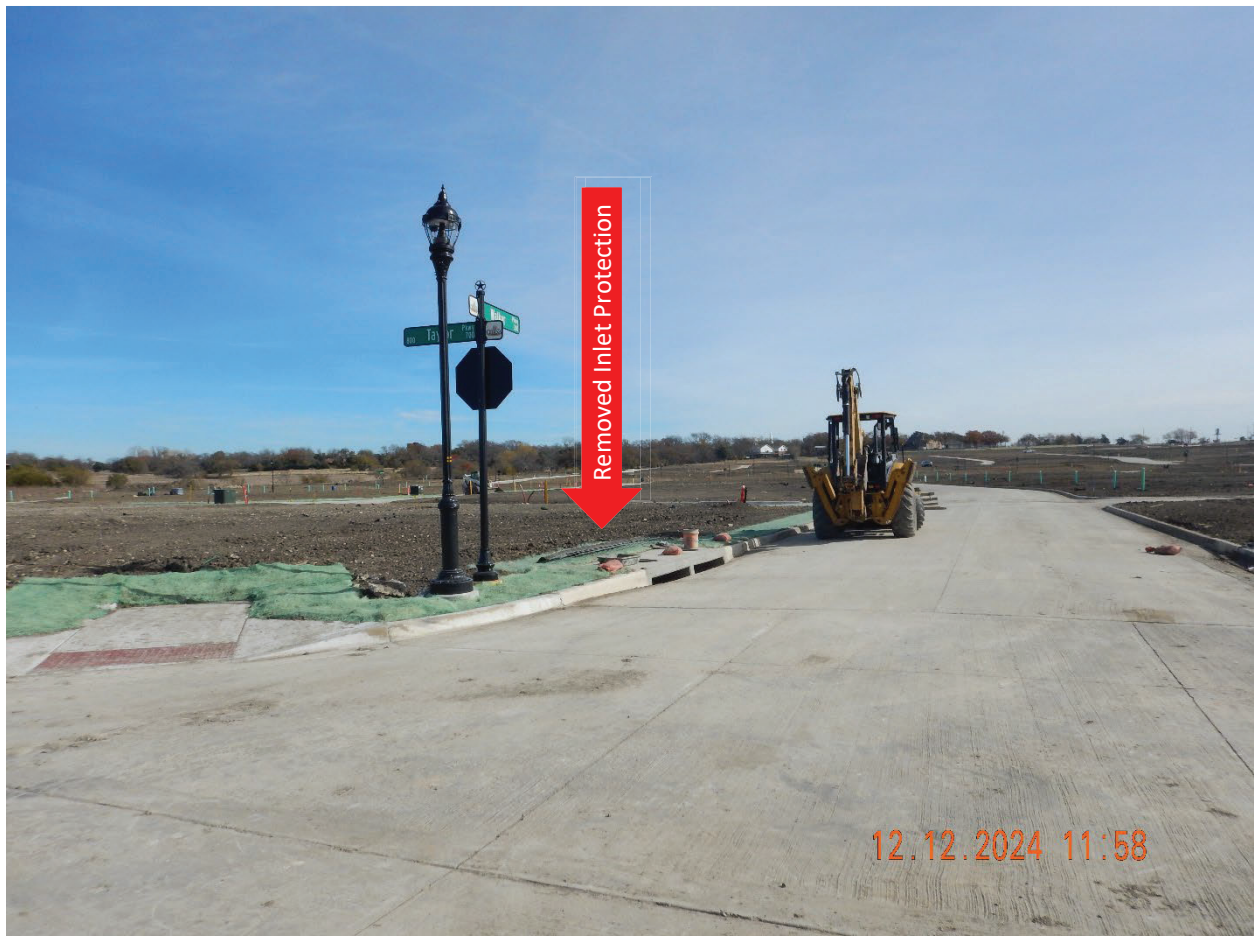
Photo no. 2

- Inlet protection was observed on most streets. However, multiple curb inlets were observed with the inlet protection missing or removed (**Appendix 1, Photos 2, 4, and 6**). Per feedback received from Mr. Fontenot, the inlet protection equipment that was removed (located near the inlet but not installed) may have been due to the inlets being cleaned by Southwest Erosion Control, at the time of the inspection. However, the inspector was unable to confirm this via visual observation(s) at the time of inspection.

Description: View of erosion control blanket(s) installed along some of the lots on Walker Parkway and Taylor Parkway. The remaining pictured lots on these streets had no BMPs installed. Also note the curb inlet with the inlet protection removed.

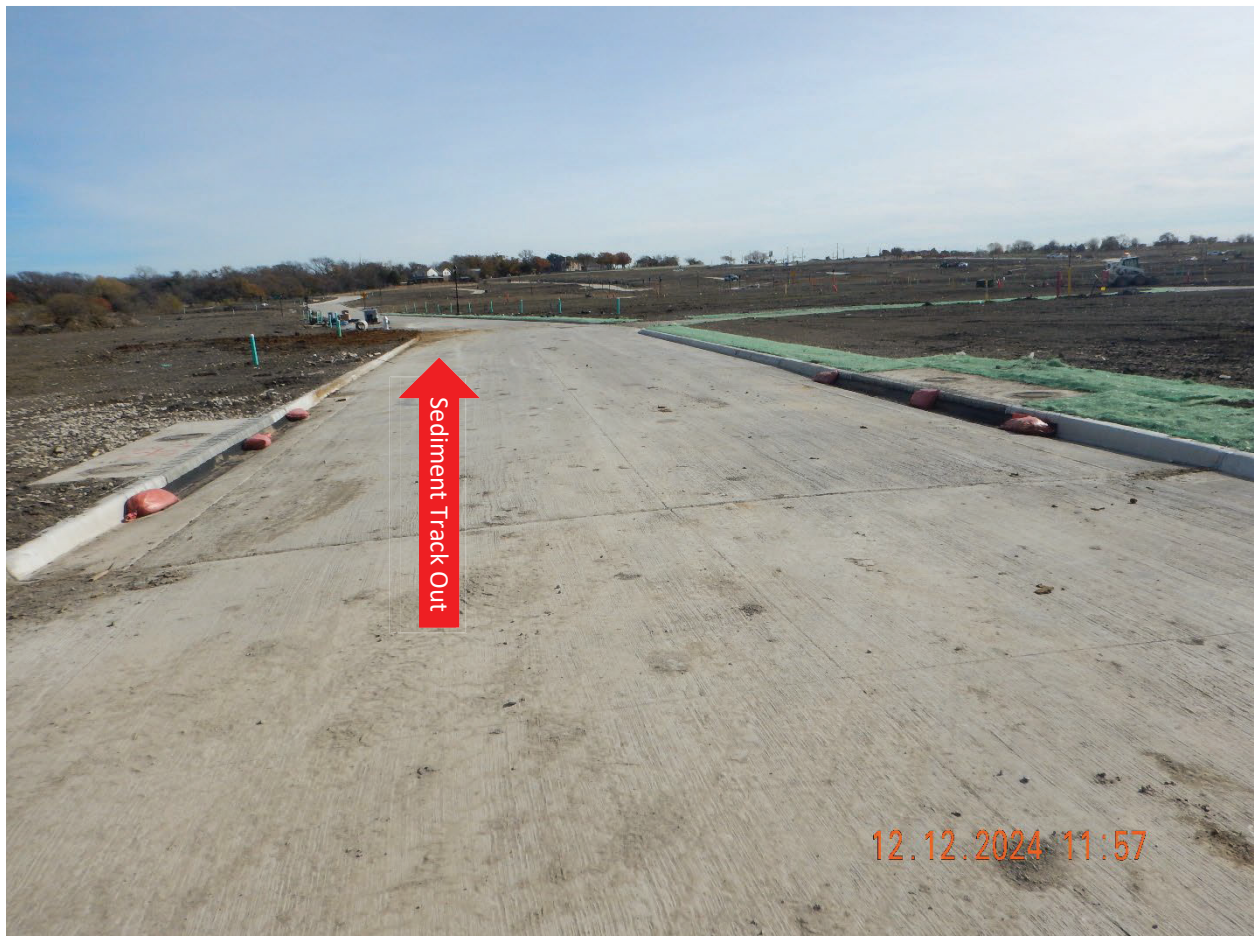
Photo no. 3

- Sediment was observed on the paved areas on multiple streets throughout the site (**Appendix 1, Photos 3, 5, 8 and 9**).
- At the time of inspection, a noticeable amount of sediment was being visibly blown by the wind throughout the project site.

Description: View of erosion control blanket(s) along one (1) side of Banks Street while the other side had no BMPs installed to minimize exposed soil. Curb inlets on both sides of the street had inlet protection installed. Sediment/sediment track-out was also observed on the street.

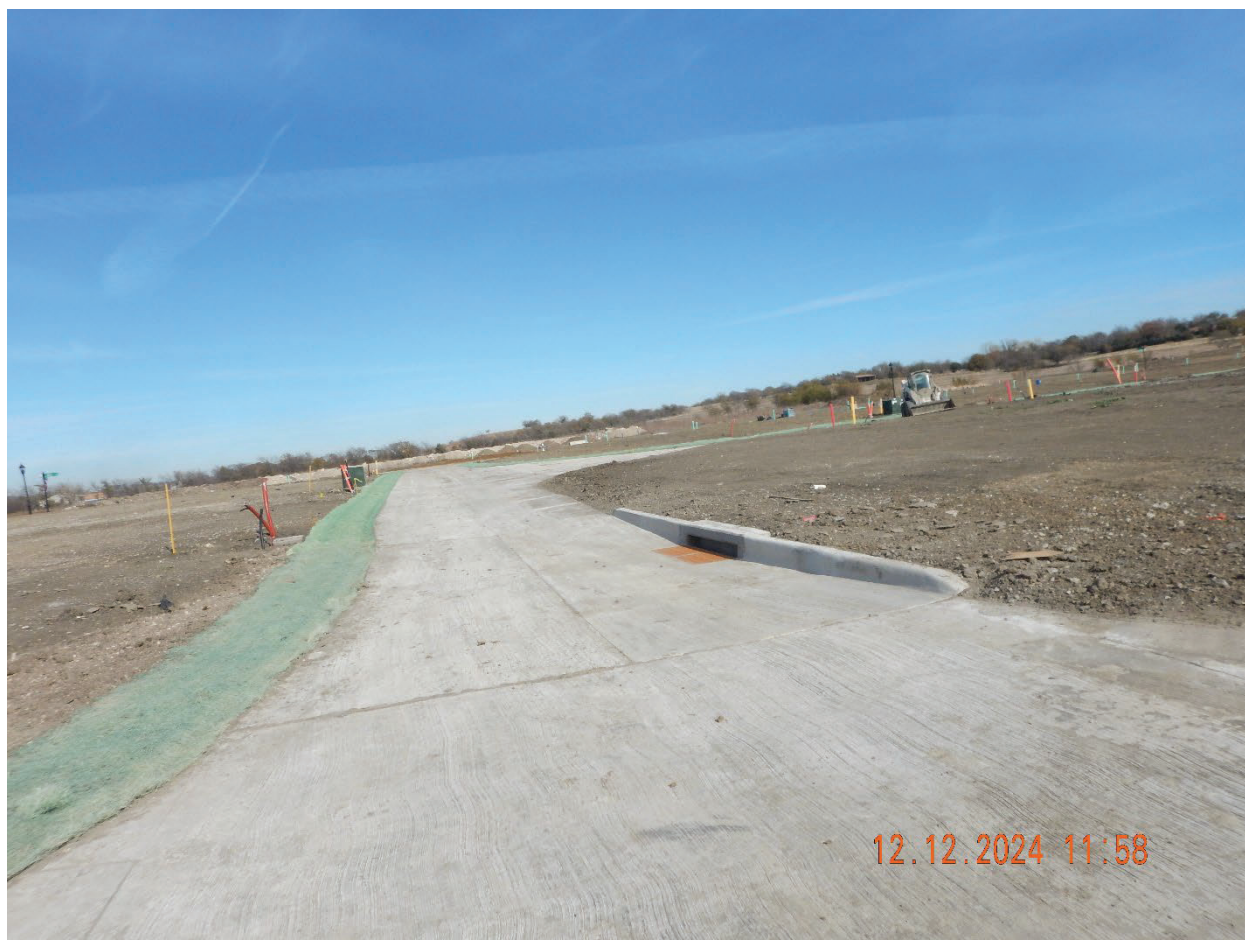
Photo no. 4

Description: View of erosion control blanket(s) installed along one (1) side of the alley off Taylor Parkway. The curb inlet in the alley had no BMPs installed and is located directly next to/underneath exposed sediment.

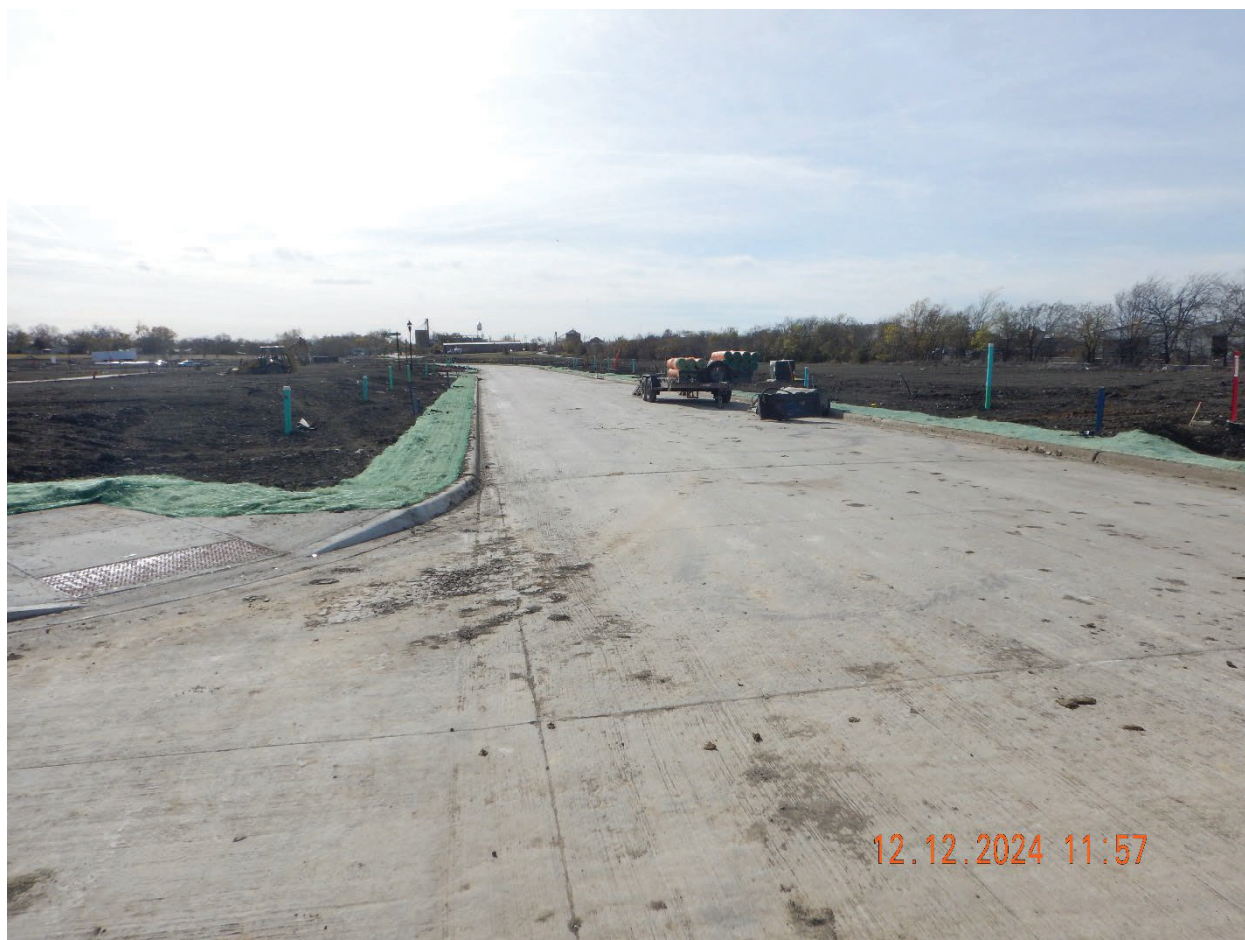
Photo no. 5

- A utility trailer with rolls of erosion control blanket(s) was observed on Taylor Parkway (**Appendix 1, Photo 5**)
- A Southwest Erosion Control truck was observed on-site with erosion control blankets on the truck bed. Mr. Fontenot advised the inspector that Southwest Erosion Control was also on-site to clean the streets and inlets.

Description: View of erosion control blanket(s) along both sides of the street on Taylor Parkway. Also pictured is a utility trailer with erosion control blankets on the bed. Sediment/sediment track-out was also observed on the street.

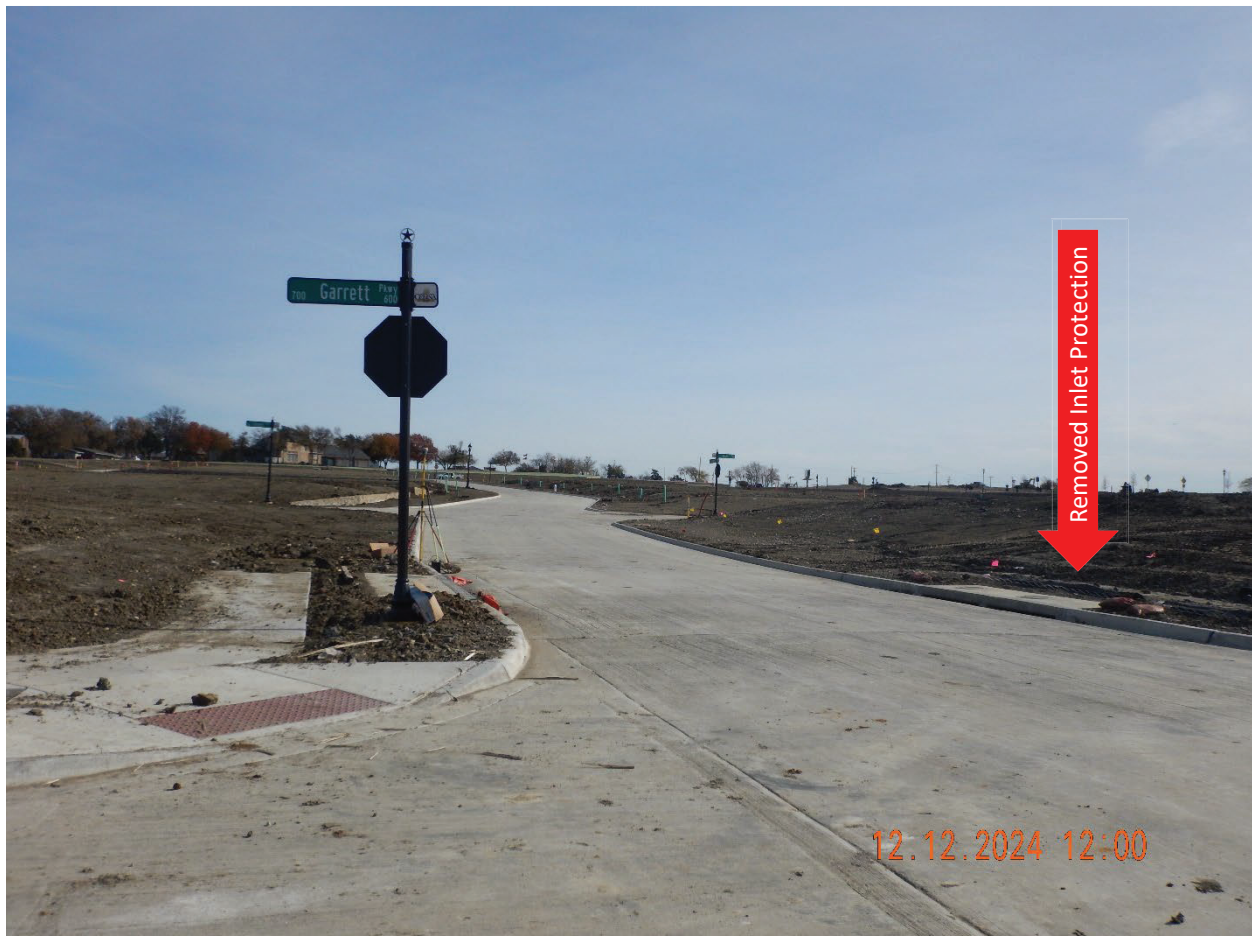
Photo no. 6

Description: View of exposed sediment along all pictured lots, near the intersection of Garrett Parkway and Walker Parkway, facing east. The curb inlet on the right had the inlet protection removed.

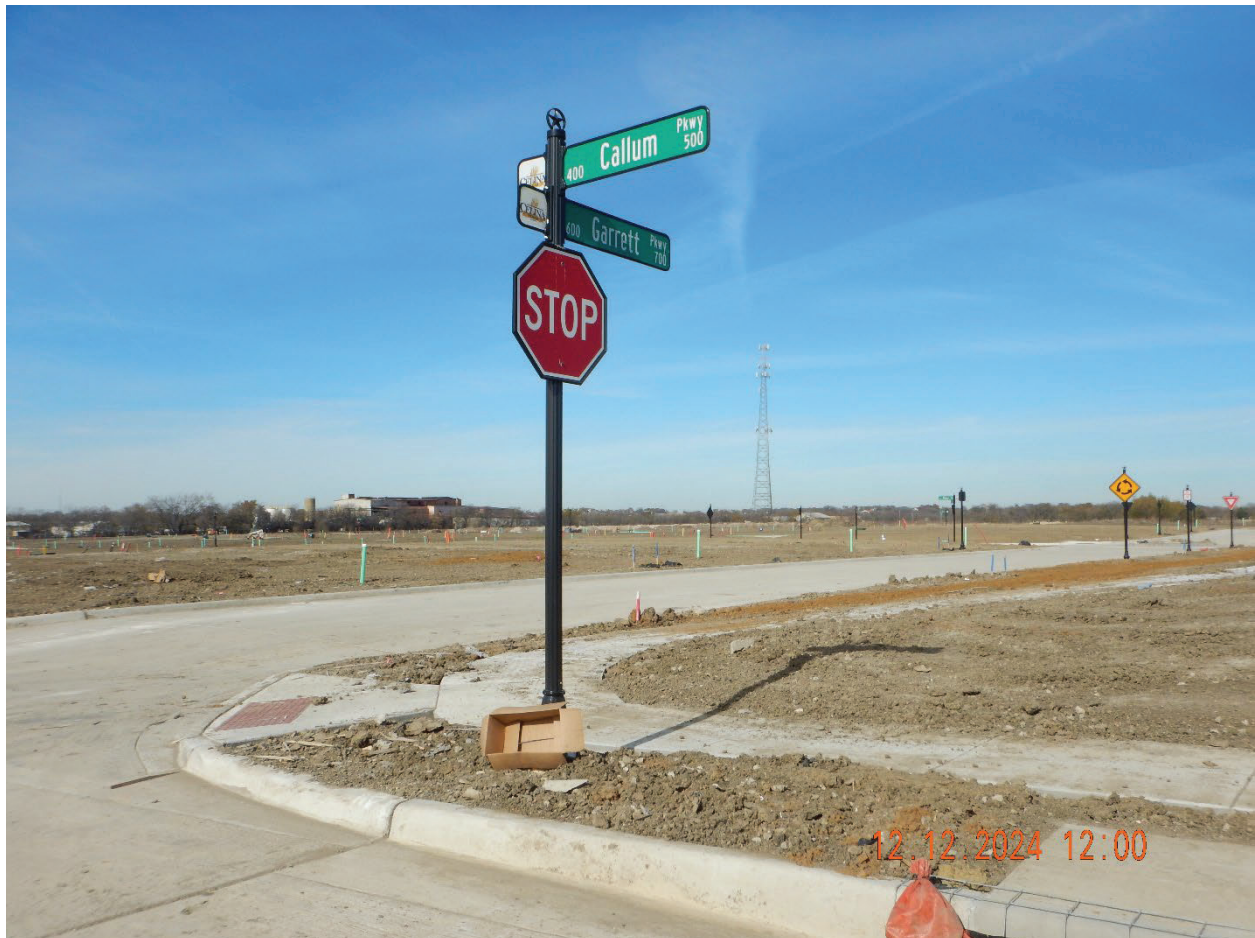
Photo no. 7

Description: View of exposed sediment along all pictured lots near the intersection of Garrett Parkway and Callum Parkway, facing westward. Trash was also observed in the area.

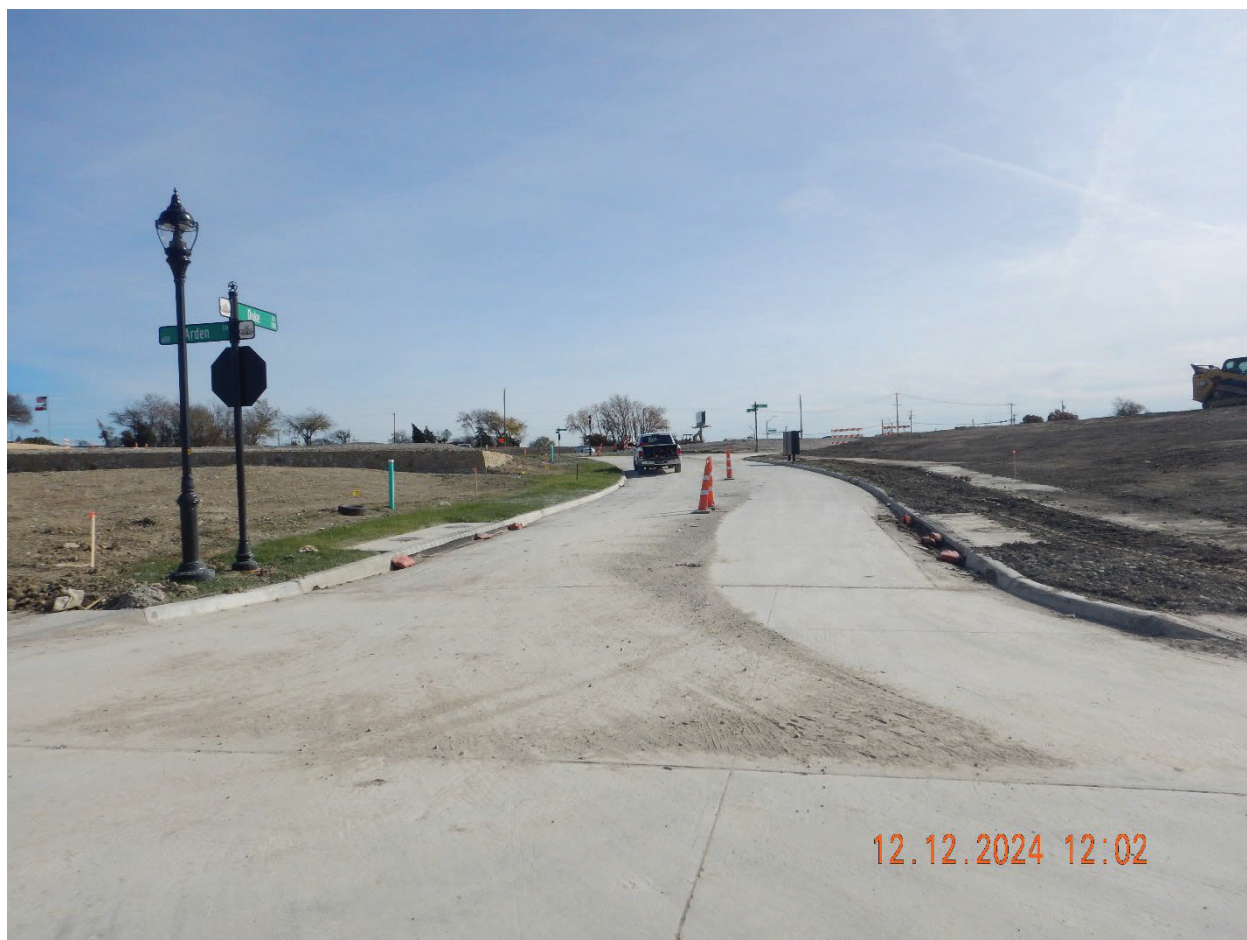
Photo no. 8

Description: View of lots on the left side of Duke Lane (facing east) with BMPs installed, whereas lots on the right side have no BMPs present. Sediment/sediment track-out was observed on the street.

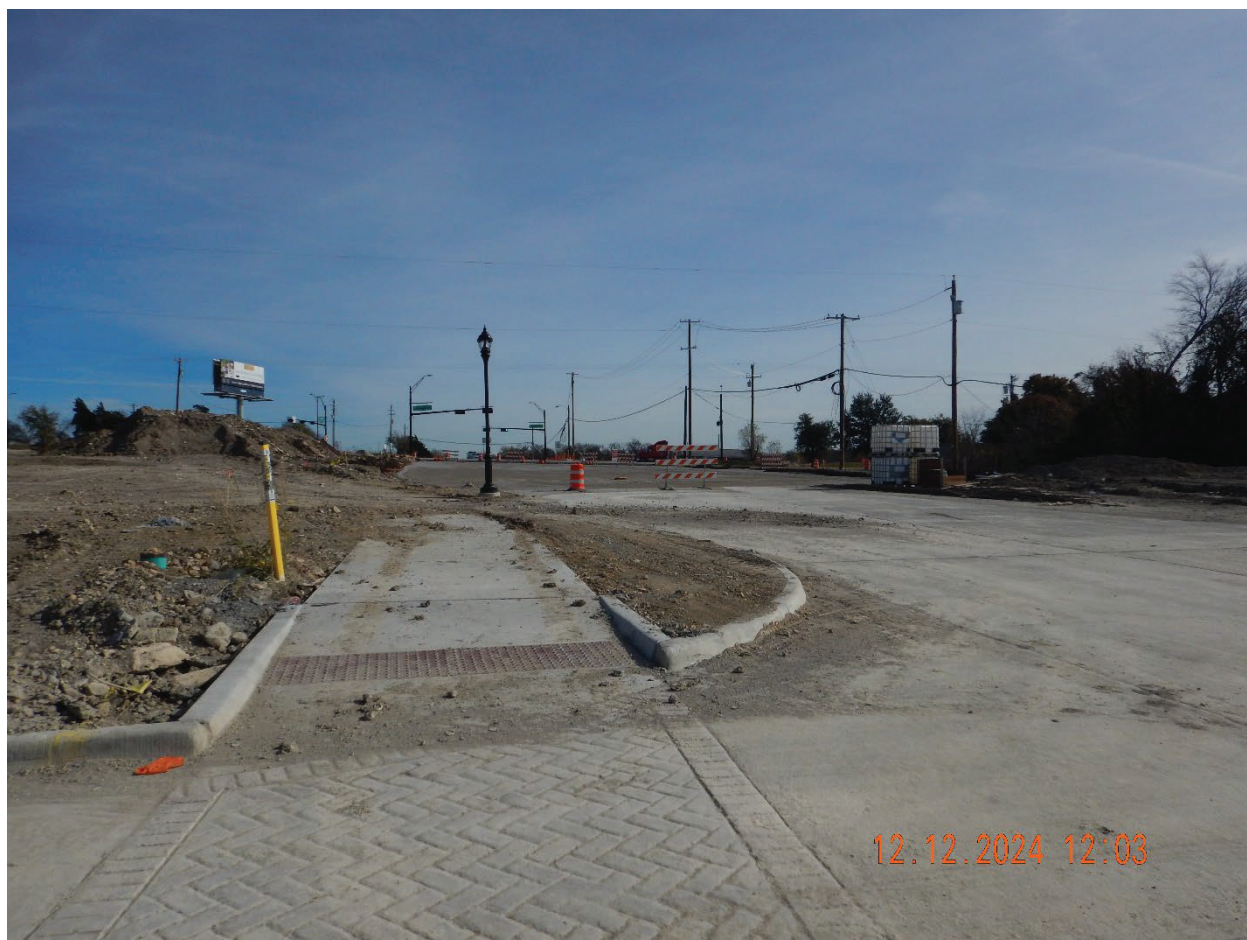
Photo no. 9

Description: View of lots along Stambaugh Parkway with no BMPs installed. Sediment/sediment track-out was observed on the street.

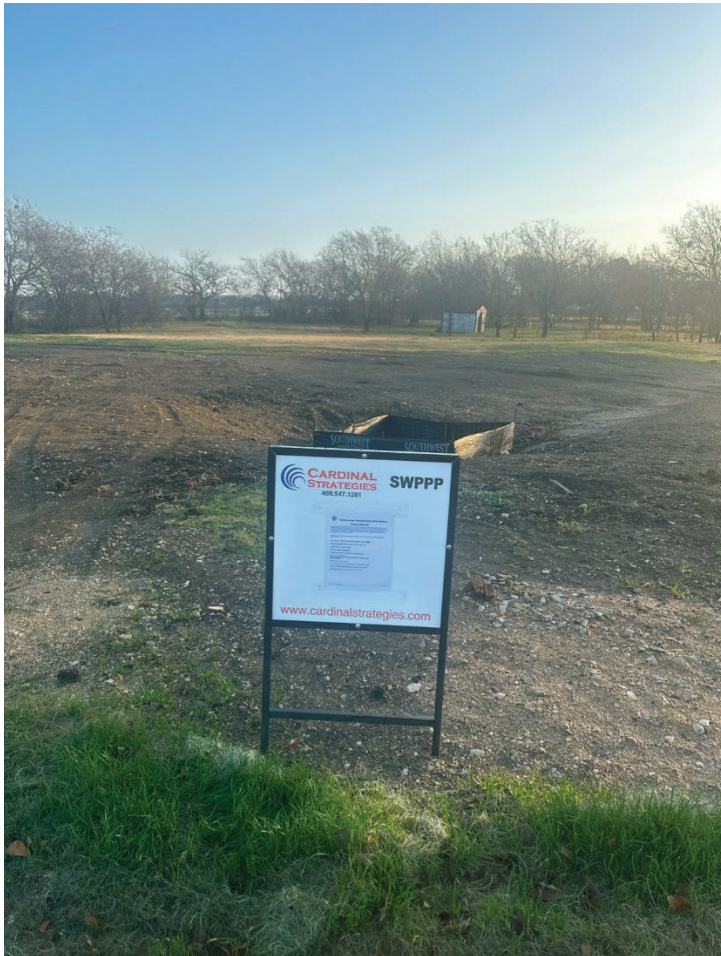
Photo no. 10

- The Construction Site Notice (CSN) was not observed on-site at the time of inspection. Mr. Fontenot informed the inspector that the CSN was likely removed due to construction activities in the area it was last posted.

- At a later date, a representative of Cardinal Strategies provided the inspector with a photo and the location of the CSN, as described in Section IV of this report and shown in Appendix 1 (**Photo 10**).

Description: View of the CSN notice posted within the vicinity of 33°19'37.7"N 96°46'55.6"W. Note: This photo was emailed by Kyle Trzupek of Cardinal Strategies on 12/17/2024.
