# Clean Air Act Compliance Inspection Report

## *Clean Air Act Partial Compliance Evaluation Inspection Report*

**Gas Transmission Northwest LLC  
Grass Valley, Oregon  
Madras, Oregon  
Bend, Oregon**

**Inspection Dates: July 19-20, 2022**

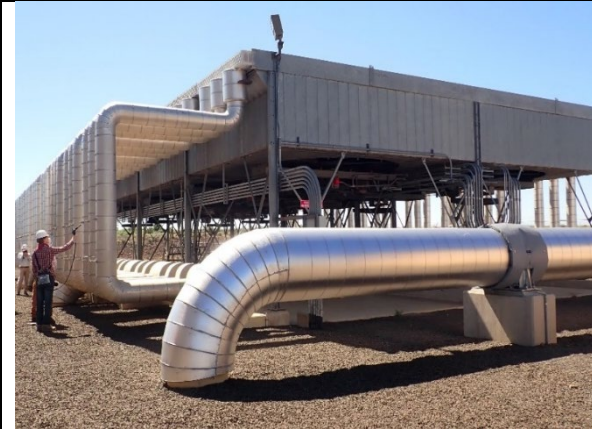
**Gas Cooler.** Natural gas coming through the facility becomes heated when it is compressed. Before leaving the facility, gas is cycled through a cooling system which resembles a large radiator cooled with roof fans. See Figure 1, below. 11 vapor leaks were found on components of the Gas Cooler system using Method 21. The leaks were found coming from valves installed in vertical pipe runs of the cooling system. See Figure 2, below. VOC concentrations measured by the TVA 2020 ranged from 2,000 – 50,000 ppm. At one or more locations the TVA 2020 “flamed out” while getting a reading. “Flame out” also occurred at times while monitoring other locations at Compressor Station 10 that day. The first seven leaks were not visible while using OGI by either EPA Inspector Pavitt or Montrose contractors. Bright sunshine reflecting off of the shiny metallic surface of the cooling pipes made viewing more difficult. It is the understanding of the EPA inspectors that after they departed at the end of the day, Montrose re-monitored the leaking components which EPA had discovered using Method 21 at the Gas Cooler and that Montrose confirmed the vapor leaks. The last four leaks, on the shaded side of the gas cooler, were found by Montrose using OGI. The four leaks were found to be coming from threaded connectors underneath insulation.

Figure 1: Gas Cooler System. EPA Inspector Heins (foreground) checking for fugitive emissions using a TVA 2020 instrument (Method 21), while EPA Inspector Pavitt (background) uses a FLIR Camera (OGI).

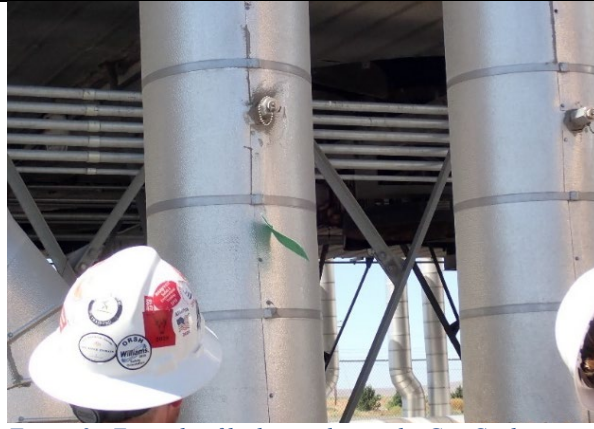
Figure 2: Example of leaking valve on the Gas Cooler found using Method 21. A tag was applied to the location by Montrose. All 11 leaks from the Gas Cooler were repaired by 8/9/22 according to facility records. (See Attachment 5-D, 7/19/2022 OOOOa Survey Details.)

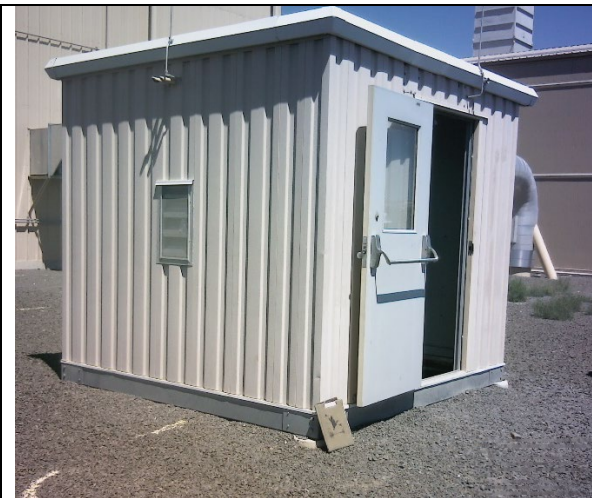
Figure 3: Shelter for Valve 65 B (B-Line Blowdown Valve). One of multiple shelters that are part of the facility's monitoring plan for undergoing quarterly Leak Detection and Repair (LDAR).

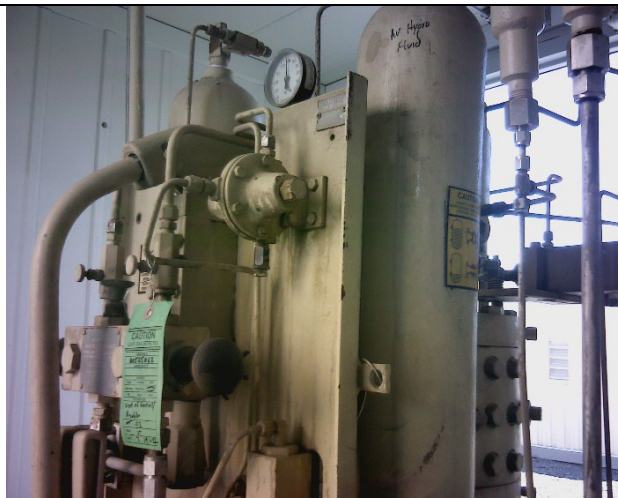
**Valve Shelters.** Compressor station valves are housed in sheds for weather protection. Before stepping inside the shelters, Site Operator Dainty and EPA Inspector Heins measured ambient VOC levels, which was elevated in some locations. EPA inspectors waited with doors open for the air to ventilate briefly before entering. See Figures 1 and 2, below. At some shelters, we found leaks from components inside the shelters and also from pressure relief valves connected to them and venting outdoors.

Figure 4: Inside Valve 65 B Shelter. A leak was found on this valve regulator. Montrose tagged the leaking component upon discovery. Tag No. 60525062. Source: Open-Ended Line. This leak was repaired on 8/9/22 according to facility records. (See Attachment 4-D, 7/19/2022 OOOOa Survey Details.)
