# NPDES Compliance Inspection Report

## Preserve at Illahee Springs

NPDES Permit Tracking Number  
# WAR306947

Inspection Dates: 01/28/2021 & 02/11/2021

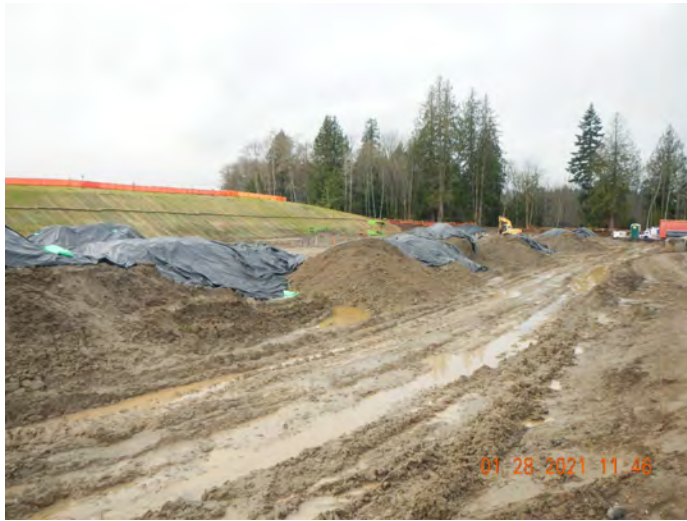
Photo #:09 (DSCN2026)

Description: Facing west from the northern perimeter within the Phase 3 area, photo of the temporary stockpiles. Some of the stockpiles were covered with plastic sheeting and some were active at the time of inspections.

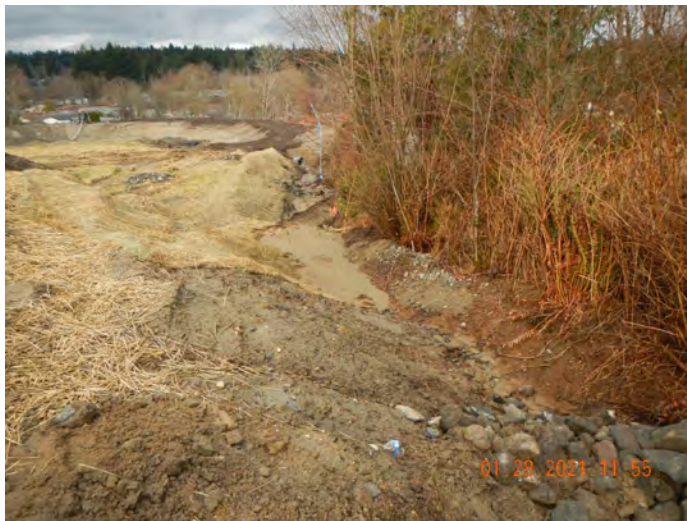
Photo #:11 (DSCN2028)

At the time of inspection, during our site walk-through on January 28, 2021, I observed a conveyance channel along the east perimeter to be in need of maintenance (**Photo 11**), it appeared that the sediment had built up and some of the rock check dams had failed. I notified Mr. Sita and Mr. Dunne of this observation during our closing conferences, I also included the observation in my email correspondence to Mr. Dunne following my January 28, 2021 walk-through inspection (**Attachment C**).

During my file review on February 11, 2021, when reviewing a January 3, 2021 Inspection Report completed by Samantha Harrison of OSG Environmental, I observed a note stating “-conveyance ditch along east perimeter has build up of sediment. Recommend removing excess sediment, lining with geotextile/plastic, and reinstalling check dams.” Within the inspection report the status of the Stabilize Channels and Outlets BMP Designation was checked “Not OK.”

The concern is that the BMP issue was identified by the contracted CESCL inspector on January 13, 2021 and had not been addressed within 10 days of discovery as observed and documented during my January 28, 2021 inspection. I returned to this area during my walk-through on February 11, 2021, it appeared sediment had been removed and check dams had been reinstalled (**Photo 23**).

Description: Facing north from the eastern perimeter, photo of the northern portion of a stormwater conveyance channel that runs along the eastern perimeter. This portion of the channel and associated check dams appeared to be in need of maintenance.

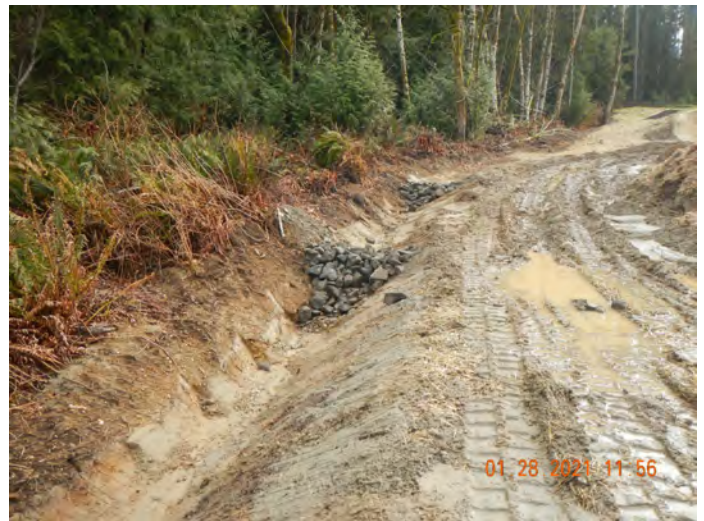
Photo #:12 (DSCN2029)

Description: Facing south from the eastern perimeter, photo of the southern portion of a stormwater conveyance channel that runs along the eastern perimeter. This portion of the channel was observed to be bare and unlined.

- DSCN2029 – Facing south from the eastern perimeter, photo of the southern portion of a stormwater conveyance channel that runs along the eastern perimeter. This portion of the channel was observed to be was bare and unlined.

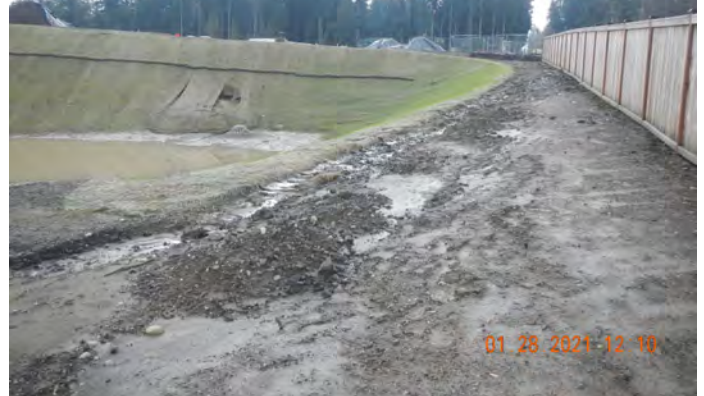
Photo #:16 (DSCN2033)

In addition to the conveyance channel, during the on-site walk-through on January 28, 2021 I observed an unstabilized area along the southern fence line. It appeared that stormwater had caused some channeled erosion (**Photo 16**) and could contribute to sediment entering a southern detention pond. I notified Mr. Sita and Mr. Dunne of this observation during our closing conferences. I also included the observation in my email correspondence to Mr. Dunne following my January 28, 2021 walk-through inspection (**Attachment C**).

Description: Facing east, photo of the unstabilized area along the southern perimeter fence line. Channelized erosion was observed in the direction of a stormwater detention pond.

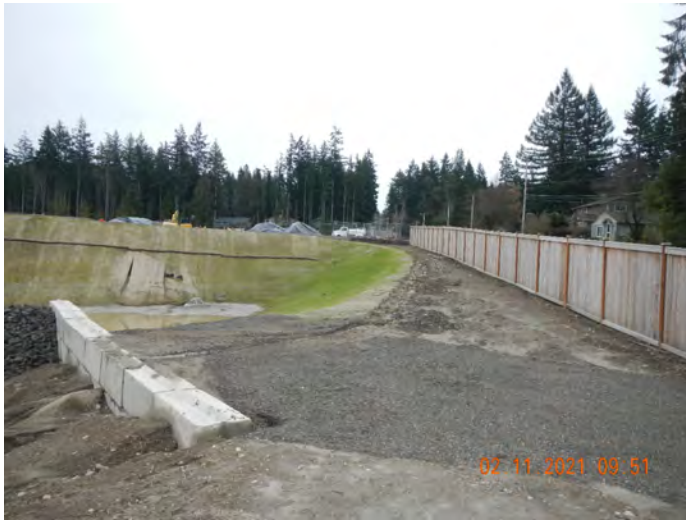
Photo #:19 (DSCN2045)  
Description: Facing east, photo of the unstabilized area along the southern fencing line. Photo taken on 02/11/21.

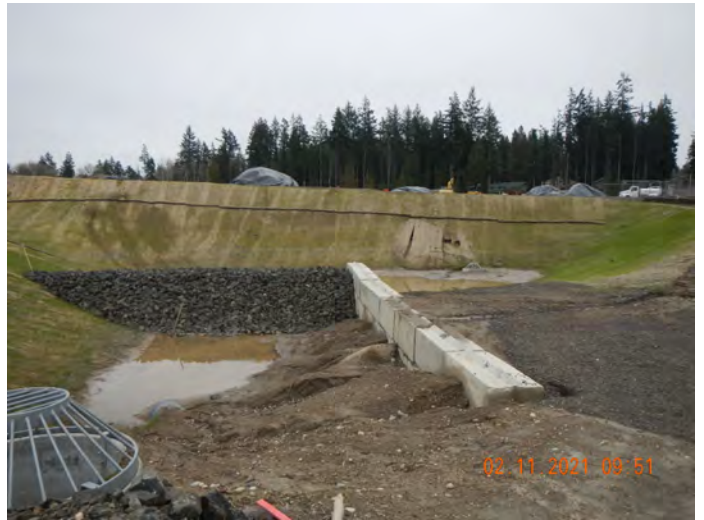
Photo #:20 (DSC2046)  
Description: Facing east, photo of the unstabilized area along the southern perimeter fence line. Channelized erosion was observed in the direction of a stormwater detention pond. Photo taken on 02/11/21.

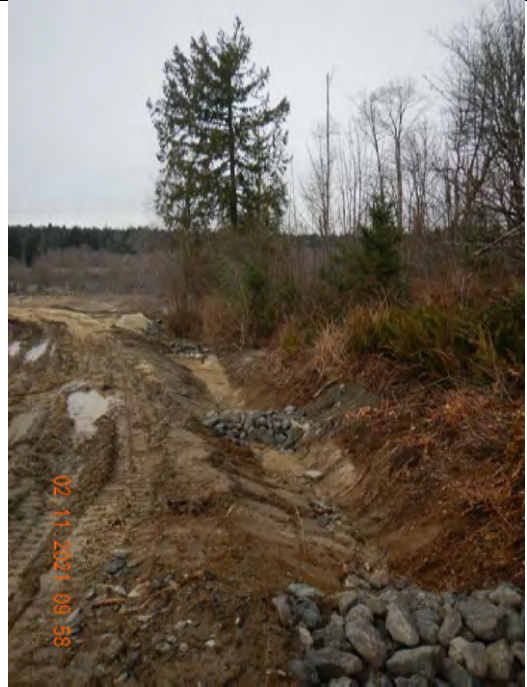
Photo #:22 (DSC2048)

Description: Facing south from the eastern perimeter, photo of the southern portion of a stormwater conveyance channel that runs along the eastern perimeter. This portion of the channel was observed to be bare and unlined. Taken 02/11/21

- DSCN2048 – Facing south from the eastern perimeter, photo of the southern portion of a stormwater conveyance channel that runs along the eastern perimeter. This portion of the channel was observed to be was bare and unlined.

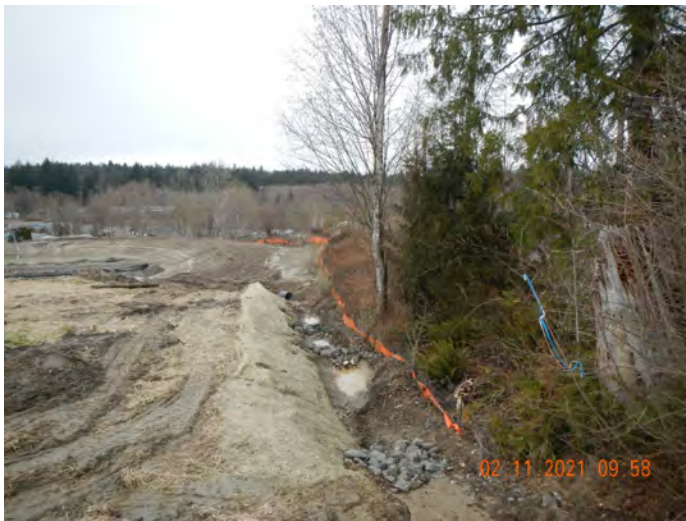
Photo #:23 (DSCN2049)

Description: Facing north from the eastern perimeter, photo of the northern portion of a stormwater conveyance channel that runs along the eastern perimeter. Photo taken on 02/11/21.
