## Region 6 - Enforcement & Compliance Assurance Division

### INSPECTION REPORT

| Company Name: | <b>LBOC, LLC</b> | |
| Facility Name: | <b>Baker Sand Unit Tank Battery</b> | |

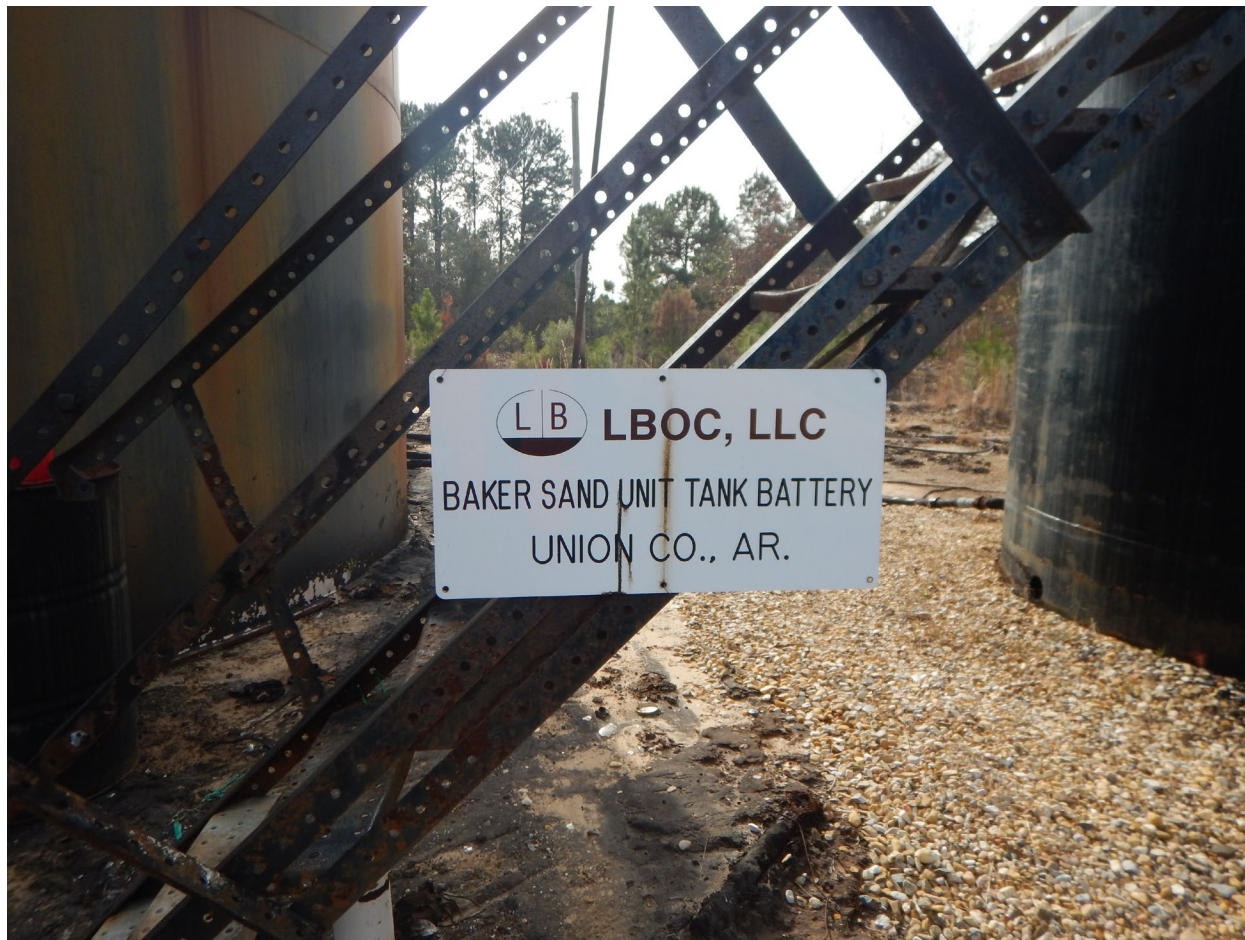
Photo No. 1

**Description:** This photo was taken looking S at the facility showing the facility sign.

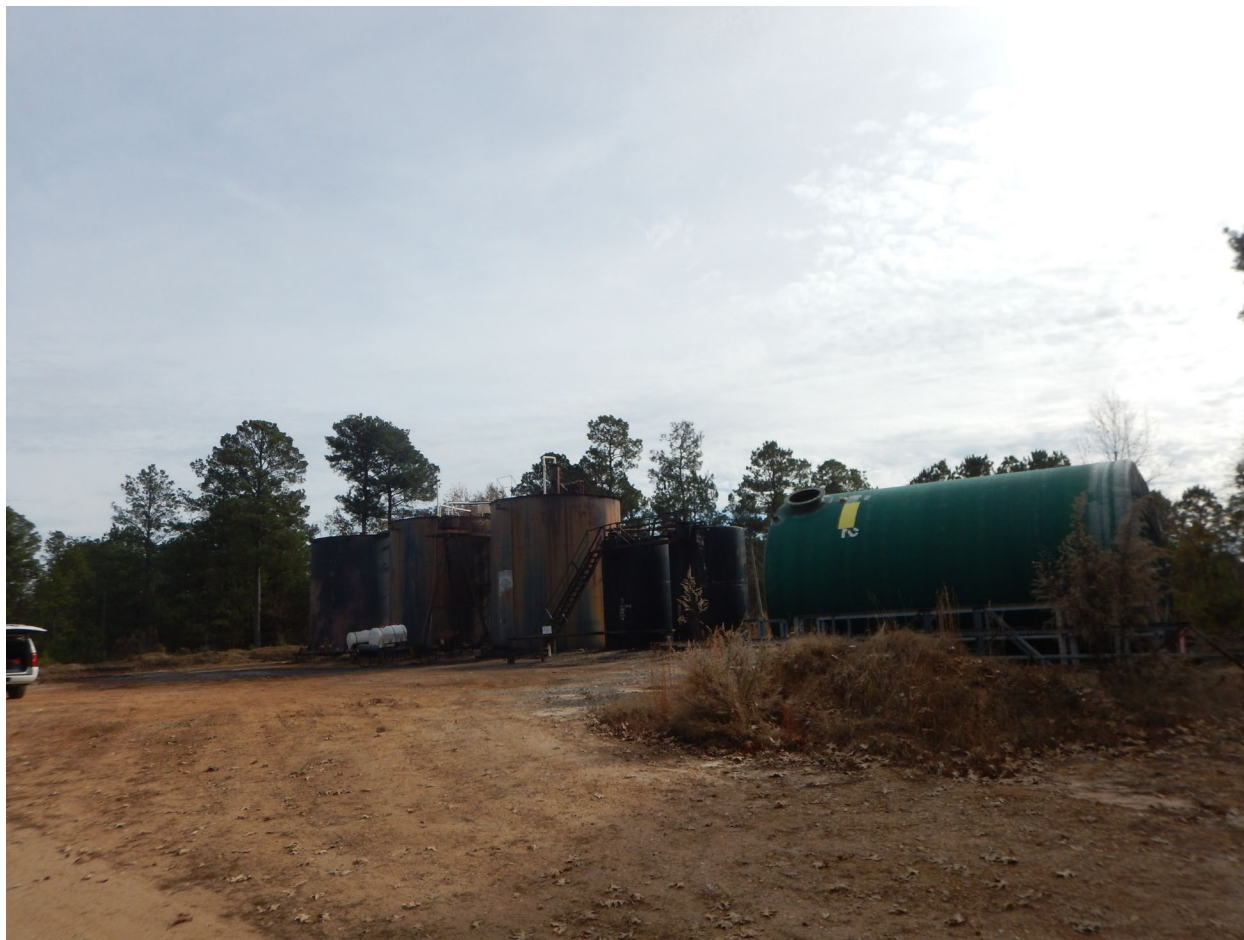
Photo No. 2

I observed no secondary containment on the front (northwest) side of the facility, see photo No. 2.

**Description:** This photo was looking SE showing an overview of the facility. Note: no secondary containment on the front (northwest) side of facility.

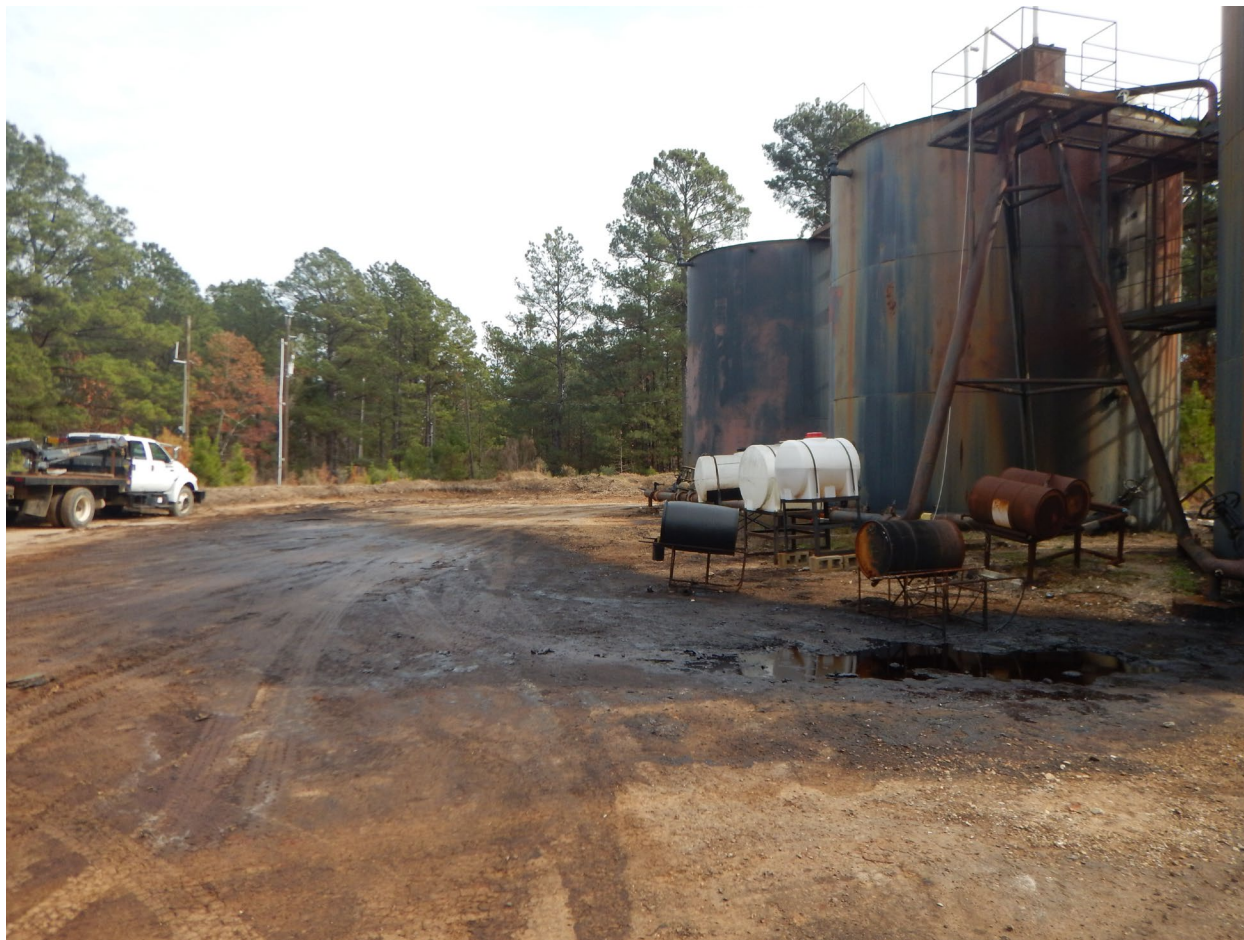
Photo No. 3

I observed loose oil, oil stains, and crystallization on soil within secondary containment, see photo No. 3.

I observed multiple unmarked barrels, see photo No. 3.

**Description:** This photo was looking E showing loose oil, oil stains and crystallization on soil, and unmarked barrels.

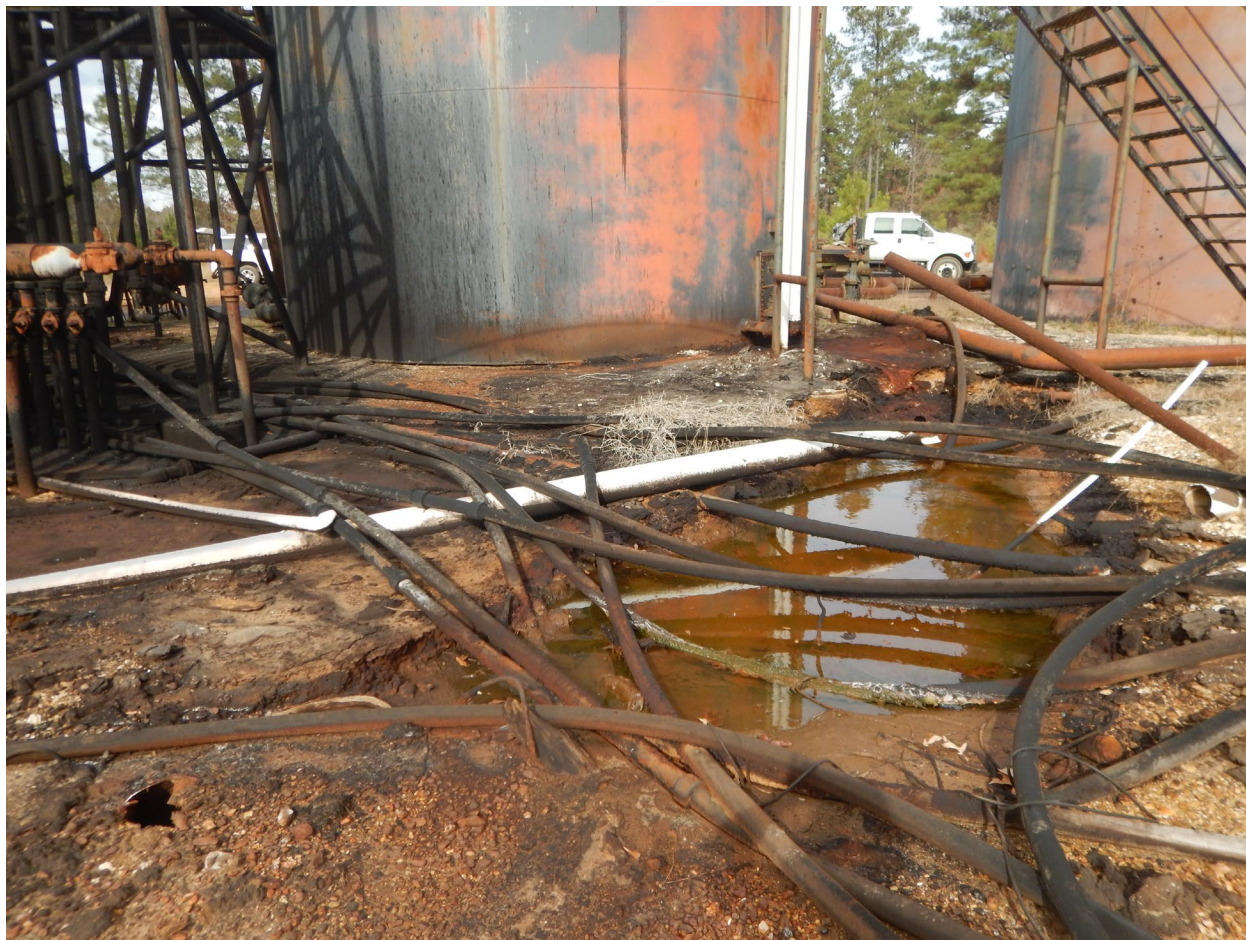
Photo No. 4

I observed loose oil and brine around the chine of the tank along with oil and brine stained soils around tanks, see photo No. 4.

I observed a large erosional hole in the ground with reddish, orange tinted water mixed with oil, photo No. 4.

**Description:** This photo was looking N showing oil and brine stained soils around tank and large erosional hole in the ground with reddish, orange tinted water mixed with oil.

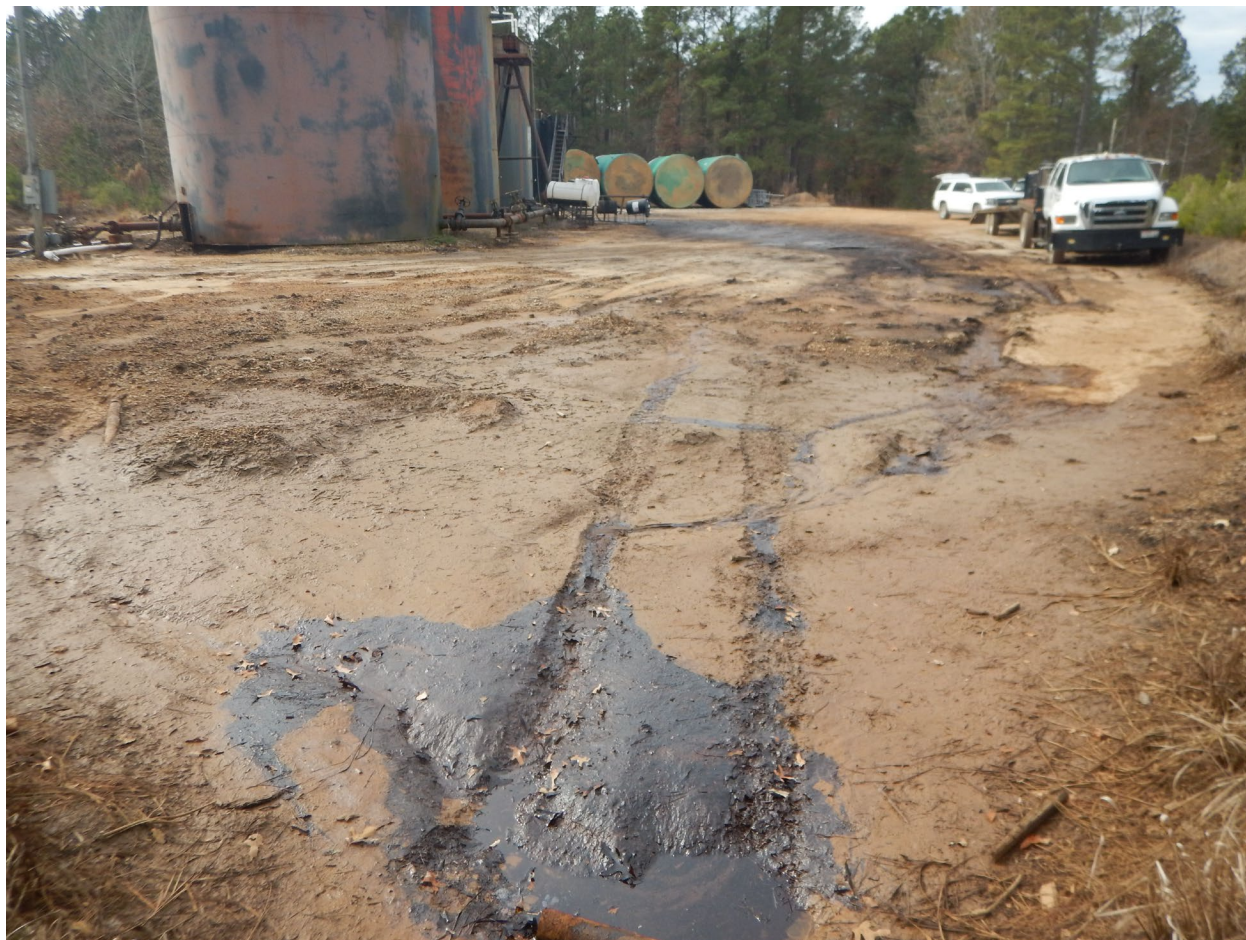
Photo No. 5

I observed loose oil and brine going into pipe that discharges from secondary containment, see photo No. 5.

I observed large gapping on bottom of tank, service plate was removed, and the tank was not properly clean and marked out of service, see photo No. 5.

**Description:** This photo was looking SW showing loose oil and brine going into pipe from secondary containment. Also, note gapping on tank and no service plate on back left tank.

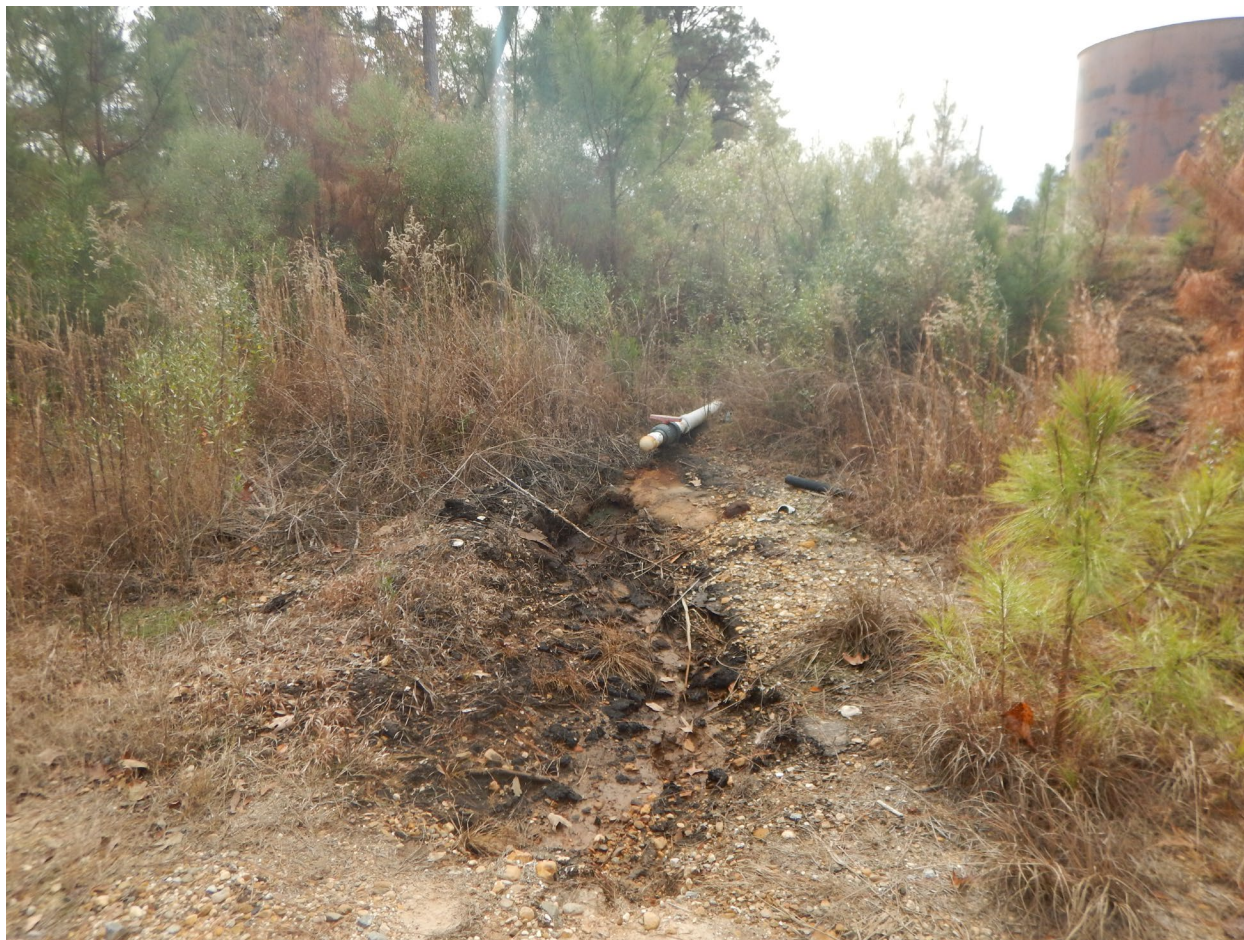
Photo No. 6

I observed active leaking from pipe coming out of secondary containment with black and reddish, orange staining on soil, gravel, and vegetation. Note: stressed and dead vegetation, see photo No. 6.

**Description:** This photo was looking S showing oil leaking from pipe coming out of secondary containment. Note: flow path, stressed and dead vegetation, and appeared to be saltwater and oil stains on soil, gravel, and vegetation.

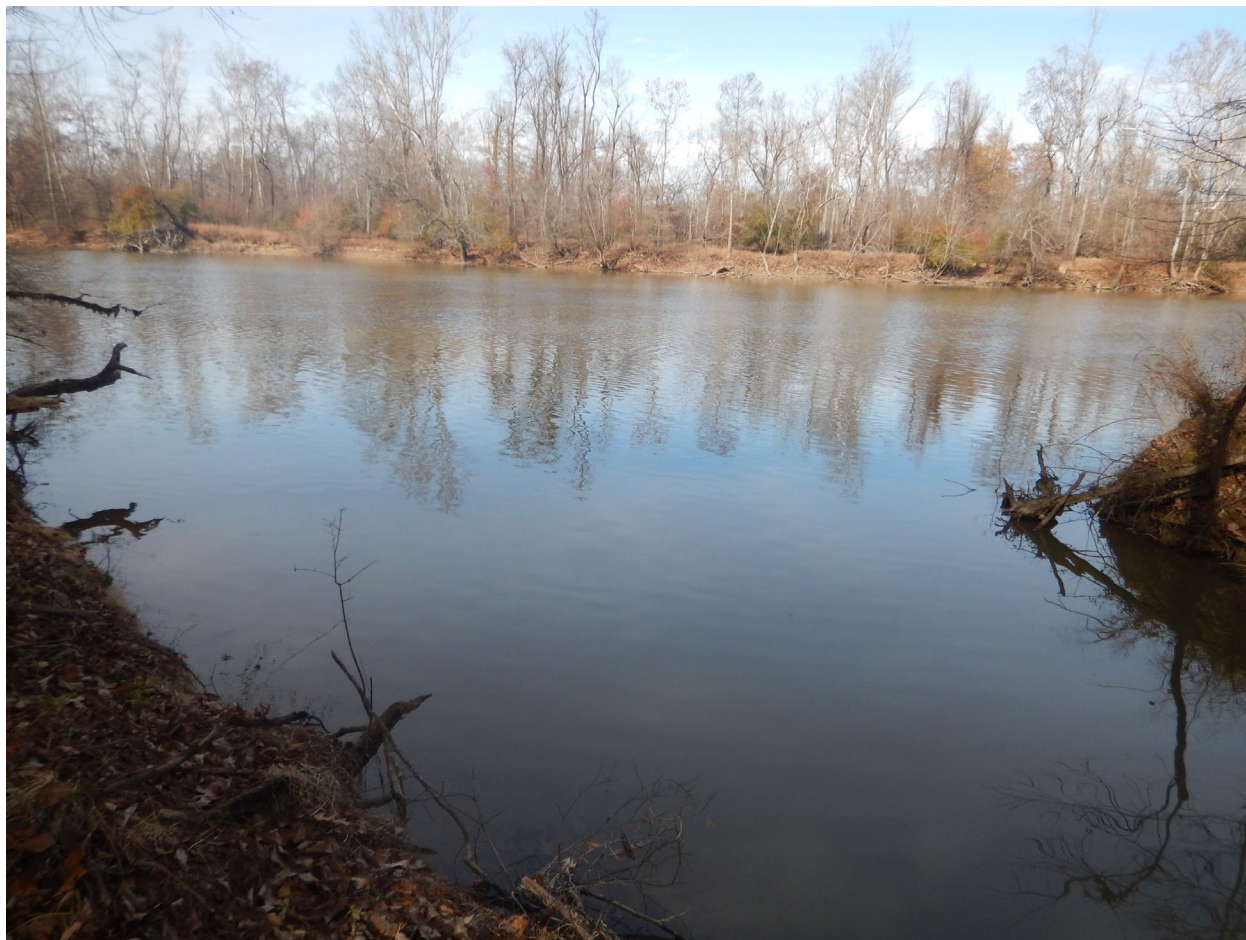
Photo No. 7

I observed the confluence of the impacted tributary and the Ouachita River, see photo No. 7.

**Description:** This photo was taken looking N at the confluence of the impacted unnamed tributary 2 and the Ouachita River.

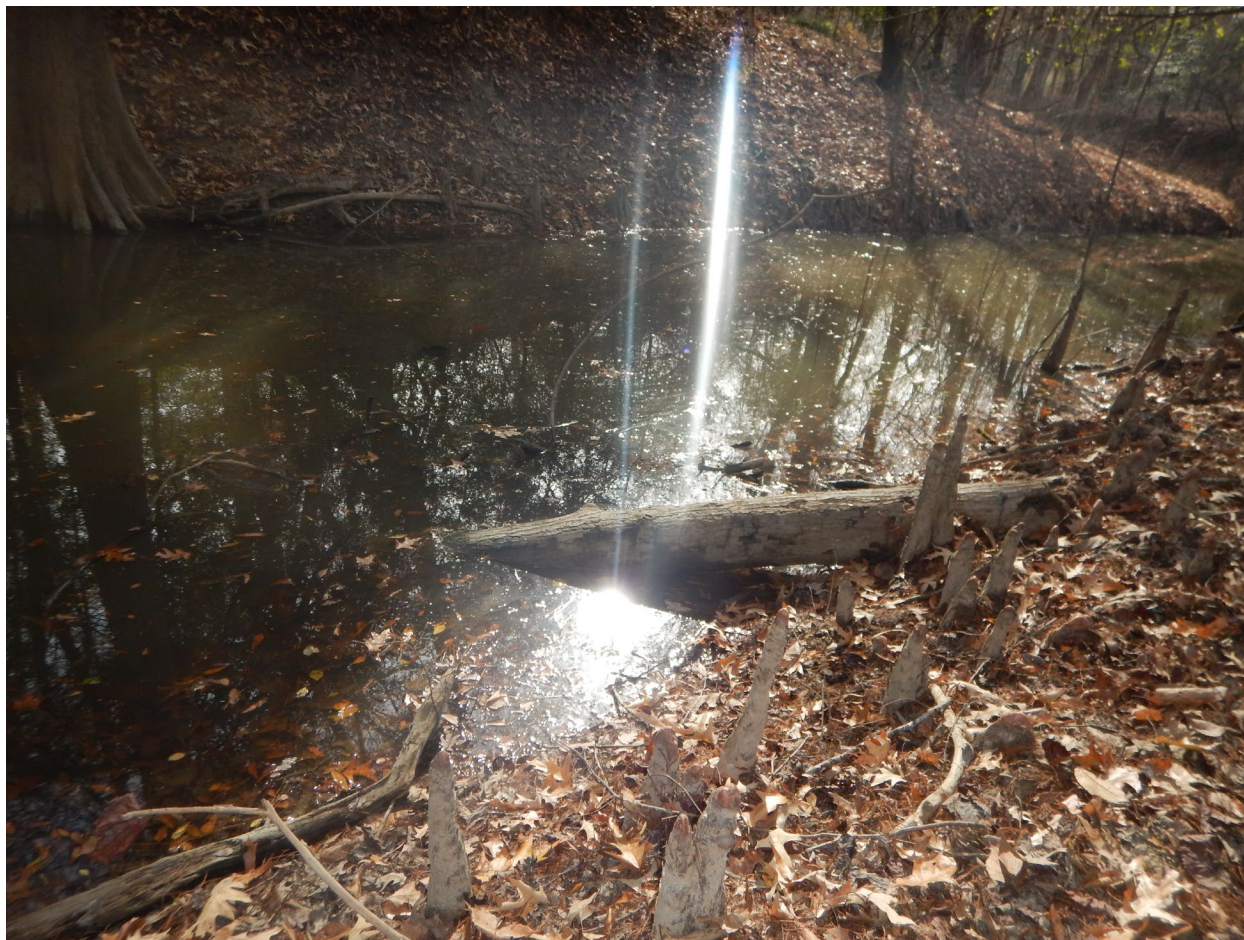
Photo No. 8

**Description:** This photo was taken looking S, from river left of the impacted unnamed tributary 2 facing upstream. The TDS field reading observed in photo No. 9 was taken at this location. The TDS field reading observed in photo No. 9 was taken at this location.

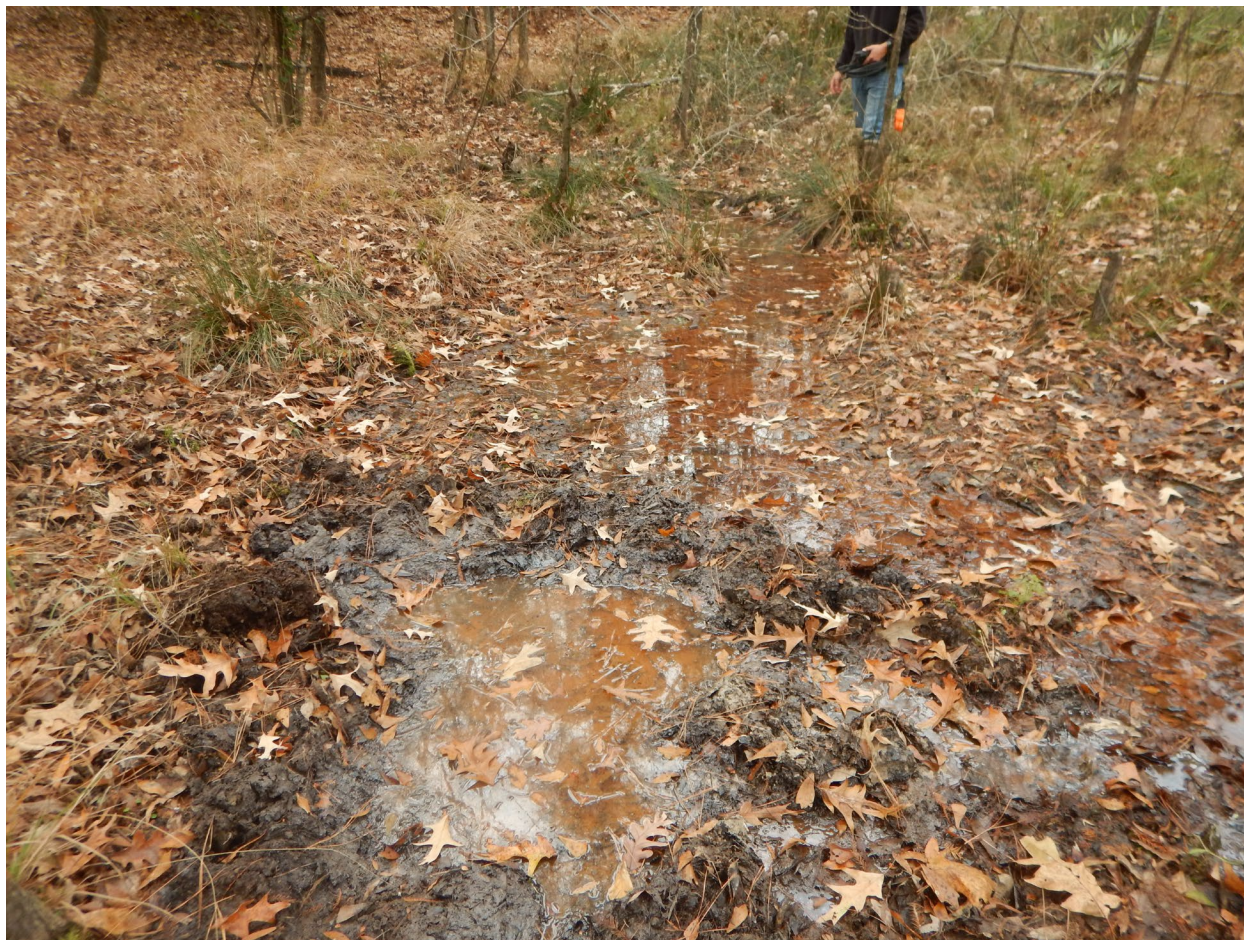
**Description:** This photo was looking S, upstream of unnamed tributary 1/wetland complex showing reddish, orange tint to water and thick oil sheen on water. The TDS field reading observed in photo No. 32 was taken at this location.

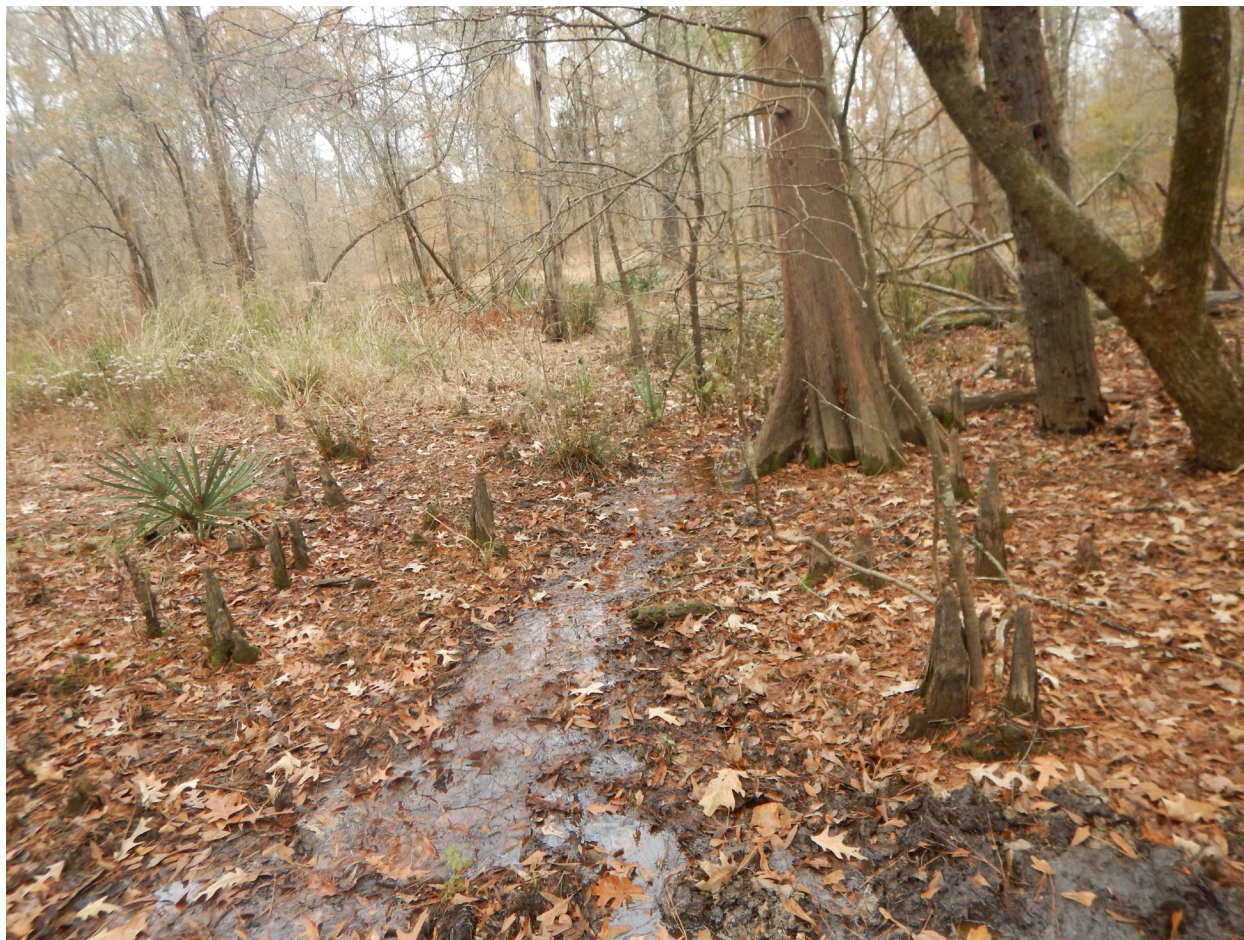
**Description:** This photo was looking N, downstream of unnamed tributary 1/wetland complex showing reddish, orange tint to water and thick oil sheen on water. The TDS field reading observed in photo No. 32 was taken at this location.

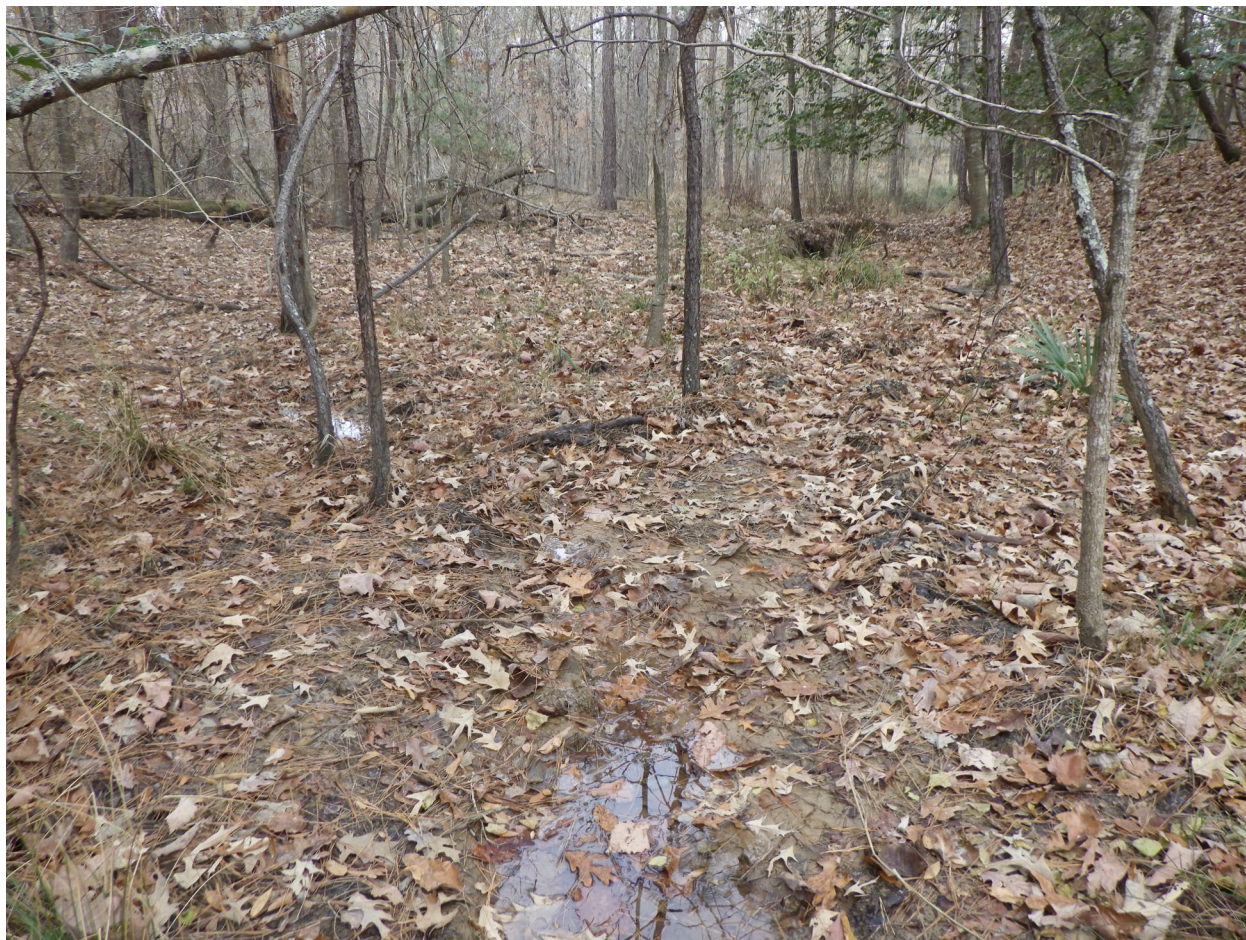
**Description:** This photo was looking N, downstream of unnamed tributary 1 showing black staining on sediment and reddish, orange tinted water. The TDS field reading observed in photo No. 34 was taken at this location.

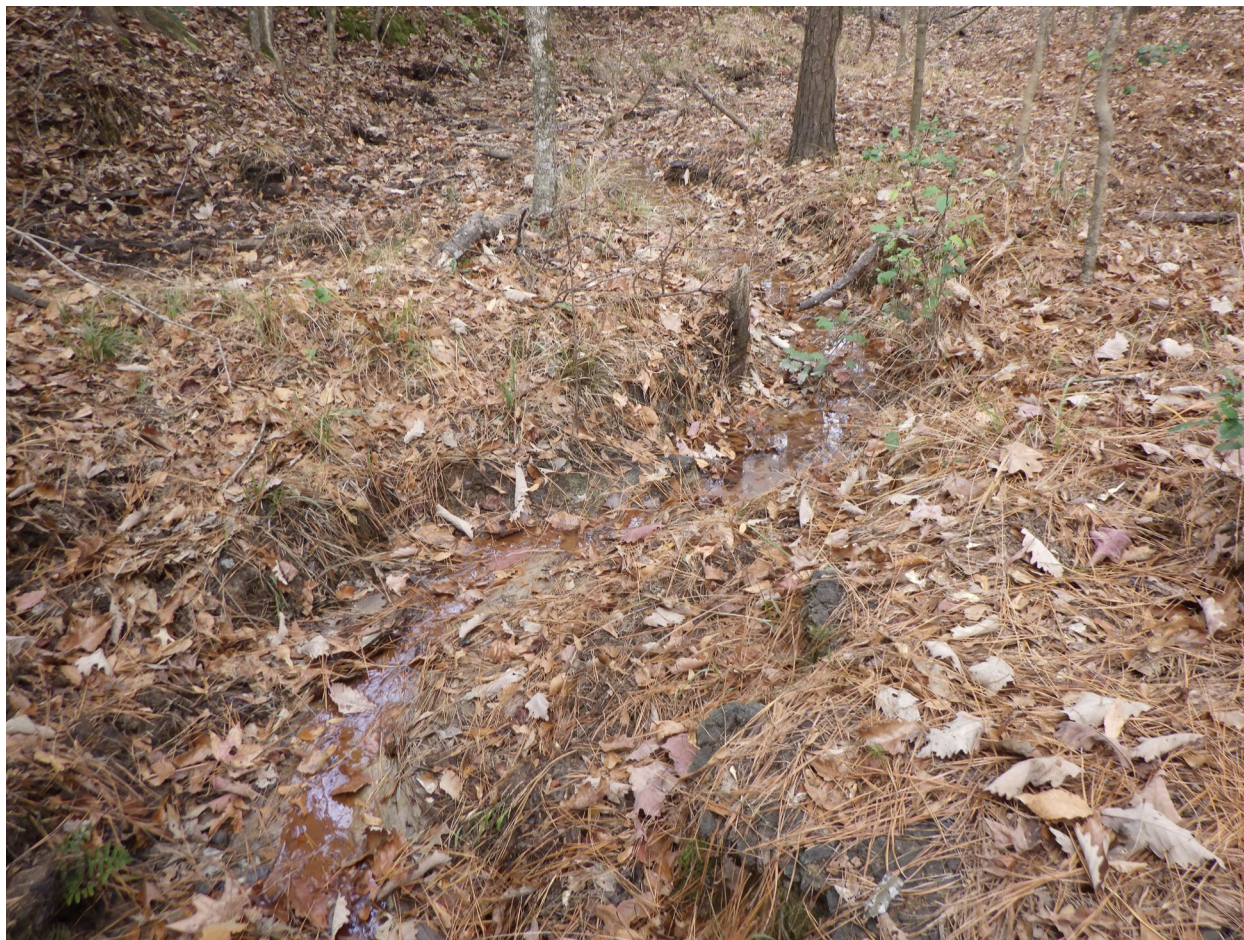
**Description:** This photo was looking N, downstream of unnamed tributary 1 showing thick oil sheen on water and reddish, orange tinted water. Also note appears to be black/grey staining on the soil and vegetation below Ordinary High Water Mark and on top of stream bank.

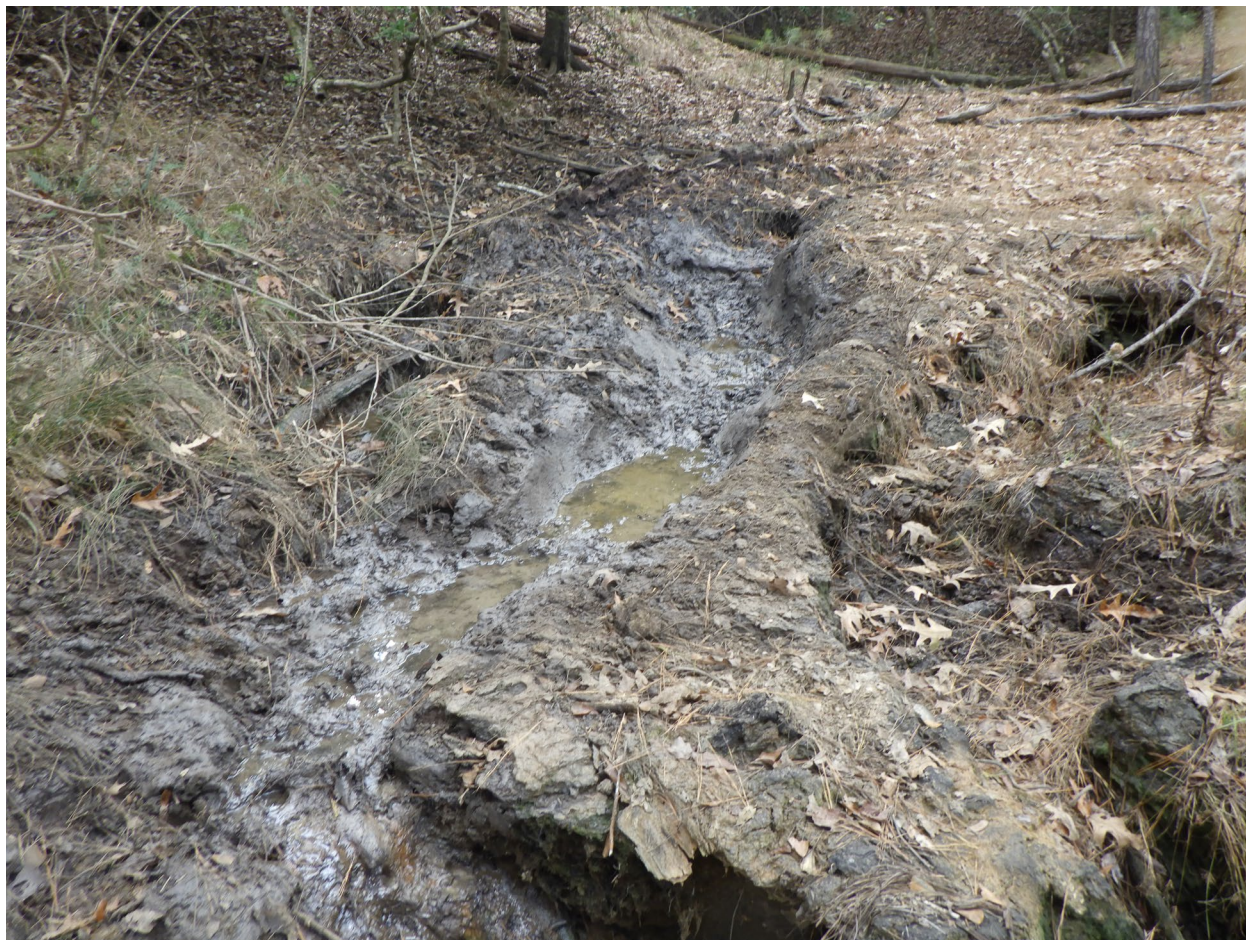
**Description:** This photo was looking S, upstream of unnamed tributary 1, showing thick oil sheen on water and black/grey staining on soil and stressed vegetation. Also, noted a strong chemical odor. Note: Photo R0010335 is duplicate and blurry so not included. The TDS field reading observed in photo No. 41 was taken at this location.

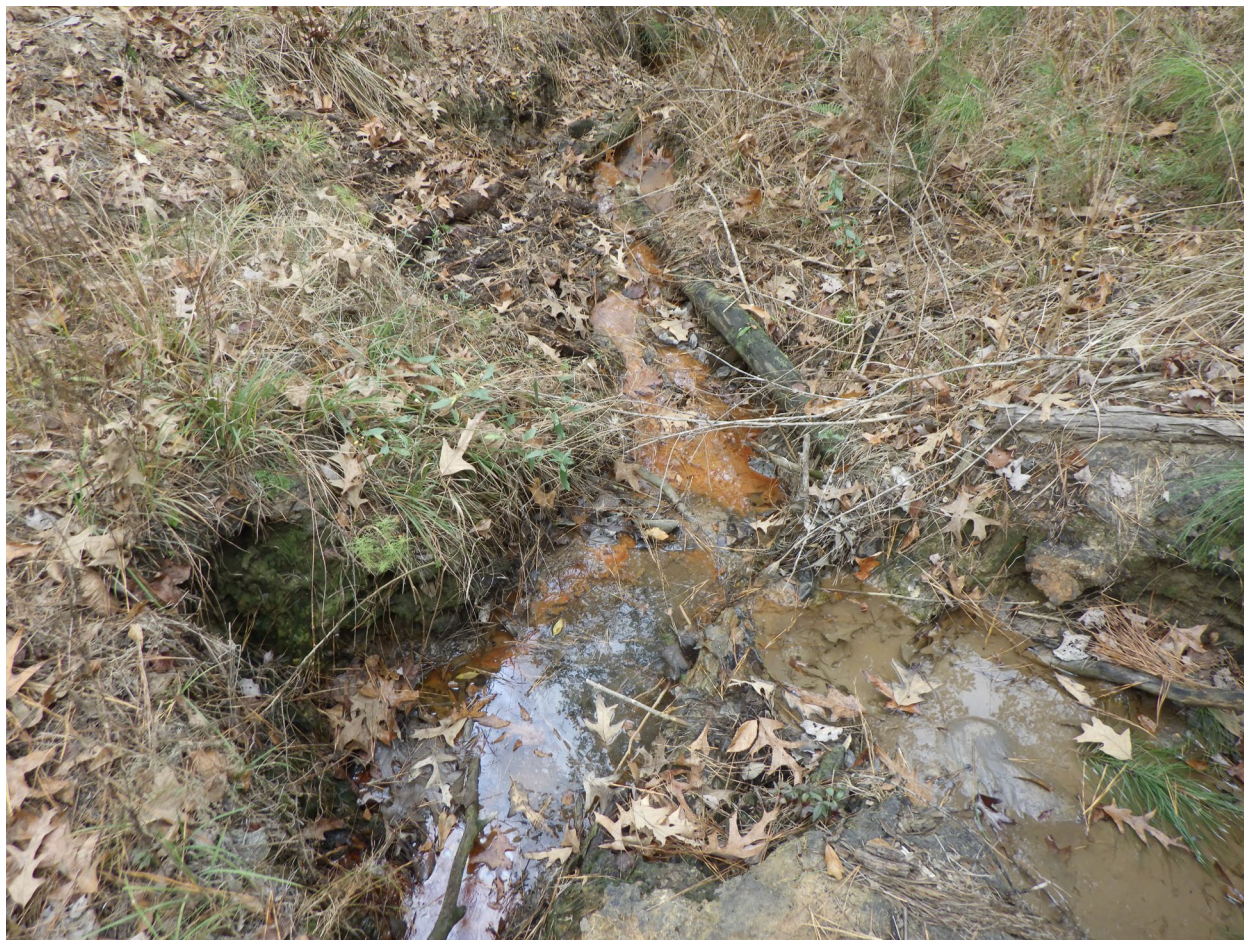
**Description:** This photo was looking N, downstream of unnamed tributary 1 showing reddish, orange tinted water, thick oil sheen on water and black staining on soil and vegetation. The TDS field reading observed in photo No. 41 was taken at this location.

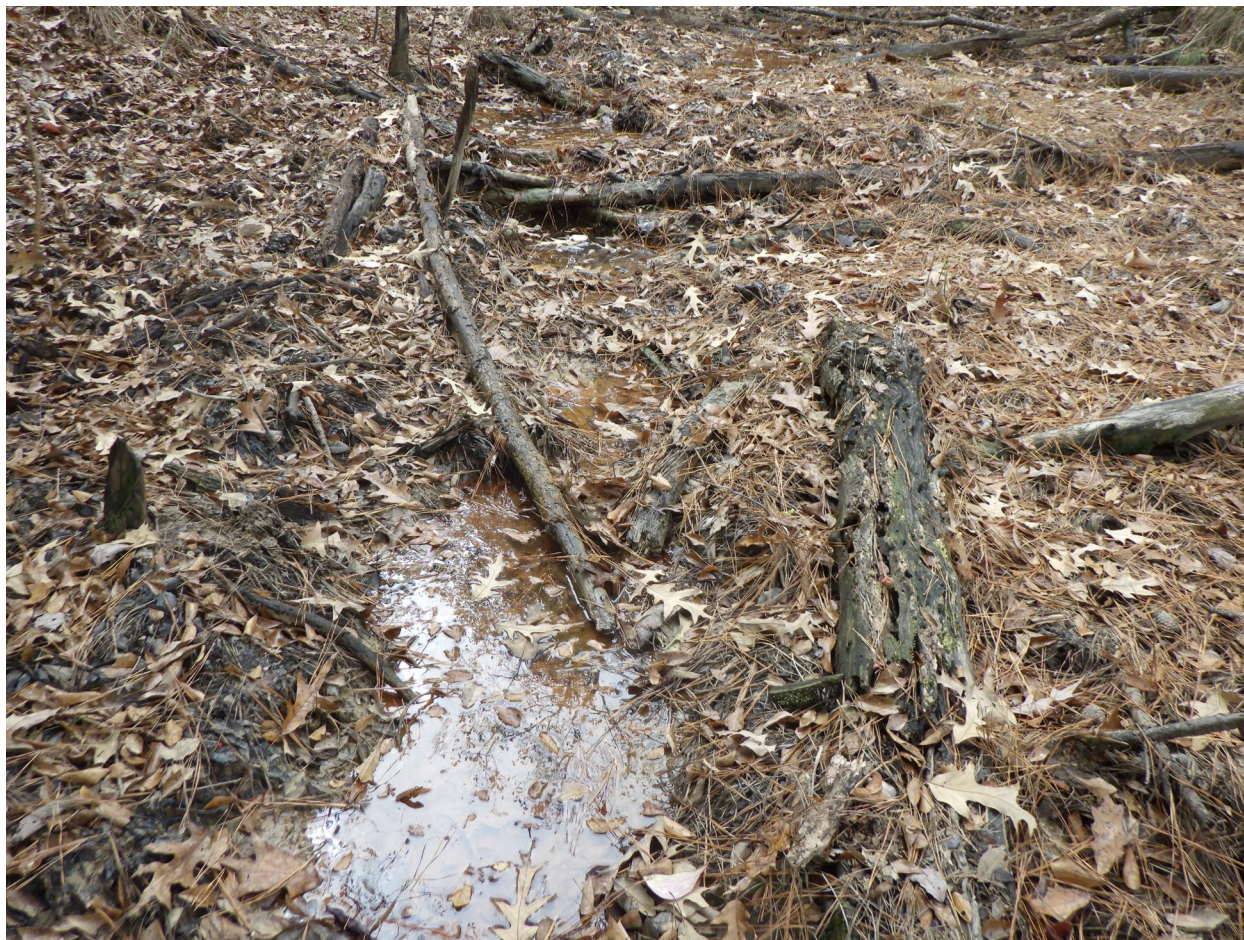
**Description:** This photo was looking S, upstream of unnamed tributary 1 showing reddish, orange tinted water, oil sheen on water, and black stained sediment along banks.

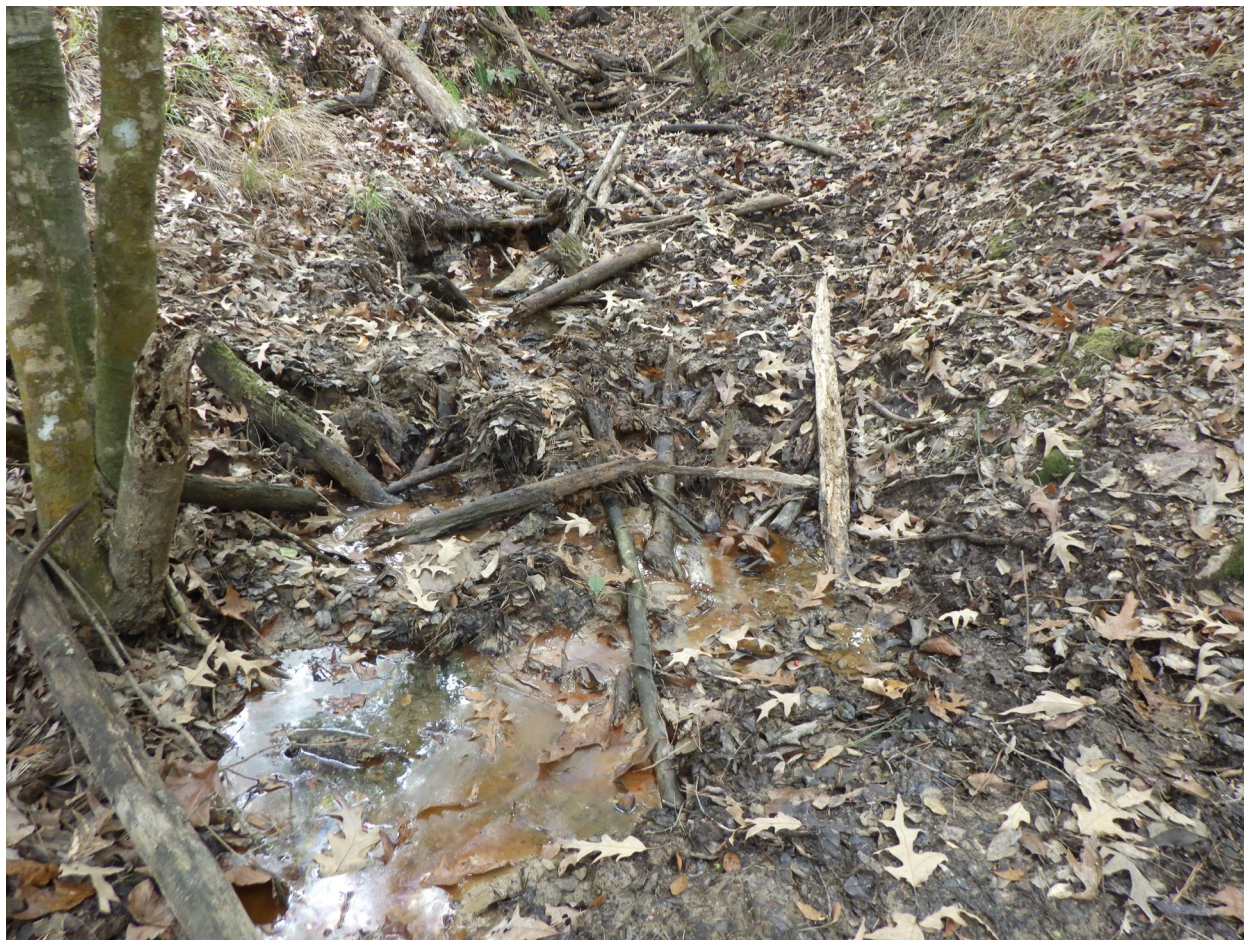
**Description:** This photo was looking S, upstream of unnamed tributary 1 showing thick oil sheen on water and reddish, orange tinted water. Also note black/grey stained soils.

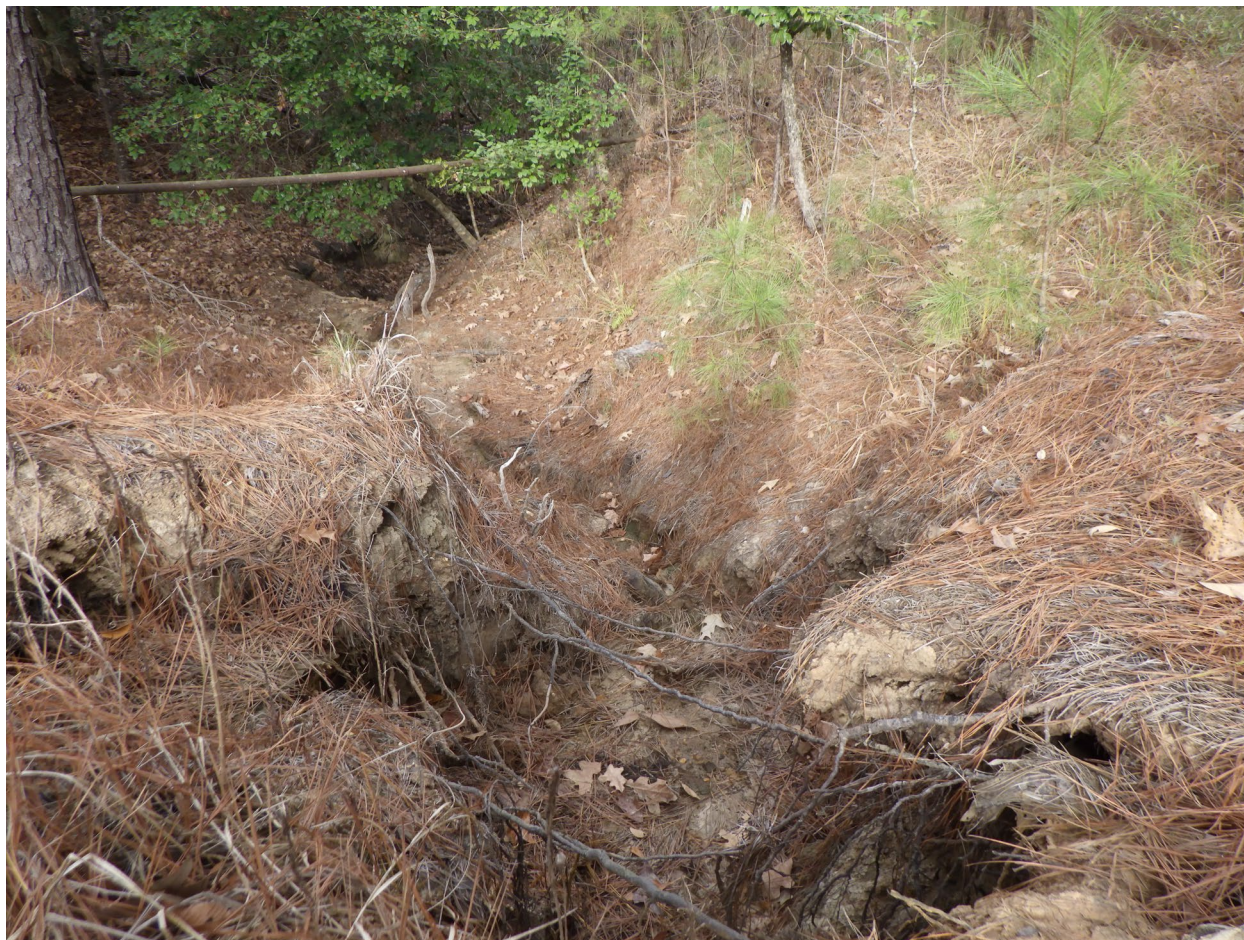
**Description:** This photo was looking N, downstream of unnamed tributary 1 showing black/grey staining on stream bed and banks.

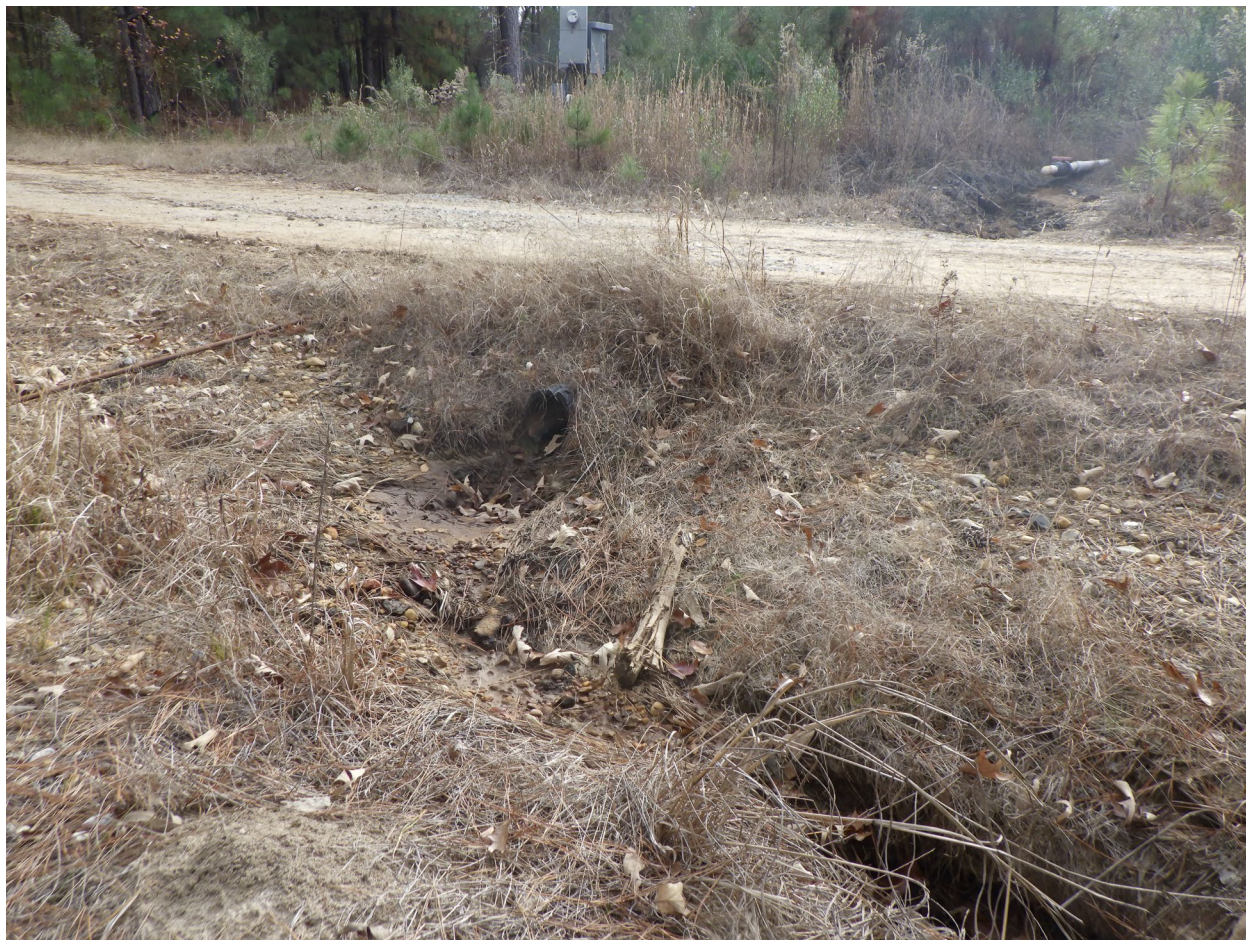
I observed the Point of Entry into unnamed tributary 1 from discharge pipe from secondary containment, see photo No. 45.

**Description:** This photo was looking S, upstream at Point of Entry into unnamed tributary 1, showing the culvert under road and the discharge pipe from secondary containment.
