# Multi-Media Inspection Report

Camp Santiago Joint Maneuver Training Center  
Salinas, PR  
May 2023

## **MULTI-MEDIA INSPECTION REPORT**

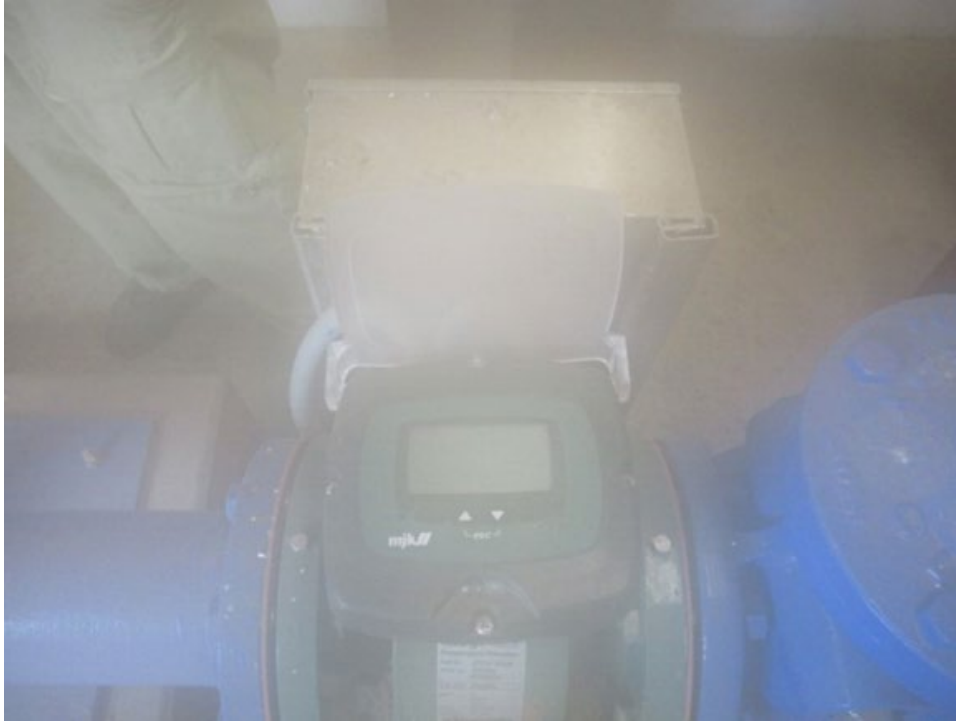
| Water System Management & Operations | <p>We observed that the piping from the well was equipped with a flow meter, but it was not operational at the time of inspection.</p> <p>Flow meters for both Wells No.1 &amp; No. 2 were not operational at the time of inspection (Photos 5 &amp; 10).</p> <p>Facility representatives expressed no knowledge of the type of resin observed on floor of shed in Well No.2 enclosure; Safety Data Sheet for the material was unavailable.</p> |

Photo 5-Well No.1 flow meter (non-functional)

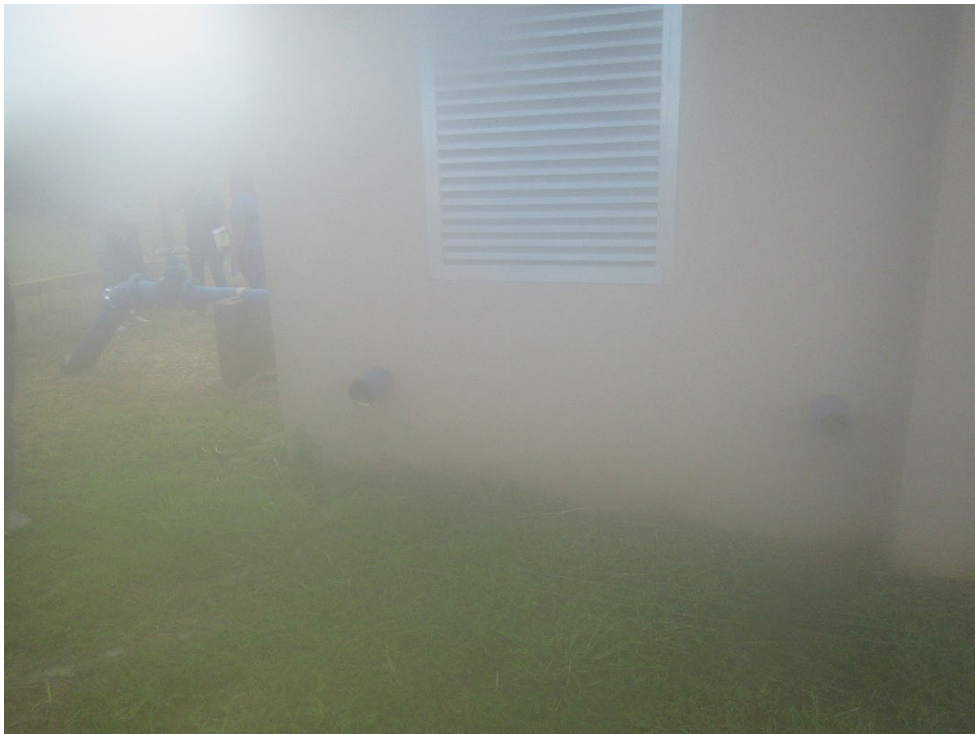
- The pressure relief valve on Well No. 1 discharges to an open pipe outside the building. The pipe opening was not screened (Photo 6). By text the following week, Mr. Velasquez provided photographs of #24-mesh screening on this pipe and on the other open pipes we observed to be unscreened (see below) in the buildings at Wells No. 1 and 2 and the chlorine injection building.

| <b>SIGNIFICANT DEFICIENCIES</b> | |
|---|---|
| Source | <p>The pressure relief valve on Well No. 1 discharges to an open pipe outside the building. The pipe opening was not screened (Photo 6).<br/> <u>Corrective Action:</u> Mr. Velasquez provided photographs via text message the following week of #24-mesh screening on this pipe, and on the other open pipes we observed to be unscreened in the buildings at Wells No. 1 and 2, and the chlorine injection building.</p> <p>Three flow valves, two check valves and a pressure relief valve receiving flow from the Well No. 1 wellhead were inoperable. CSJMTC/PRANG representatives stated that valve operation was last confirmed in 2019 and valve testing is not recorded.</p> <p>We observed a similar piping configuration and conditions for Well No. 2 as for Well No. 1. In addition to the meter not working (Photo 10), Camp Santiago representatives stated that the pressure relief valve for Well No. 2 could not be calibrated.</p> <p>In a shed within the Well No. 2 enclosure, we observed several dozen opened/destroyed bags of an ion exchange resin, and resin scattered about the floor of the shed, unprotected from the elements (Photo 12).</p> |

Photo 6 – Bldg.002; unscreened pipes at the rear of building

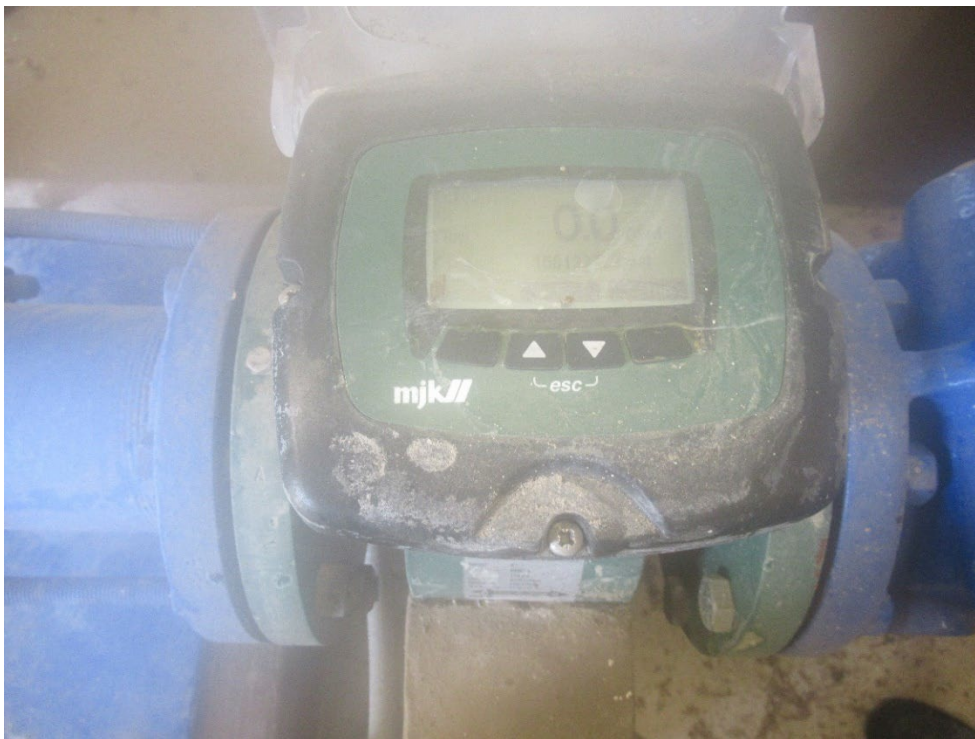
contained one room only. We observed a similar piping configuration and conditions for Well No. 2 as for Well No. 1. In addition to the meter not working (Photo 10), Camp Santiago representatives stated that the pressure relief valve for Well No. 2 could not be calibrated.

Photo 10 – Bldg. 003; Well No.2 flow meter

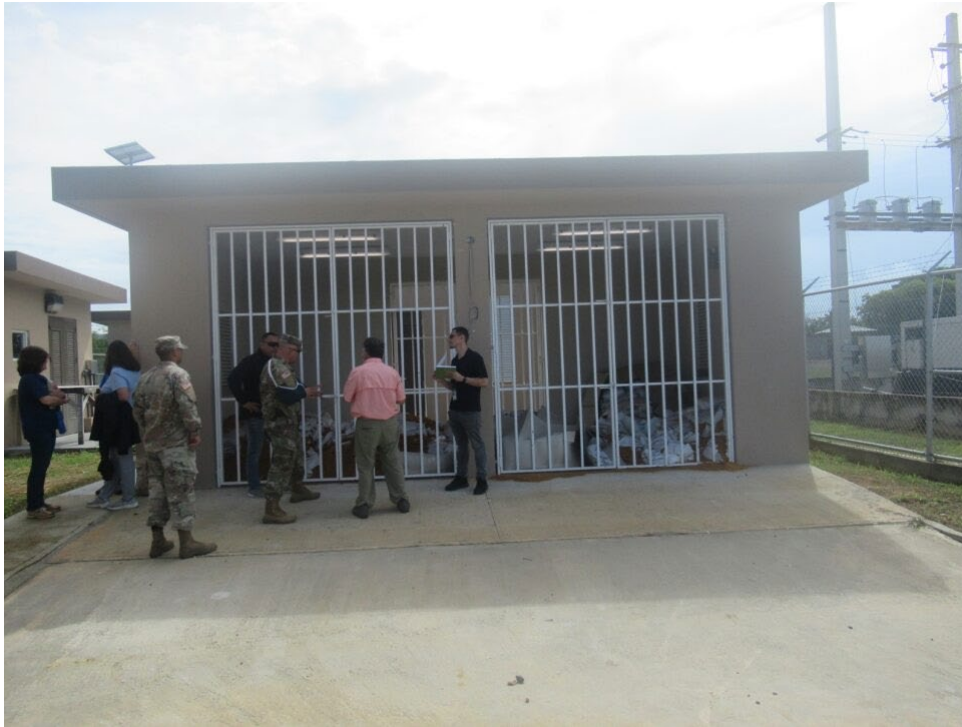
- Within the Well No. 2 enclosure was a rectangular shed with one of its long sides open to view. Within the shed, we observed at least several dozen bags of an ion exchange resin designed for water softening. Some of the bags were open and resin was scattered about the shed, unprotected from the elements (Photos 11 & 12). Upon inquiry, facility representatives expressed no knowledge of the material, or why it was there and could provide no Safety Data Sheet for it.

Photo 11 - Shed in Well No.2 enclosure, bags of ion exchange resin

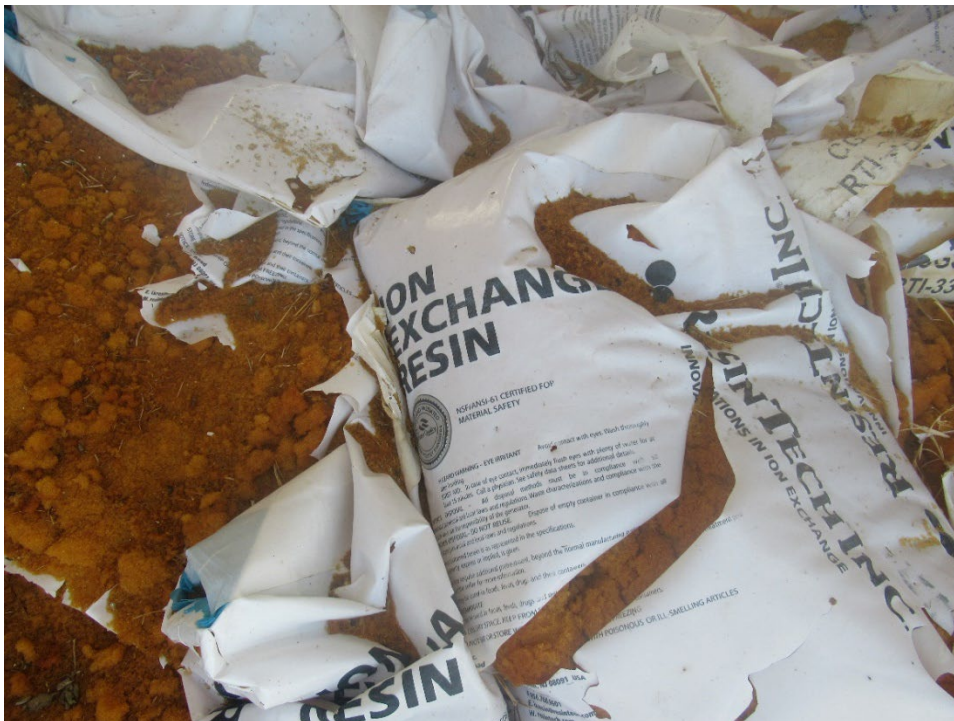
Photo 12 - Opened bags of exposed of ion exchange resin

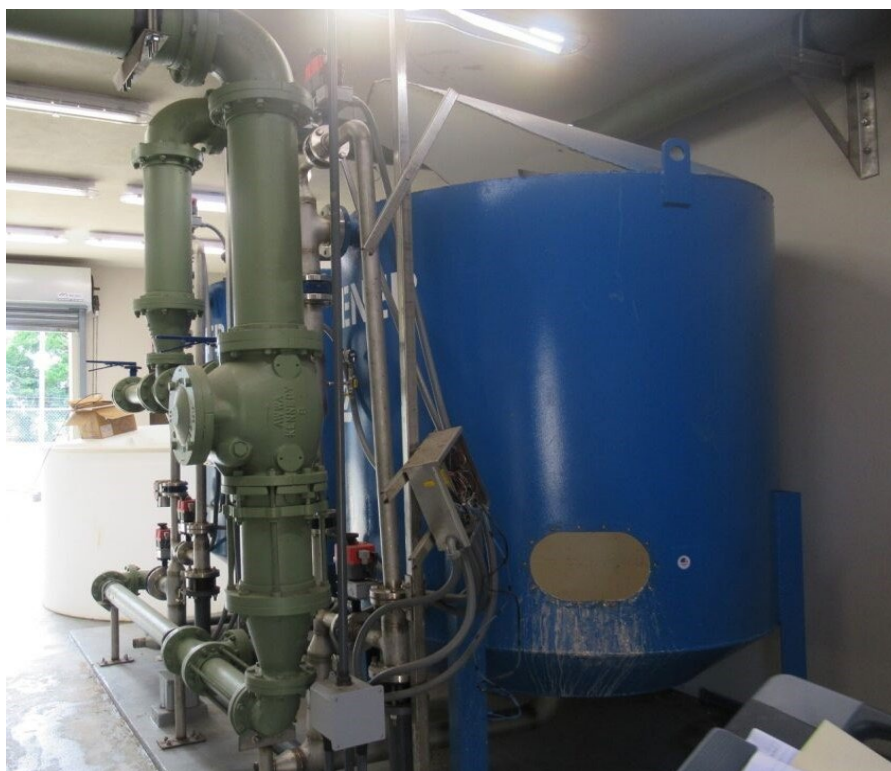
Photo 14 – Water softener tank 2; top of tank separated from its sides

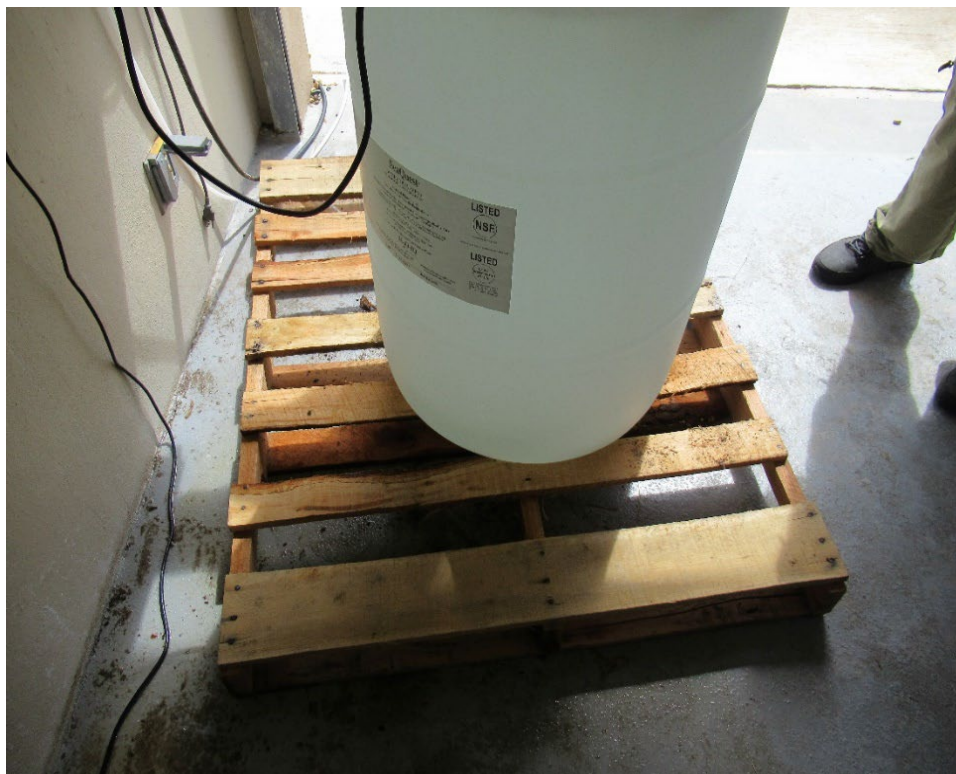
| | <p>We observed two unscreened pipes at the floor level of the chlorine injection building which opened to the outside, and a wall opening too large for the pipe within it (Photos 17 &amp; 18).</p> <p>An approximately 55-gallon drum of phosphate solution in the chlorine &amp; treatment room was not in secondary containment (Photo 17).</p> |

Photo 17 – Treatment & Chlorine Room; 55-gallon drum of phosphate chemical on wooden pallet

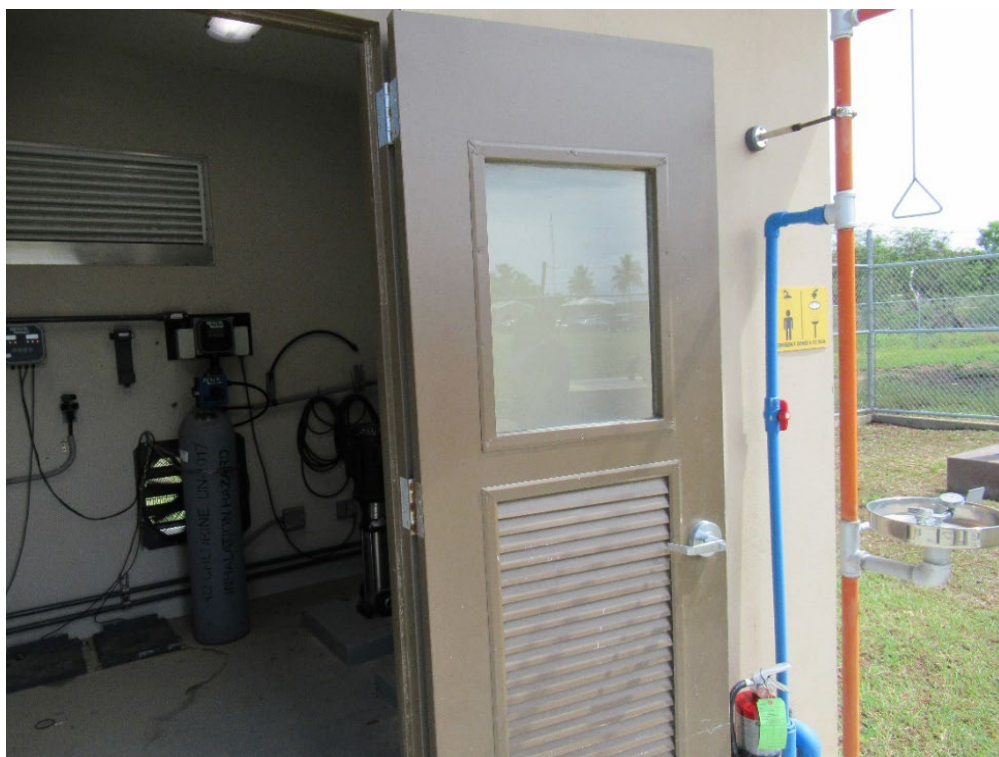
- The door of the chlorine building was not equipped with panic hardware; instead, we were advised, the door is kept open whenever the building is visited (Photo 18). The door included a window, allowing a view of room conditions before entering it. Immediately outside the building door was an eyewash station and an overhead shower. Upon testing them, we found that the shower worked, but the eyewash did not (Photo 18). A 150-lb chlorine tank was loosely chained to the rear wall, was not situated on a scale, and was piping chlorine gas into the water line at approximately 300 psi (Photo 19). The room was dry and housekeeping satisfactory, a fan was exhausting room air, and a chlorine sensor was appropriately located about a foot off the floor. We were advised that the sensor has never been calibrated. We observed two unscreened openings at the floor level to the outside of the building; each with wires in their primary plastic insulation, but not contained in electrical conduits (Photos 20 & 21). The windows on either side of the building were equipped with louvers, which appear to provide limited air flow (Photo 22). Upon inquiry, we learned that the personal protective equipment for the chlorine building is located approximately 200 yards away; we suggested a closer location for it since it would be needed in an emergency.

Photo 18 – Door of chlorine injection bldg. (interior facing), overhead shower & eye wash station

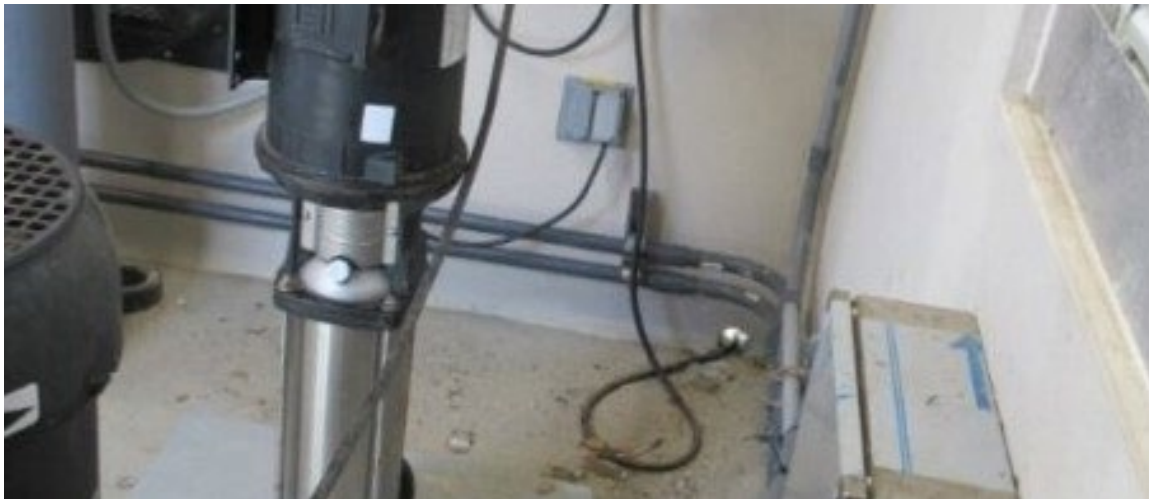
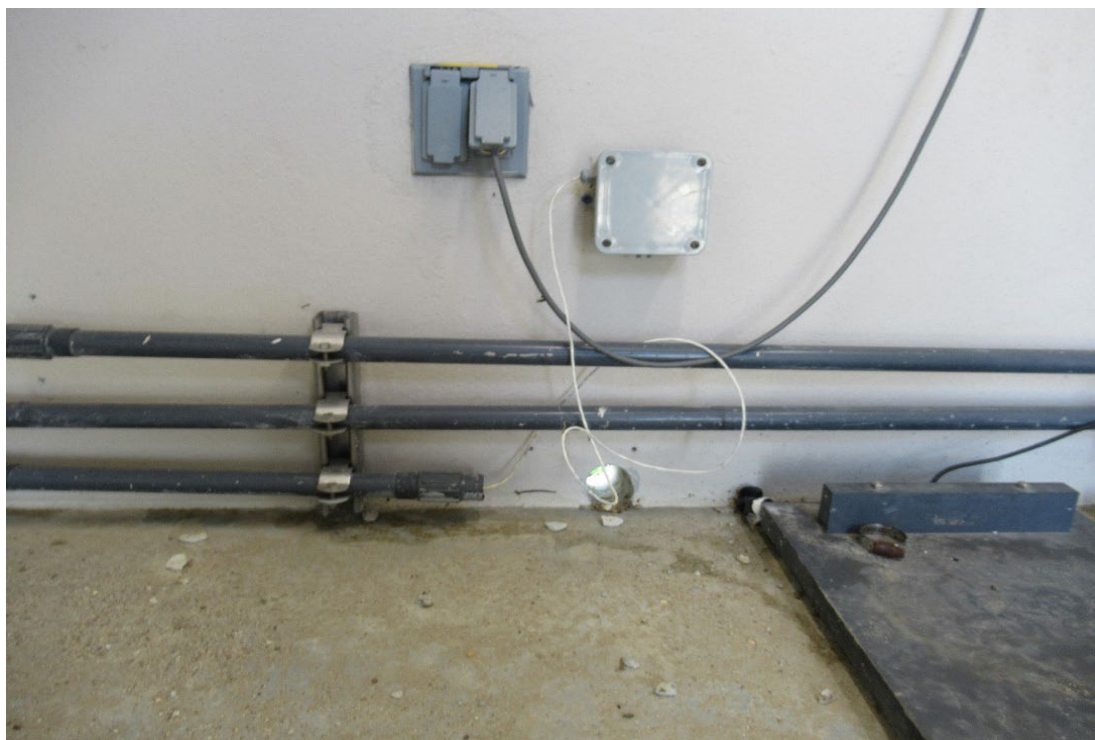
Photo 20 – Chlorine room; unscreened wall opening with unprotected wiring (1 of 2)

Photo 21 - Chlorine room; unscreened wall opening with unprotected wiring (2 of 2)

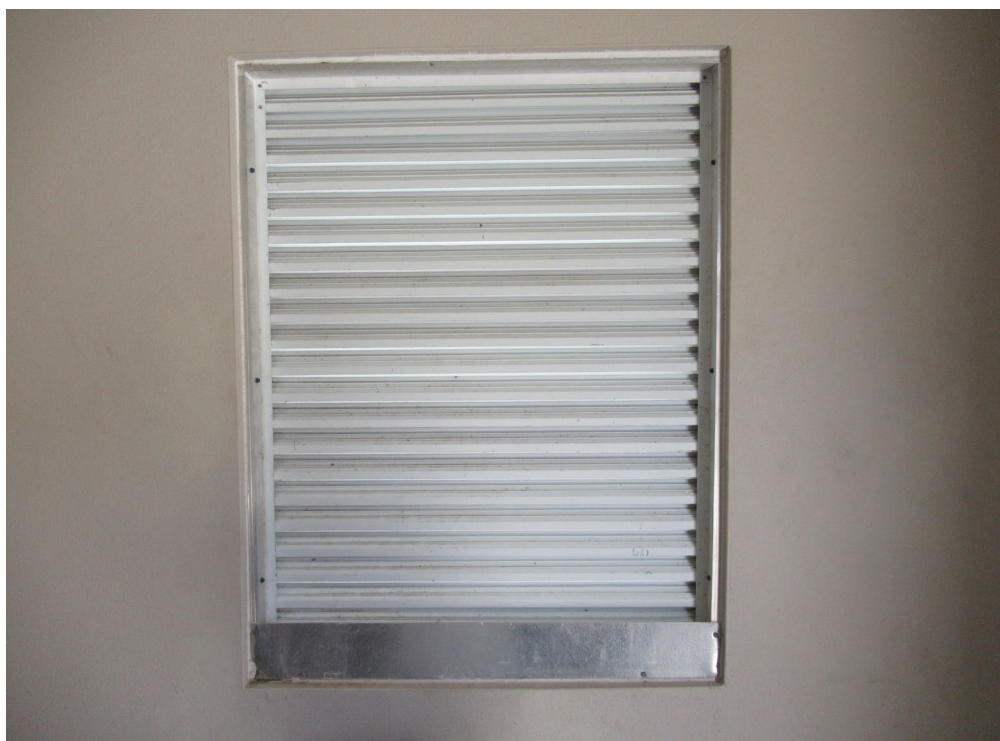
| AREAS OF CONCERN | |
|---|---|
| Treatment | The windows of the chlorine injection building and the chlorine storage building were equipped with small louvers, which provided inadequate air flow. |

Photo 22 – Chlorine injection building; louvered window

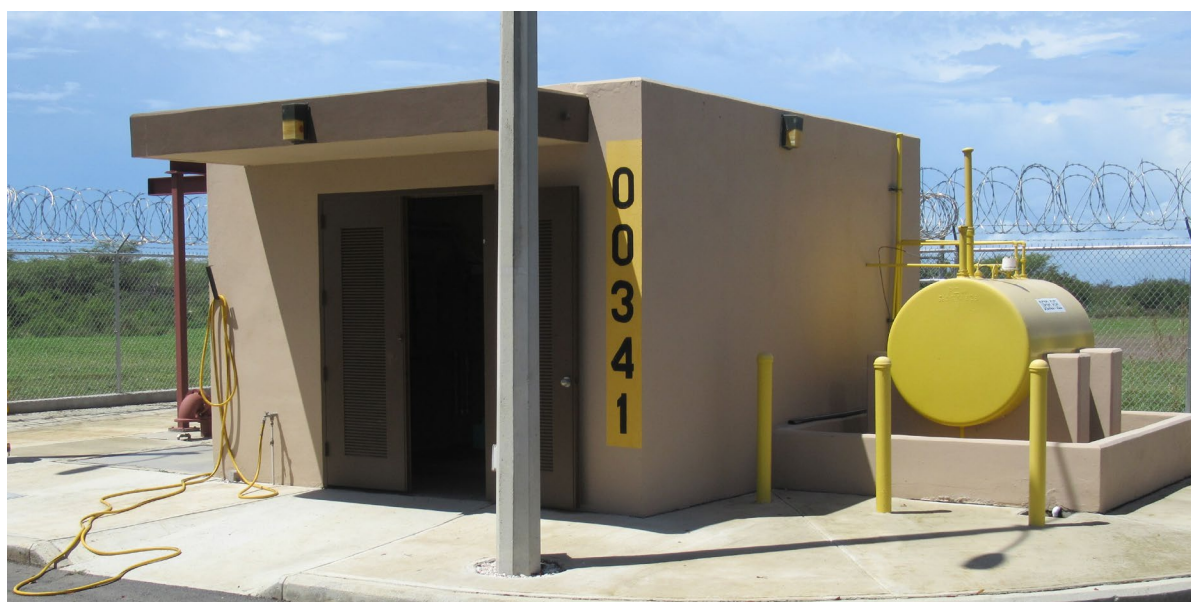
- We inspected the facility's wastewater lift station (Building 00341), where Mr. Luis Rivera identified himself as the only operator. A hose, which is used to clean the wastewater inlet rack, was screwed onto a potable water tap (Photo 28). It was not equipped with a vacuum breaker. The influent racks are cleaned weekly, with trash disposed appropriately depending on the results of toxicity testing (Photo 29). We observed that the lift station was supported by an emergency generator (Photo 30) fueled by a 550-gallon aboveground tank storing diesel fuel (Photo 31). Although the tank was in secondary containment, the containment structure also included a vertical open pipe a few inches long set into the concrete (Photo 32). Camp Santiago representatives stated that they had no idea why it was there, or where it led. By text on May 27, 2023, PRANG provided photos showing that the pipe was eliminated, and the floor sealed with concrete. Just inside the building was a fire extinguisher that was significantly undercharged and with no inspection tag attached (Photos 33 & 34).

Photo 28 – Bldg. 00341; wastewater lift station

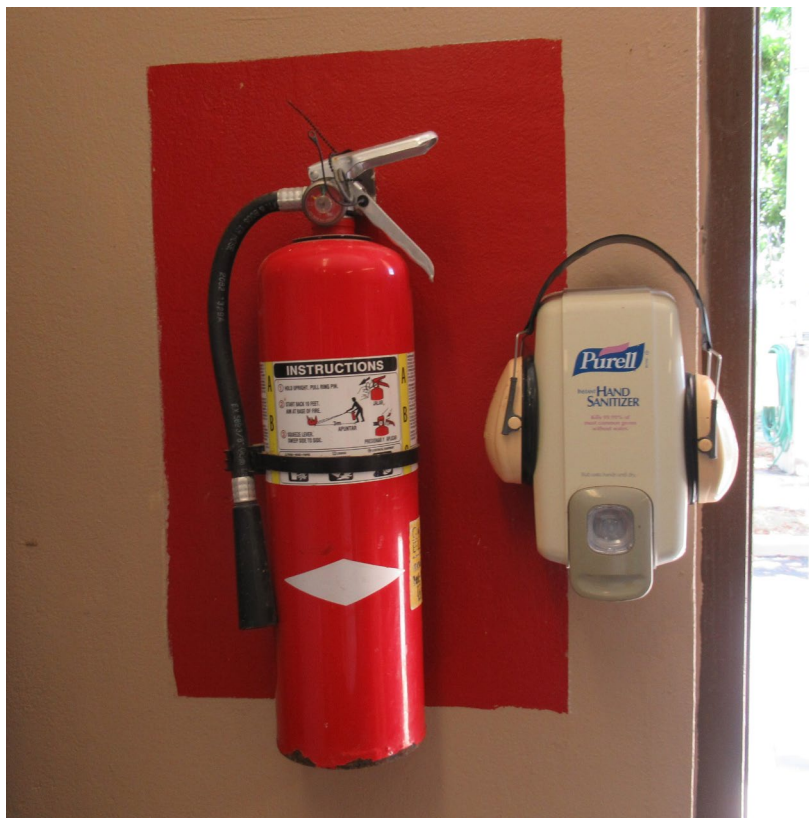
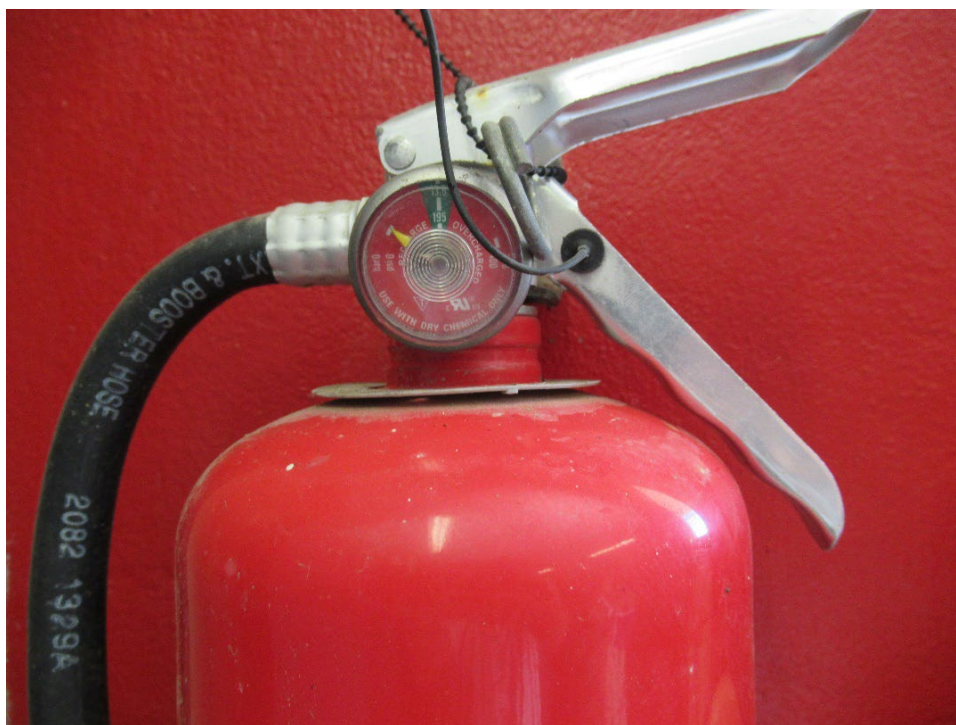
Photo 33- Bldg. 00341; fire extinguisher without inspection tag

Photo 34 – Bldg. 00341; depressurized fire extinguisher

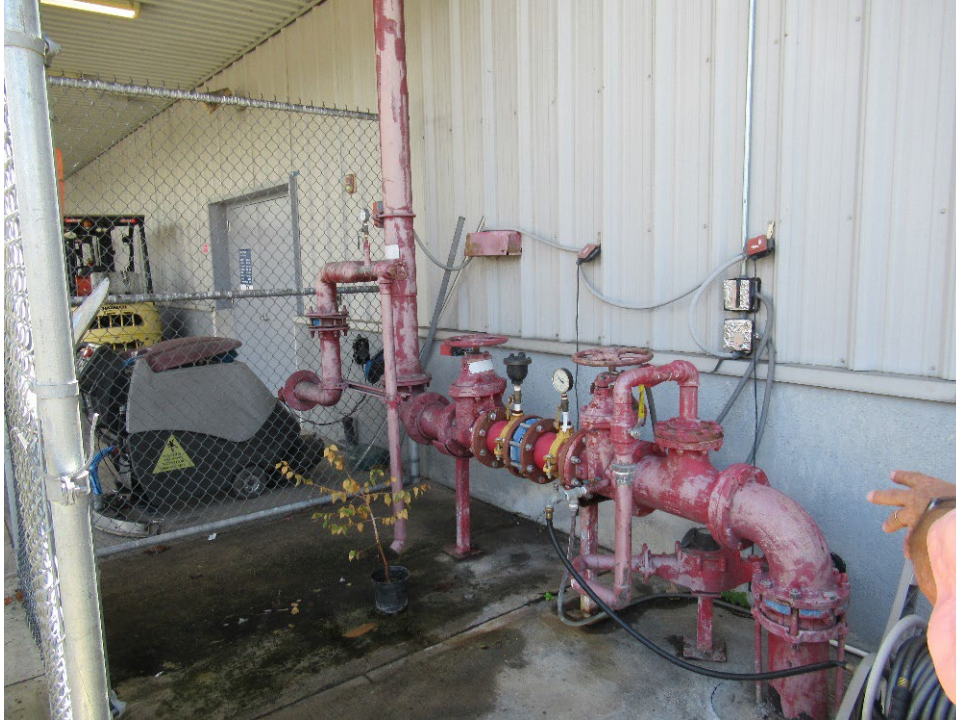
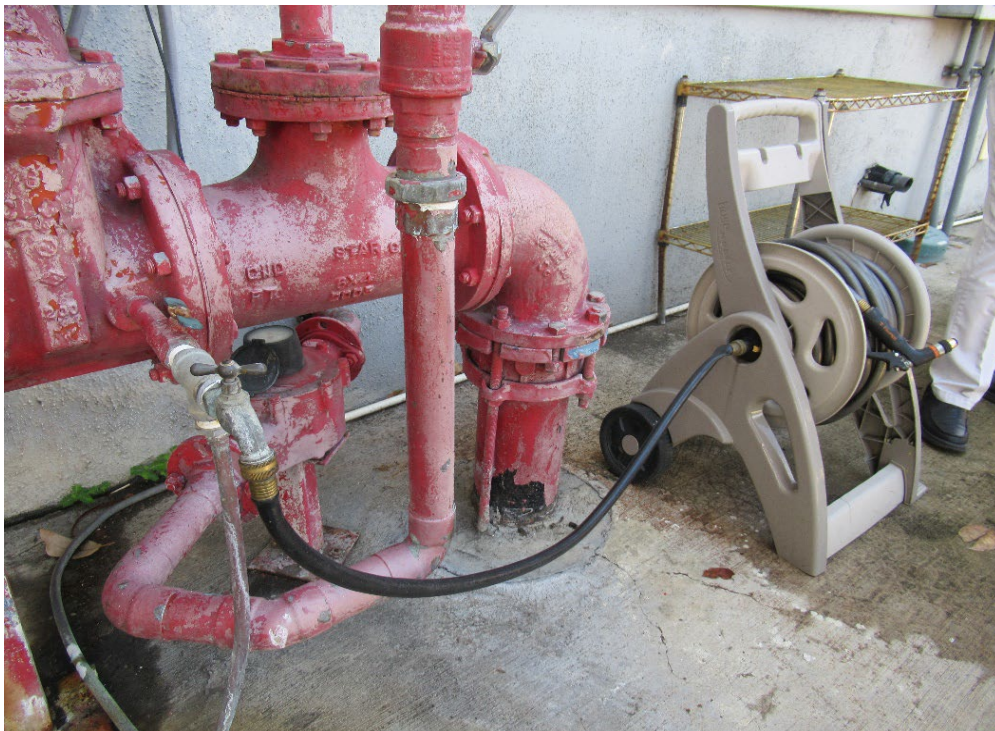
- At the PX building, the fire sprinkler suppression system included a water tap with threads and a hose attached (Photos 35 & 36).
- At Building 1011 as well as another building, we observed faucets outdoors with no cross-connection protection and with a connected hose lying on the ground (Photos 37 & 38).

Photo 35- PX bldg.; fire suppression water supply and check valves

Photo 36 – PX bldg.; hose connected directly to fire suppression water supply

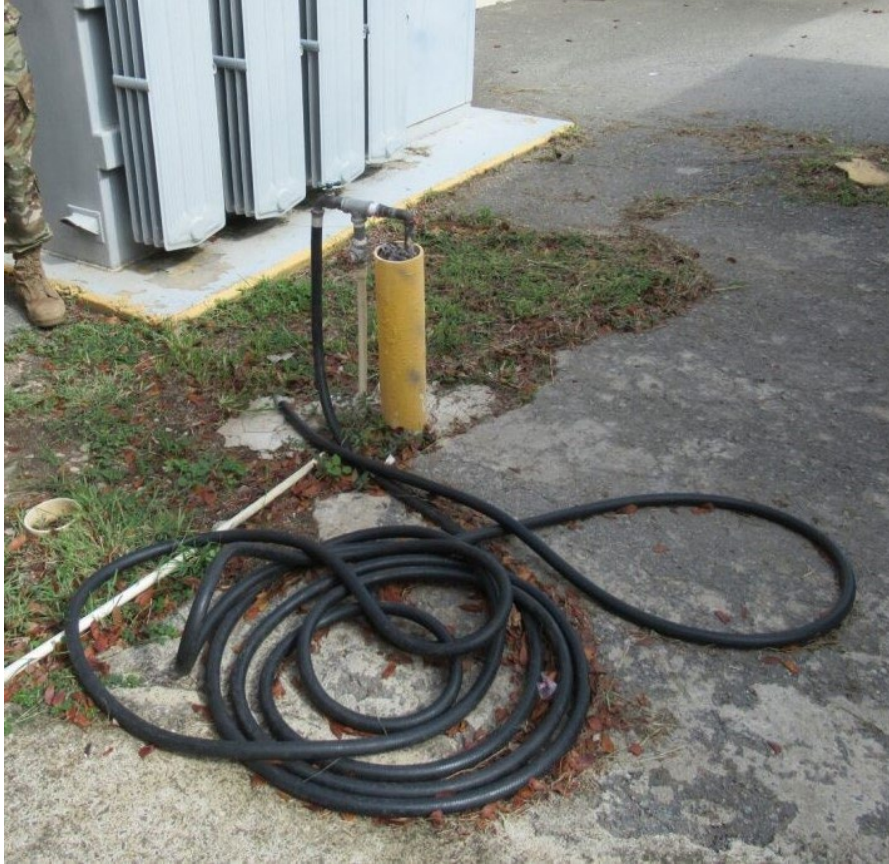
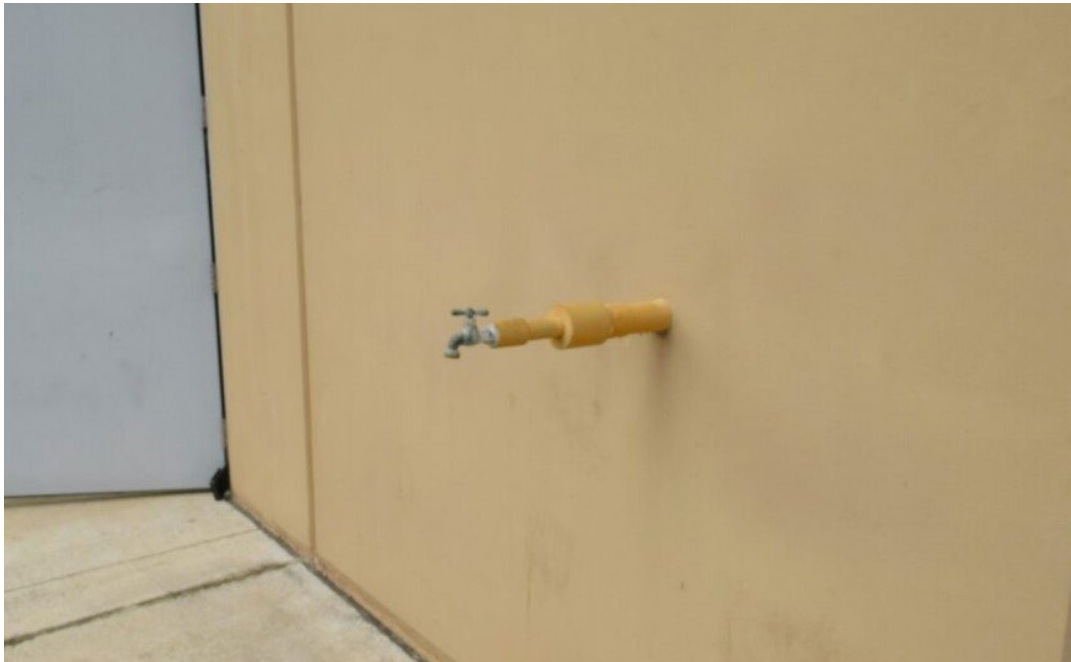
Photo 37 – Bldg. 1011; outdoor faucet with connected hose

Photo 38 – Area of Bldg. 1011; threaded outdoor faucet

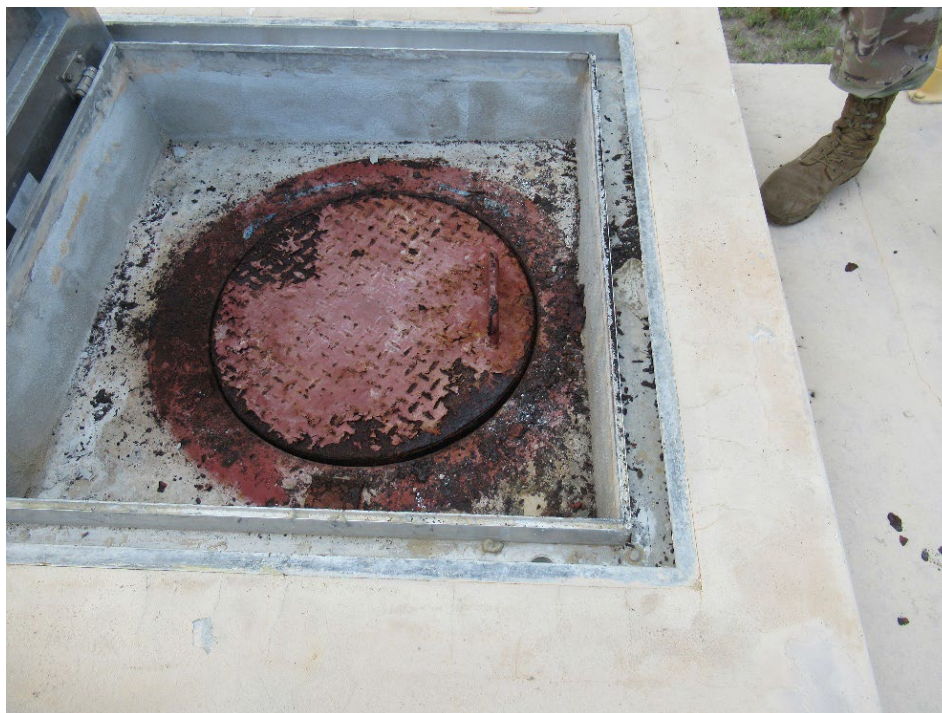
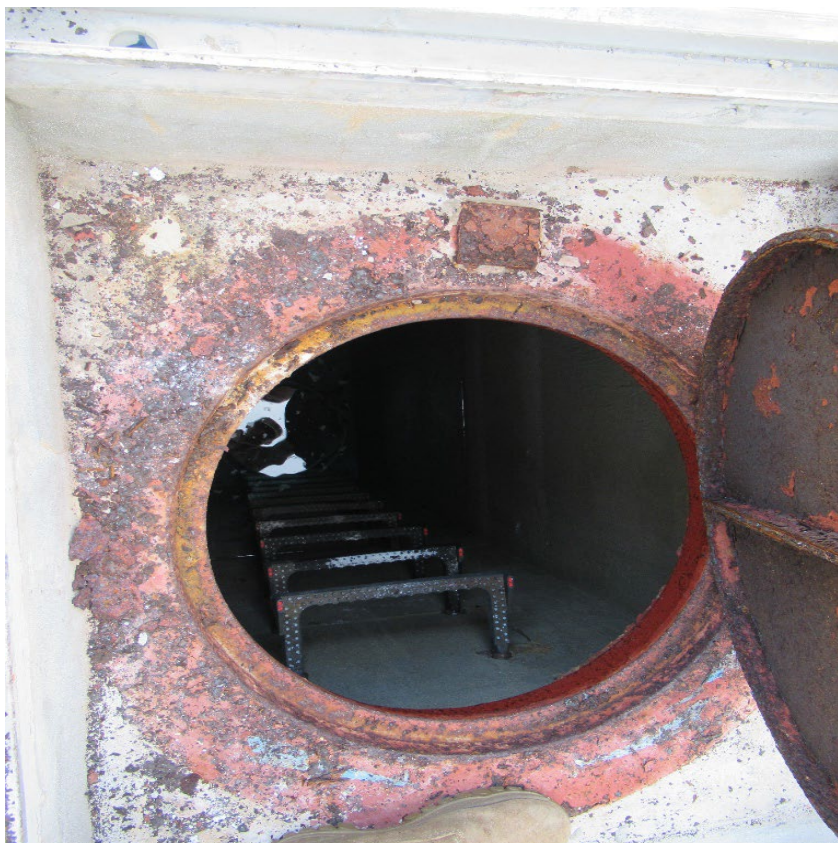
- The hatchway for the facility's 350,000-gallon concrete water storage tank (Building 845) had no sanitary seal and was flaking material (Photos 40 & 41). The surface of the tank roof appears degraded in several places (Photos 42-44).

| Finished Water Storage | <p>The hatchway for the 350,000-gallon concrete water storage tank (Building 845) had no sanitary seal and was flaking material (Photo 41).</p> <p>The surface of the tank roof appears degraded in several places (Photos 42-44).</p> |

Photo 40 – Bldg. 845; potable water storage tank hatchway (1 of 2)

Photo 41- Bldg. 845; potable water storage tank hatchway (2of 2)

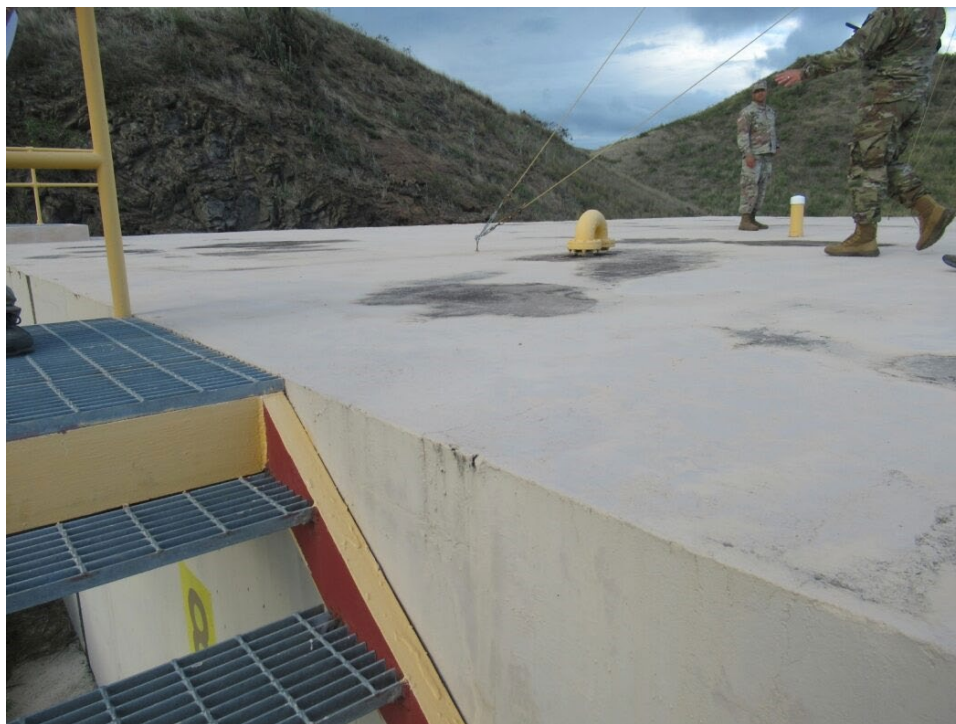
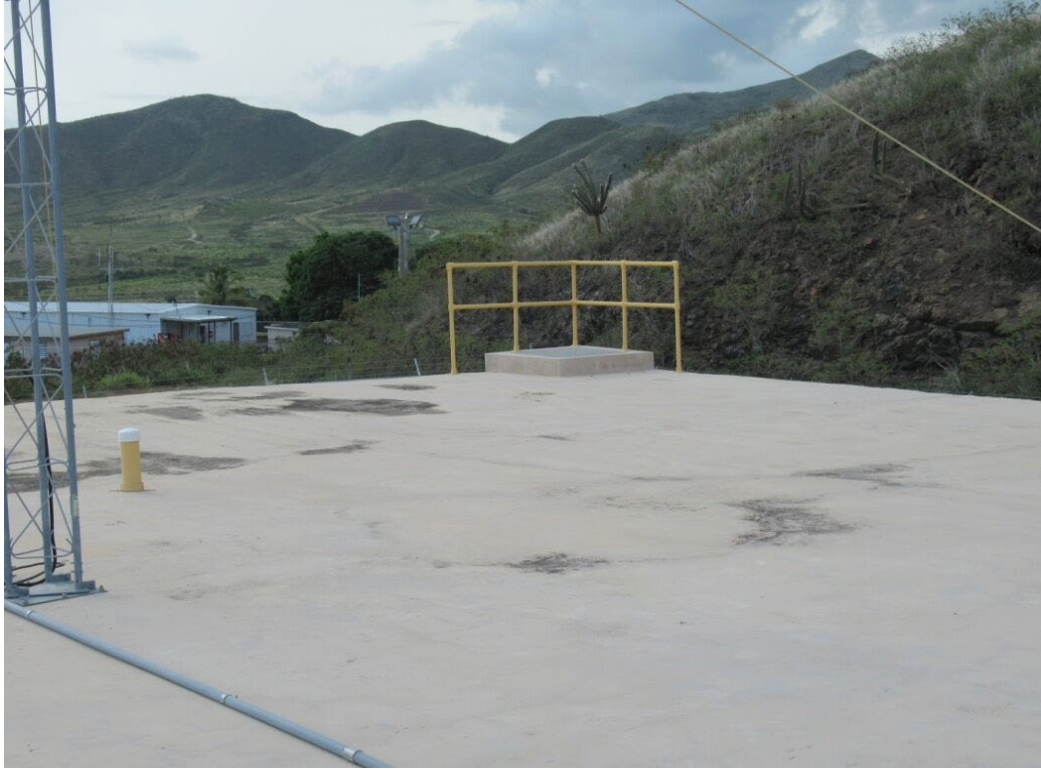
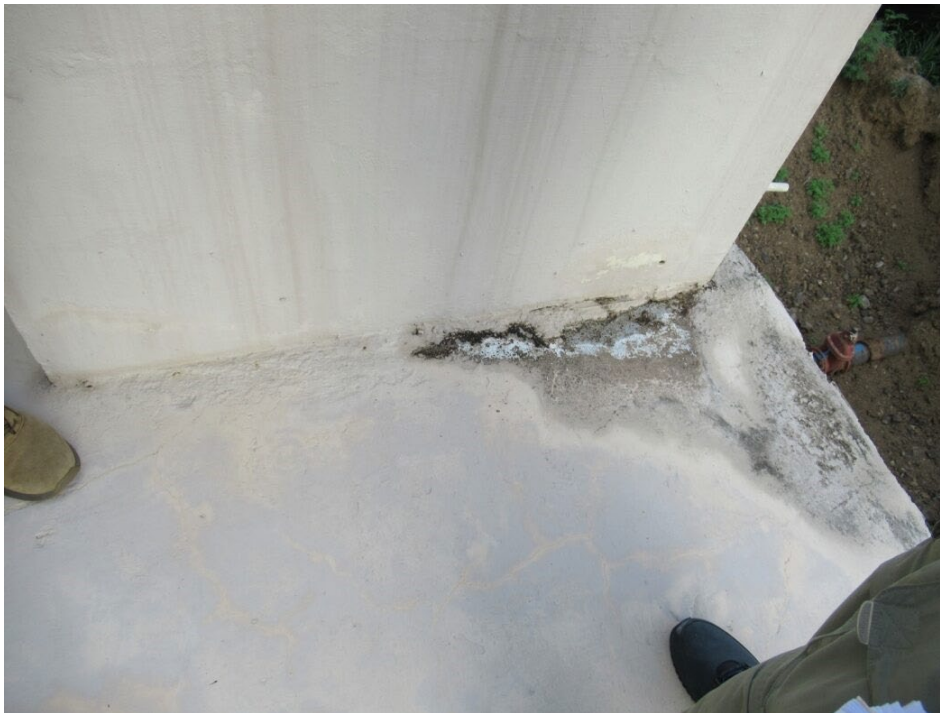
Photo 42 –Bldg. 845; surface of potable water storage tank (1 of 3)

Photo 43 -Bldg. 845; surface of potable water storage tank (2 of 3)

Photo 44 – Bldg. 845; surface of potable water storage tank (3 of 3)
