Re: Sanitary Survey Notice of Deficiencies at Nooksack Indian Tribe, Rutsatz Road, PWS ID# 105300088

RE: Sanitary Survey – Nooksack – Rutsatz Road Community Water System (CWS)  
PWSID# 1053000088

**EPA REGION 10  
DIRECT IMPLEMENTATION  
SANITARY SURVEY COLLECTION FORMS**

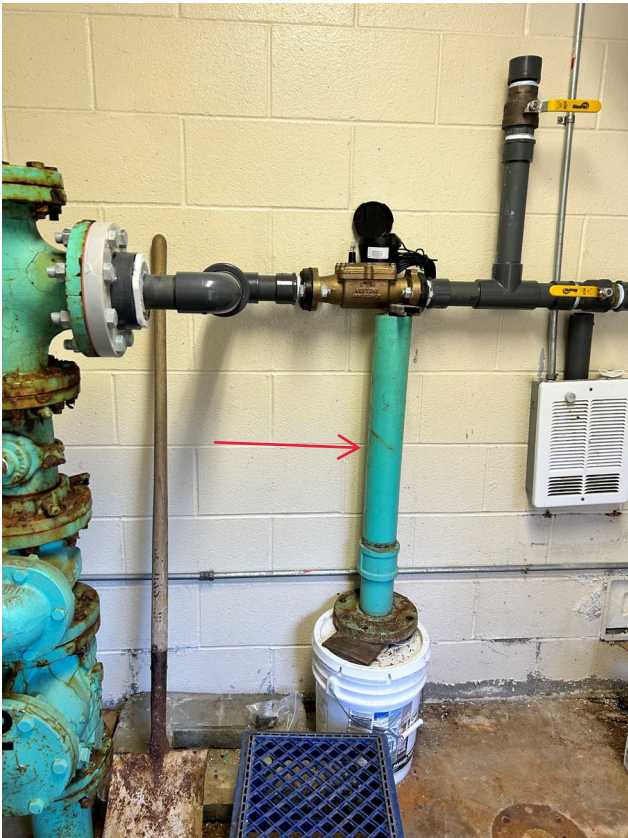
- Source: Well #1 (WL-01) cannot be pumped to waste. The shared discharge piping also needs proper support. Please submit photos of the piping to EPA once installed.

- Source: Well #2 (WL-02) cannot be pumped to waste. The shared discharge piping also needs proper support. Please submit photos of the piping to EPA once installed.

PH Piping – Need an appropriate support

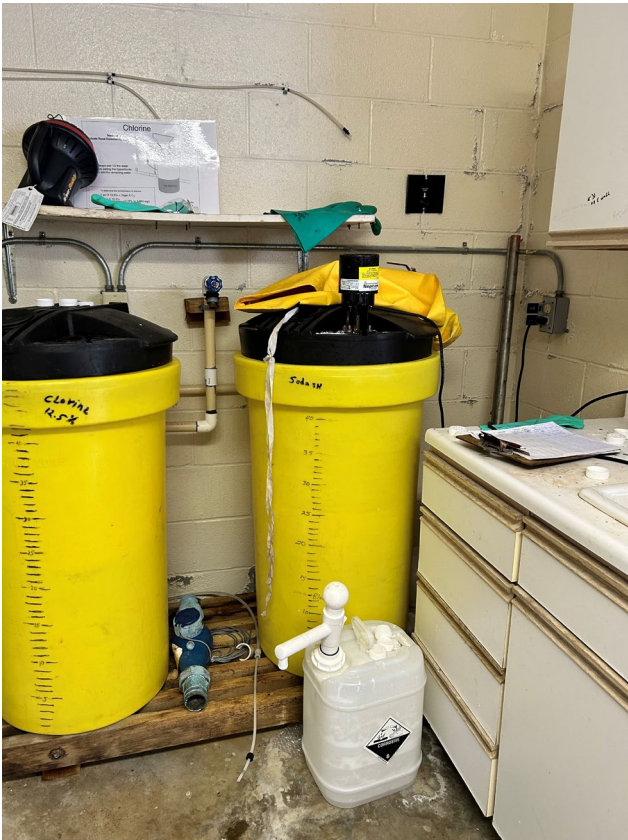
PH Piping – Soda Ash Tank Not in Use

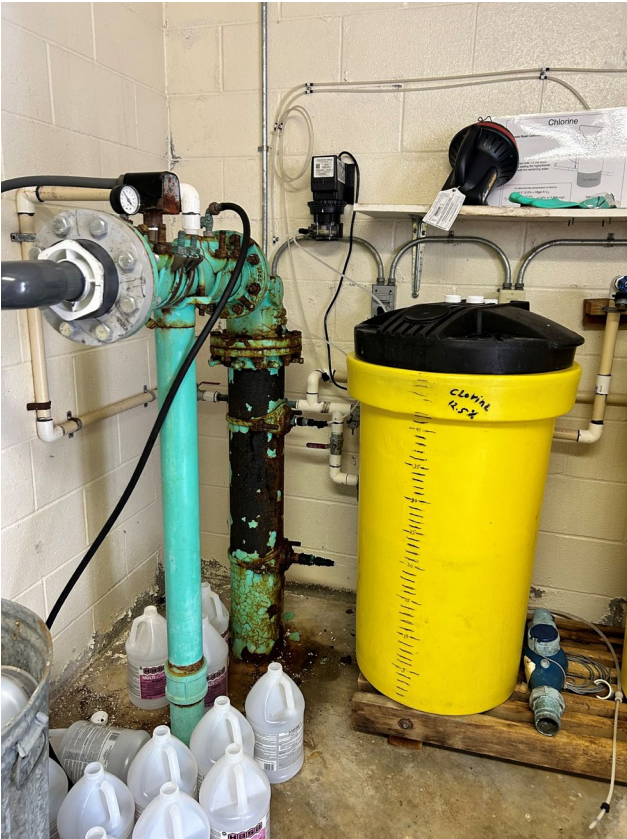
- Treatment: Chlorine residuals should be checked daily at the finished water tap.
- Treatment: There is no spill containment for the chlorine solution tank located in the TP-01 Rutsatz Road Pump House. Consider installing spill containment for the chlorine solution tank to minimize danger to personnel and damage to equipment in the event of a spill.
- Treatment: Remove empty chemical bottles from the TP-01 Rutsatz Road.
- Distribution: Consider exercising valves routinely and no less than annually to ensure proper operation.
- Distribution: Consider routinely reading service line meters.
- Finished Water Storage: Vegetation should be kept clear from around the overflow drainpipe outlet to ensure proper operation.

PH Piping – Chlorine Tank

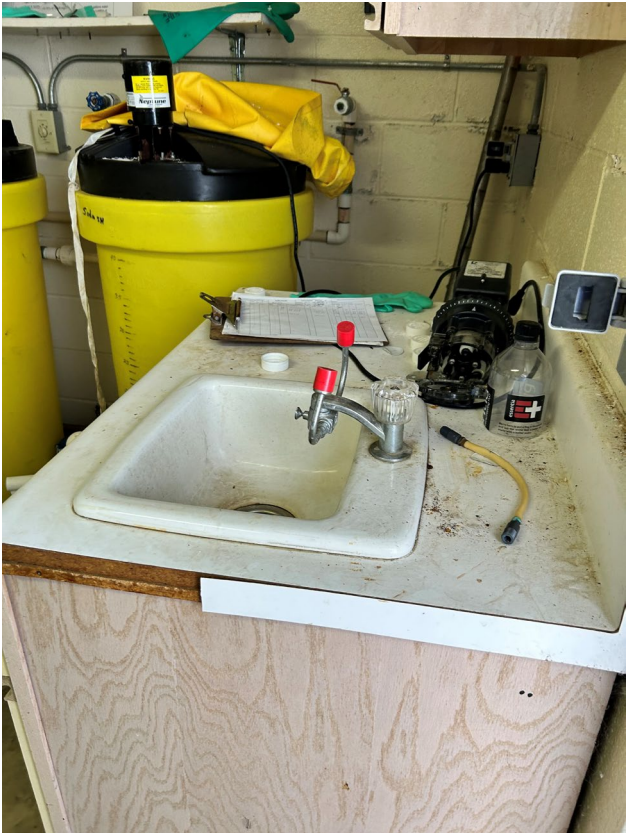
PH – Eye Wash device was not working correctly

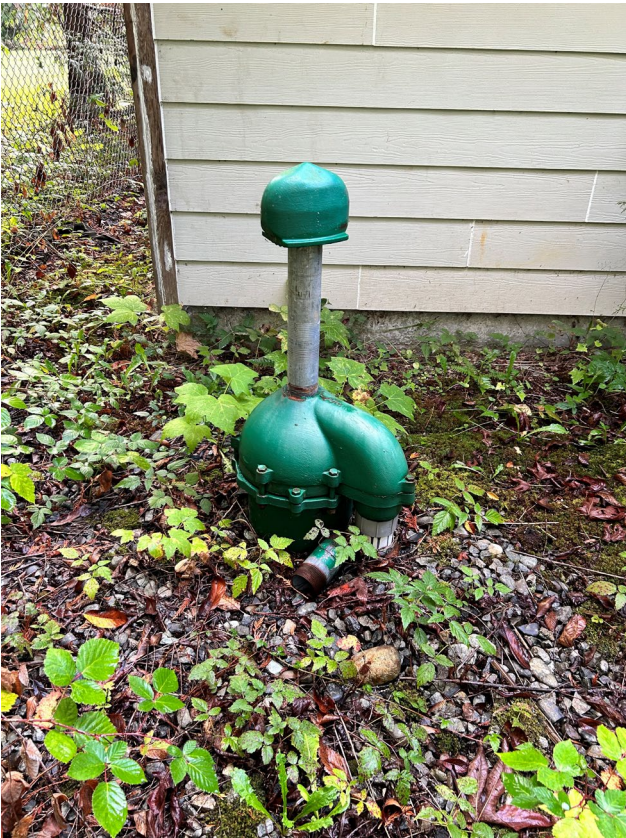
Well 2

- Source: The casing height for Well #2 (WL-02) is not 18 inches above the ground surface. This significant deficiency was first identified from the sanitary survey conducted on 9/11/2014. Please submit photos of the new casing height to EPA once corrected.

| Comments: | IHS Project PO-20-N02 plans to extend both well casings to meet 18-inch minimum height requirement and update pump house plumbing to include pump to waste capability. | | |

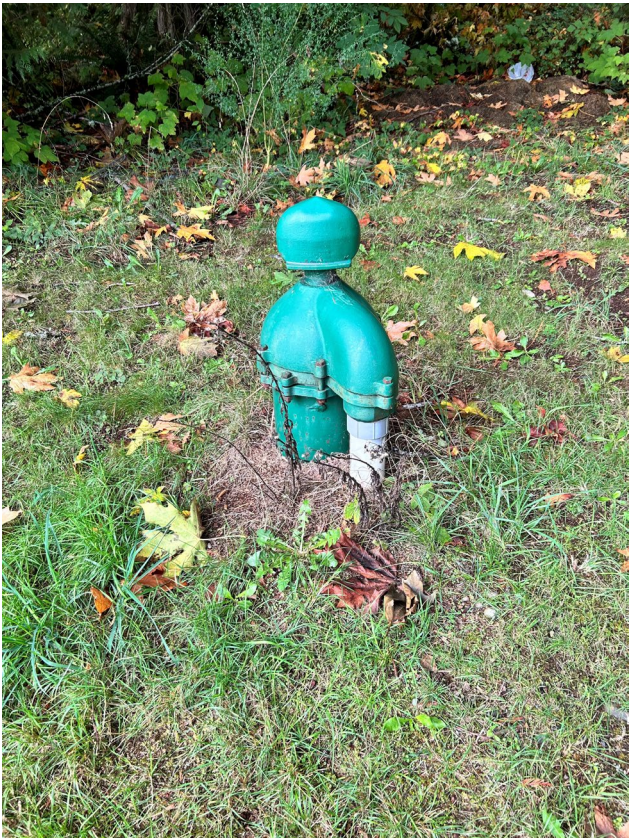
- Source: The casing height for Well #1 (WL-01) is not 18 inches above the ground surface. This significant deficiency was first identified from the sanitary survey conducted on 9/11/2014. Please submit photos of the new casing height to EPA once corrected.

- Source: Well #1 (WL-01) is located less than 100 feet away from a septic tank. This significant deficiency was first identified on 9/11/2014. Bollards will be added to protect the well and the septic tank is serviced regularly to mitigate the contamination concern.

Well 1 – Not in use

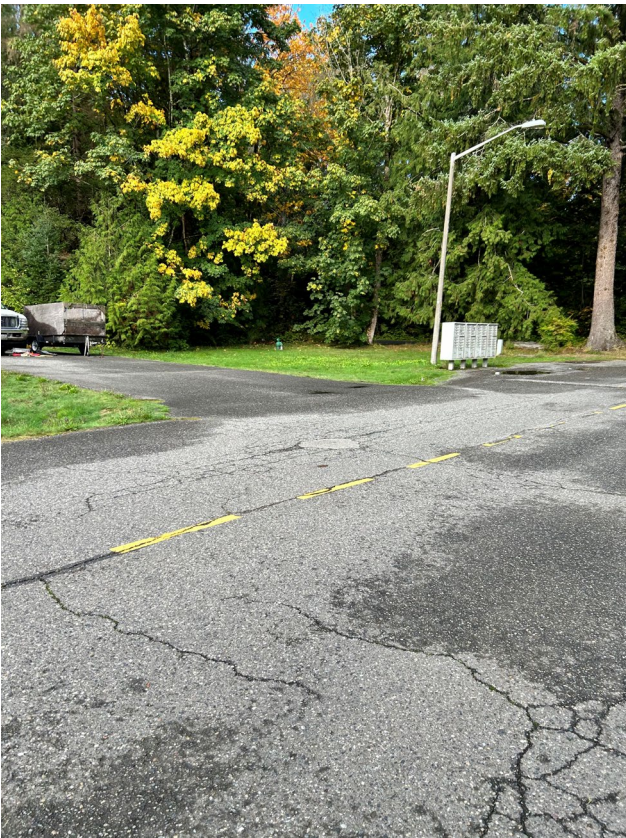
Well 1 – Not in Use

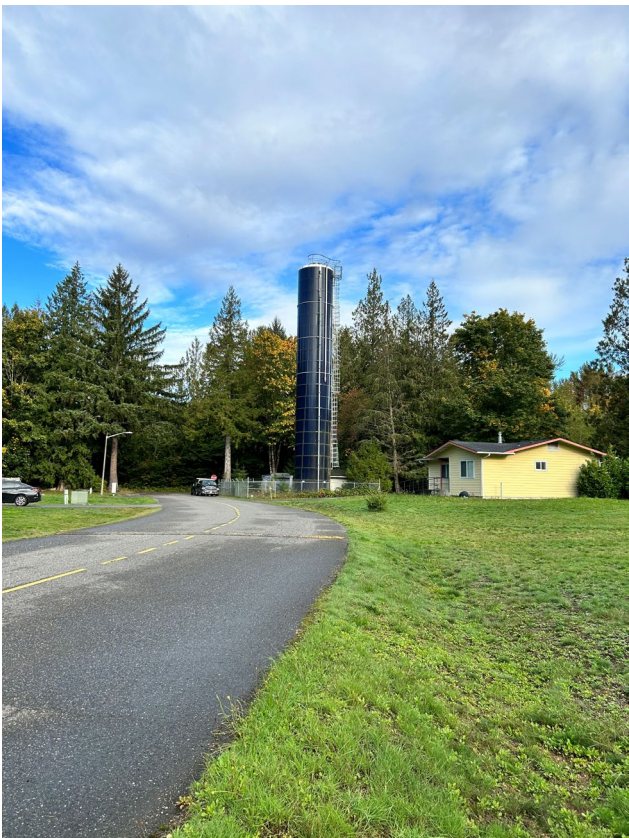
Water Storage Tank

- Finished Water Storage: Parts of Tank #1 (ST-01), were not inspected at the time of the sanitary survey. Please provide documentation as soon as possible for the following:
  - The hatch must be raised 4 inches above the tank roof and tightly sealed with a gasket. Please submit pictures of the hatch and installed gasket.
  - The storage tank hatch must be secured against unauthorized access. Please submit pictures of the hatch lock.
- Operator Compliance: Operator certification documents were not presented at the time of the sanitary survey. Therefore, it is unknown if the system has a certified operator. Please submit a copy of the operator's certification.
