INSPECTION REPORT

| Type of Inspection | Focused Compliance Inspection (FCI) | | | |
| Facility or Site Name | P.C. Pfeiffer Co., Inc. | | | |
| Facility/Site Physical Address | 1255 Main St. | | | |

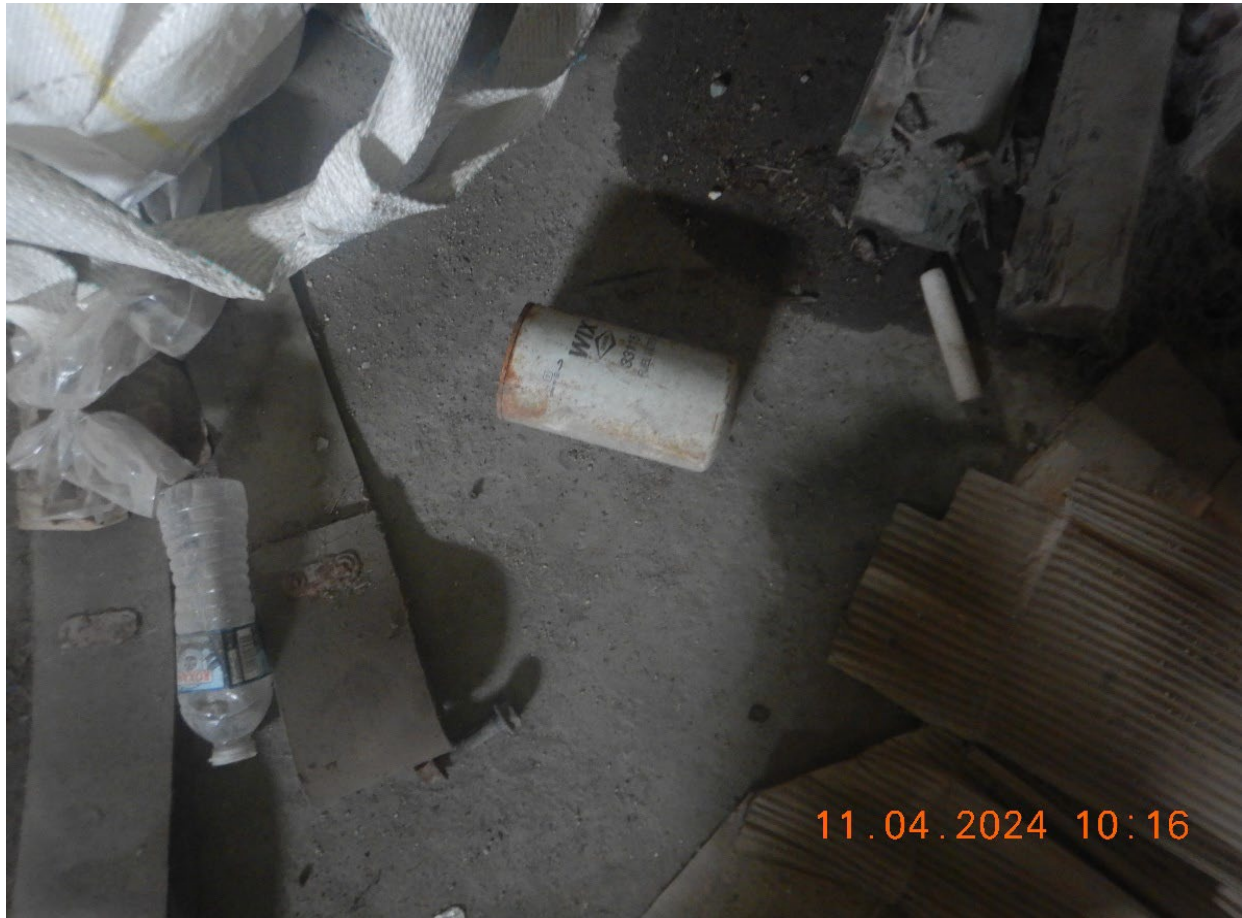
Photo No. 2

discarded used oil filters in the fuel tank shed (see Appendix 1 – Photos 2 and 8). The filters were discarded for what appeared to be a long time and did not contain any free-flowing oil at the time of the inspection. Behind the fuel shed, the inspection team observed an oily sheen found accumulating on the water and concrete pad which shows evidence of an oil spill that was not properly managed (see Appendix 1 – Photos 10 to 11) [**AOC #2** – PCP did not respond to and properly manage a release of used oil – 40 CFR 279.22 (d)].

Description: View of a discarded used oil filter that was found on the floor of the fuel tank shed.

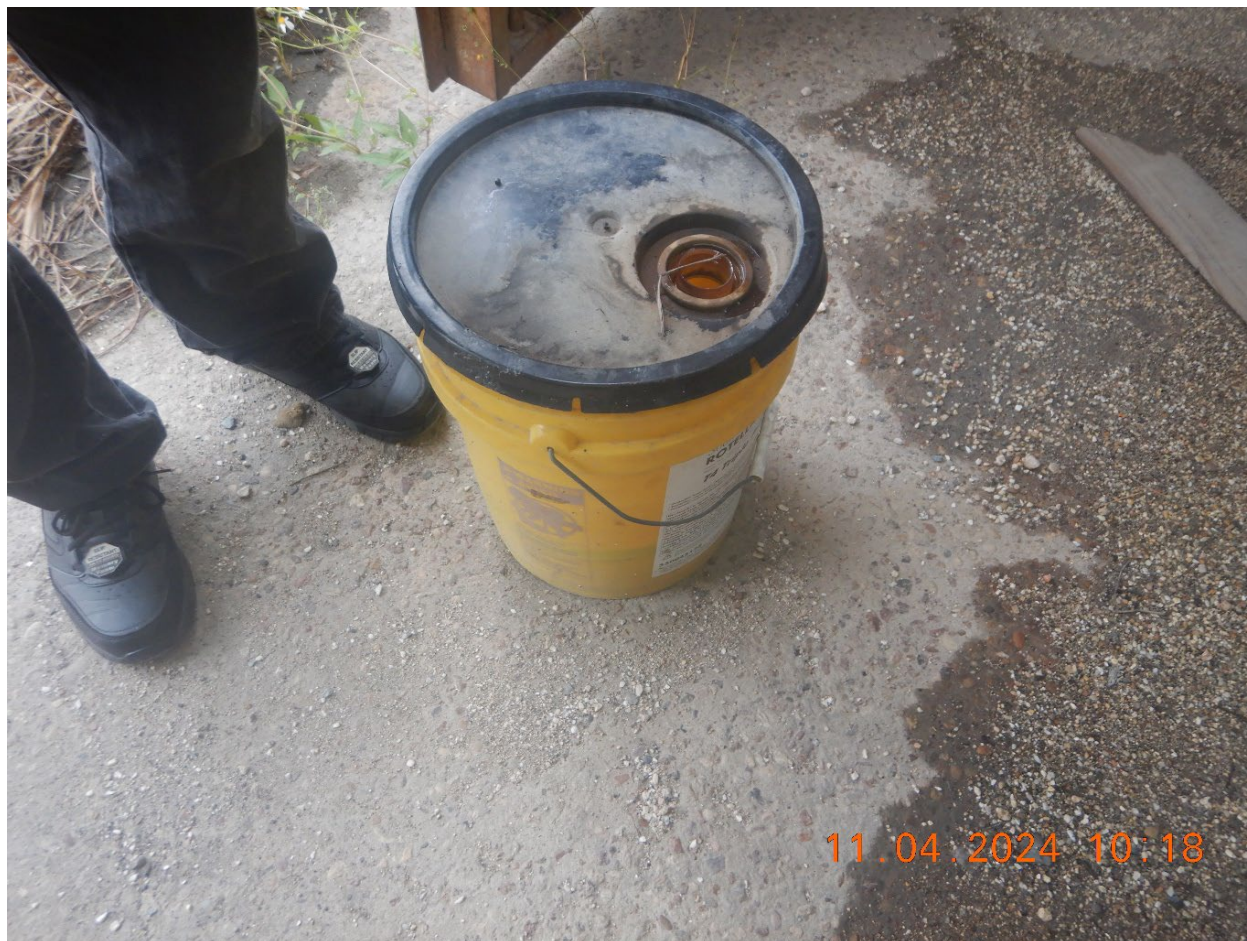
Photo No. 3

Description: View of a half-full 5-gallon container found in the fuel tank shed; the contents were unknown at the time of the inspection but appeared to be an oily liquid.

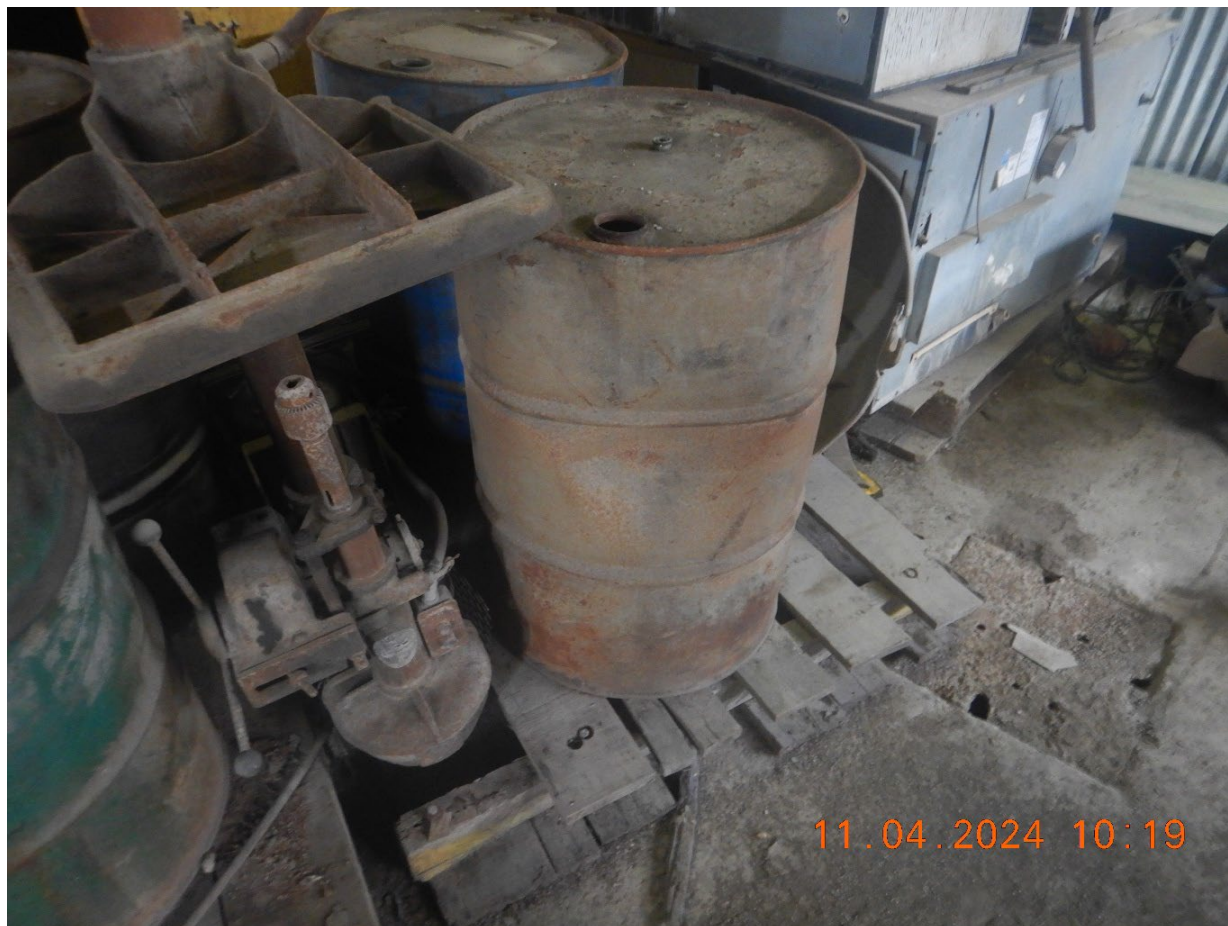
**Photo No. 4**

Description: View a 55-gallon drum found in the fuel tank shed that was  $\frac{1}{4}$  full of an unknown material. The drum appeared to be old and rusted.

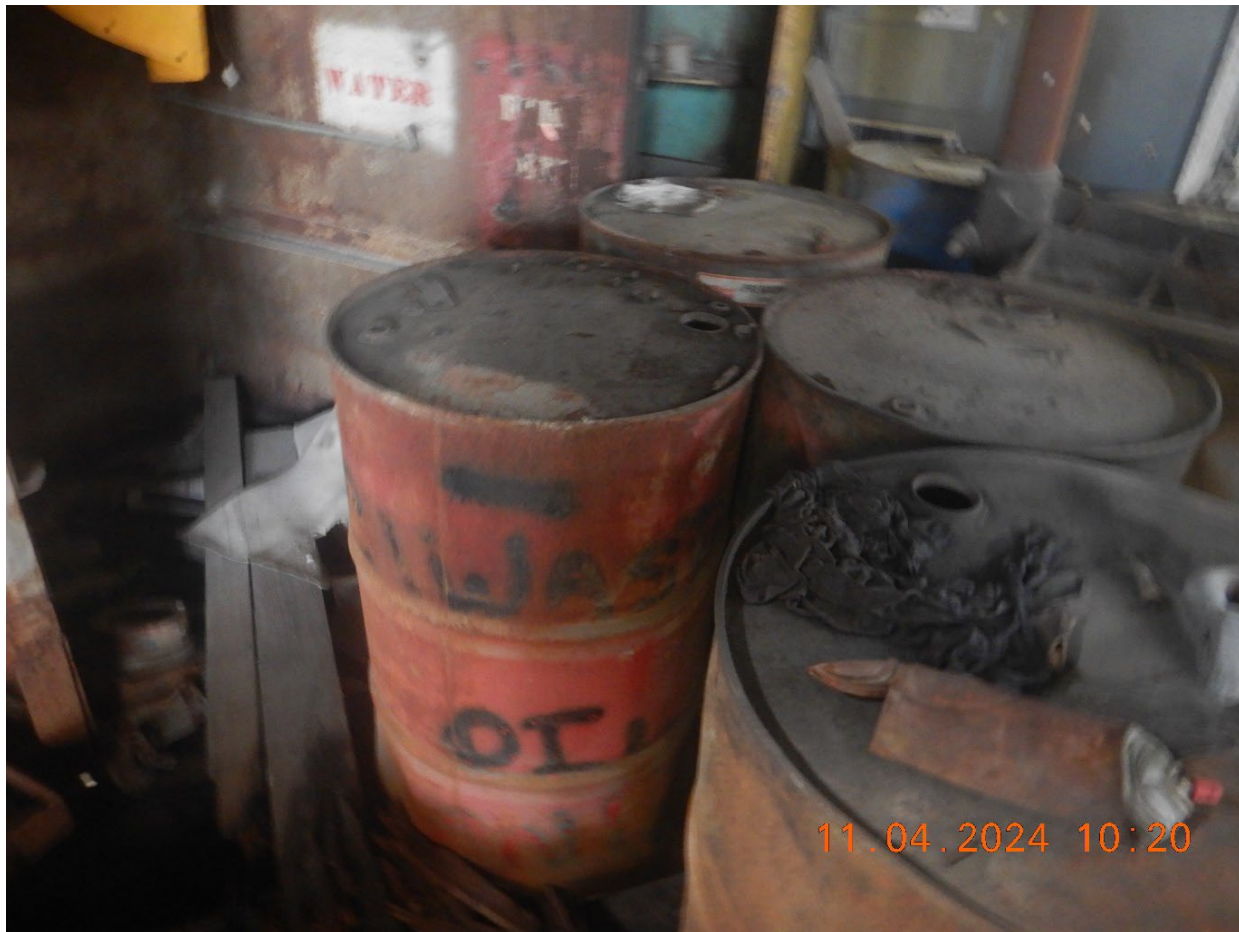
Photo No. 5

Description: View of two full 55-gallon drums (red drum in the front and the drum directly behind the red one) found in the fuel tank shed that was storing unknown material at the time of the inspection. The other drums pictured were empty.

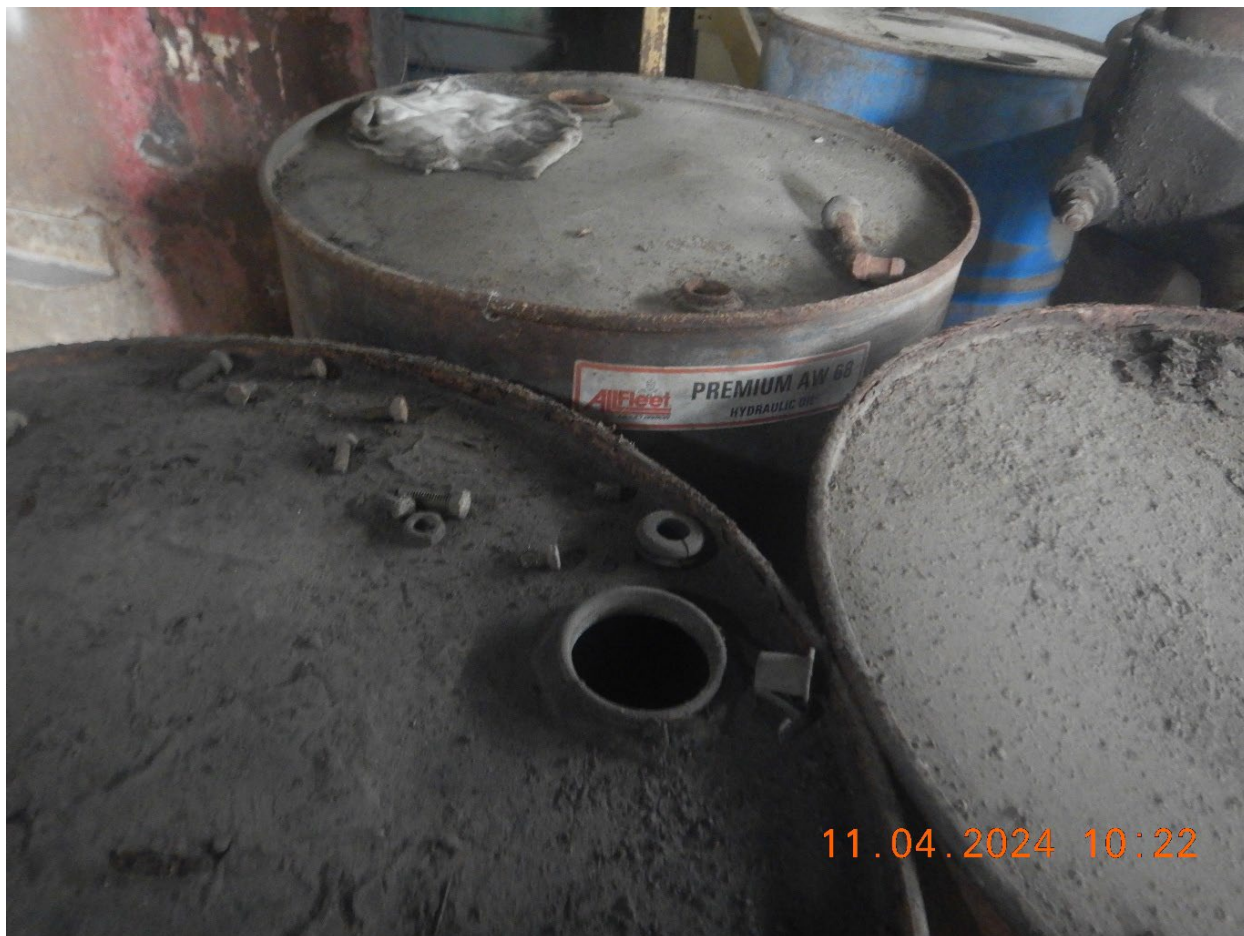
Photo No. 6

Description: View of a label on one of the 55-gallon drums found in the fuel tank shed found to be storing unknown liquids.

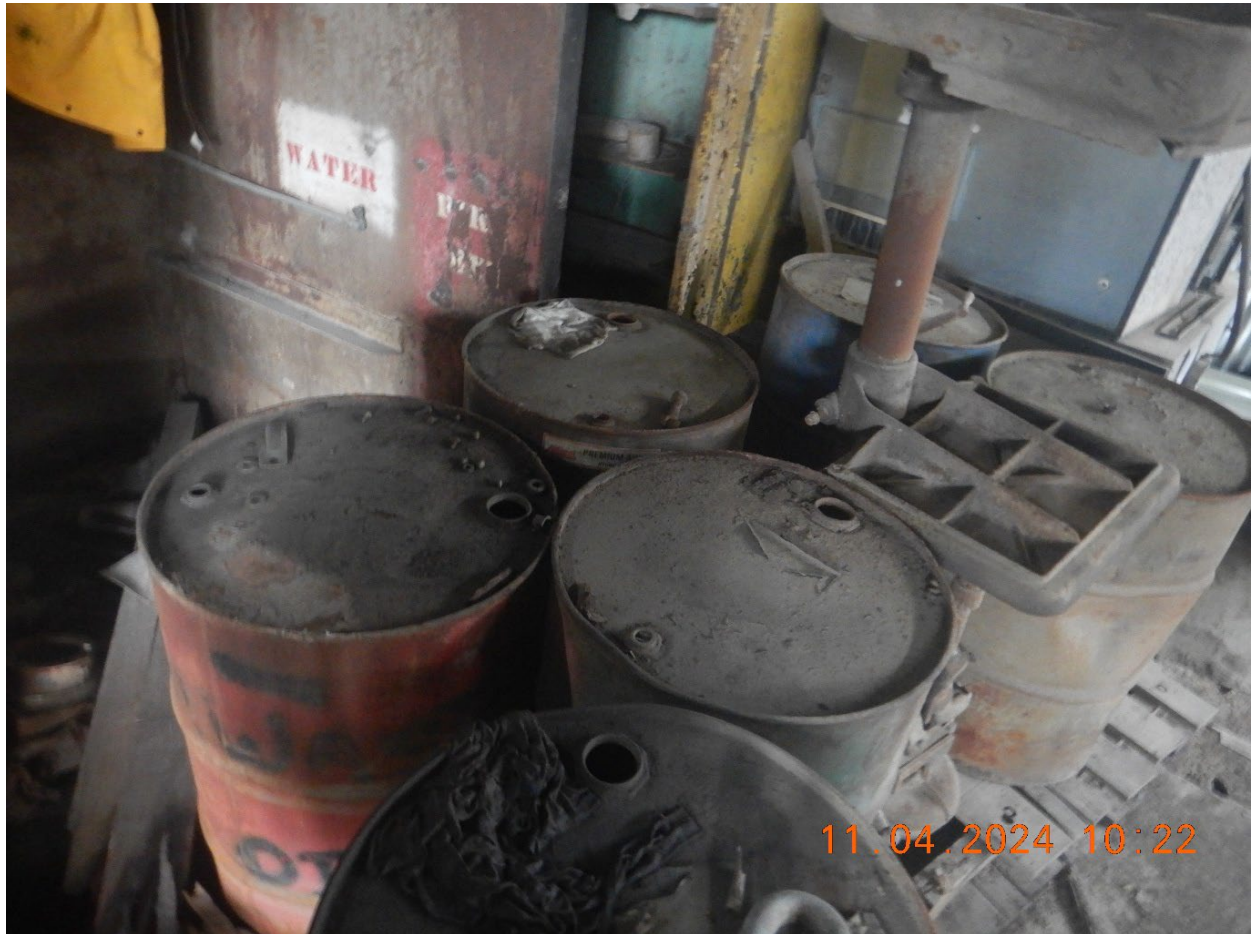
Photo No. 7

Description: Another view of the drums discussed above in Photos 5 and 6.

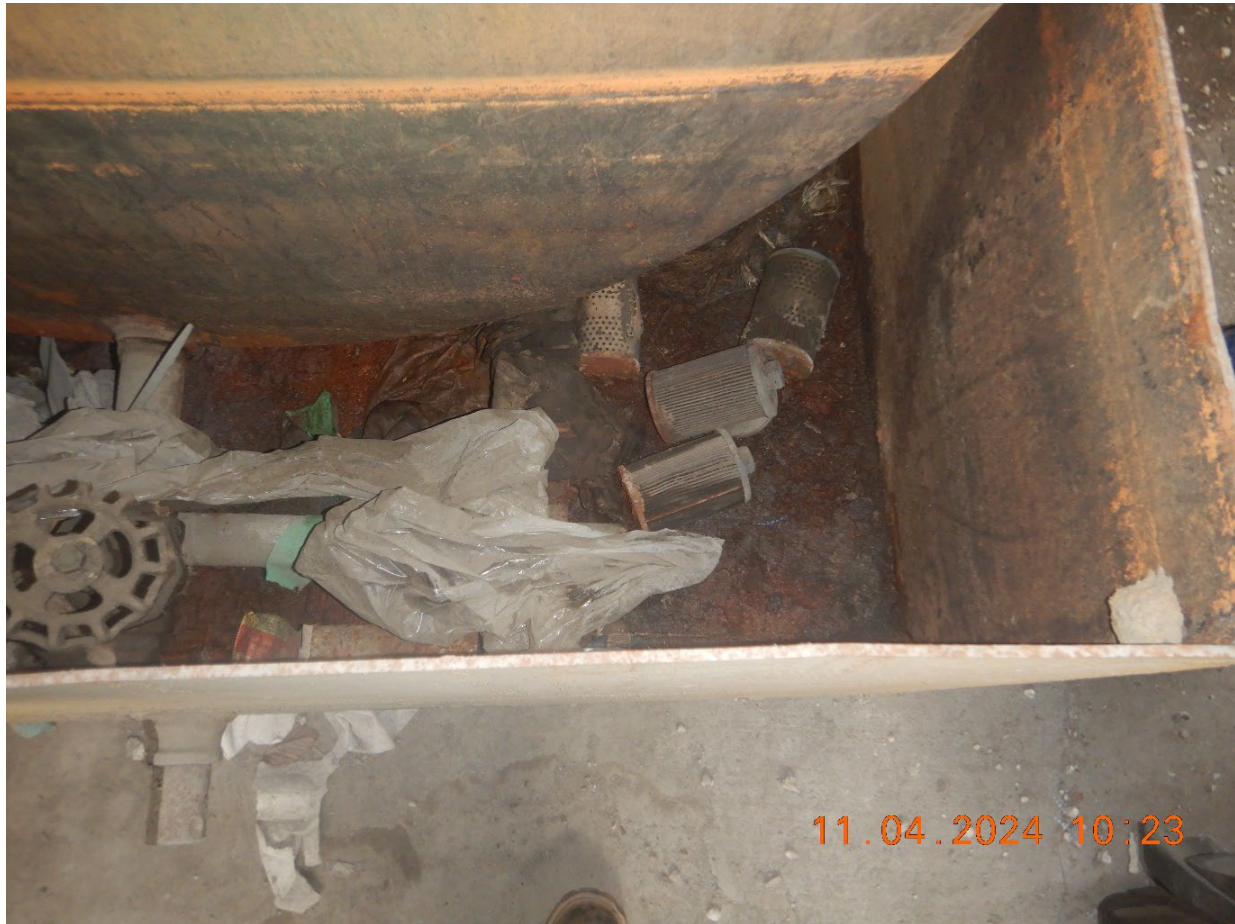
**Photo No. 8**

Description: View of three discarded used oil filters found in the fuel tank shed.

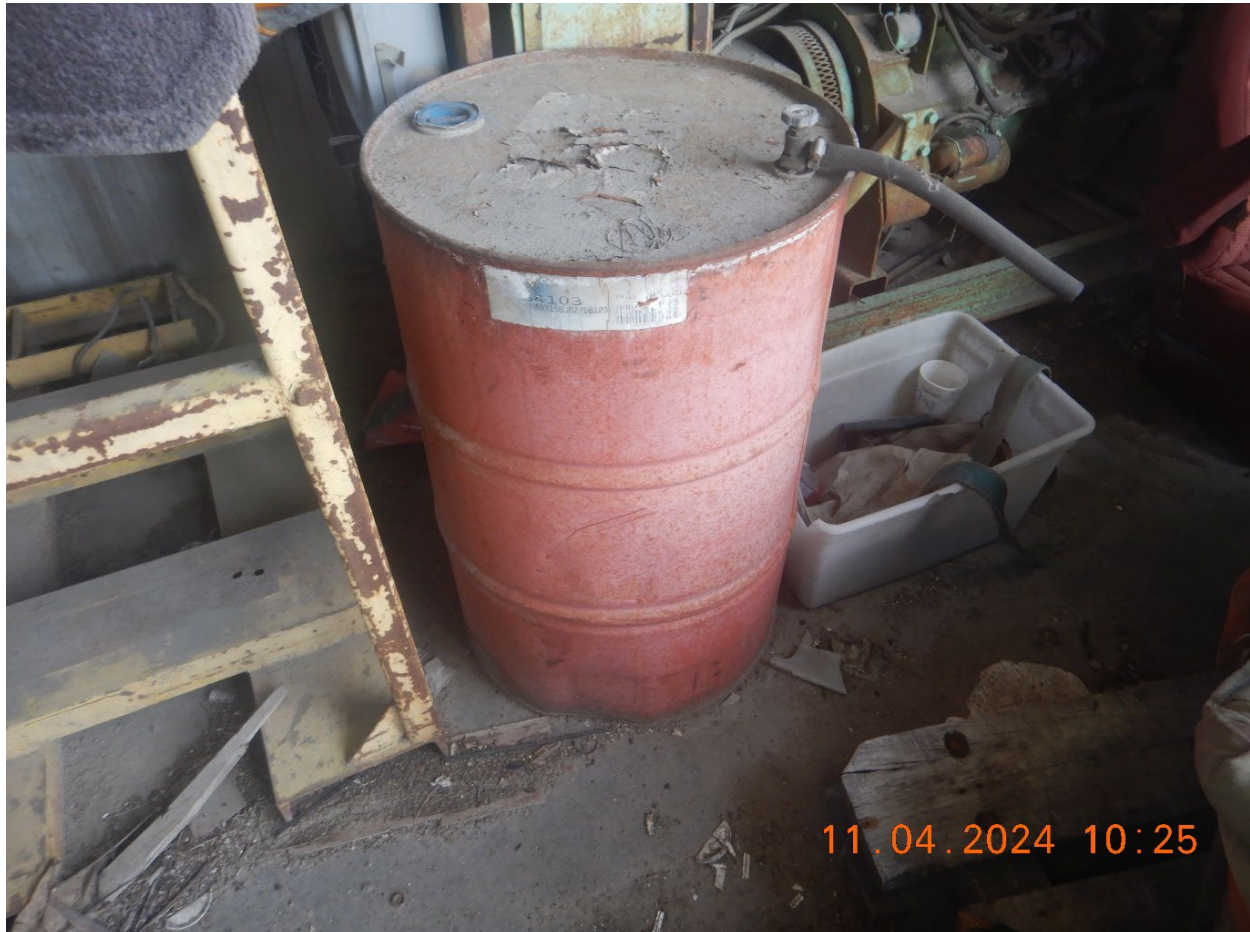
Photo No. 9

Description: View of a half-full 55-gallon drum found inside the fuel tank shed that was storing an unidentified liquid at the time of the inspection.

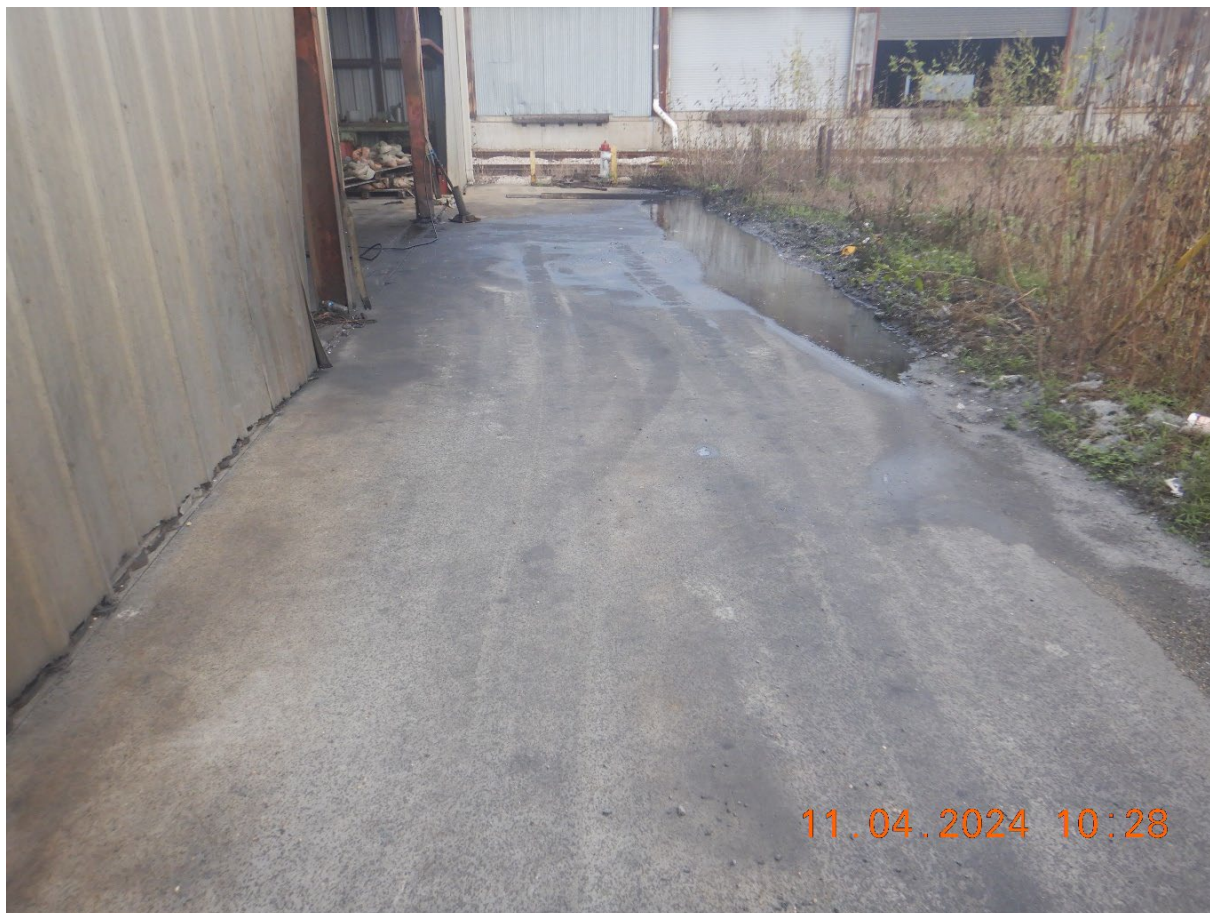
Photo No. 10

Description: View of the concrete pad behind the fuel tank shed that had evidence of a used oil spill that was not properly cleaned up.

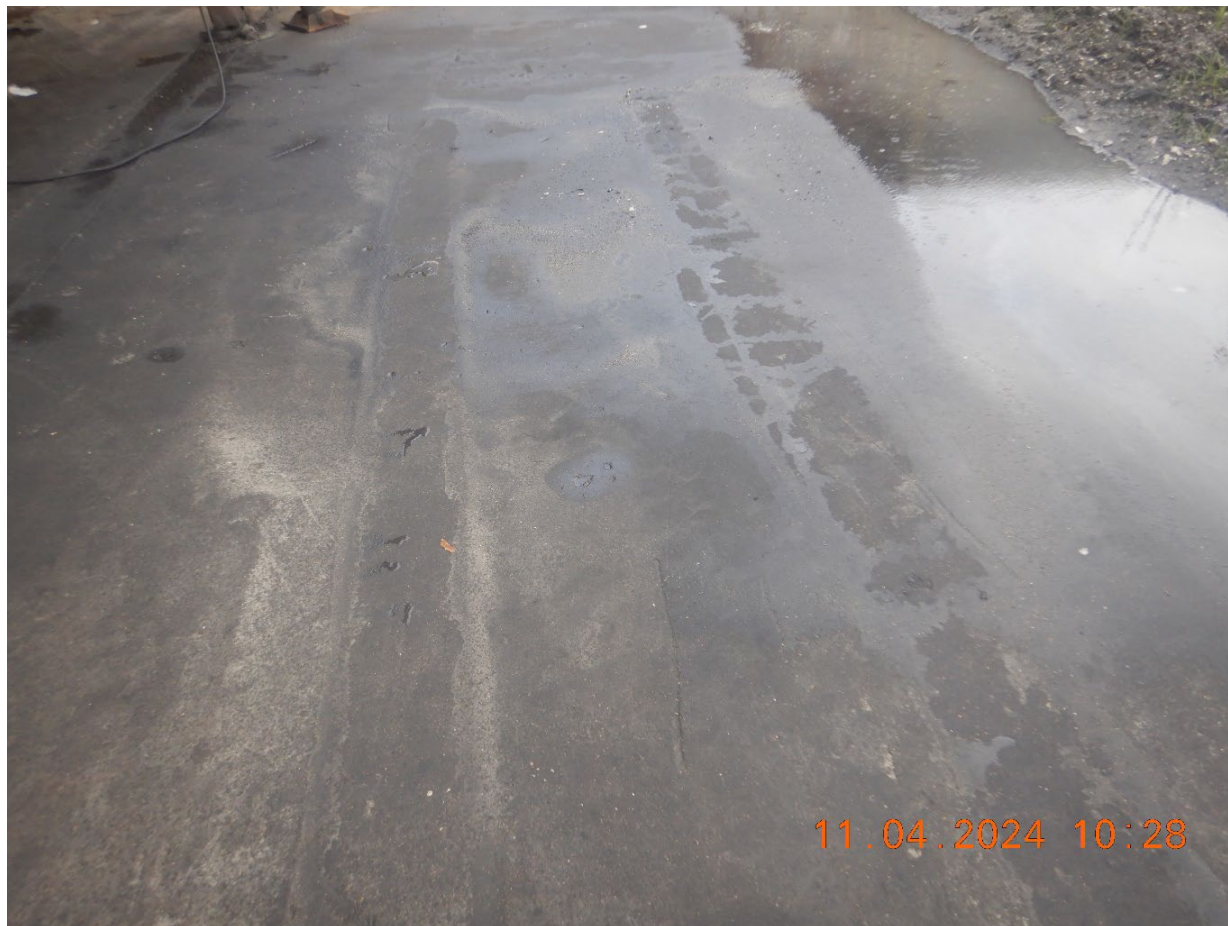
**Photo No. 11**

Description: Another view of the concrete pad behind the fuel tank shed that had evidence of a used oil spill that was not properly cleaned up.

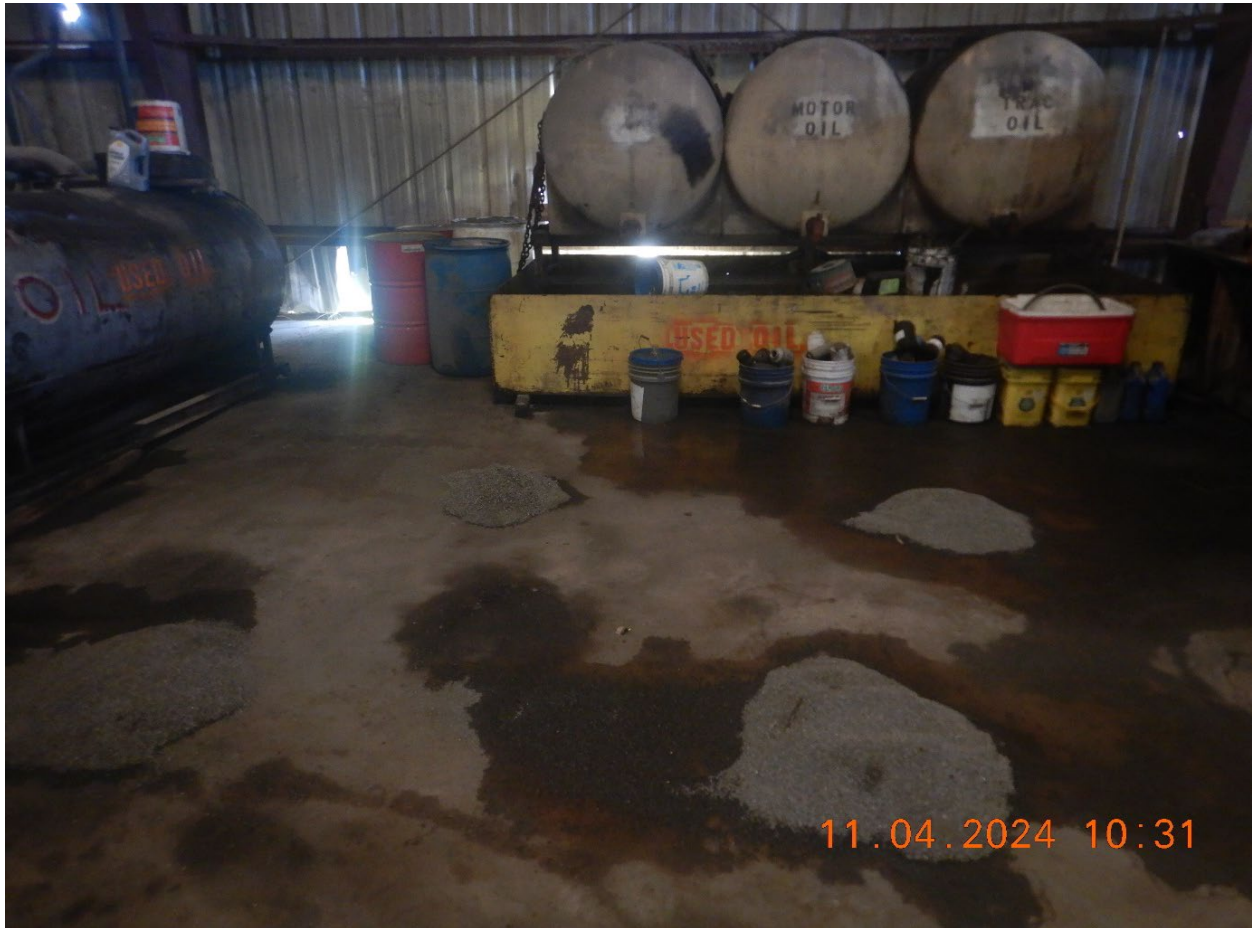
Photo No. 12

The inspection team moved into the maintenance area where PCP repairs their equipment. The inspection team observed several instances of used oil spills accumulating on the concrete floor throughout the maintenance area (see Appendix 1 – Photos 12 and 17 to 20) [see **AOC#2**]. PCP staff was actively cleaning up and containing used oil spills while the inspection team was conducting the visual inspection, as shown in Photo 12. Next, the inspection team observed PCP's used oil storage area found within the maintenance area. The inspection team observed one 500-gallon used oil container that was labeled "Used Oil." The container was closed and in good condition. PCP has three other 500-gallon containers that are no longer in use. On the ground of the used oil storage area, the inspection team observed six 5-gallon containers and one 10-gallon container storing used oil filters that still contained used oil (see Appendix 1 – Photos 12 to 14). Above the containers on the ground, there were several used oil filters draining into drip pads (see Appendix 1 – 15 and 16). Since the used oil filters were not drained by one of the methods in 40 CFR 261.4(b)(13), the used oil filters should be properly managed and labeled as "Used Oil" [**AOC #3**: PCP did not clearly label containers used to store used oil with the words "Used Oil." – 40 CFR 279.22 (c)(1)].

Description: View of used oil spills found inside the maintenance area. PCP personnel were actively cleaning the spills during the inspection which are the piles of absorbent seen in the photo.

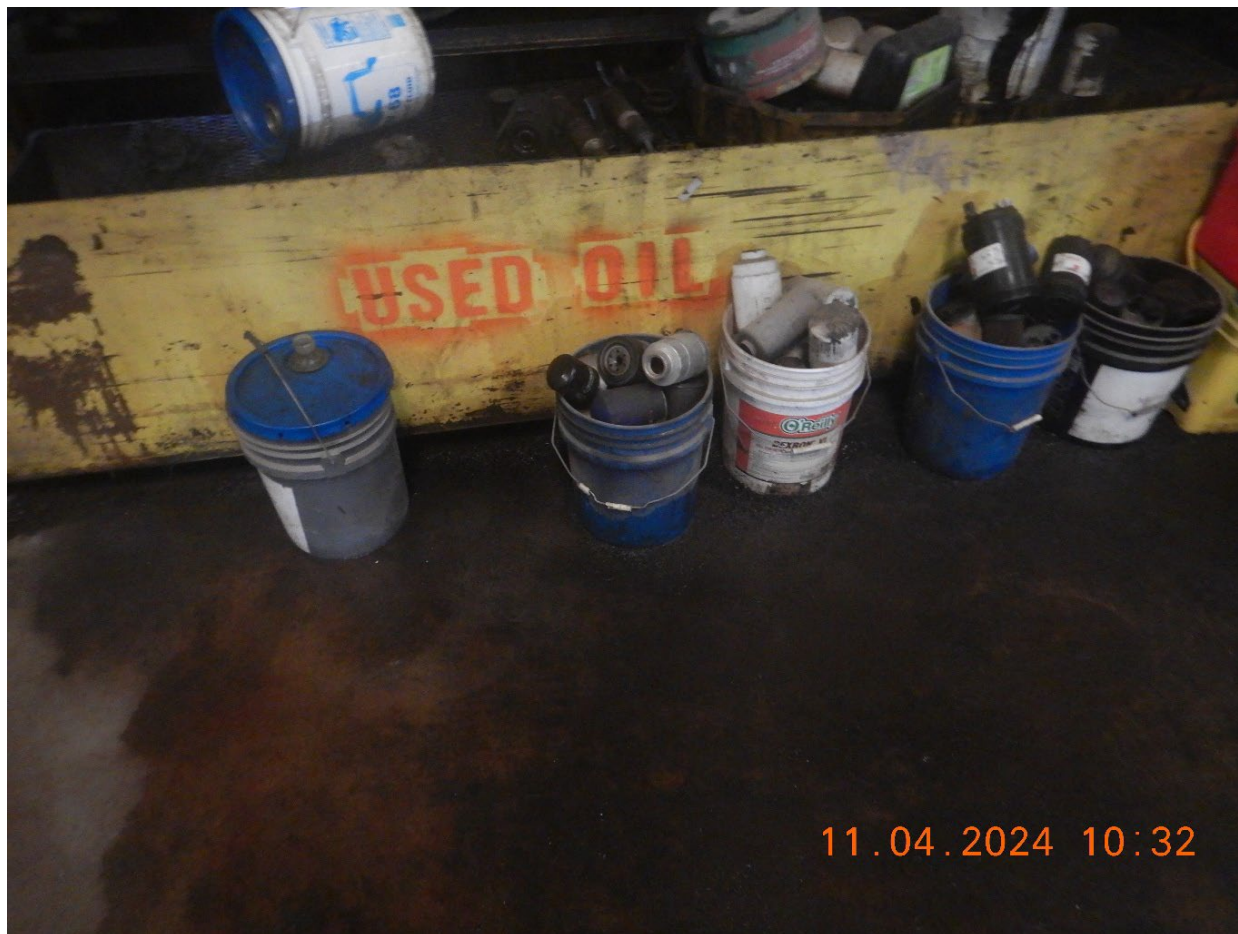
Photo No. 13

Description: View of four 5-gallon containers storing used oil filters that were not labeled found in the used oil storage area.

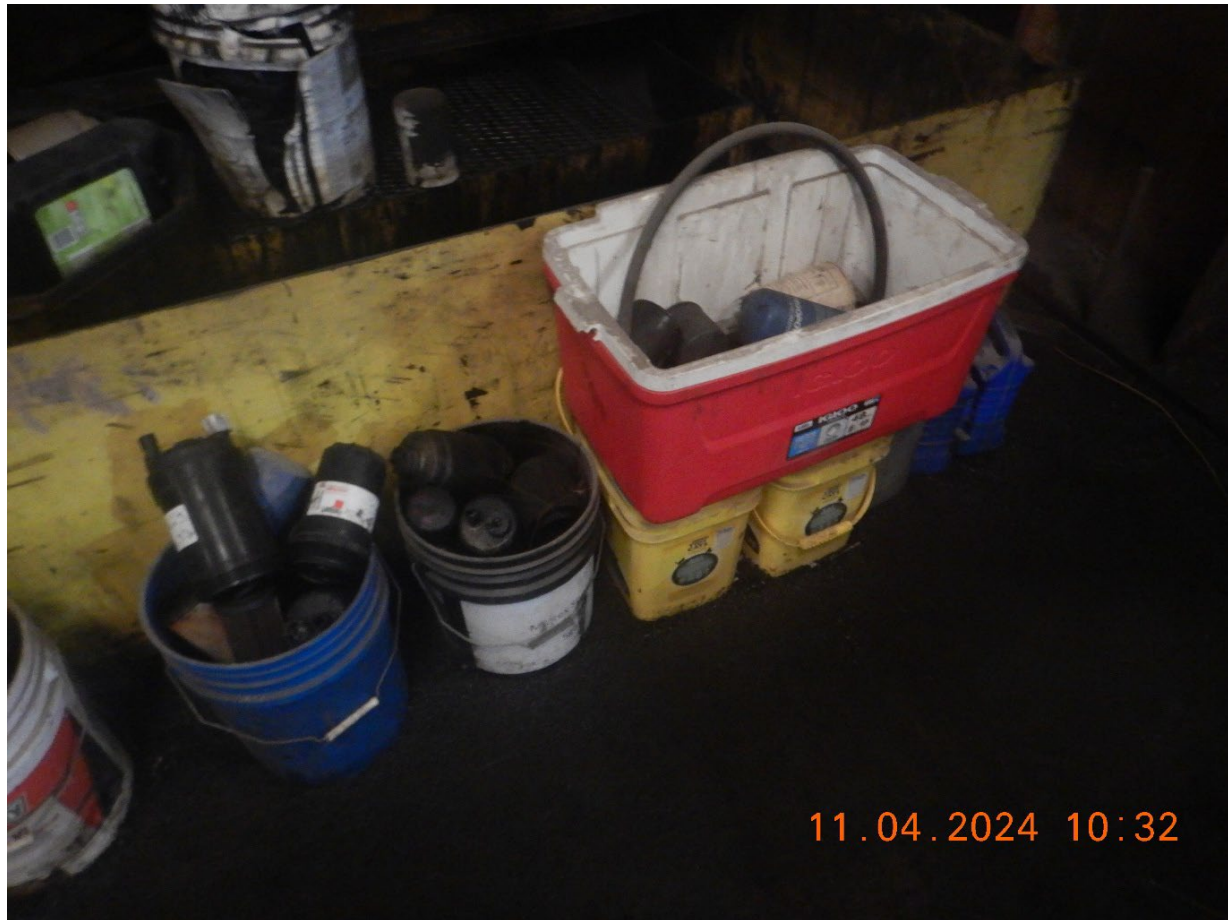
Photo No. 14

Description: View of one 10-gallon container storing used oil filters which was not labeled found in the used oil storage area.

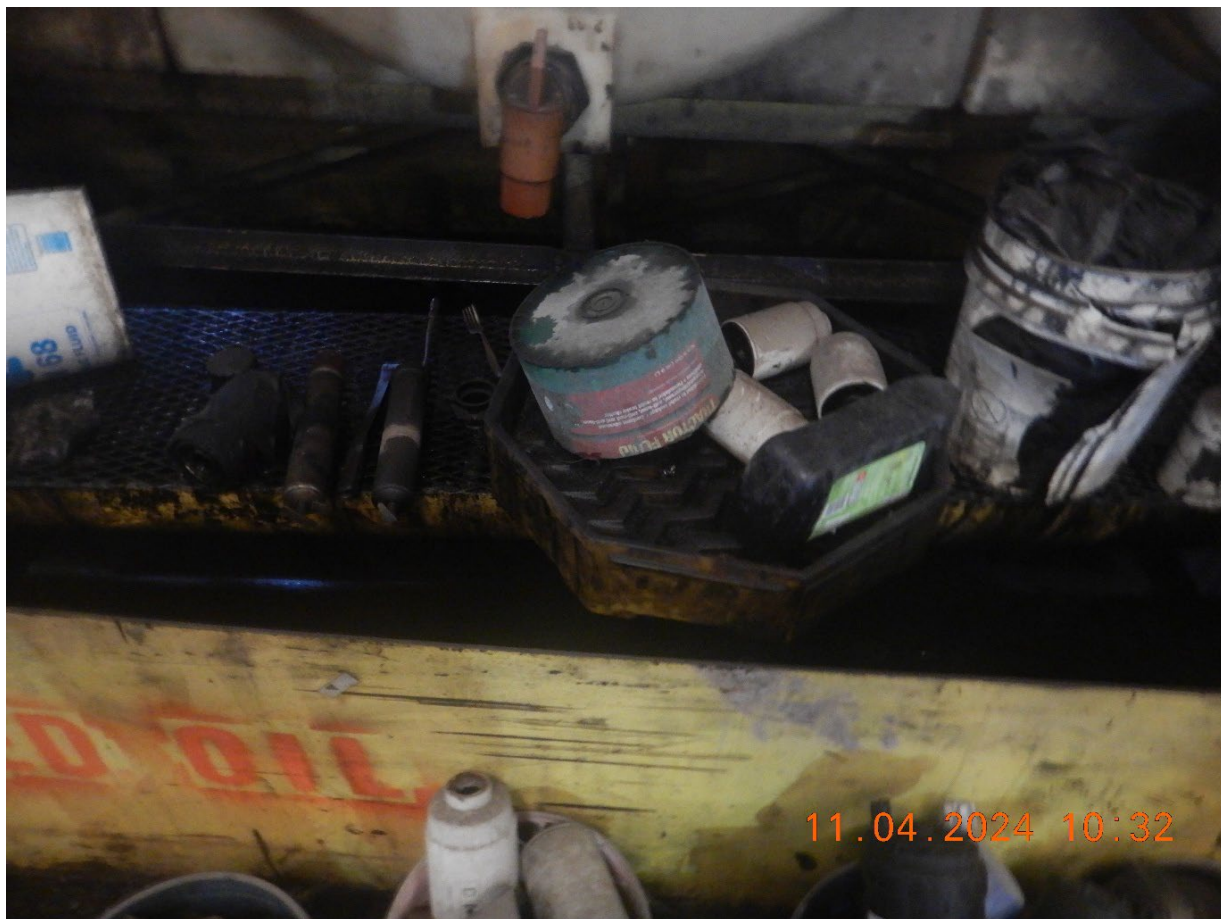
Photo No. 15

Description: View of two drip pads storing used oil filters which were not labeled found in the used oil storage area.

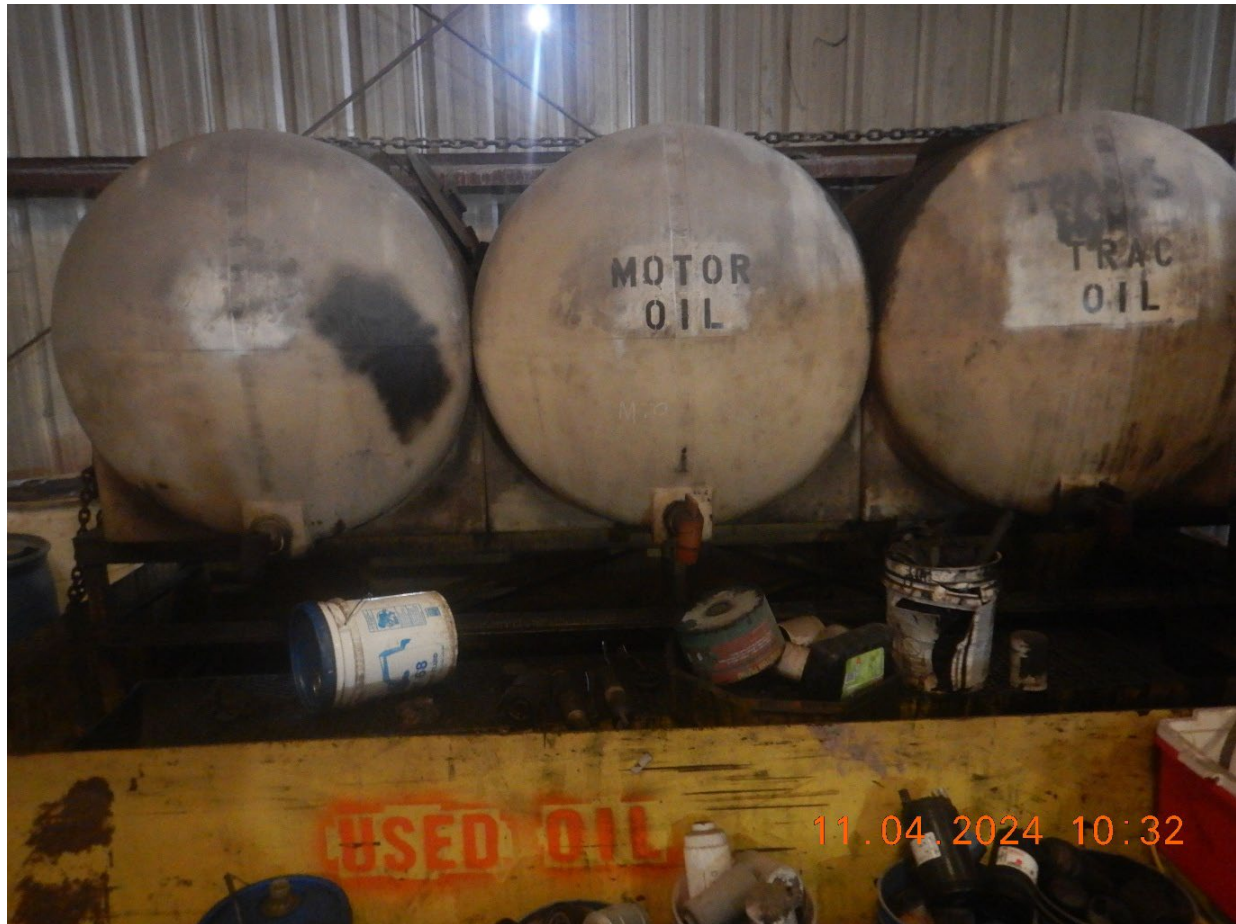
Photo No. 16

Description: Overview of the used oil storage area including inactive oil storage tanks and used oil filters.

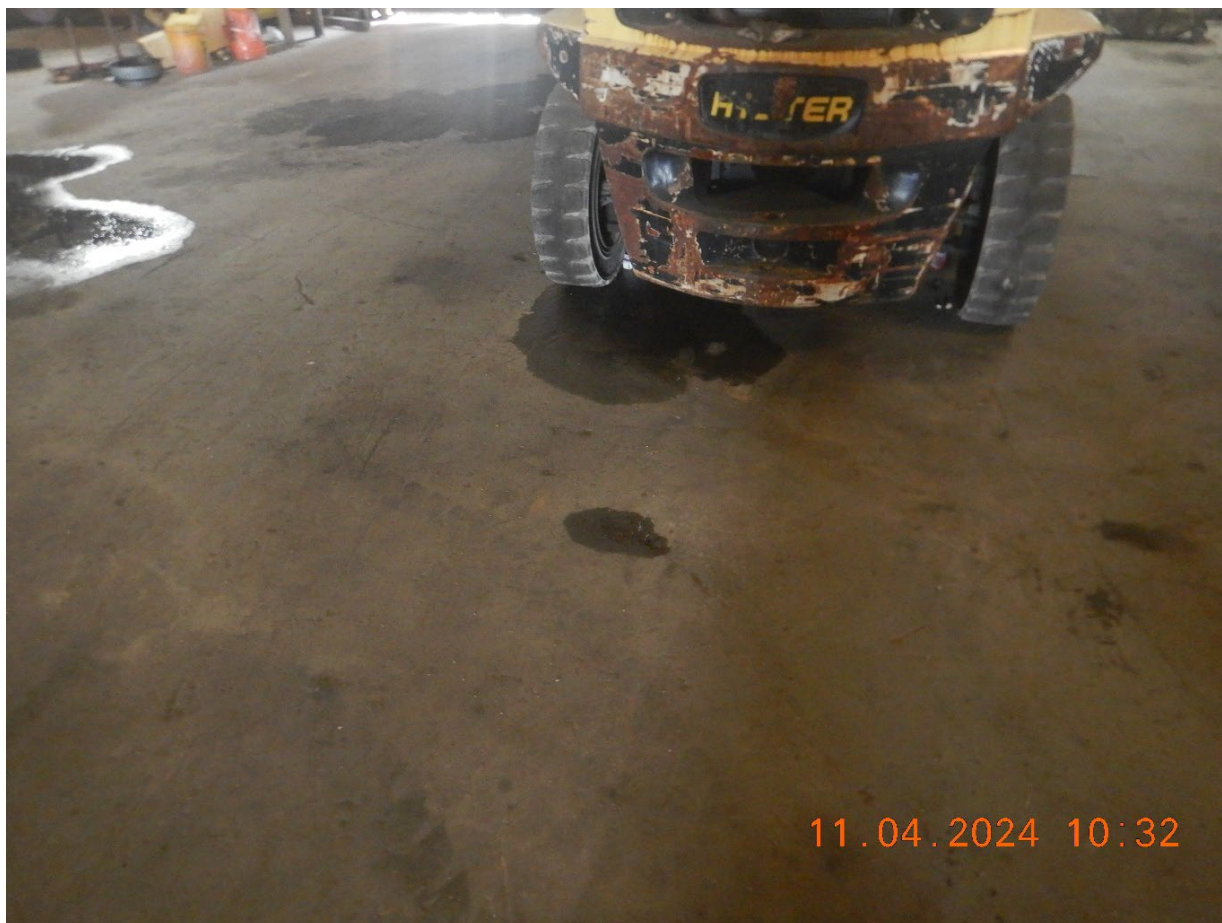
Photo No. 17

Description: View of a used oil spill found on the concrete floor of the maintenance area.

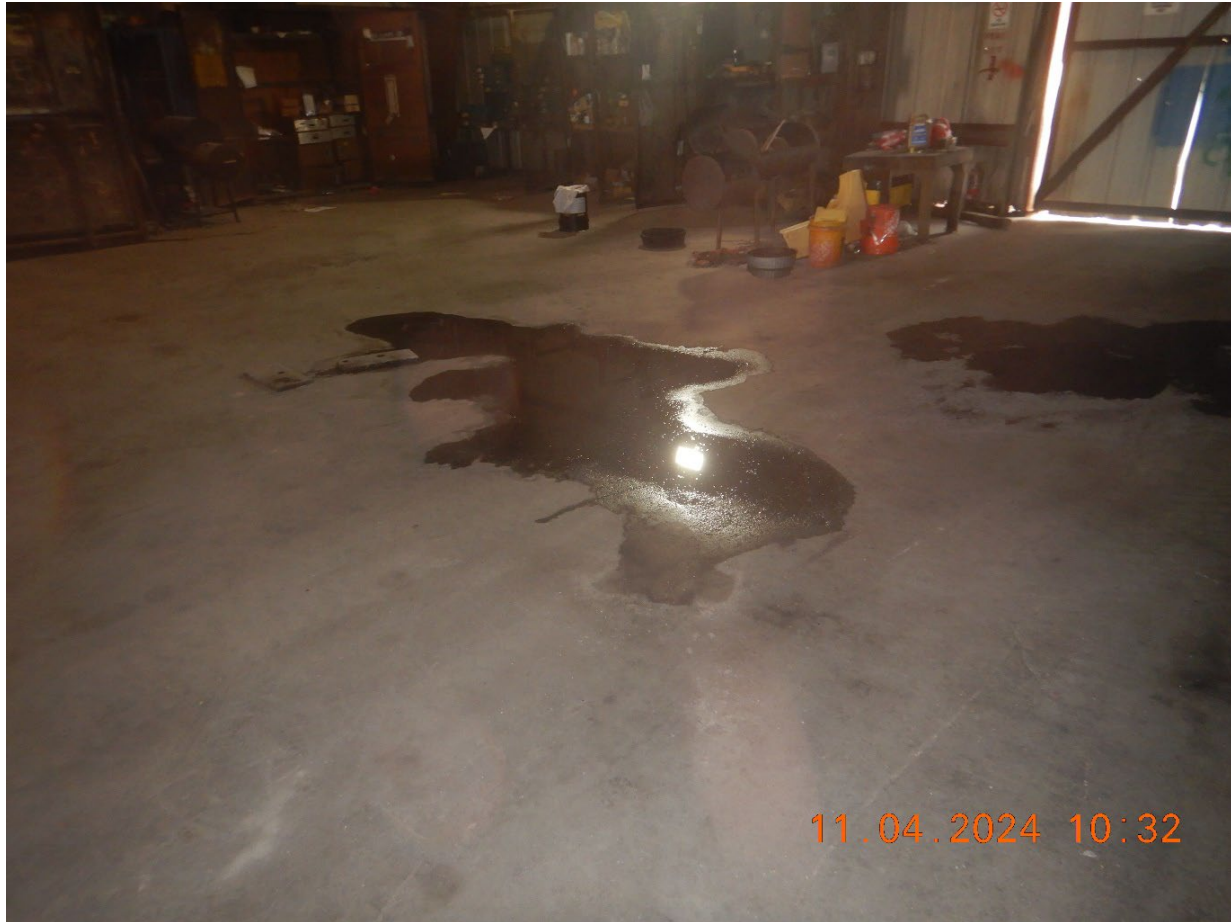
**Photo No. 18**

Description: View of a used oil spill found on the concrete floor of the maintenance area.

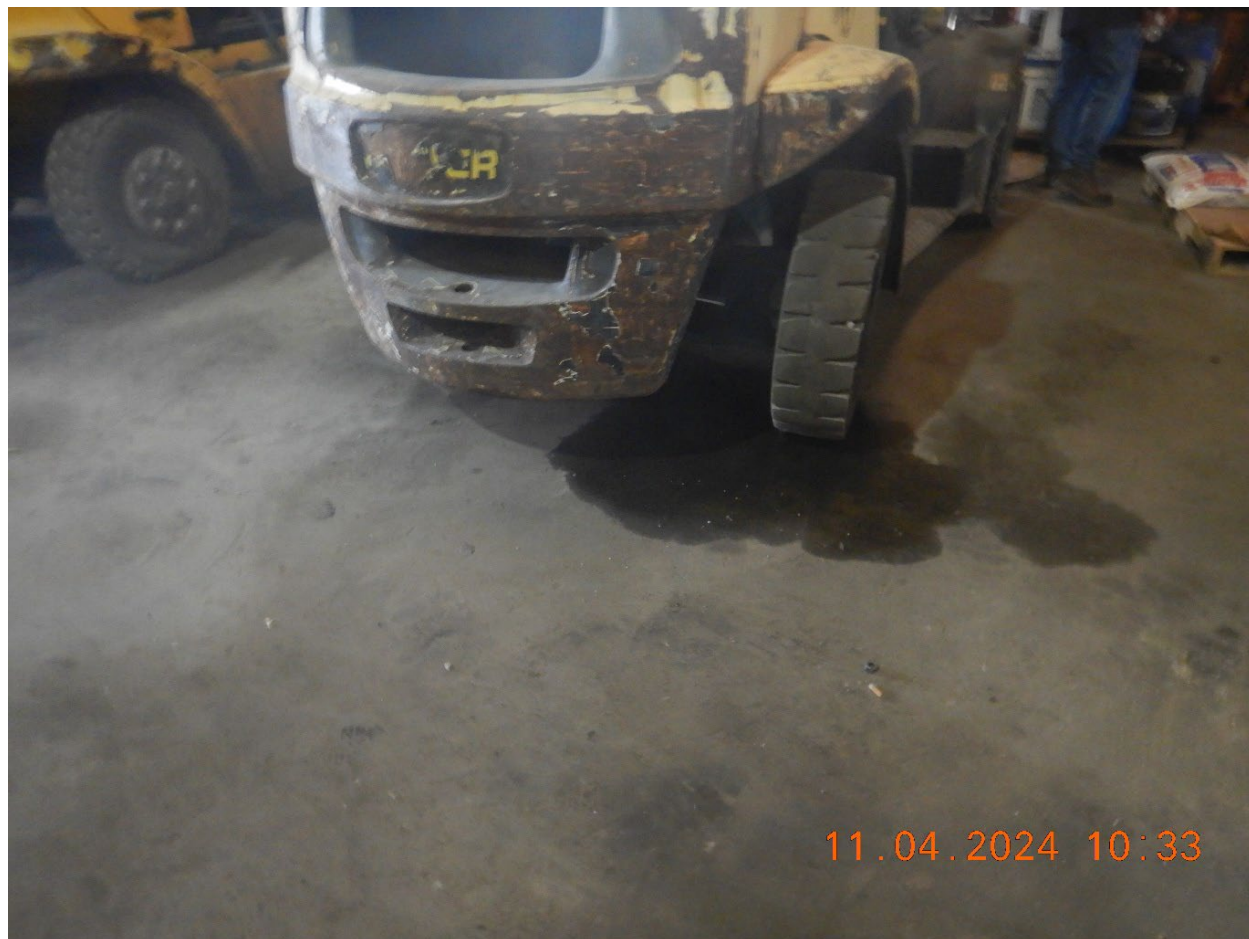
**Photo No. 19**

Description: View of a used oil spill found on the concrete floor of the maintenance area.
