INSPECTION REPORT

| Type of Inspection | Focused Compliance Inspection (FCI) | | | |
| Facility or Site Name | P.C. Pfeiffer Co., Inc. | | | |
| Facility/Site Physical Address | 1255 Main St. | | | |

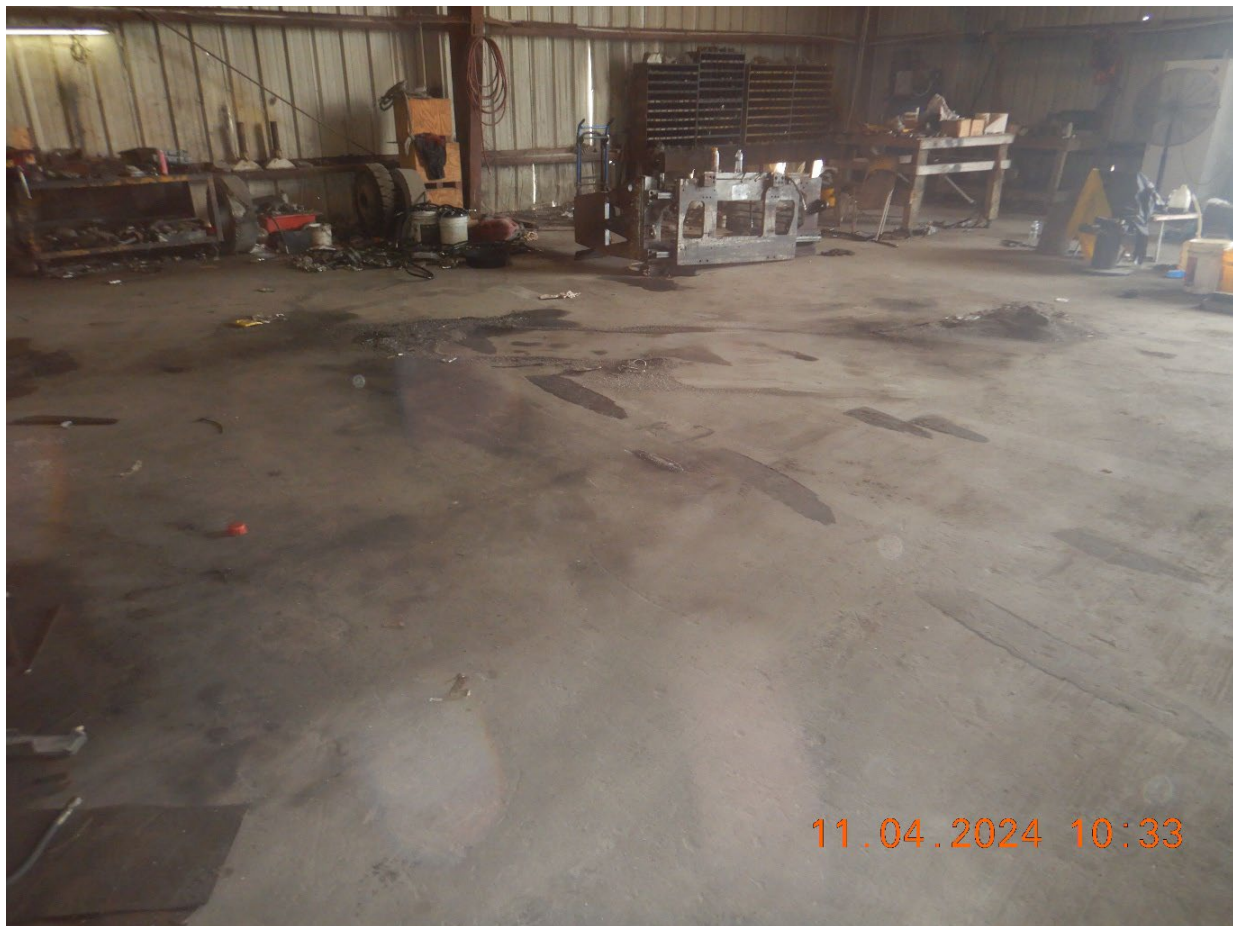
**Photo No. 20**

The inspection team moved into the maintenance area where PCP repairs their equipment. The inspection team observed several instances of used oil spills accumulating on the concrete floor throughout the maintenance area (see Appendix 1 – Photos 12 and 17 to 20) [see **AOC#2**]. PCP staff was actively cleaning up and containing used oil spills while the inspection team was conducting the visual inspection, as shown in Photo 12. Next, the inspection team observed PCP's used oil storage area found within the maintenance area. The inspection team observed one 500-gallon used oil container that was labeled "Used Oil." The container was closed and in good condition. PCP has three other 500-gallon containers that are no longer in use. On the ground of the used oil storage area, the inspection team observed six 5-gallon containers and one 10-gallon container storing used oil filters that still contained used oil (see Appendix 1 – Photos 12 to 14). Above the containers on the ground, there were several used oil filters draining into drip pads (see Appendix 1 – 15 and 16). Since the used oil filters were not drained by one of the methods in 40 CFR 261.4(b)(13), the used oil filters should be properly managed and labeled as "Used Oil" [**AOC #3**: PCP did not clearly label containers used to store used oil with the words "Used Oil." – 40 CFR 279.22 (c)(1)].

Description: View of a used oil spill found on the concrete floor of the maintenance area.

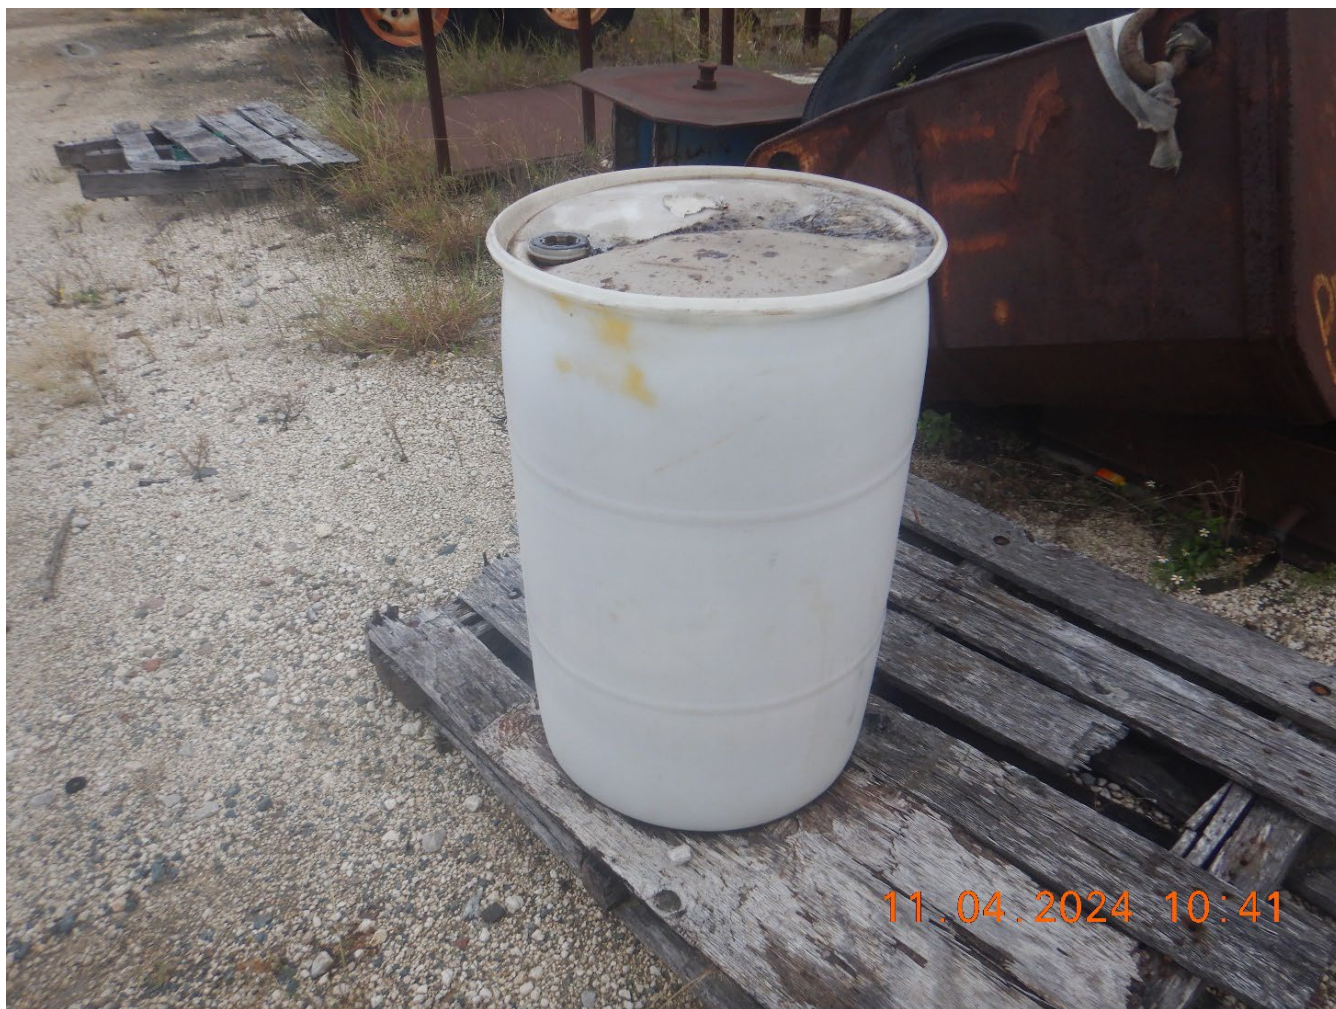
**Photo No. 21**

The inspection moved outside of the maintenance area where two 55-gallon drums were found storing liquid; both drums were approximately three-quarters full (see Appendix 1 – Photos 21 and 22). Mr. Gobert was uncertain about the contents of the two drums but guessed it may be rainwater. The inspection requested a waste determination (see **AOC#1**). The inspection team continued to conduct the visual inspection along the perimeter of the maintenance building and observed two discarded aerosol cans (see Appendix 1 – Photos 23 and 24). The aerosol cans were rusted and appeared to be left outside for some time.

Description: View of a 55-gallon drum that was found in front of the main entrance to the msintenance area storing unkown liquid; approximatley  $\frac{3}{4}$  full.

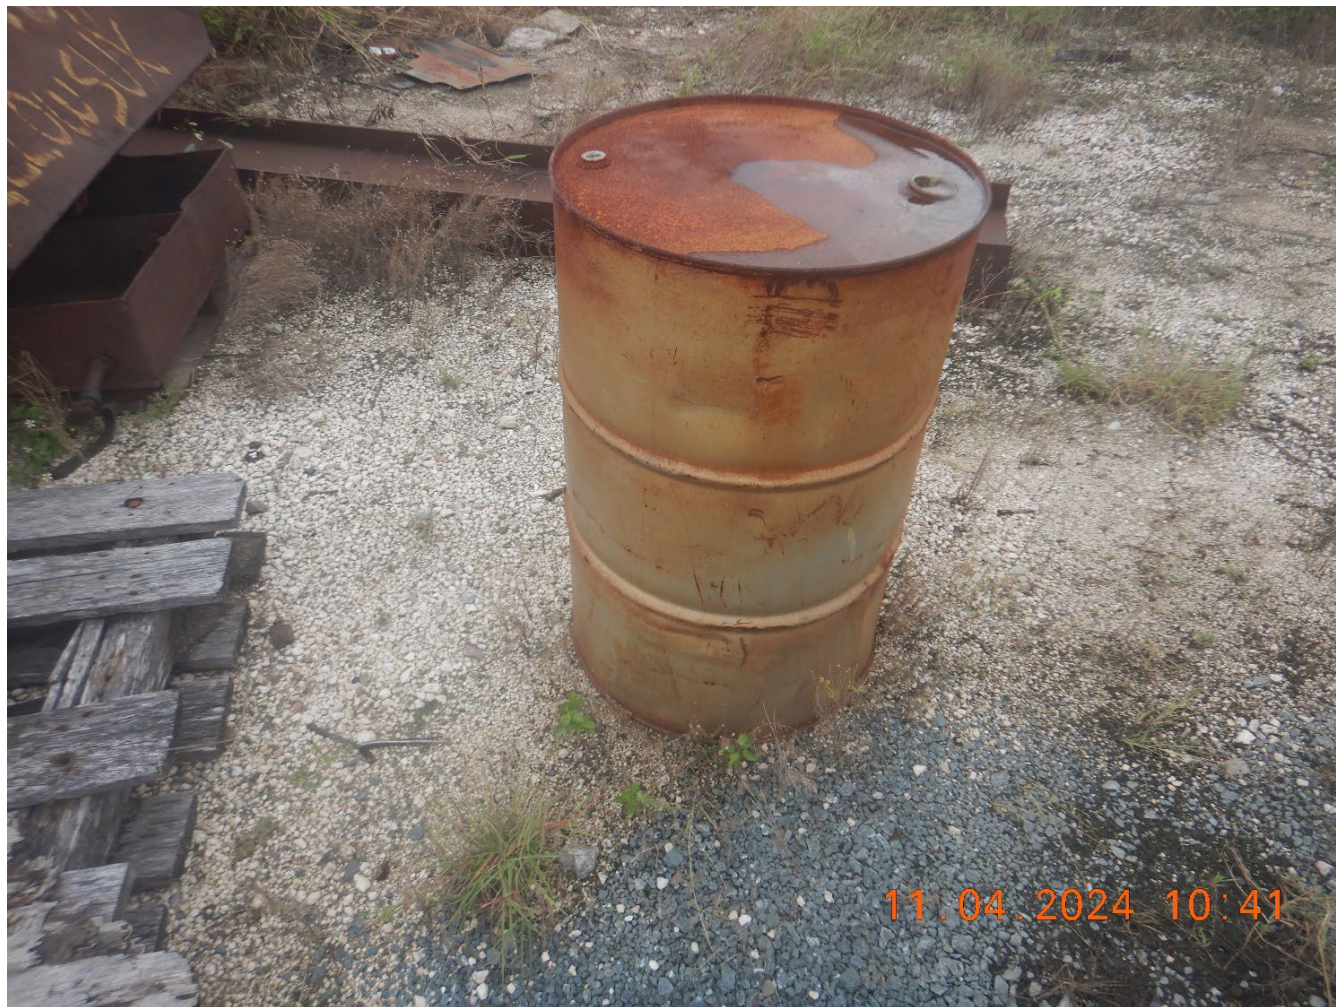
Photo No. 22

Description: View of a 55-gallon drum that was found in front of the main entrance to the msintenance area storing unkown liquid; approximatley  $\frac{3}{4}$  full.

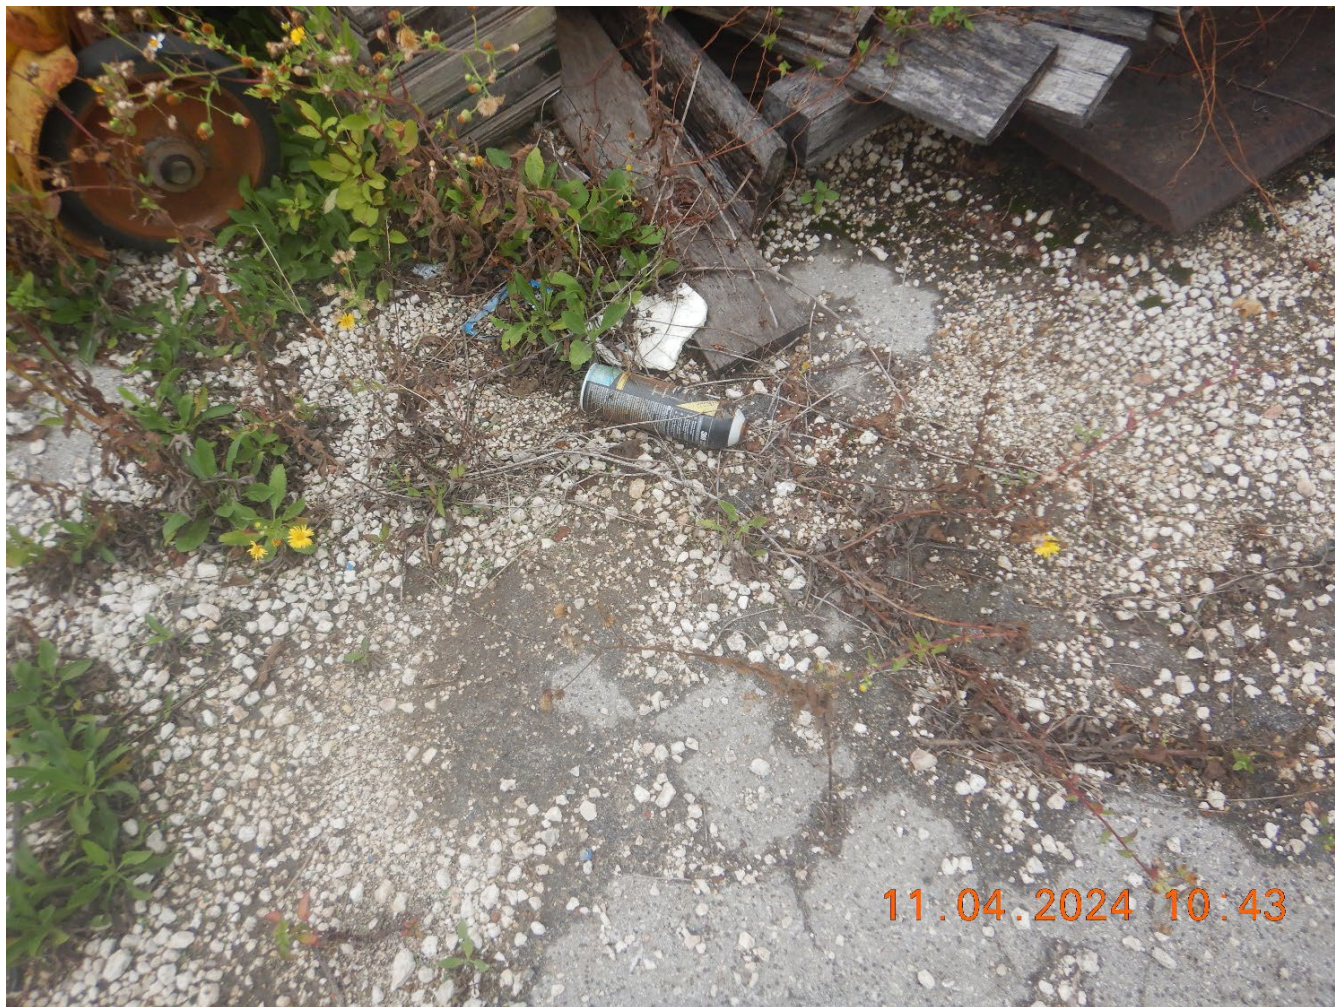
**Photo No. 23**

Description: View of a discarded aerosol can found on the ground along the perimeter of the maintenance building.

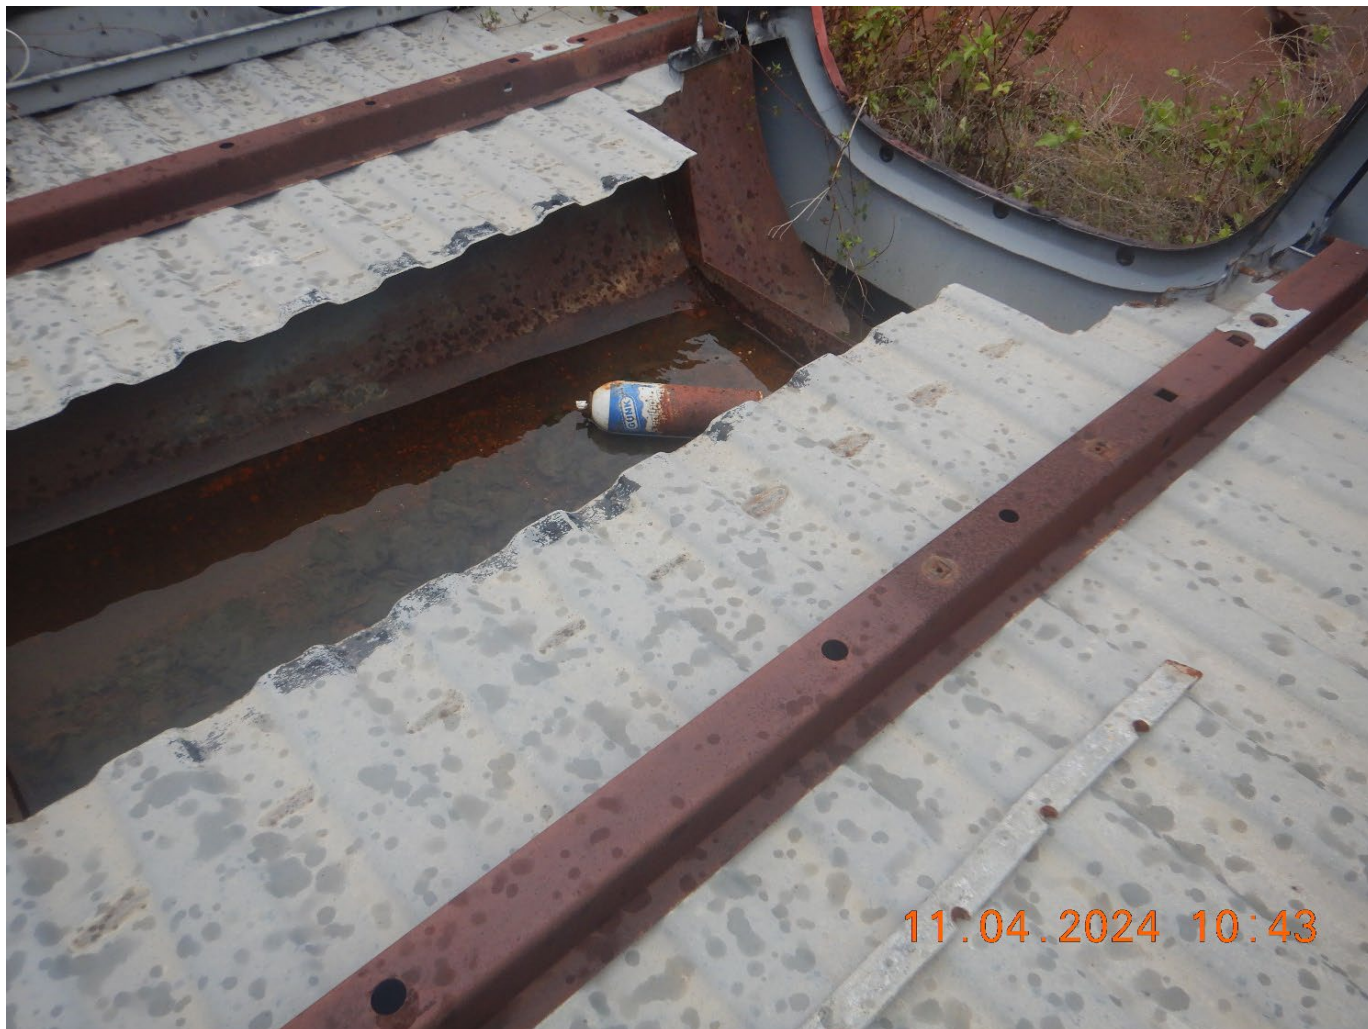
Photo No. 24

Description: View of a discarded aerosol can found on the ground along the perimeter of the maintenance building.

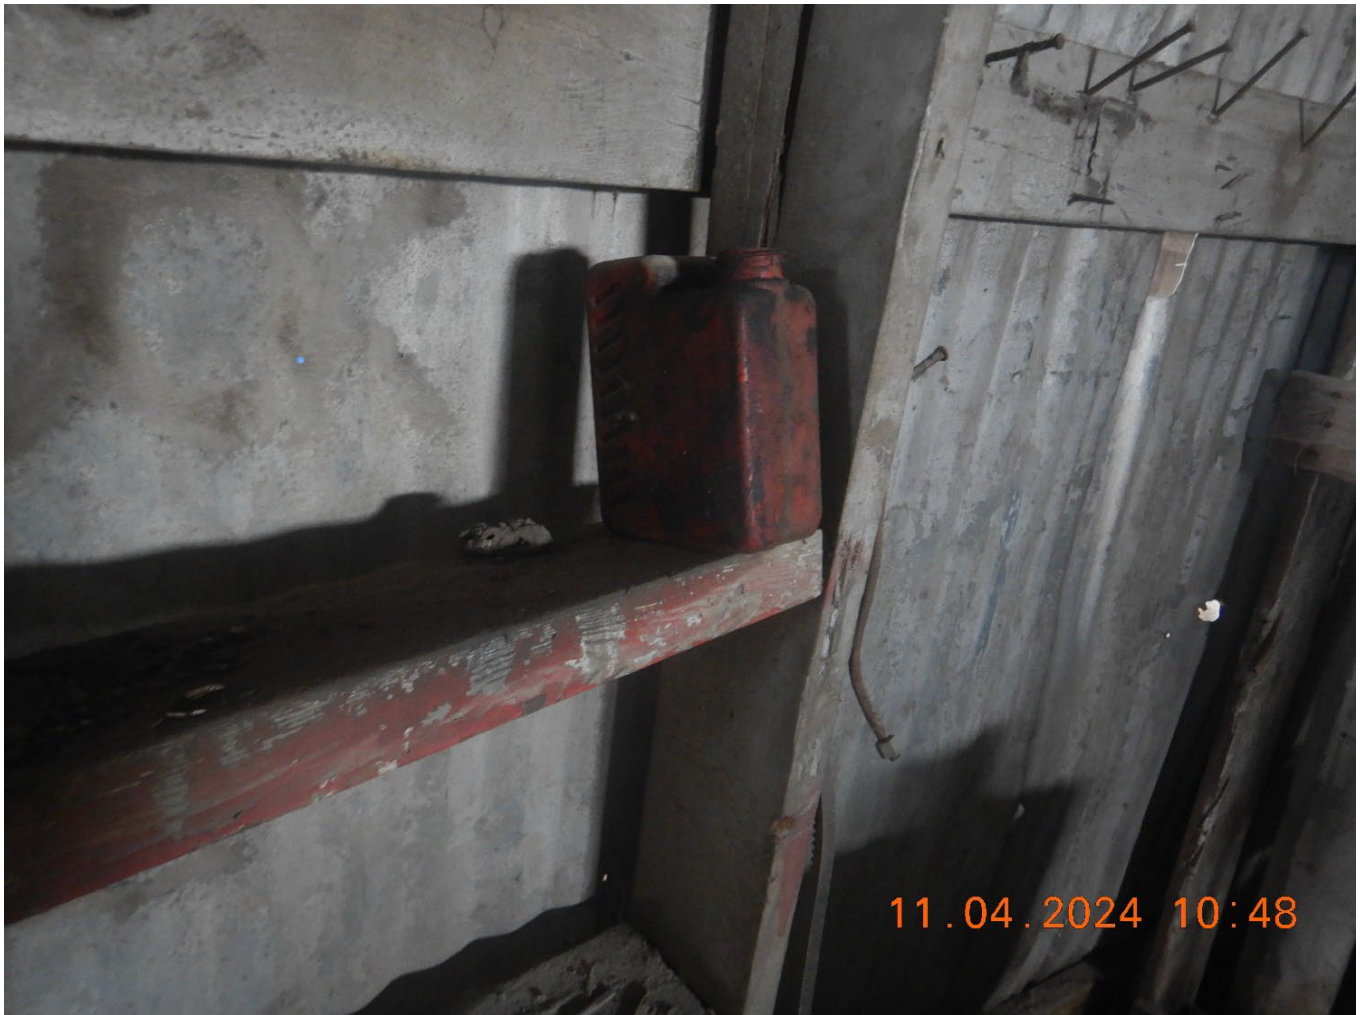
**Photo No. 25**

Description: View of a 1-gallon container found on a shelf inside the fuel tank shed. The container was about full of unknown liquid.
