**UNITED STATES ENVIRONMENTAL PROTECTION AGENCY**  
**OFFICE OF ENFORCEMENT AND COMPLIANCE ASSURANCE**

**SUBJECT:** CLEAN AIR ACT INSPECTION REPORT  
Republic Services McCarty Road Landfill, Houston, TX

**Facility Name:** Republic Services McCarty Road Landfill

**Purpose of Inspection:** Surface monitoring and partial compliance evaluation for the Clean Air Act

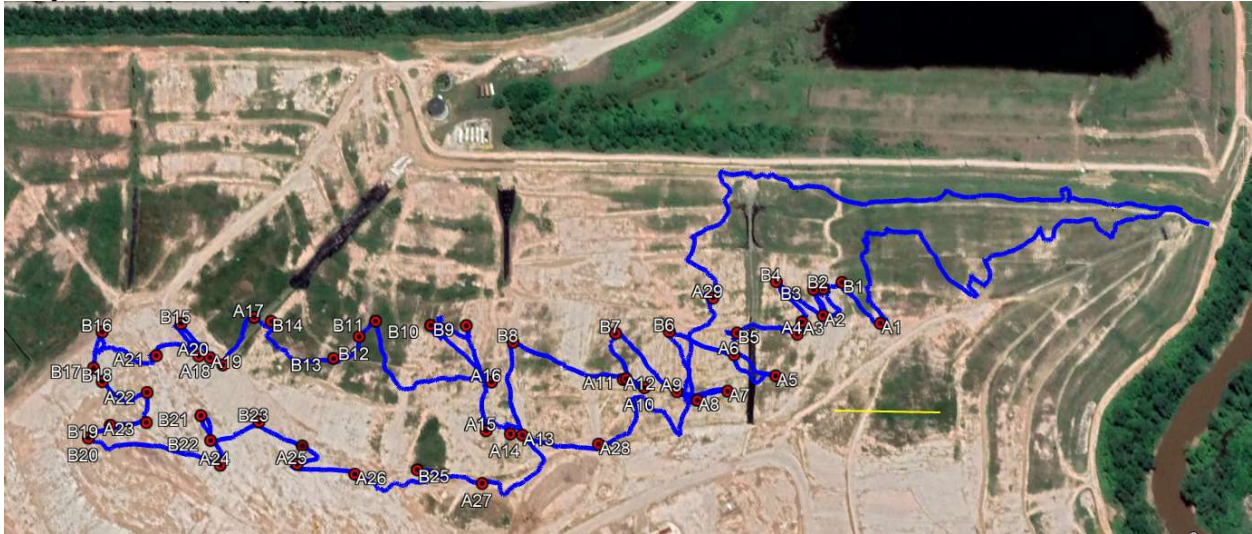
## Map of Detected Exceedances

In the main area of SEM survey on the northern portion of the Landfill, exceedances were found primarily at penetrations and areas of erosion/exposed waste.

- EPA noted the disparity between the number of exceedances they had found compared with the reviewed recent SEM surveys, indicating possible concerns with the quality of the SEM surveys
- EPA noted that erosion and exposed waste was seen across the survey area
- EPA noted that some of the pneumatic pump outlets were venting landfill gas (and condensate), and that the carbon canisters being utilized did not effectively control the emissions

Blue line roughly shows EPA survey coverage, tracing the confirmation reading instrument. Exceedance locations labeled with their flag numbers. Yellow line is 100m, north is up. Satellite imagery dated to April 2022 as shown on Google Earth. Survey area covered less than 40 acres.
