# Riverside/Gees Mill Subdivision

## Photolog

Stormwater CEI August 24, 2023

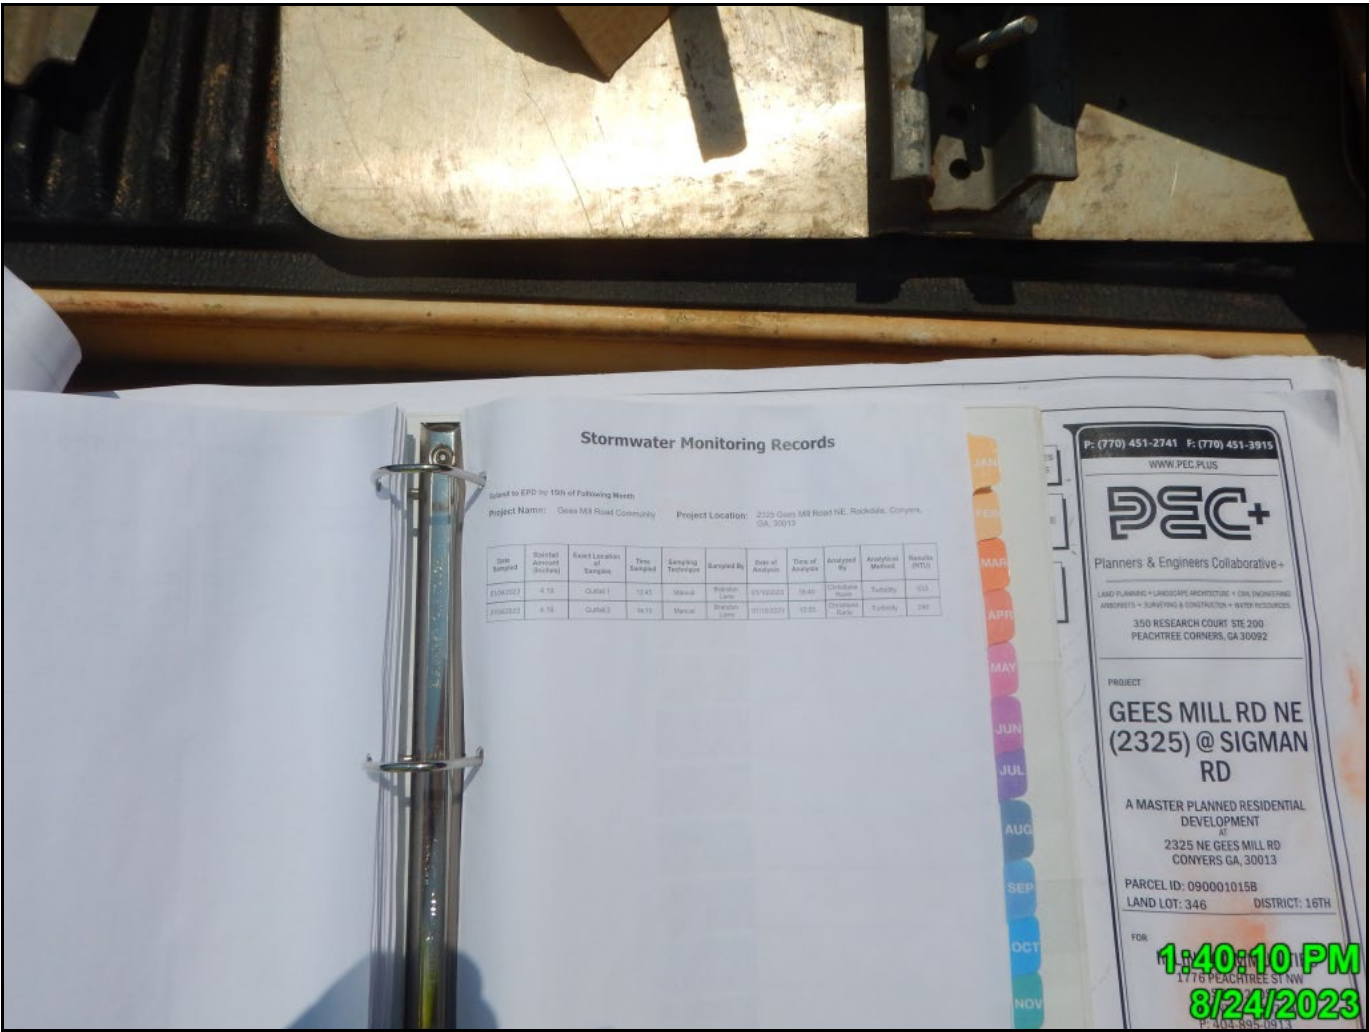
| Attributes | |
|---|---|
| Description | Stormwater runoff sampling from January 2023 shows turbidity of 533 and 246 turbidity units at the two sampling locations. |

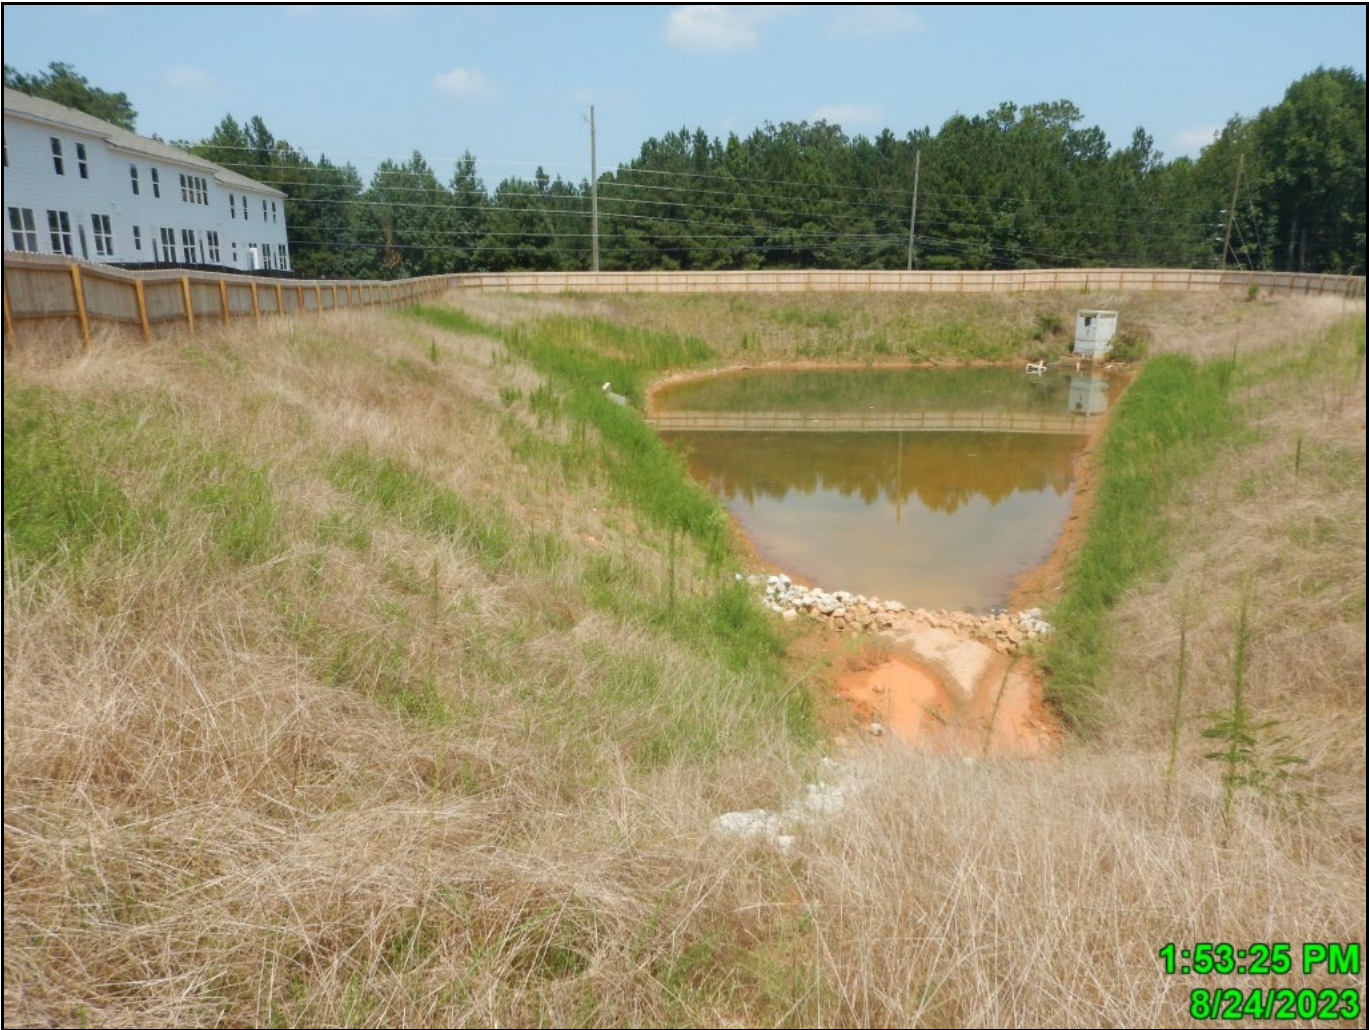
| Attributes | |
|---|---|
| Description | The northeasterly pond. One inlet in the foreground and one inlet in the left center of the pond. The outlet is at the back right of the photo, in the northeast corner. |

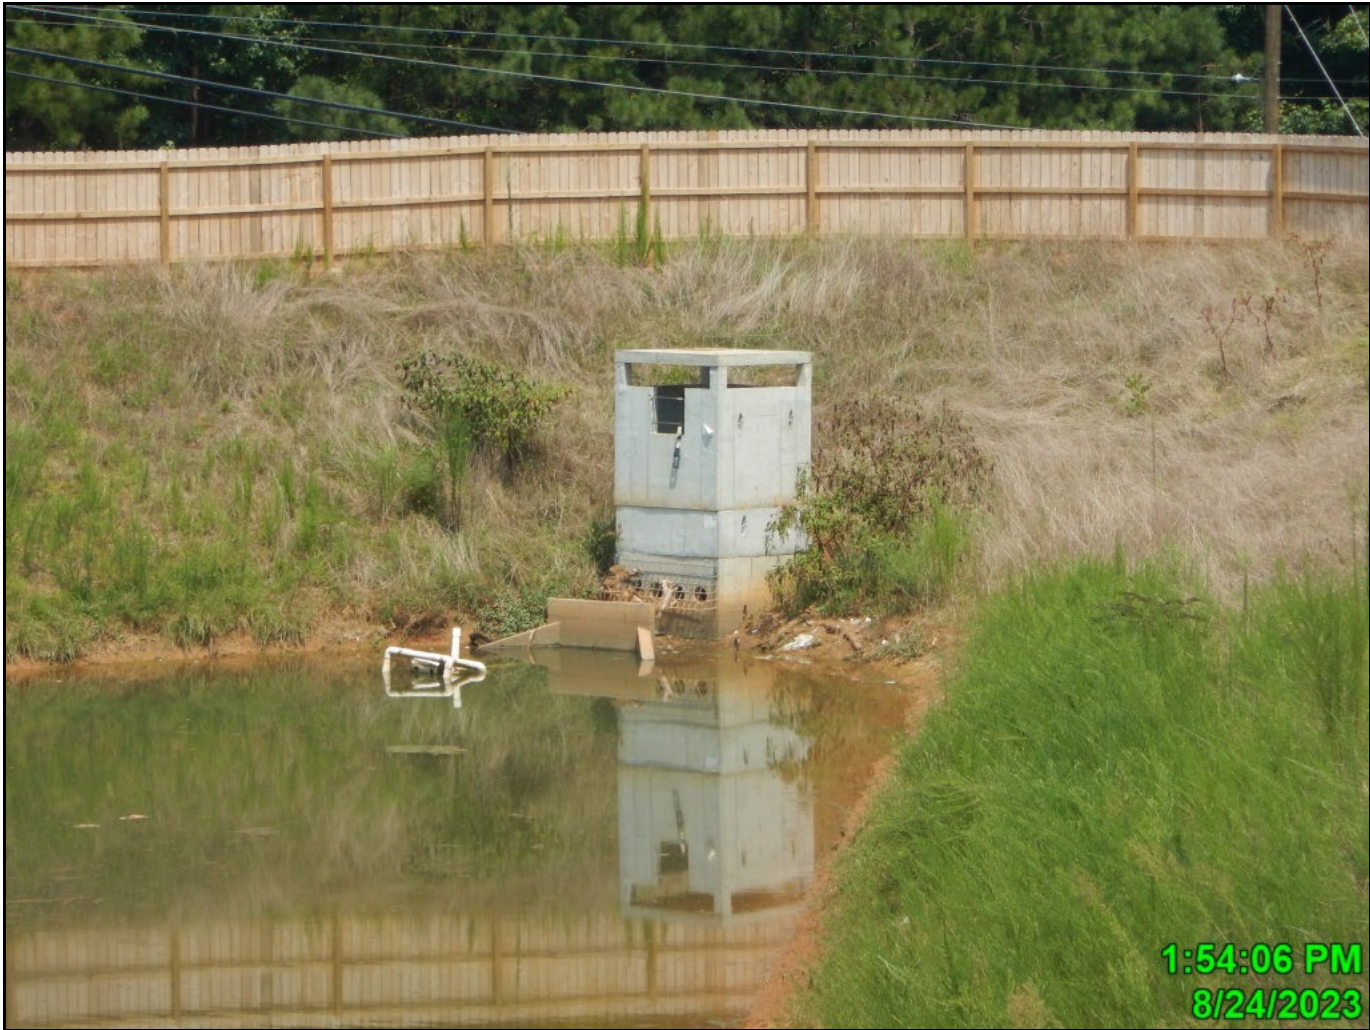
| Attributes | |
|---|---|
| Description | Zoomed-in detail of the outlet structure for the northeast pond. |

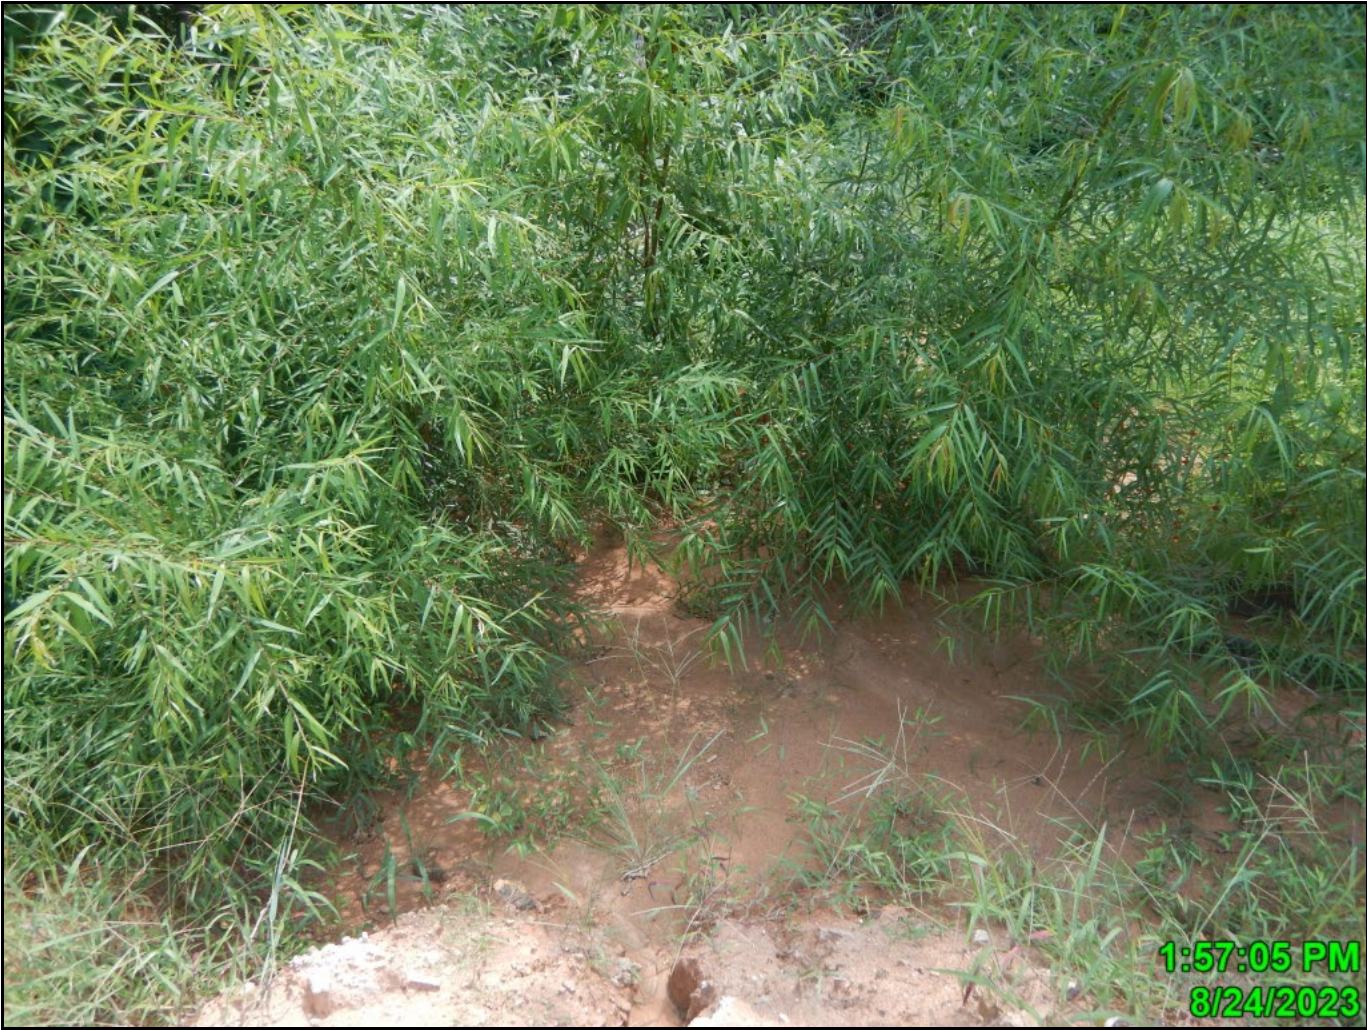
| Attributes | |
|---|---|
| Description | At the northeast pond outlet, there had been some sediment transfer from the pond to the outlet area. The sediment did not continue to a receiving water. |

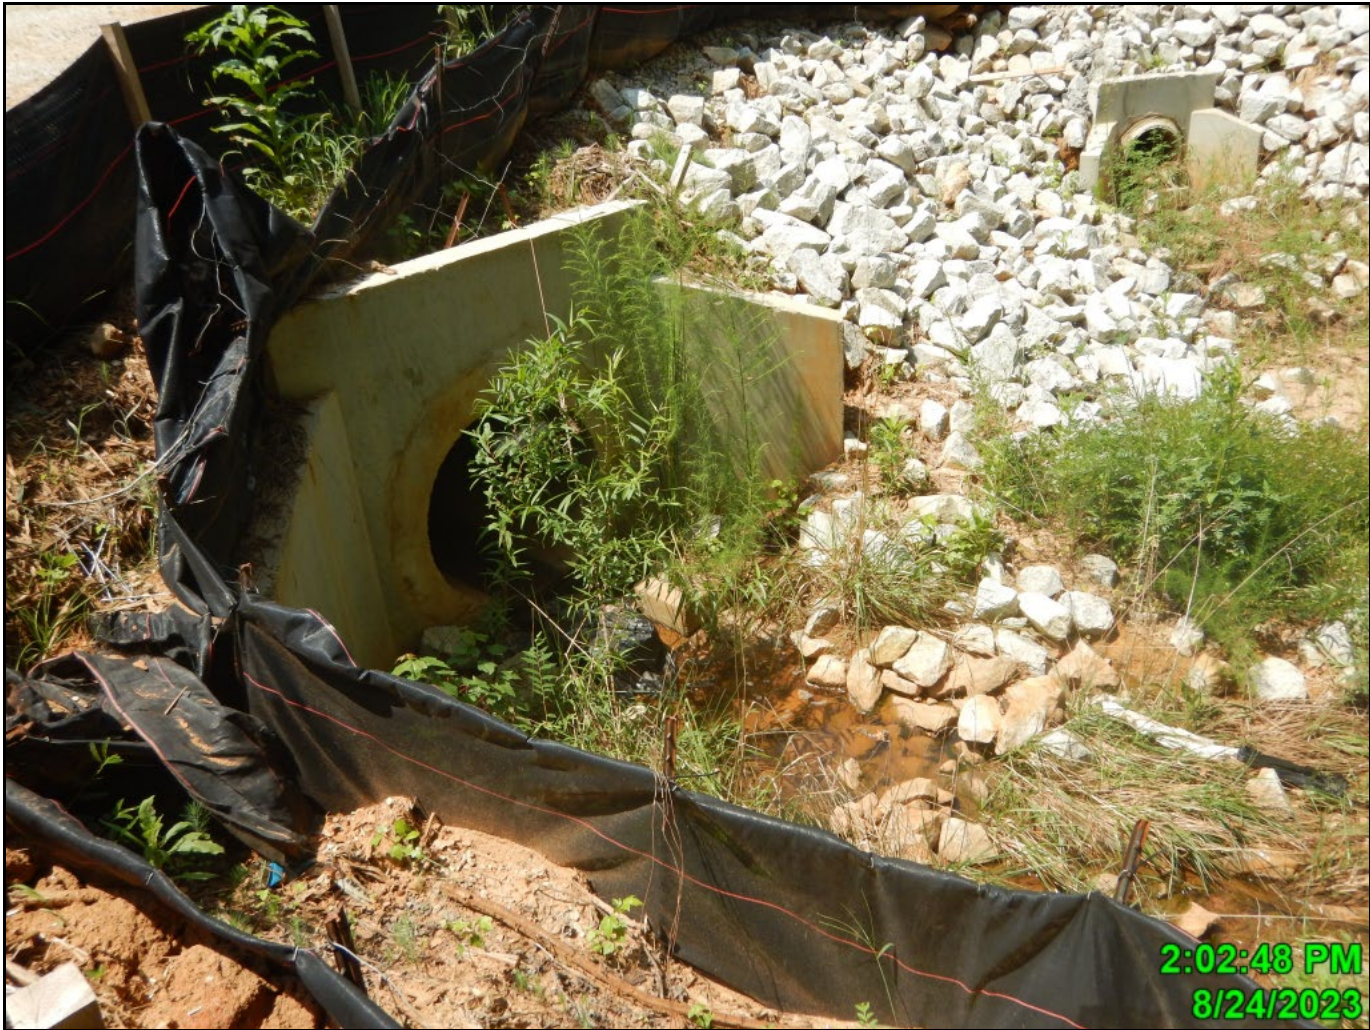
| Attributes | |
|---|---|
| Description | At the outlet structure for the northeasterly pond, there was a double row of silt fence installed. Some of the fence was damaged, and the riprap was irregularly covering the surface. The Manual for Erosion and Sediment Control in Georgia, 2016 edition, has proper design information for outfall structures. The smaller outlet on the right discharges from the roadside ditch. |

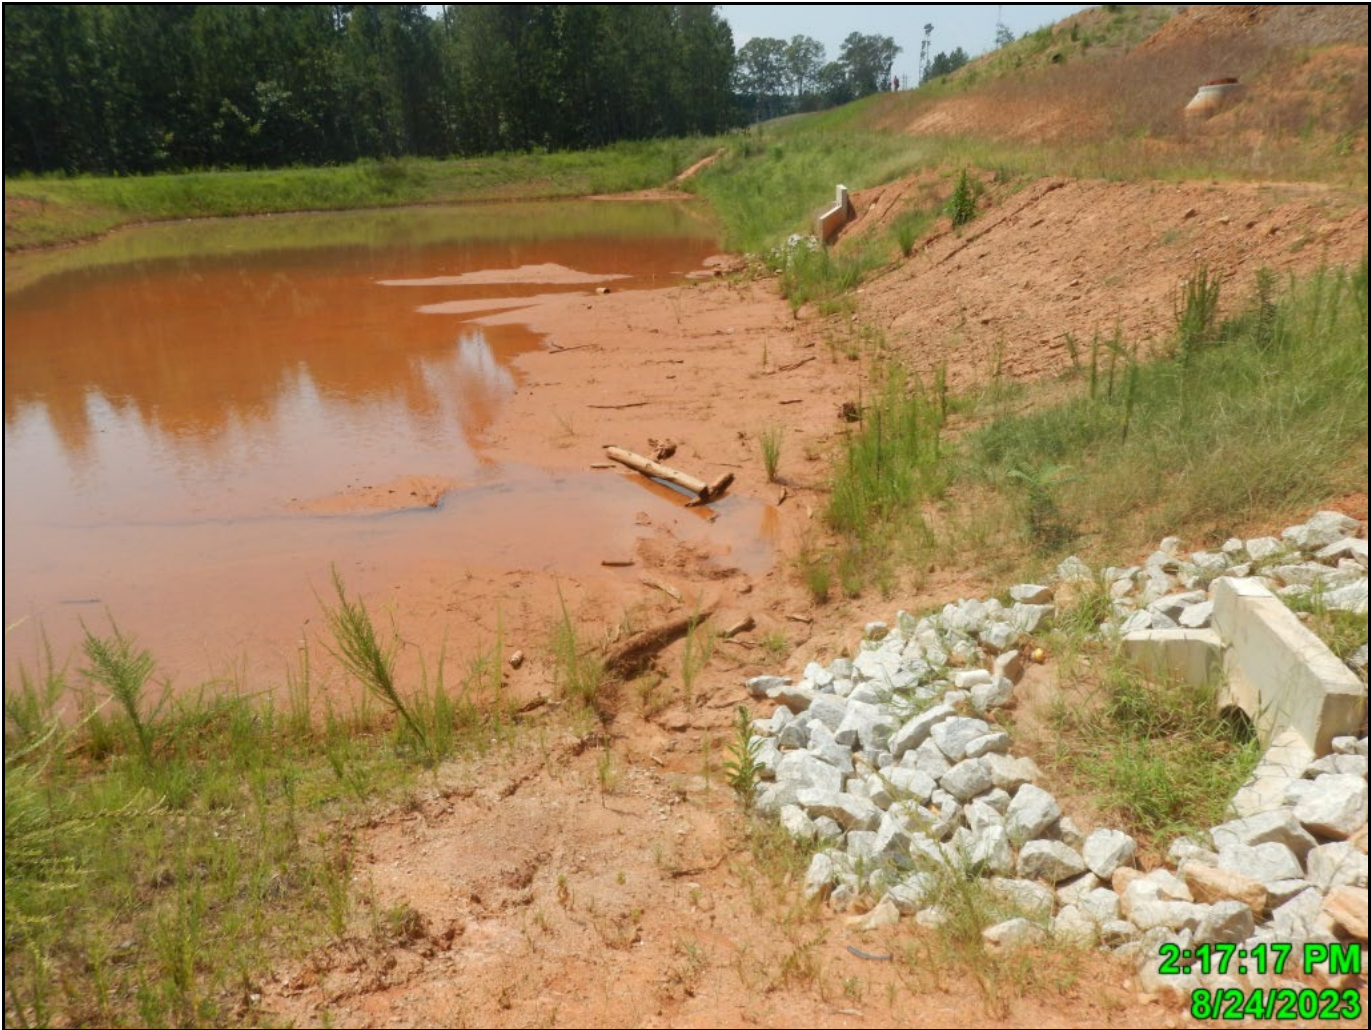
| Attributes | |
|---|---|
| Description | The main pond serving the phase 2 area had two basins. This is a view of the incompletely stabilized northerly wall of the basin and the three inlet structures from the phase 2 area. Improper rock installation was causing partial plugging of the pipe closest to the photographer. |

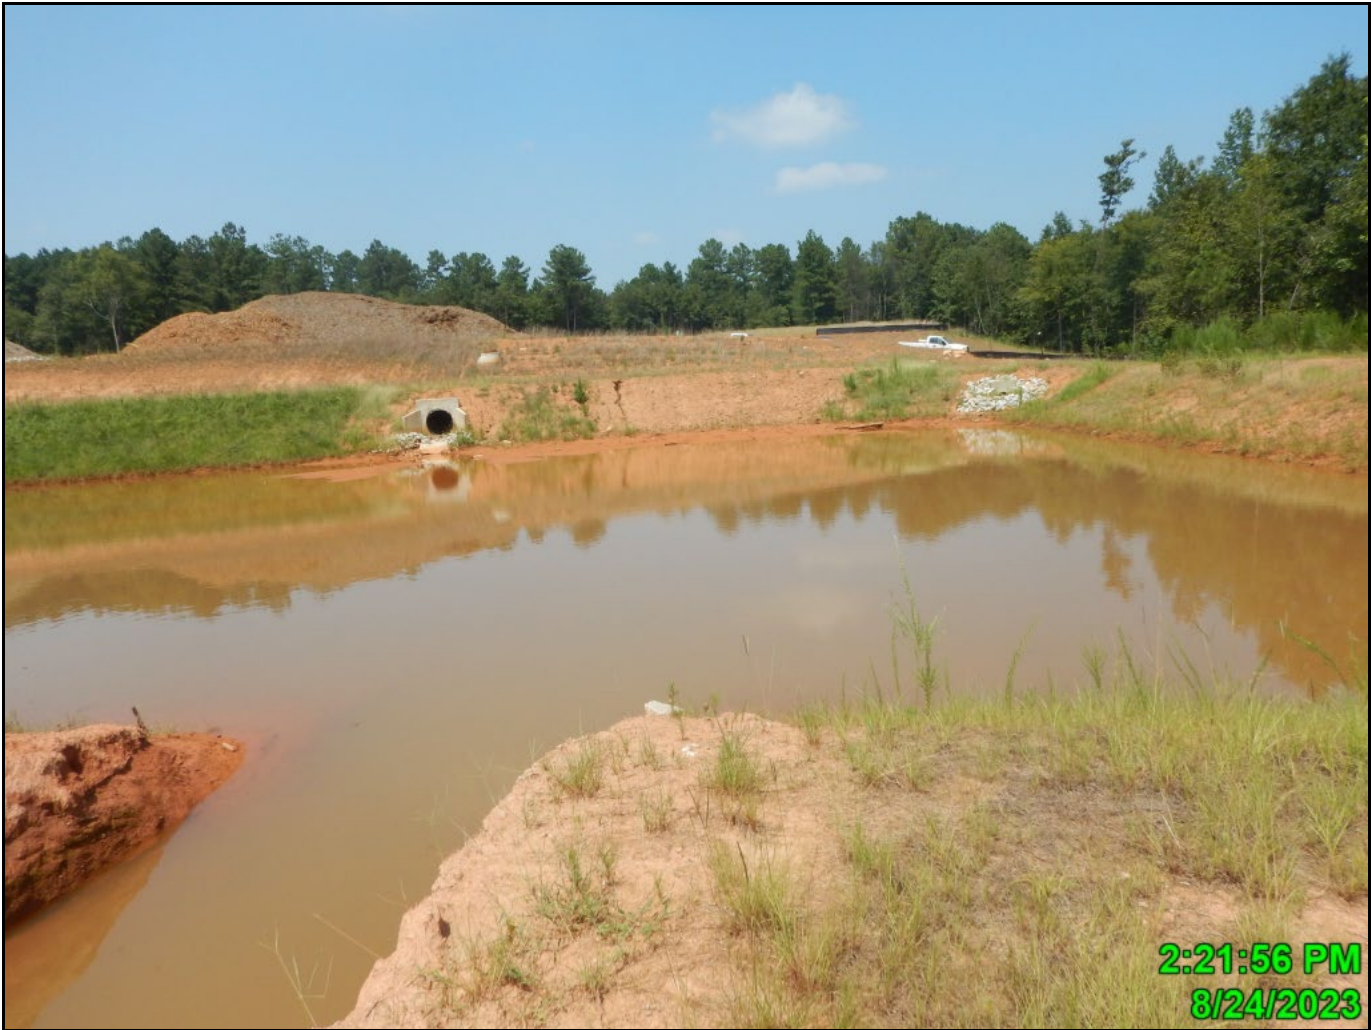
| Attributes | |
|---|---|
| Description | A look at the higher basin of the southerly pond, looking at the northerly wall. To the photographers left is a cut channel from the higher basin to the lower basin. |

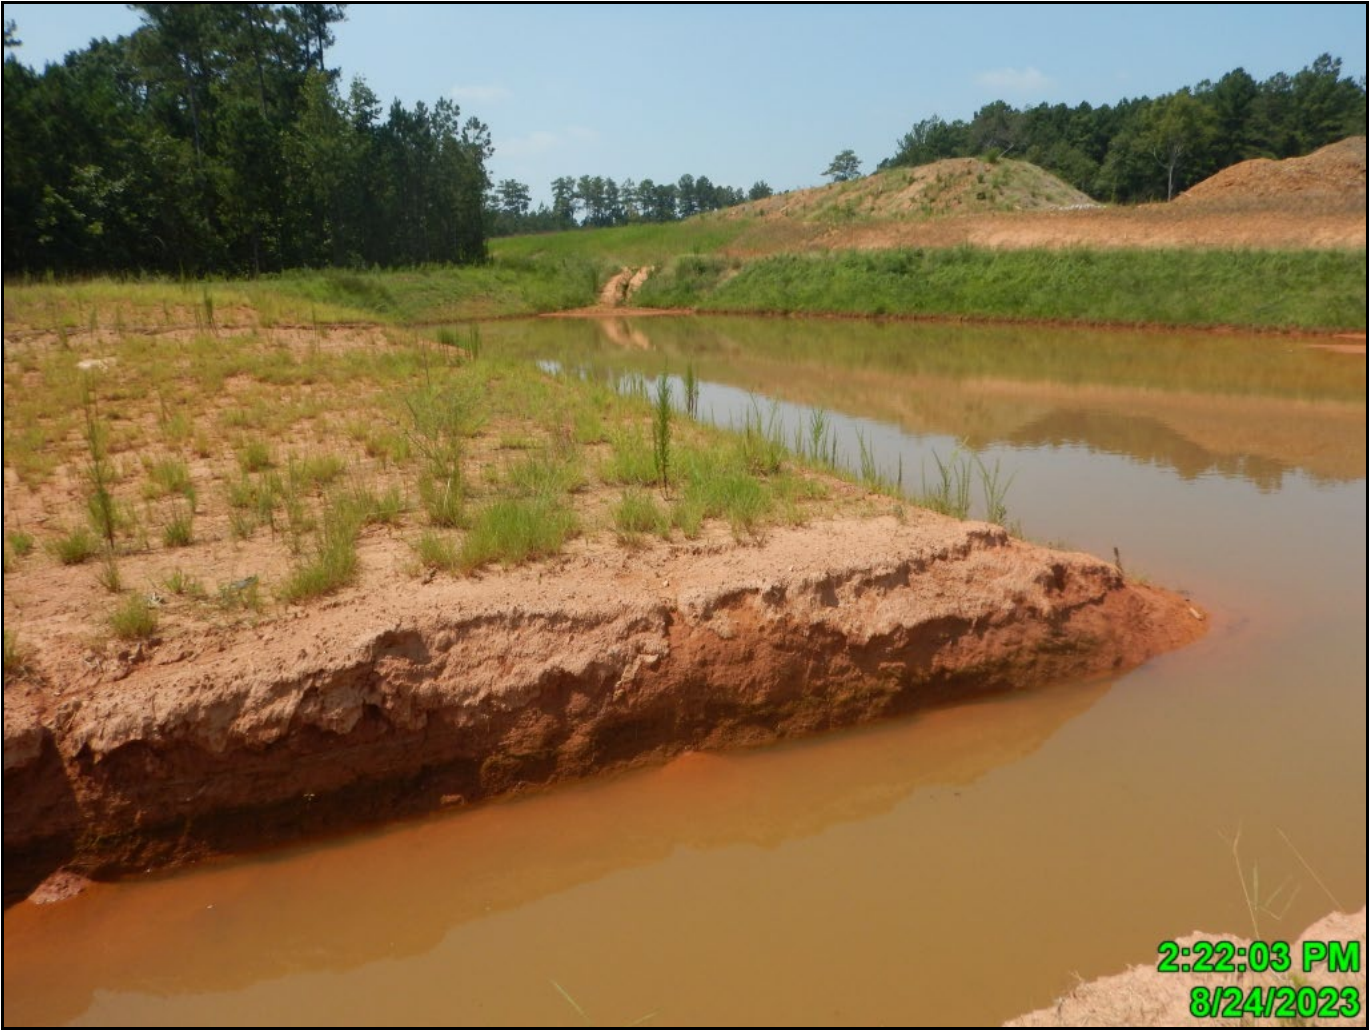
| Attributes | |
|---|---|
| Description | A view of the higher basin of the southerly pond, looking northwesterly. There is some ongoing erosion at the northwest corner. Pond banks are not properly stabilized. |

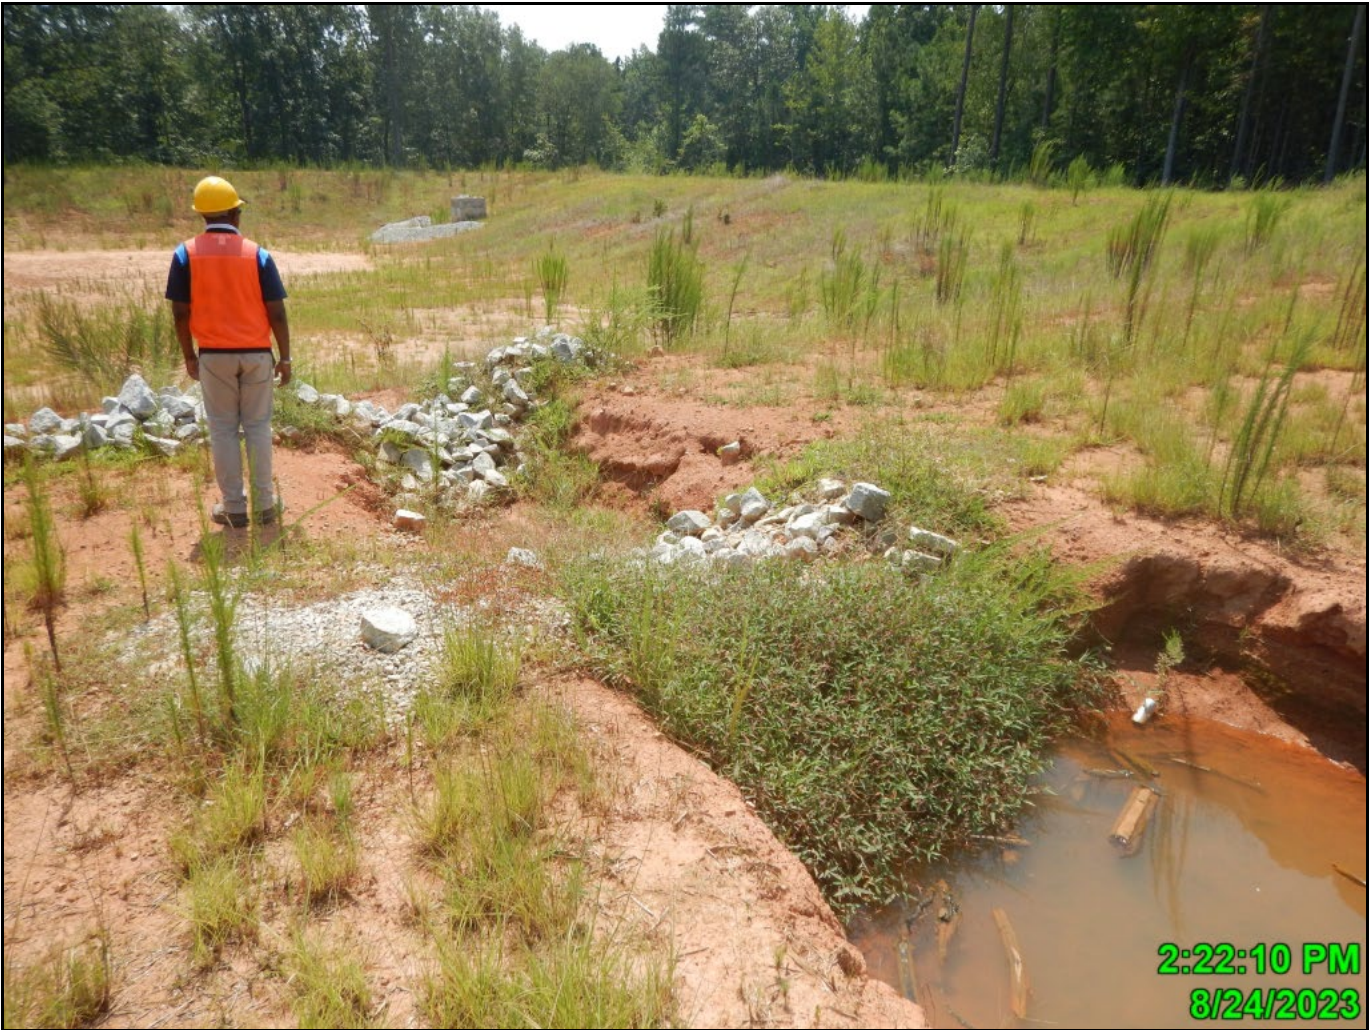
| Attributes | |
|---|---|
| Description | The trench in the foreground links the upper and lower stormwater basins in the southerly pond. The banks and bottom of the pond are not properly vegetated. This trench is not properly stabilized and could lead to upper basin collapse. |

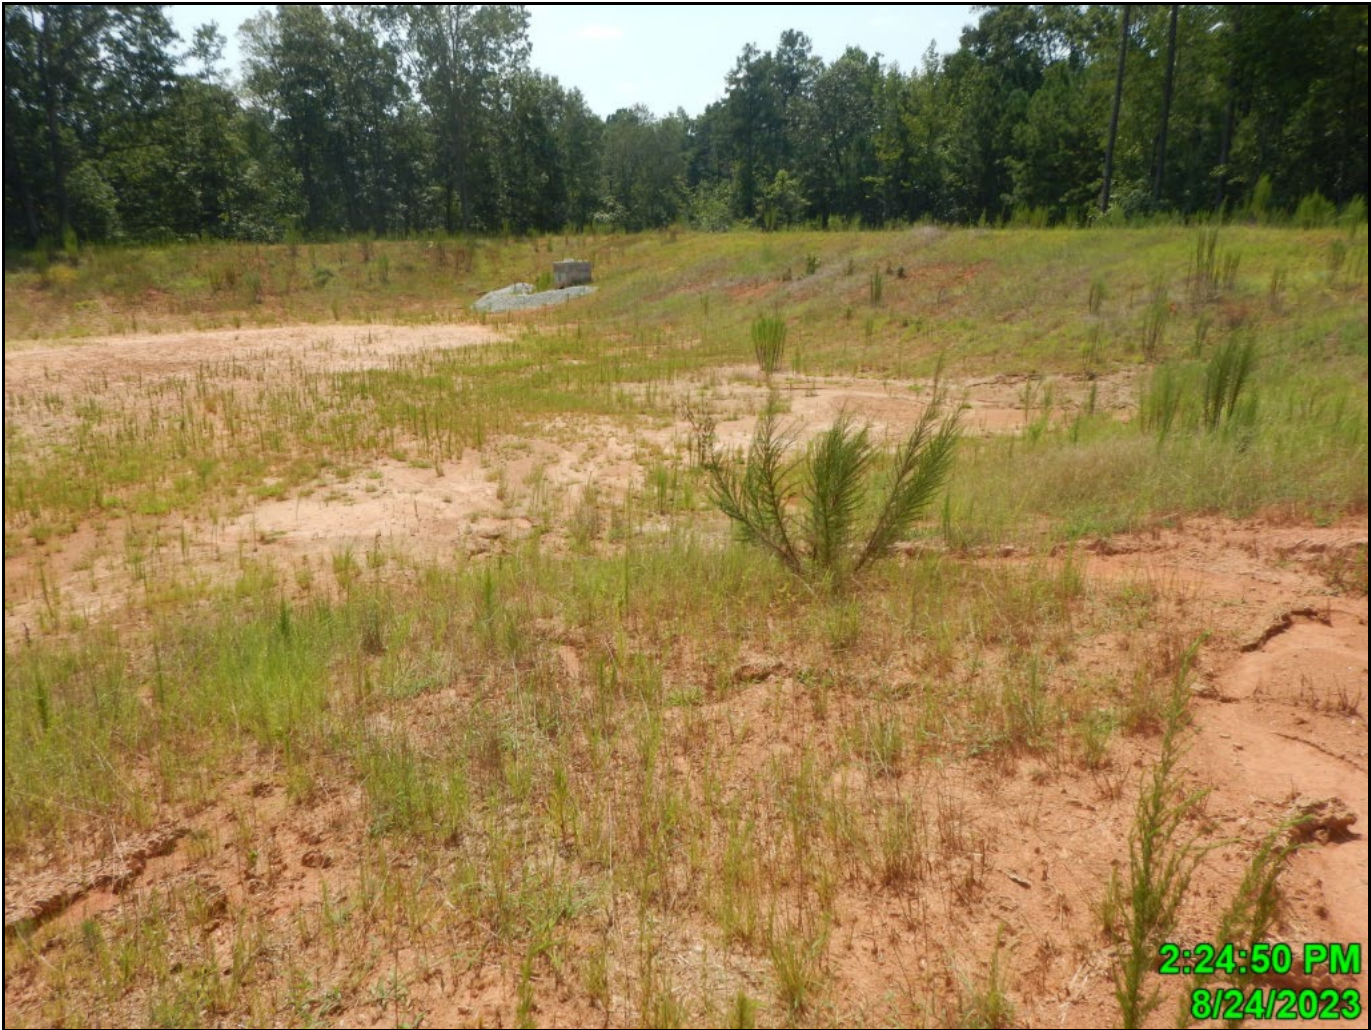
| Attributes | |
|---|---|
| Description | The western half of the lower basin is not properly vegetated or stabilized. |

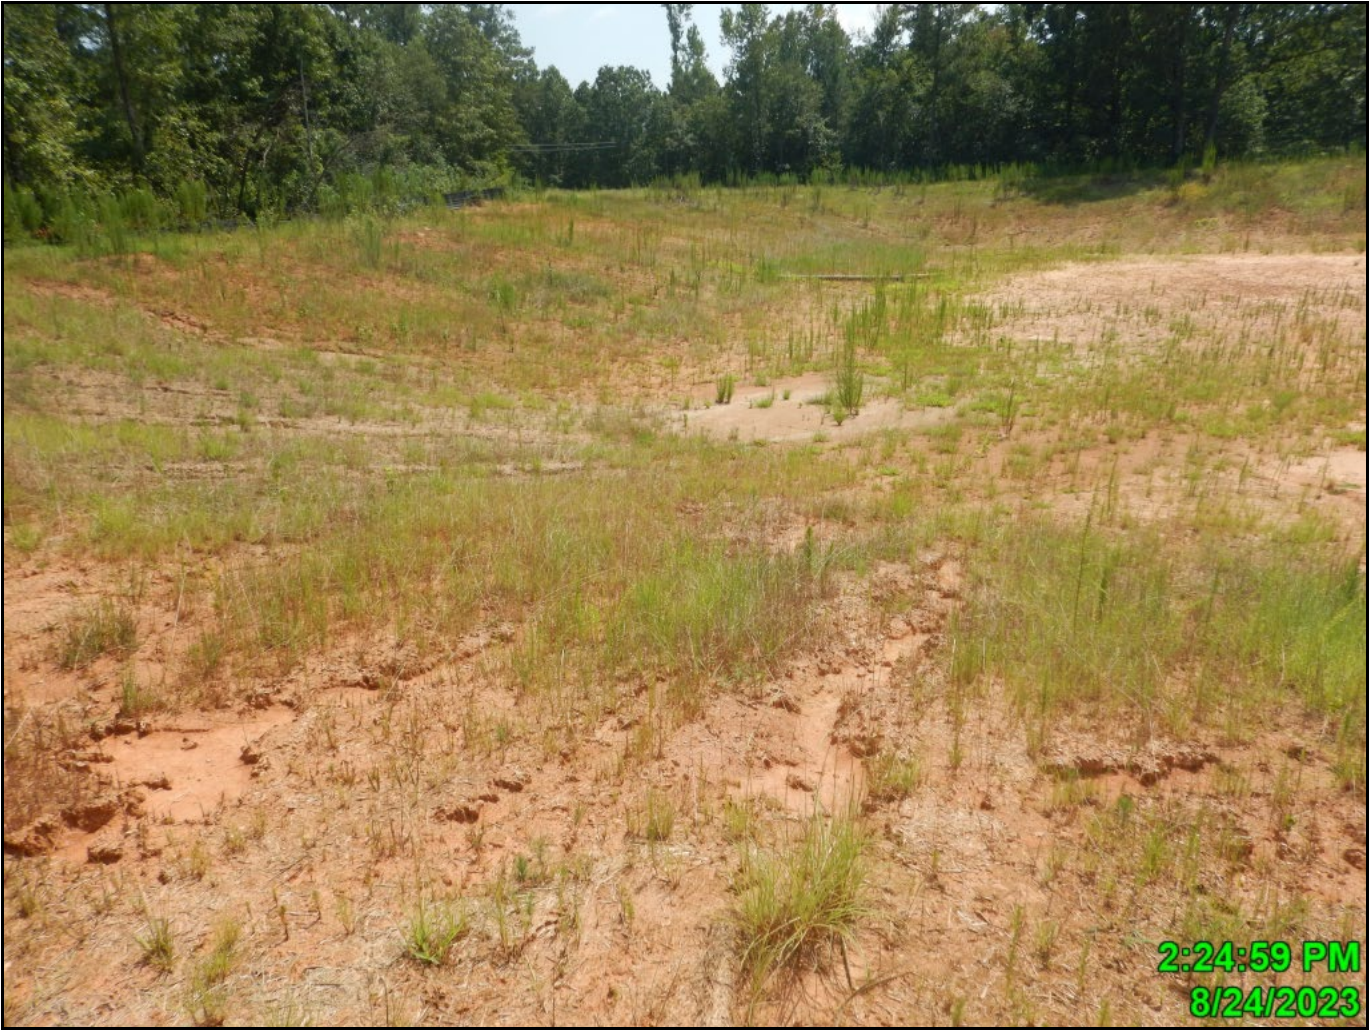
| Attributes | |
|---|---|
| Description | The eastern half of the lower basin is not properly vegetated or stabilized. |

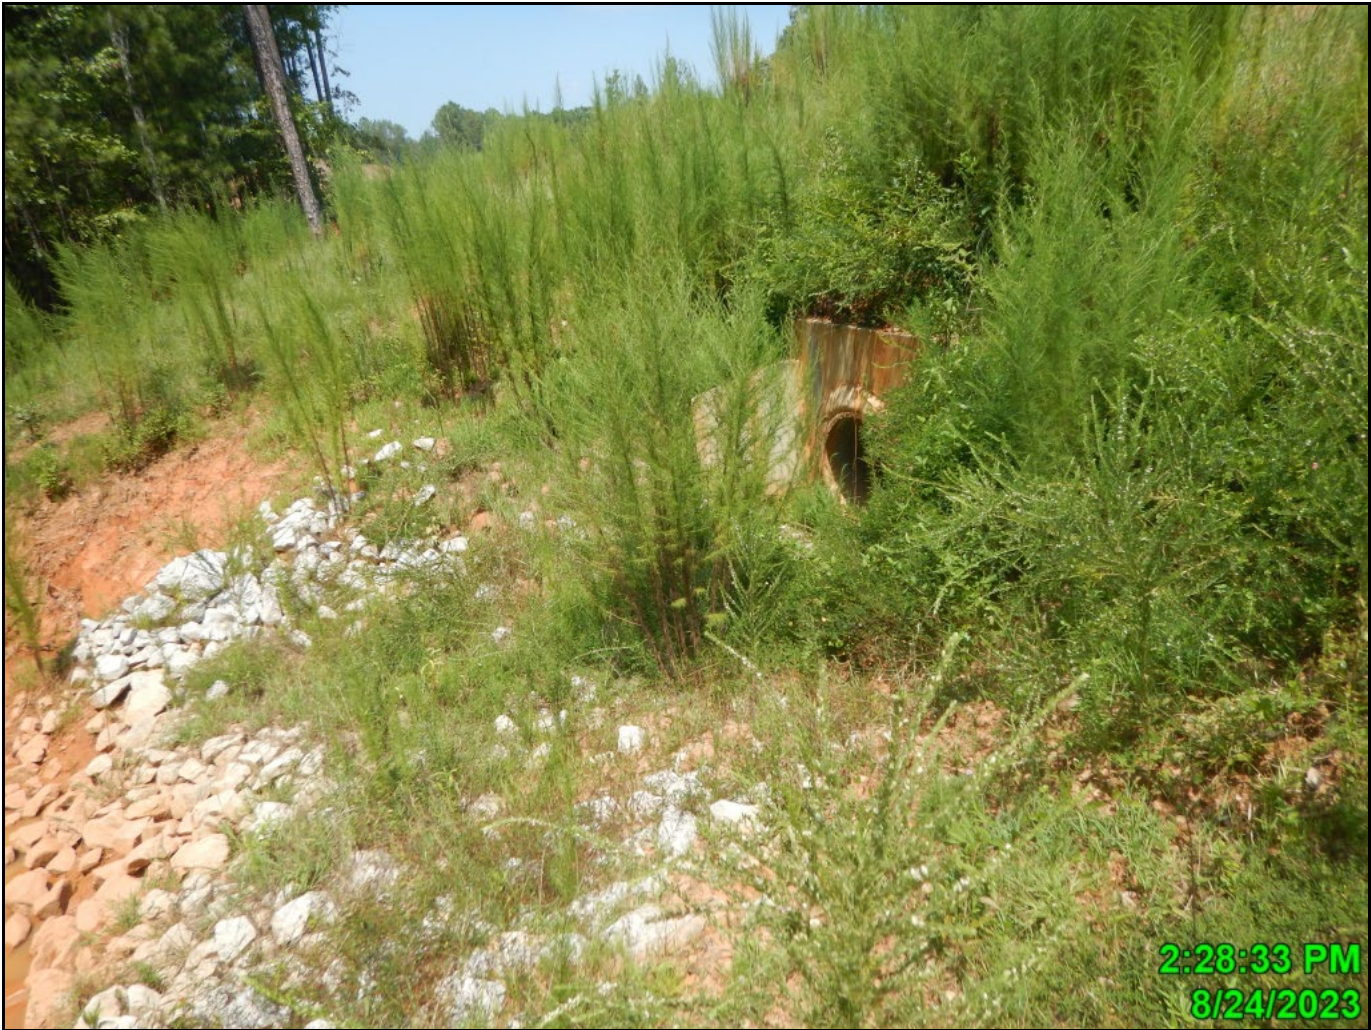
| Attributes | |
|---|---|
| Description | Outfall structure from the lower basin of the south pond. Camera was not horizontal. |

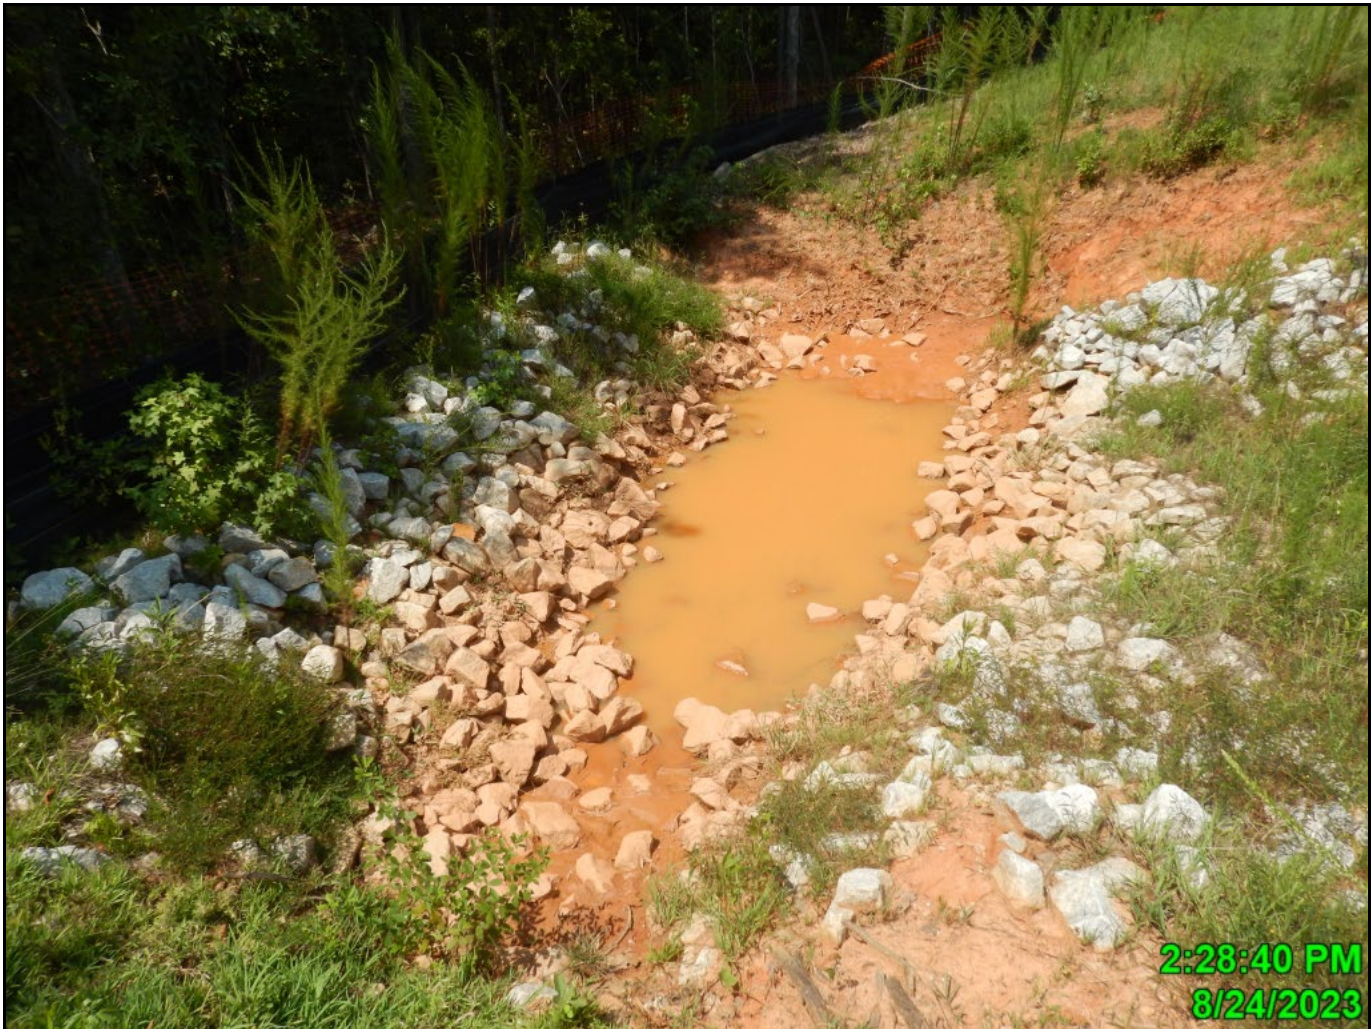
| Attributes | |
|---|---|
| Description | Outlet structure from the southerly pond: riprap may be improperly installed. |

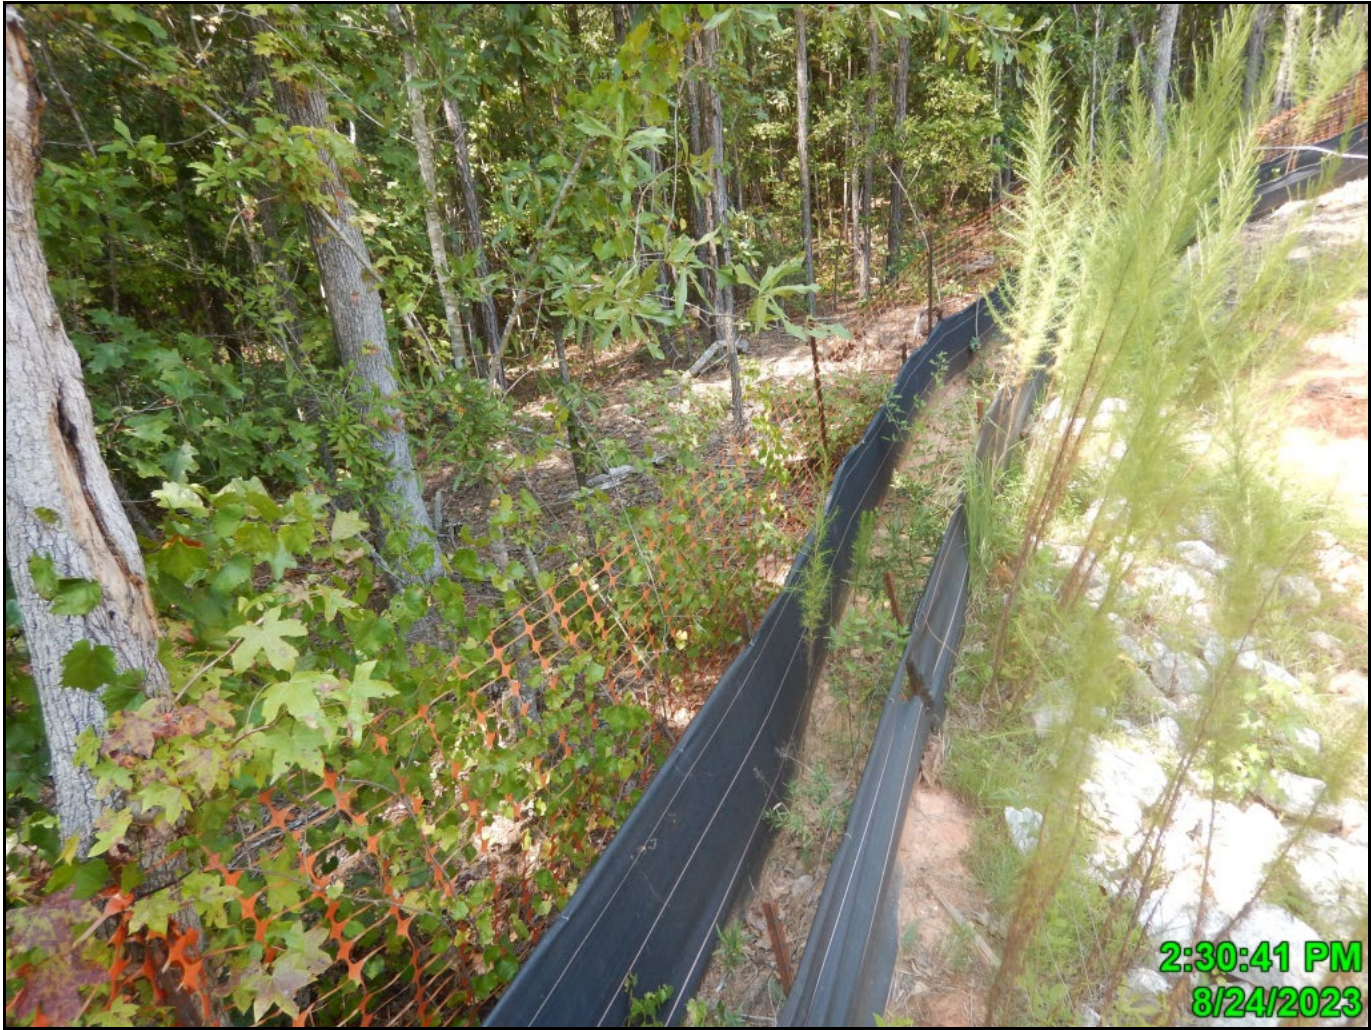
| Attributes | |
|---|---|
| Description | Near the outlet structure for the south pond, there was some sediment loss past the silt fences, but the silt deposition only went a few feet into the adjacent woods. |
