**Region 6 - Enforcement & Compliance Assurance Division**  
**INSPECTION REPORT**

| Company Name: | <b>Motiva Enterprises LLC</b> | |
| Facility Name: | <b>Port Neches Terminal</b> | |

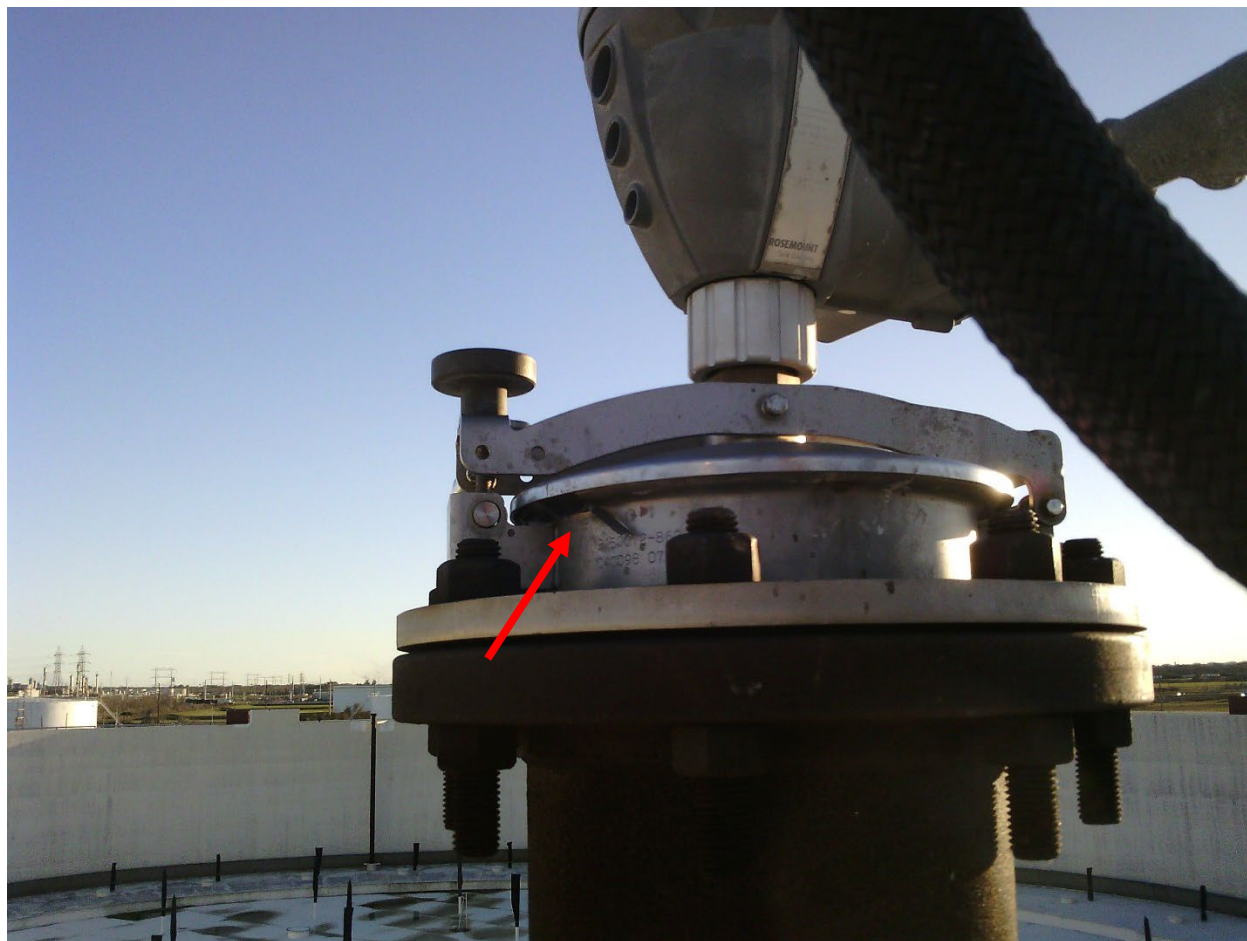
Photo No. 1

| Tank # | Tank Contents | Design | Notes and Observations |
|---|---|---|---|
| 34030 | Debutanized Aromatic Concentrate | EFR | <ul style="list-style-type: none"> <li>EPA inspectors noted hydrocarbon odors at the tank’s platform and along the circumference of the tank’s shell.</li> <li>EPA inspectors noted visual defects of gasket material of the tank’s guidepole hatch (Photo 1) and measured a concentration of 3,300 parts per million using the FID. <b>[AOC 1]</b></li> <li>Light hydrocarbon emission observed with the OGI camera at the base of the secondary rim seal. <b>[AOC 2]</b></li> </ul> |

- 1) At Tank 34030, upon detecting hydrocarbon odors at the tank's platform, we observed the gasket material at the guidepole hatch was torn. Mr. Rosenthal also measured emissions with the FID and confirmed that emissions were emanating from the hatch near the torn gasket.
- 2) At Tanks 34030, 1835, and 275, we observed hydrocarbon emissions with the OGI camera along the rim seals indicating that the secondary seals may not be controlling emissions as required.

| Description: | Torn gasket material at hatch on Tank 34030. EPA recorded approximately 3,300 parts per million VOC, as methane, with the FID. |
