## Region 6 - Enforcement & Compliance Assurance Division

### INSPECTION REPORT

| Company Name: | <b>City of Aztec</b> | |
| Facility Name: | <b>Aztec Wastewater Treatment plant</b> | |

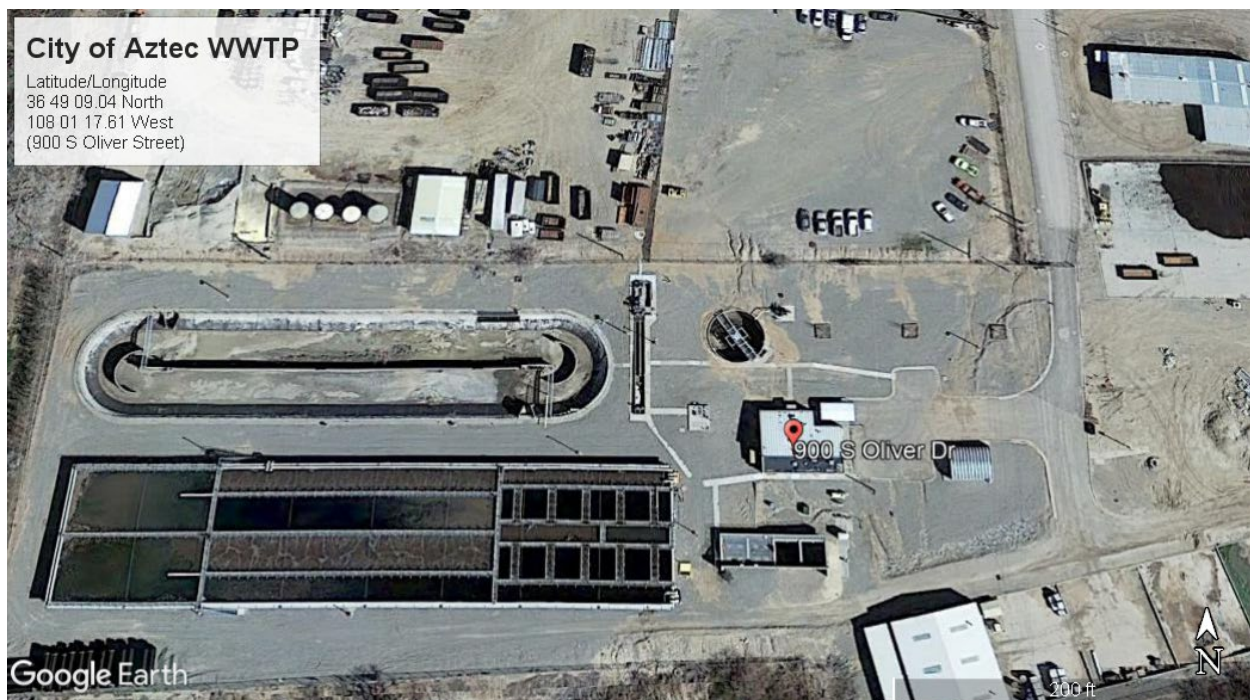
Aerial Image #1 Overall view of the City of Aztec's Wastewater Treatment Plant. Aerial from Google Earth.

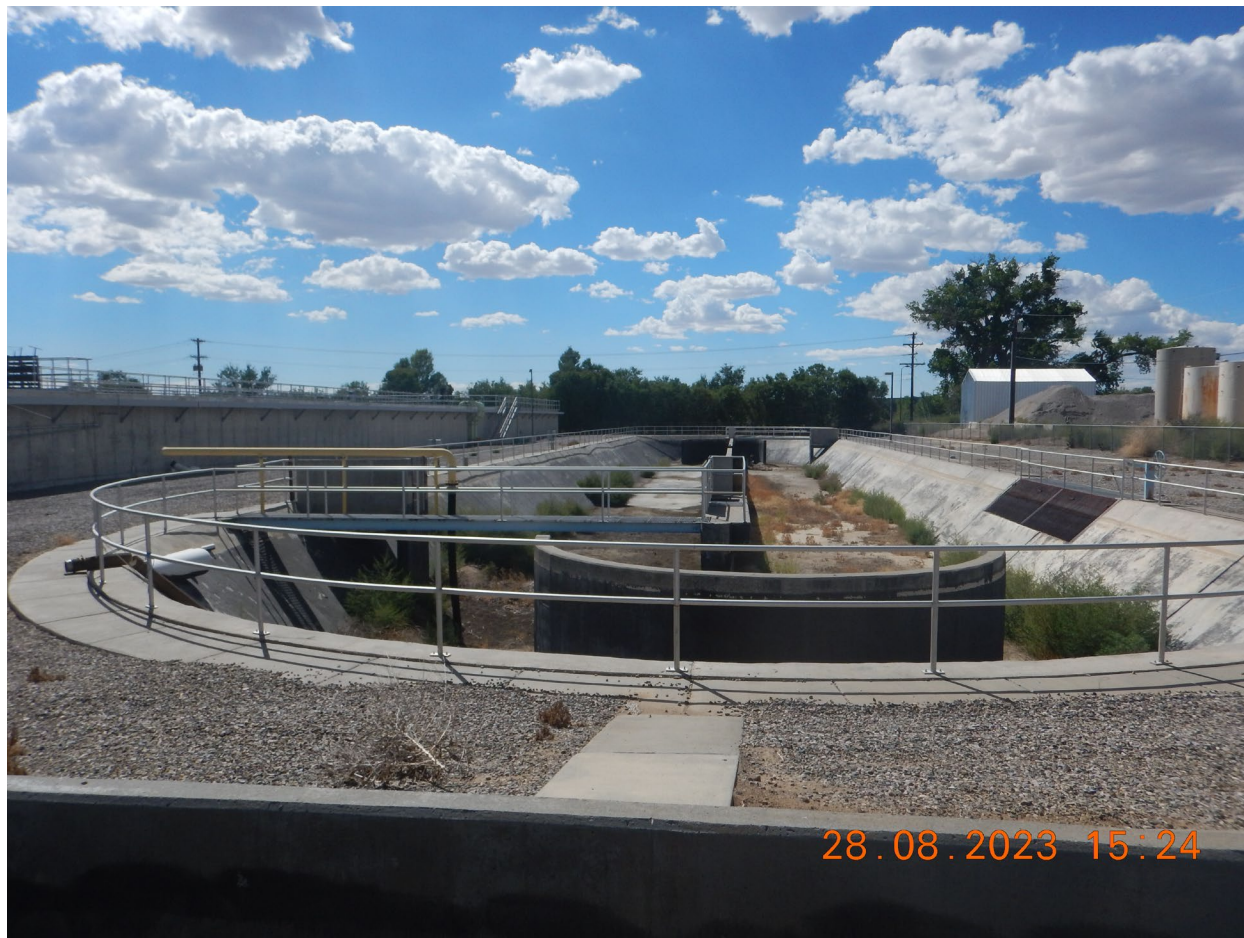
Photo No. 1

View of the old racetrack design clarifier (utilized for overflow), used in conjunction with a 1 million-gallon (MG) oxidation ditch for flow equalization (EQ), and a permanently positioned pump at the WWTP should a bypass occur to the EQ. (DSCN2617). Photographed by D. Esparza

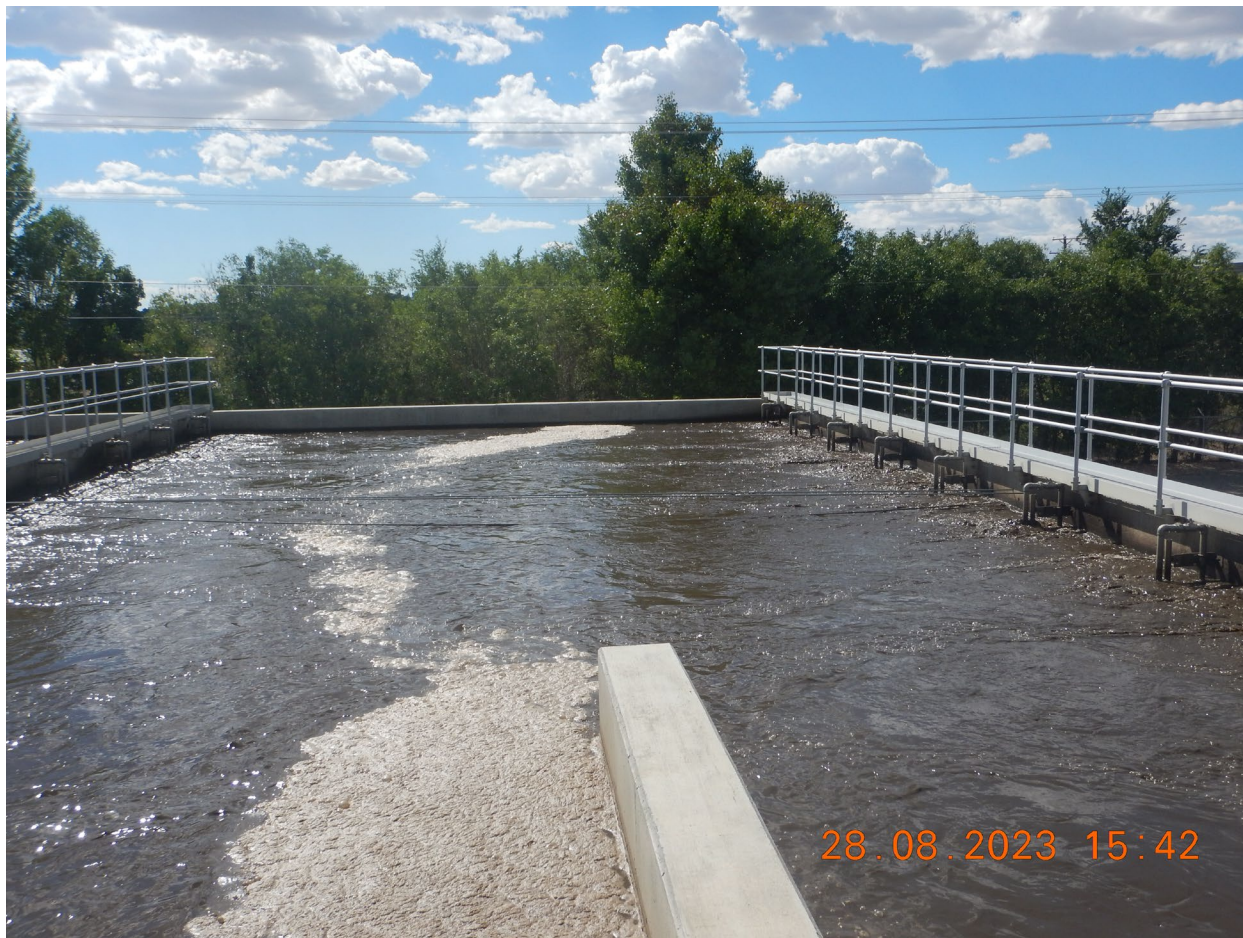
Photo No. 2

- The aeration basin experienced a potential sidewall structural failure in January 2014 (sidewalls were sagging or bulging). An assessment was done, and multiple strands of wire rope cable and structural steel (I-beams) were placed along the outside of the basin in 2014. It was observed the basin wall penetrations were not sealed offering potential caustic chemical gases or liquid intrusion and concrete degradation. Additionally, it was observed several of the wire rope cables had frayed, broken, or were significantly sagging; thus, potentially causing increased stress on the remaining rope cables. Furthermore, the increased tension in the remaining wire rope cables, due to hydrostatic pressure pose an extreme safety hazard to WWTP personnel in the event of failure and sidewall collapse.

View of the several wire rope cables frayed, broken, or significantly sagging thus, potentially causing increased stress on the remaining rope cables. NOTE: the rope cable lying at and into the process treatment surface. (DSCN2619). Photographed by D. Esparza

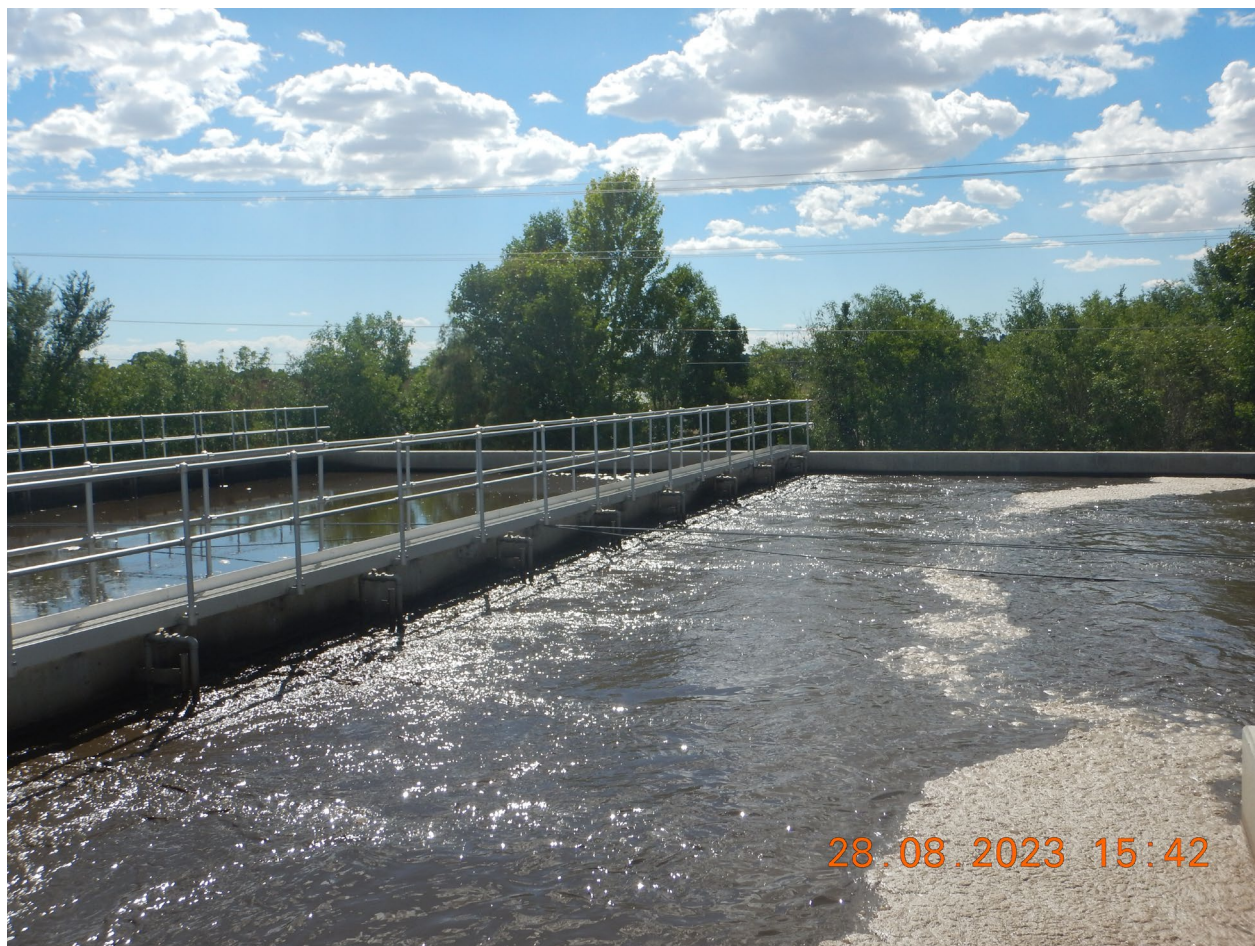
Photo No. 3

Another view of the wire rope cables frayed, broken, or significantly sagging; thus, potentially causing increased stress on the remaining rope cables. NOTE: the rope cable lying at and into the process treatment surface. Additionally, these process treatment basins are located approximately 250-feet Northeast of the Animas River. (DSCN2620). Photographed by D. Esparza

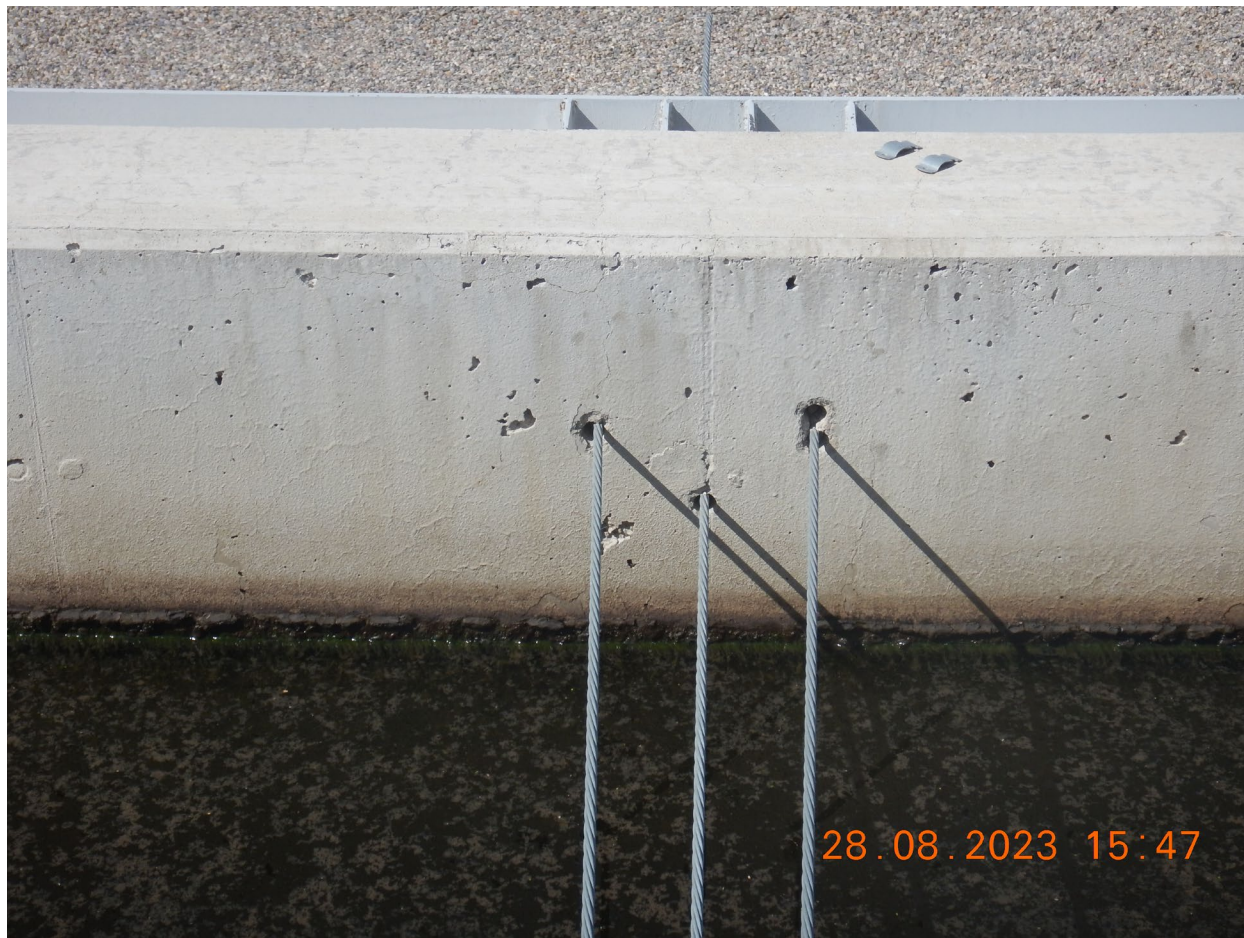
Photo No. 4

View of one (1) location of the wire rope cable basin wall penetrations not sealed offering potential caustic chemical gases or liquid intrusion and concrete degradation. (DSCN2624). Photographed by D. Esparza

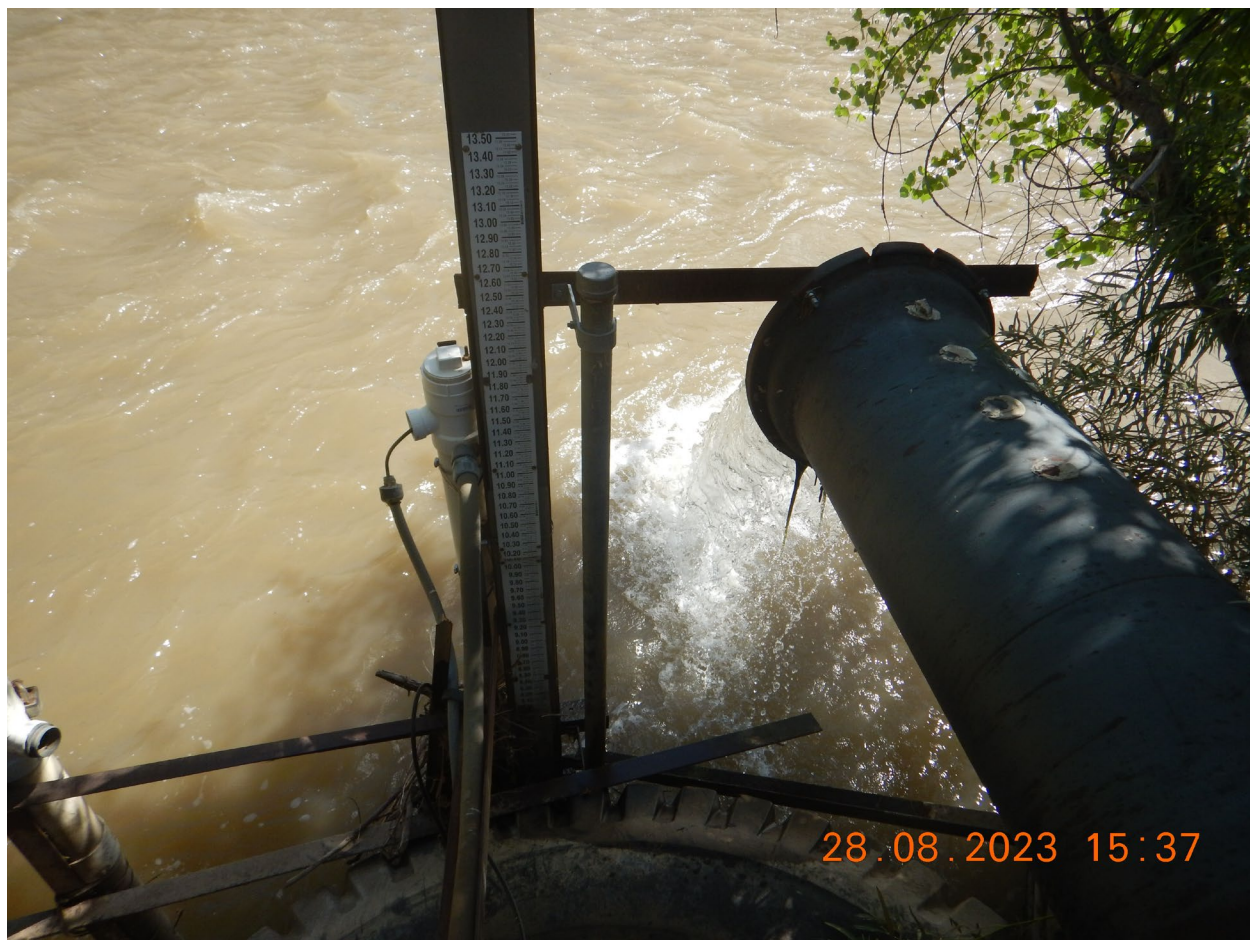
Photo No. 5

View of the WWTP outfall (discharge) of effluent into the Animas River. (DSCN2618). Photographed by D. Esparza
