## CAA112(r) INSPECTION REPORT

| <b>Name:</b> Glycerin Traders | |
| <b>Process:</b> NAICS 325611-03, Glycerin Manufacturing | |

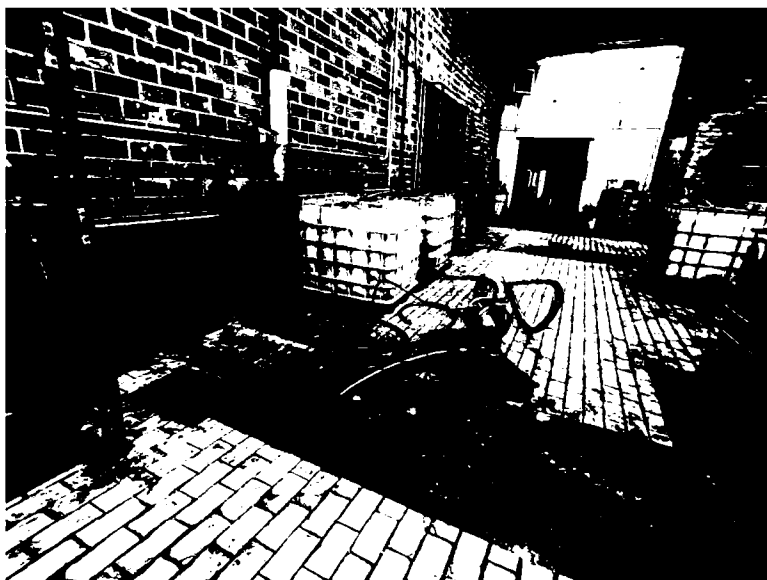
IMG\_0469.JPG: Pump for pumping spills to a tote. Entire floor area is covered in residue from spills and chemicals puddles on the floor and evidence of acid etching of cement flooring.

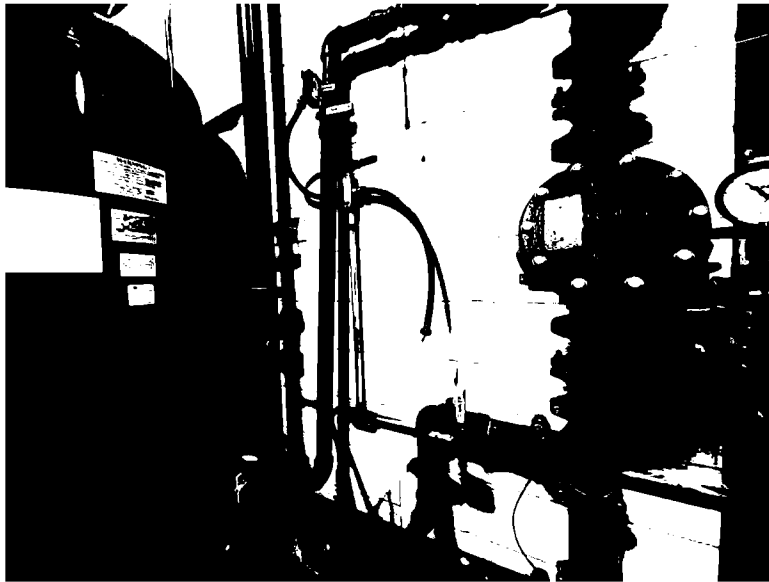
IMG\_0497.JPG: Close-up of system – electrical is disconnected and hanging with exposed wires, valves along the water line in closed positions. Water pressure gauge indicates pressure however, part of the system has been disabled and was told that the foam tank is not used.

- Disconnected electrical conduit with exposed wiring on the facility water suppression system (Appendix 1, digital image IMG\_0497.JPG).
- Disconnected electrical conduit where the active leak occurred during the inspection (Appendix 1, digital image IMG\_0504.JPG).
