**INSPECTION REPORT**

| <b>Type of inspection:</b> | CEI - Compliance Evaluation Inspection | |
| <b>Permittee Name:</b> | Midwest Terminal Ironville | |
| <b>Permit Number:</b> | OHR000007 (OEPA Facility Permit #: 2GR02035*BG) | |

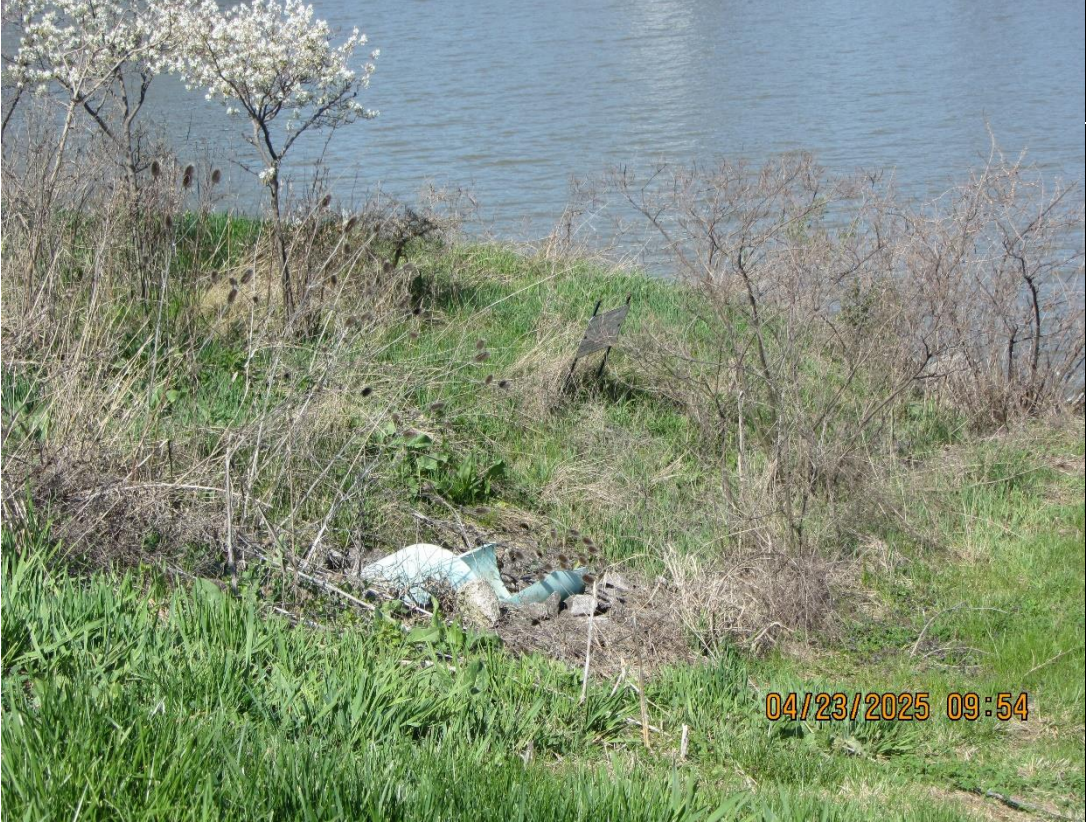
| <b>Photo No.:</b> 1 | <b>Time:</b><br>10:54AM | | |

| <b>Photo Description:</b><br>Outfall 002-A into<br>the Maumee River. | | | |

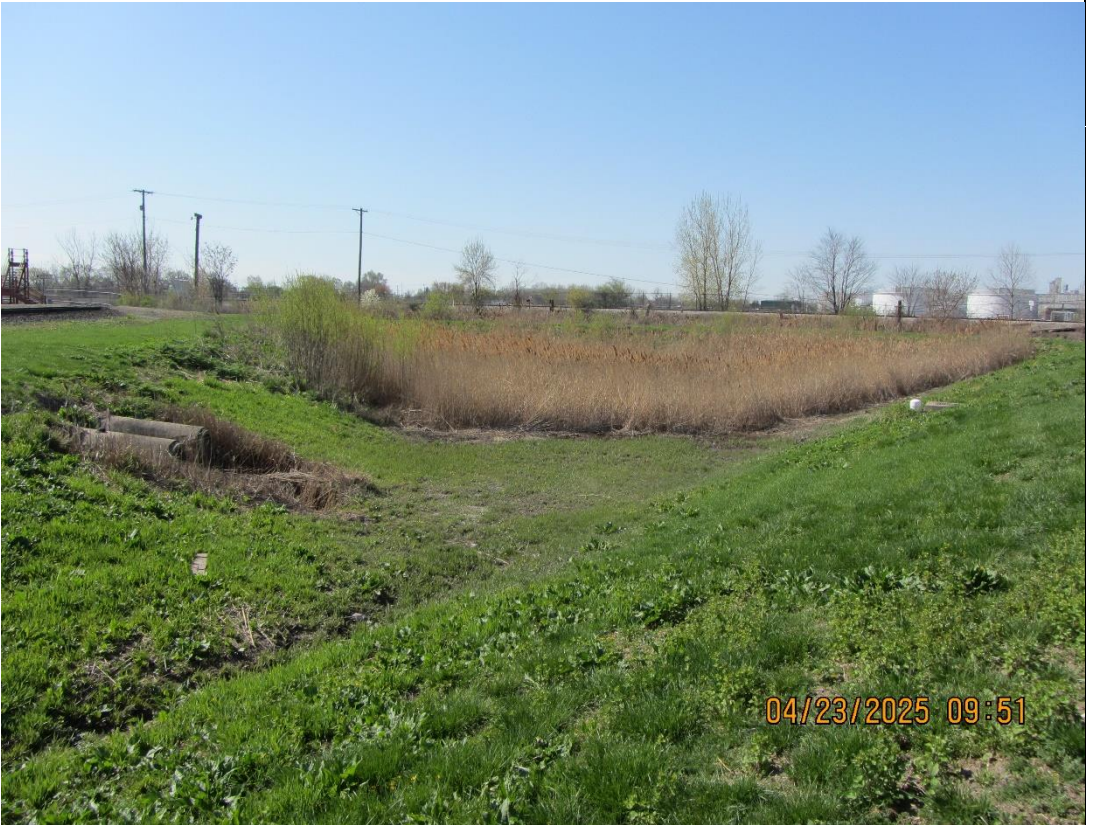
| <b>Photo No.: 2</b> | <b>Time:</b><br>10:51AM | | |

| <b>Photo Description:</b><br>Containment Area prior to Outfall 002-A. | | | |

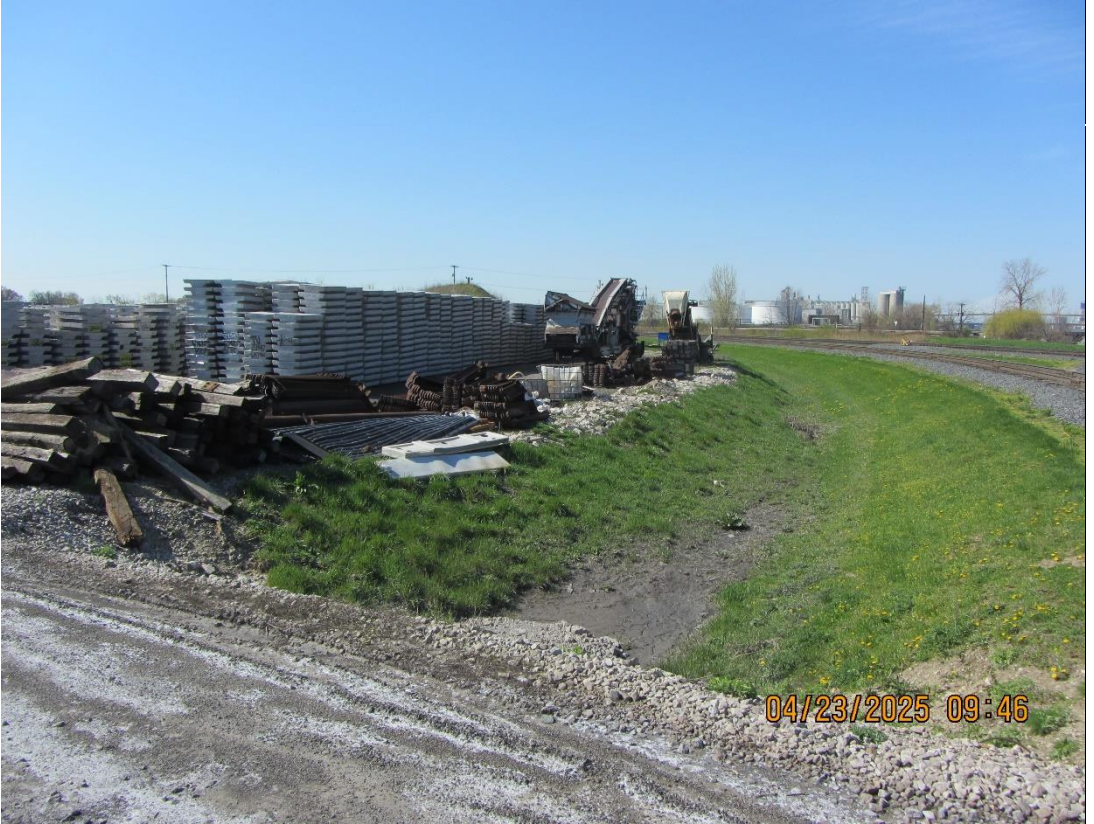
| <b>Photo No.:</b> 3 | <b>Time:</b><br>10:47AM | | |

| <b>Unique Identifying No.</b> | <b>Observations</b> | <b>Area of Concern?</b> |
|---|---|---|
| <b>MS-OB-003</b> | During the site tour, inspectors observed some storage areas surrounded by ditches and berms to prevent runoff of materials (Photos: #3 and #4). | No |

| <b>Photo Description:</b><br>Aluminum storage pile surrounded by ditch and berm. | | | |

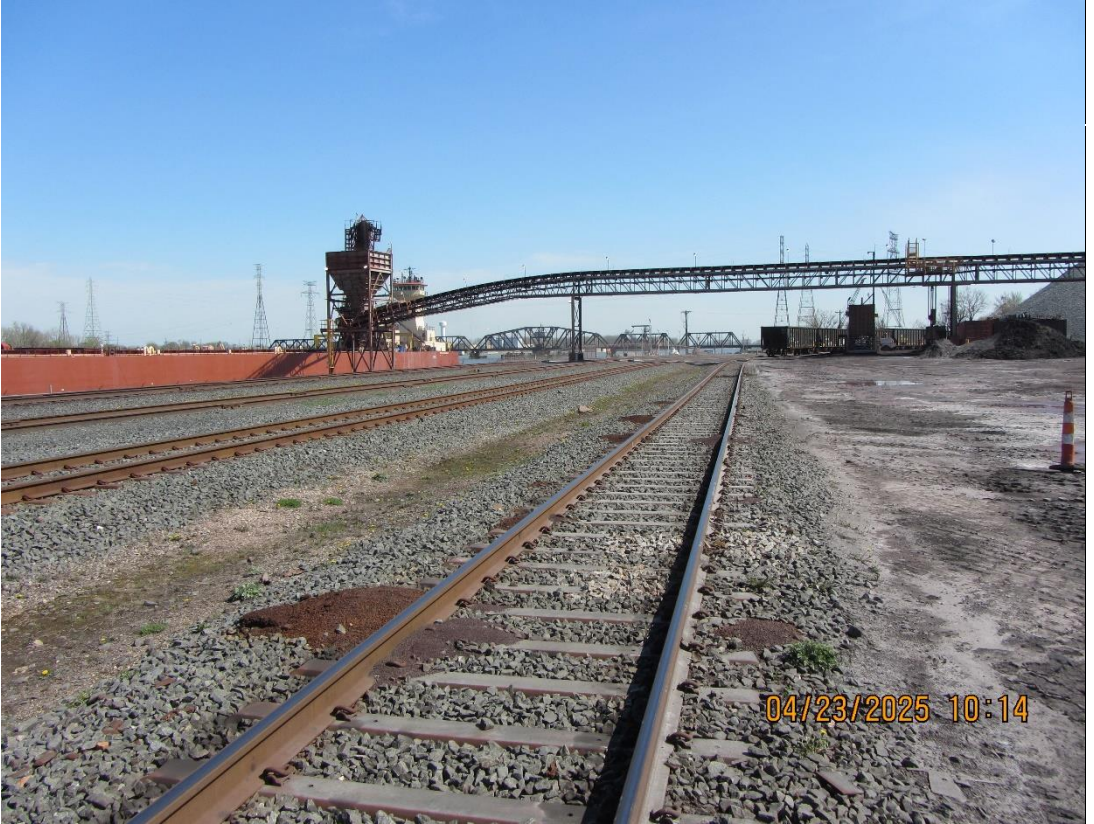
| <b>Photo No.:</b> 4 | <b>Time:</b><br>11:14AM | | |

| <b>Photo Description:</b><br>Train tracks and berm to west of storage piles. | | | |

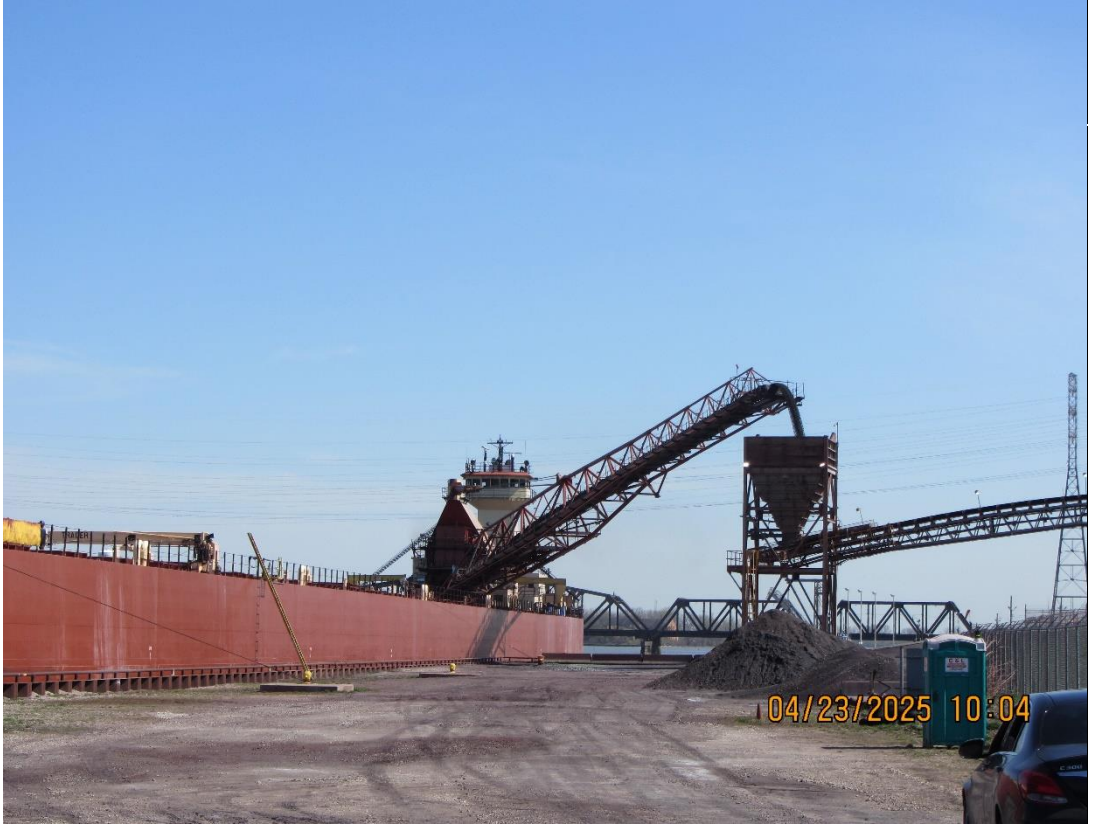
| <b>Photo No.:</b> 5 | <b>Time:</b><br>11:05AM | | |

| <b>Unique Identifying No.</b> | <b>Observations</b> | <b>Area of Concern?</b> |
|---|---|---|
| <b>MS-OB-001</b> | During the site tour, inspectors observed spilled material from unloading vessels stored on piles in the dock area (Photo #5). | Yes |

| No. | |
|---|---|
| <b>MS-OB-001</b> | <p>Spilled material from unloading vessels is stored on piles in the dock area (Photo #5).</p> <p>Facility's SWPPP: Section 3.2 – Good Housekeeping</p> <ul style="list-style-type: none"> <li>Maintaining clean area at the dock face area using brooms and/or shovels, cleaning fines and spillage from conveyor bents.</li> </ul> <p>EPA observed that the Facility's dock does not contain any berms or other barriers to prevent the piles of material from entering water runoff during rain events. Facility has stated that the spilled material is moved off the dock within a day or two.</p> |

| <b>Photo Description:</b><br>Vessel unloading area and pile of spilled material. | | | |

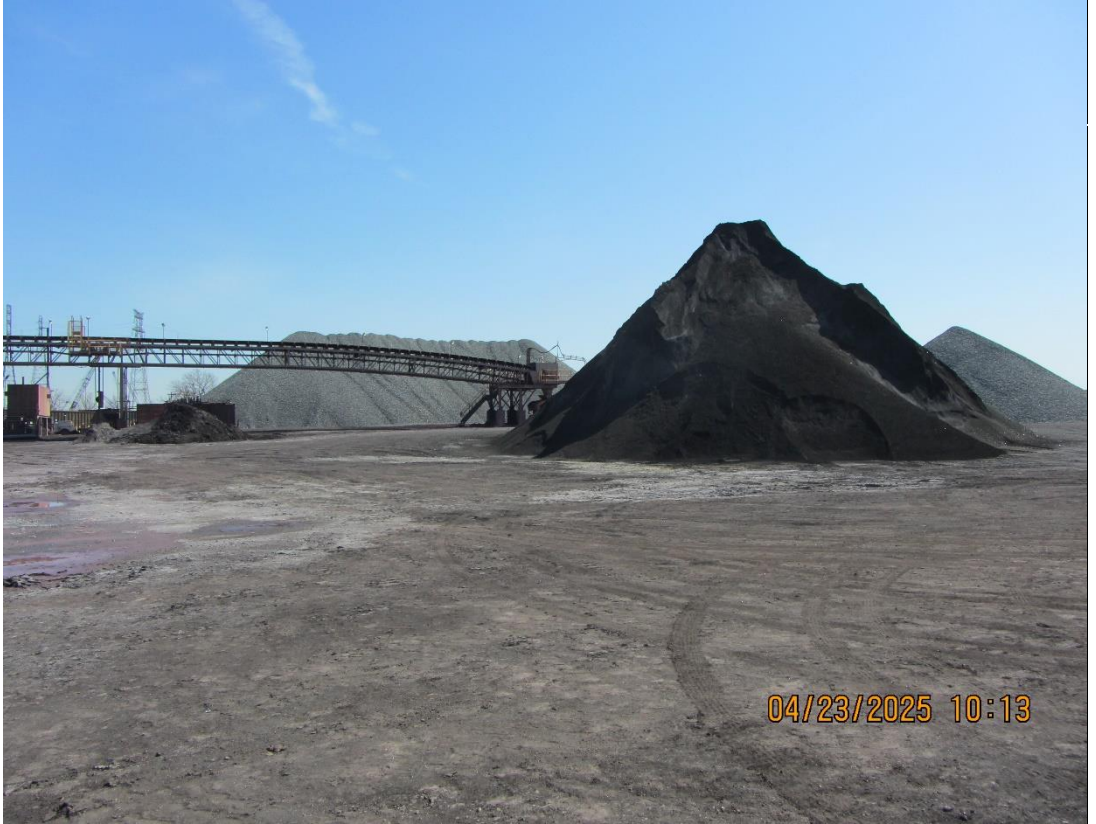
| <b>Photo No.:</b> 6 | <b>Time:</b><br>11:14AM | | |

| <b>Photo Description:</b><br>Storage piles and track from vessel dock. | | | |

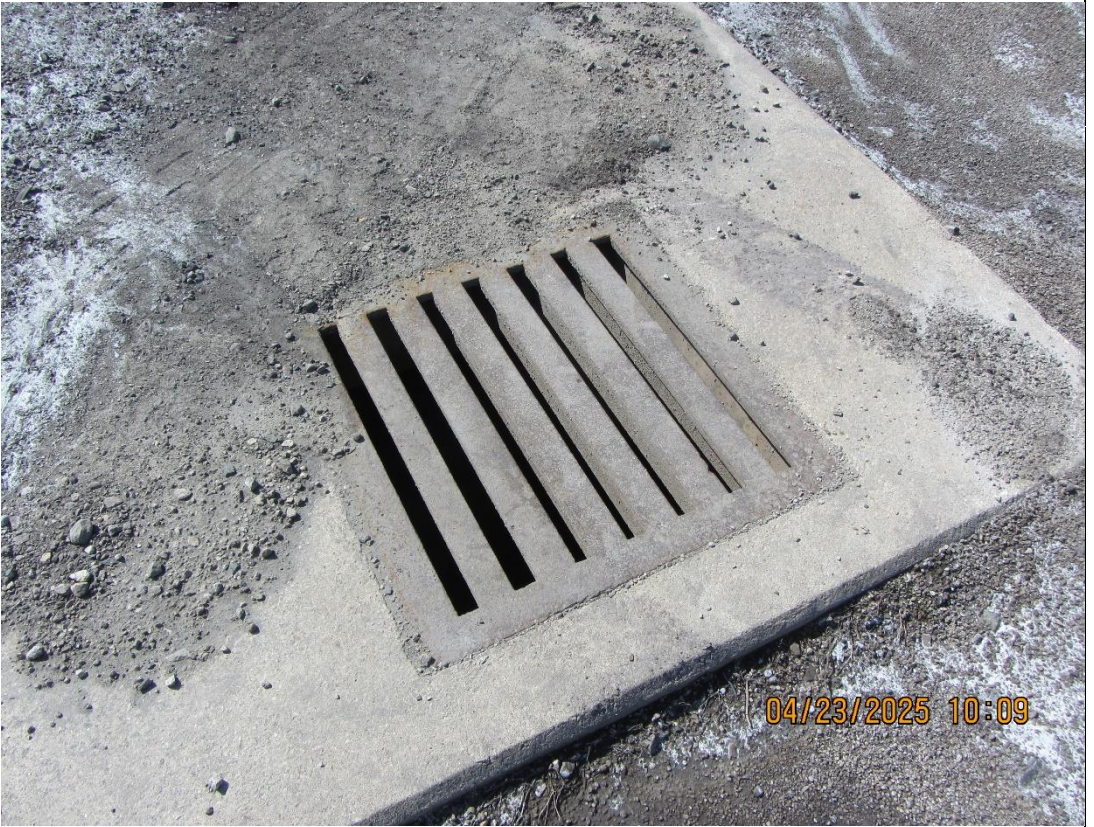
| <b>Photo No.:</b> 7 | <b>Time:</b><br>11:10AM | | |

| <b>Unique Identifying No.</b> | <b>Observations</b> | <b>Area of Concern?</b> |
|---|---|---|
| <b>MS-OB-002</b> | During the site tour, inspectors observed storm water drains throughout the facility located near material piles (Photo #7). | Yes |

| No. | |
|---|---|
| <b>MS-OB-002</b> | <p>Some storm water drains throughout the facility are located near material piles (Photo #7).</p> <p>Facility's SWPPP: Section 3.2 – Good Housekeeping</p> <ul style="list-style-type: none"> <li>Cleaning catch basins when the depth of debris reaches 60% of the sump depth.</li> </ul> <p>Debris should be prevented where possible from entering the catch basins, and cleaning may be required for routine operation and maintenance.</p> |

| <b>Photo Description:</b><br>Drain leading to containment area for Outfall 002A | | | |
