| Inspection Date(s): | 05/20/25 | |
| Company Name: | <b>Tri-County Special Utility District – Public Water System</b> | |
| Facility Name: | <b>Tri-County Special Utility District</b> | |
| PWS ID: | TX0730004 | |

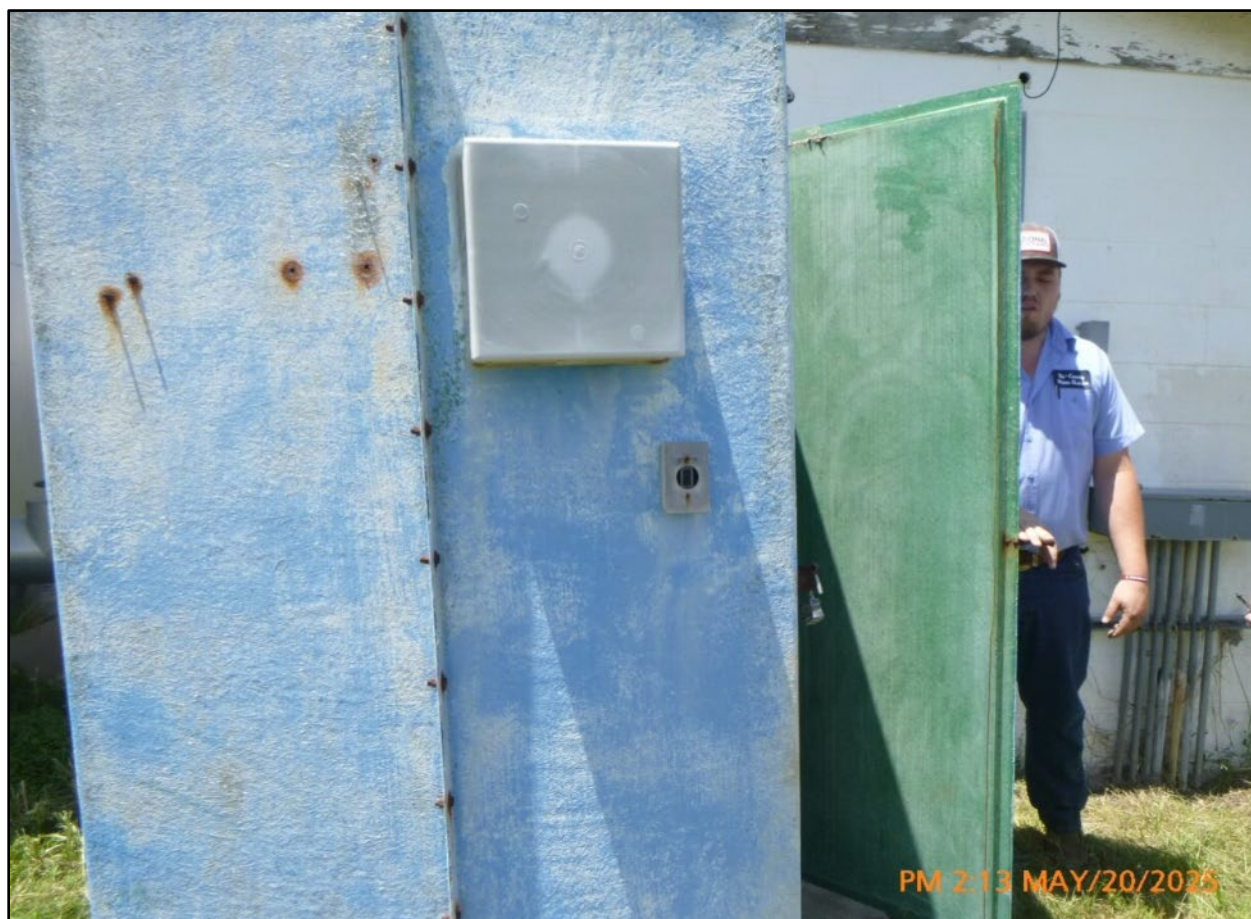
**Photograph 2. 05/20/2025 02:13 P1010534.JPG**

**Observation 3.** The EPA Inspection Team observed the chlorine gas room door lacked panic hardware at Plant 6 (Refer to [Appendix 3, Photograph 2](#)) and Plant 11 (Refer to [Appendix 3, Photograph 3](#)).

**Observation 4.** The EPA Inspection Team observed the chlorine gas room lacked a viewing window at Plant 6 (Refer to [Appendix 3, Photograph 2](#)) and Plant 11 (Refer to [Appendix 3, Photograph 3](#)).

Description: Plant 6. Gas chlorine room with no crash bar or window.

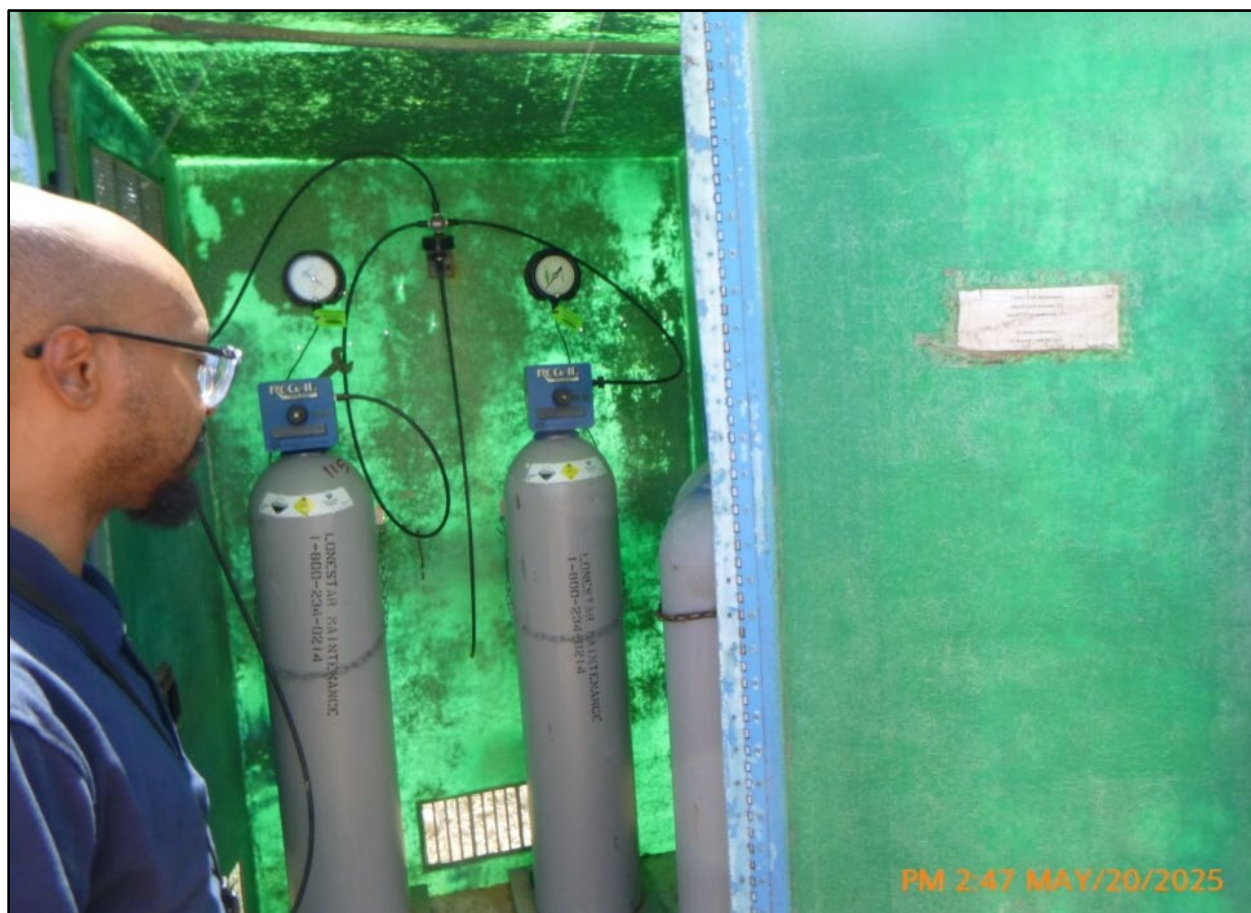
**Photograph 3. 05/20/2025 02:47 P1010543.JPG**

**Observation 5.** The EPA Inspection Team observed the chlorine gas room lacked gas detectors and alarms at Plant 6 (Refer to [Appendix 3, Photograph 4](#)) and Plant 11 (Refer to [Appendix 3, Photograph 3](#)).

Description: Plant 11. Gas chlorine room with no crash bar, window, gas sensors, or alarms.

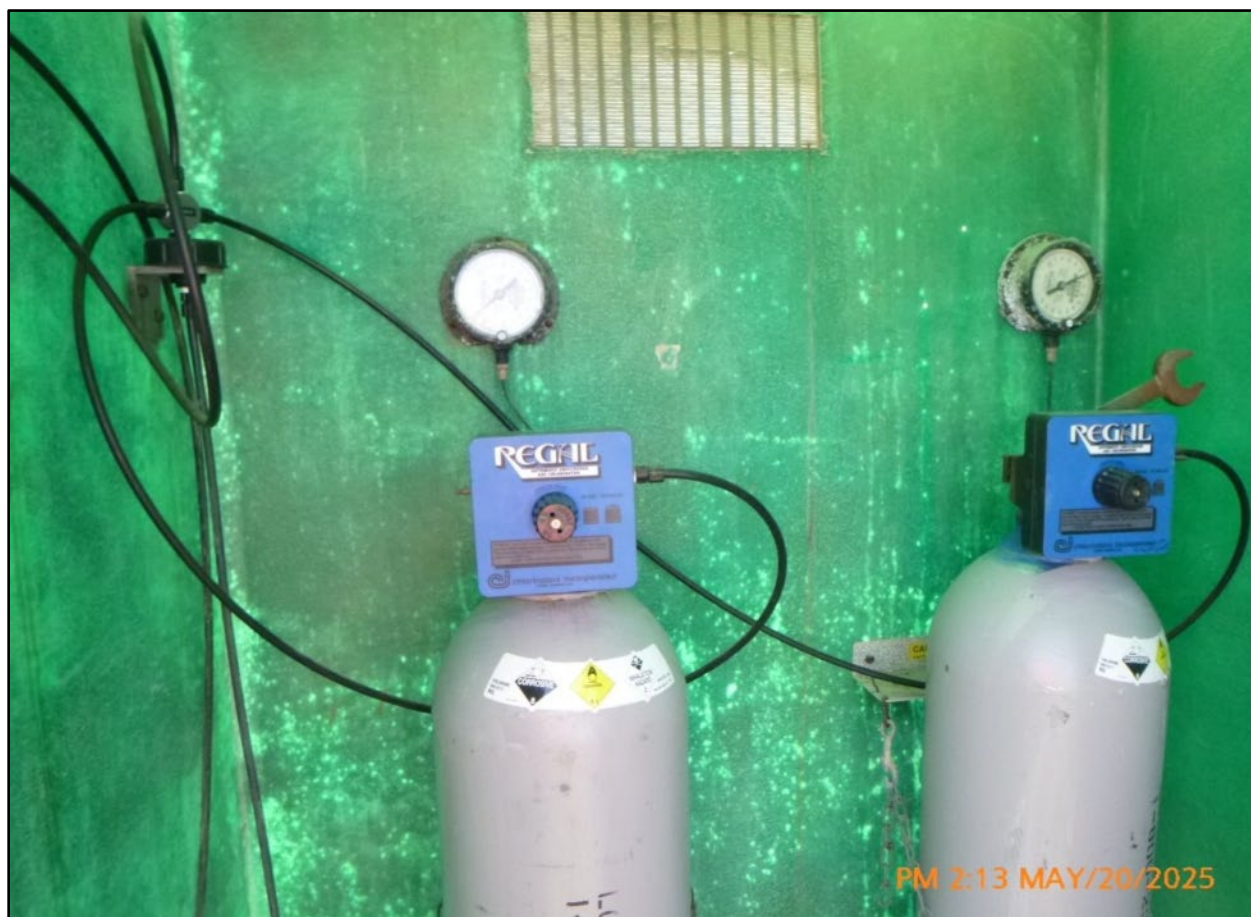
**Photograph 4. 05/20/2025 02:13 P1010532.JPG**

Description: Plant 6. Chlorine room with no gas sensors or alarms.

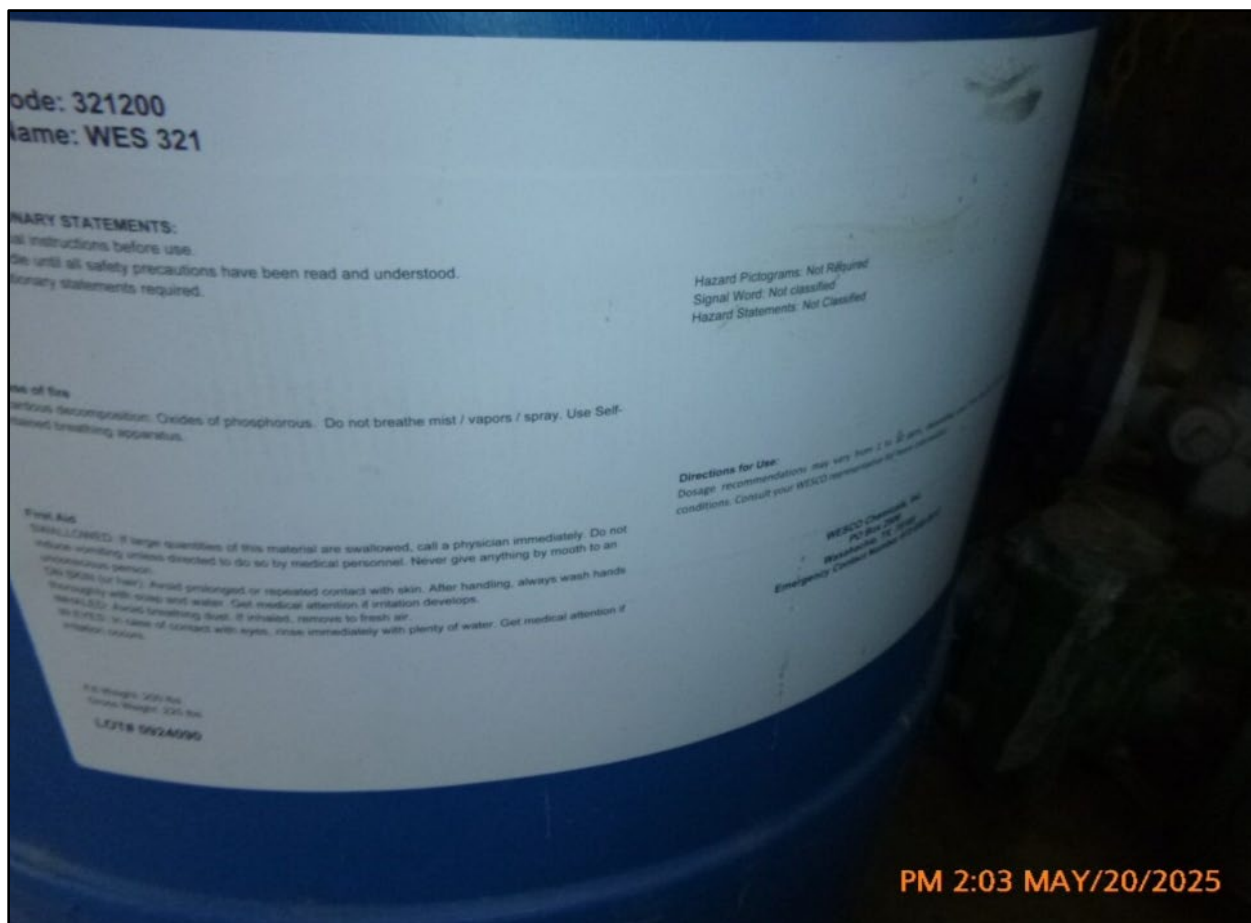
**Photograph 5. 05/20/2025 02:03 P1010524.JPG**

Description: Plant 6. Polyphosphate dry barrel lacks an NSF-60 label. This condition is also representative of what was observed at Plant 11.

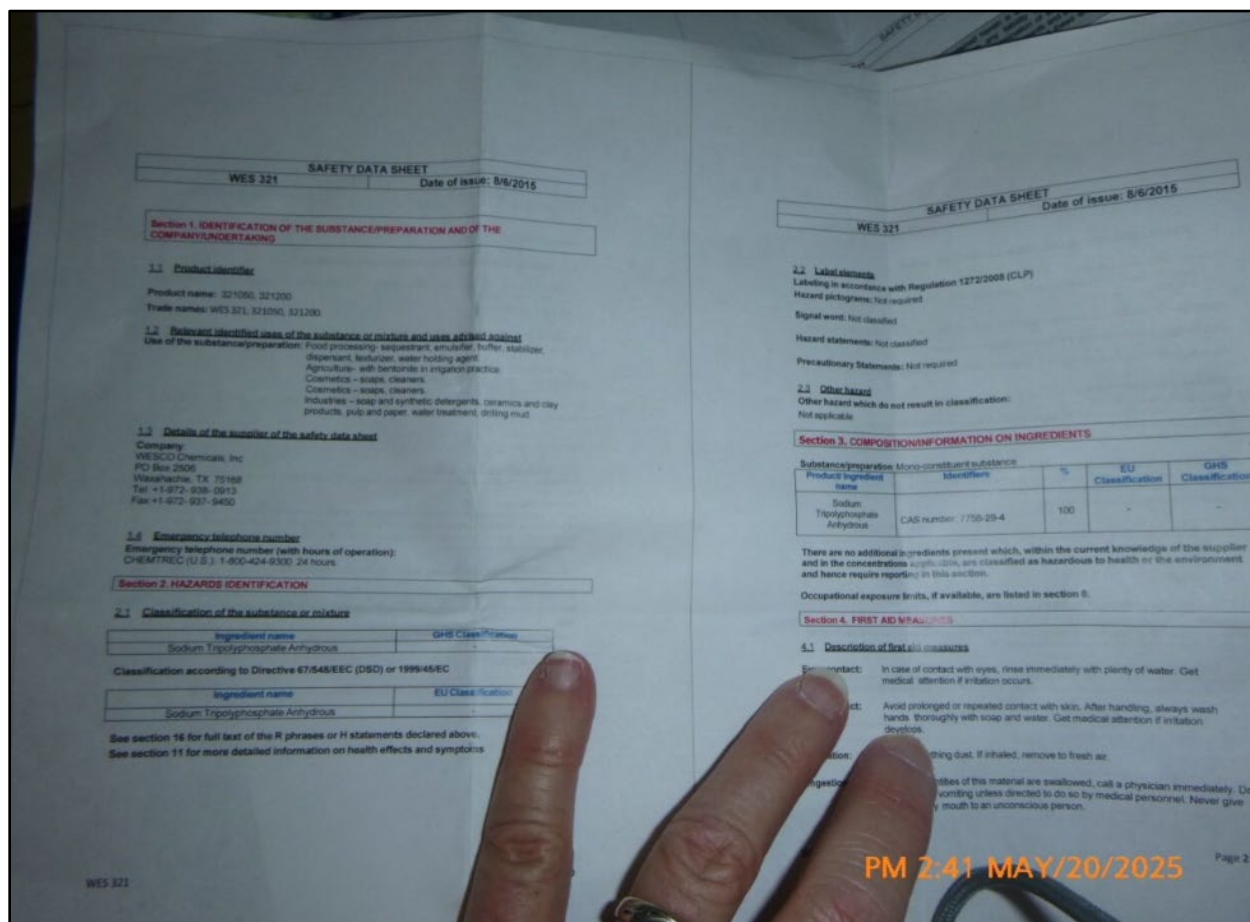
Photograph 6. 05/20/2025 02:03 P1010524.JPG

Description: Plant 11. Safety Data Sheet for polyphosphate dry barrel with no NSF-60 certification.

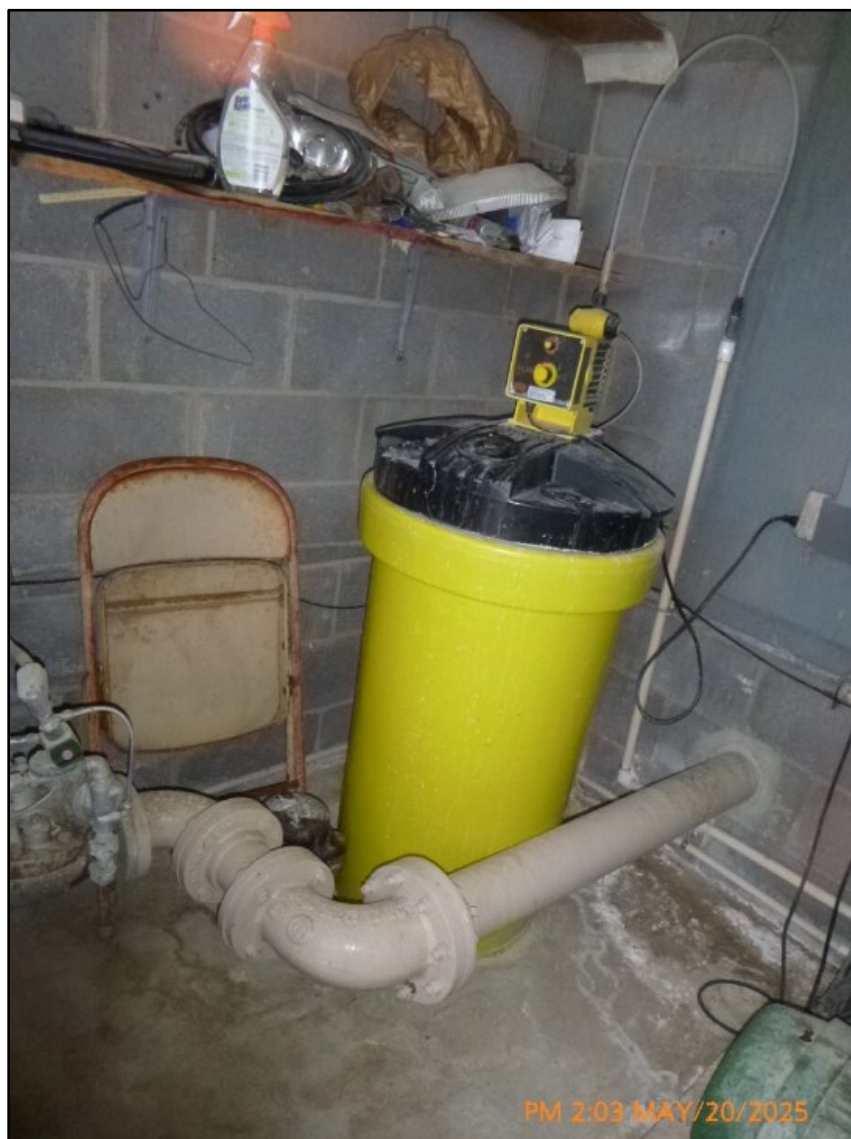
**Photograph 7. 05/20/2025 02:03 P1010525.JPG**

Description: Plant 6. Polyphosphate chemical feed barrel without secondary containment.

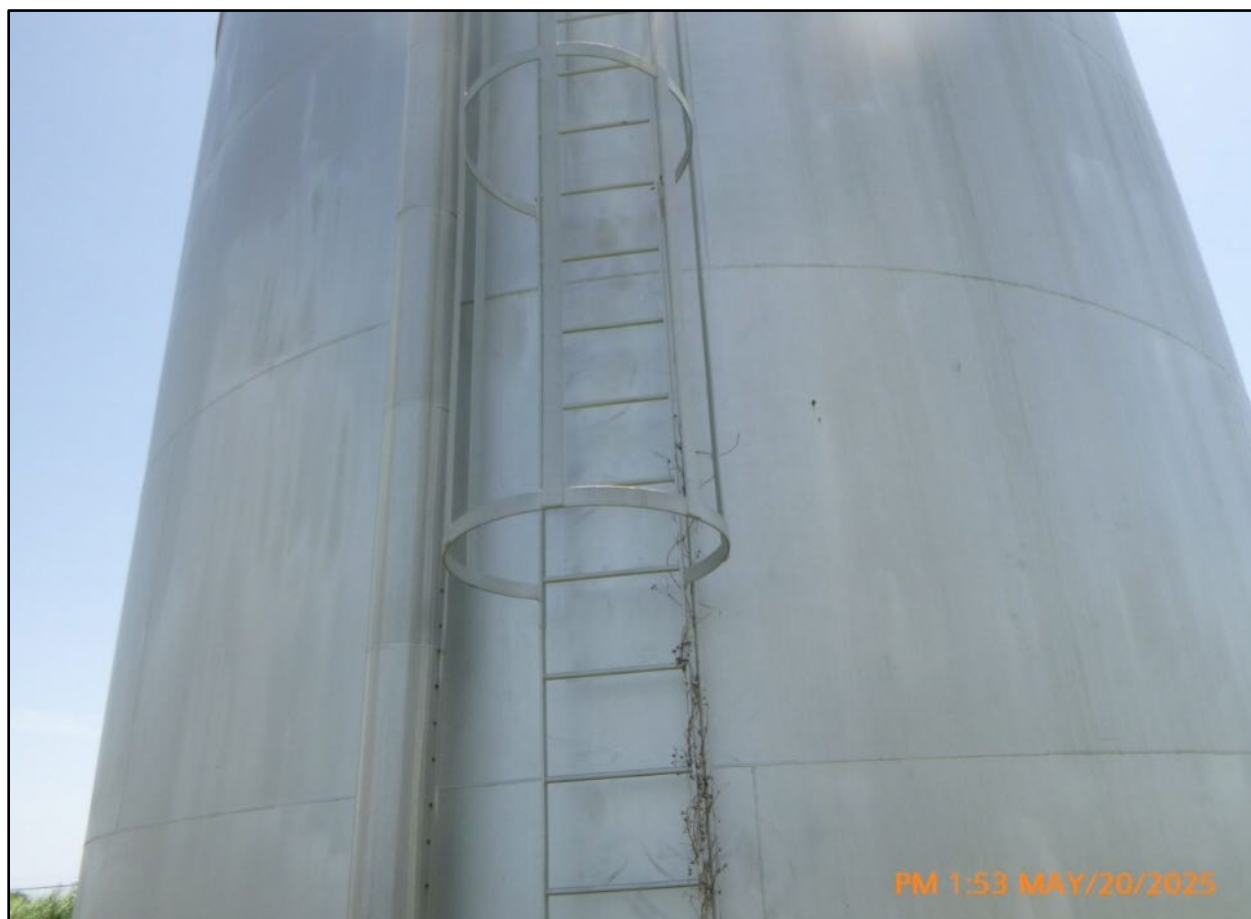
**Photograph 8. 05/20/2025 01:53 P1010521.JPG**

**Observation 8.** At Plant 6, vegetation was observed growing around the foundation of the 100,000-gallon ground storage tank and up the ladder (Refer to [Appendix 3, Photograph 8](#)).

Description: Plant 6. Fixed ladder extending to the ground and lacking a lock on the 100,000-gallon ground storage tank.

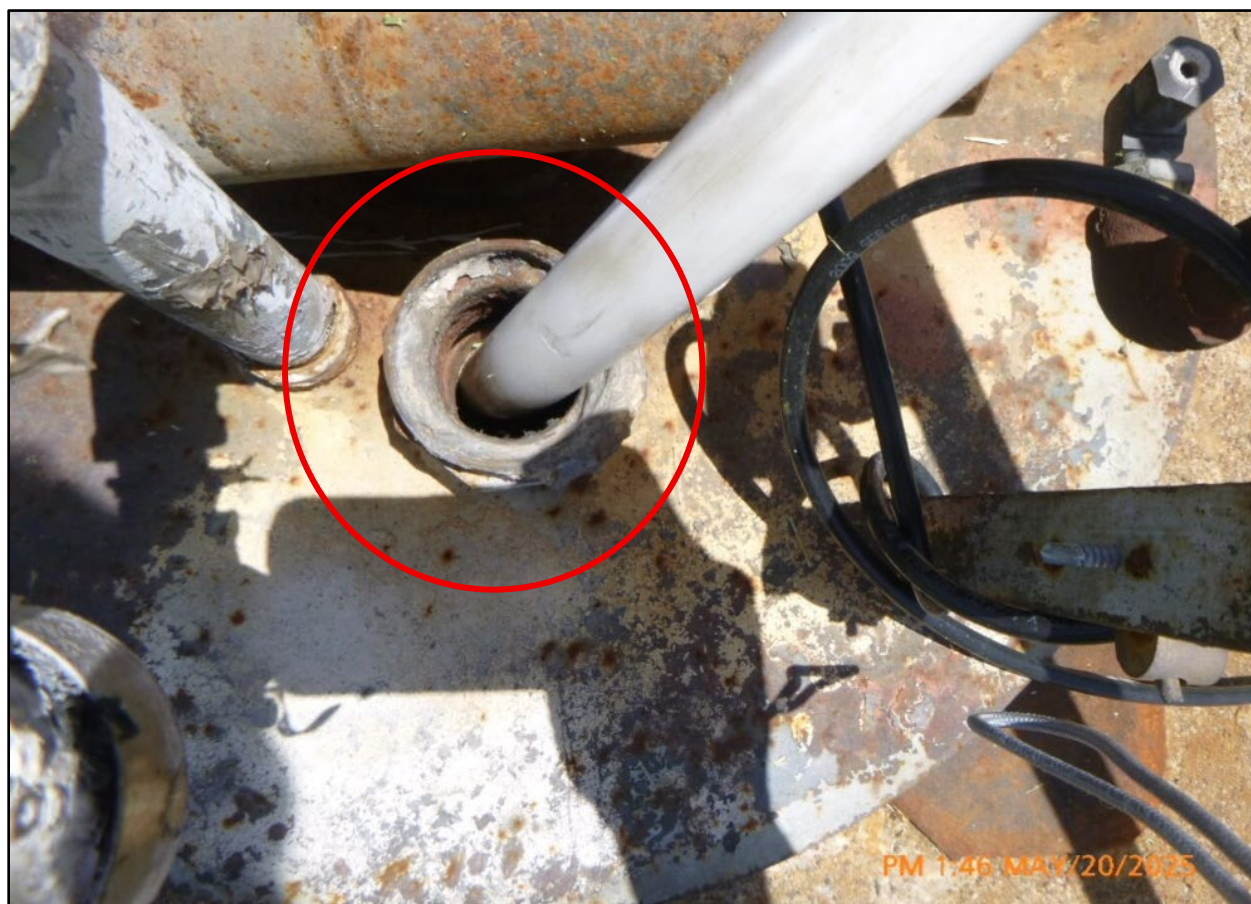
**Photograph 9. 05/20/2025 01:46 P1010519.JPG**

**Observation 10.** The EPA Inspection Team observed an unsealed opening in the wellhead for the submersible pump’s electrical conduit at Plant 6, Well No. 4 (Refer to [Appendix 3, Photograph 9](#)). The vent on Well No. 4 also lacked a screen.

Description: Plant 6. Opening in the electrical conduit on the Well No. 4 wellhead.

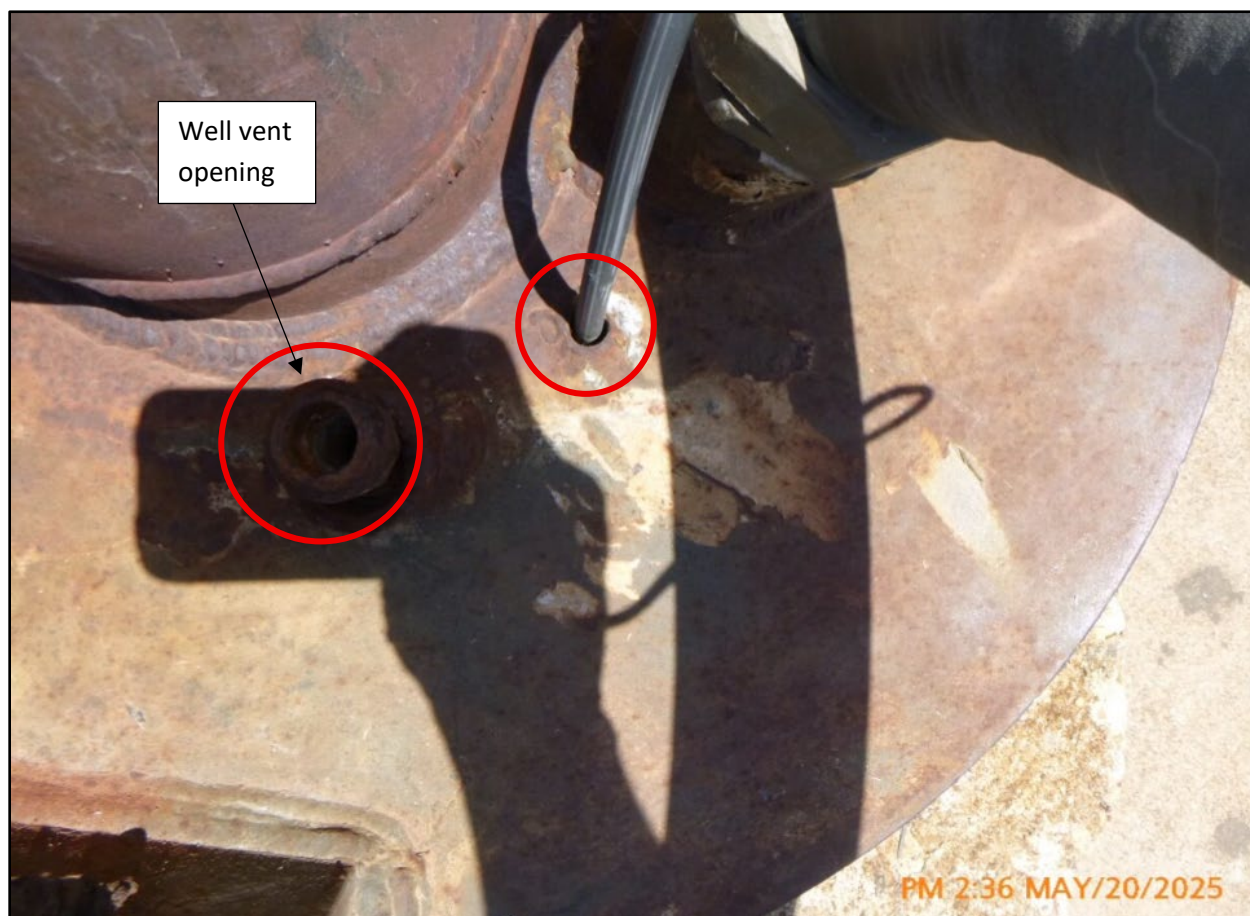
**Photograph 10. 05/20/2025 02:36 P1010538.JPG**

**Observation 11.** The EPA Inspection Team observed an unsealed opening in the wellhead for the purge line at Plant 11, Well No. 5 (Refer to [Appendix 3, Photograph 10](#)).

**Observation 12.** The EPA Inspection Team observed an opening in the wellhead where the vent was previously installed at Plant 11, Well No. 5. The wellhead lacked a screened vent (Refer to [Appendix 3, Photograph 10](#)).

Description: Plant 11. Openings in the Well No. 5 wellhead around the purge line and lack of screen on the vent opening.
