**U.S. ENVIRONMENTAL PROTECTION AGENCY  
REGION 3 WATER BRANCH, ENFORCEMENT  
AND COMPLIANCE ASSURANCE DIVISION  
CLEAN WATER ACT  
COMPLIANCE INSPECTION REPORT**

**Name of Facility:** Central Supply Company of West Virginia  
**Facility Address:** Summersville Plant, 7900 Webster Rd, Summersville, WV 26651  
**Mailing Address:** 4923 Benedum Dr., Bridgeport, WV 26330

| <b>Type of Inspection:</b> | Compliance Evaluation Inspection |

**DSB ID:** ECAD-5716

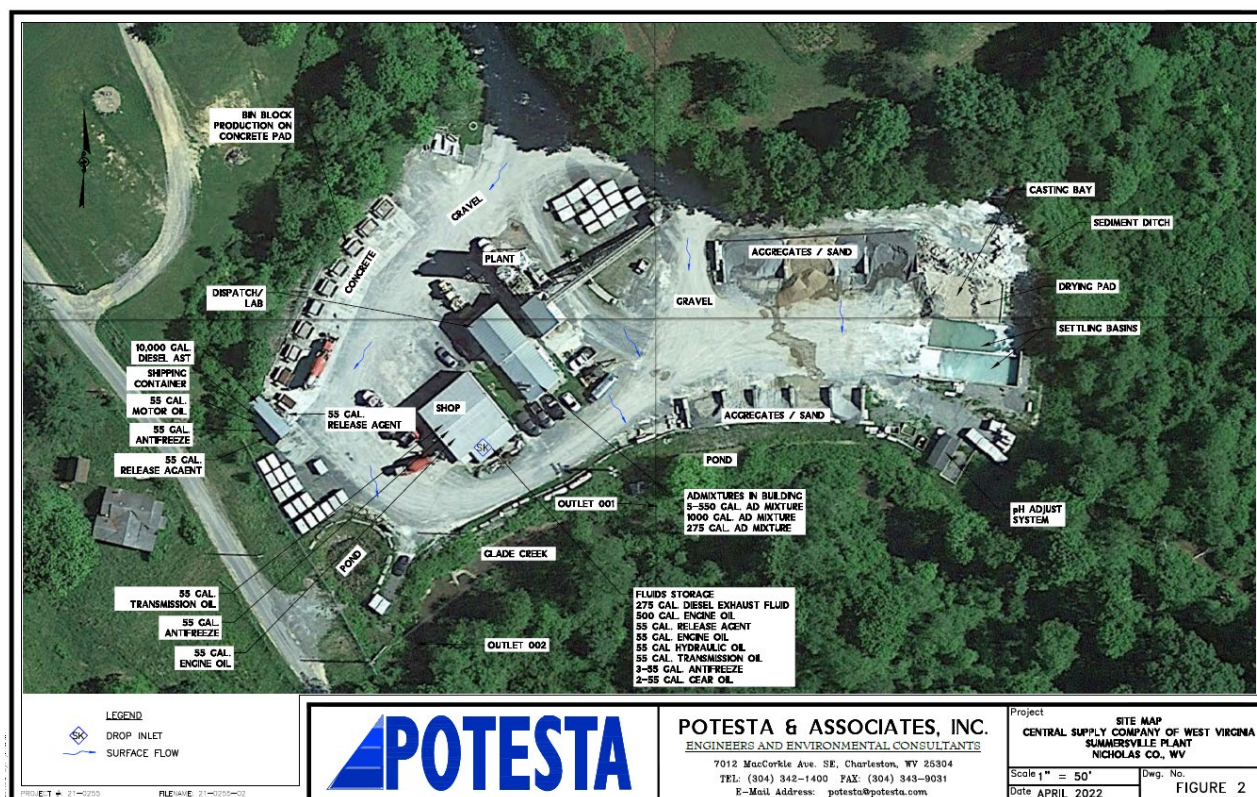
Figure 1. SWPPP Site Drainage Map

There are two discharge points at the Facility. Outlet 002 is located in the southwestern corner of the Facility, along Lower Glade Creek Road and collects runoff from the northern and western portions of the site, including the gravel road north of the main building, the fueling area, and the concrete bin block area. Outlet 001 is located northeast of Outlet 002 and collects runoff from the eastern portion of the site, including the concrete loading area, aggregate storage area, and concrete wash area. Detention ponds were located immediately upstream of each outlet.

Figure 1 shows the Facility layout from the SWPPP Drainage Map. Additional details related to the Facility conditions at the time of the inspection are included in the *Summary of Observations* section of this report.
