**Region 6 - Enforcement & Compliance Assurance Division**  
**INSPECTION REPORT**

| Inspection Date(s): | 11/07/2019 | |
| Company Name: | LBOC, LLC | |
| Facility Name: | Barton-Proetz | |

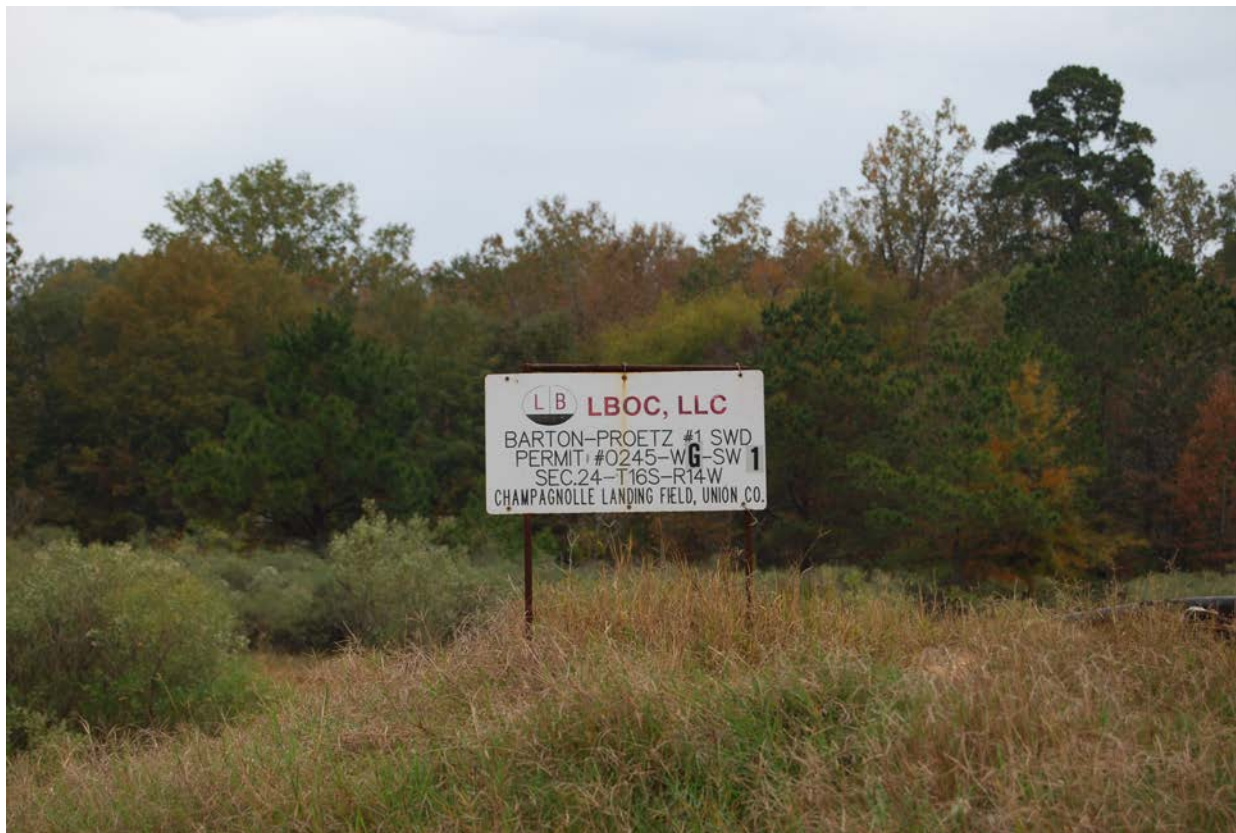
Photo No. 1

I initially arrived at the LBOC, LLC, Barton-Proetz lease at about 10:00 am on November 7, 2019. Photos 1 and 2 show the location and source of the discharge of produced water, or brine. The tank battery pit had a large amount of oil and brine during the inspection in it (Photo 3). I observed recent dirt work around the tank battery that showed the containment had been repaired recently. The drain valve at the battery was shown in Photo 4. I observed that oil and brine ran from the battery via the valve or an overflow line towards an area with two pits shown in Photo 5. The left pit was shown in Photo 6. That pit was full of fluids. I observed that most of the current discharge fluids went into the pit on the right side (Photo 7). Oil staining was present along the flow path to the right sided pit. With a calibrated YSI Pro 30 conductivity meter, I took Total Dissolved Solids (TDS) readings at the pit shown in Photo 8 and it measured 18,975 milligrams per liter (mg/L). Another view of the right-sided pit was shown in Photo 9. The lake or bayou was clearly seen in the background of the photo several yards west. The pit had a trench located on the northwest side (Photo 10) that lead the flow to a smaller pool, which was closer to the lake. I observed oil staining in the trench leading to the smaller pool. Photo 11 showed the shallow pool close to the lake and the TDS in that pool measured 4,862 mg/L (Photo 12). The pool had an exit or cut that was shown in Photo 13. That exit became a shallow trench that lead to the lake or bayou (Photos 14 and 15). The discharge or produced water entered the lake as shown in Photo 16. TDS at the entry point measured 2,253 mg/L (Photo 17). The lake/bayou eventually drained into Lewter Creek (Photos 18 and 19). I observed that Lewter Creek flowed into the Ouachita River a short distance away from the point of entry.

Description: I observed that produced water, or brine was discharged from this lease and tank battery.

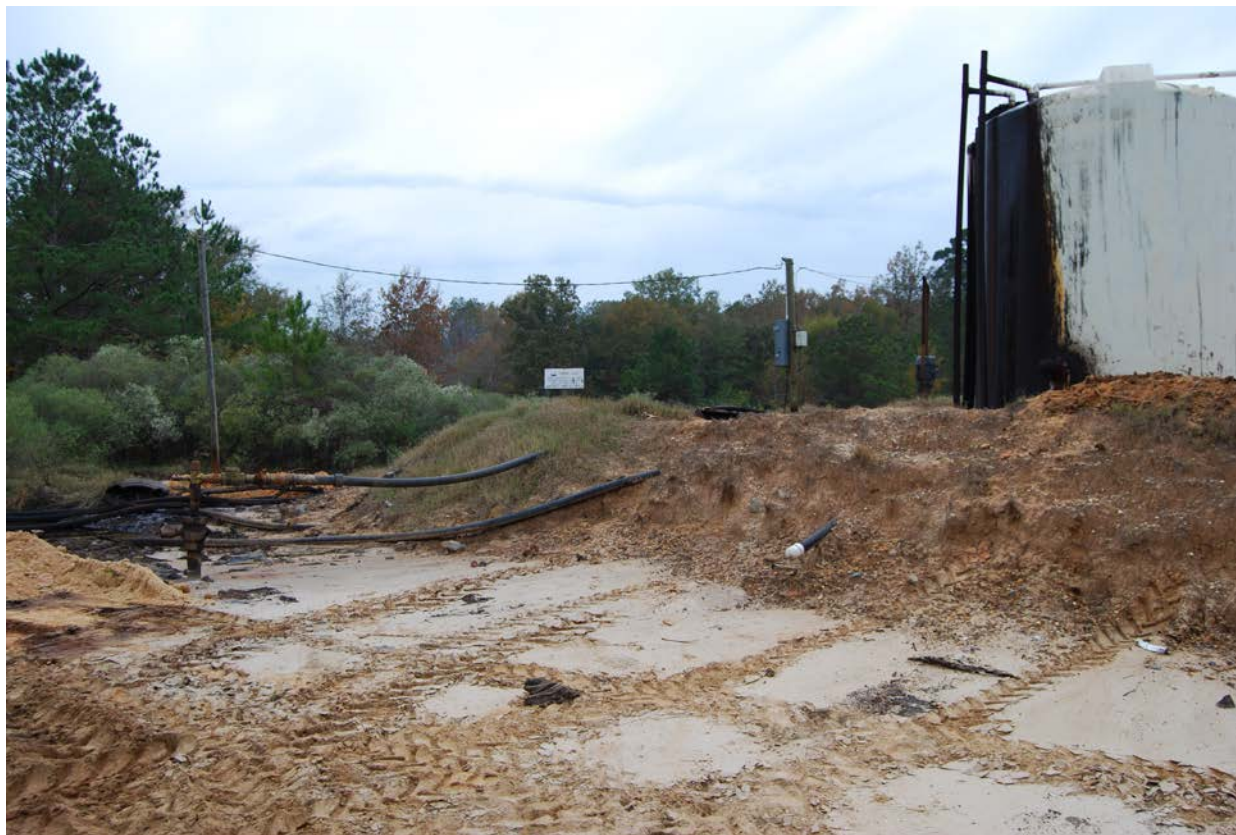
Photo No. 2

Description: The tank battery where the discharge occurred had recent dirt work to improve the secondary containment.

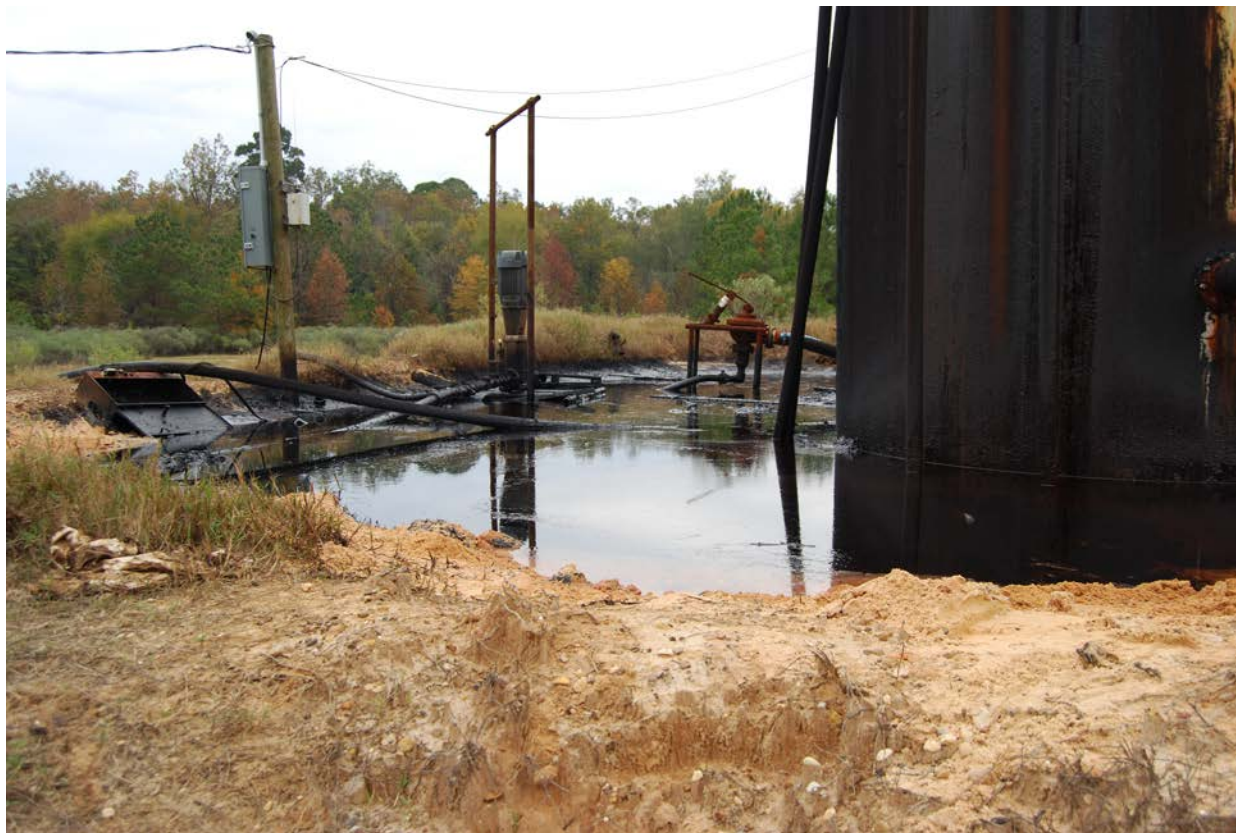
Photo No. 3

Description: The secondary containment pit was full of oil and brine during the inspection. I observed that the brine storage tanks at the tank battery leaked into the pit during the inspection.

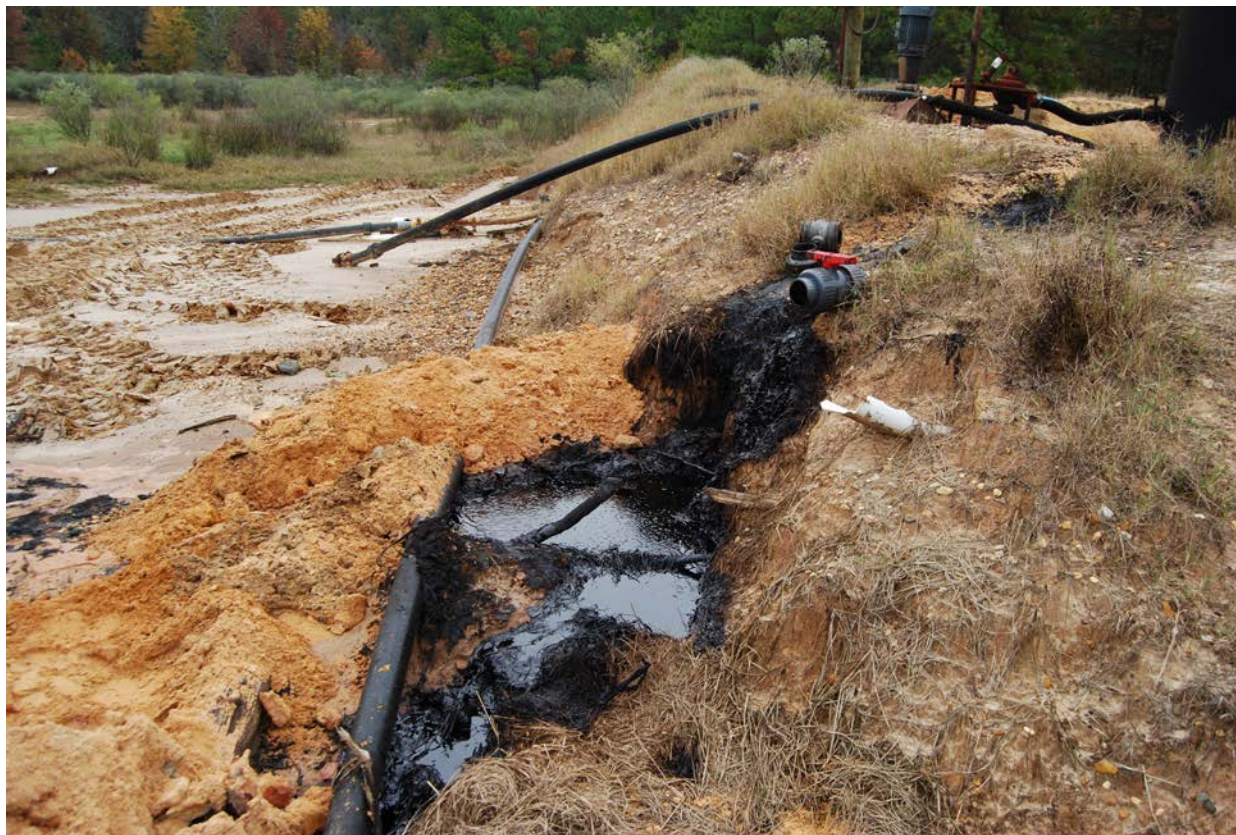
Photo No. 4

Description: It was unclear whether the pit overflowed or was drained out of the valve, seen here, to discharge the fluids, including brine and oil, from the secondary containment area. There was significant amounts of oil staining observed outside of the secondary containment area at the valve during the inspection.

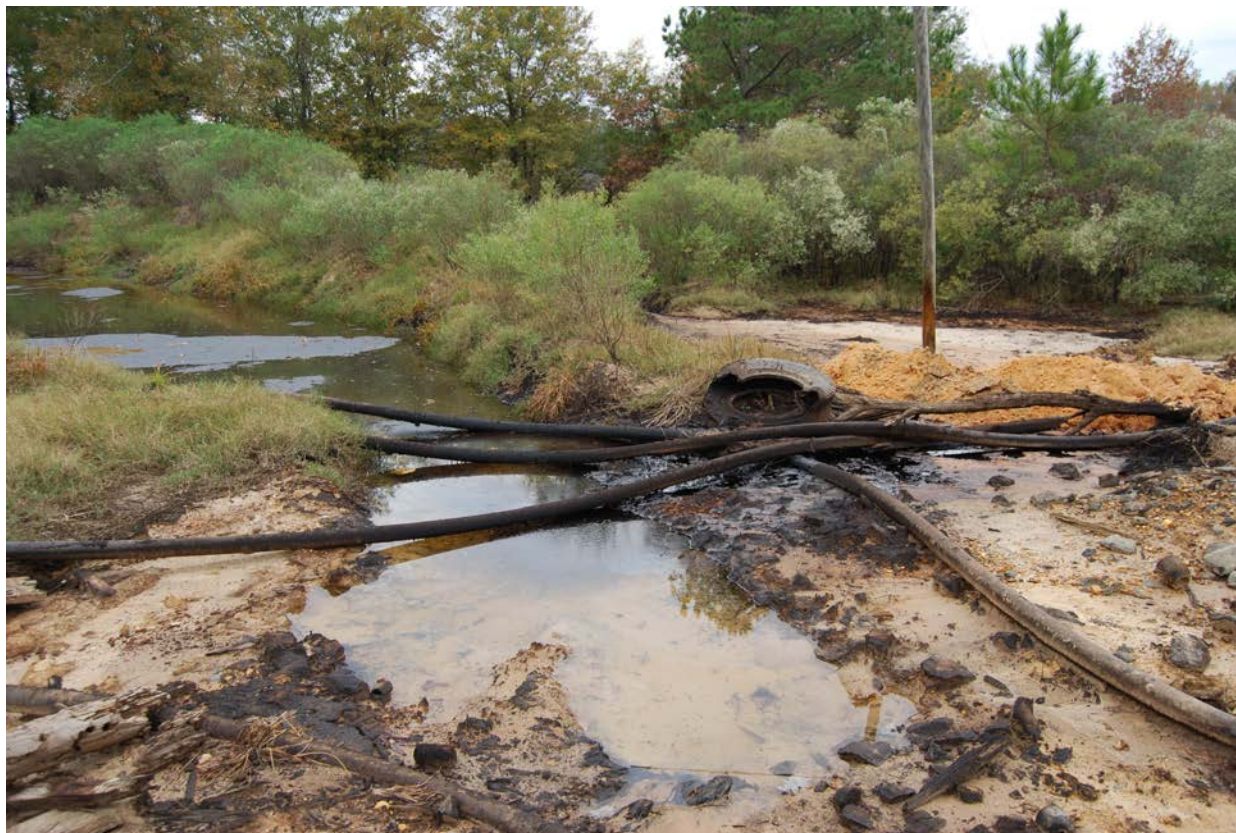
Photo No. 5

Description: The brine and oil discharge was directed at two pit areas not a part of the secondary containment area of the pit. The one on the left shown here was nearly full and most of the fluid entered the pond/pit to the right, further along the flow path towards Lewter Creek.

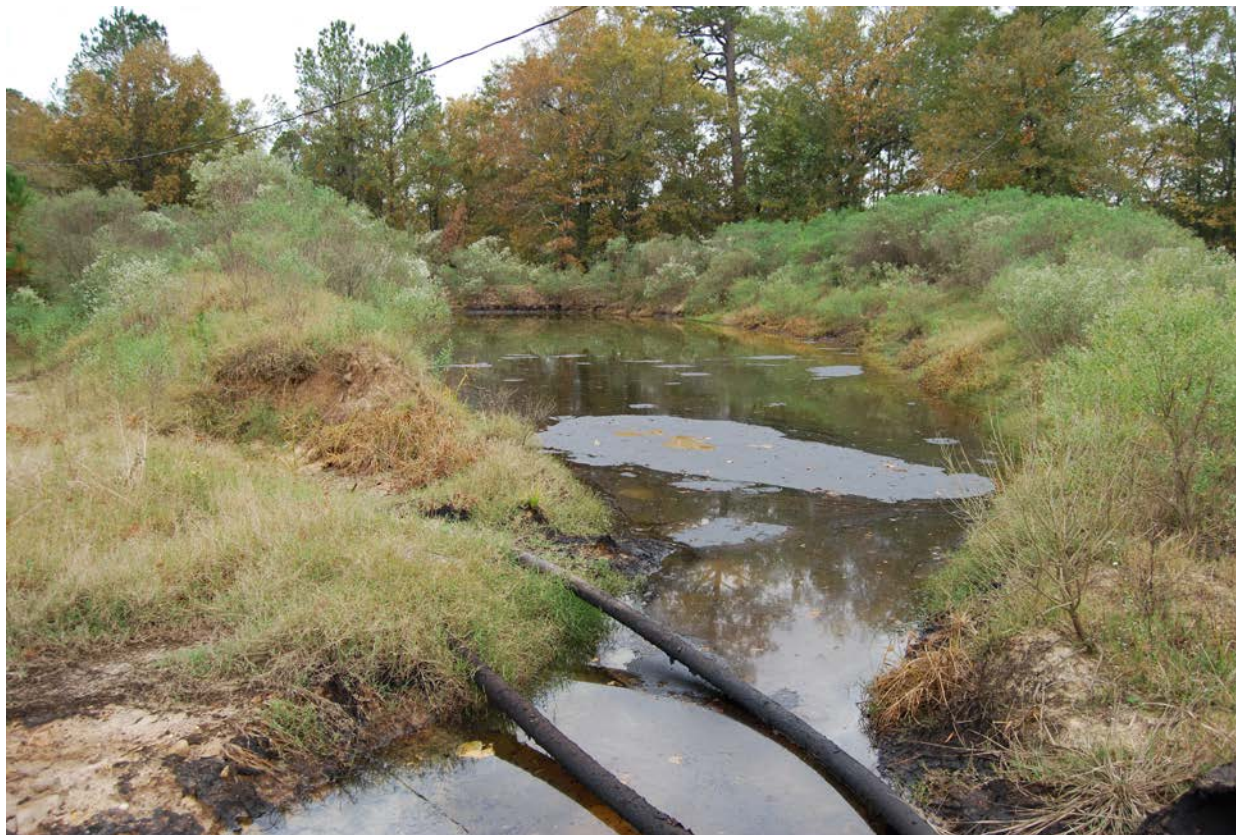
Photo No. 6

Description: The left pit shown here was full of brine, rainwater, and some oil on top. I observed it did not have a flow path/exit, during the inspection.

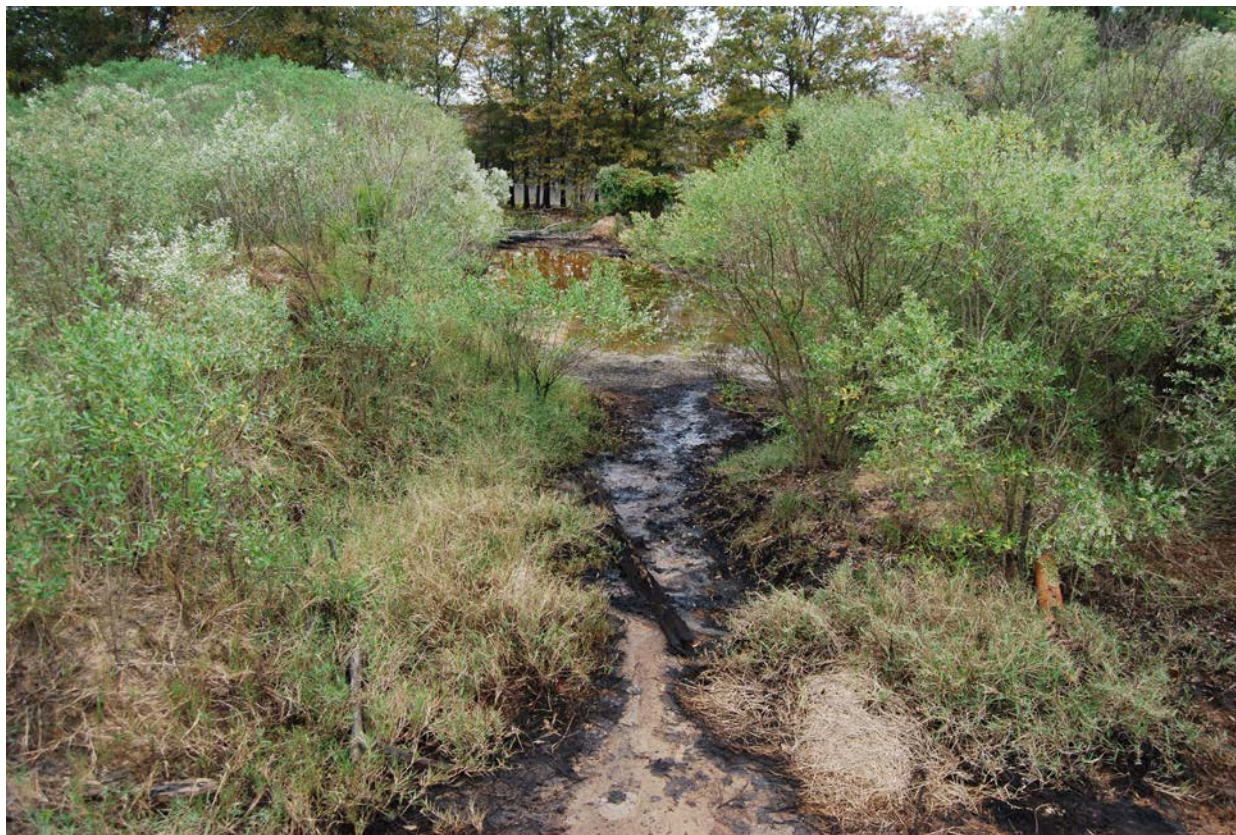
Photo No. 7

Description: The entrance to the pond or pit on the right was shown here. I observed oil residue remains in the neck of the pit from the recent discharge.

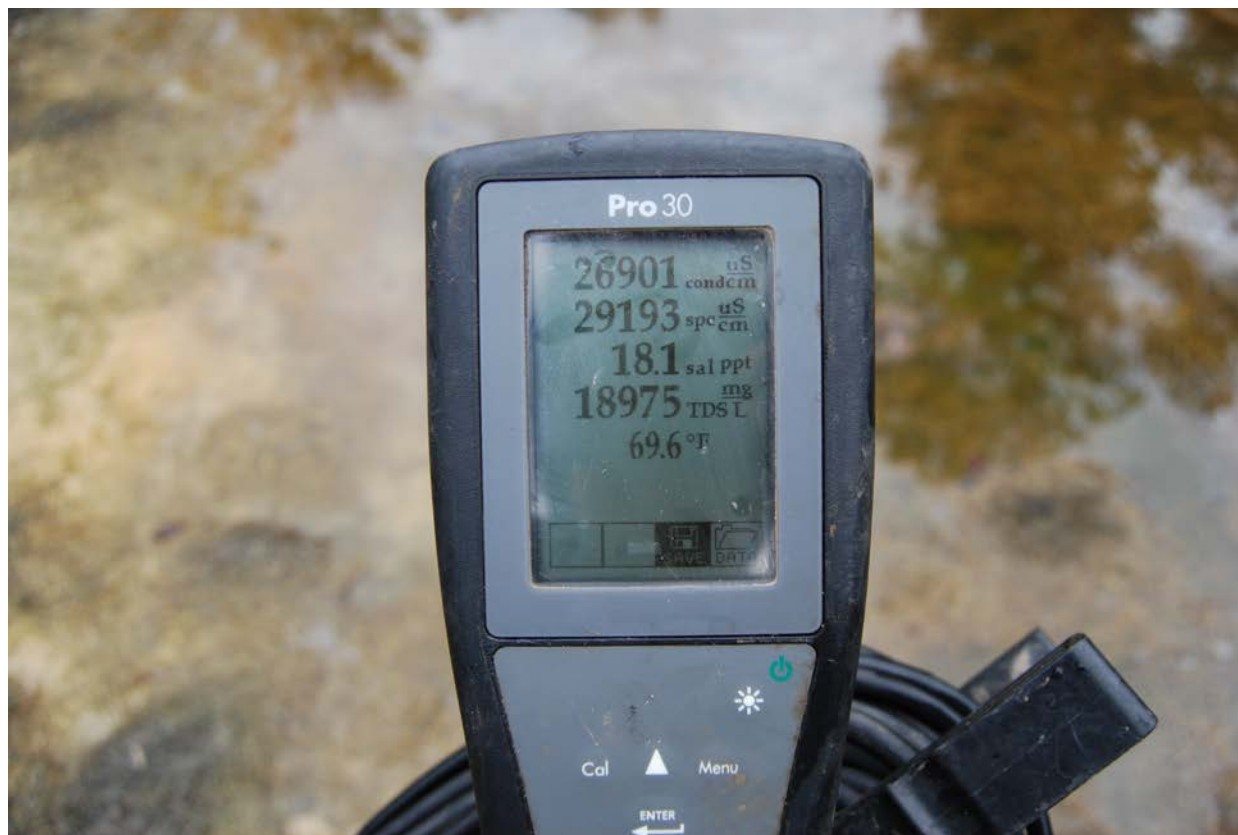
Photo No. 8

Description: With a calibrated YSI Pro 30 Conductivity Meter, I took a Total Dissolved Solids (TDS) reading of the right side pit/pond and it measured 18,975 milligrams per liter (mg/L).

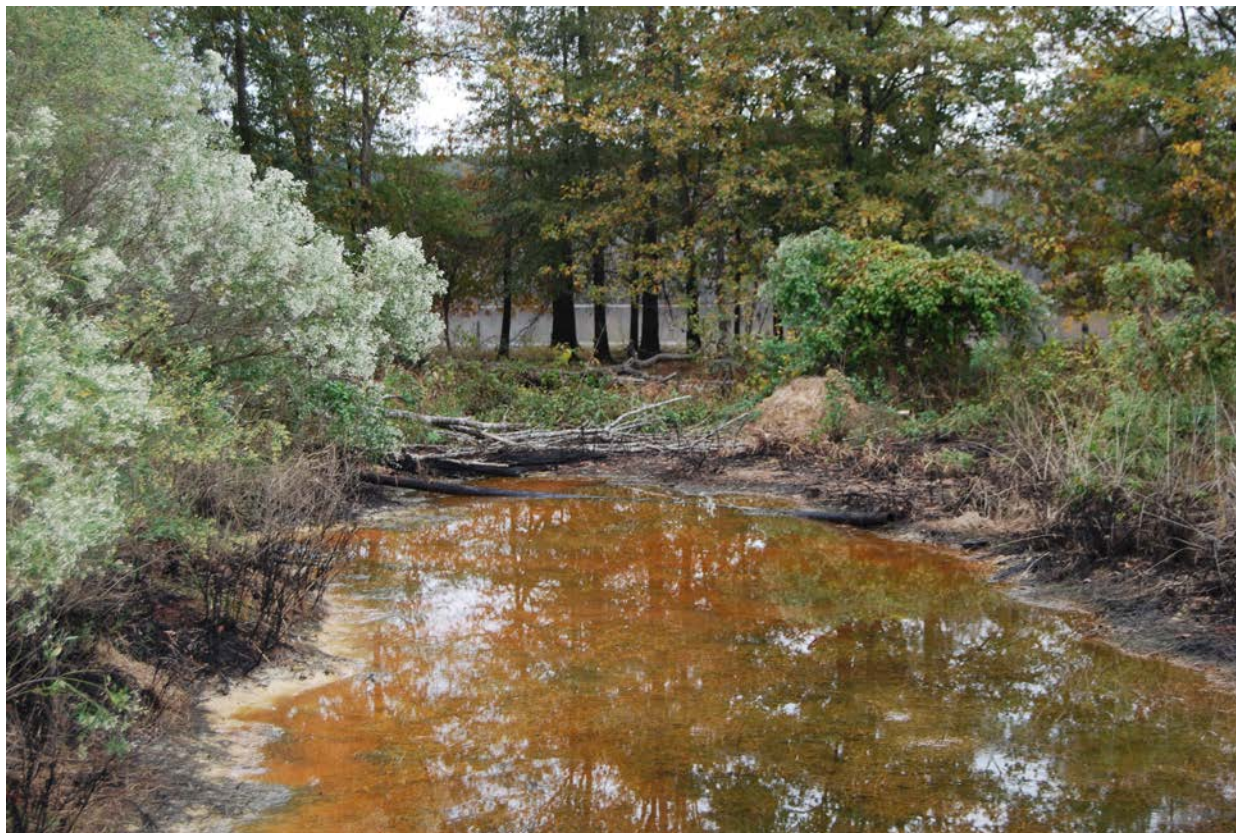
Photo No. 9

Description: This was a view from the right sided pit. This pit drained to the small lake or bayou seen in the background.

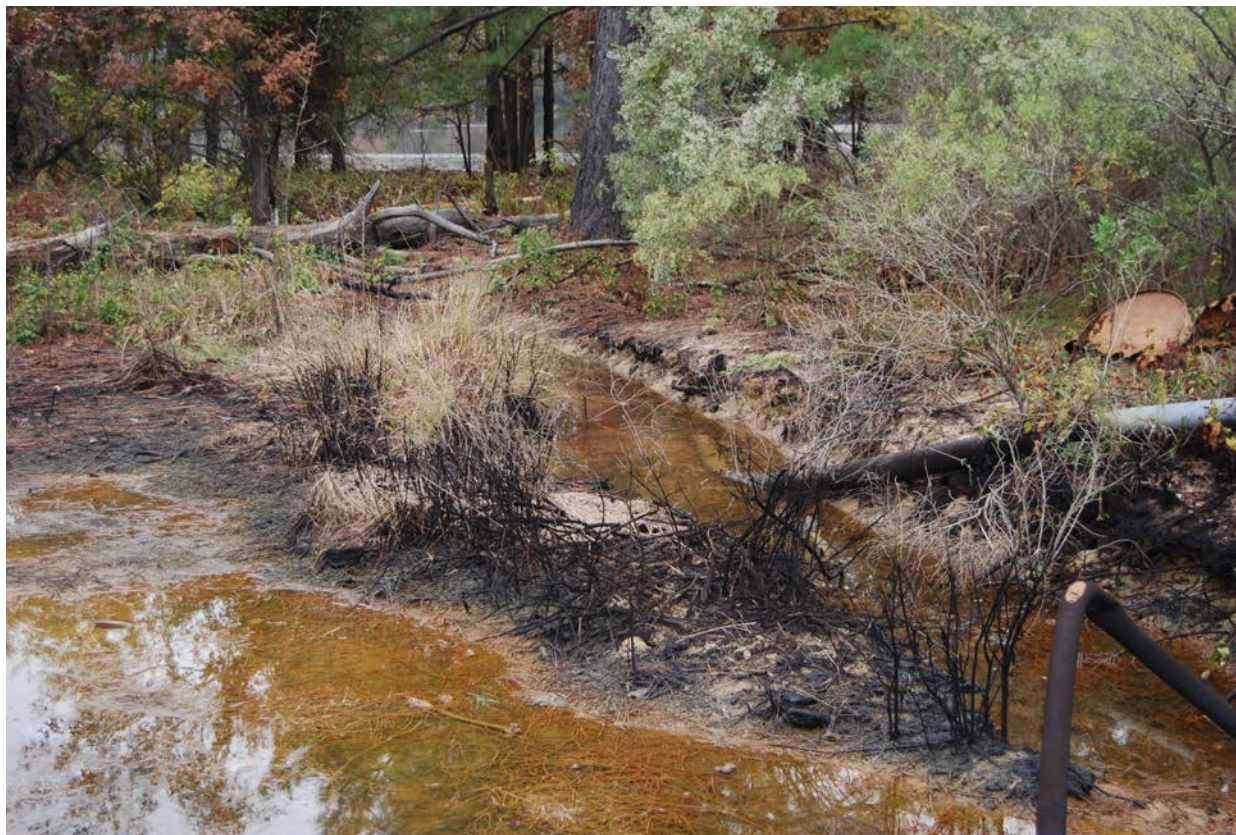
Photo No. 10

Description: The right-side pit shown here and in Photo 9 flowed out via the small narrow trench seen on the right side of this photo toward the small lake in the background. I observed oil staining throughout the flow path.

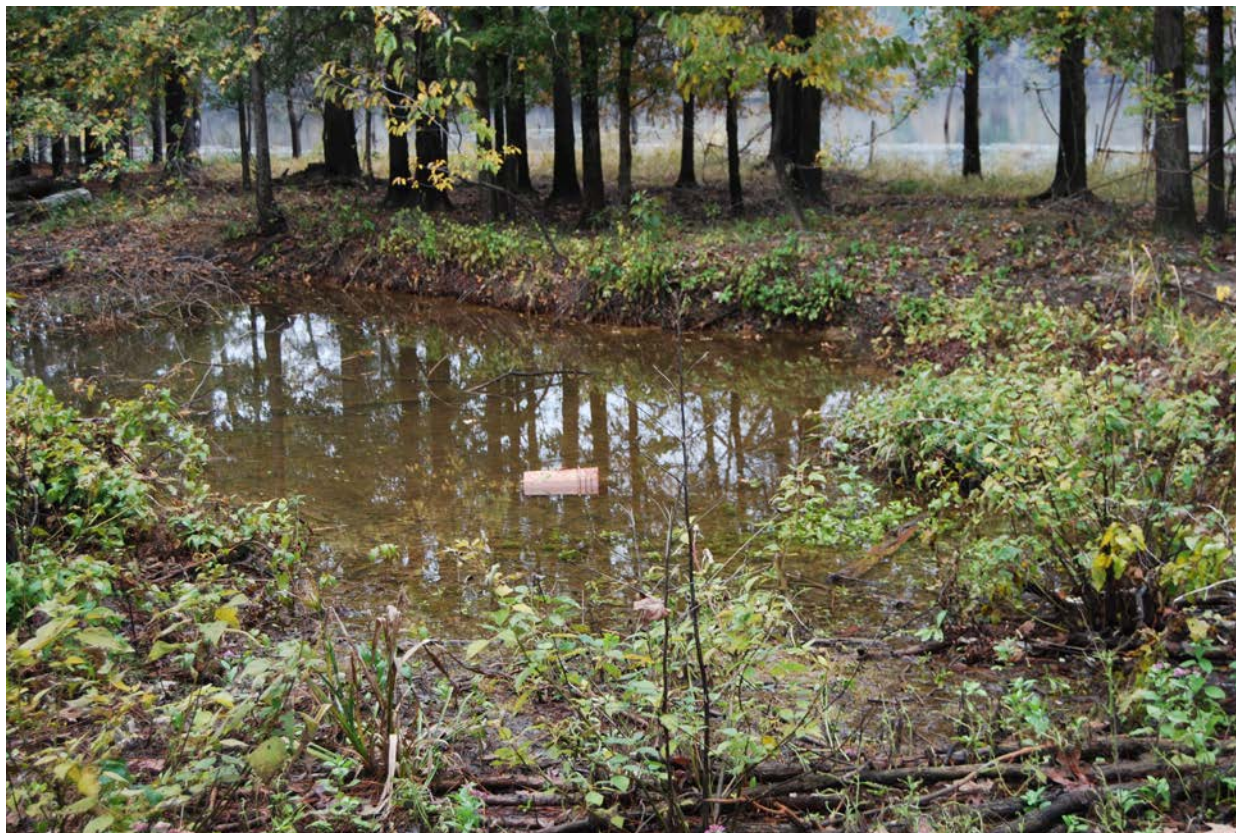
Photo No. 11

Description: The trench in Photo 10 emptied into this shallow pool prior to entering the lake or bayou.

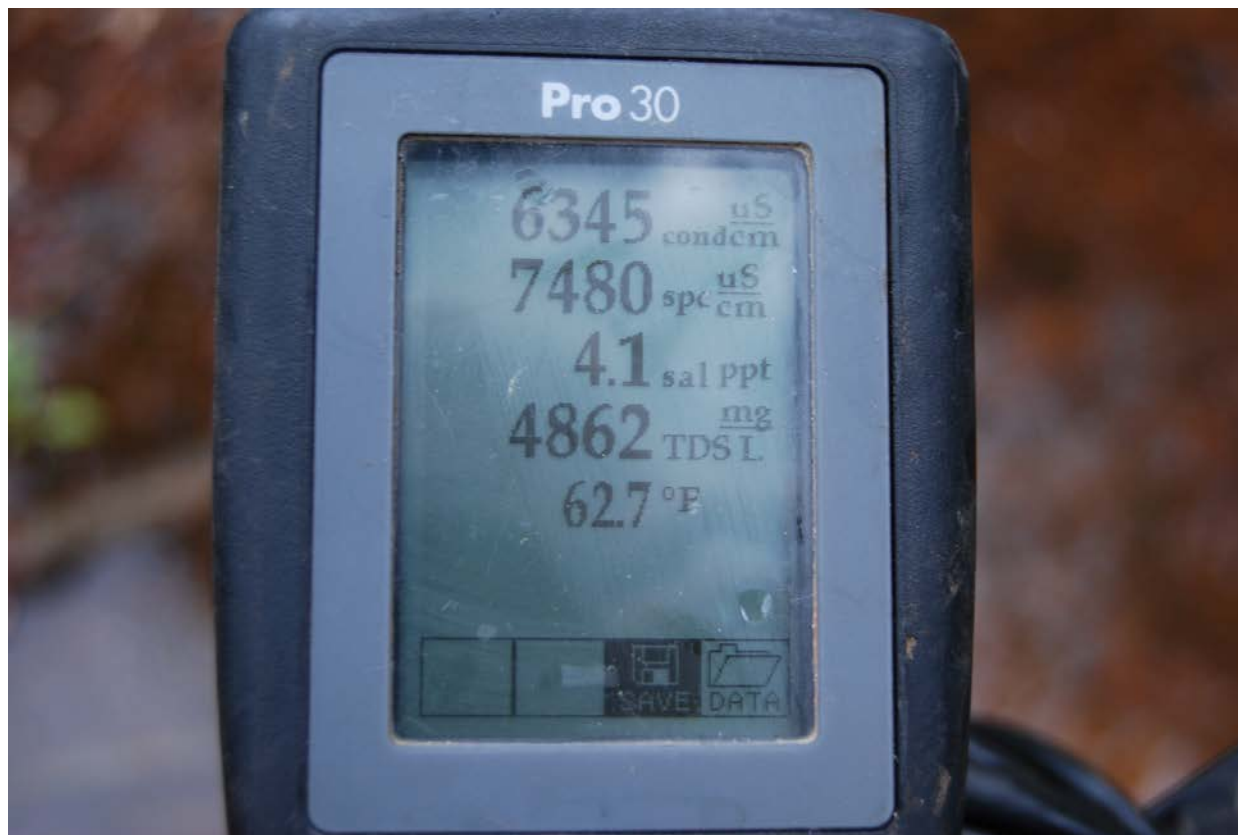
Photo No. 12

Description: The TDS of the small pool shown in Photo 11 measured 4,862 mg/L.

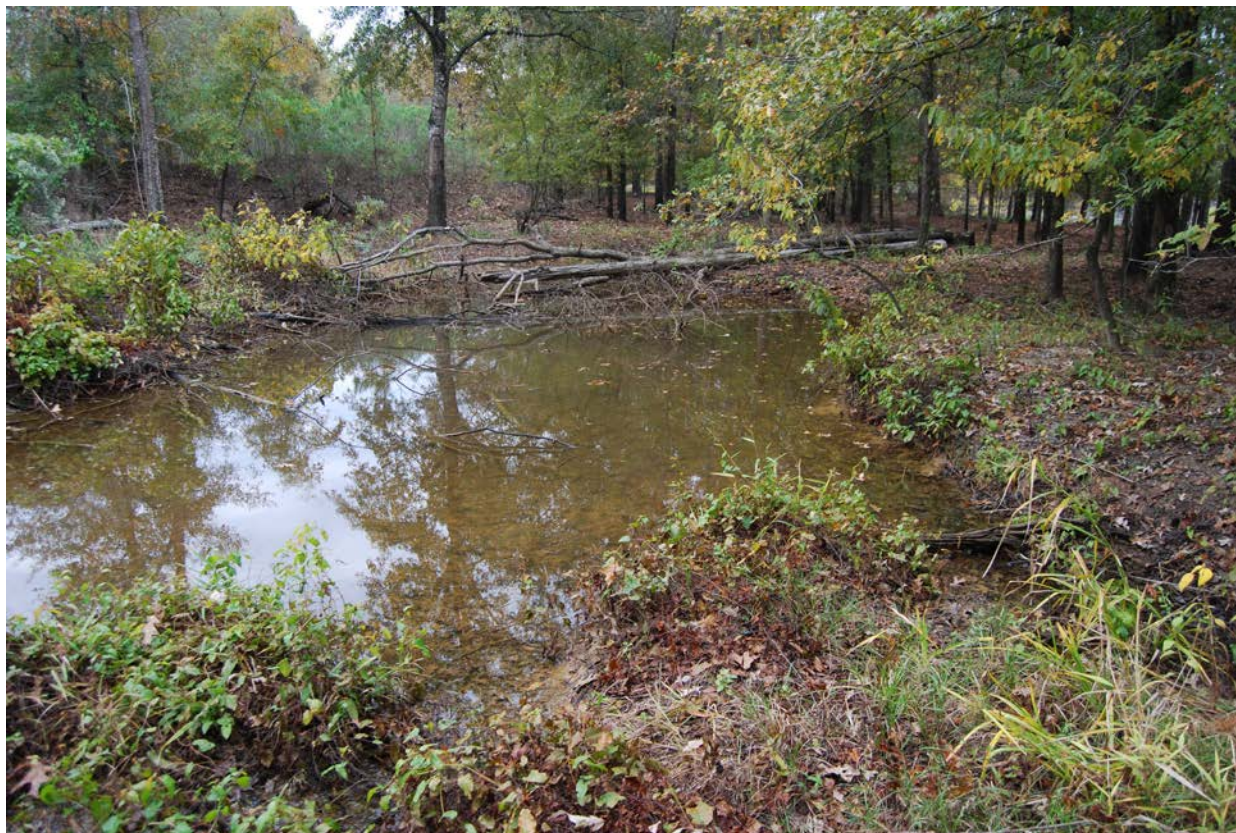
Photo No. 13

Description: The shallow pool flowed to the right as shown here toward the small lake.

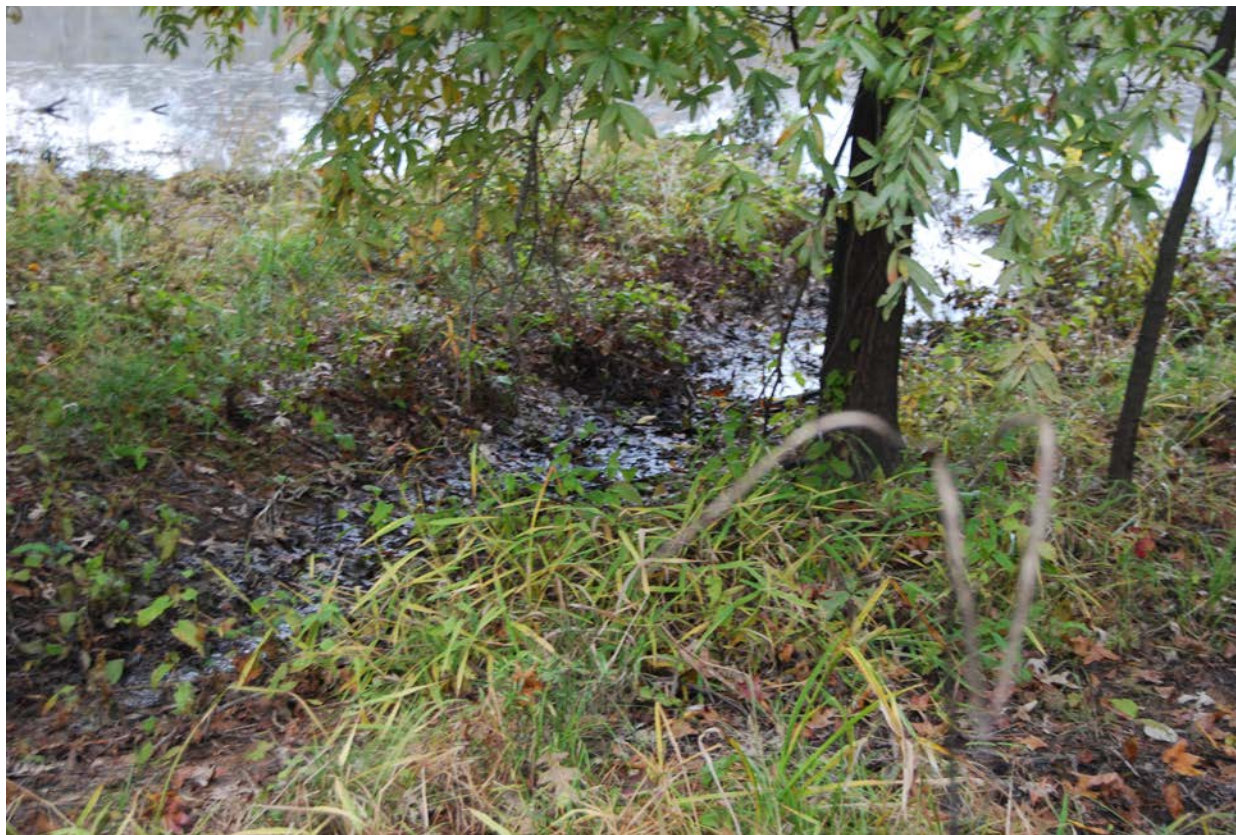
Photo No. 14

Description: The exit from the small pool entered the lake or bayou here.

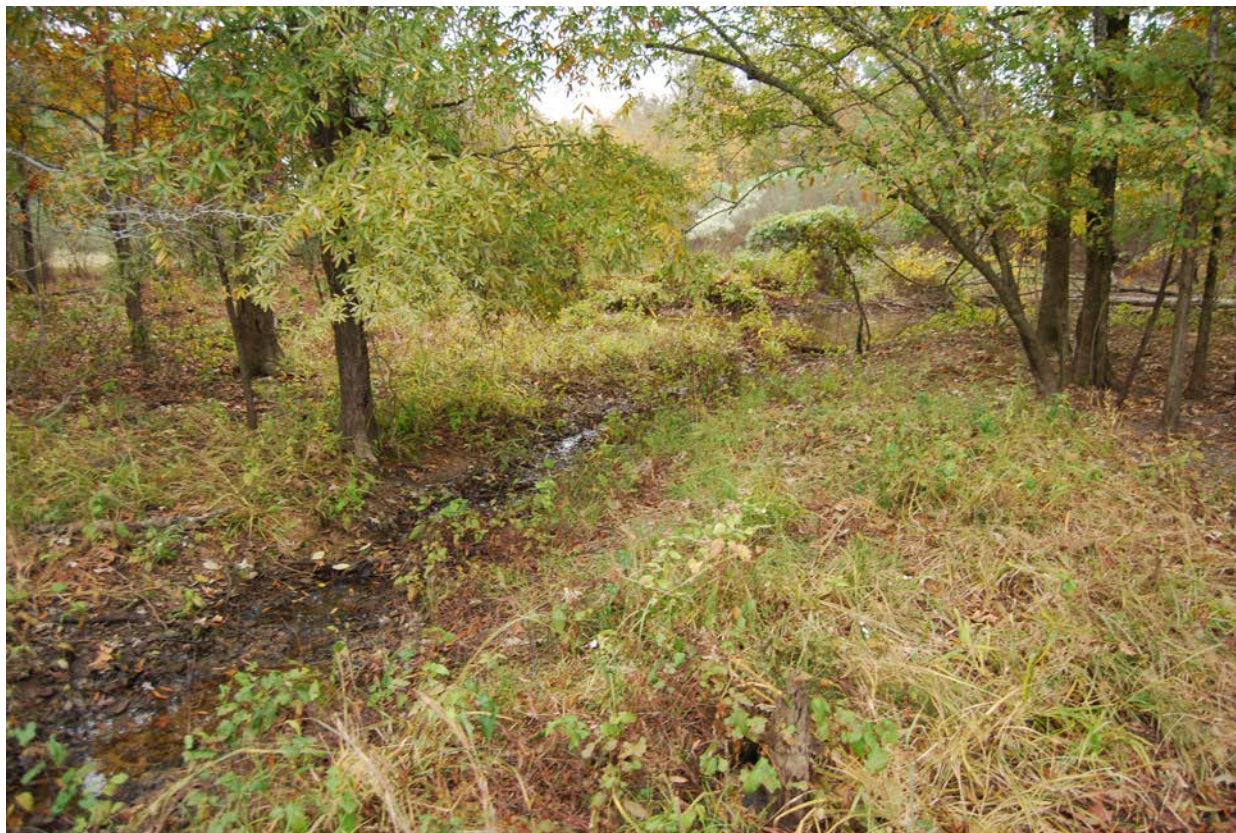
Photo No. 15

Description: This was a reverse angle view from the lake showing the trench from the shallow pool to the small lake or bayou.

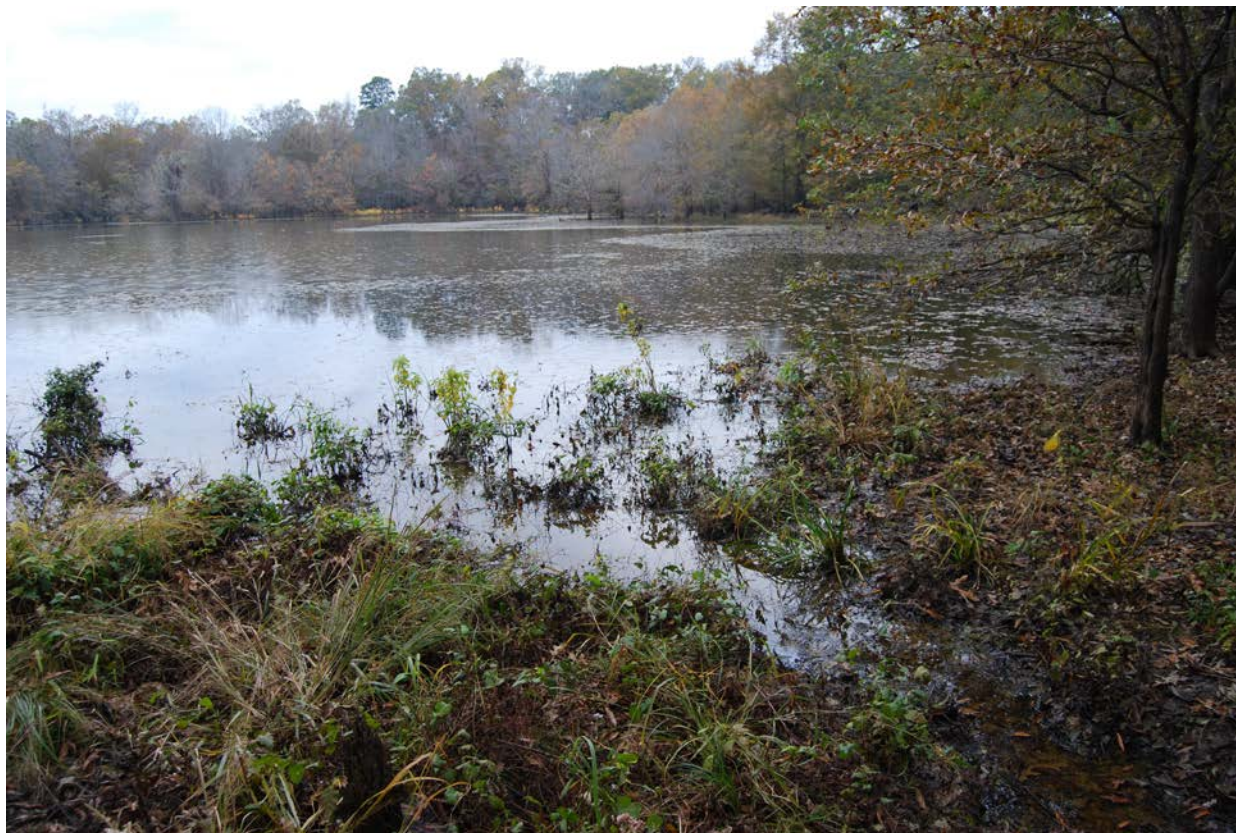
Photo No. 16

Description: I observed the point of entry of brine fluids into to the small lake or bayou here.

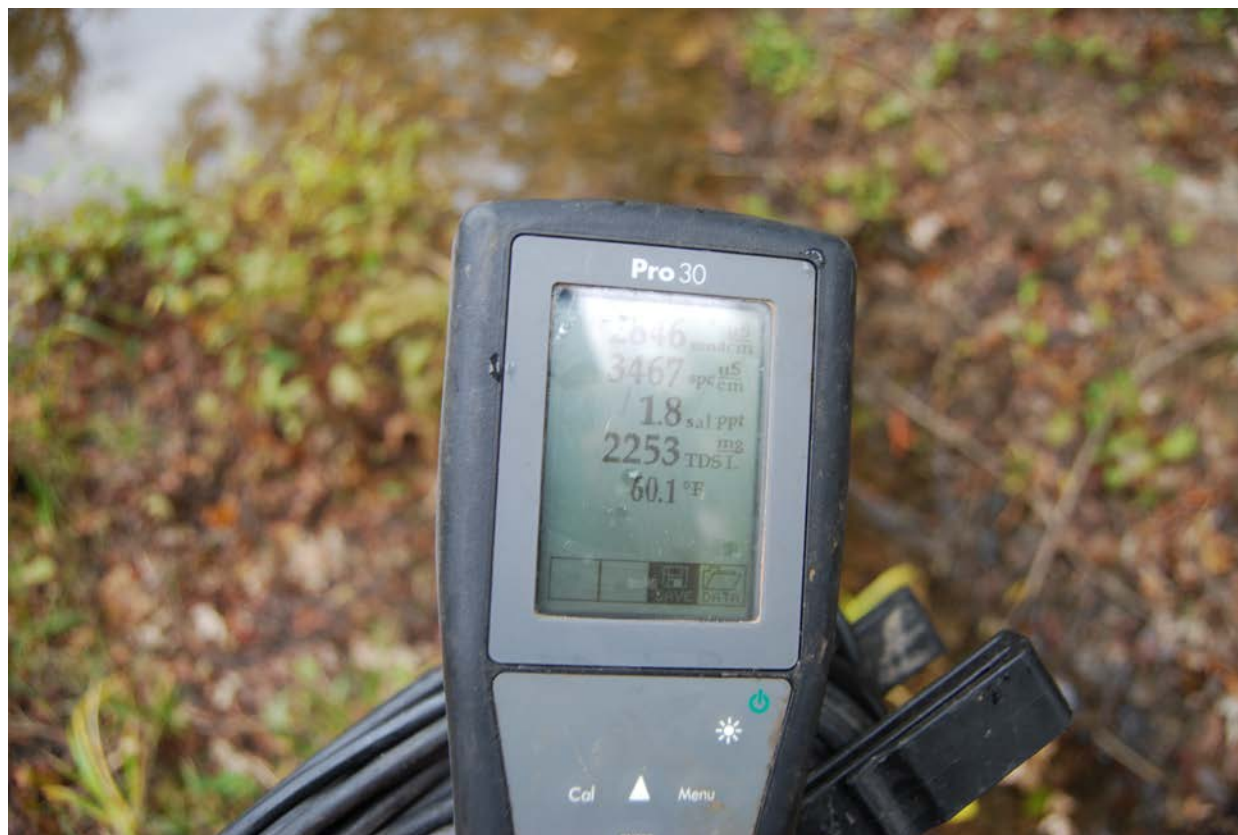
Photo No. 17

Description: the TDS at the point of entry to the lake was 2,253 mg/L. The TDS measurement was not taken at the deepest part of the lake due to the size of the lake. Brine is more dense than freshwater and sinks, therefore the TDS at the point of entry was measured during the inspection from a shallower portion of the small lake or bayou.

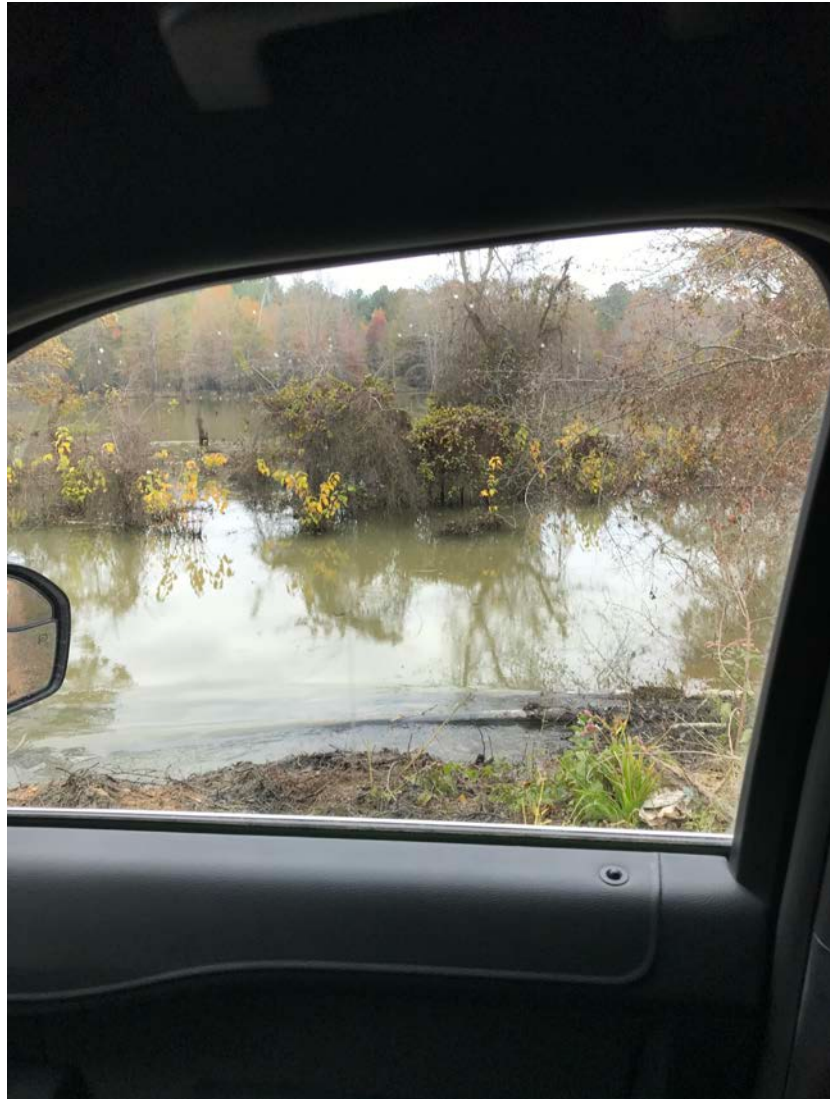
Photo No. 18

Description: This was a view of the small lake or bayou where it flowed to Lewter Creek.

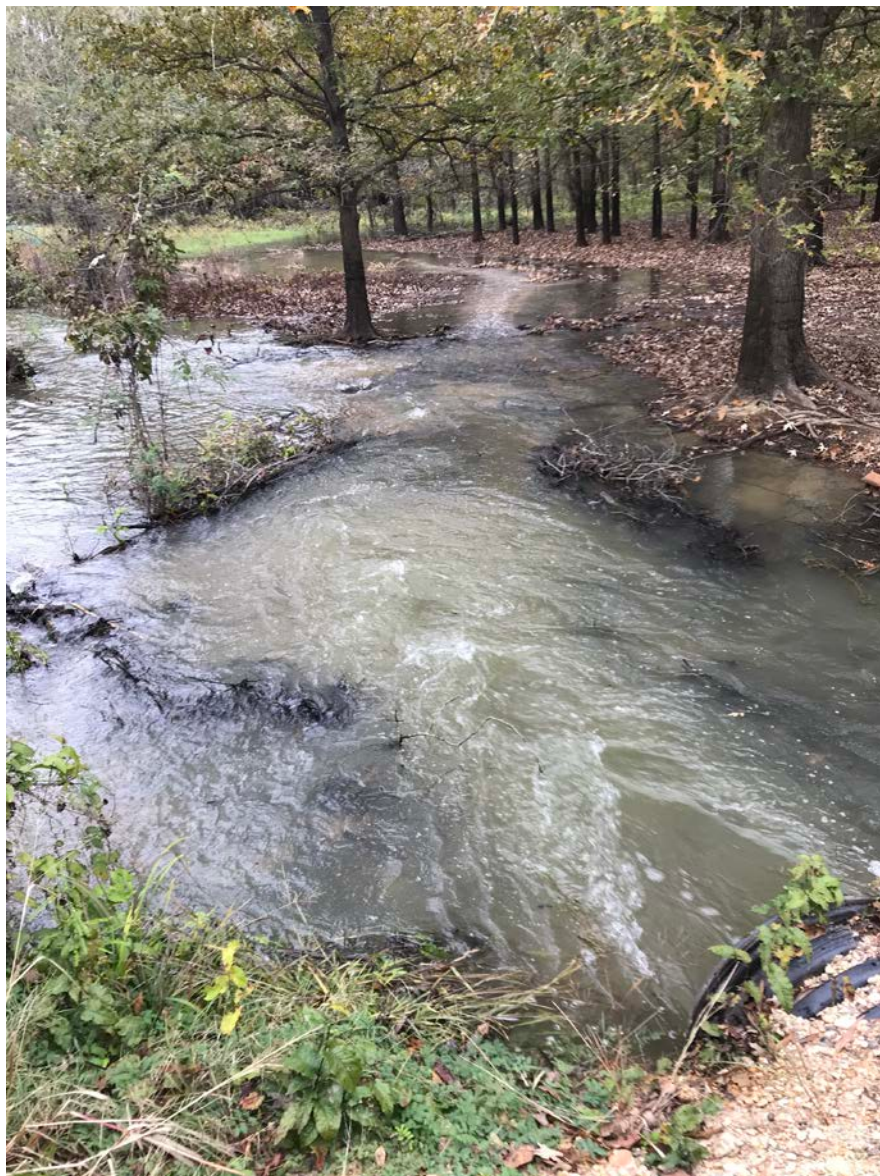
Photo No. 19

Description: This was a reverse angle view of Photo 18. I observed fluids, including water entering Lewter Creek from the small lake or bayou.
