**Region 6 - Enforcement & Compliance Assurance Division**  
**INSPECTION REPORT**

| Inspection Date(s): | 03/13/2025 | |
| Company Name: | <b>Calgary Energy, LLC</b> | |
| Facility Name: | <b>Tidal Osage 1 Lease</b> | |

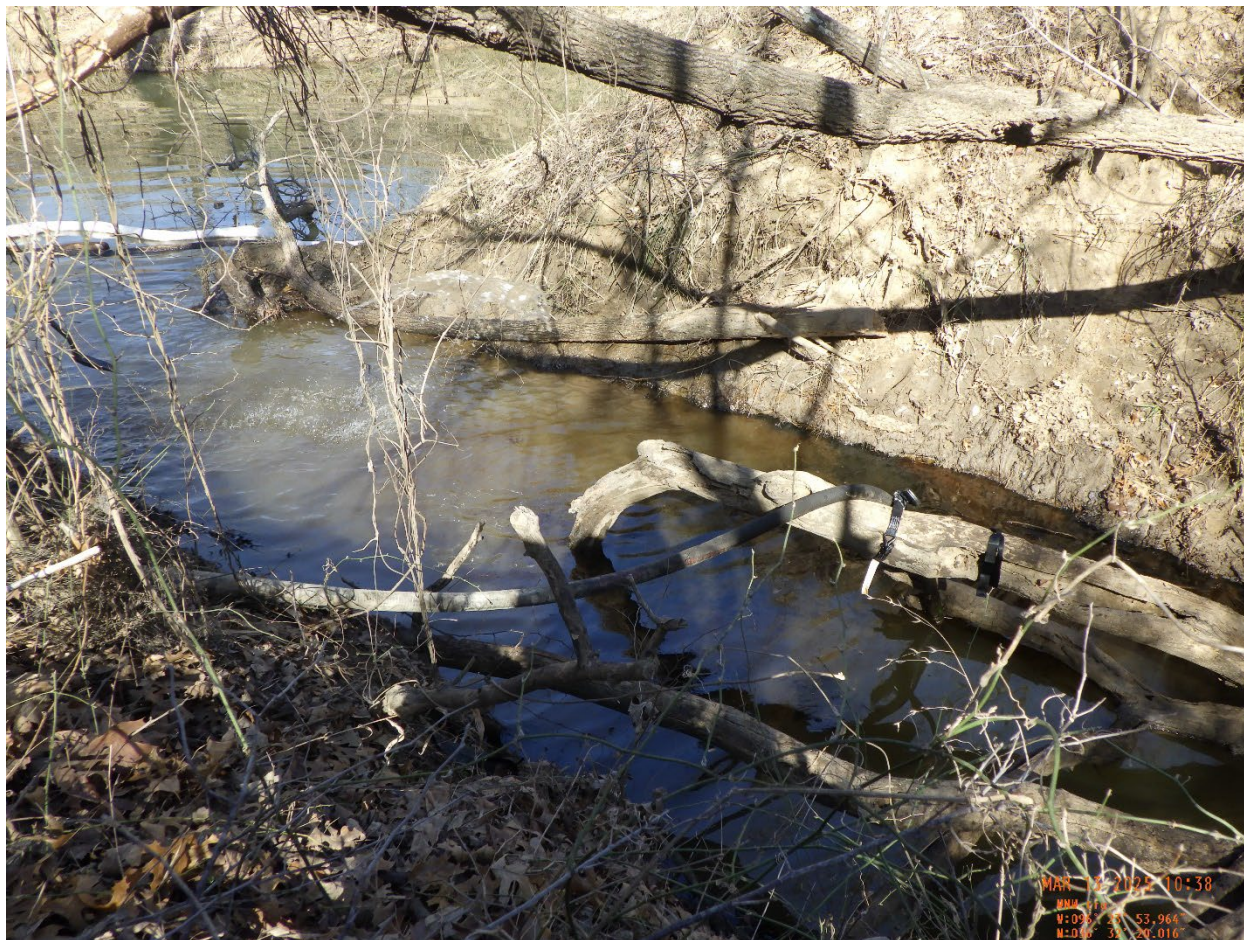
Photo No. 1

I observed the confluence of the impacted, unnamed tributary with Little Hominy Creek. Cleanup was ongoing during the inspection. I observed significantly less oil on the tributary than during the initial spill inspection conducted 3/11/2025. See photo No. 1. For additional GPS location information and photo metadata, please see Appendix 1 (photo log) attached to this report.

**Description:** This was a view of the impacted, unnamed tributary as it spilled into Little Hominy Creek. This photo showed ongoing cleanup efforts and significant reduction in crude oil compared to the initial spill inspection.

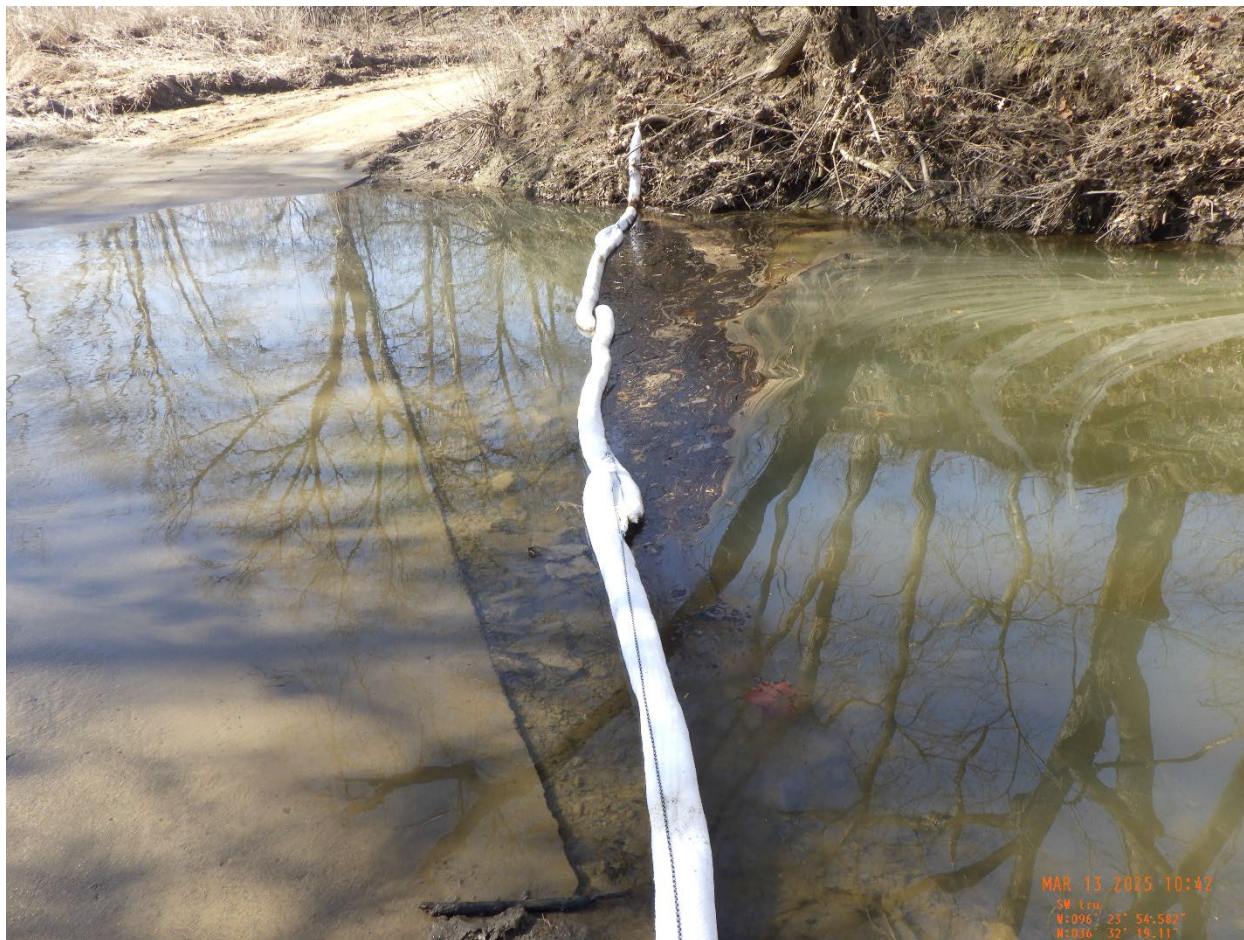
Photo No. 2

At the low water bridge, I observed the floating, oil absorbent containment boom with crude oil being held back from further downstream migration. From this same location, along the bottom of Little Hominy Creek in the main channel, I observed a TDS field reading of 15,086 mg/L. This was the highest TDS observed during the inspection but did represent an improvement over the initial spill inspection observations. See photos No. 2 & 3.

**Description:** This was the floating, oil absorbent containment boom with crude oil being held back from further downstream migration.

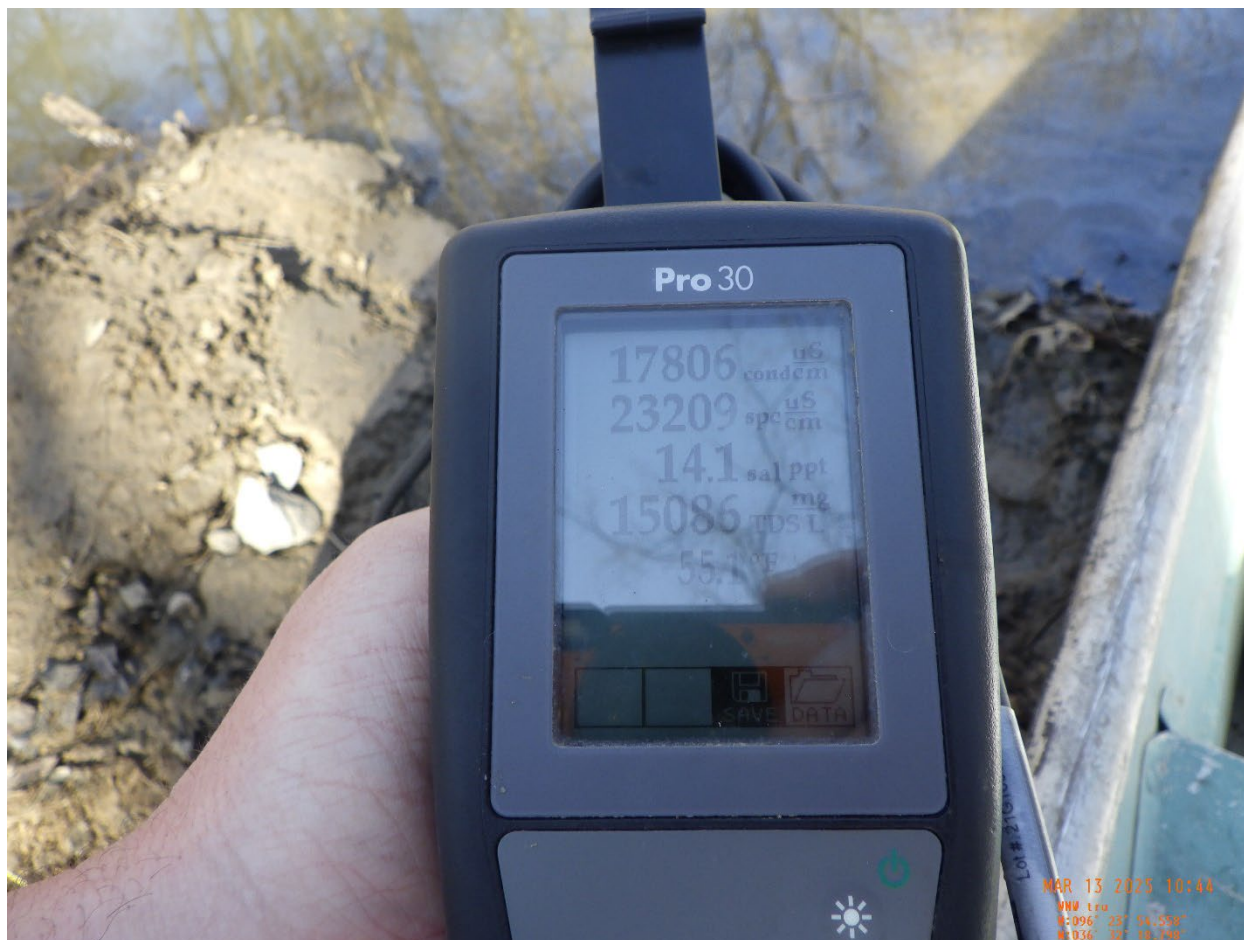
Photo No. 3

**Description:** This was a TDS field reading of 15,086 mg/L which was observed in the main channel of Little Hominy Creek immediately upstream from the cement low water crossing. This was the highest TDS observed during the inspection but showed improvement from the initial spill inspection conducted on 3/11/2025.
