**Report Title:** Clean Air Act Inspection of Recovermat, LLC  
**Inspection Date(s):** March 18, 2022  
**Regulatory Program(s):** SIP, Title V

**Company Name:** Recovermat, LLC  
**Facility Name:** Recovermat, LLC  
**Facility Location:** 2202 Halethorpe Farms Road  
Baltimore, MD 21227

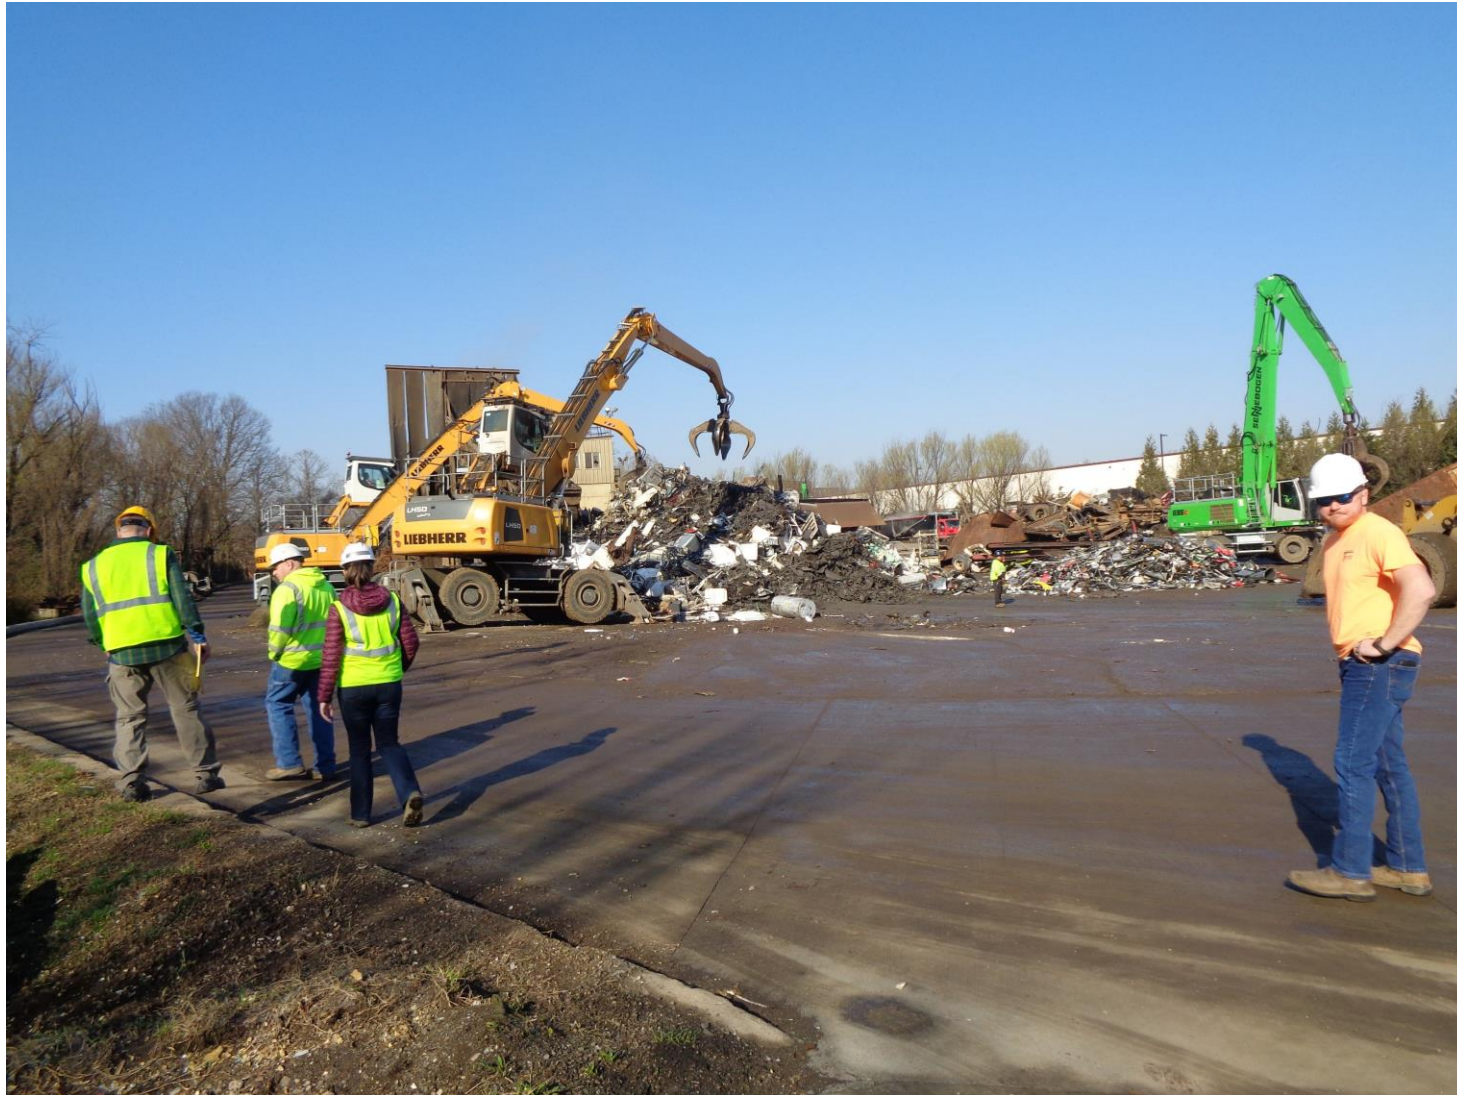
Overview of scrap feed pile

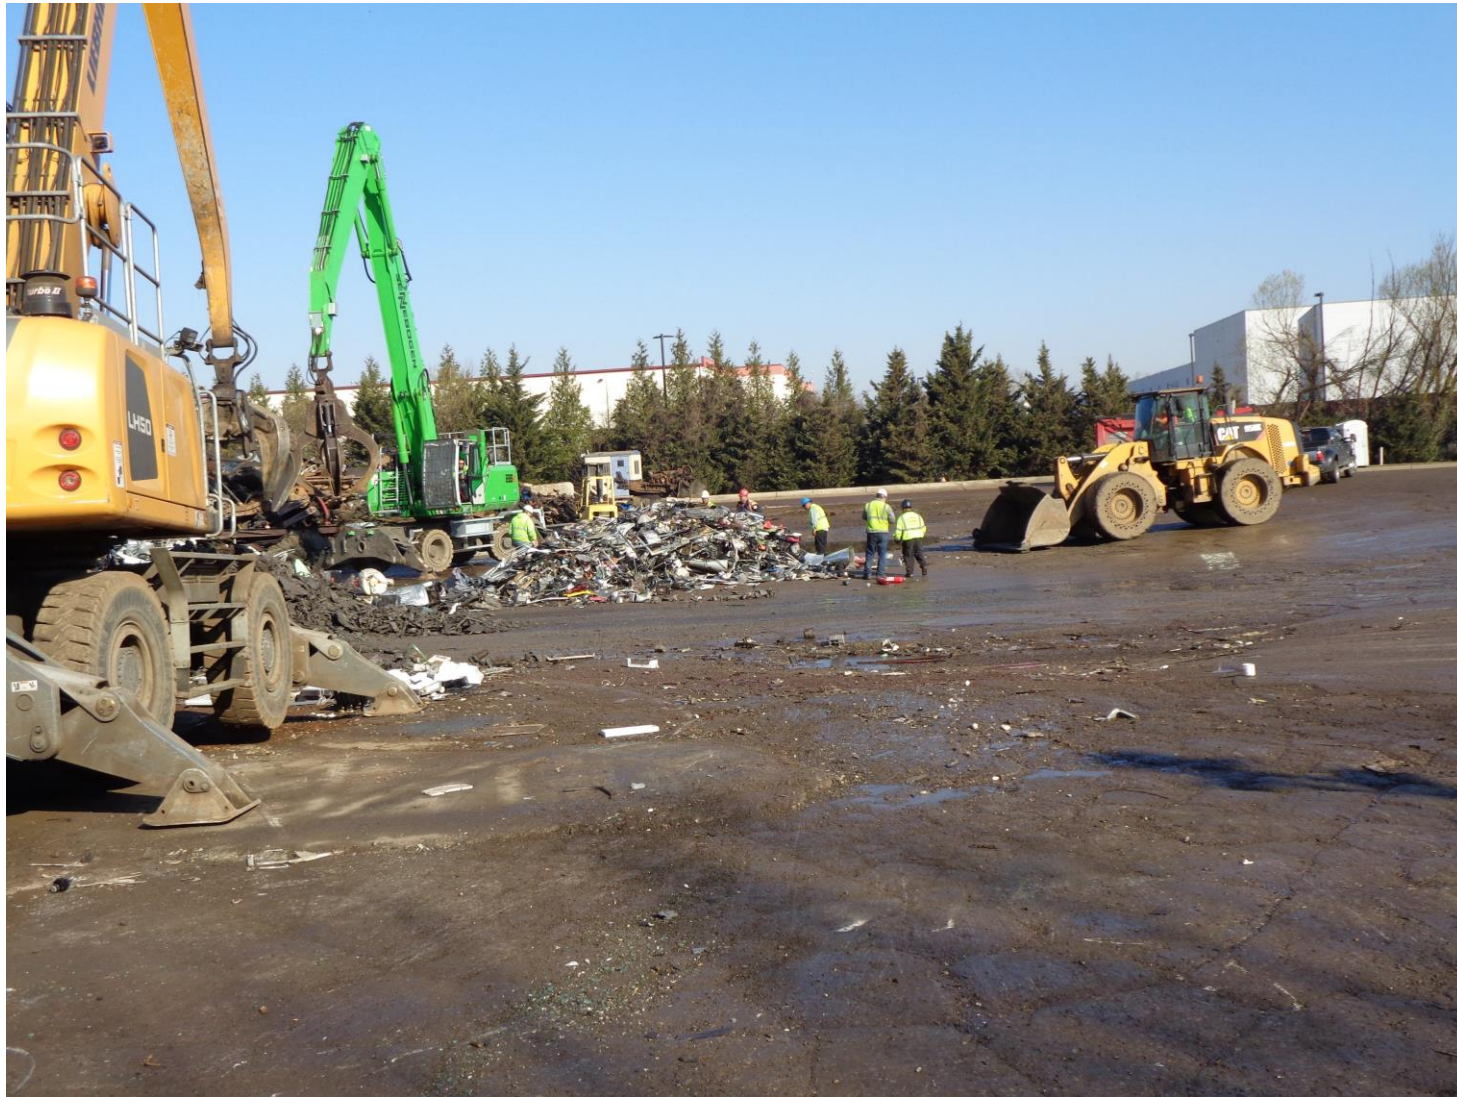
The inspection team left the meeting room and proceeded to the scale area of the facility. A pickup truck load of scrap was being unloaded and inspected. Recovermat staff were hand sorting the materials and looking for prohibited items. While sorting the load, Recovermat staff found a fire extinguisher, which then resulted in numerous staffers to begin to fully pull the pile apart to ensure that there were no other hazardous materials present. Mr. Kelly indicated that pressurized tanks, including fire extinguishers are not accepted, and this violation could cause the scrap seller to be banned from the site.

Hand sorting a newly dropped load of scrap. Note red fire extinguisher on the ground.

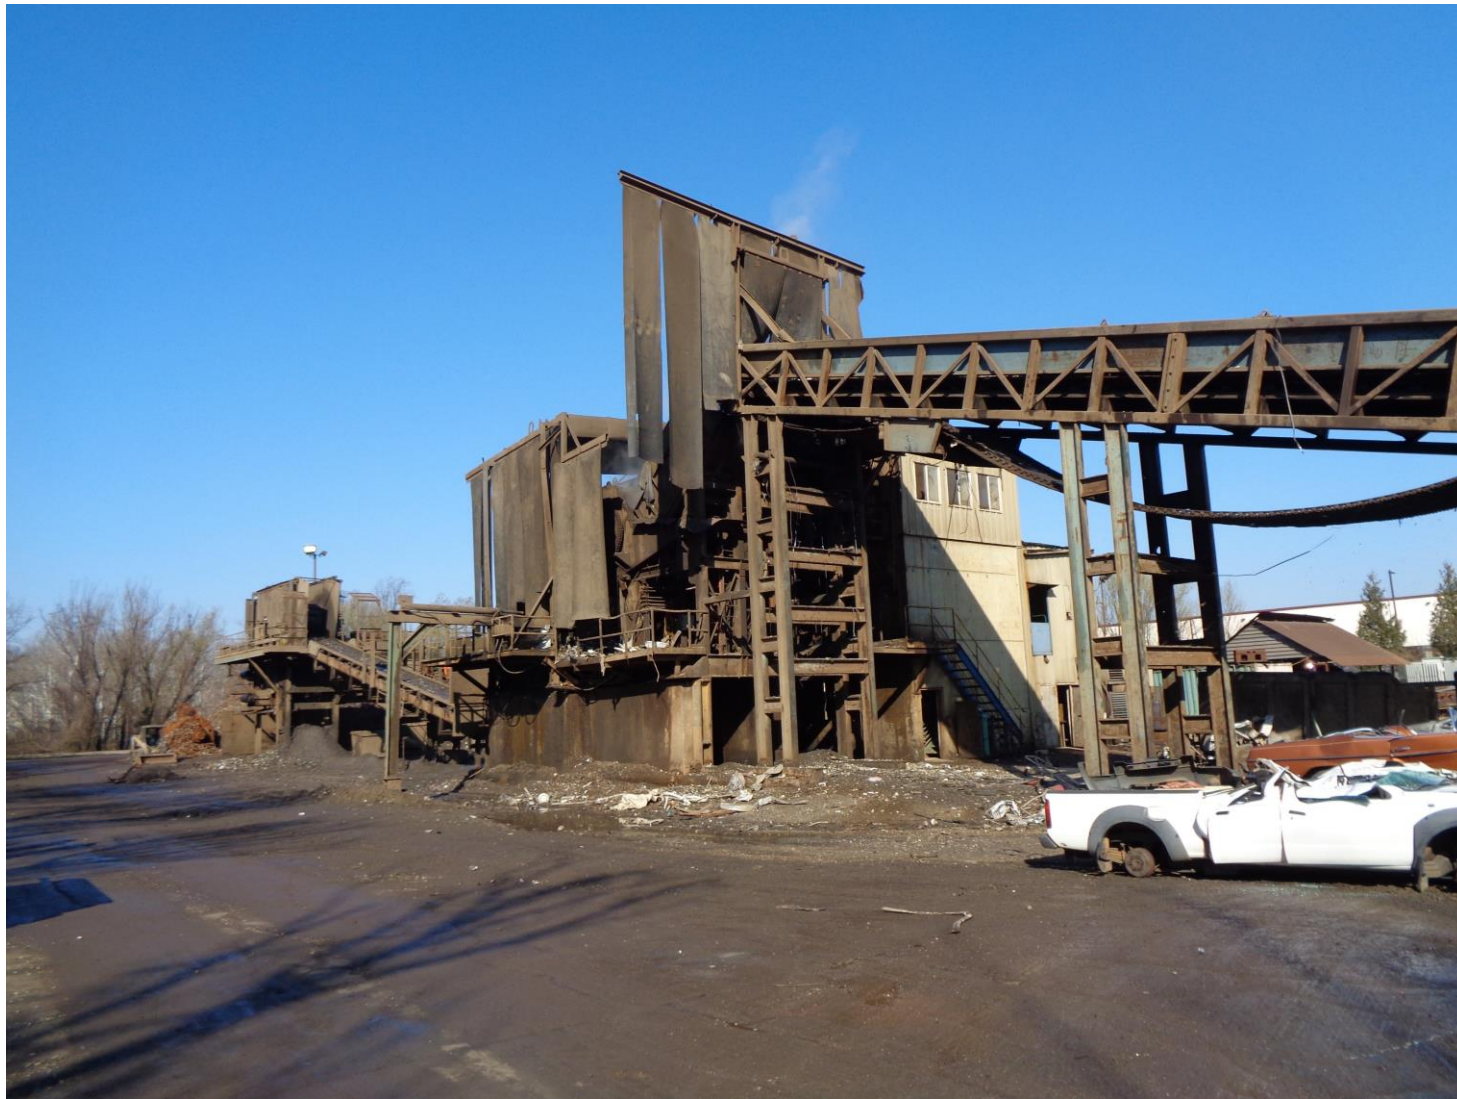
EPA noted that the shredder was operating at the time of the walkthrough, and an employee was using an excavator to load scrap onto a belt that was feeding into the shredder. Steam was visible coming from the shredder box. Shredded material was visible exiting the mill, and the team was able to view the drum magnets used to separate “frag” from the “fluff”. Piles of the different materials were located around the shredder, being added to by conveyor belts.

Feed conveyor and shredder. Note steam from the shredder.

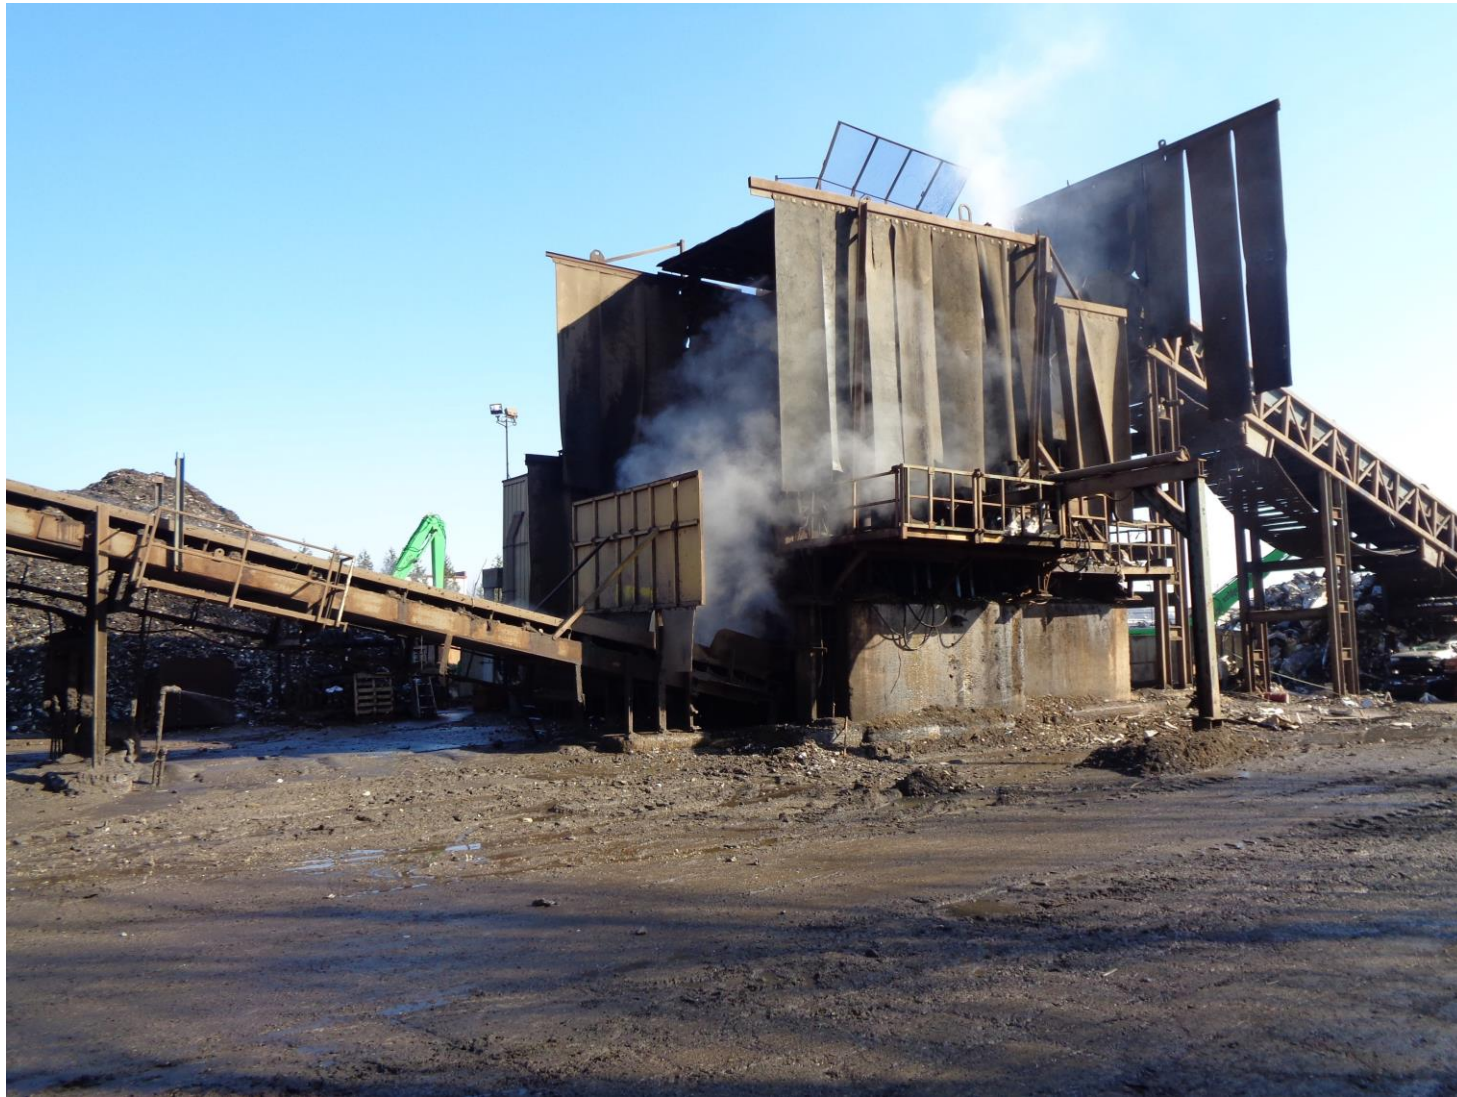
Shredder (back view) with conveyor to magnet sorting
