**U.S. Environmental Protection Agency  
Region 5**

**Purpose:** Clean Water Act National Pollutant Discharge Elimination System Compliance Evaluation Inspection

**Facility:** Watco Transloading, LLC  
5297 River Road,  
Cincinnati, Ohio, 45233

**Inspection Date:** February 23-24, 2023

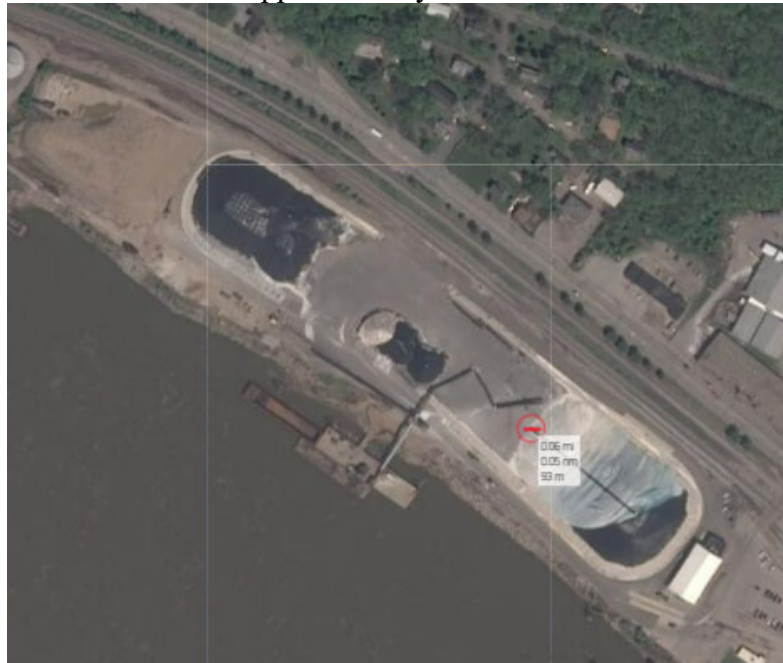
Carlton Lawrence confirmed in the March 28, 2023 email that documentation is not available for the maintenance activities taken to address the uncovered salt pile on these three dates.
- A review of aerial images from the DigitalGlobe service showed three dates when the uncovered portion of the salt pile exceeded 150 feet. Screenshots of those three dates are included with measured estimates of salt pile storage on the following dates
  - April 22, 2020
  - November 3, 2020
  - July 5, 2021

April 22, 2020 – 93 Meters is approximately 305 feet.

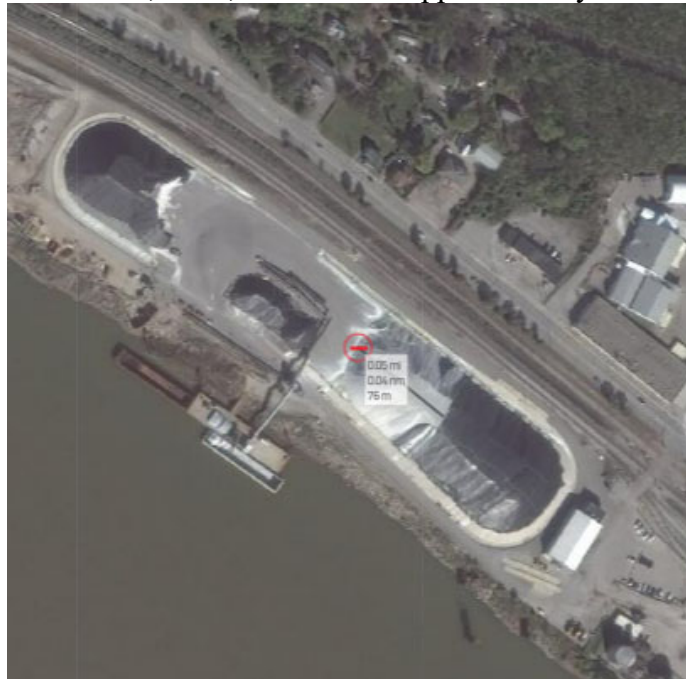
November 3, 2020, 76 meters is approximately 250 feet.

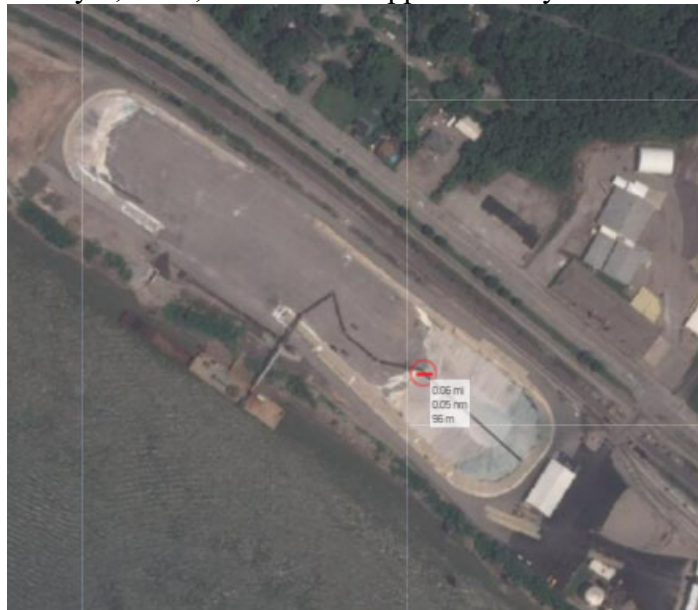
July 5, 2021, 96 meters is approximately 315 feet.

- In an email dated March 28, 2023, Carlton Lawrence confirmed that the conditions shown in the July 5, 2021 aerial were caused by high winds on July 5, 2021, and were corrected on July 15, 2021. He also confirmed that Watco does not have the ability to place or replace covers or tarps on the salt piles. The salt pile covers are the responsibility of Watco's customers.

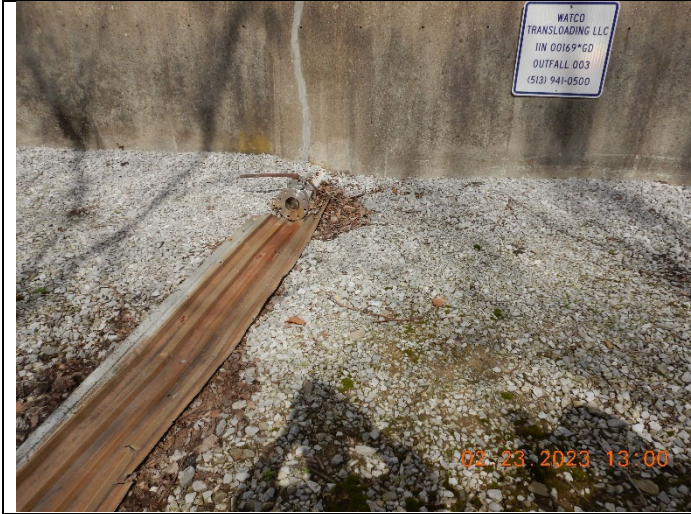
1: DSCN1278.JPG

Location: Watco Transloading  
 Photographer: Jonathan Moody  
 Date/Time: 2/23/2023 1:00 PM  
 Description: Looking at the valve controlling the discharge at Outfall 003. This is the downstream end of Photo 6.

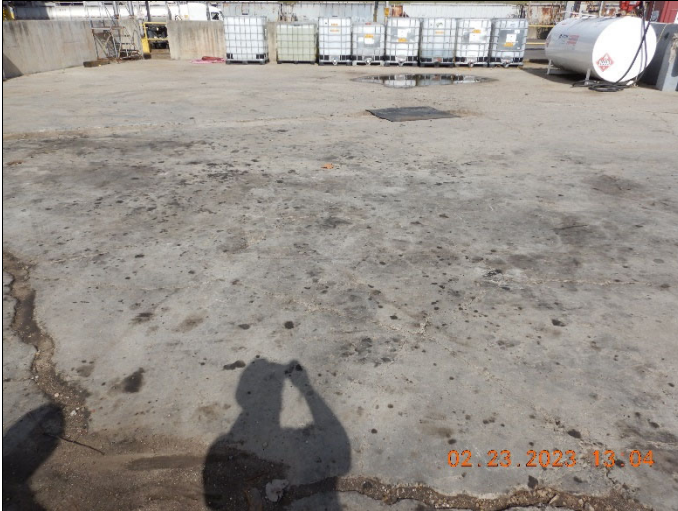
2: DSCN1279.JPG

Location: Watco Transloading  
 Photographer: Jonathan Moody  
 Date/Time: 2/23/2023 1:04 PM  
 Description: Truck washing pad. There is a drain under the black rubber sheet in this photo. The drain is connected to the plastic tank shown in Photo 3.

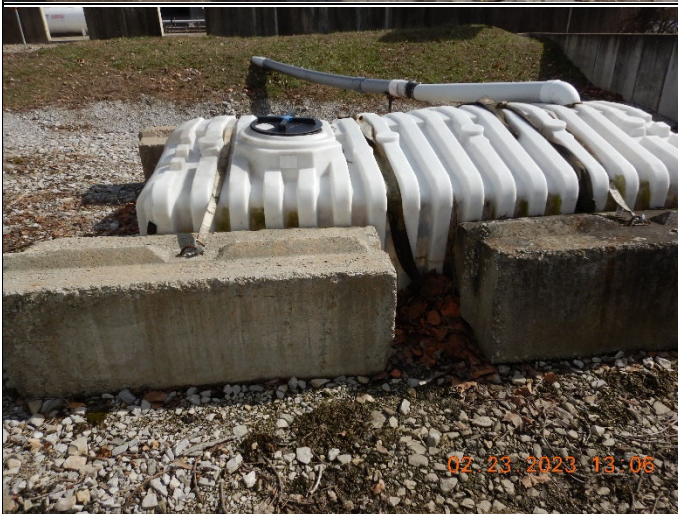
3: DSCN1280.JPG

Location: Watco Transloading  
 Photographer: Jonathan Moody  
 Date/Time: 2/23/2023 1:06 PM  
 Description: Tote used to hold the water from the wash rack shown in Photo 2.

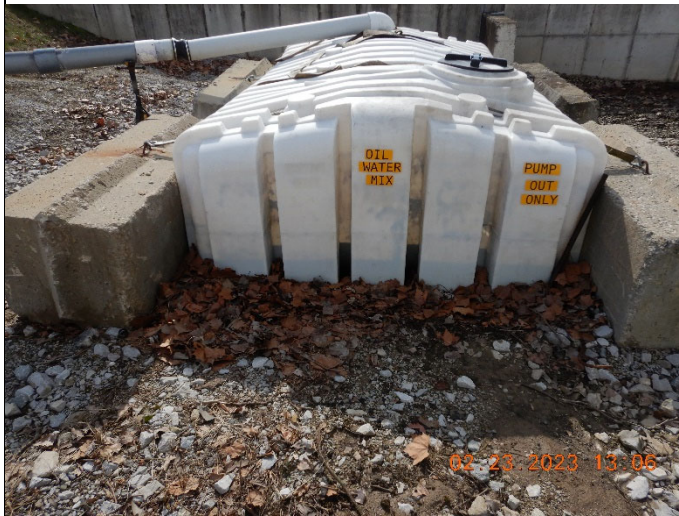
4: DSCN1281.JPG

Location: Watco Transloading  
 Photographer: Jonathan Moody  
 Date/Time: 2/23/2023 1:06 PM  
 Description: Tote used to hold the water from the wash rack shown in Photo 2.

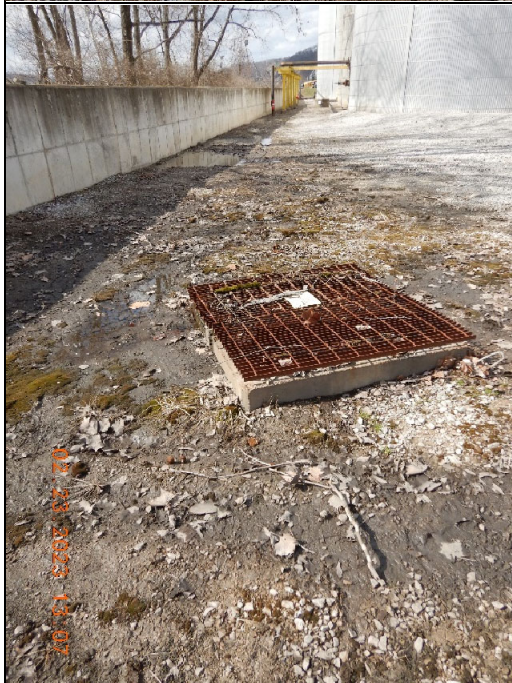
5: DSCN1282.JPG

Location: Watco Transloading  
 Photographer: Jonathan Moody  
 Date/Time: 2/23/2023 1:07 PM  
 Description: Sewer in the Midland Containment. Runoff from the loading rack goes into a storm sewer and flows up and out the structure shown in this photo. This area is tributary to Outfall 003.

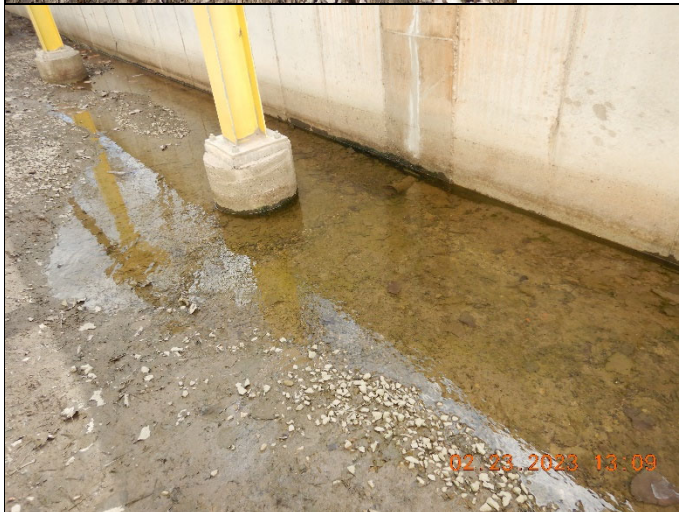
6: DSCN1283.JPG

Location: Watco Transloading  
 Photographer: Jonathan Moody  
 Date/Time: 2/23/2023 1:09 PM  
 Description: Water impounded inside the Midland Containment. This is upstream of the valve shown in Photo 1.

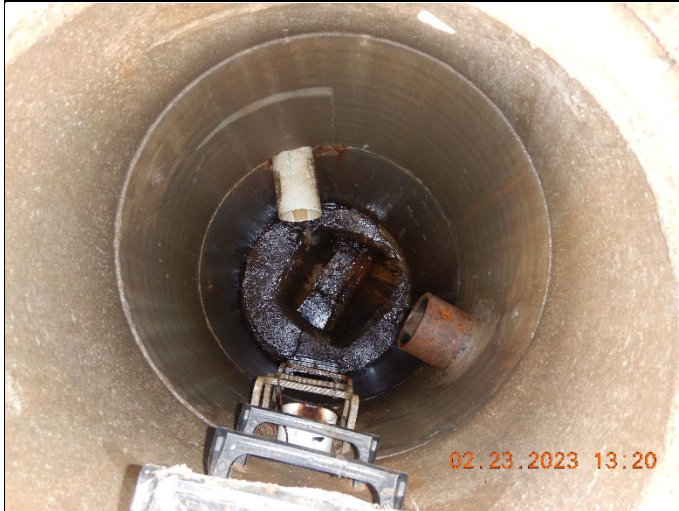
7: DSCN1284.JPG

- Monitoring for Outfall 002 occurs inside a manhole located between the loading rack and the liquid storage tanks. The inside of the manhole is shown in photo 7, with north shown up in the photo. There are two white plastic pipes, one on the north side of the manhole and a second on the south side. Per Carlton Lawrence and Rodney Hamilton, the white pipe on the north side of the manhole comes from the northeast side of the liquid storage area, also known as HVC 1. The north white pipe is the pipe sampled for compliance for Outfall 002. The white pipe on the south side of the manhole is for drainage of the southwest half of the liquid storage area, also known as HVC 2, and is not monitored for NPDES compliance purposes. The clay-colored pipe on the east side of the manhole is no longer used and, per Rodney Hamilton, does not flow.

At the bottom of the manhole there was water flowing from the north to the south. Carlton Lawrence thought that this was offsite flow from a storm sewer which was associated with the rail road property located north of the Watco facility. Per Rodney Hamilton, this water is not sampled.

Location: Watco Transloading  
 Photographer: Jonathan Moody  
 Date/Time: 2/23/2023 1:20 PM  
 Description: Looking down, up is north. Location where the samples are collected from Outfall 002. Outfall 002 is plastic white pipe at the north end of the manhole. The clay pipe entering from the east side of the manhole was connected to a valve and drained a portion of the containment located east of the manhole. The second white pipe under the ladder was connected

to another valve which drained a large portion of the containment located to the east of the manhole. This second white pipe is not sampled per the facility representative. At the time of the inspection, water was flowing from the north to the south through the manhole.

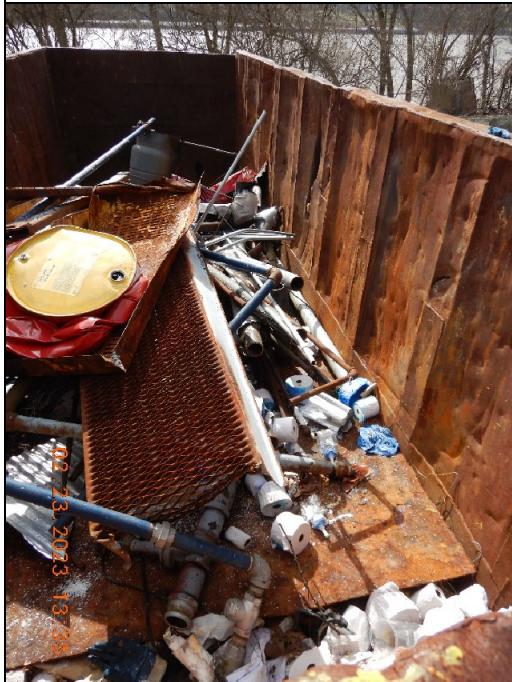
8: DSCN1285.JPG

- EPA observed a roll off container stored outside of containment and in an area where runoff is tributary to the Ohio River. The roll off container was located southeast of the truck wash. Photos 8 through 12 show the contents of that dumpster which included crushed drums used to store oil. Before the end of the inspection, the facility relocated the roll off container to inside the truck wash containment, which is tributary to a blind tank with no outlet. The relocated container location is shown in photo 35.

Location: Watco Transloading  
 Photographer: Jonathan Moody  
 Date/Time: 2/23/2023 1:35 PM  
 Description: Looking inside a dumpster stored outside of the containment structures. At the time of the inspection there were two crushed oil drums.

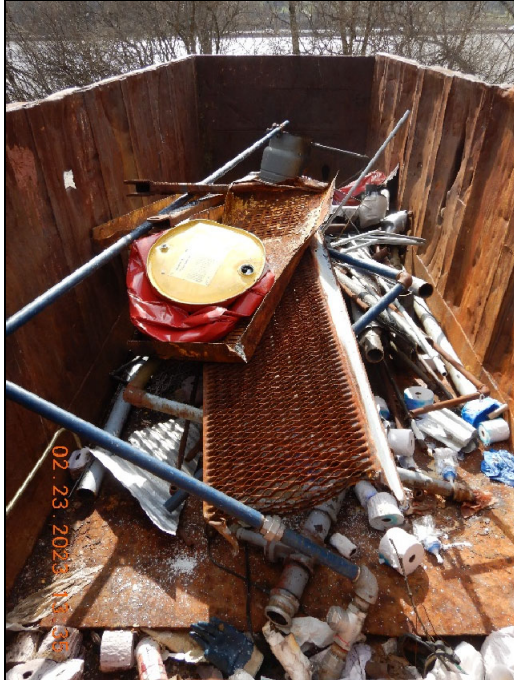
9: DSCN1286.JPG

Description: Looking inside a dumpster stored outside of the containment structures. At the time of the inspection there were two crushed oil drums.

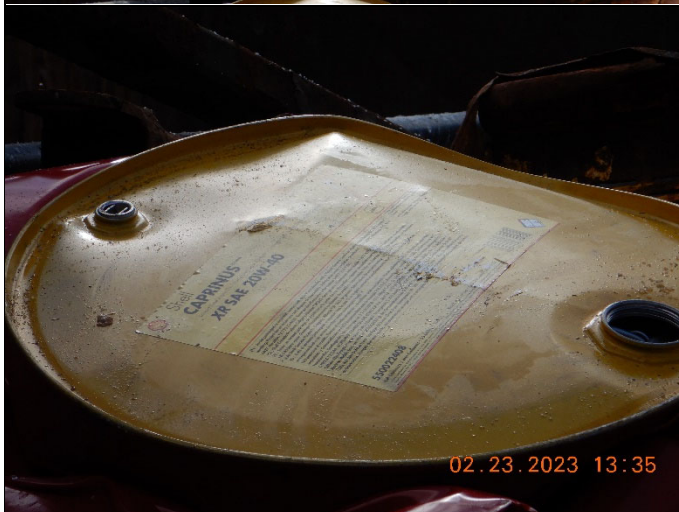
11: DSCN1288.JPG

Description: Close-up of a label on one of the oil drums inside the dumpster stored outside the containment.

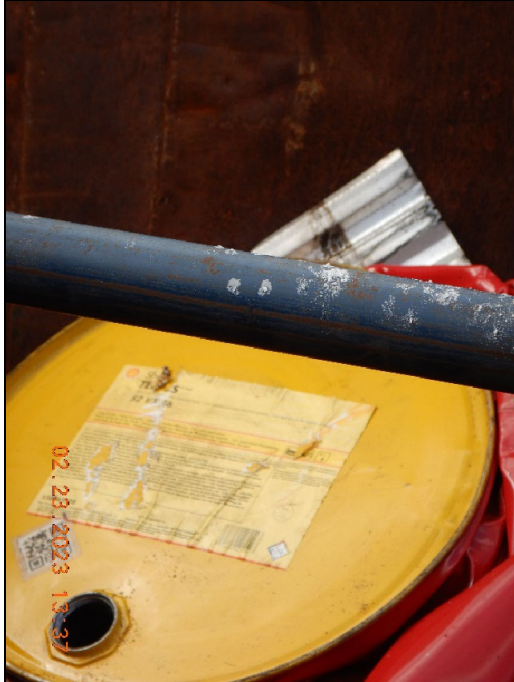
12: DSCN1289.JPG

Location: Watco Transloading  
Photographer: Jonathan Moody  
Date/Time: 2/23/2023 1:37 PM  
Description: Close-up of a label on an other oil drum inside the dumpster stored outside the containment. Photo taken through a hole in the sidewall of the dumpster.

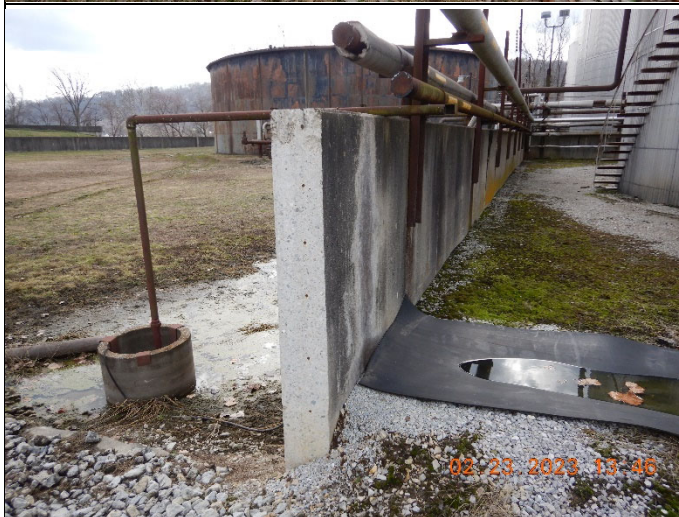
14: DSCN1291.JPG

Location: Watco Transloading  
Photographer: Jonathan Moody  
Date/Time: 2/23/2023 1:46 PM  
Description: Sump in the southern most containment. The sump pumps stormwater into one of the neighboring containment area.

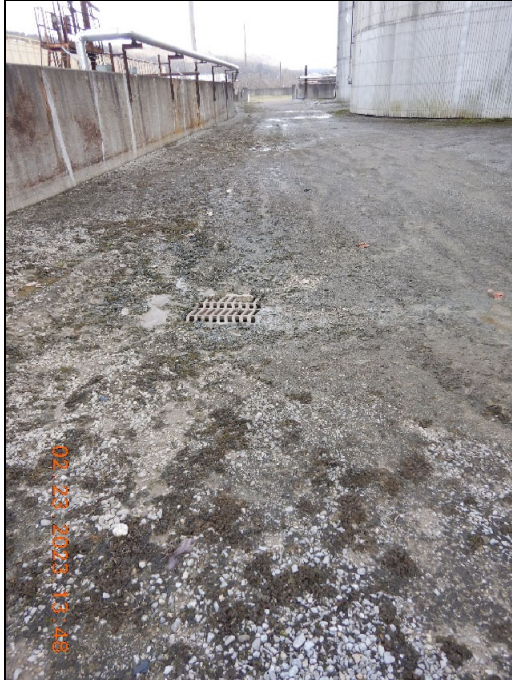
15: DSCN1292.JPG

Description: Looking inside the northern liquids containment area. Per Carlton Lawrence, the drain shown in this area leads to the manhole shown in photo 7, where outfall 002 is monitored. Camera is facing east looking along the southside of the northernmost containment wall for the liquids area containment.

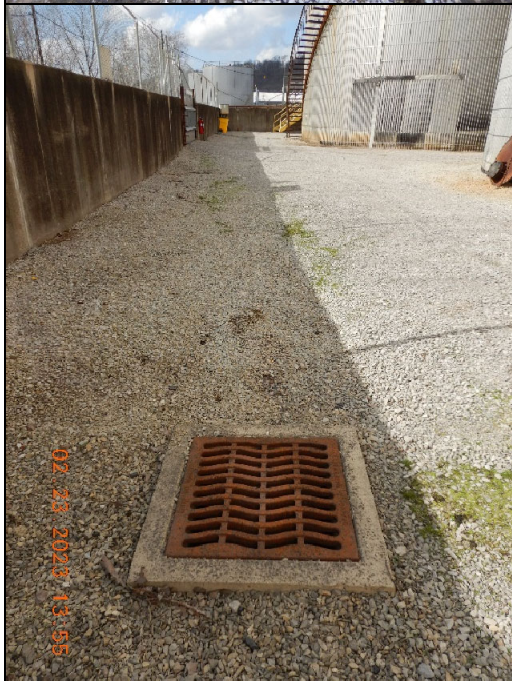
16: DSCN1293.JPG

Description: Camera looking west along the north side of the southernmost containment wall for the liquid area containment. Per Carlton Lawrence, this inlet is tributary to the same manhole in photo 7 where monitoring for outfall 002 is conducted, however, this is likely connected to the white plastic pipe which is not monitored for NPDES compliance.

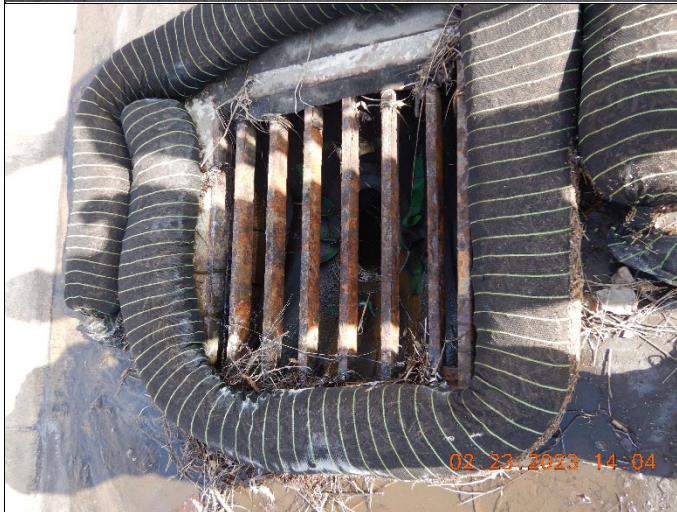
18: DSCN1295.JPG

- The inlet shown in photo 18 goes to an onsite sewer system tributary to outfall 011. At the time of the inspection there was filtersock surrounding the inlet, and a filter hat inside the inlet. There was a small rip forming along the upper edge of the hat.
- There were straw bales at locations of concentrated storm water flow. At one location shown in photo 22 the bale was loose, and another location shown in photo 24 the bale had begun disintegrating with loose straw visible on the surrounding pavement as shown in photo 25.
- A small pile of sand was present adjacent to the slope leading down to the river, and shown in photo 26. At the time of the inspection there was a filter sock surrounding the pile, but sand could be seen on the pavement downstream of the filter sock. Per Mike

Location: Watco Transloading  
 Photographer: Jonathan Moody  
 Date/Time: 2/23/2023 2:04 PM  
 Description: Closeup of the drainage structure visible in photo 17. At the time of the inspection the inlet was surrounded by filter sock and there was a filter 'hat' inside the manhole. The fabric on the hat had a small rip forming near the top.

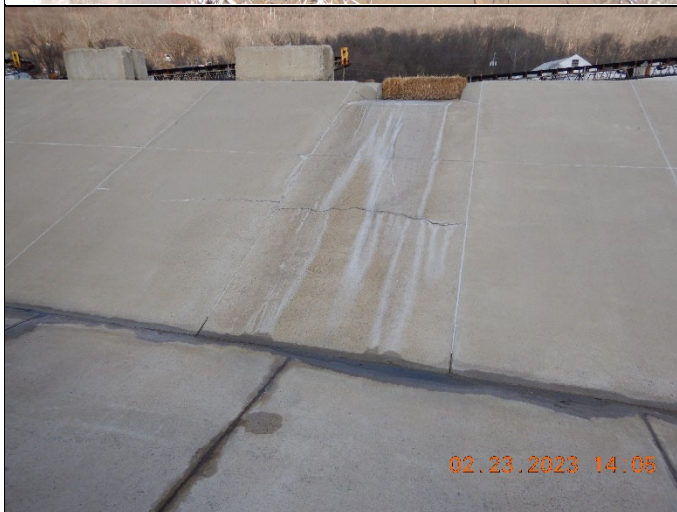
19: DSCN1296.JPG

Location: Watco Transloading  
 Photographer: Jonathan Moody  
 Date/Time: 2/23/2023 2:05 PM  
 Description: Camera is facing north, at a location along the riverside edge of the salt pile pad. A cut in the concrete berm surrounding the pad allows stormwater to flow from the pad into the collection ditch surrounding the pad. At the time of the inspection, straw bales were placed on the upstream side of the cut.

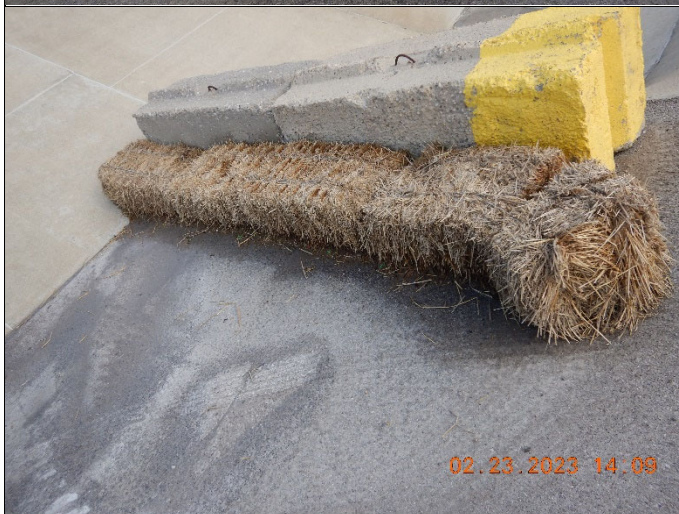
22: DSCN1299.JPG

Location: Watco Transloading  
 Photographer: Jonathan Moody  
 Date/Time: 2/23/2023 2:09 PM  
 Description: Along the riverside edge of the salt pile pad, straw bales were being used for stormwater BMPs. At the time of the inspection, the twine on the bale had failed and the bale was loose.

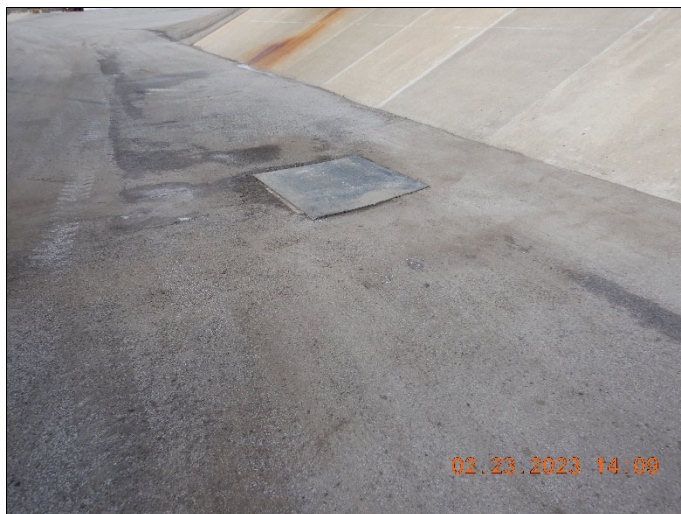
23: DSCN1300.JPG

Location: Watco Transloading  
 Photographer: Jonathan Moody  
 Date/Time: 2/23/2023 2:09 PM  
 Description: At a location along the river side of the salt pile pad near the conveyor used to move material from the barge. A rubber sheet is moved over the inlet to prevent salt from entering the onsite collection system.

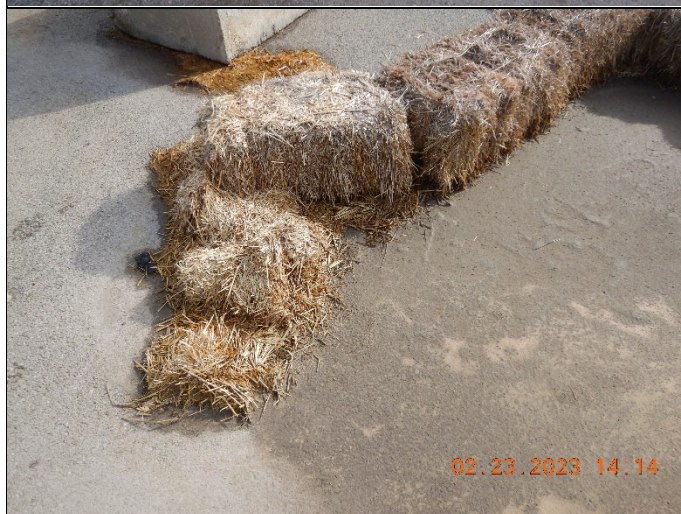
24: DSCN1301.JPG

Location: Watco Transloading  
 Photographer: Jonathan Moody  
 Date/Time: 2/23/2023 2:14 PM  
 Description: On the salt pile pad, near the northwest corner, straw bales were used as a stormwater BMP. At the time of the inspection, some of the straw bales had come loose and were shedding material.

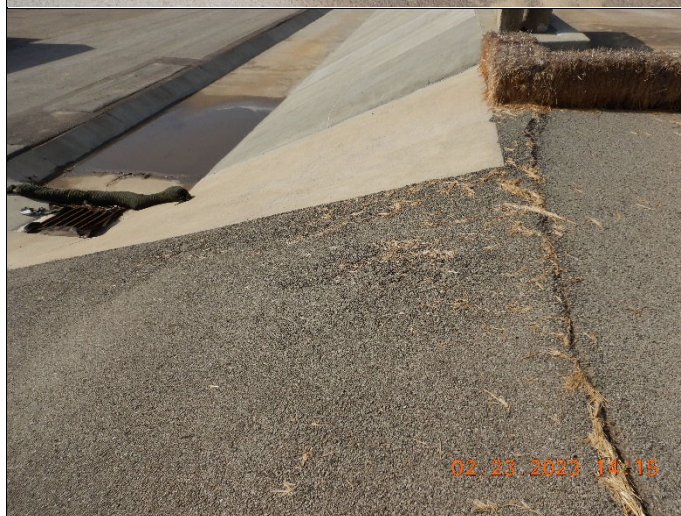
25: DSCN1302.JPG

Location: Watco Transloading  
 Photographer: Jonathan Moody  
 Date/Time: 2/23/2023 2:15 PM  
 Description: On the salt pile pad, near the northwest corner, straw bales were used as a stormwater BMP. At the time of the inspection, some of the straw bales had come loose and were shedding material. Loose straw was seen around the straw bales.

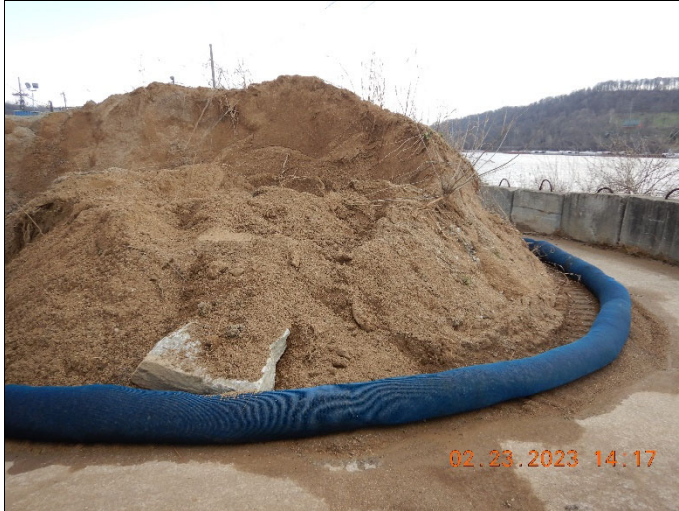
26: DSCN1303.JPG

Beatty this pile is wash sand and is used under a tank floor when the floor is repaired or replaced.

Location: Watco Transloading  
 Photographer: Jonathan Moody  
 Date/Time: 2/23/2023 2:17 PM  
 Description: At a location west of the salt pile pad and near the river. This sand was wash sand used under a tank floor when the floor is repaired or replaced. This sand was in an area that was tributary to the river. At the time of the inspection a filter sock was present, but solids were visible downstream of the filter sock.

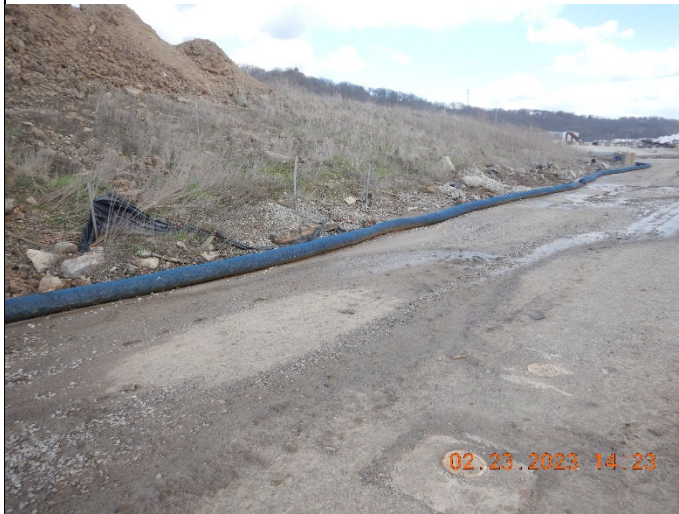
29: DSCN1306.JPG

- Northwest of the salt pile pad is a soil pile which is part of an ongoing project to install a tank for managing the wastewater discharge at outfall 011. At the time of the inspection, a portion of the soil pile was sparsely vegetated, and portion of it was not vegetated as shown in photo 29. There was also a filter sock surrounding the toe of the pile adjacent to the river.

Location: Watco Transloading  
 Photographer: Jonathan Moody  
 Date/Time: 2/23/2023 2:23 PM  
 Description: At the soil pile located west of the salt pile pad. At the time of the inspection, a portion of the pile was sparsely vegetated, there were remnants of a silt fence and an intact filter sock.

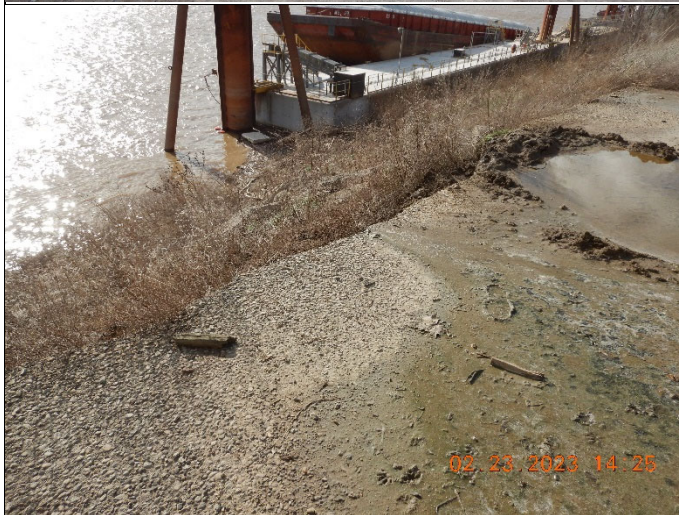
30: DSCN1307.JPG

- The approximate location of Outfall 012 is shown in photo 30. This is a location where stormwater flows off the north end of the site and into the river. At the time of the inspection there were no BMPs visible at this location and sediment was visible on the pavement leading to the bank to the river.

Location: Watco Transloading  
 Photographer: Jonathan Moody  
 Date/Time: 2/23/2023 2:25 PM  
 Description: At the location known as outfall 012. At the time of the inspection, no BMPs were visible at this location, sediment was visible on the pavement. Carlton Lawrence said that monitoring for 012 is not monitored since there is no industrial activity occurring in the area tributary to this outfall.

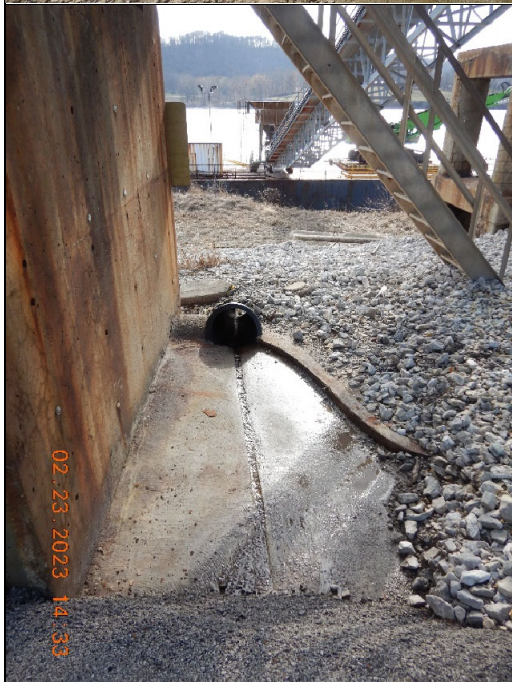
31: DSCN1308.JPG

- There is a small area of pavement tributary to a black corrugated pipe leading to the river. The area is located beneath the salt conveyor used for unloading barges. This pipe is shown in photo 31 and 34. There were no visible BMPs present at this location at the time of the inspection, and this pipe and drainage area is not shown on the maps associated with the SWPPP.

Location: Watco Transloading  
 Photographer: Jonathan Moody  
 Date/Time: 2/23/2023 2:33 PM  
 Description: Under the conveyor used to offload dry material, runoff from a small portion of pavement is conveyed toward the river through the pipe shown in this photo. See photo 34 for an overview of the area near this pipe.

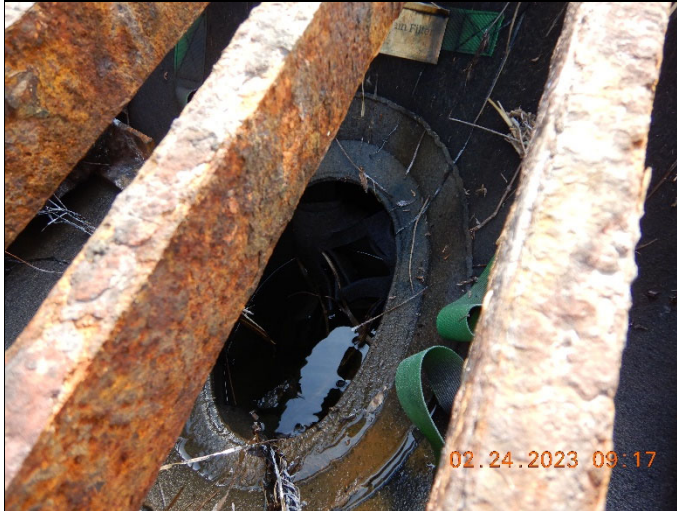
32: DSCN1309.JPG

Location: Watco Transloading  
 Photographer: Jonathan Moody  
 Date/Time: 2/24/2023 9:17 AM  
 Description: Closeup of the hat inside the structure shown in photo 18.

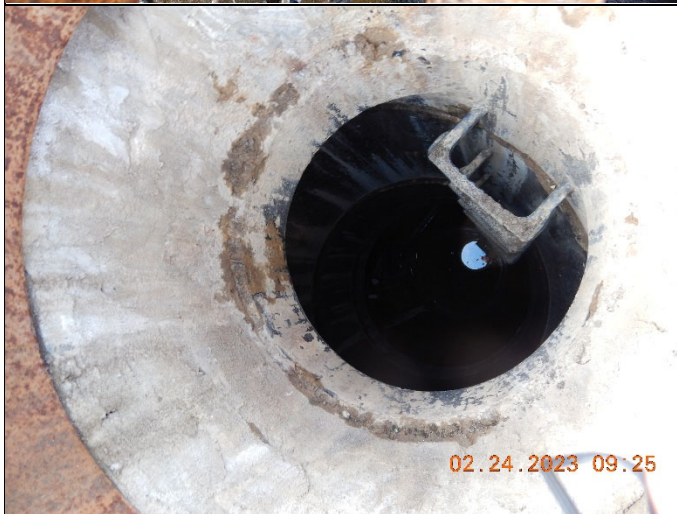
33: DSCN1310.JPG

Location: Watco Transloading  
 Photographer: Jonathan Moody  
 Date/Time: 2/24/2023 9:25 AM  
 Description: Looking into the manhole immediately upstream of outfall 011. This is the location of the field monitoring point 01.

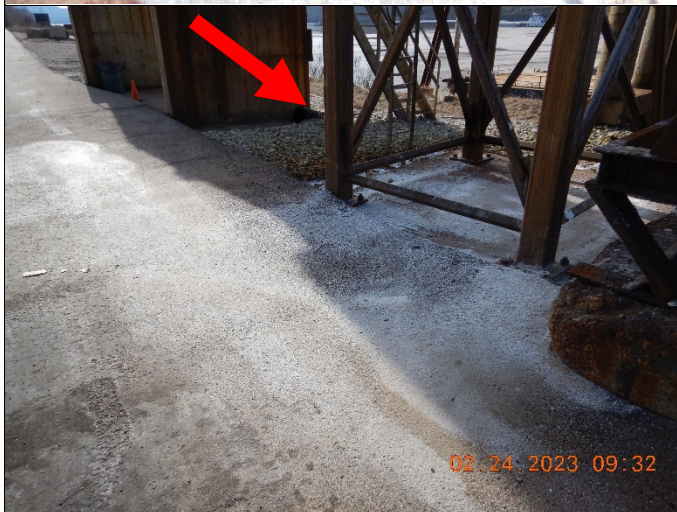
34: DSCN1311.JPG

Location: Watco Transloading  
 Photographer: Jonathan Moody  
 Date/Time: 2/24/2023 9:32 AM  
 Description: Looking at the area underneath the conveyor used to offload dry material. The location of the pipe shown in photo 31 is indicated with the red arrow.
