July 29, 1988

Subject: Instrumentation Cable Tray Fireproofing

Cable Tray With  
Asbestos Fire Protection

DL-2 Cable Tray  
Asbestos Fire

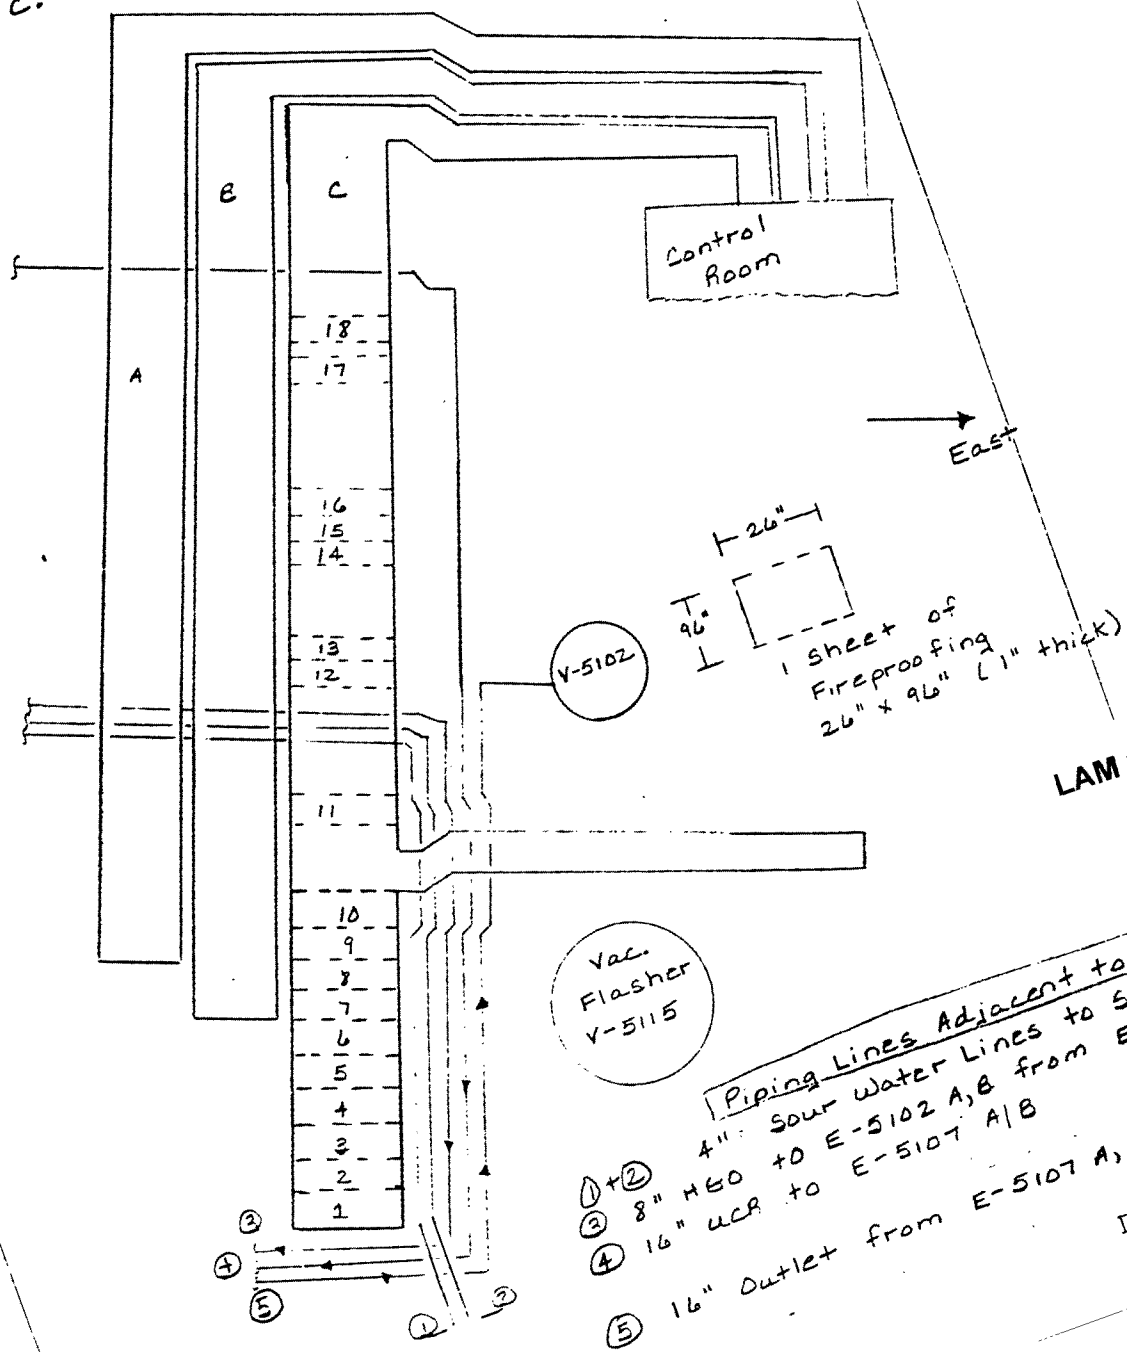
The instrument cable tray runs from the south end of the pump alley to the control room. Sheets of insulation that have been severely damaged are identified on the attached sketch.

PC Above the cable tray are overhead cooling fans which enhance the chances of the asbestos becoming airborne. Cable trays directly adjacent to the cable tray of concern ~~were found to have no fireproofing material (see sketch) on sides and the bottom.~~ Cable tray C has no insulation?

Please Note: Cable Trays A+B currently contain no fireproofing. These trays are located next to Tray C.

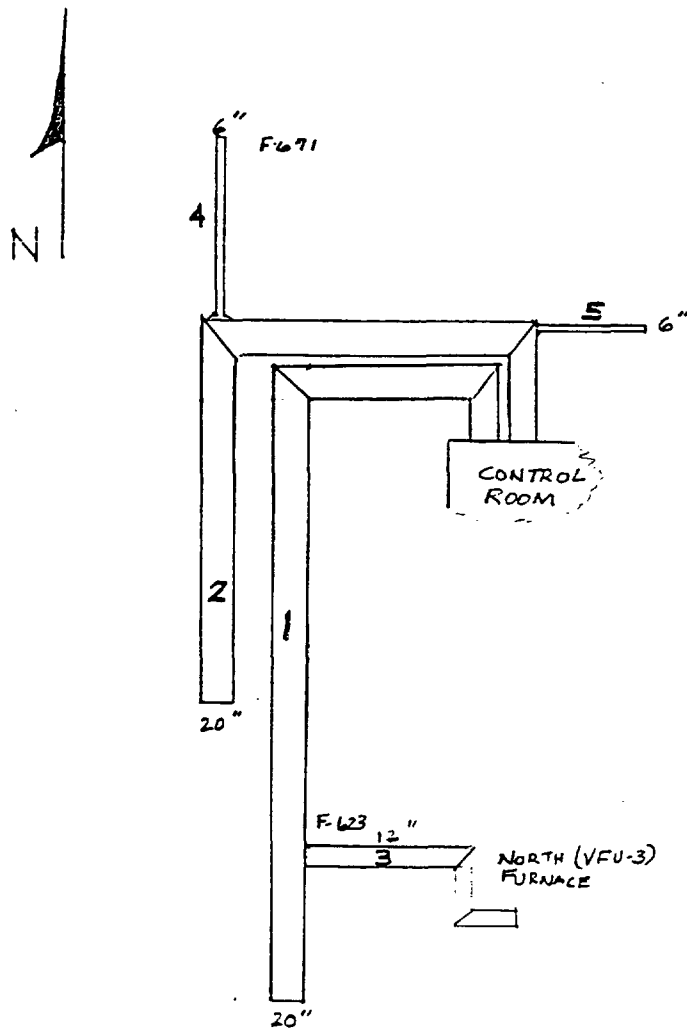
# DU-2 POWER CABLE TRAY WITH ASBESTOS FIRE PROTECTION

- 1 - 500' ; 20" - COMPLETELY ENCLOSED TRAY
- 2 - 300' ; 20" - BOTTOM AND SIDES ENCLOSED ONLY
- 3 - 125' ; 12" - PARTIALLY ENCLOSED TRAY
- 4 - 100' ; 6" - BOTTOM AND SIDES ENCLOSED ONLY
- 5 - 30' ; 6" - PARTIALLY ENCLOSED TRAY

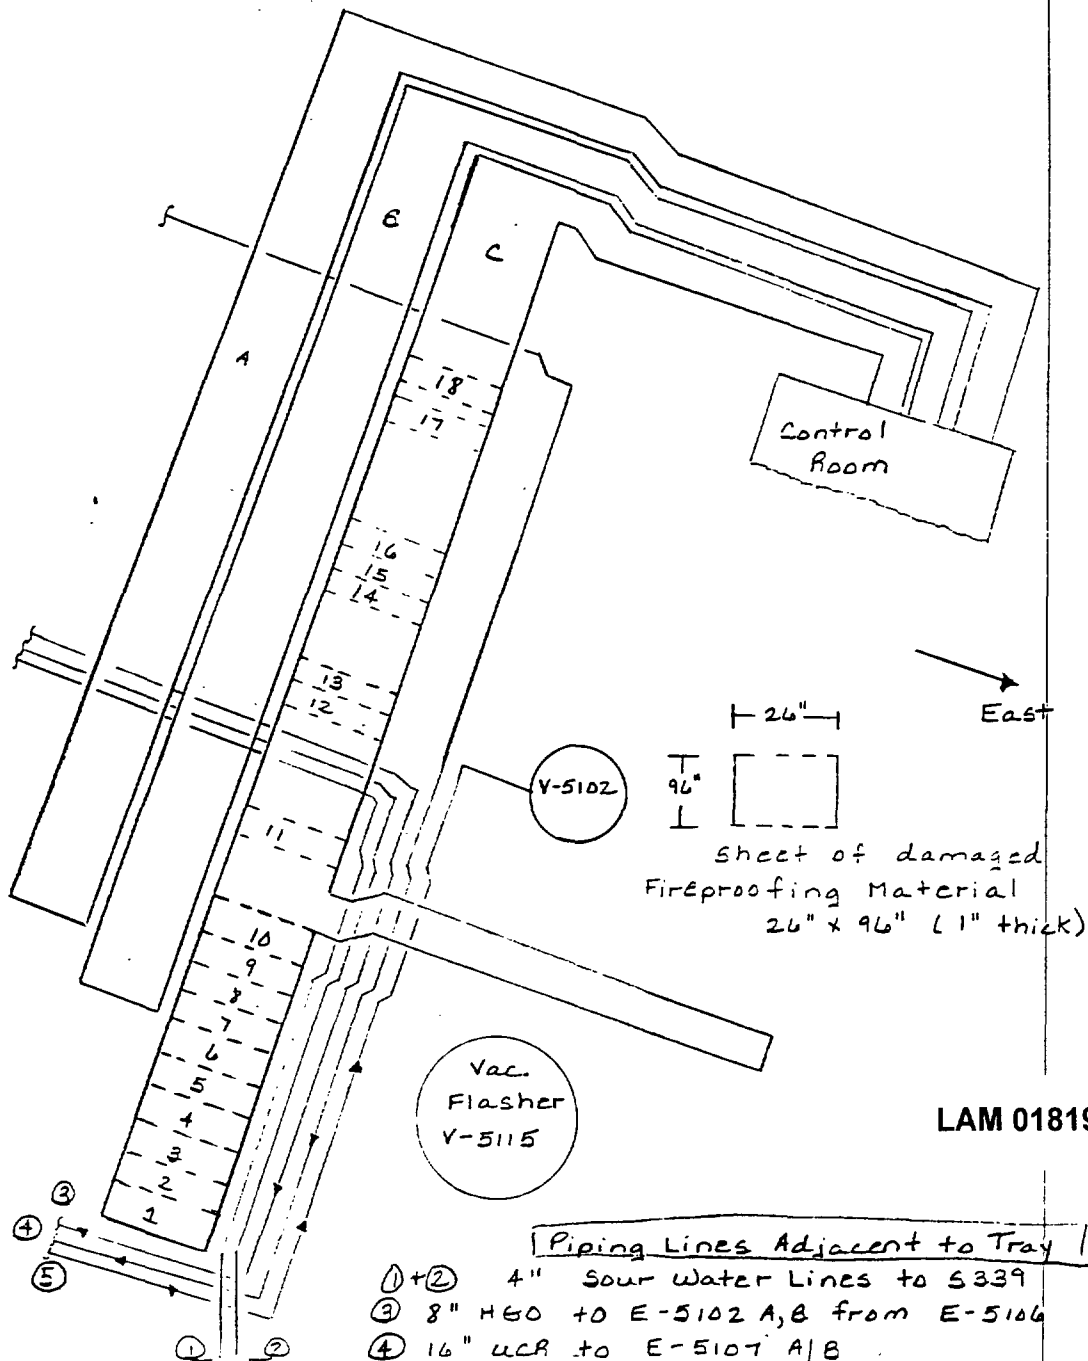
# DU-2 Cable Tray With Asbestos Fire Protection

The instrument cable tray runs from the south end of the pump alley to the control room. Sheets of insulation that have been severely damaged are identified on the attached sketch.

Above the cable tray are overhead cooling fans which enhance the chances of the asbestos becoming airborne. Cable tray B directly adjacent to cable tray C (see sketch) contains fireproofing material on the sides and bottom but has no top cover. Cable tray A contains no fireproofing material.

Due to the condition of some fireproofing sheets, I feel that the damaged material should be removed. If a decision is made to replace the damaged top fireproofing cover, I feel that we should use the Marinite I insulating board which should be sealed with undercoating and painted with epon ester gray. Also, angle iron supports attached to the cable tray on two foot centers under the top layer of Marinite will give additional strength. The Marinite for the sides and bottom of the cable tray need not be replaced but must be sealed.

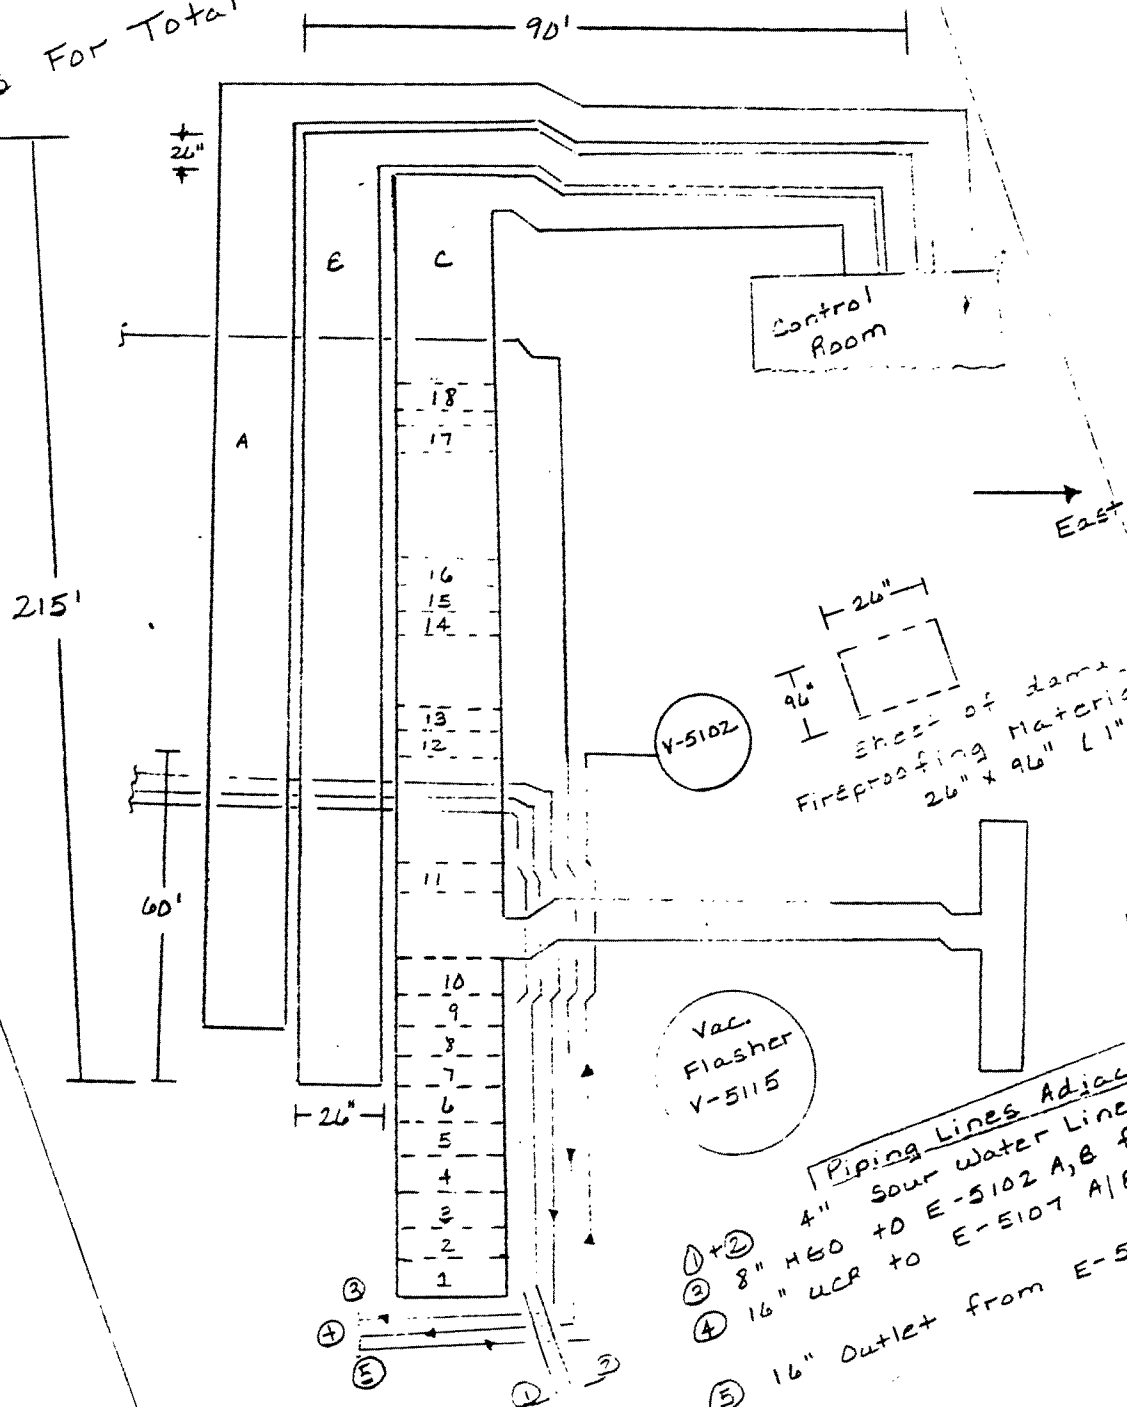
SKETCH  
 04-2 Cable Tray With  
 Asbestos Fire Protection

Raceway B: 465 ft<sup>2</sup>  
 Control Room Raceway B:  
 125 ft<sup>2</sup>

Dimensions: Cable Tray B  
 For Total Removal & Installation  
 of Trays C+B
