LONG BEACH PLANT

POLY NO. 1 VENT STACK SEPARATION - 1/23/72

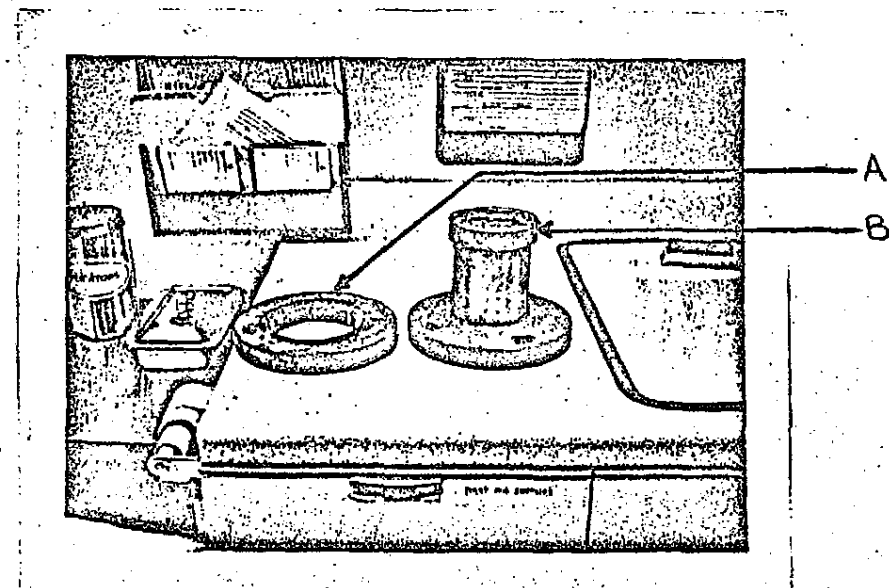
NGC 15701

The vent stack separated from the spool piece because the initial shock of the discharge forced the worn flange off of the serrated insert.

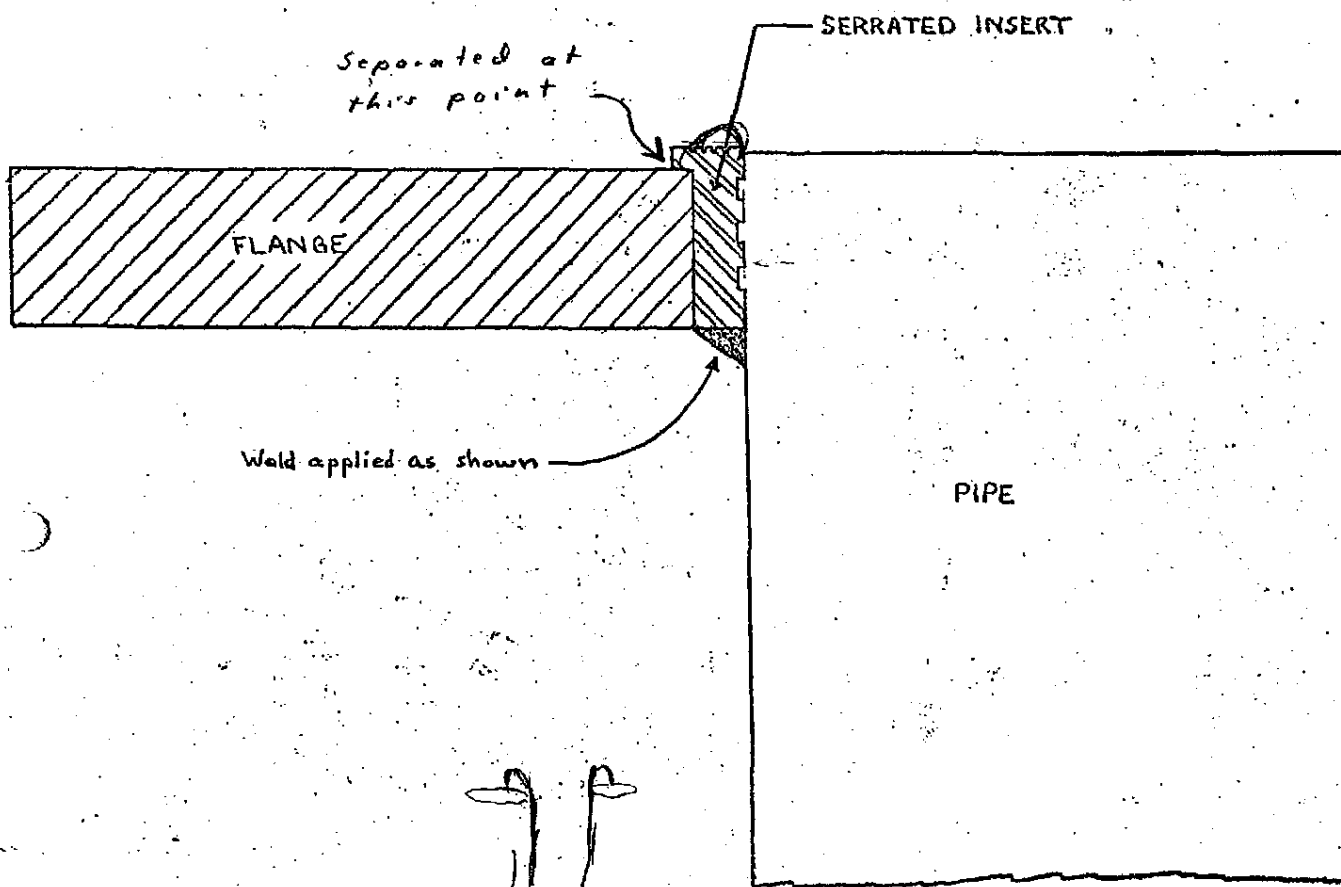
SPEEDLINE FLANGE

3. The separated spool piece was constructed of 3 inch Speedline rolled flanges rated to withstand 1900-2300 psi hydrostatic pressure. The use of this type of flange was discontinued about 1965. Upon discontinuing their use all existing flanges were either replaced or the insert was backwelded to the pipe as the result of a report that such assemblies had been known to separate. Poly No. 1, installed in 1960, was originally equipped with this type of flange and it was backwelded. The assembly did not separate at the point where the pipe is rolled into the insert and was backwelded. Instead, the flange slipped over the lip at the end of the insert (see attached sketch).

It appears moderate corrosion of the inside diameter of the flange and possibly wear on the lip of the insert allowed them to separate when subjected to the initial shock of the discharge. Both rupture discs in the vent line fully opened and there was no evidence of obstruction.

- ① Repair Poly No. 1 agitator alarm switch and agitator on/off switch. (Completed)
- ② Replace the vent nozzle spool piece with one properly constructed. (Completed)
- ③ Inspect all poly nozzle and piping systems for such other rolled flange assemblies and replace. (Completed and none found.)
- ④ Inspect all poly nozzle systems for other apparent weak points and correct. (A preliminary inspection has been conducted with a few minor repairs made. A two week schedule has been initiated to thoroughly examine each poly nozzle and flange assemblies to ensure they are safe.)
