INSPECTION REPORT

| Type of Inspection | Compliance Evaluation Inspection (CEI) | |
| Company Name | BMW of Anchorage | |
| Facility/Site Physical Address | 730 E 5Th Ave | |

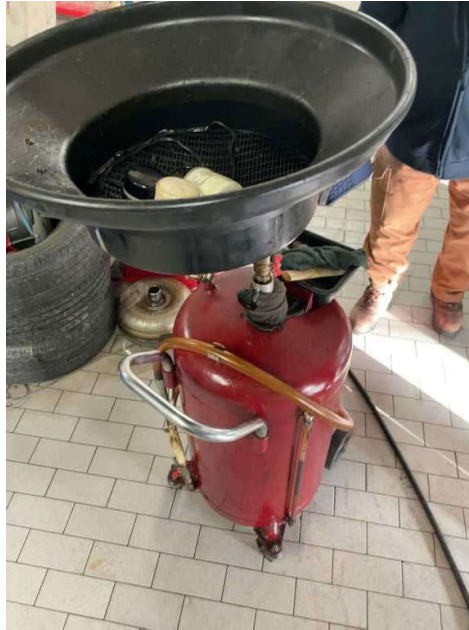
| [Title] | | | IMG-2024030809413641362406025.jpg |

| <p>While inspecting the various vehicle bays inside the Service Department we stopped at Bay 7. While there we observed a 20-gallon used oil receiver that contained used oil. The facility has many 20-gallon used oil receivers that they use to collect used oil drained from vehicles. The used oil in the receivers is periodically transferred to a larger tank with an approximate storage capacity of 500 gallons prior to being picked up for recycling. At the time of the inspection, that storage tank was labeled with the words, "Used Oil." During the inspection at Bay 7, we spoke with Mr. Randy Giddings, Service Technician, who happened to be working in the area. We asked Mr. Giddings how much used oil was in the receiver and he stated that it was full. At the time of the inspection, the 20-gallon used oil receiver was not labeled with the words "Used Oil."</p> <p>I explained that the used oil regulations required used oil storage containers to be labeled with the words "Used Oil." I explained that they could either label the container during the inspection or they could label it after the inspection and provide documentation that it had been labeled. Mr. Billman had Mr. Giddings label the 20-gallon used oil receiver during the inspection.</p> | | | |

| At the time of the inspection, a full 20-gallon used oil receiver was not labeled with the words "Used Oil."<br><br>The container was labeled, with the words "Used Oil," during the inspection. | <b>Regulation:</b> | <b>Sections:</b> |

| View of the 20-gallon used oil receiver, at Bay 7, that is full of used oil, seen here not labeled with the words "Used Oil." | | | |

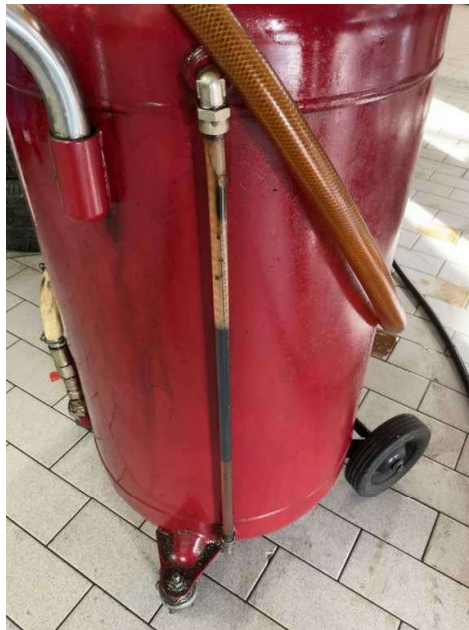
| [Title] | | | IMG-2024030809414441442537835.jpg |

| Close up view of the 20-gallon used oil receiver, at Bay 7, that is full of used oil, seen here not labeled with the words "Used Oil." | | | |

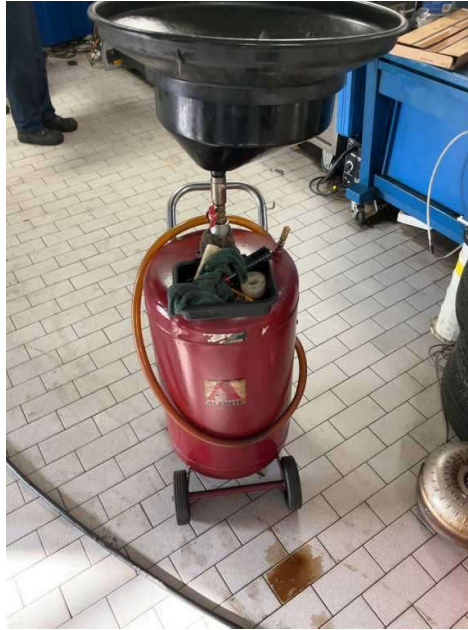
| [Title] | | | IMG-2024030809415641562649552.jpg |

| Another view of the 20-gallon used oil receiver, at Bay 7, that is full of used oil, seen here not labeled with the words "Used Oil." | | | |

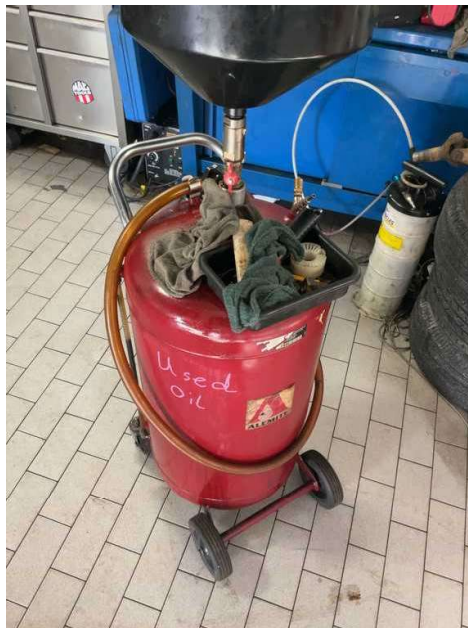
| [Title] | | | IMG-202403080943054352794961.jpg |

| View of the 20-gallon used oil receiver, at Bay 7, after being labeled with the words "Used Oil" during the inspection. | | | |

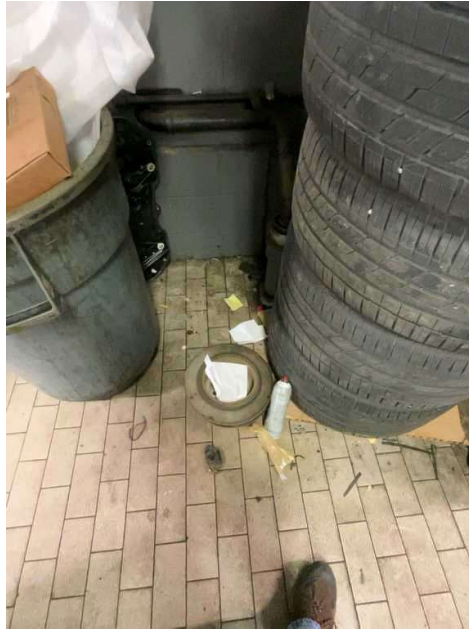
| [Title] | | | IMG-2024030809503150311396780.jpg |

| <p>While inspecting the area around Bay 9, we saw an aerosol can on the floor. I picked up the aerosol can, shook it, and determined that the aerosol can was an empty waste aerosol can. I asked Mr. Billman how the facility managed waste aerosol cans. Mr. Billman found a Service technician nearby who stated that they probably get punctured and thrown away. When I asked where they were being punctured, the shop tech said he did not puncture them, he just threw them away. During the inspection we identified additional waste aerosol cans and didn't find any evidence that they were being punctured prior to being thrown into the trash. Based on the amount of waste aerosol cans that were being generated each month, considering the other wastes that were being generated at the facility, I told Mr. Billman that I didn't think his facility was an SQG. I told Mr. Billman that from everything I had seen during the inspection, his facility was a Very Small Quantity Generator (VSQG) of hazardous waste. Based on the VSQG determination, no area of concern was identified.</p> <p>I did tell Mr. Billman that taking the waste aerosol cans to the local Household Hazardous Waste (HHW) facility at the solid waste transfer station was also an option that was available.</p> | | | |

| View of waste aerosol can on the floor. | | | |

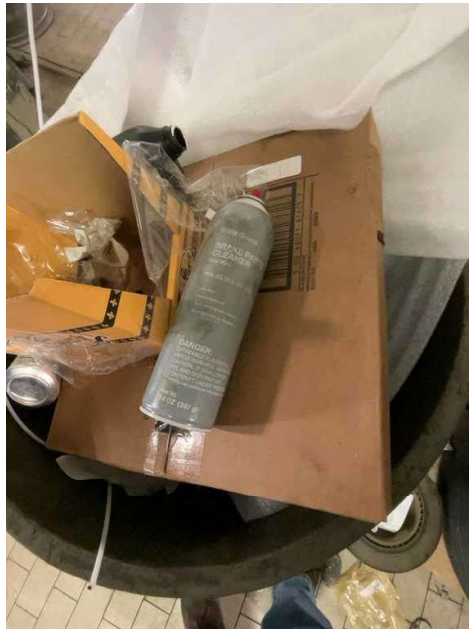
| [Title] | | | IMG-2024030809504750471261787.jpg |

| View of waste aerosol can that was found on the floor. | | | |

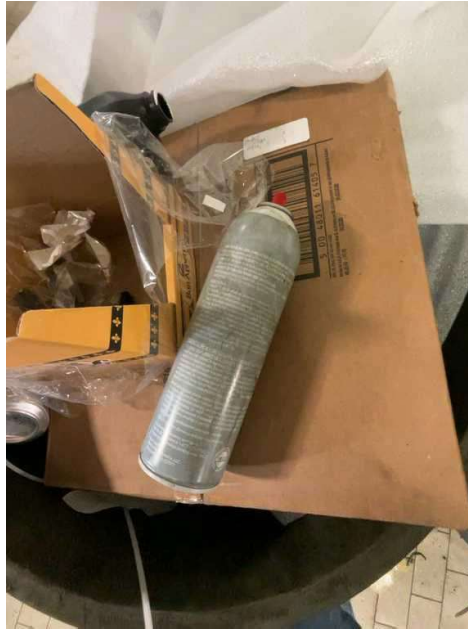
| [Title] | | | IMG-202403080951015111255152.jpg |

| Another view of the waste aerosol can that was found on the floor. | | | |

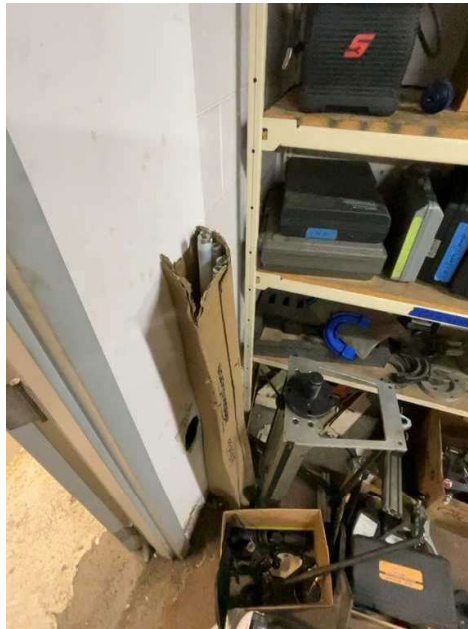
| [Title] | | | IMG-2024030810115011501336228.jpg |

| <p>While inspecting the Special Tool Room we saw a box that contained some four-foot fluorescent lamps. Upon closer inspection, we saw five of these lamps. I noticed that these lamps had darkened ends which are indicative of being waste lamps. I also saw that the lamps were marked with a manufacturer stamp on the end with green writing that is also indicative of an "Eco" lamp or low mercury lamp that will not fail TCLP for mercury.</p> <p>During the inspection, I explained to Mr. Billman that there were several ways that his facility could manage the lamps. I explained that he could manage the waste lamps as solid waste, but I encouraged him to manage the lamps through the local HHW facility at the solid waste transfer station.</p> | | | |

| View of four-foot waste fluorescent lamps in a box in the Special Tool Room. | | | |

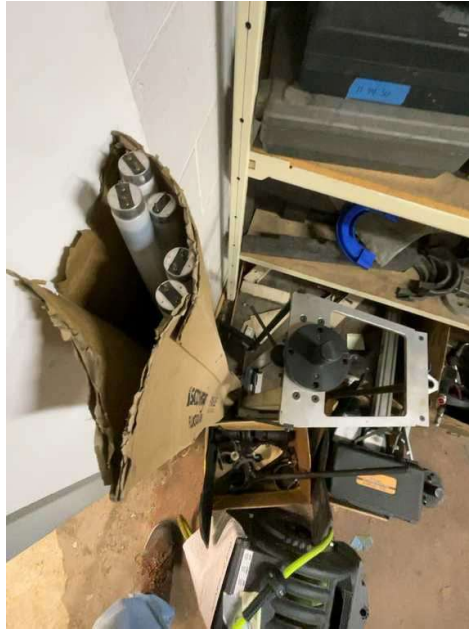
| [Title] | | | IMG-2024030810115711571306737.jpg |

| Close-up view of four-foot waste fluorescent lamps in a box in the Special Tool Room. | | | |

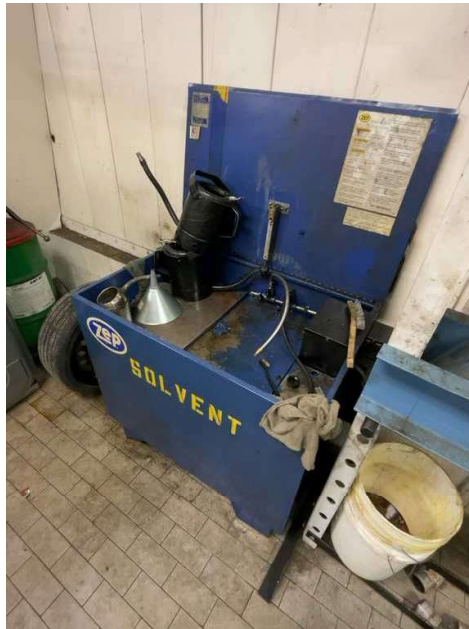
| [Title] | | | IMG-2024030810135613561317899.jpg |

| <p>During the inspection, we had questions about the facility's management of used oil, lead-acid batteries, and their parts washer.</p> <p>On 3/8/24 Mr. Billman followed up with an email and provided the requested information about his facility's parts washer and the solvent used. According to the information provided, the facility uses a high-flash (143°F) solvent. The information is included in the document log.</p> <p>On 3/27/24 Mr. Billman followed up with another email and provided the requested information for his facility's lead-acid batteries and used oil. The information is included in the document log.</p> | | | |

| View of the facility's solvent parts washer that uses a high flash (143°F) solvent. | | | |
