**UNITED STATES ENVIRONMENTAL PROTECTION AGENCY**  
**OFFICE OF ENFORCEMENT AND COMPLIANCE ASSURANCE**

**SUBJECT:** CLEAN AIR ACT INSPECTION REPORT  
Republic Services McCarty Road Landfill, Houston, TX

**Facility Name:** Republic Services McCarty Road Landfill

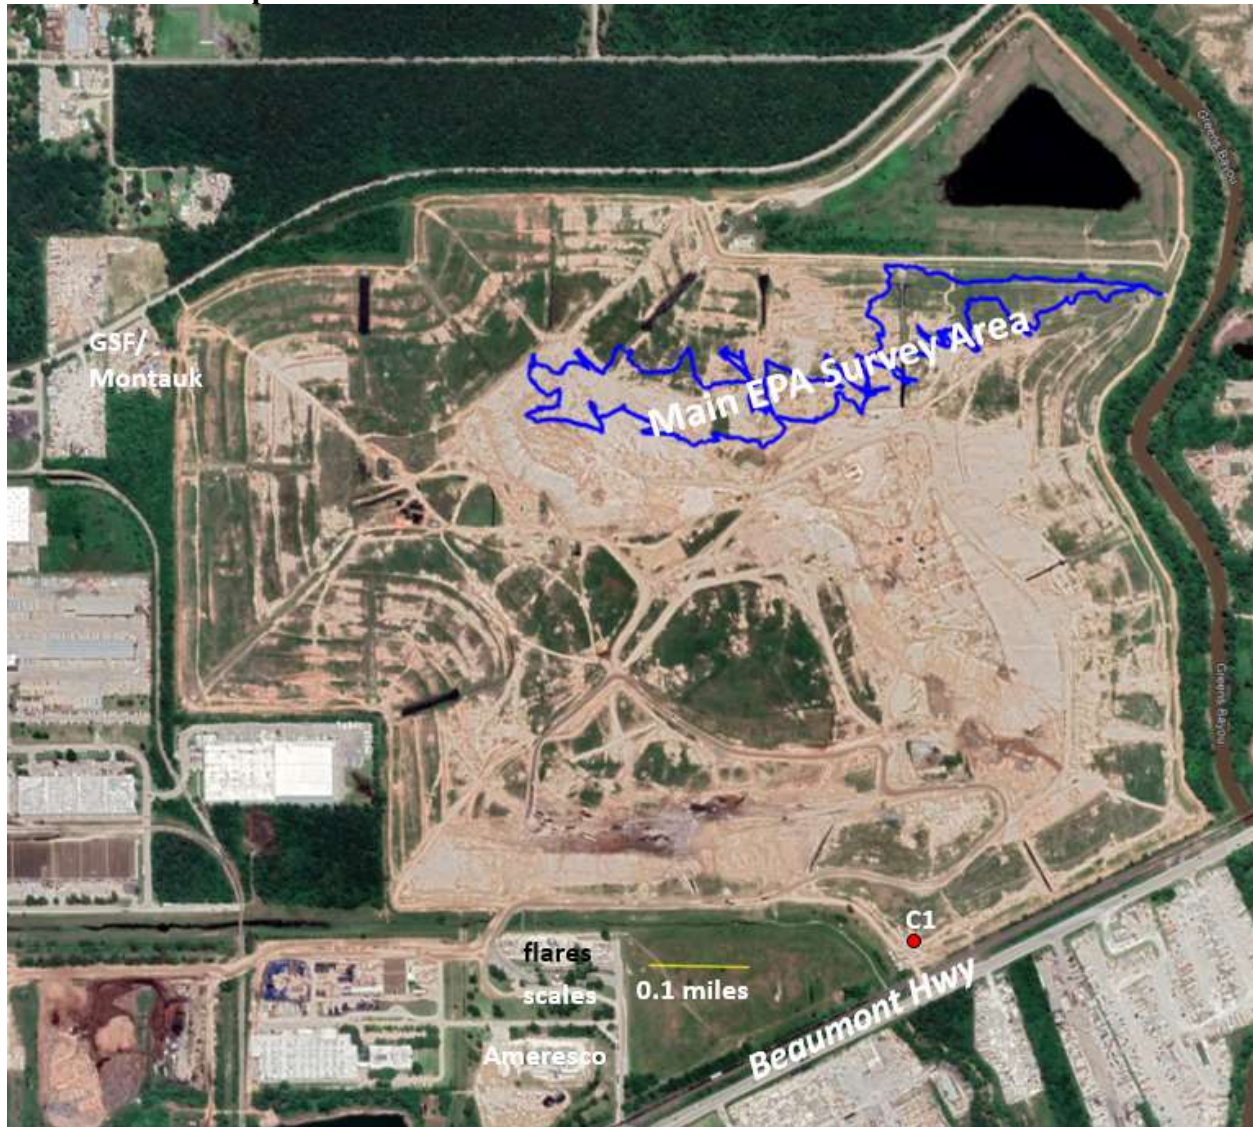
### Site Overview Map

EPA monitoring focused on part of the northern area of the Landfill, an area that had not seen any recent construction or waste deposition activity, covering an area of less than 40 acres. See Appendix C for maps. EPA inspectors identified 55 total points above 500 ppm methane. Only two points were not able to be confirmed.

While driving around the landfill to take upwind and downwind measurements, EPA noted an elevated area of methane. This was a widespread area of exceedance by ES-2, with exceedances at gaskets and from the base and top of nearby survey posts.

Blue line shows main EPA survey coverage, tracing the confirmation reading instrument. C1 marks the additional exceedance separately from main survey. Active area in central eastern portion of landfill at time of survey. Satellite imagery dated to April 2022 as shown on Google Earth.

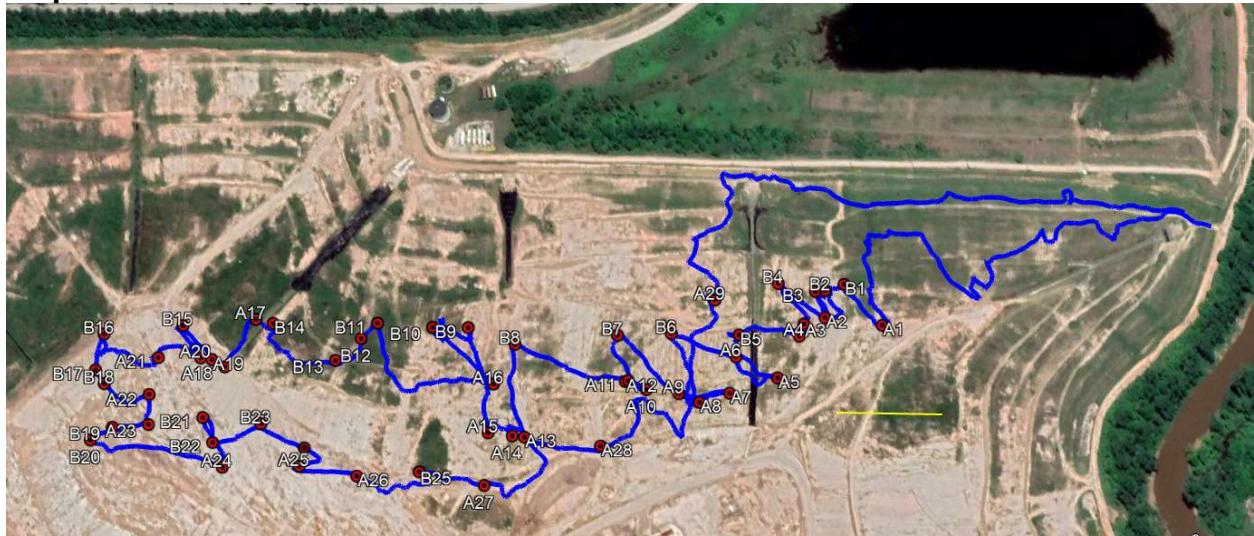
## Map of Detected Exceedances

In the main area of SEM survey on the northern portion of the Landfill, exceedances were found primarily at penetrations and areas of erosion/exposed waste.

- EPA noted the disparity between the number of exceedances they had found compared with the reviewed recent SEM surveys, indicating possible concerns with the quality of the SEM surveys
- EPA noted that erosion and exposed waste was seen across the survey area
- EPA noted that some of the pneumatic pump outlets were venting landfill gas (and condensate), and that the carbon cannisters being utilized did not effectively control the emissions

Blue line roughly shows EPA survey coverage, tracing the confirmation reading instrument. Exceedance locations labeled with their flag numbers. Yellow line is 100m, north is up. Satellite imagery dated to April 2022 as shown on Google Earth. Survey area covered less than 40 acres.
